AIRCRAFT ACCIDENT REPORT

NEW YORK AIRWAYS, INC.
SIKORSKY S61-L, N618PA
NEWARK, NEW JERSEY
APRIL 18, 1979

NTSB-AAR-79-14

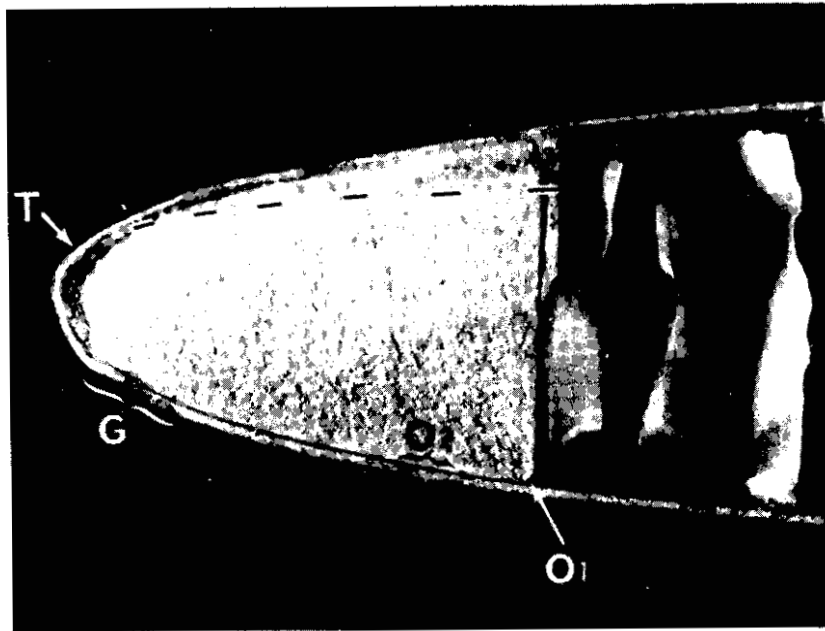
The fracture on the outboard portion of the blade was examined with the aid of a bench binocular microscope. Markings indicative of preexistent fatigue cracking were found in both the blade spar and skin. The cracking in the spar began at the outboard corner of the aft face of the spar. (See Figure 2) The fatigue extended through 90 percent of the spar cross-section before the spar failed.

Fatigue in the skin appeared to initiate from multiple origins in an area on the bonded, interior surface of the skin. Fatigue propagated away from the origin area in opposite directions toward both the leading and trailing edges. The skin fatigue crack extended around the leading edge out to the area indicated by the arrow T in Figure 2. The skin fatigue in the other direction extended to a point about 1 1/2 in. from the leading edge. The total length of the skin fatigue crack was less than 2 in.

An area of skin at the fracture had been gouged on the outboard face of the blade near the leading edge. The gouge was about 0.2 in. long. (See Figure 2) A portion of the bond material beneath the gouge had been squeezed out from between the skin and spar, indicating that the skin had been gouged after separation of the blade.

Figure 2. Fracture at the leading edge of the blade. Arrow "O1" indicates the fatigue origin in the spar and bracket "O2" the origin area in the skin. Arrow T indicates the terminus of the portion of the skin fatigue crack which propagated toward the leading edge. Bracket G indicates a gouge in the skin (X3 approximate).

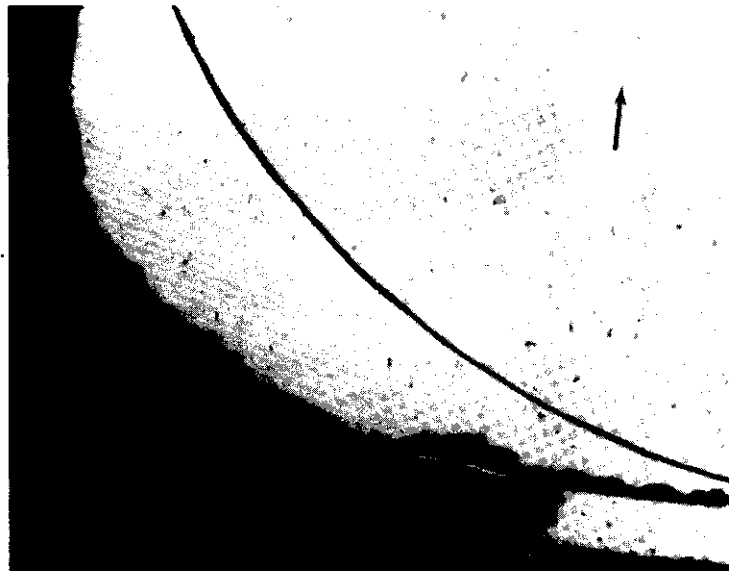
The radius of the corner of the spar near the origin was about 0.009 to 0.011 in. The radius could not be measured precisely because of the uneven surface of the spar. The engineering drawing for the spar specifies that the radius at this location must be between 0.025 in. and 0.050 in. (See Figure 4.)

Figure 4. Spar section adjacent to the fracture. Arc represents a 0.025 in. radius. Arrow points in the direction of the leading edge. (X200, as polished)

In order to determine if the radii on the aft surface of the spars on the remaining tail rotor blades met specifications, a section was cut from each of the blades at locations similar to the fracture location on the black blade. Only the outboard radius of the white blade spar appeared to be within the specified limits. The inboard radius on the leading edge spar on the white blade and both radii on the leading edge spars of the remaining three blades were irregular and below the 0.025 specified minimum radius.

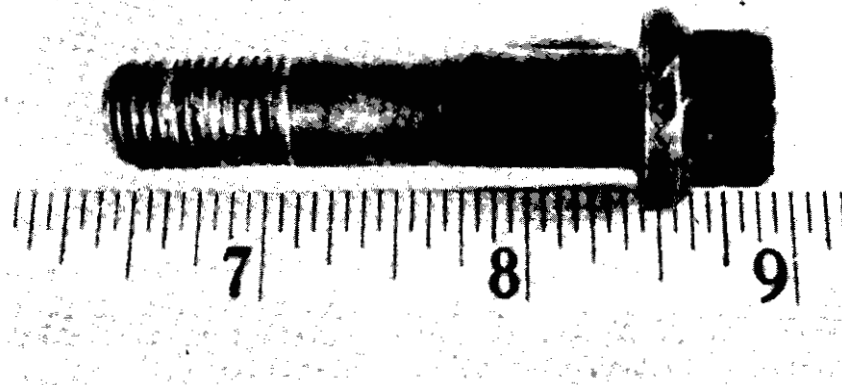
The bolt from the left aft flange position was bent slightly, and the threads were damaged extensively, particularly those threads closest to the bolt head. (See Figure 6.) Most of the thread appeared to have been damaged by transverse contact directly on the crowns of the threads, which resulted in widened crowns and compression bulging of the thread flanks. (See Figure 7.)

Figure 6. Left aft gearbox mounting bolt (lower left bolt in Figure 5). Note that this bolt in Figure 5 contains tape on the shank just below the head which was used to maintain identification.

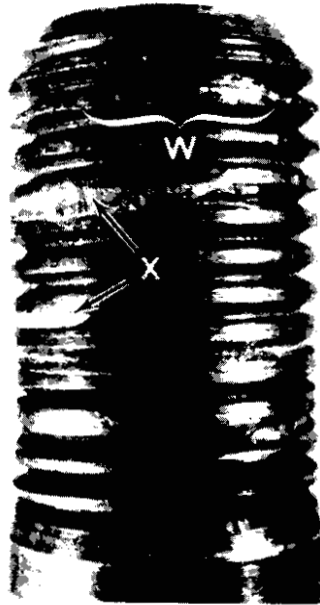
Two portions of one of the threads contained a different type of damage. The threads in these areas had been deformed in a direction away from the bolt head by heavy contact along the flank. One of these areas is indicated by bracket W in Figure 7. The second such area was on the same thread approximately 90° around the bolt.

Figure 7. Thread damage on the left aft bolt. "W" denotes area containing deformation. "X" denotes areas where metal deposits were found. (X4)

Foreign metal deposits were found in some areas between the threads. (See Arrow X Figure 7.) This material was rich in aluminum rather than iron, the bolt material. This indicated that the source of the foreign material was probably the aluminum gearbox mounting plate. About 225% of the thread root circumference closest to the bolt shank also contained shallow cracks.

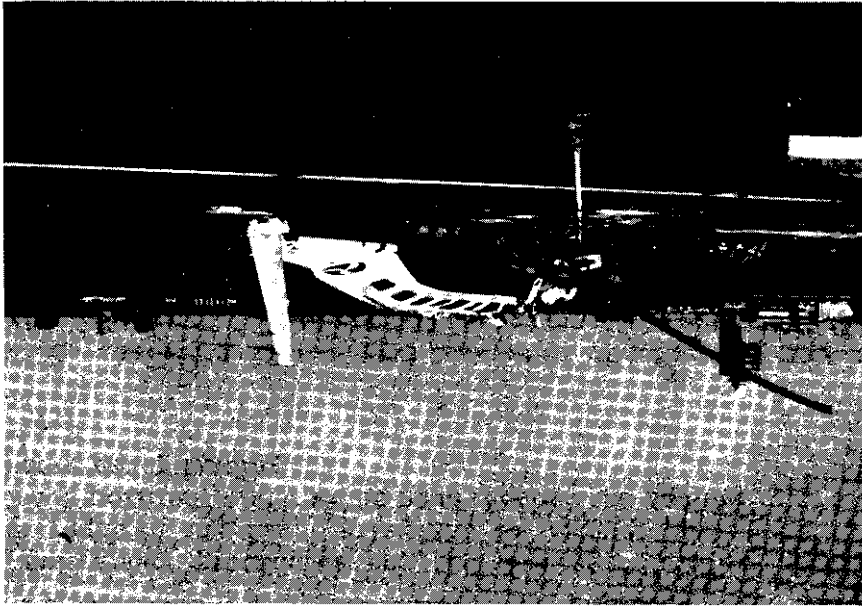
Figure 10. Views of structural damage.

The bottom of the fuselage from the nose aft to fuselage station (FS) 391 was crushed upward about 9 in. to waterline (WL) 70. Both main landing gears had separated aft and upward. The tail cone fuselage structure from FS 493 aft was relatively undamaged. The engine cowlings, engines, transmission fairings, and transmissions were not damaged.

The accident was survivable. The cabin area near rows 3 and 4 was damaged most severely; the floor and sidewalls were distorted. Only three of the occupied passenger seats remained intact and all of those seats showed some degree of distortion. All of the remaining occupied seats were either totally or partially separated from the sidewall attach points and legs. Typical failures involved the separation of the tubing from the seat frame support structure. The failures were usually located adjacent to the point at which the seat leg attachment bracket was welded to the seat frame support tubes. The failures were usually accompanied by the separation of one or both fuselage sidewall attachment points.

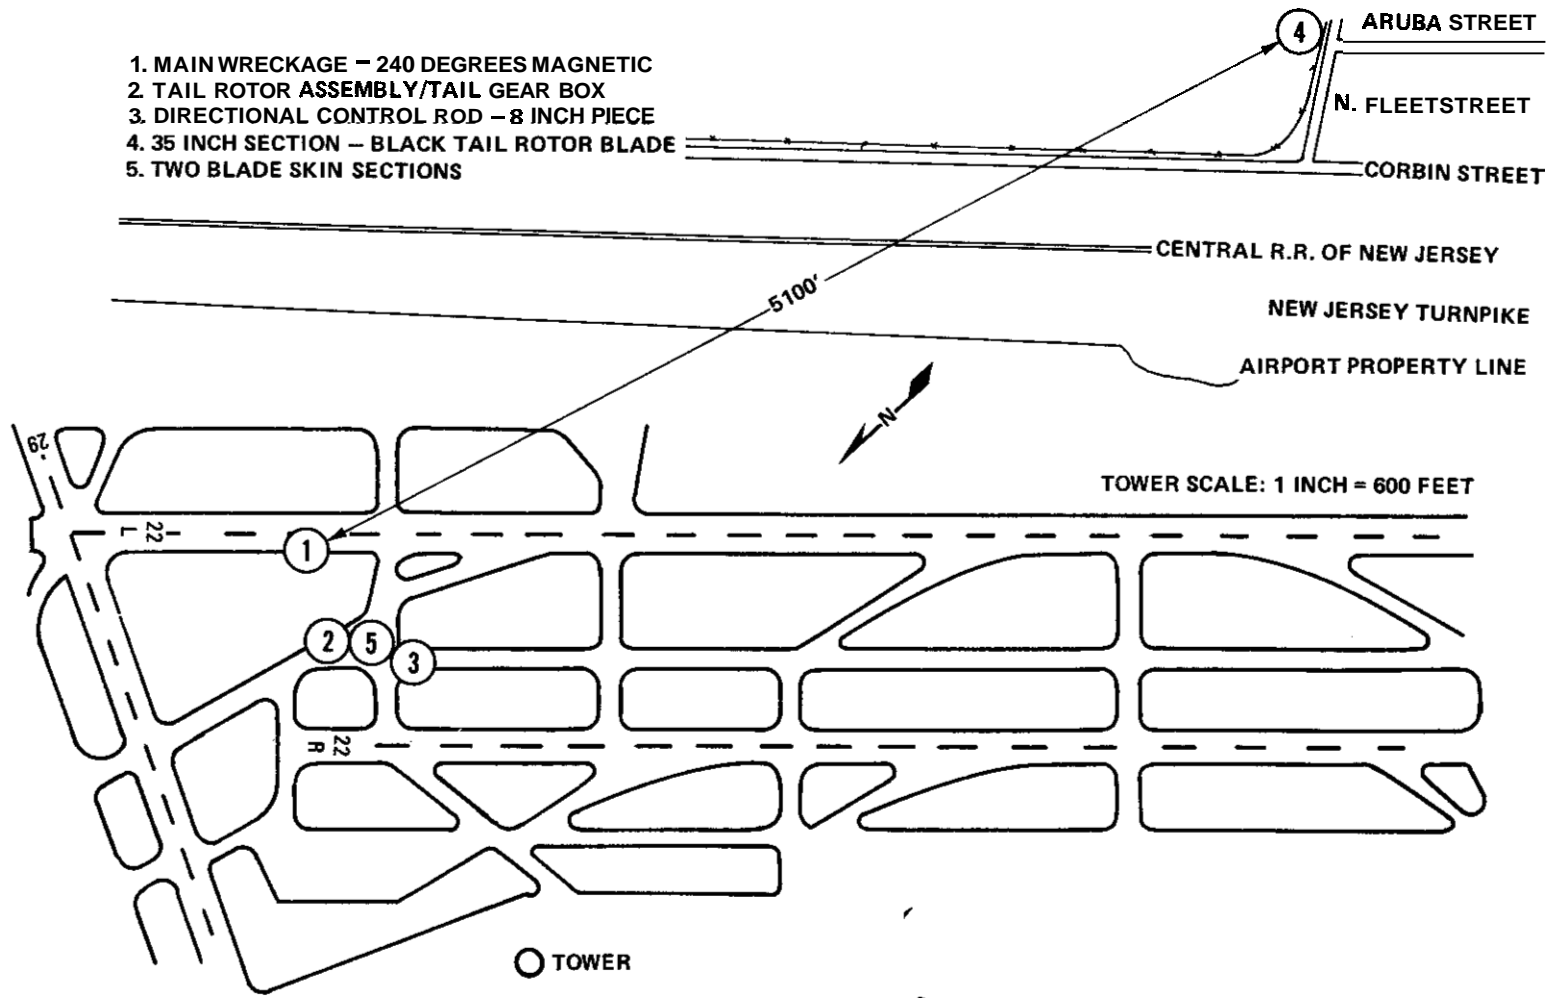
WRECKAGE DISTRIBUTION CHART

The tail rotor gearbox and the attached tail rotor assembly were found about 410 ft west of the main wreckage; an 8-in. section of the tail rotor control rod was found 650 ft west of the main wreckage; two blade skin sections were found about 500 ft west of the main wreckage; and a 35-in. outboard section of one of the tail rotor blades was found 5,100 ft south of the main wreckage site. All other major components were found at the main wreckage site.

- 1. MAIN WRECKAGE - 240 DEGREES MAGNETIC
- 2. TAIL ROTOR ASSEMBLY/TAIL GEAR BOX
- 3. DIRECTIONAL CONTROL ROD - 8 INCH PIECE
- 4. 35 INCH SECTION - BLACK TAIL ROTOR BLADE
- 5. TWO BLADE SKIN SECTIONS
