UNITED STATES AIR FORCE
AIRCRAFT ACCIDENT INVESTIGATION
BOARD REPORT

KC-135R, T/N 63-8877

DATE OF ACCIDENT: 3 MAY 2013

SUMMARY OF FACTS AND STATEMENT OF OPINION
KC-135R, T/N 63-8877
3 MAY 2013

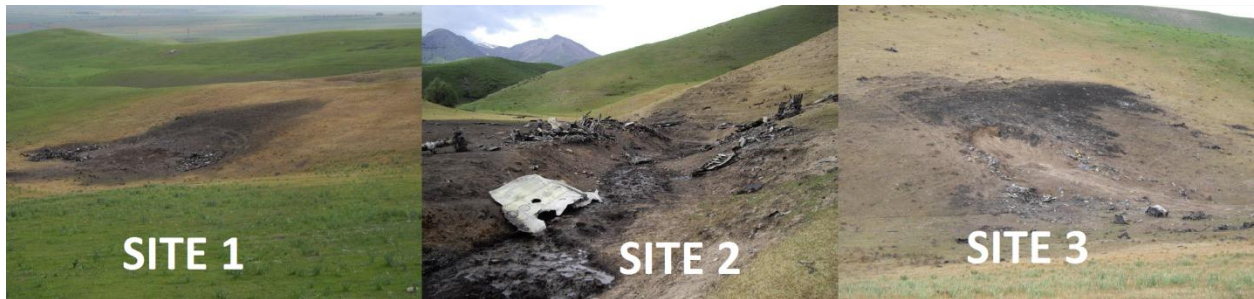
Figure 1. Impact Craters (Tab FF-7 to FF-8, FF-11)

On 3 May 2013, at approximately 1448 hours local time (L), the mishap aircraft (MA), a KC-135R, tail number 63-8877, assigned to the 22d Expeditionary Air Refueling Squadron (22 EARS), 376th Air Expeditionary Wing (376 AEW), Transit Center at Manas, Kyrgyz Republic, crashed approximately 6 miles south of Chaldovar, Kyrgyz Republic (Tabs K-4, Q-5, Q-7). The mishap crew (MC), which consisted of the mishap pilot (MP), the mishap co-pilot (MCP), and the mishap boom operator (MBO), perished during the accident (Tab Q5 to Q-6). Following the loss of its tail section, the MA exploded inflight and further separated into three main sections, impacted the earth, and burned (Tabs J-28 V-24.2, V-25.2). The three impact points were craters in hilly terrain used for grazing livestock (See Figure 1) (Tab FF-5). Approximately 228 cubic meters of soil were contaminated with jet fuel and each crater contained a pattern of burned grass and trees about 35 meters diameter on average (Tab FF-6 to

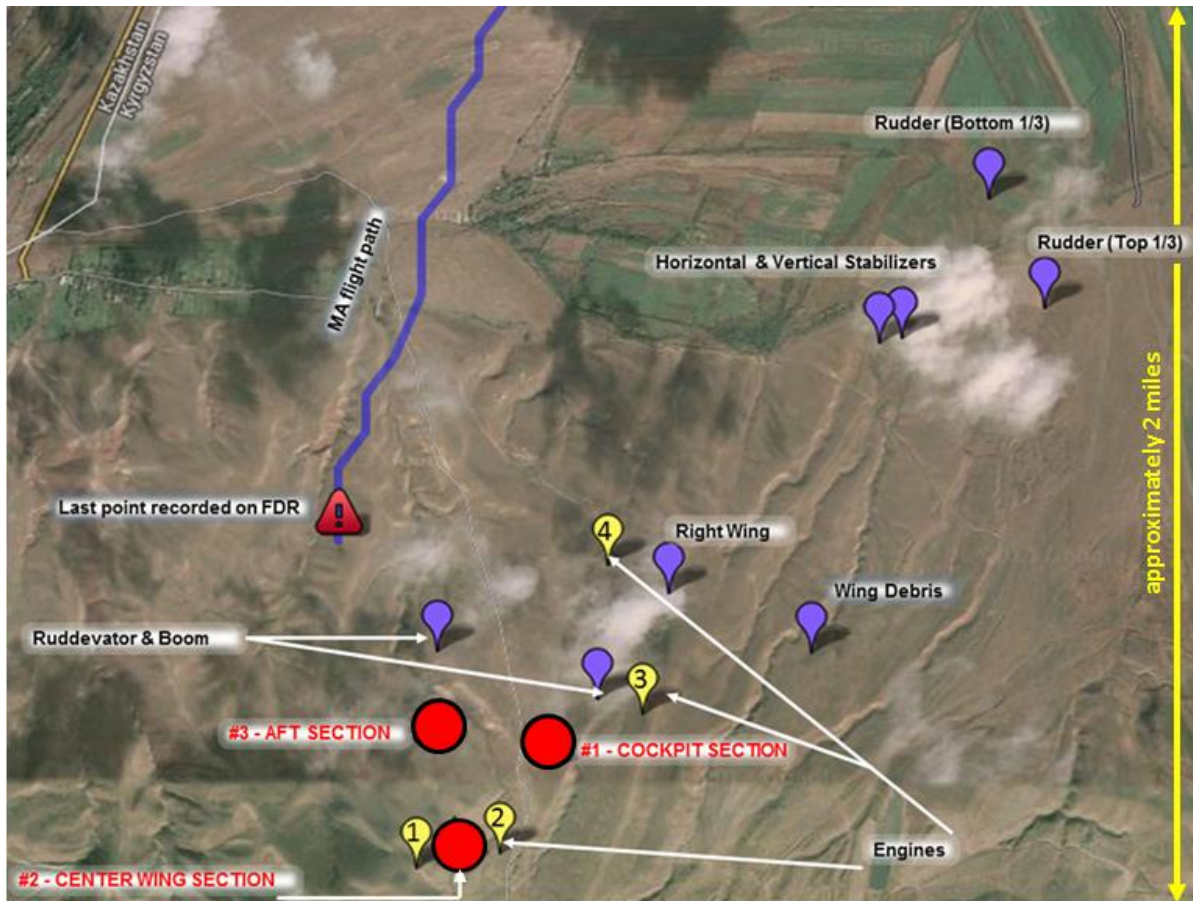
Figure 5. Plot of MA Wreckage (Tab Z-4)

The MA impacted the terrain at 1448L (0848Z) about 6 miles south of Chaldovar, Kyrgyz Republic (Tabs Q-5, GG-3). In addition to the three main sections mentioned above, the right wing and all four engines fell separately. The rudder, vertical stabilizer, and horizontal stabilizer separated from the MA prior to the explosion (Tab J-28). These relatively lighter aircraft parts were carried by the wind about 1.5 miles northeast of the main crash site (See Figure 5) (Tabs F-19, Z-4 to Z-5). The MA’s configuration before breakup was flaps and landing gear up (Tab N-8 to N-9).

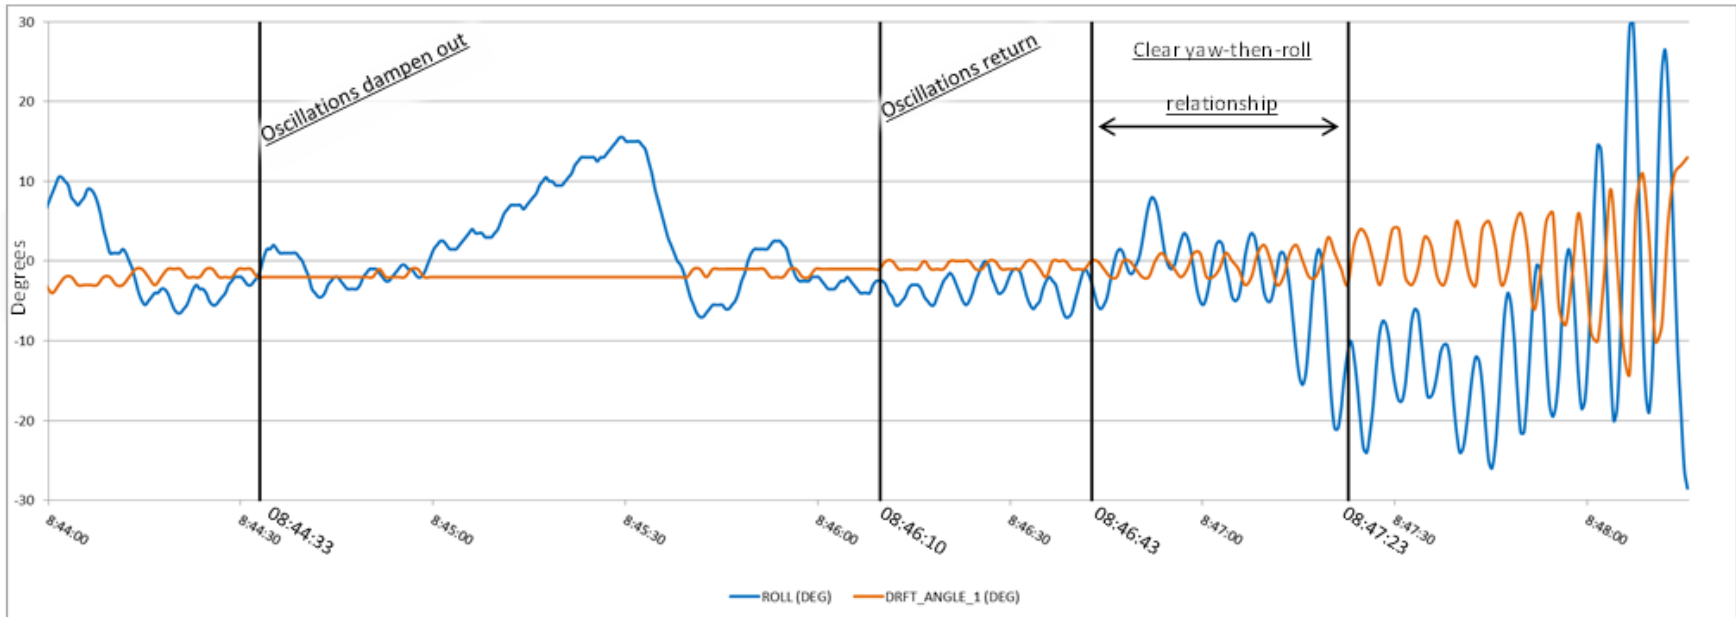
Figure 6. Onset of Dutch Roll of the MA (Tab EE-8)

In Figure 6 below, the blue plot is the MA's roll and the orange plot is the MA's drift angle, or yaw. Positive values indicate rolling/yawing to the right and negative values indicate rolling/yawing to the left (Tab EE-4, EE-8). Beginning with takeoff at 08:37:23Z, the MA experienced a series of uncommanded yaw movements that caused the nose of the MA to oscillate left and right (Tab EE-5, EE-8, EE-10). At around 08:44:33Z, the oscillations dampened out almost entirely, characterized by the flat segment of the orange line in Figure 6 (Tab EE-8). At approximately 08:46:10Z, the MA resumed the oscillations (Tab EE-5, EE-8). The period between 08:46:43Z and 08:47:23Z depicts a clear yawing-then-rolling relationship that is symptomatic of dutch roll (Tabs AA-27, EE-8). Each "peak" of roll occurs about two seconds after each peak of yaw. In this 40-second time frame, eight peaks equate to a period of about five seconds (Tab EE-8).

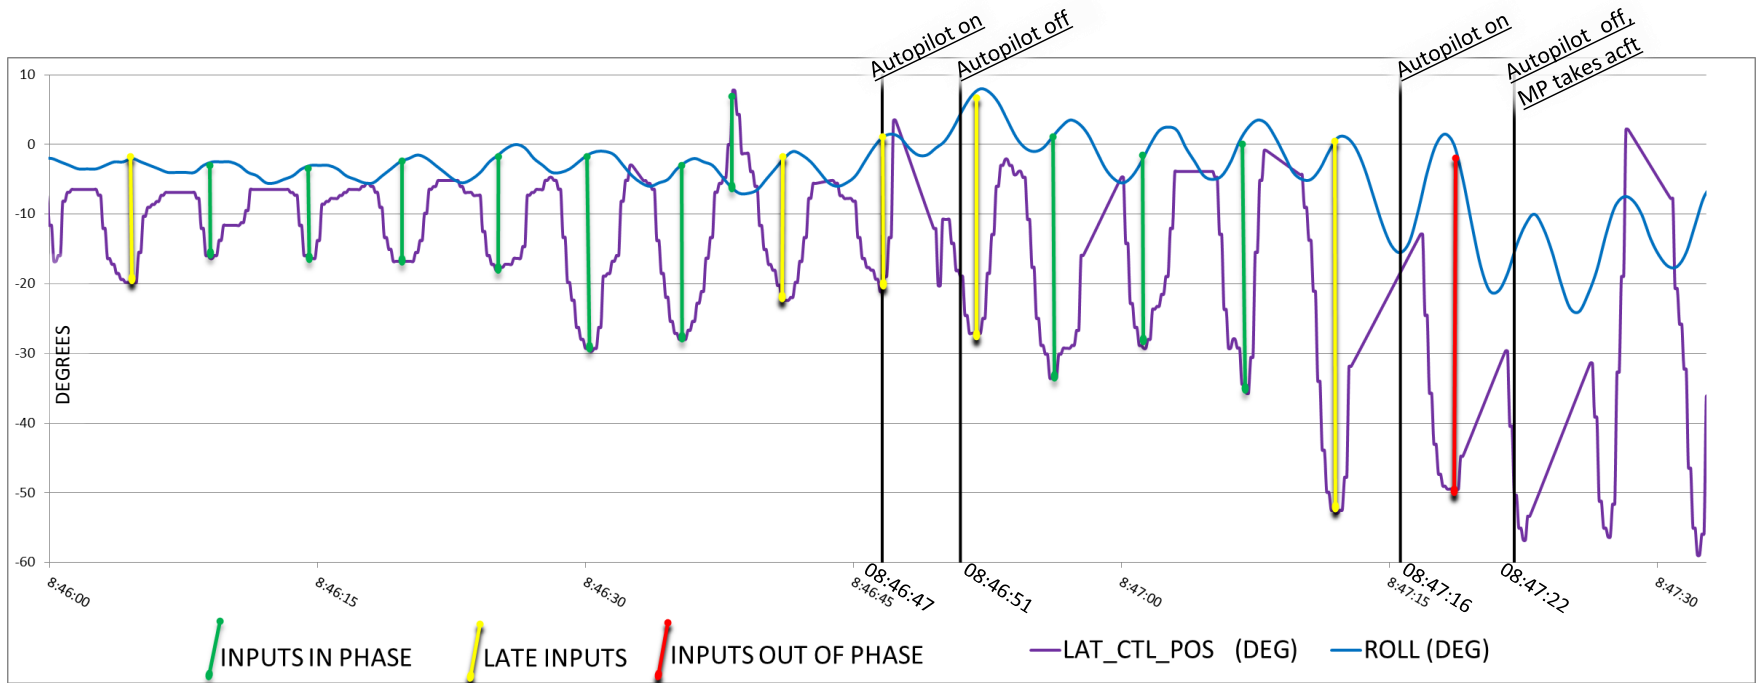
Figure 9. Lateral Inputs Made by MCP & Autopilot (Tab EE-9)

The FDR plot of the MCP's inputs is shown below in Figure 9. The yoke inputs of lateral, control, and position (LAT_CTL_POS) are mostly in-phase between 08:46:00Z and 08:47:22Z, except when the autopilot is engaged. Negative values are left yoke movements, and positive values are right yoke movements (Tab EE-4). When the MCP initially engages the autopilot, it makes two late lateral control inputs. The second time the autopilot is engaged it makes one large out-of-phase input before being disengaged by the MP (Tab EE-9).

Most of the lateral control inputs accomplished by the MCP resemble the example in Figure 8 regarding the in-phase properly timed inputs. As a trend, the roll oscillations of the MA did not get larger with in-phase inputs. The amplitudes of the inputs appear to be greater than that of the roll. When engaged, the autopilot applied late corrections and in turn generated a larger, steeper roll in the opposite direction (Tab EE-9). Once the MP takes control of the MA, the lateral control inputs can no longer be reliably measured due to the FDR constraints and rudder input (Tab EE-4 to EE-5, EE-9).

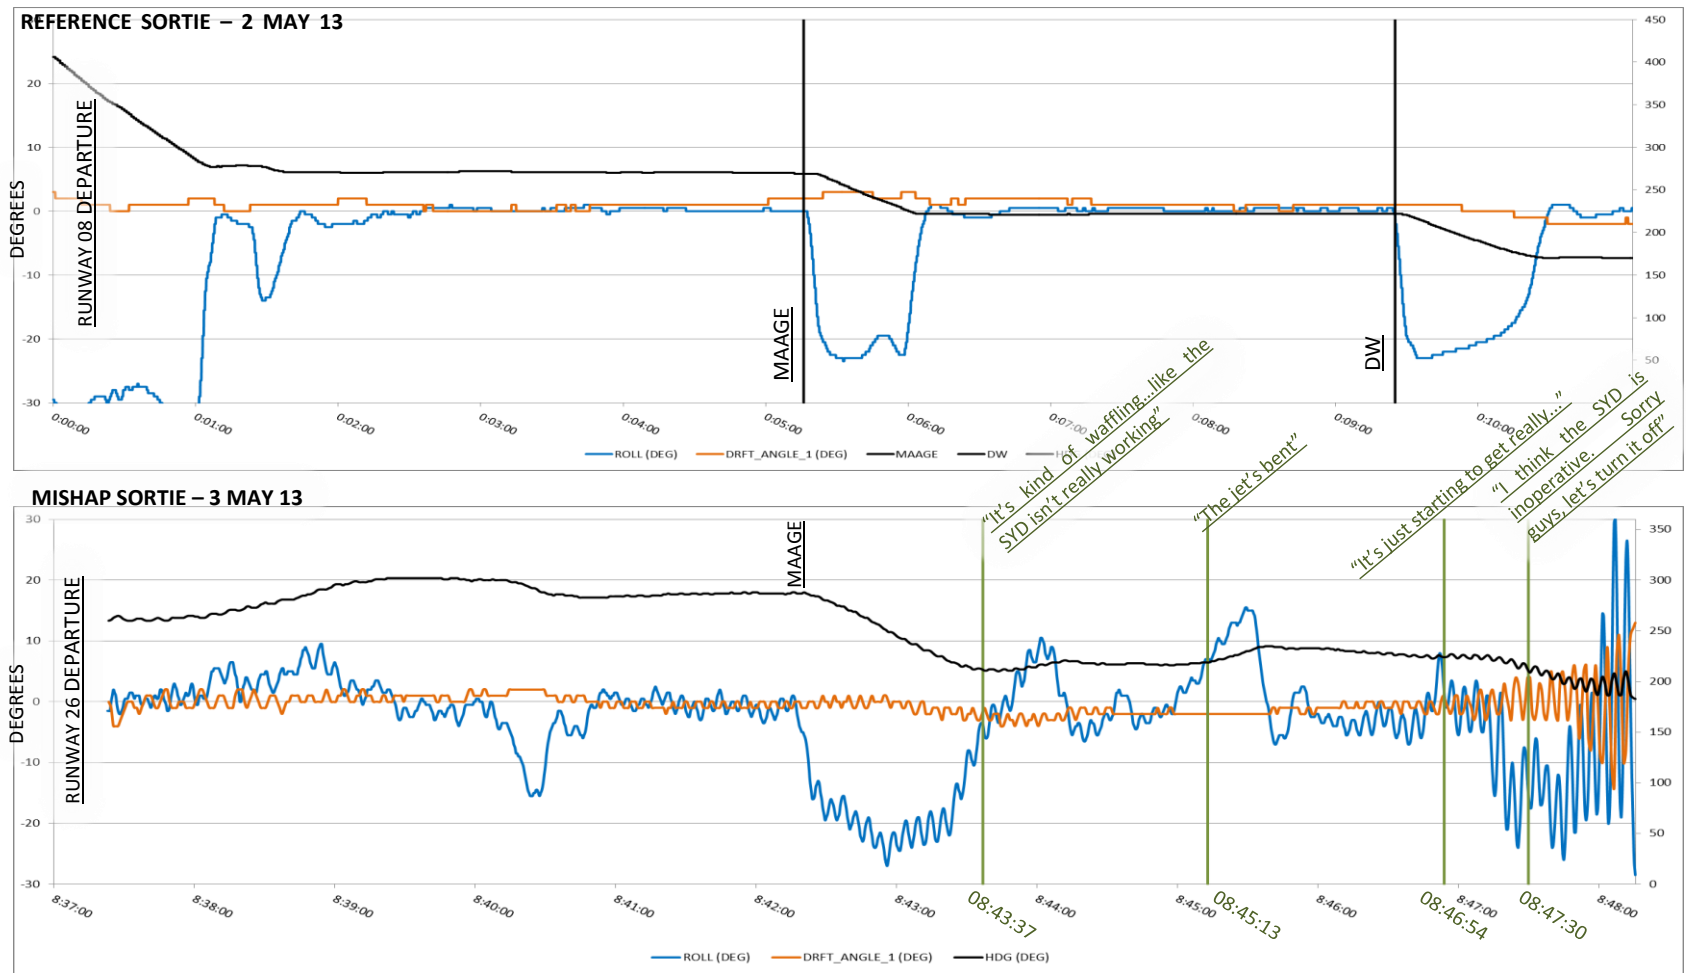
Figure 10. Comparison of Reference Sortie vs. Mishap Sortie on MAAGE Departure (Tab EE-10)

Figure 10 below depicts the yaw oscillations of the MA compared to another KC-135R flying a similar route of flight with all systems operating normally (Tab EE-5 to EE-6, EE-10).

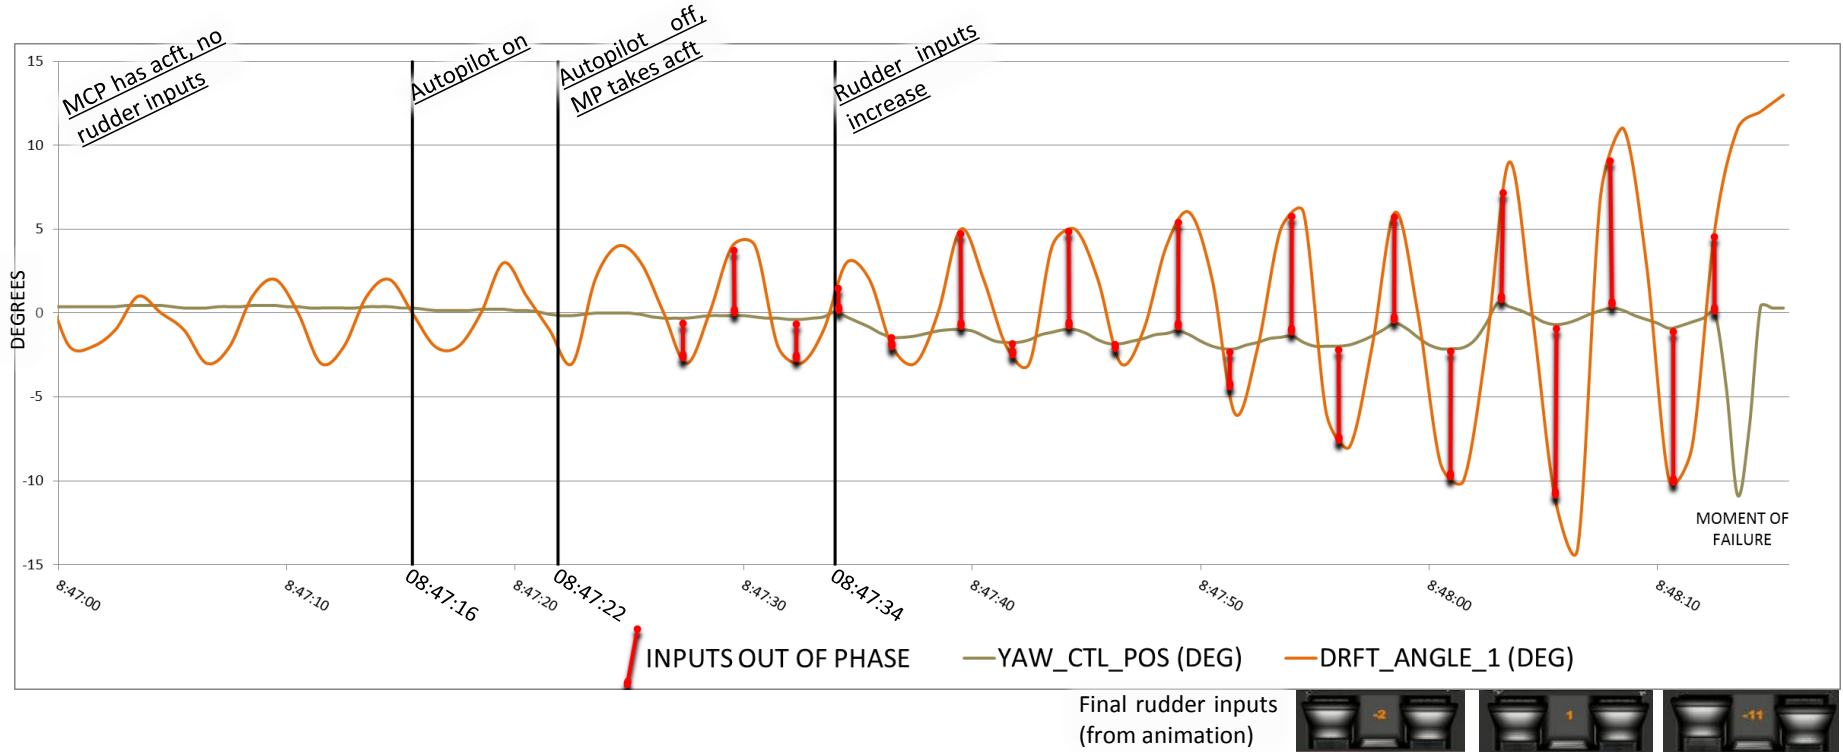
Figure 11. FDR Plot of MP's Rudder Input vs. Sideslip (Tabs Z-7, EE-11)

The sideslip oscillations of the MA represent rudder inputs (some abrupt) and a progressively increasing sideslip. Due to the timing of the input, each peak rudder input (depicted as red bars in Figure 11) occurs in the same direction as the sideslip as depicted in Figure 11. Instead of decreasing the sideslip, the MP's inputs compounded it. At 08:48:14Z, the final rudder input of 11 degrees coincides with the final FDR and cockpit voice recorder (CVR) data indicating failure of the MA's tail section. One second later the MA pitches over at 08:48:15Z (Tab EE-3, EE-11, EE-18).

The MP's rudder response in Figure 11 is analogous to the expected response shown in red in Figure 12. The rudder input is nearly zero between 08:47:00Z and 08:47:34Z, and the sideslip oscillates steadily around plus or minus three degrees. From 08:47:34Z until the end of the flight, rudder inputs correspond with increasing sideslip on each cycle. Figure 12 below depicts the same divergent sideslip tendency when rudder input is applied two seconds late (Tabs AA-28, EE-11). The amplitudes of the building sideslip are indicative of undesirable rudder inputs, as shown below in Figure 12 (Tab AA-28).

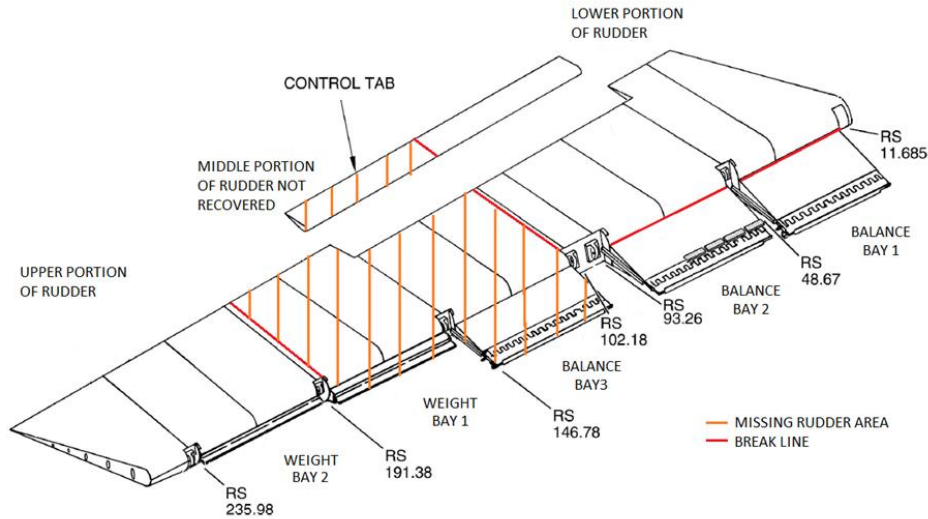
Figure 13. Rudder Shown Laying Flat with Balance Panels and Control Tab (Tab Z-9)

The rudder separated from the MA and landed separately from the vertical and horizontal stabilizers (Tab J-15). It was broken into multiple pieces. The bottom, middle, and top pieces of the rudder failed at the riveted splice joints shown by the red the break lines in Figure 13 (Tab J-88). The middle section of the rudder was not recovered (Tab J-15).

All seven of the vertical stabilizer-rudder hinge assemblies (fittings, bolts and nut plates), located at the Rudder Stations (RS) shown in Figure 13, failed at either the vertical stabilizer or the rudder side of the assembly (Tab J-87).

Examination of the failed rudder hinge parts and hardware revealed only evidence of overload, indicating failure above the design ultimate loads (Tab J-17, J-29). No evidence of preexisting failures such as fatigue or stress-corrosion was found (Tab J-88). Analysis was unable to provide a specific load case based on FDR data at which the observed failures would be expected to occur (Tab DD-12).

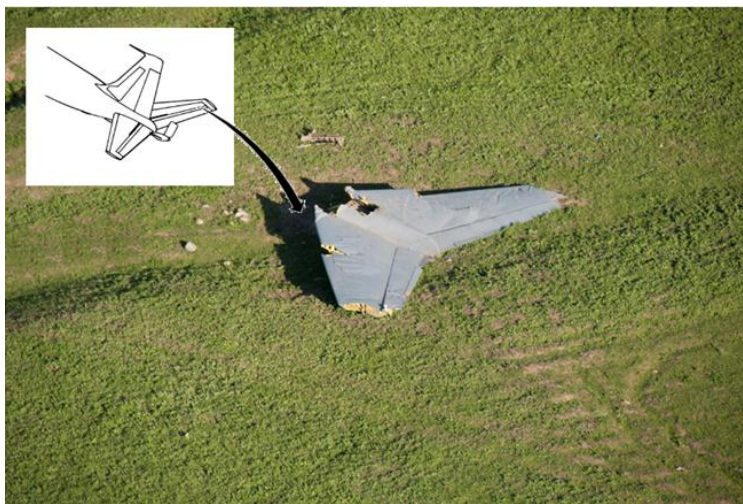
Figure 15. Horizontal Stabilizer Sections and Portion of Aft Fuselage (Tab Z-8)

The horizontal stabilizers (left hand, right hand and center sections) departed the MA intact along with their respective elevators (Tab J-20). There was no apparent damage to the stabilizer attachment points (Tab J-20). Symmetric outboard “V” shaped skin buckling and tears were present in the left and right horizontal stabilizers upper skins due to ground impact (See Figure 15) (Tab J-20, J-86).

All spar, rib, and skin fractures of the horizontal stabilizers and elevators were typical of overload with no evidence of pre-existing failures such as fatigue or stress-corrosion (Tab J-86).

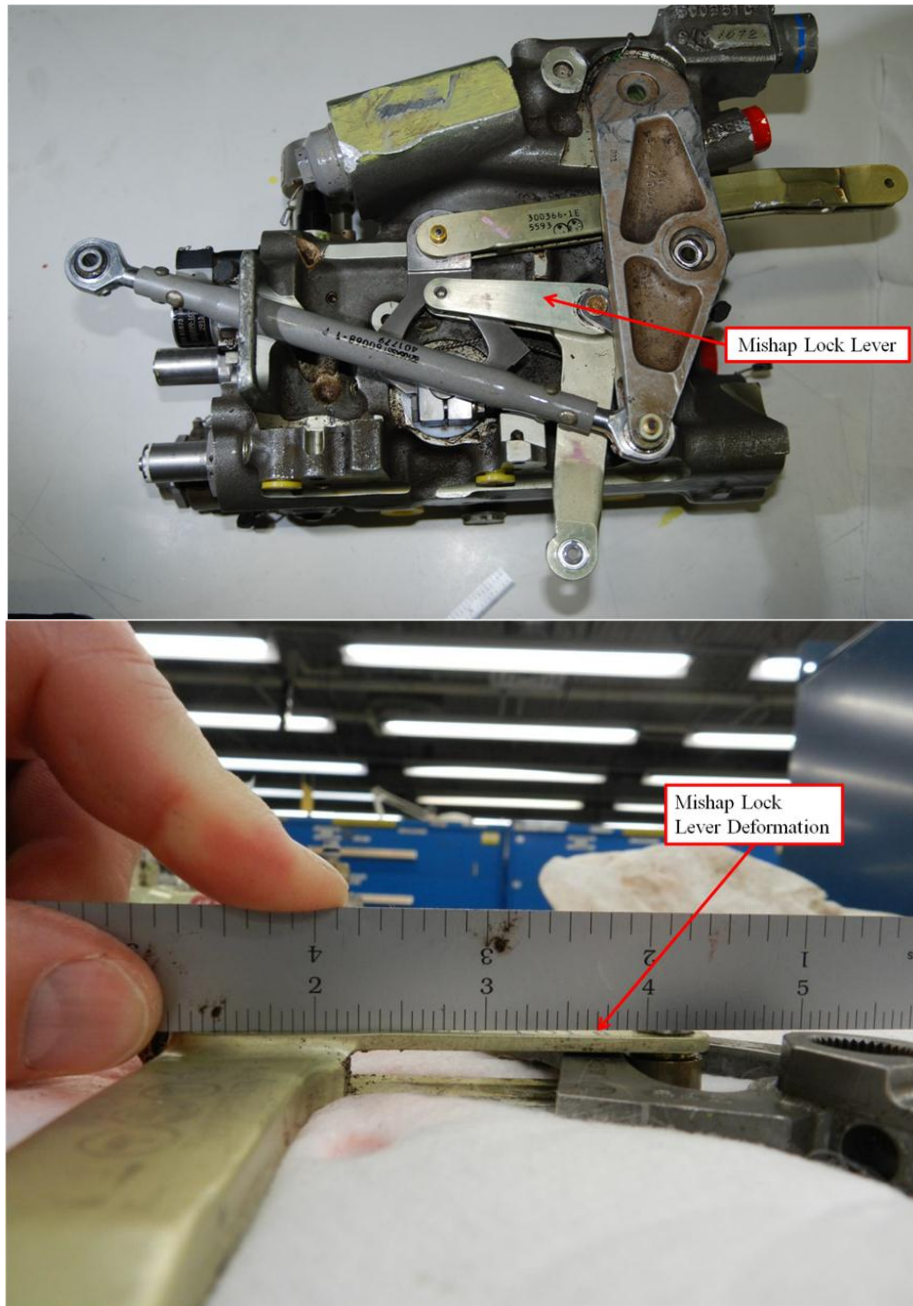
Figure 19. Mishap PCU with Bent Lock Lever (Tab Z-12)

The PCU main actuator shaft was broken in the vertical plane after the rudder hinges overloaded and subsequently failed (Tab J-35 to J-36). Failure of PCU linkages also occurred including a broken tablock H-assembly (Tab J-125). The outer fork of the main clevis of the lock lever was bent toward the actuator at the bearing rivet (See Figure 19) (Tab DD-12).

Due to the severe nature of the mishap, it is not possible to know if the damage to the lock lever occurred during flight or as a result of the mishap. However, the contact marks on the lock lever roller would indicate that the lock lever could have been bent and rubbing on the input arm cam during flight (Tab DD-12 to DD-13).
