NUCLEAR SAFETY, SECURITY AND SAFEGUARDS IN UKRAINE

2nd Summary Report by the Director General

28 April – 5 September 2022

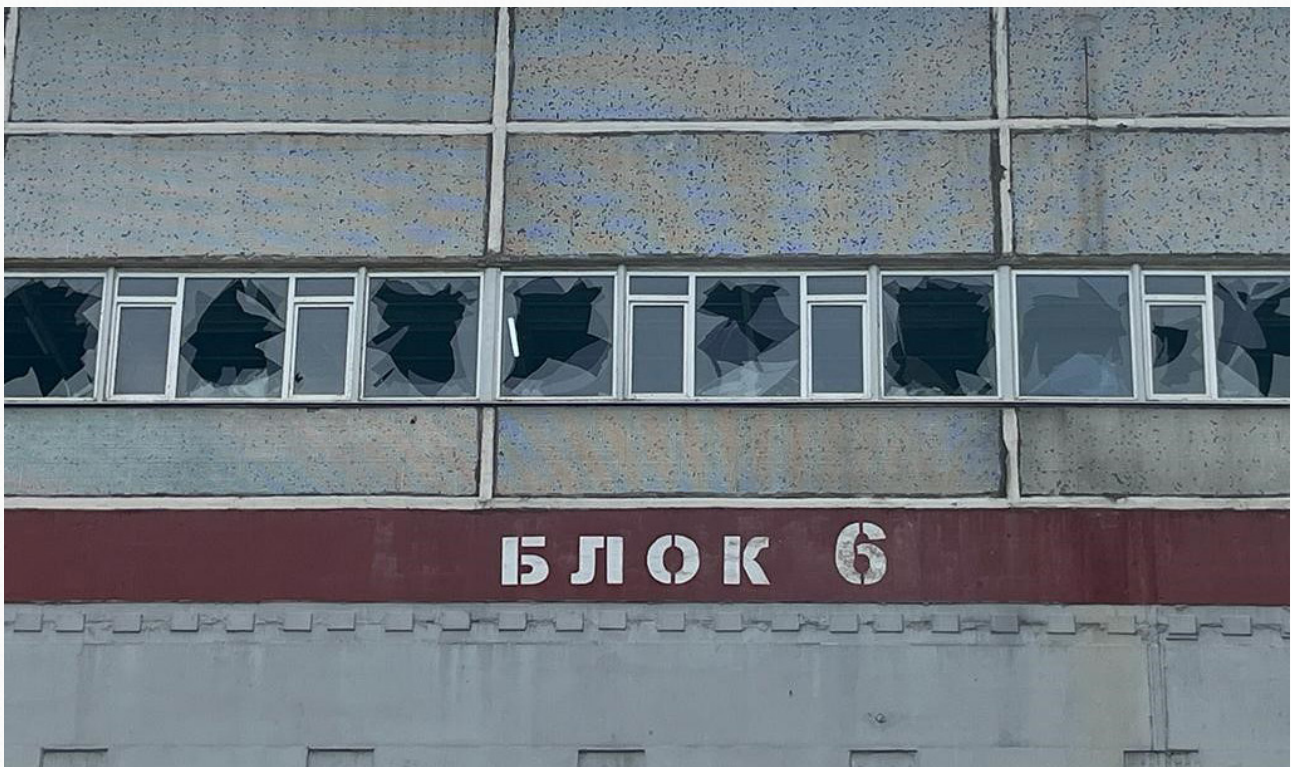
31. The ISAMZ reported first hand observations of damage to the road surface, walls and windows of various buildings, as well as at the overpass connecting the reactor units at the ZNPP.

Damage caused by shelling to the elevated passage of Unit 6. (Photo: IAEA)

Recommendation 1: The IAEA recommends that shelling on site and in its vicinity should be stopped immediately to avoid any further damages to the plant and associated facilities, for the safety of the operating staff and to maintain the physical integrity to support safe and secure operation. This requires agreement by all relevant parties to the establishment of a nuclear safety and security protection zone around the ZNPP.

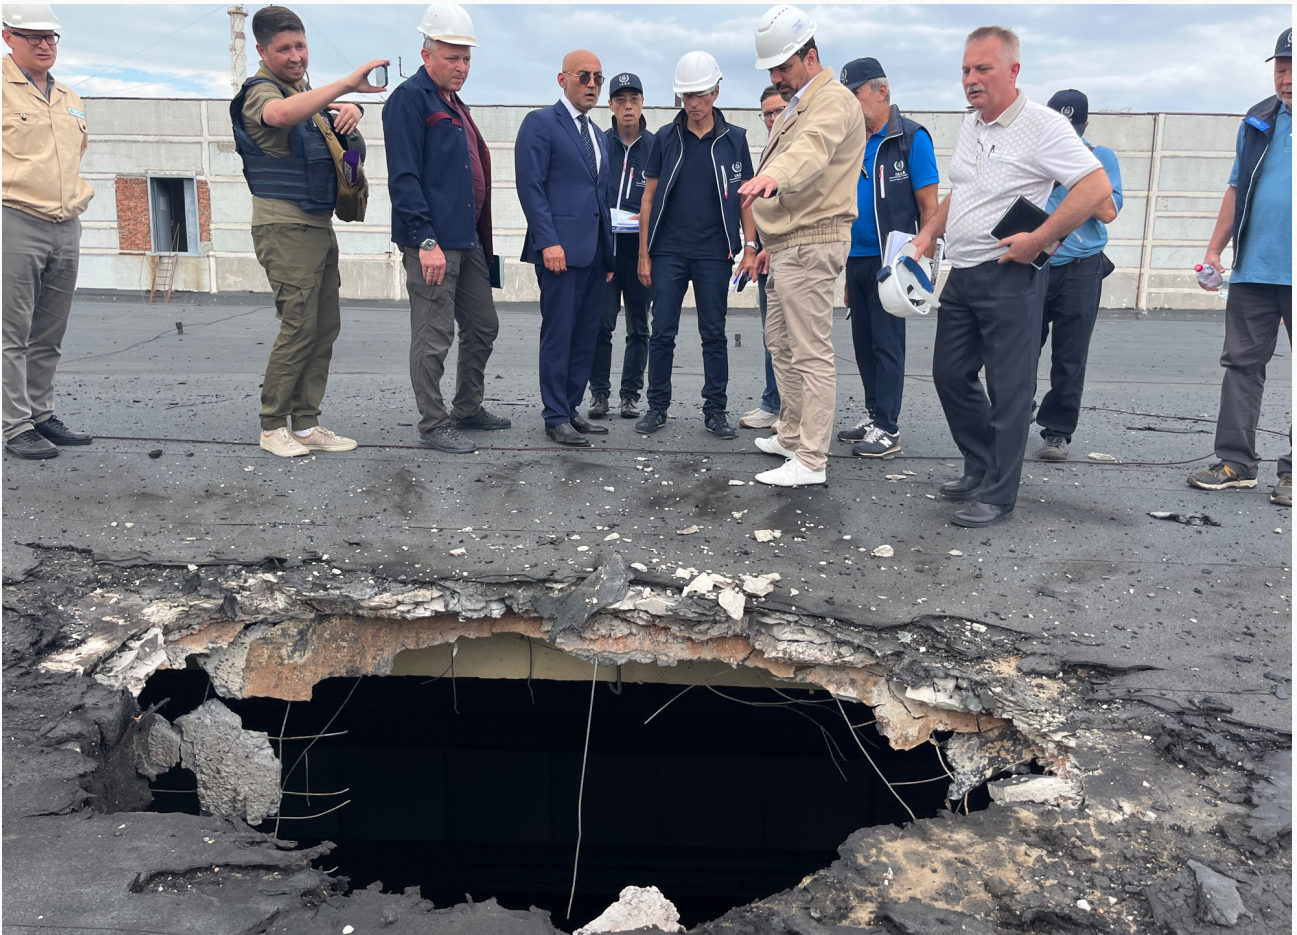
The IAEA team observes the damage caused by shelling on the roof of the special building at the ZNPP that houses, among other items, the fresh nuclear fuel and the solid radioactive waste storage facility. (Photo: IAEA)
