LONG TERM PERFORMANCE AND DURABILITY OF EPS AS A LIGHTWEIGHT FILLING MATERIAL

Tor Erik Frydenlund¹ and Roald Aabøe²

ABSTRACT

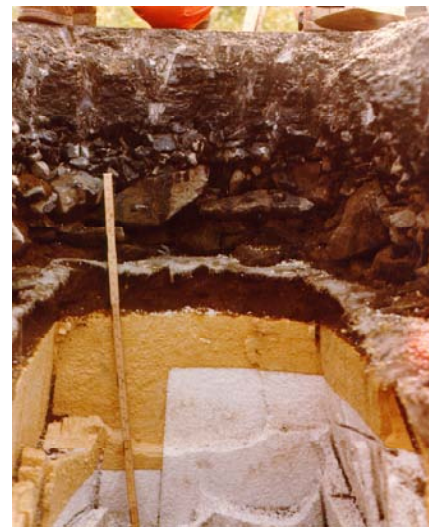
Figure 2. Excavation of the first EPS embankment at Flom bridge

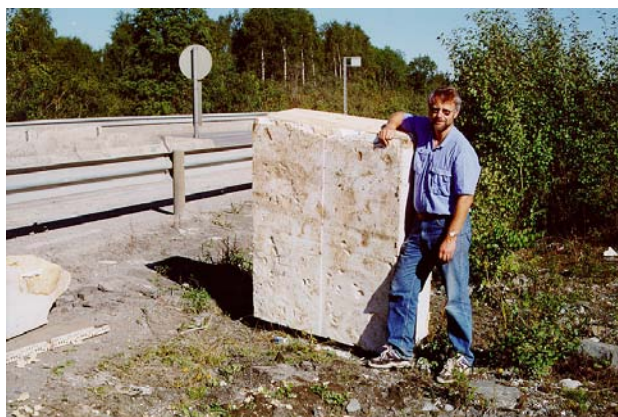
Figure 3. Excavation of a 24 years old EPS block from the first EPS embankment at Flom bridge

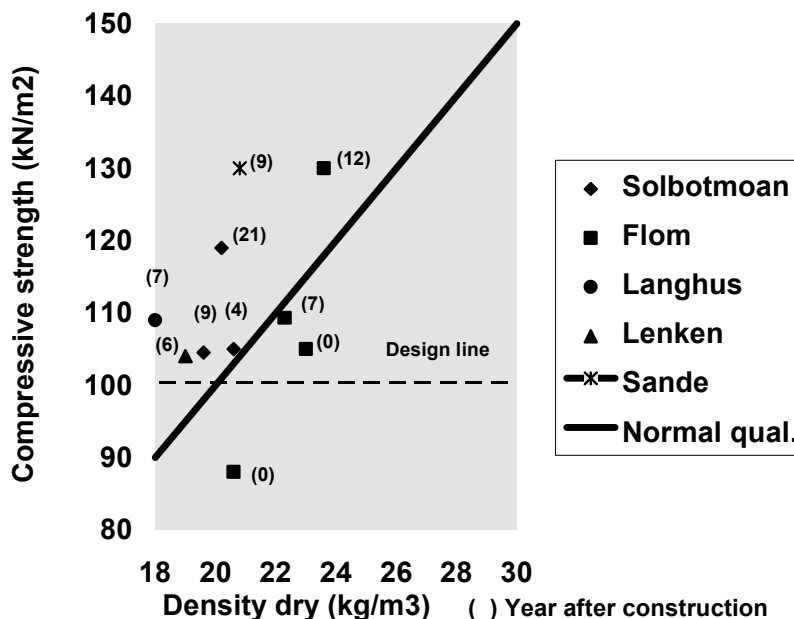
From figure 4 it may also be observed that the majority of tests show values of compressive strength in relation to unit density above that of a normal quality material. Although it is of course impossible to make exact comparisons between material strength at the time of construction and some time afterwards since tests cannot be performed on the same specimen twice, the results indicate clearly that there are no signs of material deterioration over the total time span of 24 years. If a change tendency is to be noted, this would go towards a

Figure 4. Compressive strength on retrieved samples from EPS fills

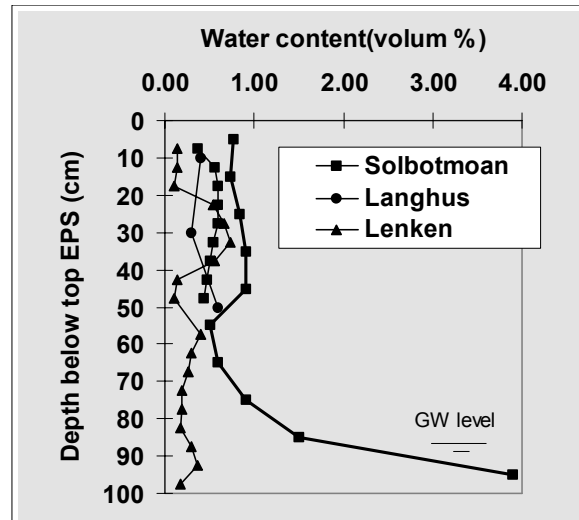
Tests performed on samples retrieved from three EPS fills placed in a drained position, i.e. blocks are located above the highest groundwater or flood level, all show water contents below 1 % by volume after more than 20 years in the ground (fig. 5).

Figure 5. Typical drained situation from 3 EPS fills

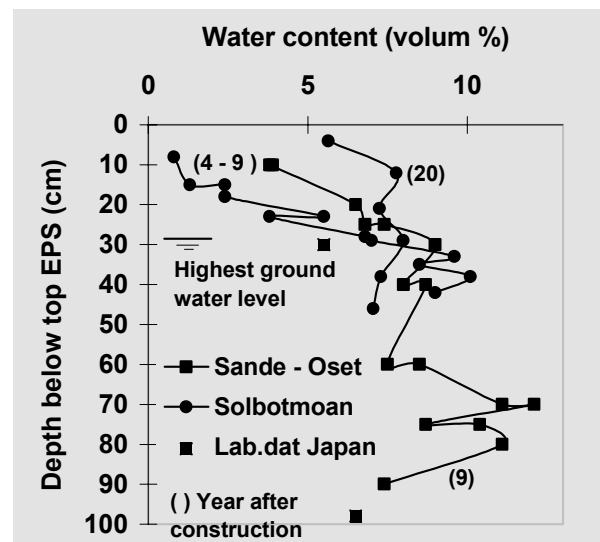
In blocks, which are periodically submerged, water contents of up to 4 % by volume have been measured. In permanently submerged blocks measured water contents have reached values close to 10 % by volume with some increase over the years fig. 7. Further increases above 10 % by volume are, however, not to be expected. For submerged fills the average density is therefore of the order of $\rho = 90 - 95 \text{ kg/m}^3$ after some 20 years in the ground. The water content decreases rapidly above the water table and show values for drained conditions only some 200 mm above the highest water level.

Figure 7. Typical water content in submerged EPS blocks

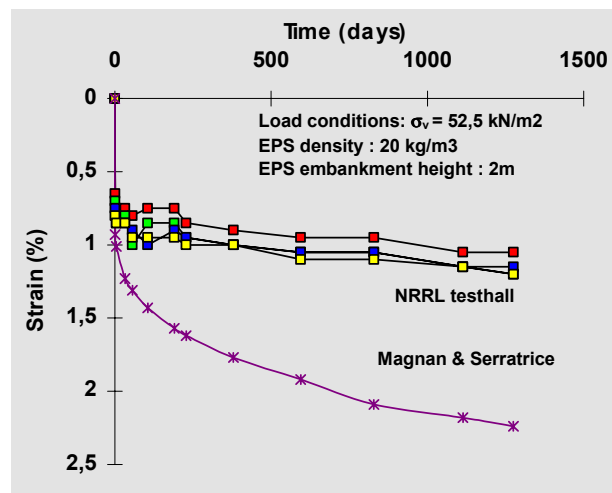
As may be seen the observed deformations are only about half of the calculated values and creep deformations with time are also much smaller.

Figure 9. Deformation / creep in the test fill

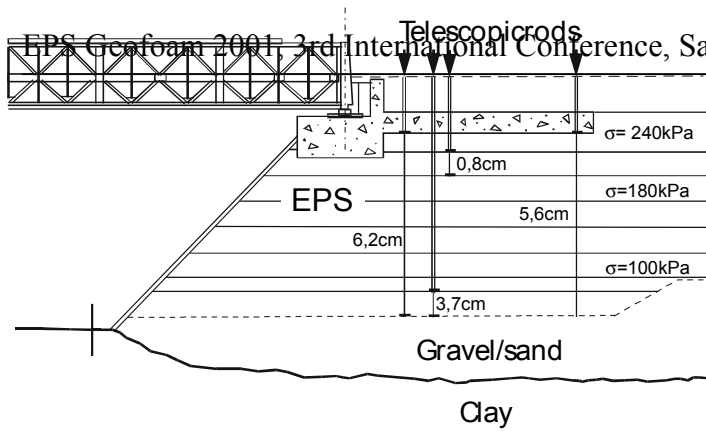
Figure 12. Deformations in EPS embankment at Løkkeberg.

After 12 years in service measurements show only small deformations 6 cm (1,3 % of the EPS height) in the EPS embankment. Most of the deformation occurred during the construction period and only minor creep effects have been measured. Creep deformations as an average and creep deformations for the lowest EPS layer (6,5 % of the layer thickness) are shown in fig. 13 for a period of 10 years.

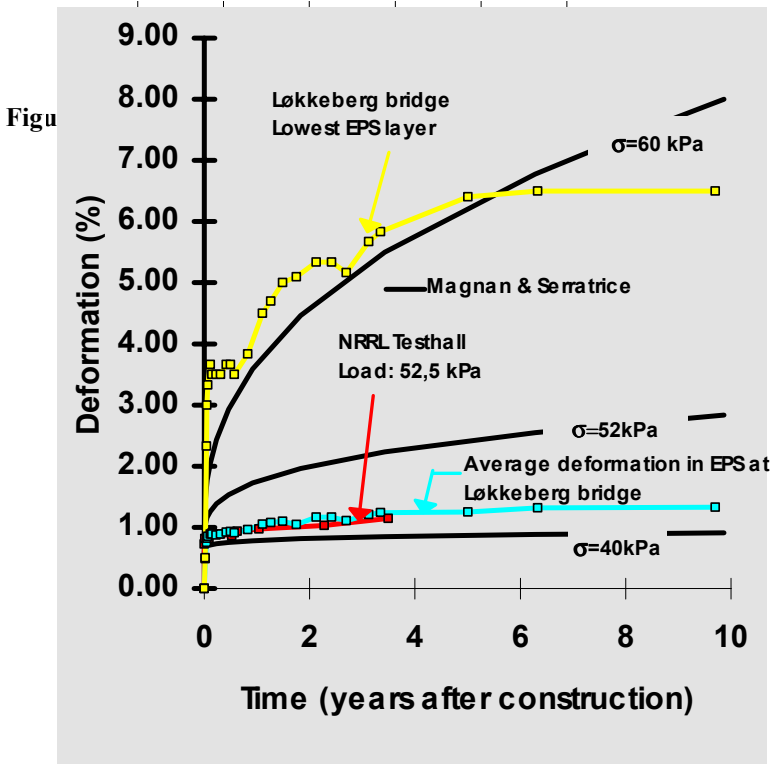
The figure clearly shows that the average deformation at the Løkkeberg bridge is small and slightly over 1 % of the total fill height. Also observed creep effects are almost negligible for the total fill although deformations in the bottom block layer was 4 % initially and later creep effects amount to further 2.5 %. Creep deformations in the bottom layer correspond with the theoretical values the first 5 years but has later slowed down to almost zero.

Figure 14. Creep deformations in EPS.

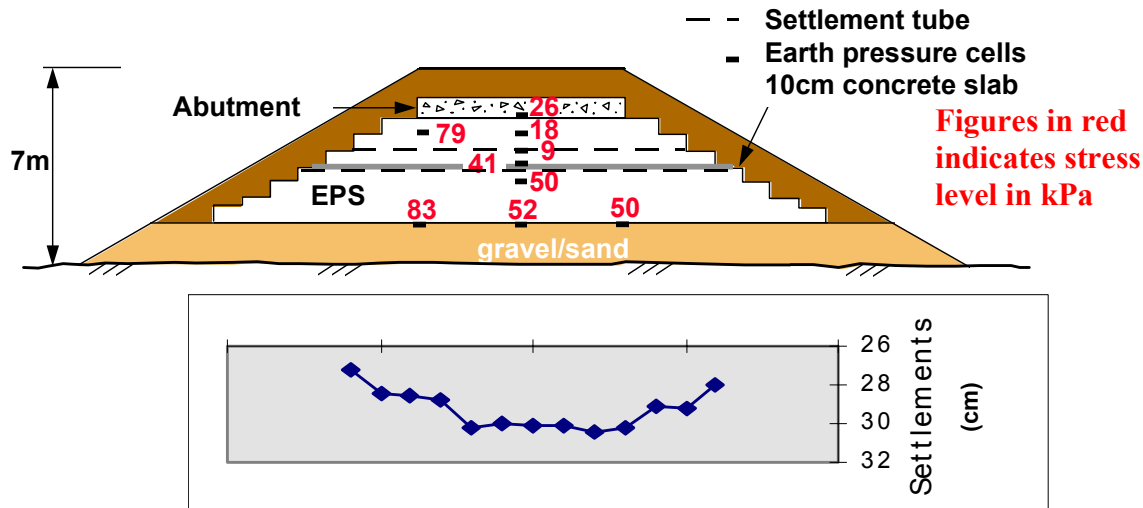
Figure 15. Løkkeberg bridge. Observed stress distribution and settlements in the cross section after 10 years in operation.

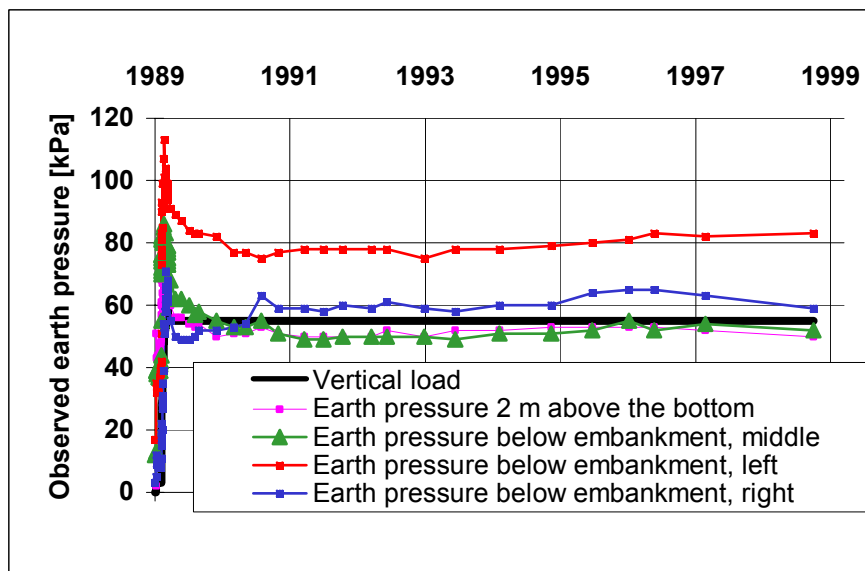
Figure 16. Long term measurements of earth pressure at Løkkeberg bridge

Long term measurements from 3 earth pressure cells below the fill and one situated 2 m higher up have been plotted in fig. 16. During the first year of operation a stress decrease of 15 - 30 % was observed. Later only small variations with time have been observed. Measured stresses corresponds well with the theoretical vertical load in the lower part of the EPS fill.

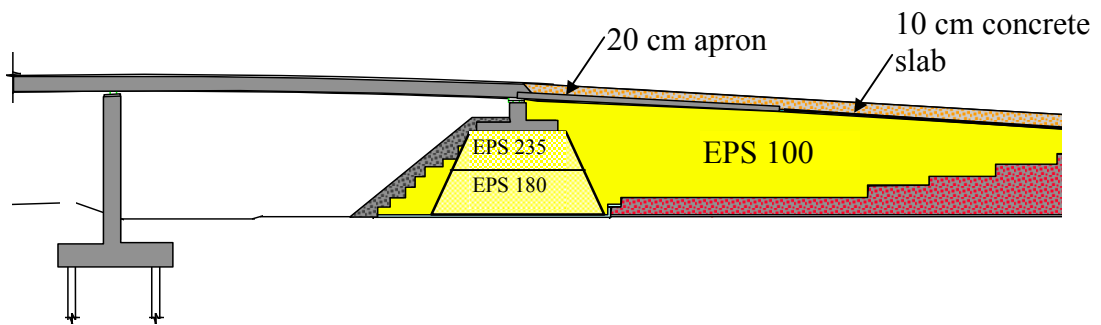
Some 2 years after completion it became evident that the bearing capacity of the soil beneath the abutments had been exceeded as excessive settlements occurred and the abutments inflicted damage to the bridge deck. Deformation monitoring was initiated and it soon became clear that immediate repair measures had to be initiated. Since settlement caused by the approach fills was the main problem, it was decided to reduce the load on the subsoil by some 30 – 40 kN/m² in order to re-establish the initial subsoil stress conditions. This involved replacing parts of

Figure 19. Supporting bridge abutments directly on EPS, Hjelmungen bridge, Norway

the fills with EPS blocks and supporting new bridge abutments directly on the EPS. The repair design is indicated in figure 19.

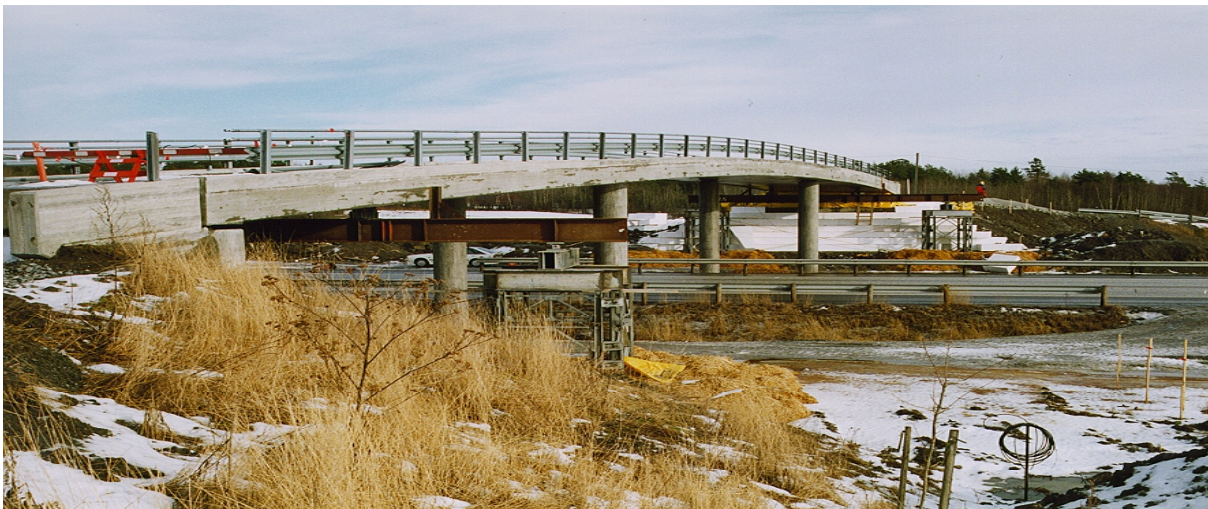
Figure 20. Temporary support of abutments at Hjelmungen

Repair works were initiated in December 1995 and completed in the spring of 1996. One abutment was treated at a time while the bridge deck was provided with a temporary support as shown in figure 20. Thickness and densities of the original filling materials were recorded as they were removed in order to have accurate data for control of load and settlement calculations. After removing the old abutments, the concrete piles were inspected regarding possible damage before being cut at ground level. No pile damage was observed. Construction of the EPS fills could then start. In this case three different qualities of EPS were utilized. In the zone directly beneath the bridge abutment, as indicated by the trapezoidal shaped lines in figure 19, a material quality of $\sigma = 235$ kPa was specified for the first three block layers beneath the bottom slab of the abutment. Further down a material quality of $\sigma = 180$ kPa was

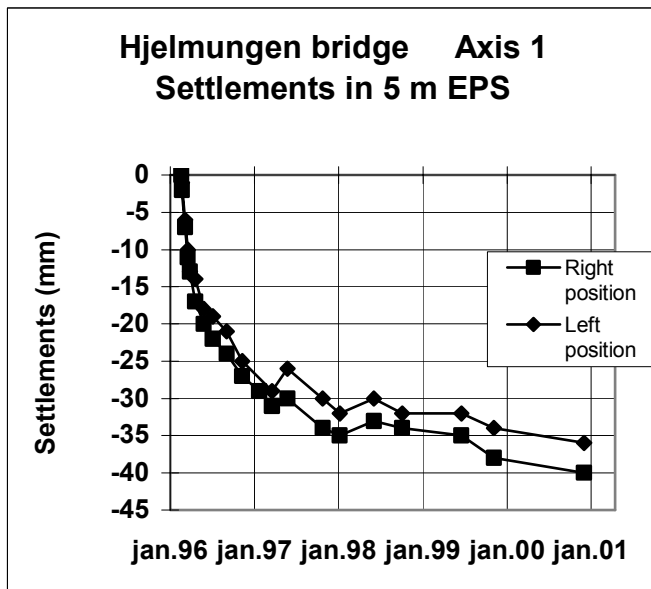
In order to monitor the behaviour of the reconstructed bridge both settlement and stress gauges have been installed. The different types of gauges and their locations in relation to the bridge abutment are indicated on the cross section in figure 21. Prior to reconstruction the settlement rates of the adjoining fills were observed to be 100 mm/year and constant. After reconstruction the settlements have nearly been halted as shown on figure 22.

Figure 22. Measured settlements at Hjelmungen

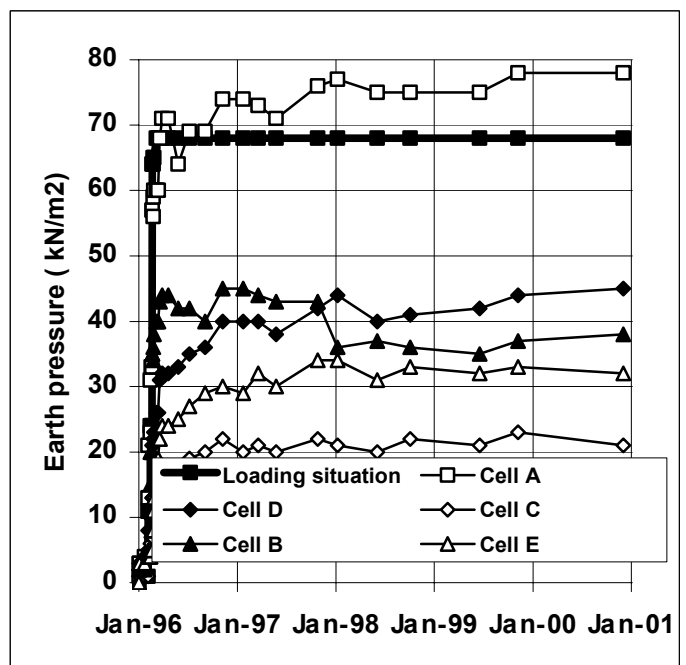
Observed stresses beneath the EPS fill indicate a higher stress under the central part of the abutment than under the edges as shown in figure 23. Calculated loads on the abutment are indicated by the heavy line drawn in the diagram. Problems associated with providing enough lifting force when jacking up the bridge deck may, however, indicate that reaction forces from the bridge deck are somewhat higher than calculated.

Figure 23. Earth pressure below EPS layer at Hjelmungen
