*Hurricane Sally Post-Storm
Beach Conditions and Coastal Impact Report*

**Office of Resilience and Coastal Protection
Florida Department of Environmental Protection**

November 2020

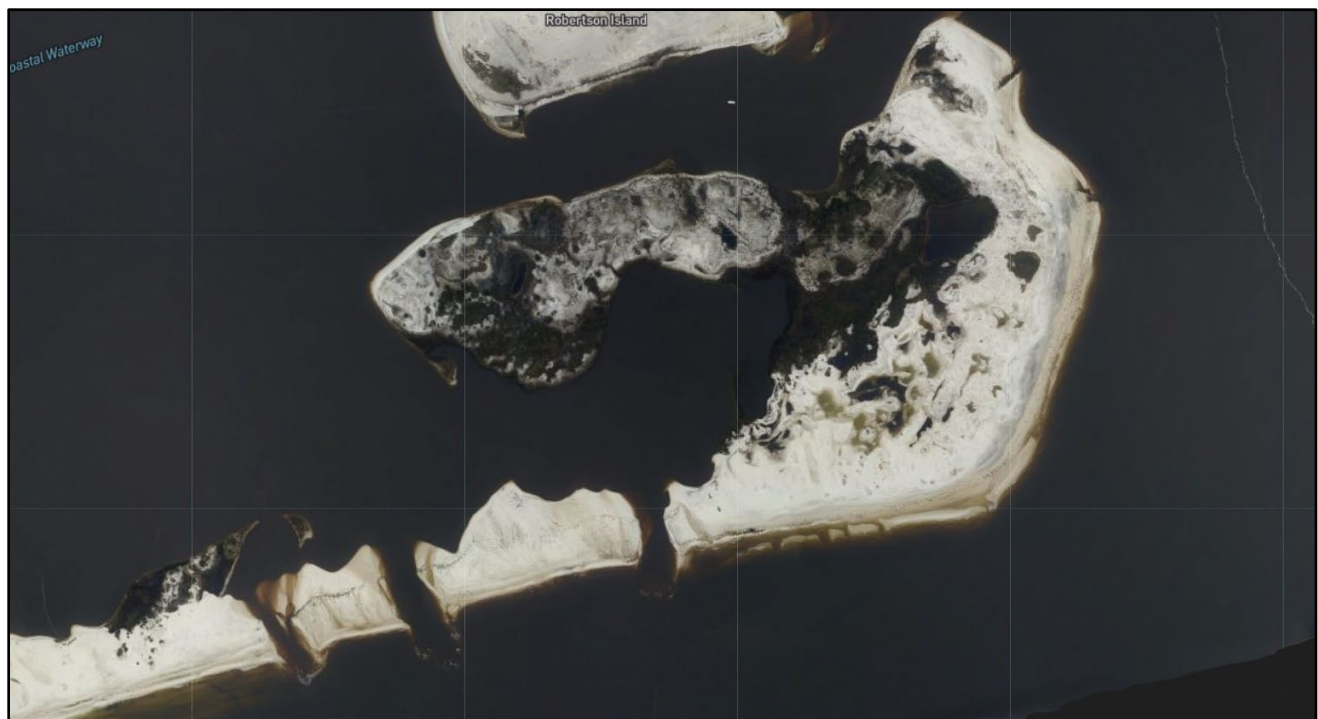
Figure 10. Post-Hurricane Sally aerial photo comparison of the three barrier island breakthroughs on Perdido Key (R60-R63) [Source: NOAA aerial photography, 09-2020].

Along the undeveloped eastern 6 miles of Perdido Key (R32-R67), major dune erosion (Condition IV) was sustained within the Gulf Islands National Seashore. Numerous overwash fans are observed along the national seashore with three new barrier island breakthroughs at R60, R61 and R63 (**Figure 10**).

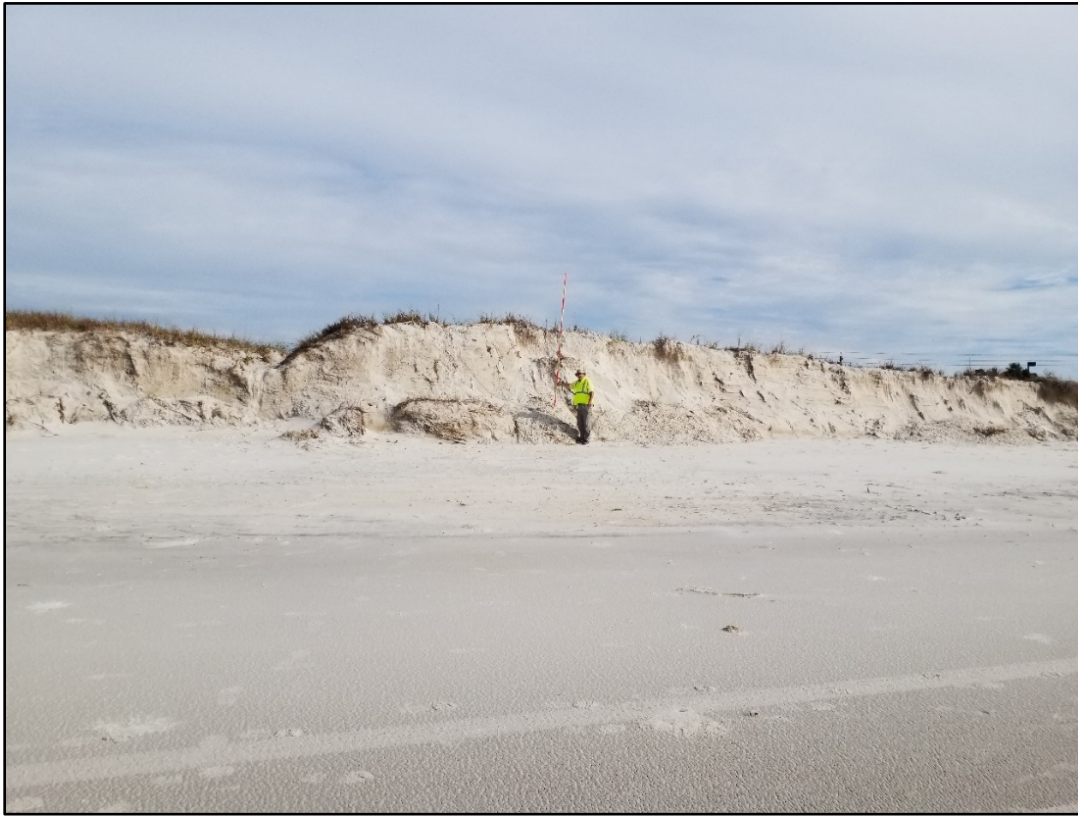
- R13 where the dune was breached causing road damage
- R23-R24

Figure 12. Major dune erosion on Perdido Key, R23 to R24.

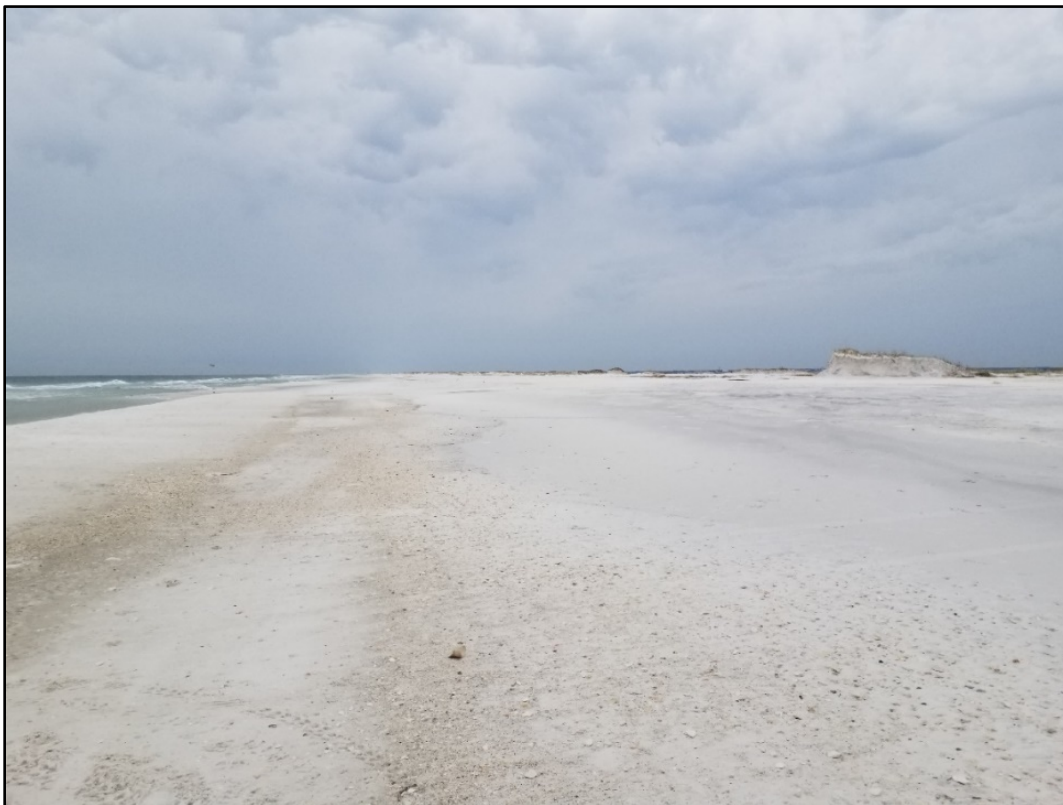
Figure 13. Major dune erosion at Fort Pickens Unit of Gulf Islands National Seashore, R106.

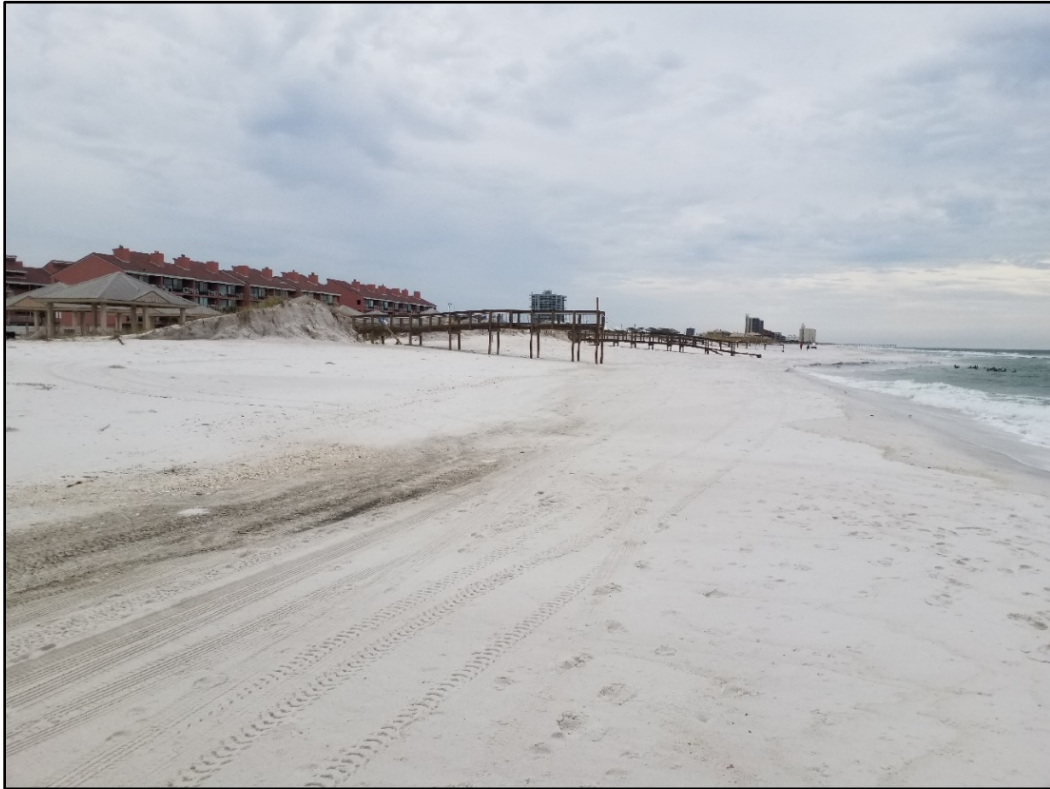
Figure 14. Major dune erosion in western Pensacola Beach, R108.

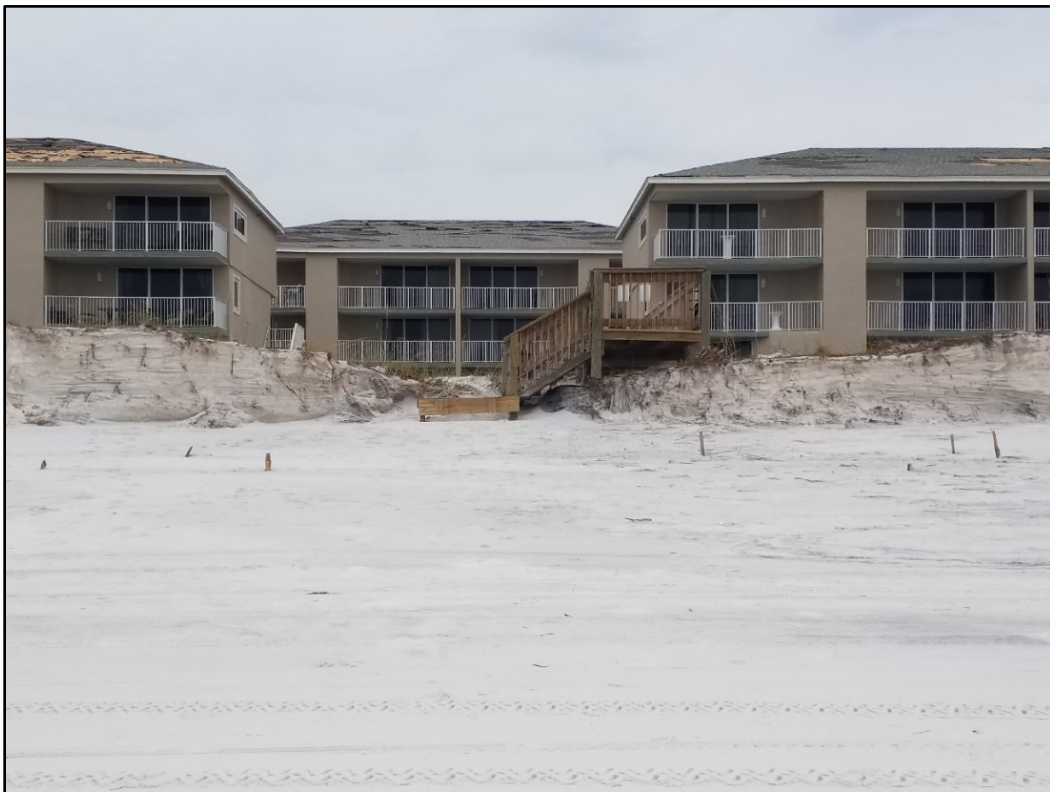
Figure 15. Major dune erosion in Pensacola Beach, R111.

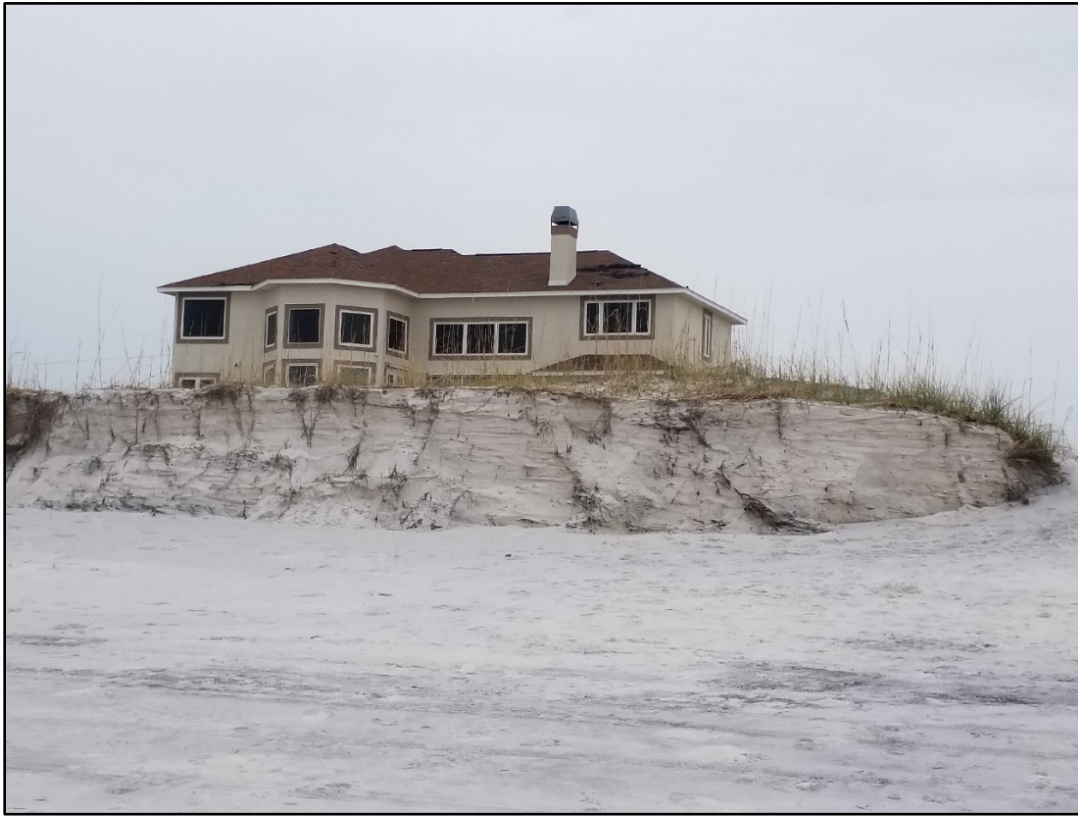
Figure 16. Major dune erosion in Pensacola Beach, R129.

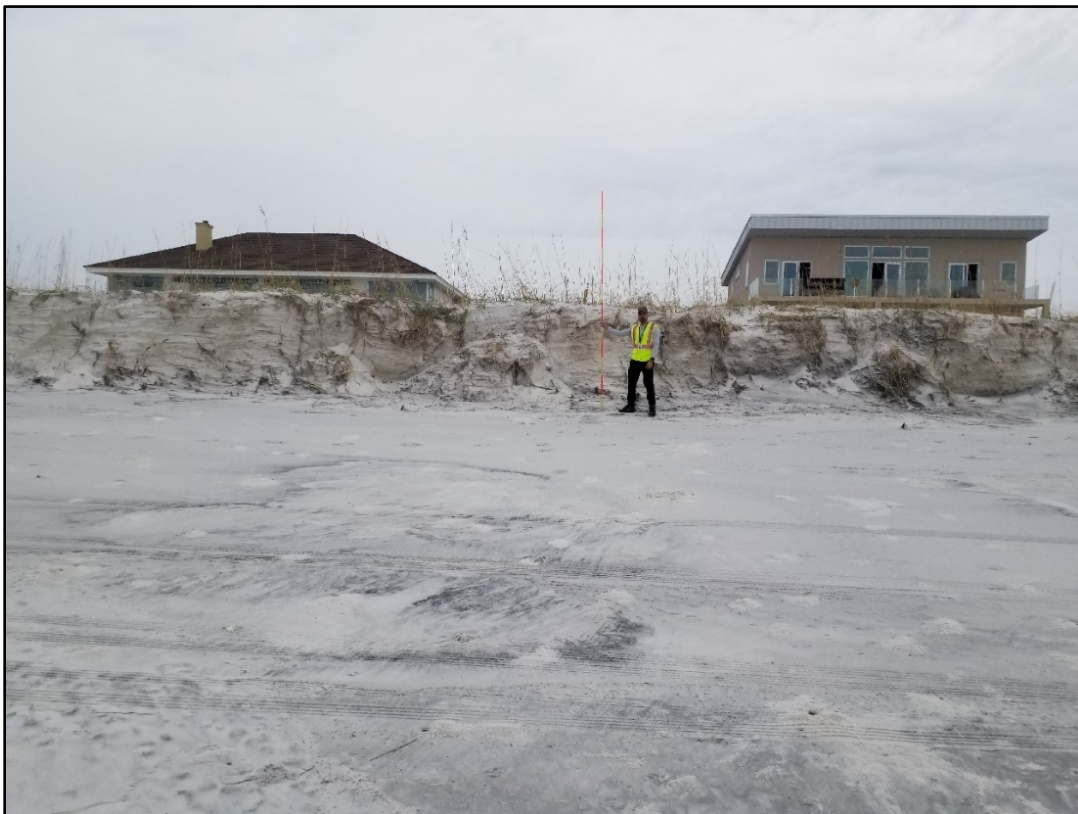
Figure 17. Major dune erosion, Pensacola Beach, R130.

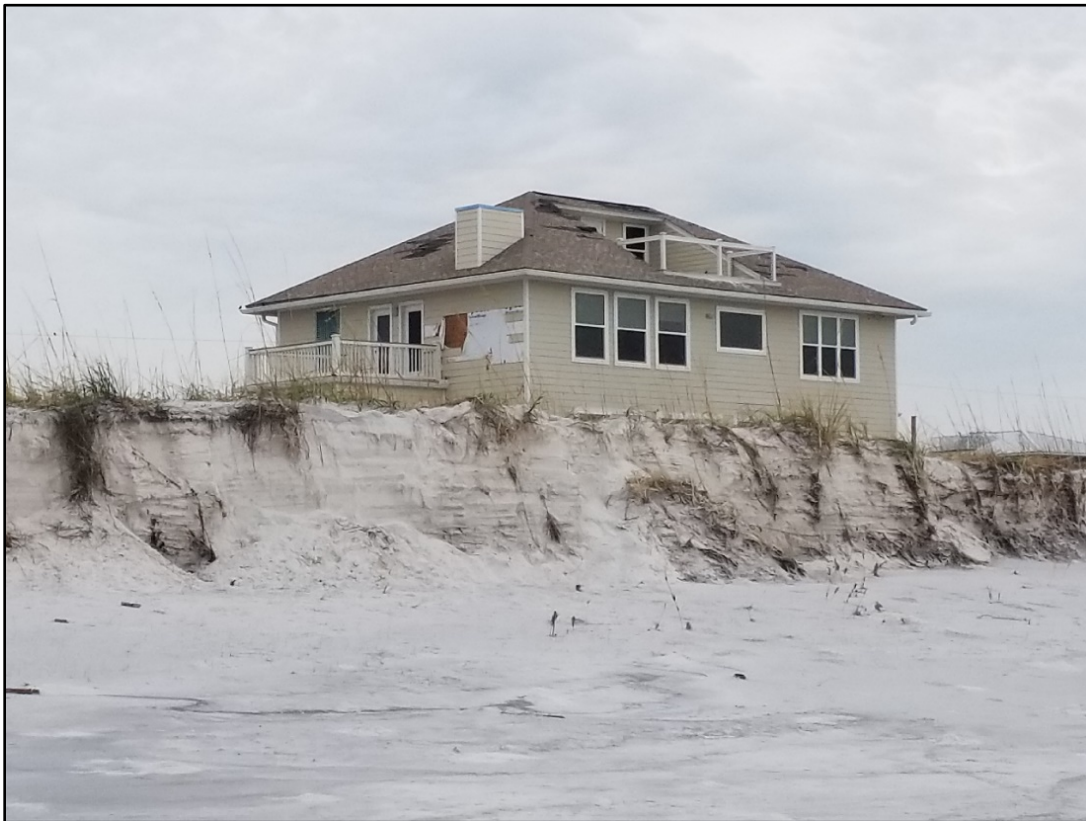
Figure 18. Major dune erosion, Pensacola Beach, R134.

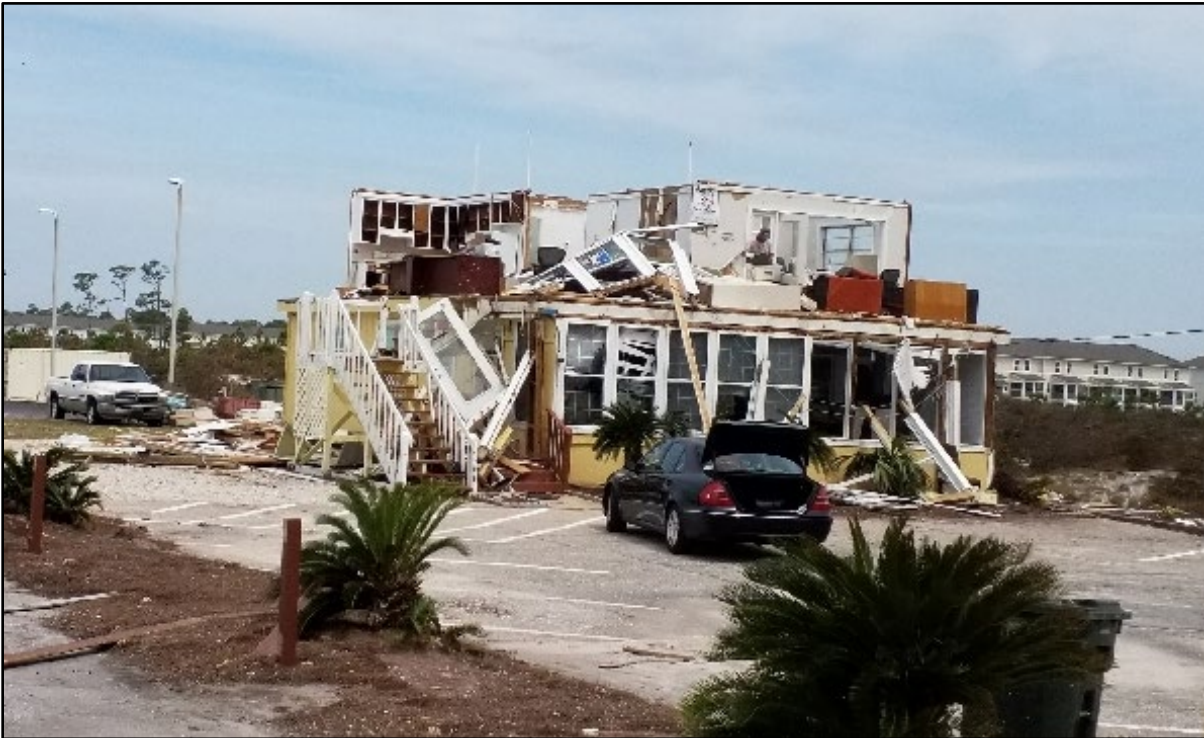
Figure 19. Commercial building destroyed by wind, Perdido Key, R24.

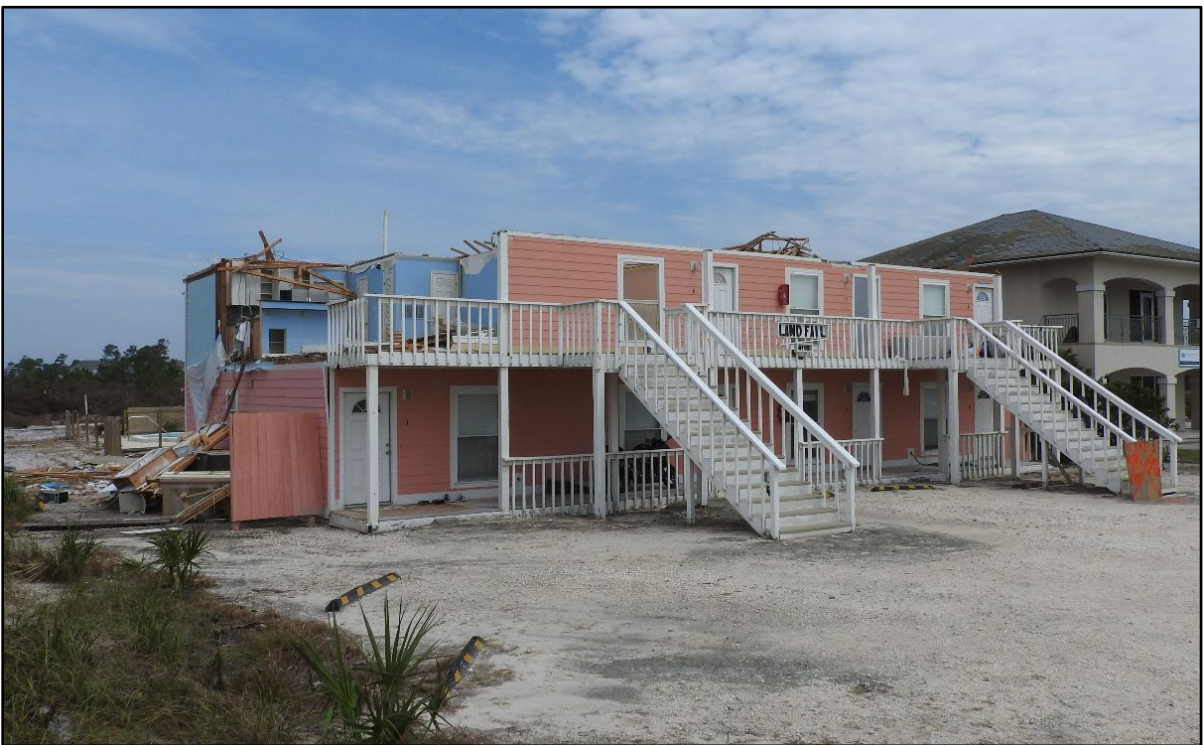
Figure 20. Multi-family dwelling destroyed by wind, Perdido Key, R26.

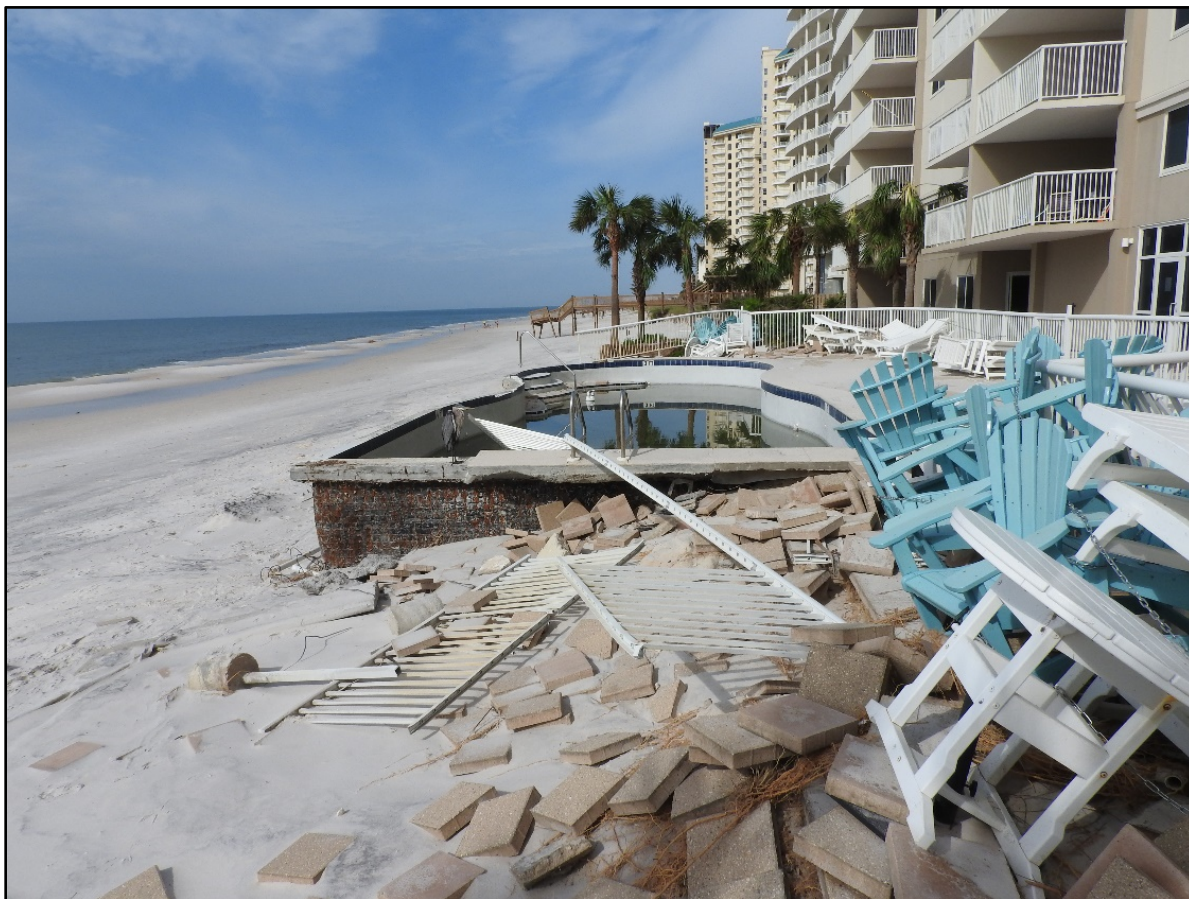
Figure 21. Swimming pool destroyed by waves and erosion, Perdido Key, R30.

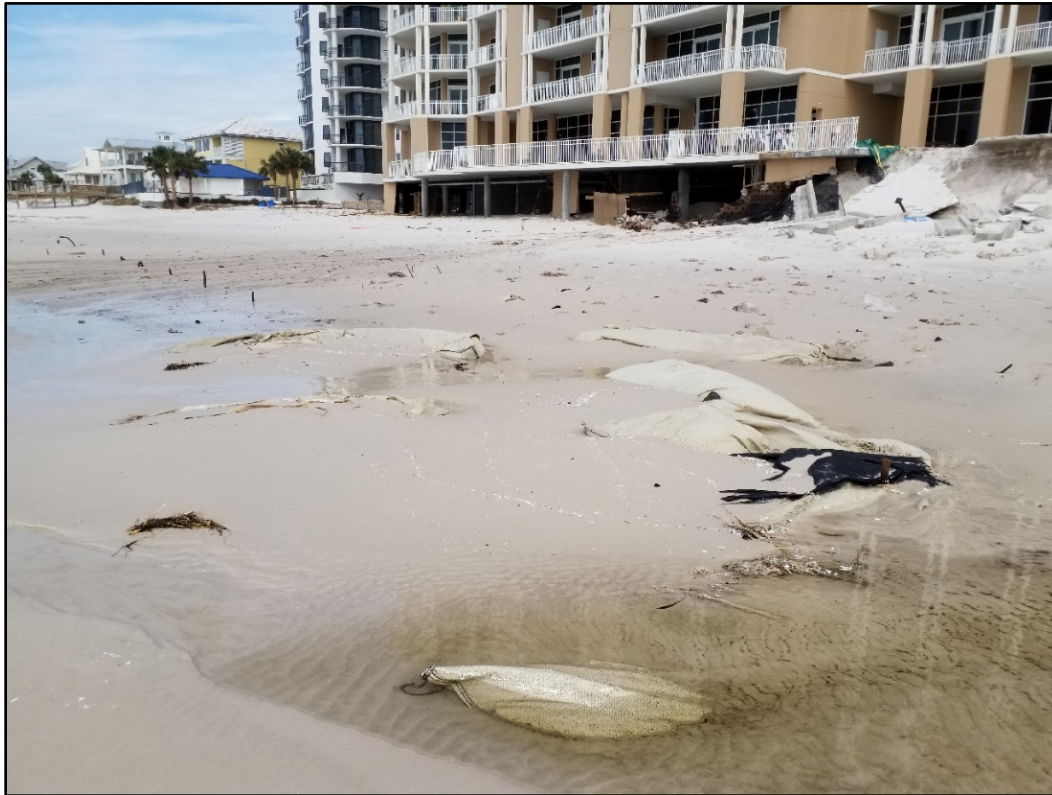
Figure 22. Sand-filled geotextile armoring structure destroyed next to multi-family dwelling with understructure damage, Perdido Key, R32.

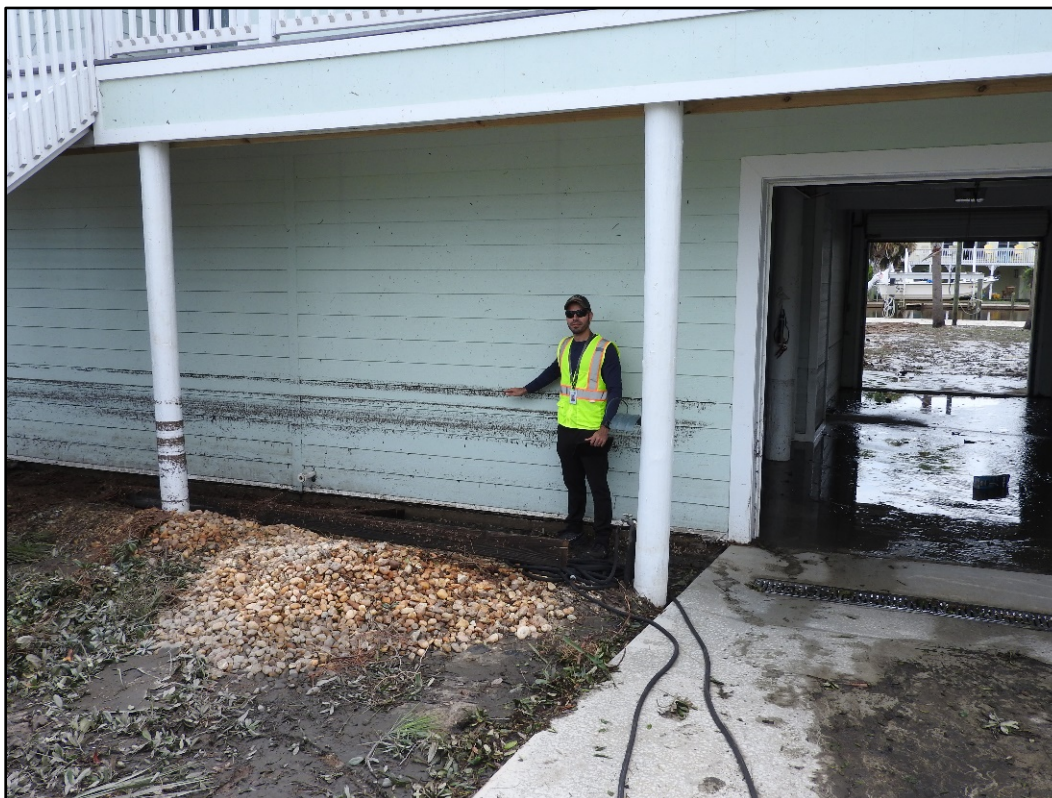
Figure 23. Typical flooding at ground level, Perdido Key.

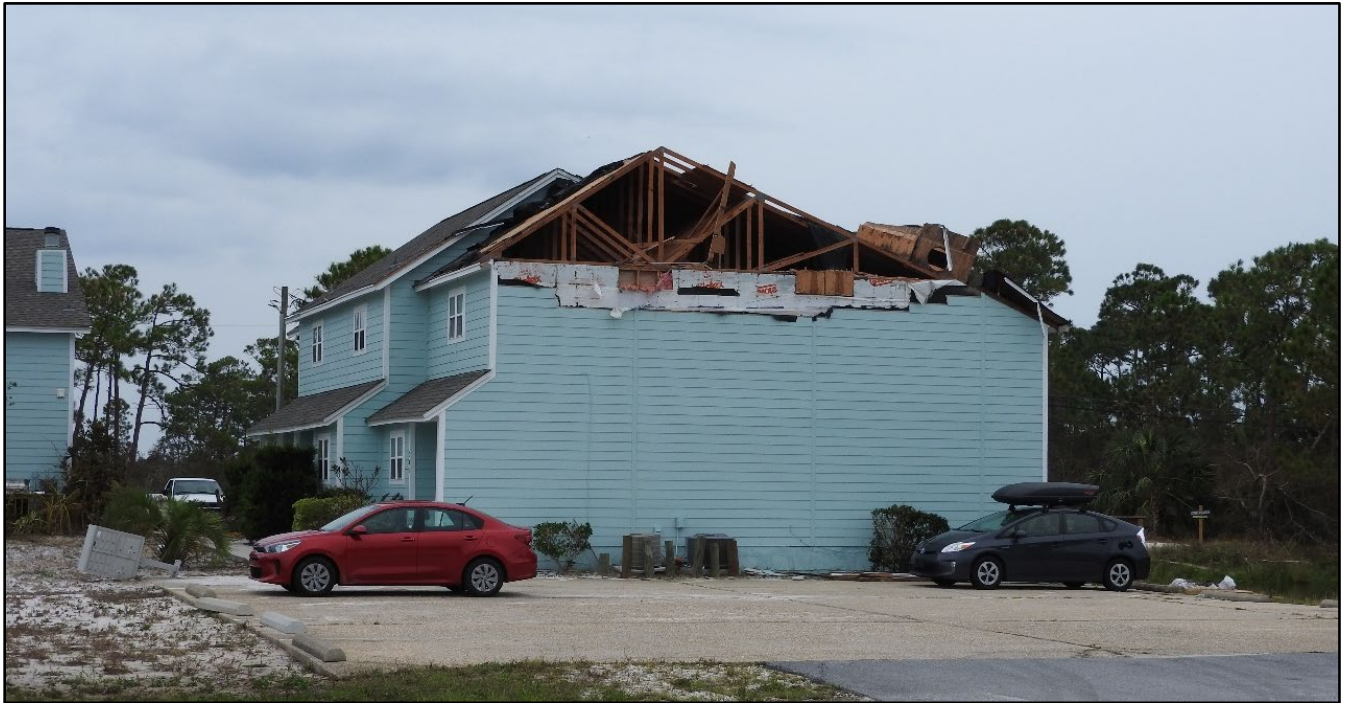
Figure 24. Major roof damage to multi-family building, Perdido Key.

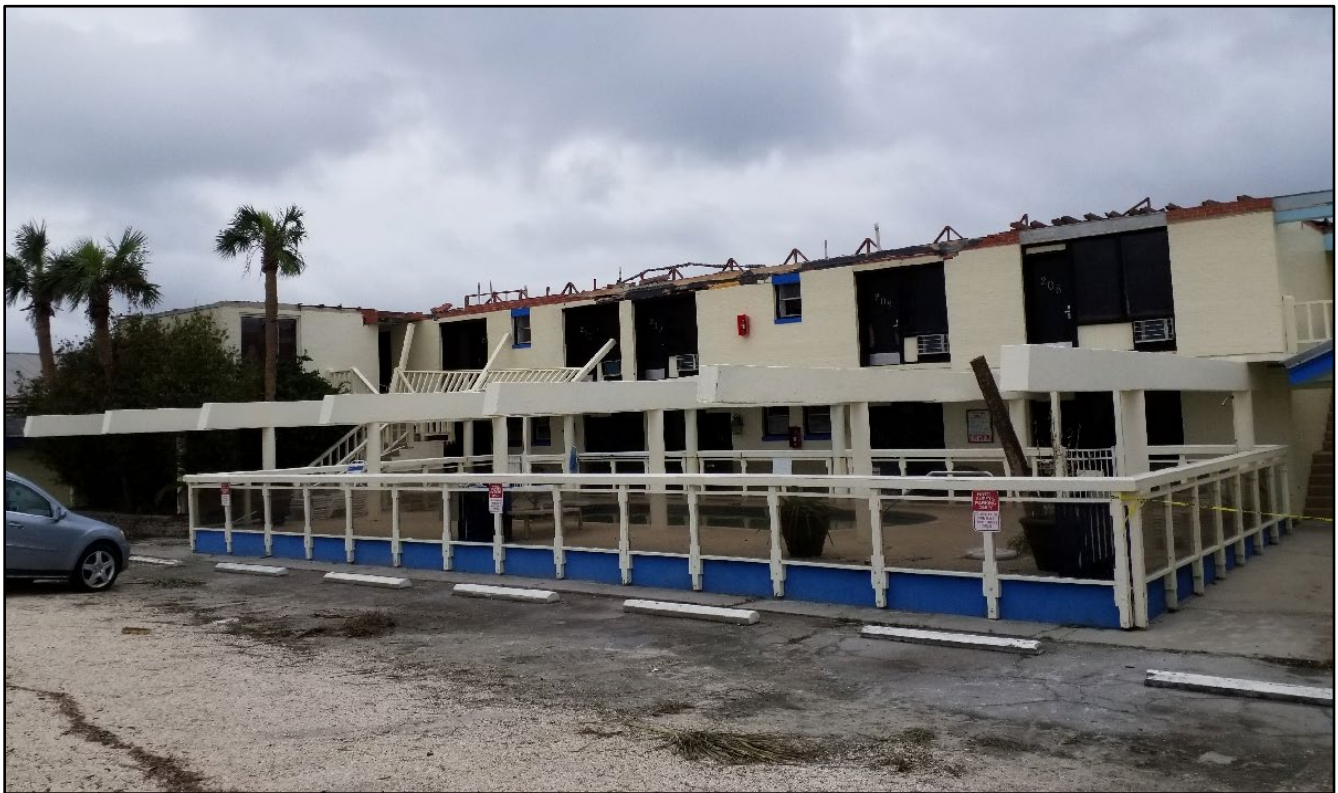
Figure 25. Major roof damage on the Pensacola Inn, Pensacola Beach, R123.

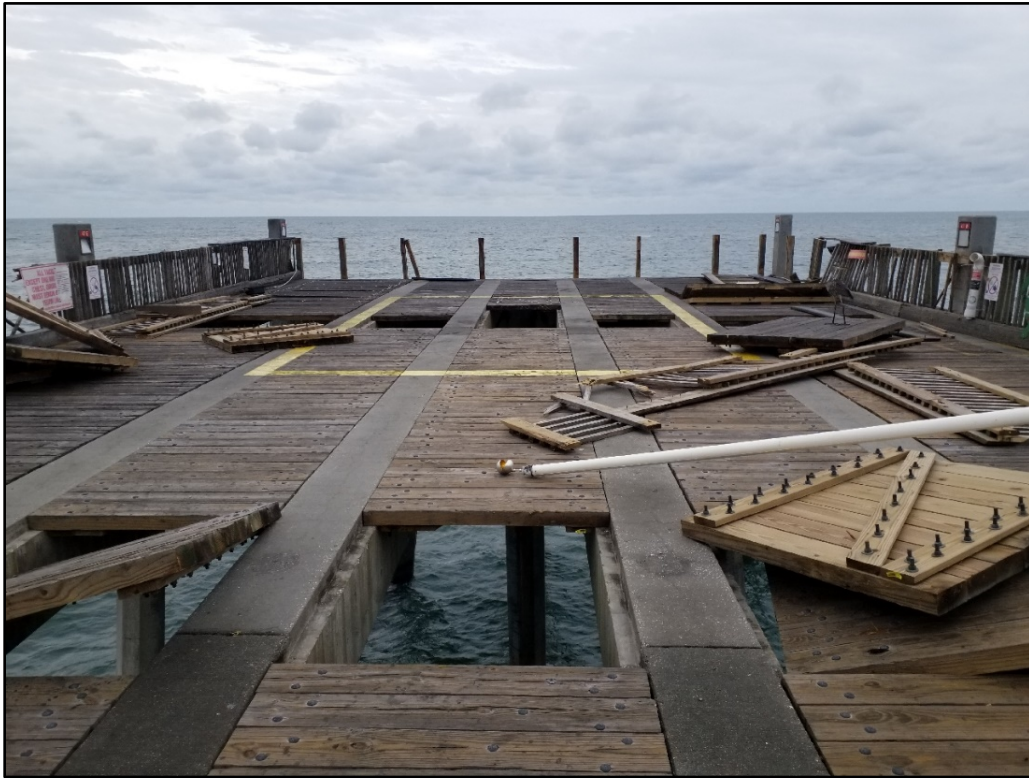
Of special note in Pensacola Beach was the storm effects on the 1,470-foot-long, concrete Pensacola Beach Fishing Pier, which was constructed in 2001. Previously, Hurricane Ivan – a 200-year return interval storm surge event in 2004 – and Hurricane Dennis, another major hurricane in 2005, caused substantial damage to breakaway deck sections along the length of the pier, but inflicted no major structural damage. With Hurricane Sally, once again, breakaway deck sections and breakaway rails were dislodged; however, no major structural damage appears to have occurred (see **Figure 26** and **Figure 27**). As designed, the dislodging of breakaway deck sections and rails by the vertical uplift forces of breaking storm waves, eliminates much of the structural resistance, allowing enhanced survival of the concrete pier frame.

Figure 26. Pensacola Beach Fishing Pier with breakaway deck sections and handrails displaced, but no major structural damage, R120.5.

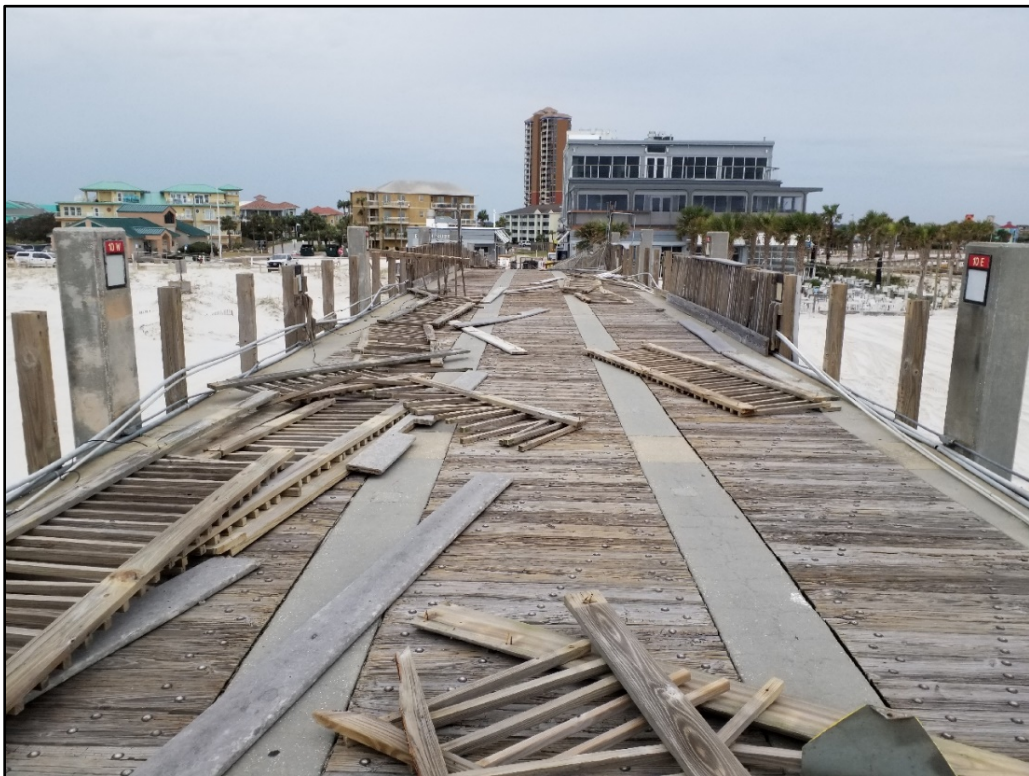
Figure 27. Pensacola Beach Fishing Pier with breakaway handrails displaced, but no major structural damage, R120.5.

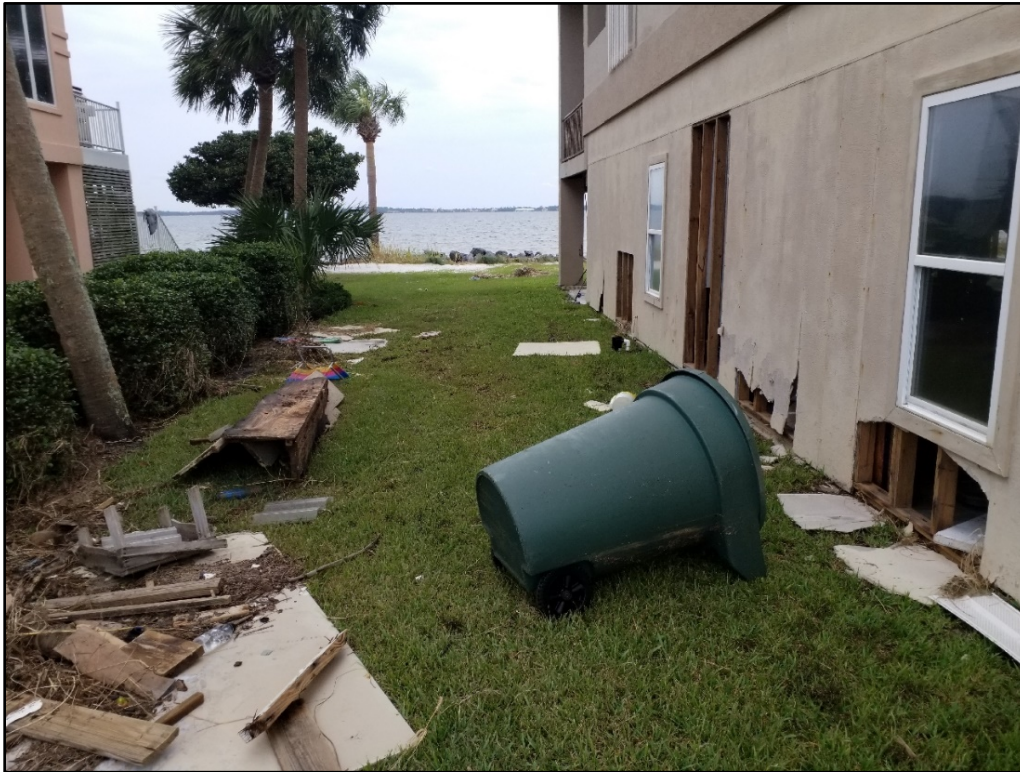
Figure 28. Typical flooding and understructure damage to breakaway walls in Pensacola Beach, R138.

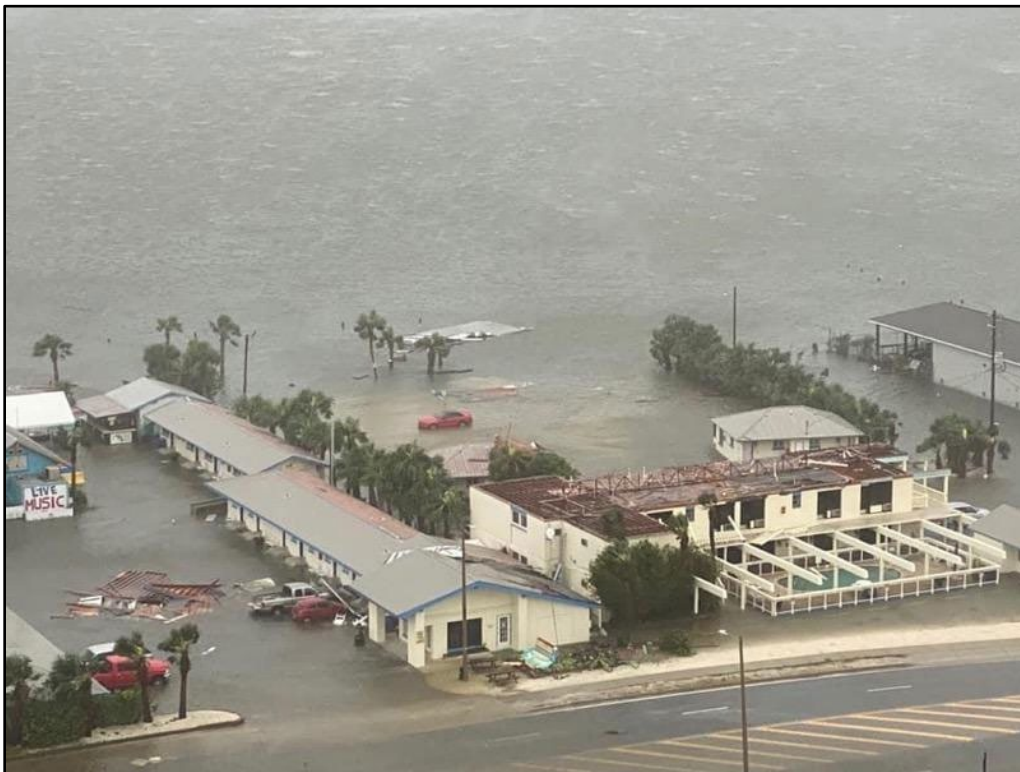
Figure 29. Flooding during the storm at the Pensacola Inn, Pensacola Beach. [Courtesy of Pensacola resident]

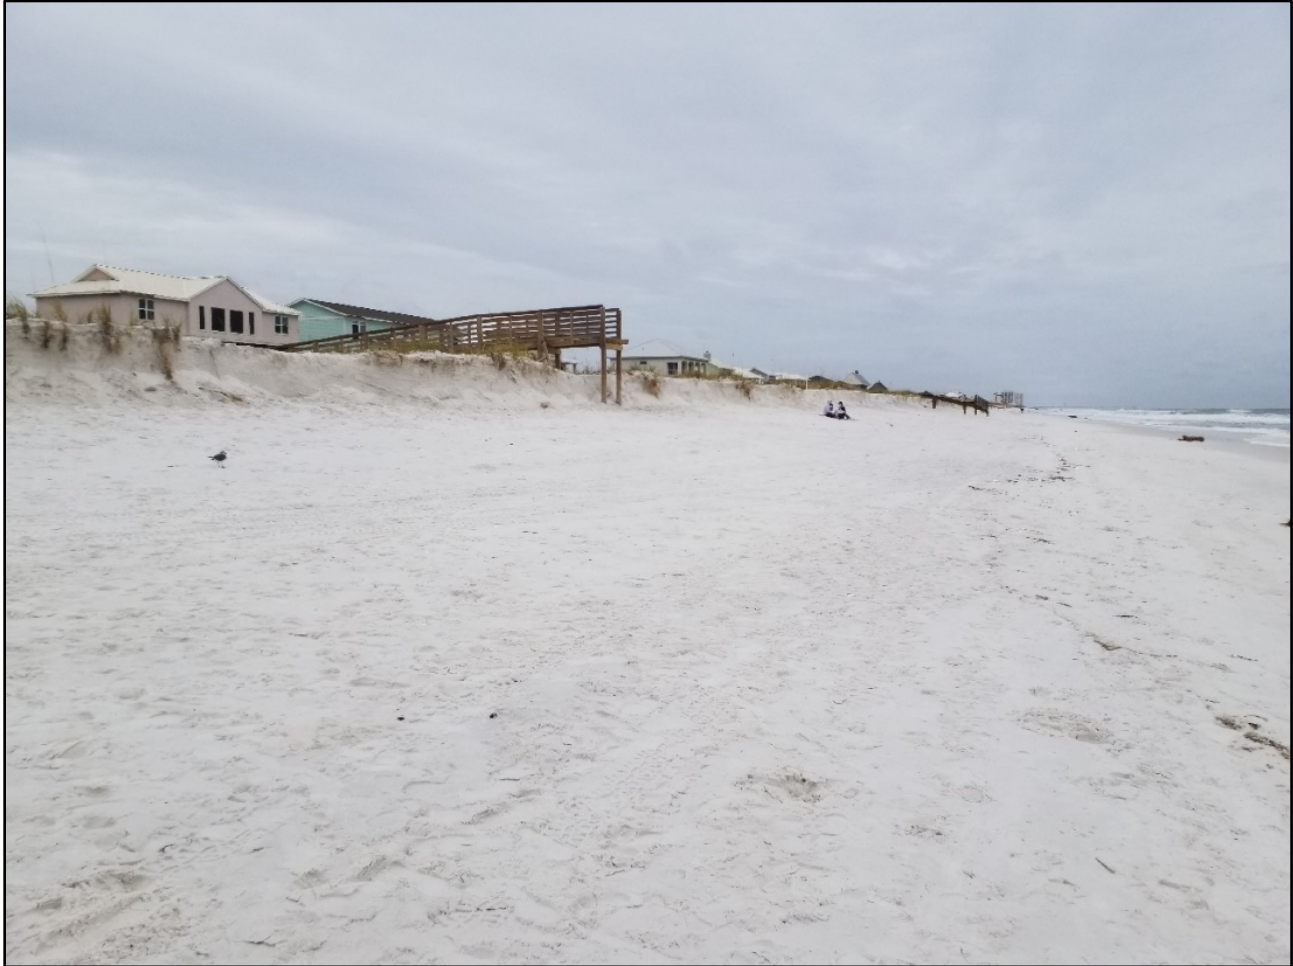
III (moderate beach and dune erosion), see **Figure 31**. A salient of lesser erosion exists adjacent the Navarre Pier (R208-R211; Condition II). To the east of Navarre Beach, Condition III (moderate beach and dune erosion) extended along the Eglin Air Force Base.

Figure 31. Major to moderate beach and dune erosion in western Navarre Beach, Santa Rosa County, R194.

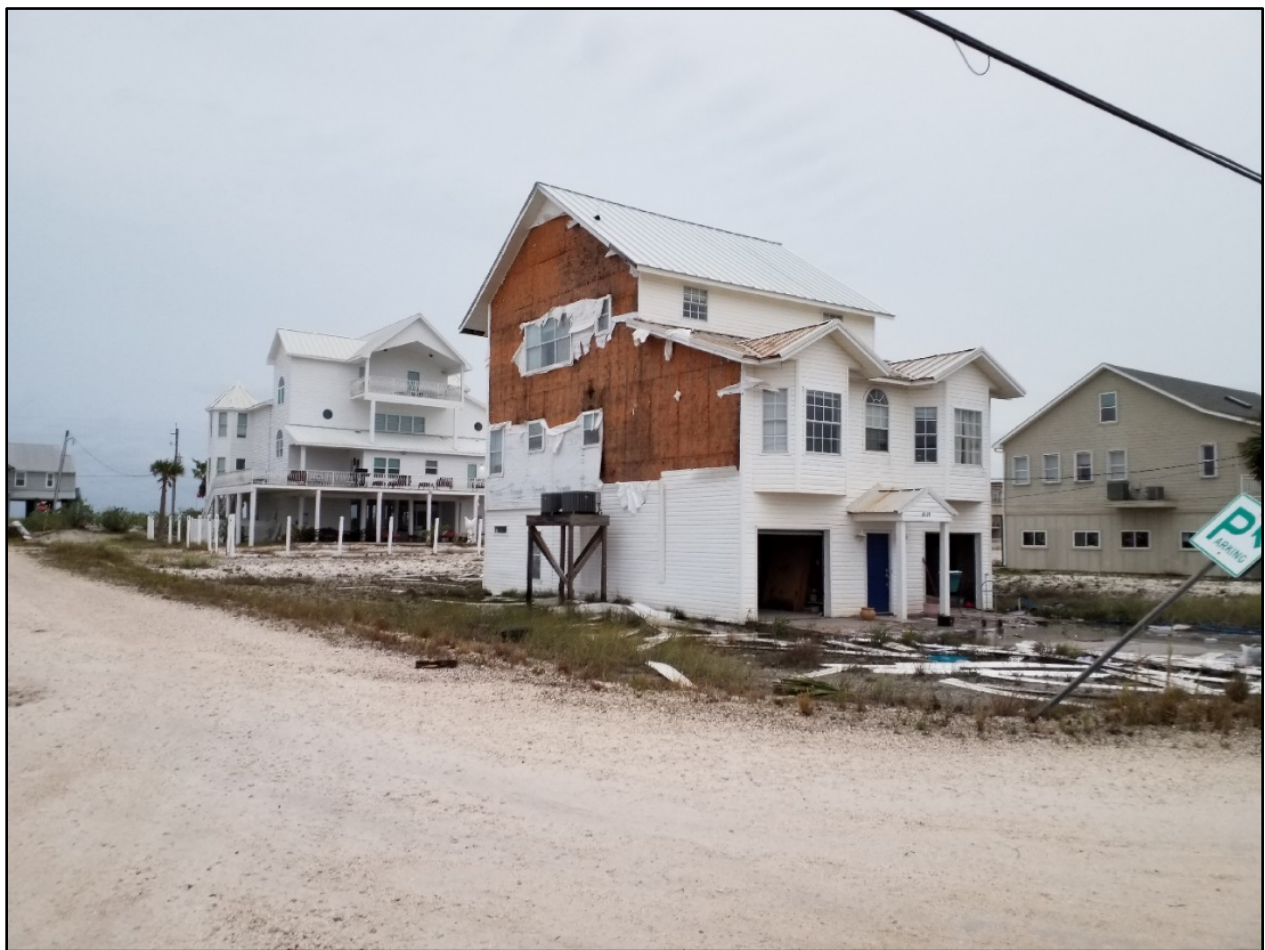
Figure 32. Major siding damage to a single family dwelling, Navarre Beach, R203.

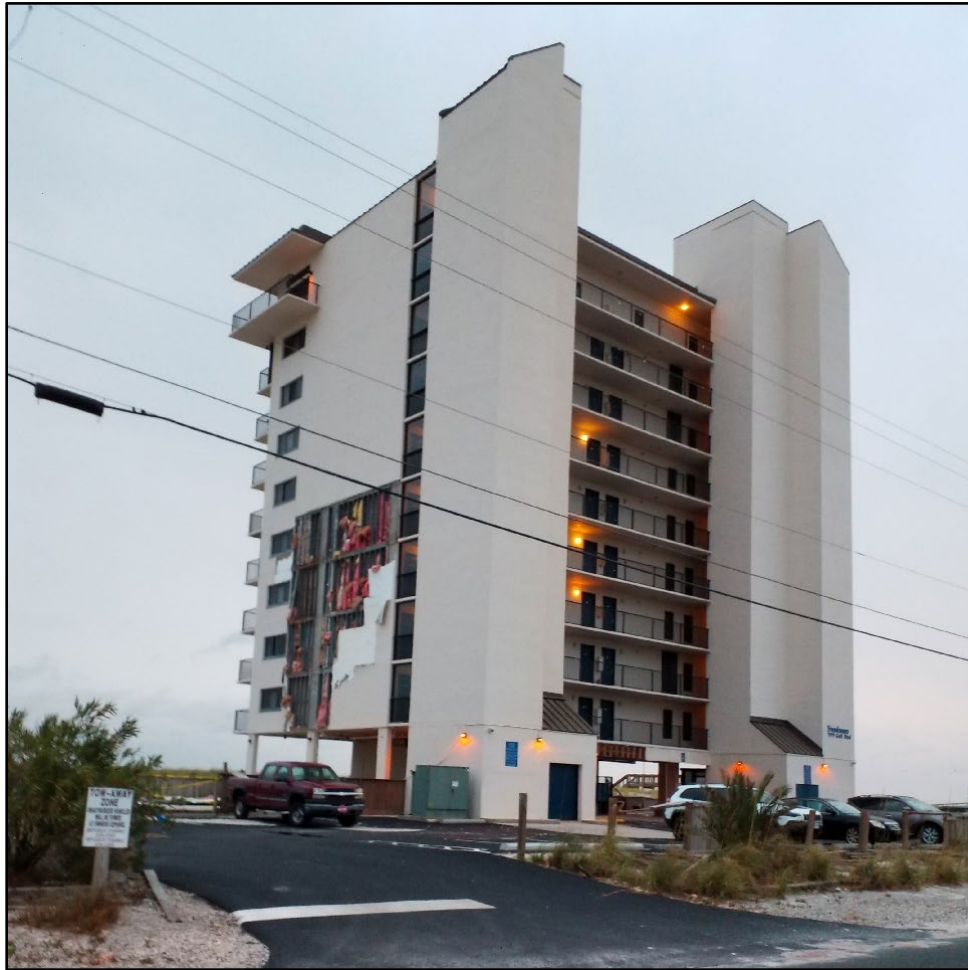
Figure 33. Major siding damage to a multi-family building, Navarre Beach, R201.5.

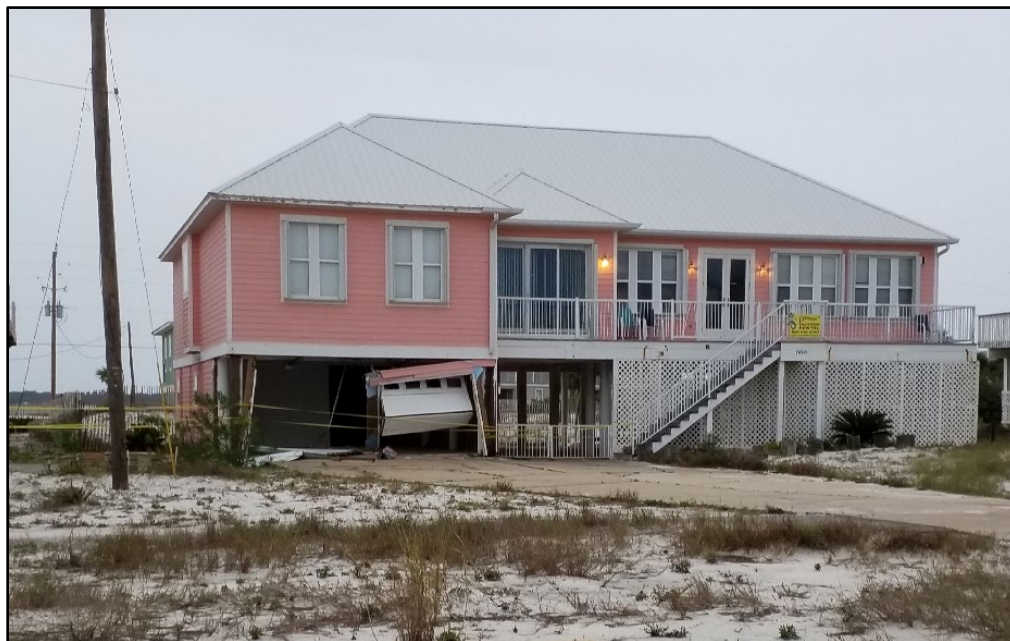
Figure 34. Typical understructure damage due to the storm surge, Navarre Beach, R195.

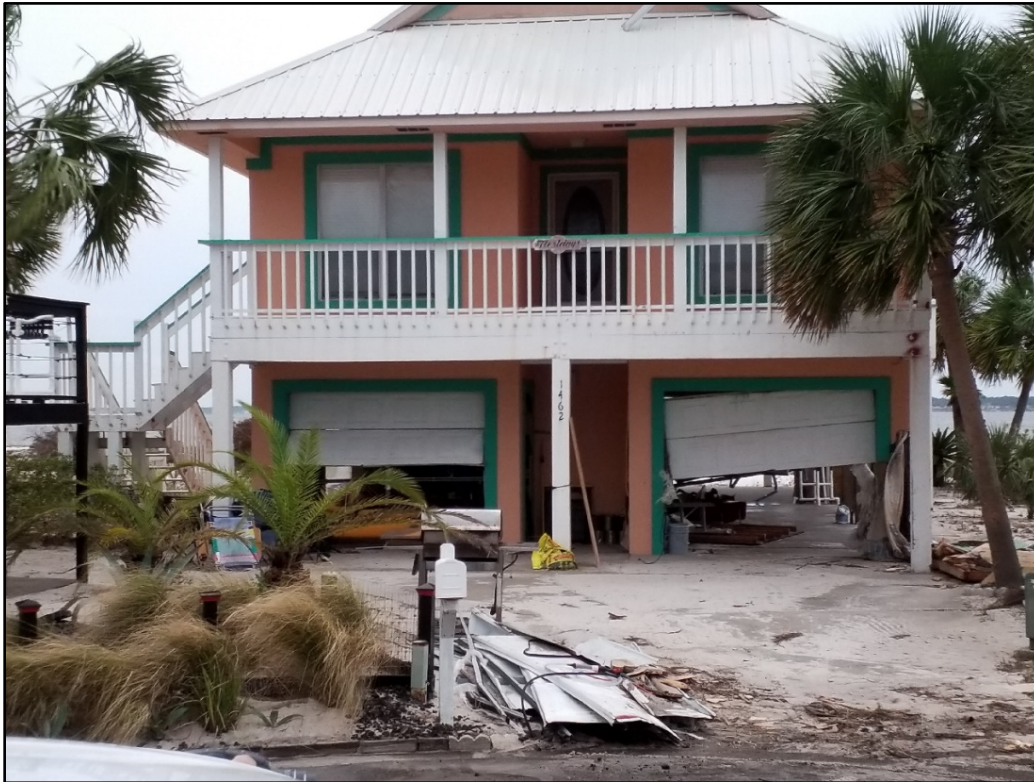
Figure 35. Understructure damage, Navarre Beach, R203.5.

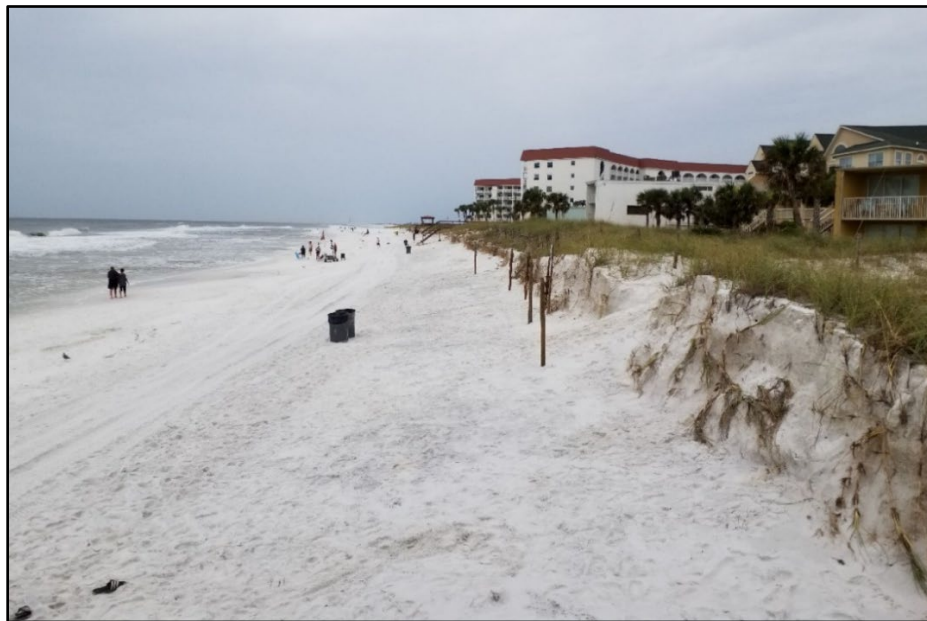
Figure 38. Moderate beach and dune erosion in western Okaloosa Island on Santa Rosa Island near R2.
