*Hurricane Sally Post-Storm
Beach Conditions and Coastal Impact Report*

**Office of Resilience and Coastal Protection
Florida Department of Environmental Protection**

November 2020

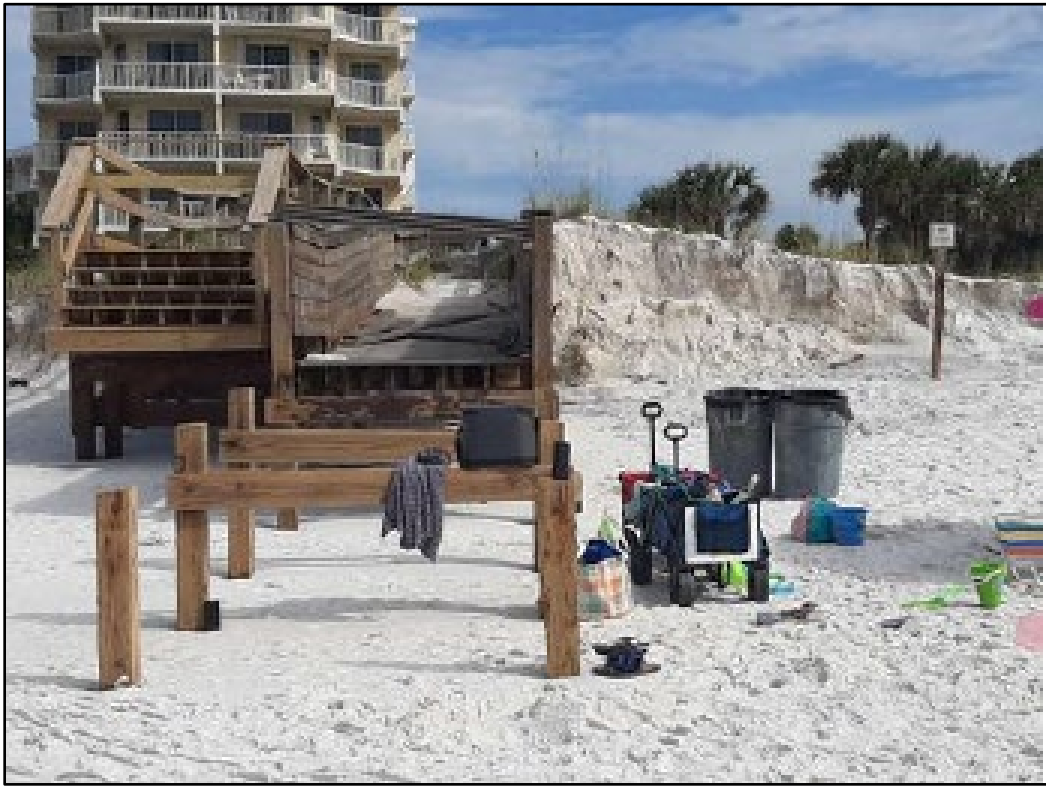
Figure 39. Moderate beach and dune erosion in Okaloosa Island, R114.5.

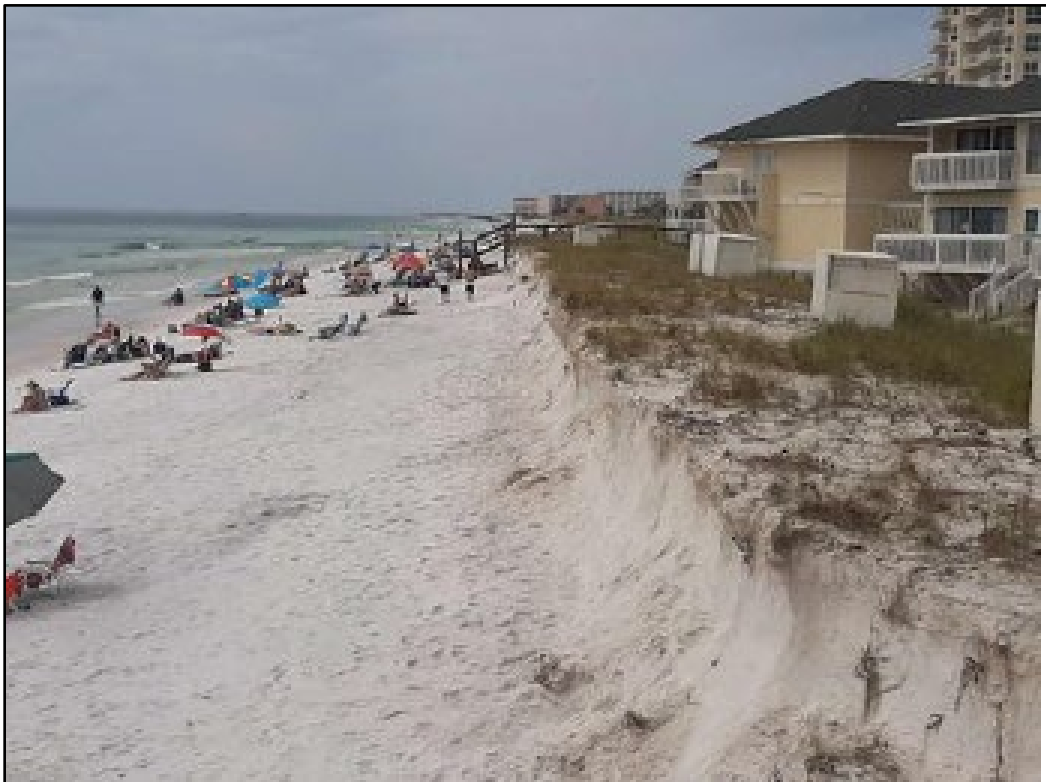
Figure 40. Major dune erosion at Sandpiper Village, Destin, R24.

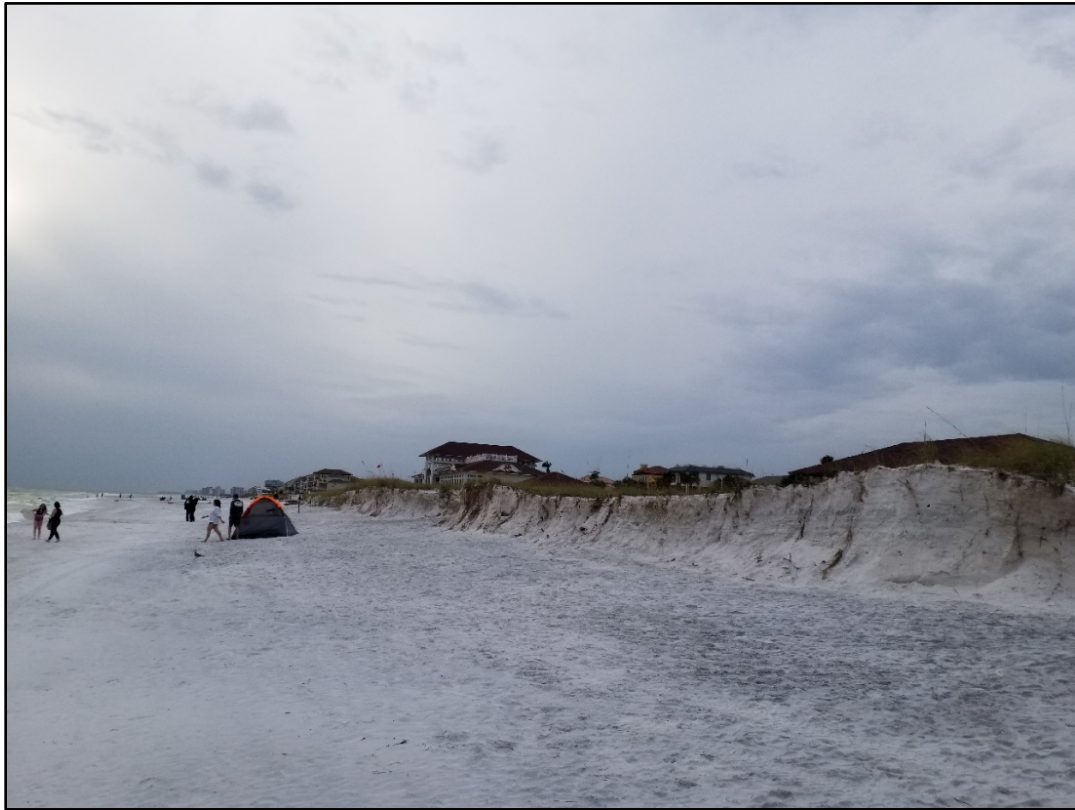
Figure 41. Major dune erosion at James Lee Park, Destin, R47.

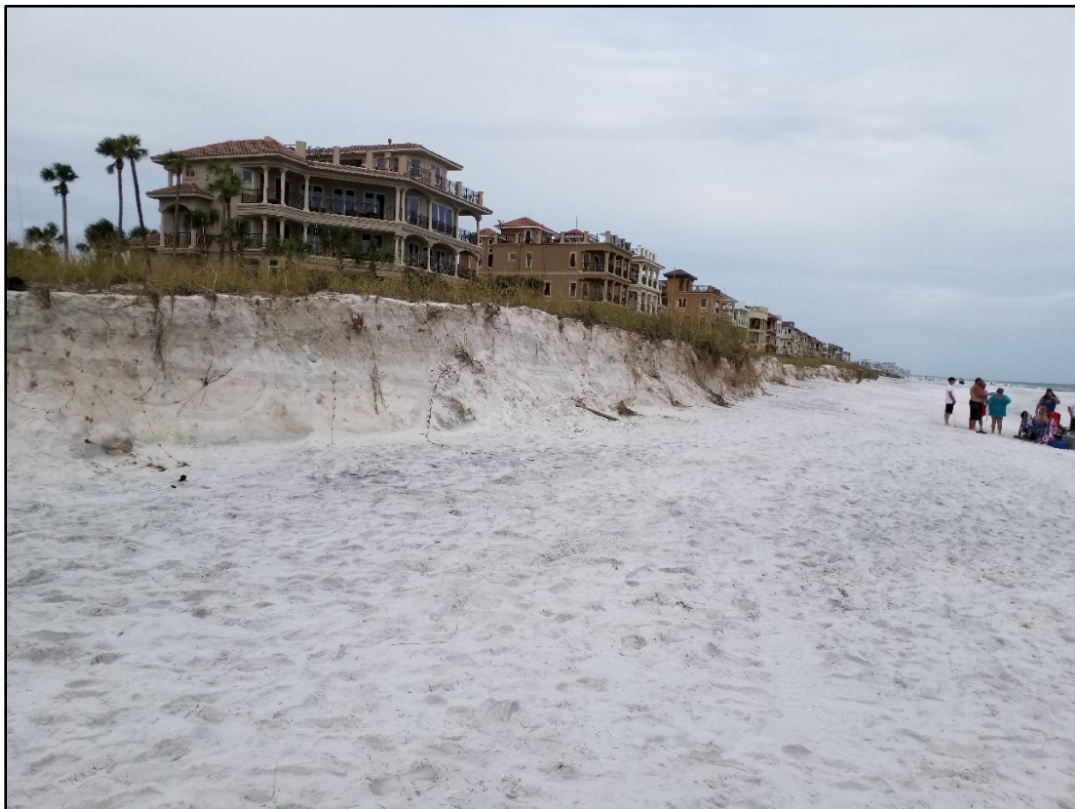
Figure 42. Major dune erosion in eastern Destin, R48.

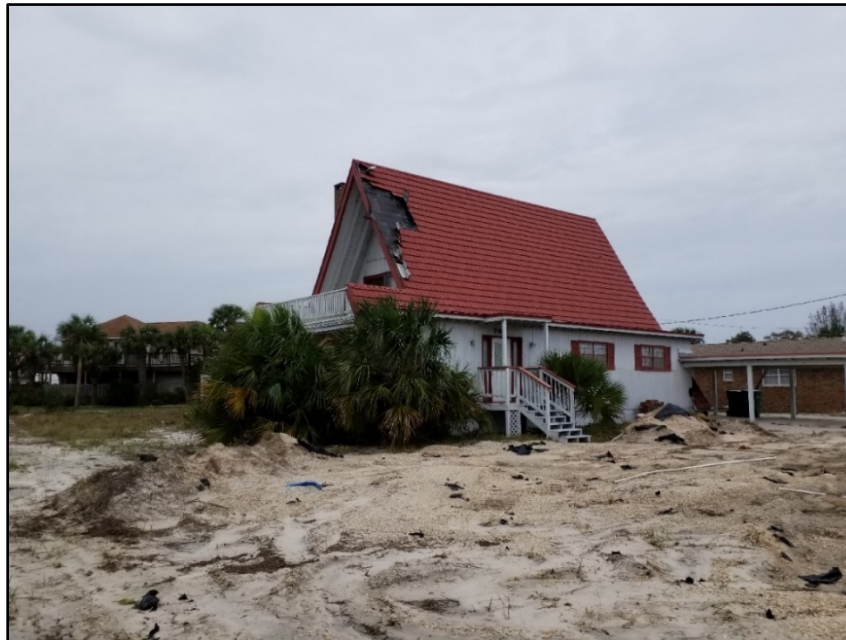
Figure 43. Typical roof damage in Okaloosa Island, R4.

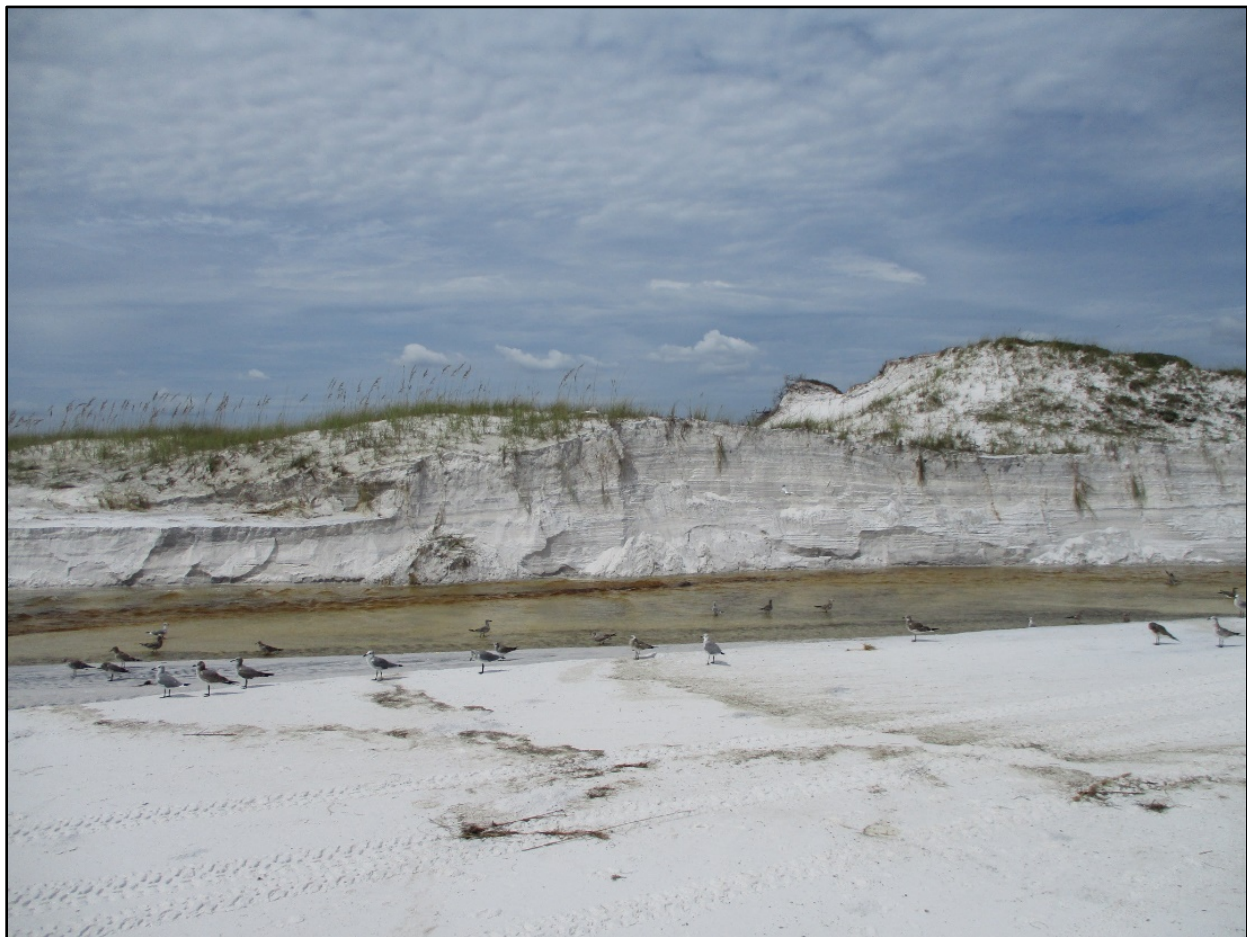
Figure 45. Dune erosion at Morris Lake Outlet in Topsail Hill State Park, R28.5.

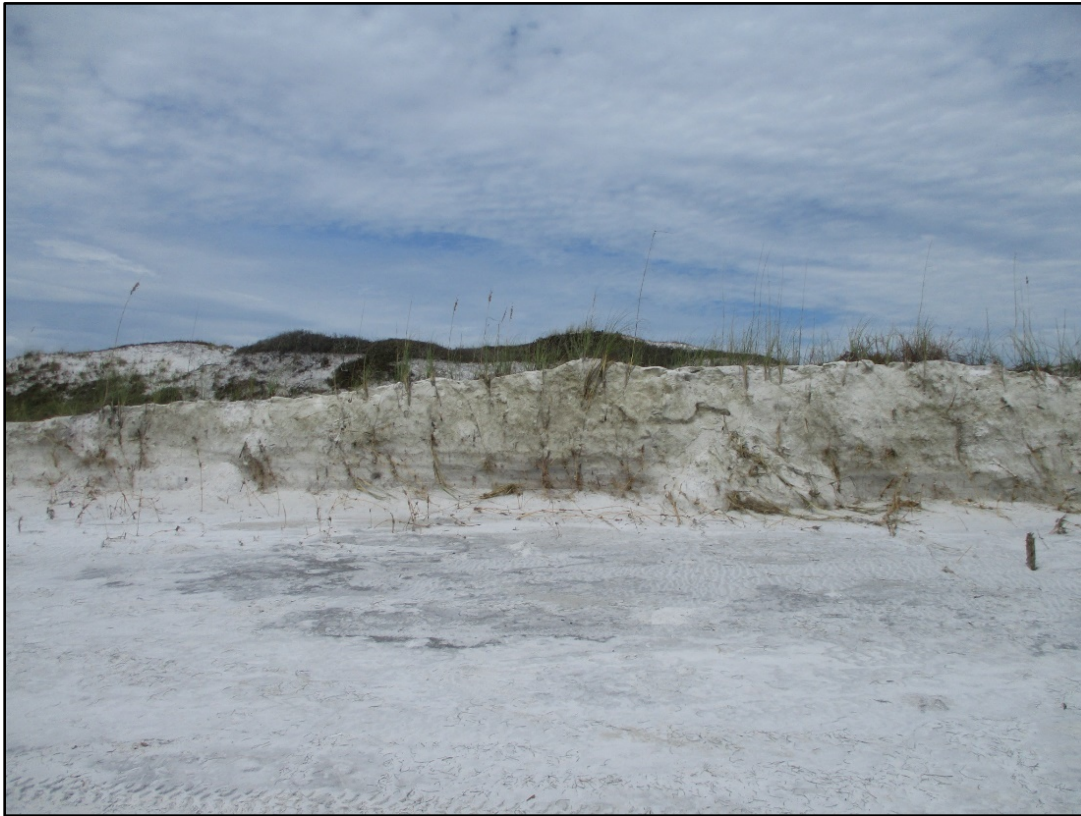
Figure 46. Major dune erosion in Topsail Hill State Park, R32.

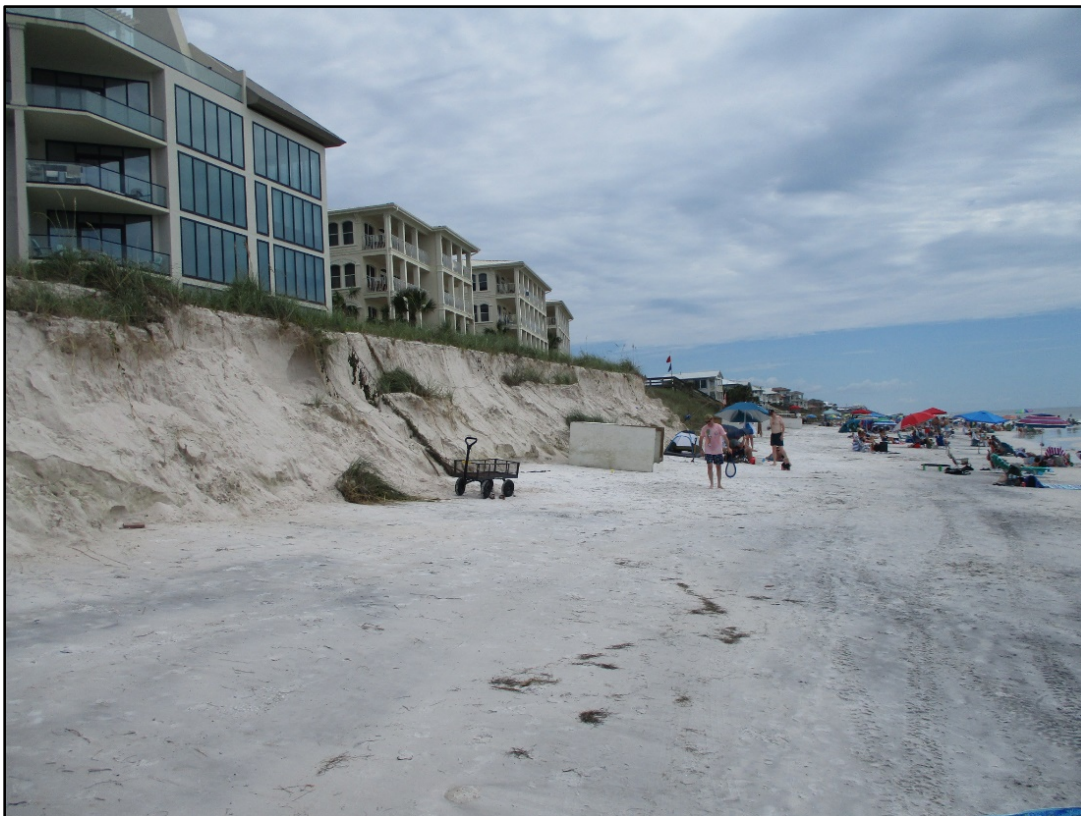
Figure 47. Major dune erosion in Dune Allen Beach, R50.5.

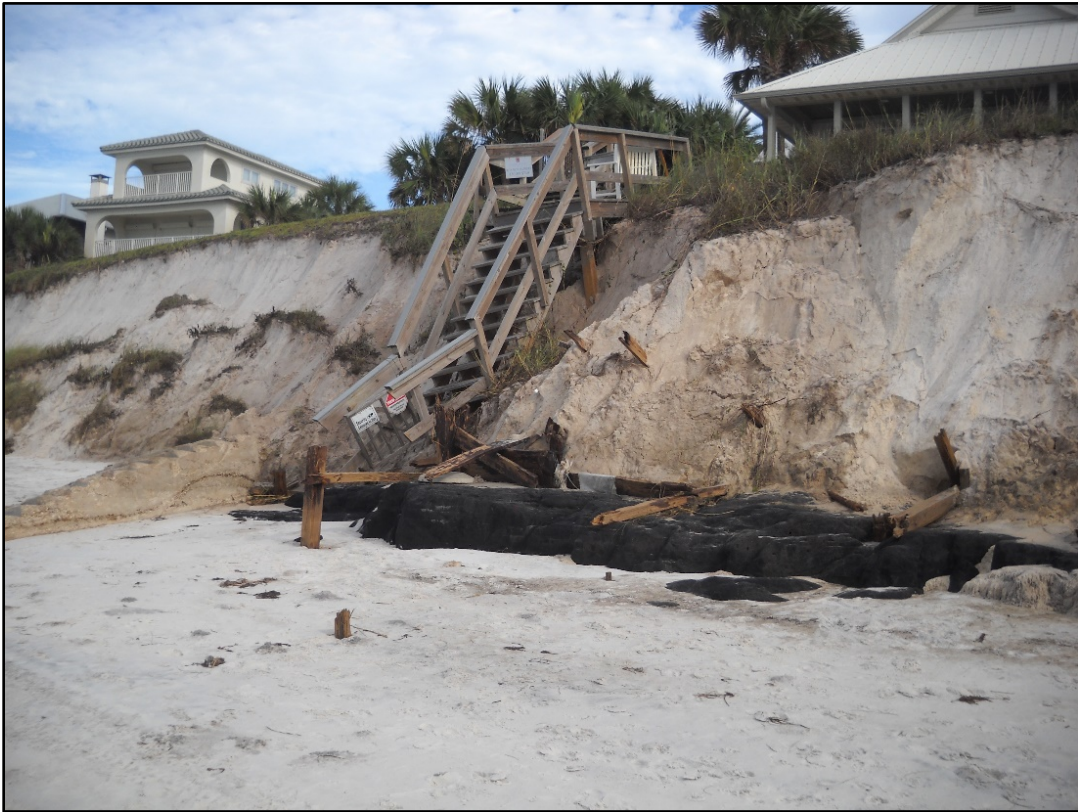
Figure 48. Major dune erosion exposing peat layer in Seacrest Beach, R112.5.

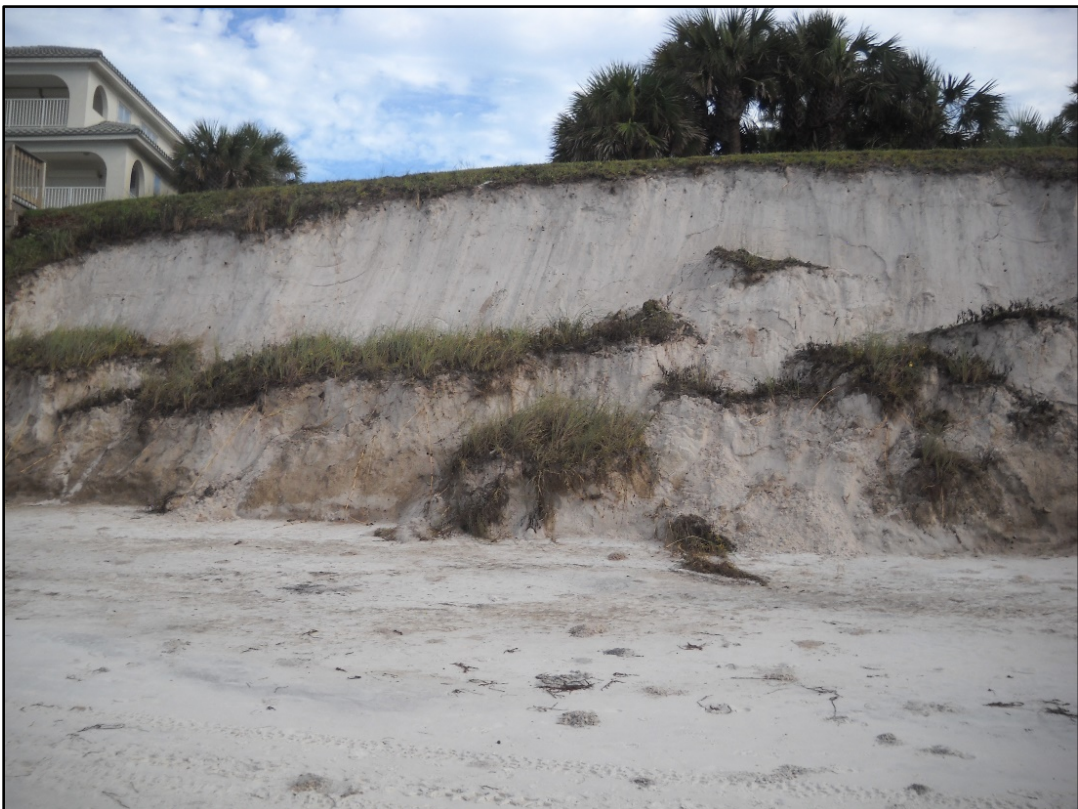
Figure 49. Major dune erosion in Seacrest Beach, R112.5.

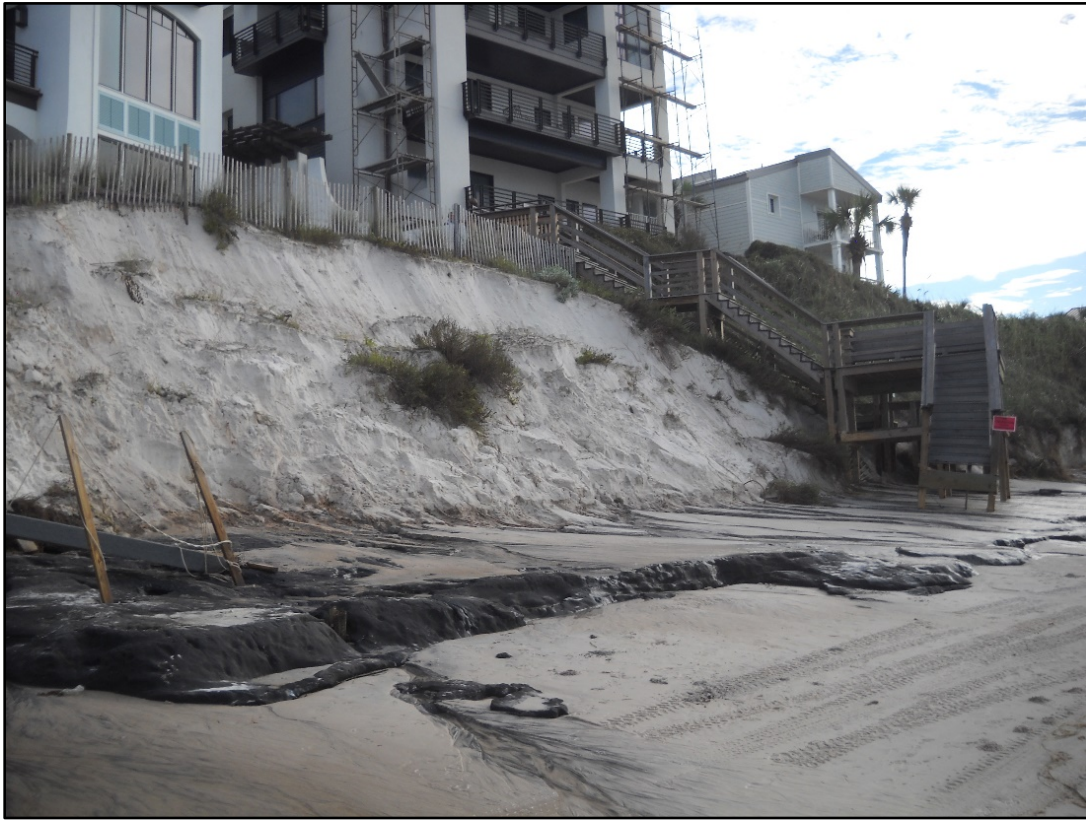
Figure 50. Major dune erosion exposing peat layer in Seacrest Beach, R113.

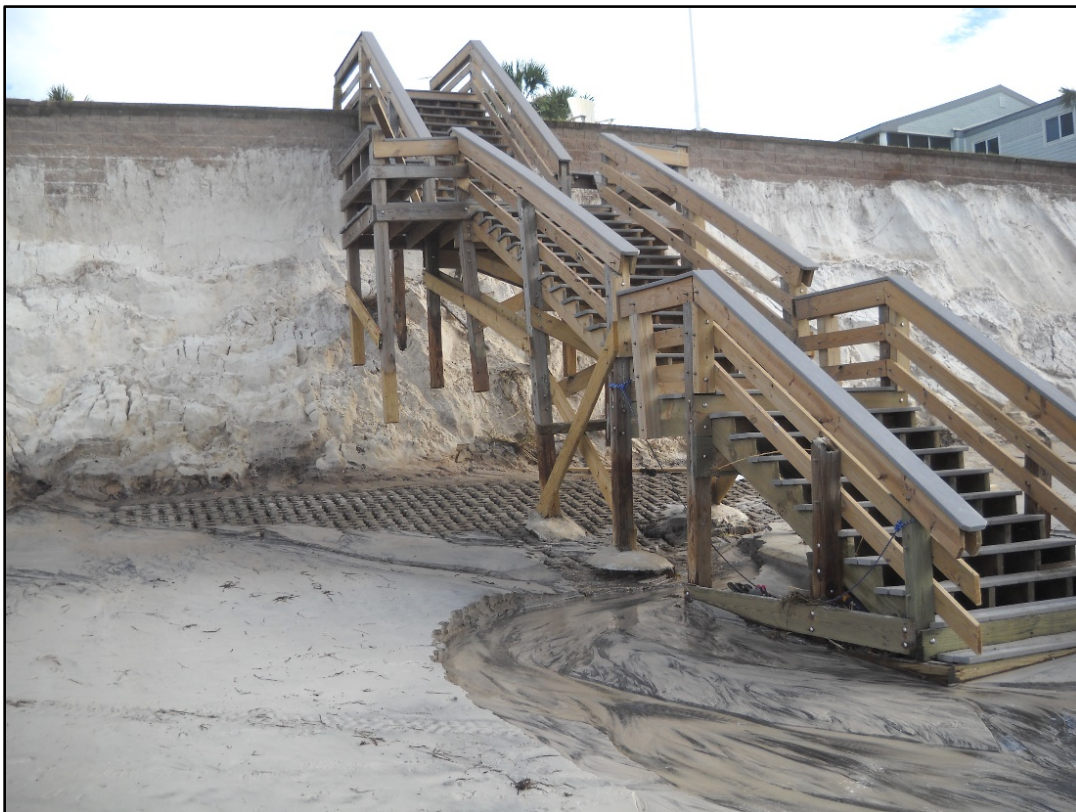
Figure 51. Major dune erosion and exposure of armoring structures, R113.5.

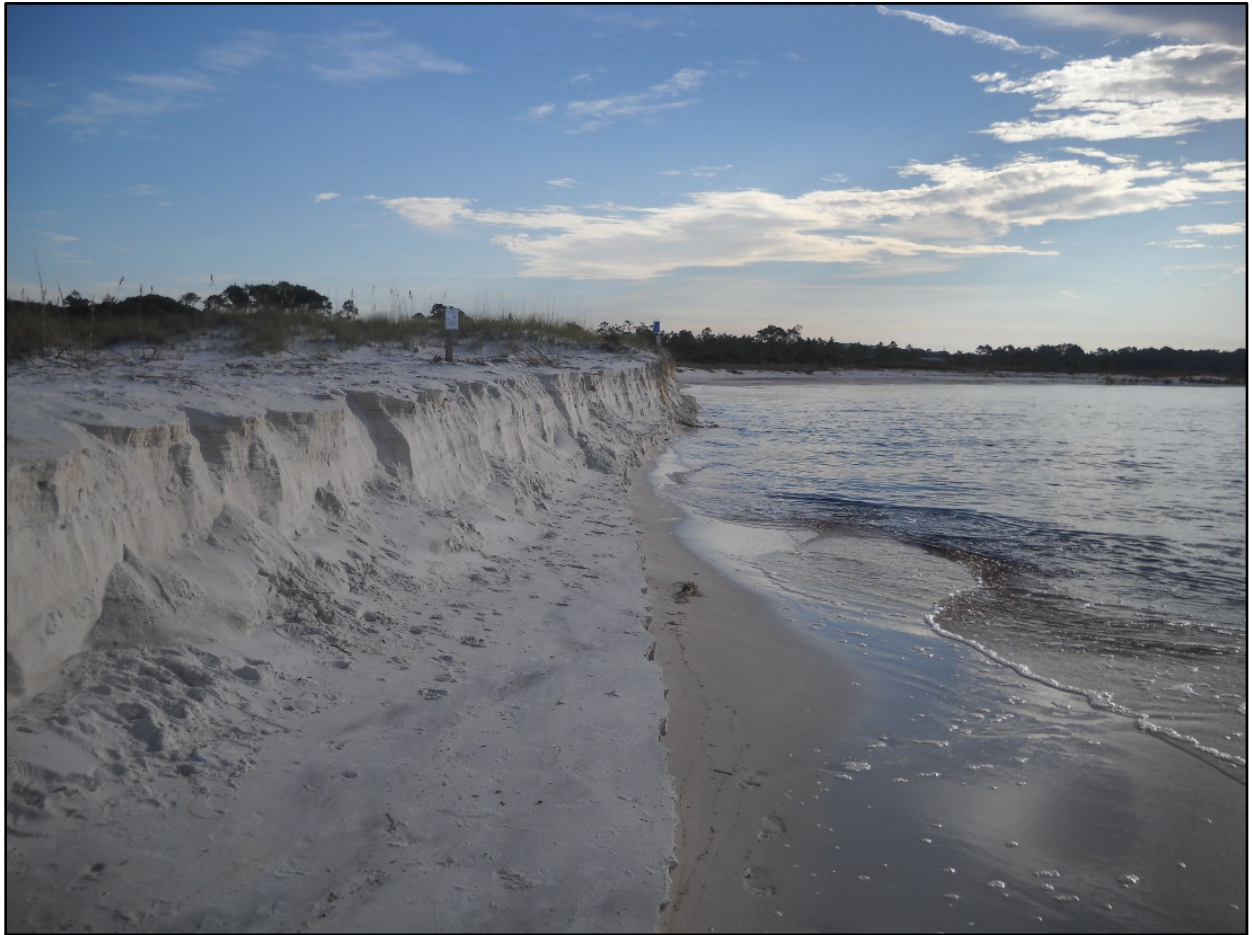
Figure 52. Erosion scarp in Camp Hellen State Park at the Lake Powell Outlet, R127.

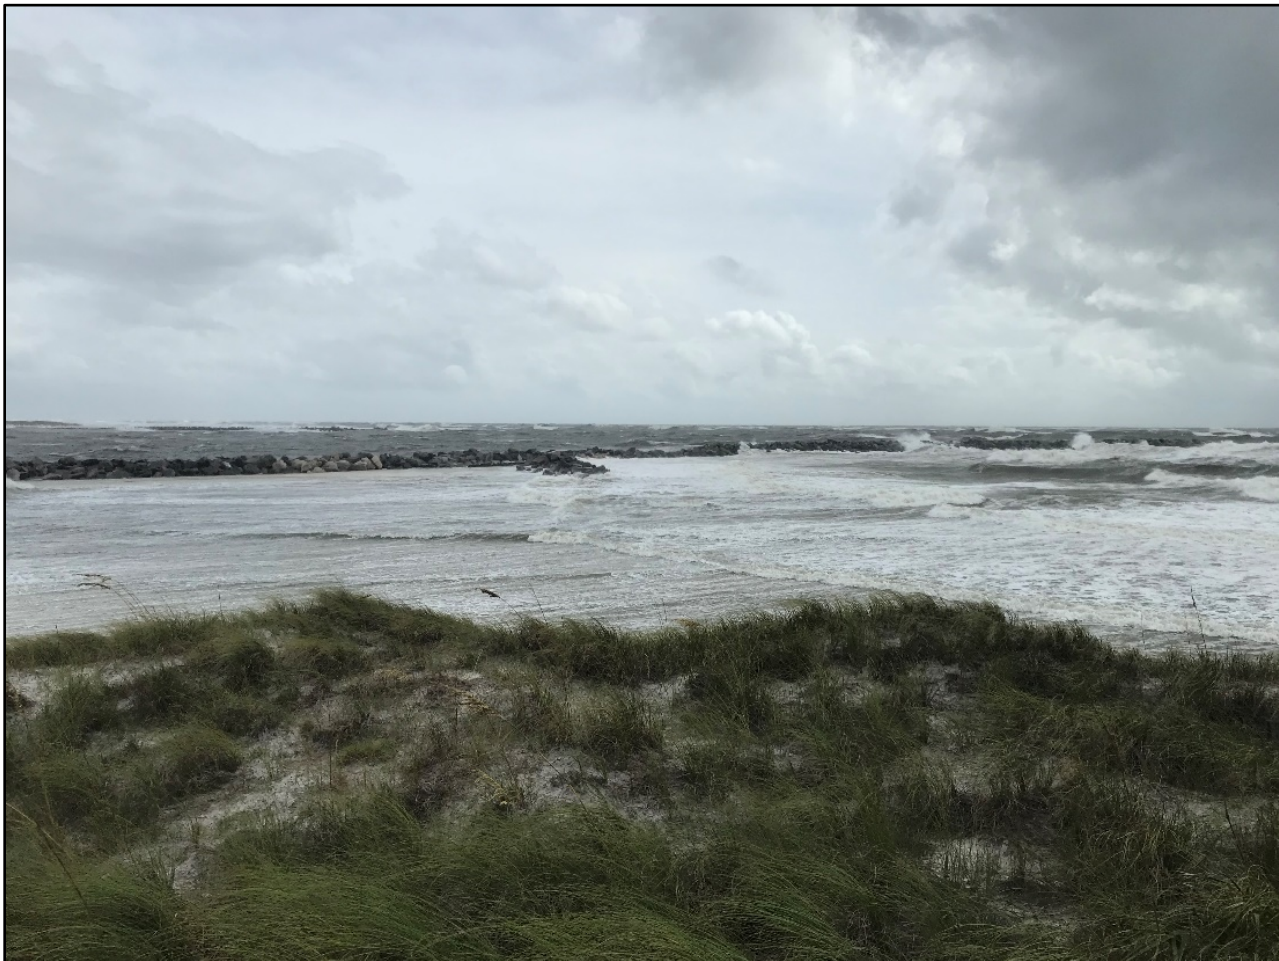
Figure 54. Looking across the breach during Hurricane Sally toward the west jetty at St. Andrews Inlet (R97) [Courtesy of Scott Robinson, FDEP].

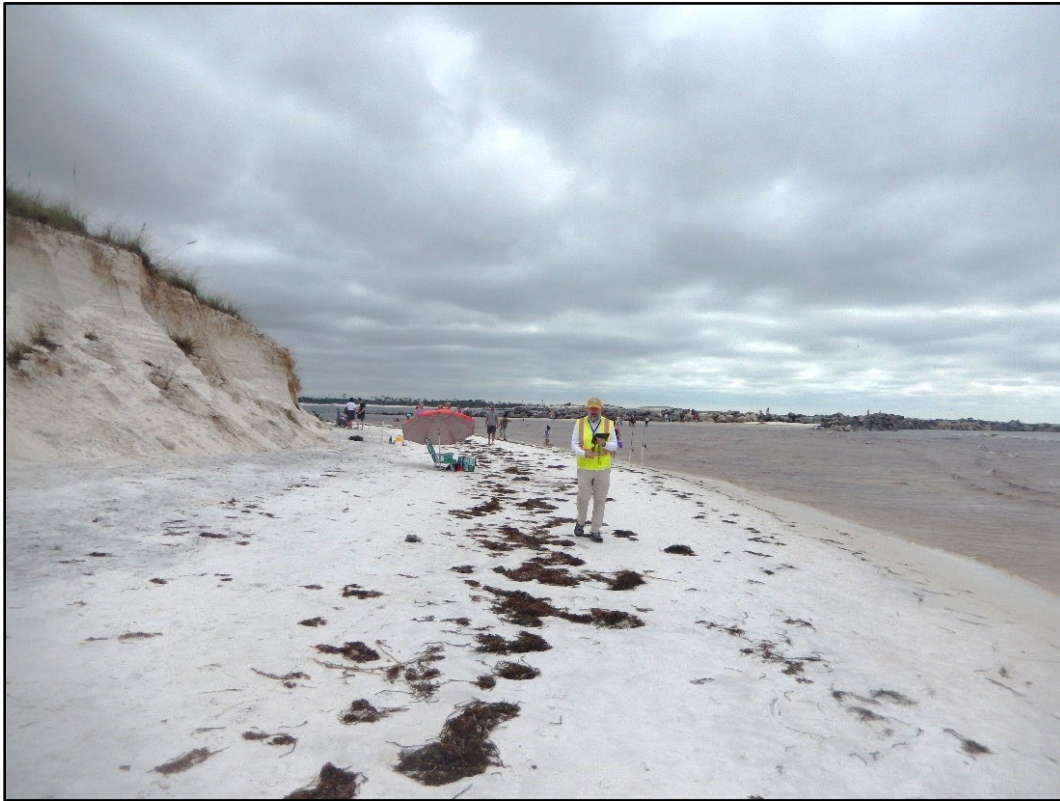
Figure 57. Looking past the eroded park uplands toward the breach and west jetty after Hurricane Sally (R97).

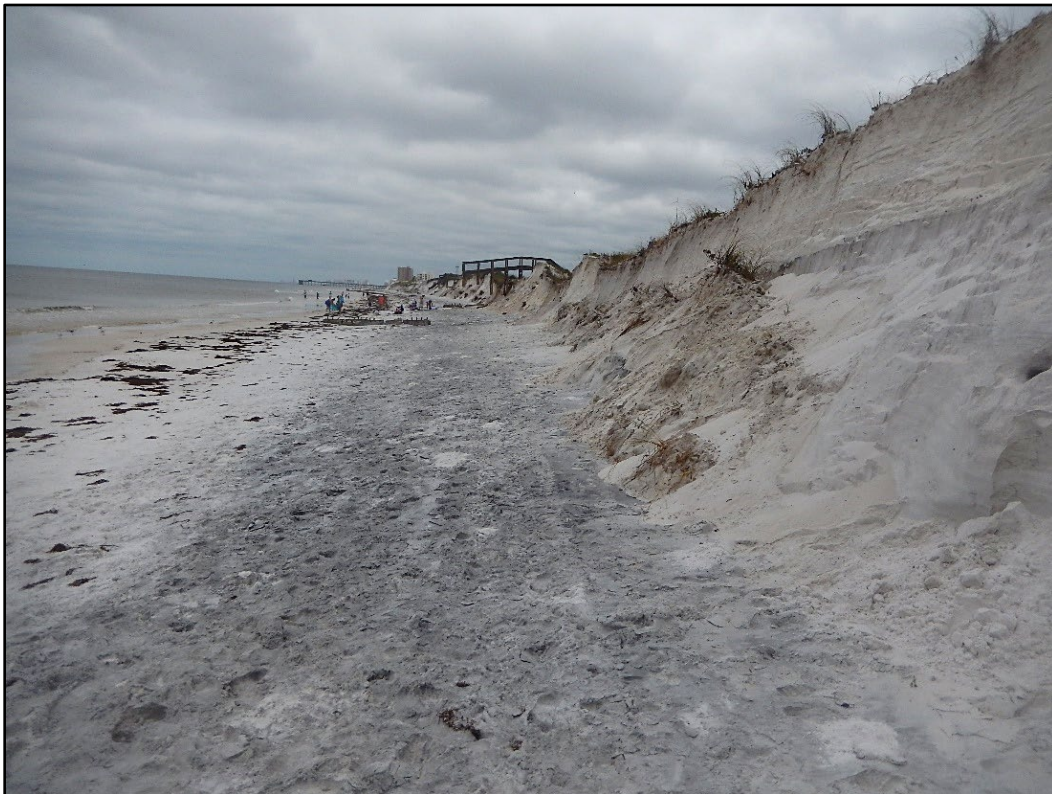
Figure 58. Major dune erosion along St. Andrews State Park (R92-R97) following Hurricane Sally.

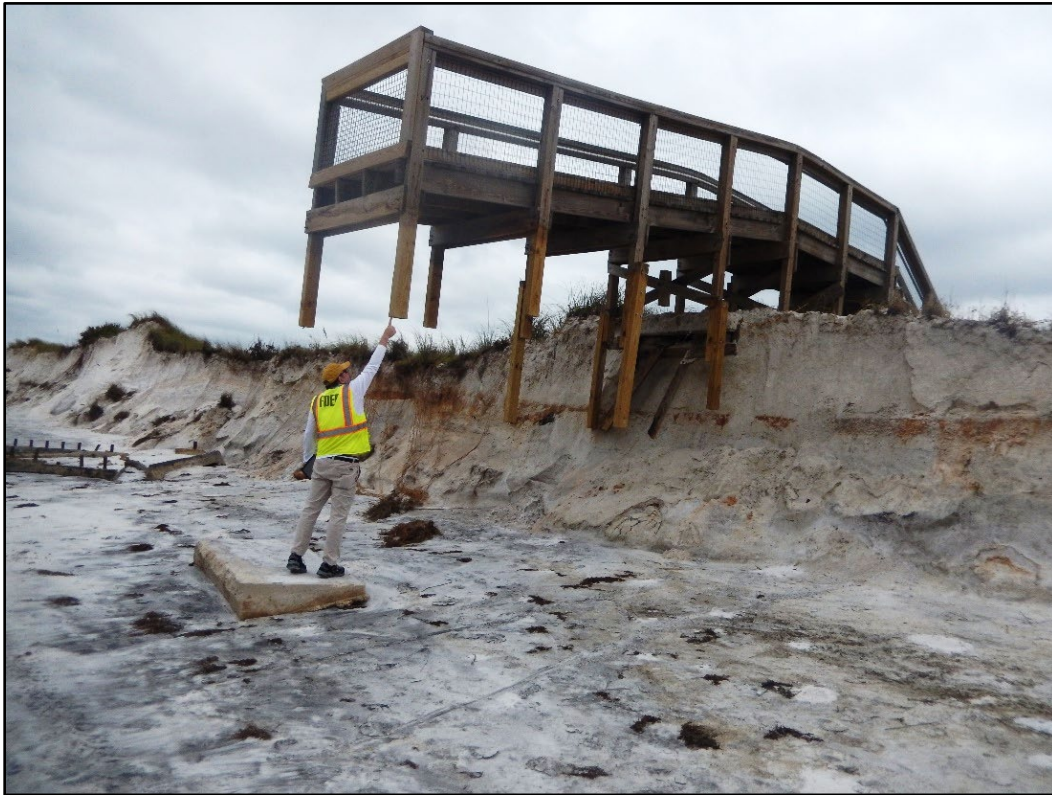
Figure 59. Major dune erosion with park infrastructure damage (R96) following Hurricane Sally.

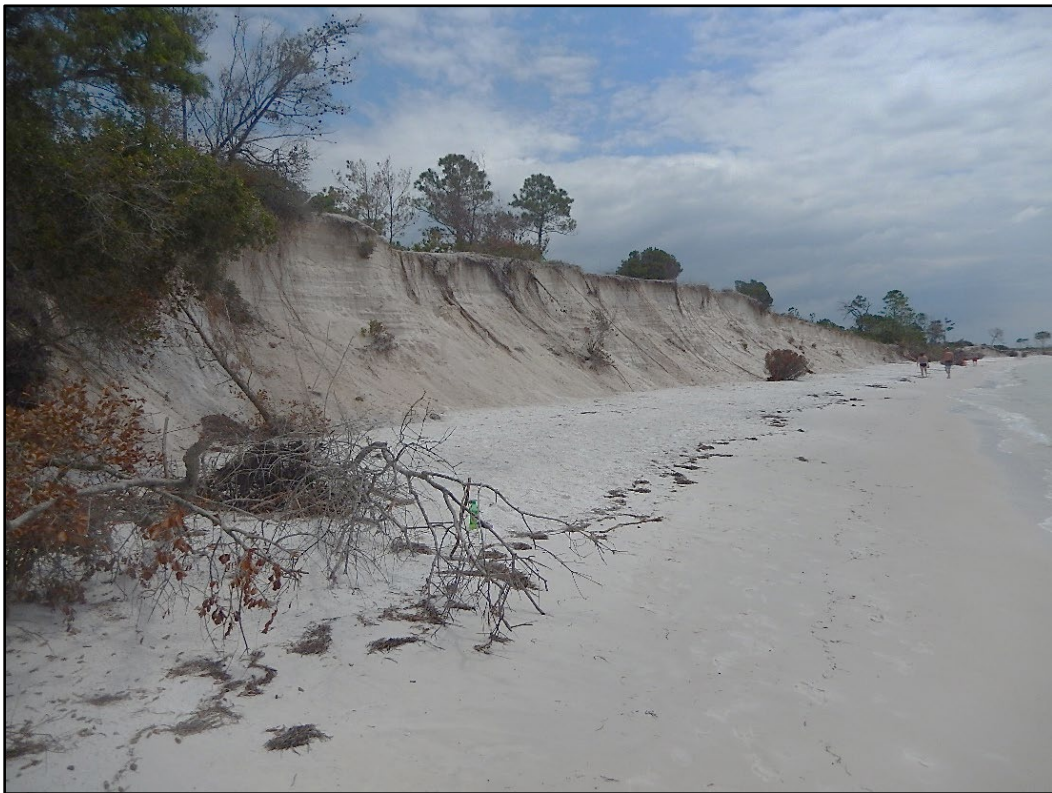
Figure 60. Severe erosion of state park uplands along the west shoreline of St. Andrews Inlet north of the Gator Lake breakwaters and groin.

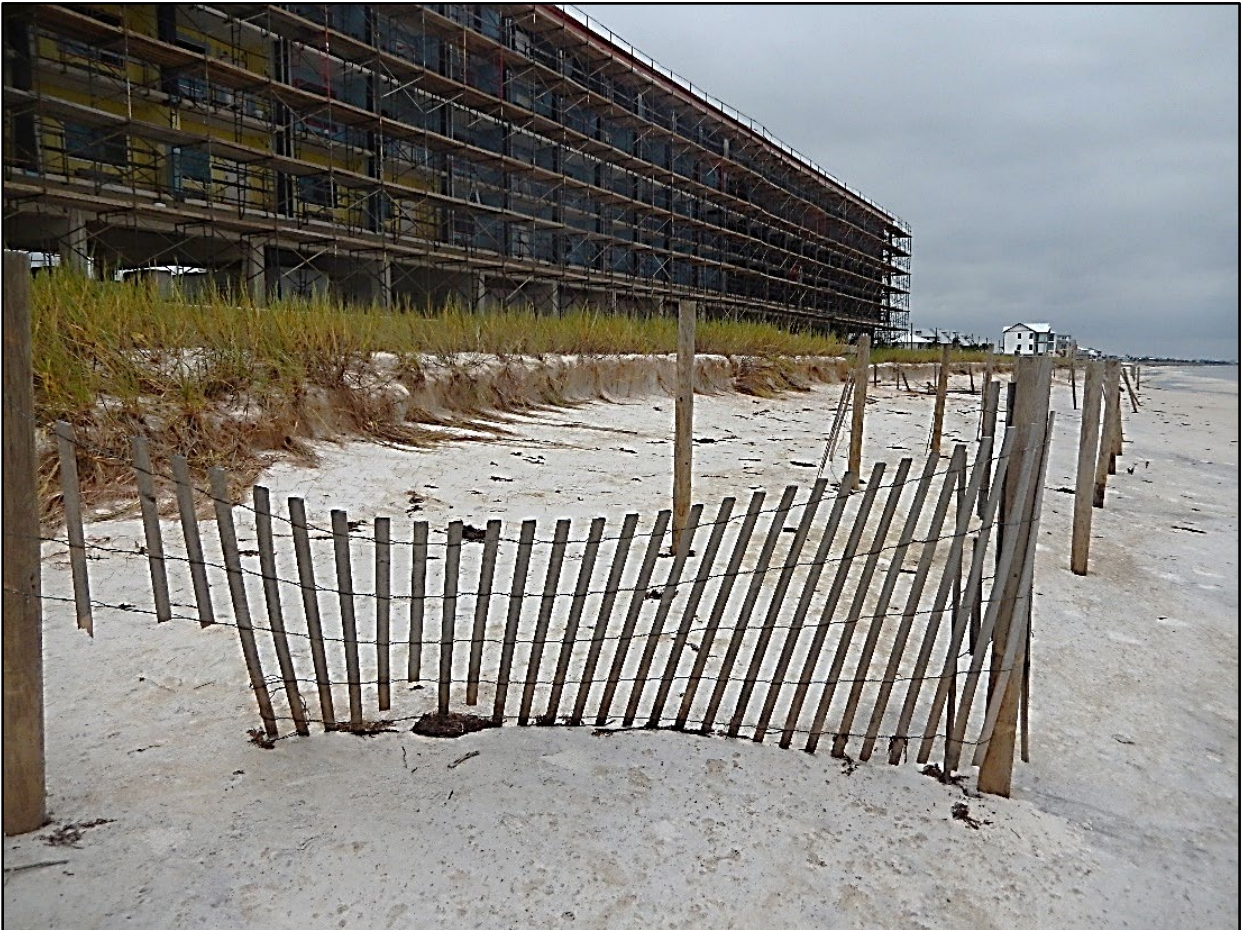
Figure 61. Isolated minor beach and dune erosion (Condition II) in Mexico Beach adjacent the El Governor Hotel (R134.3).

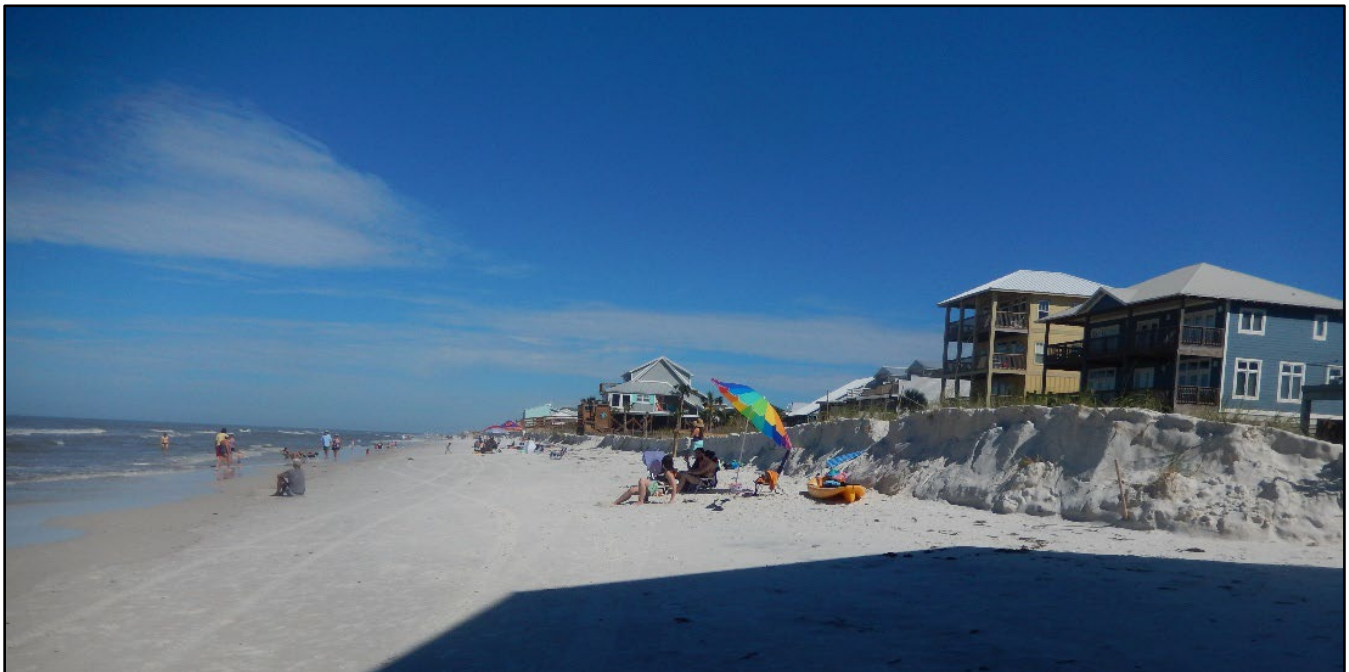
Figure 63. Major dune erosion at R97 near Aruba Drive.

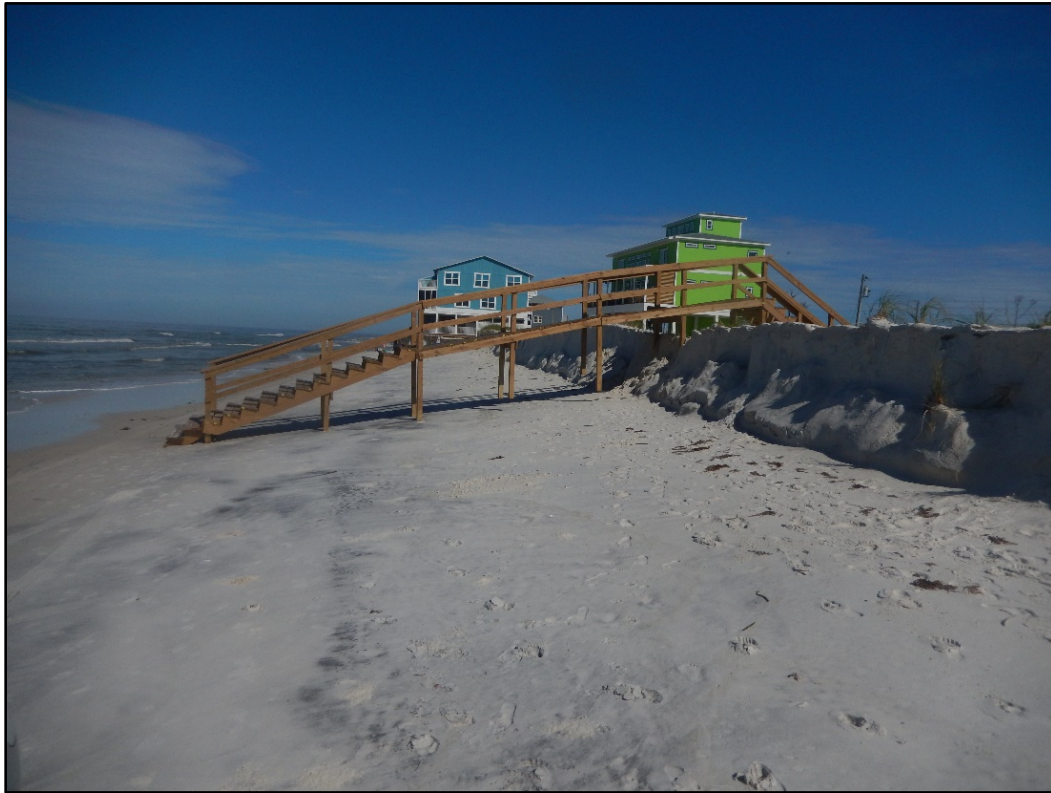
Figure 64. Major dune erosion at R103, north of Stump Hole in Gulf County.

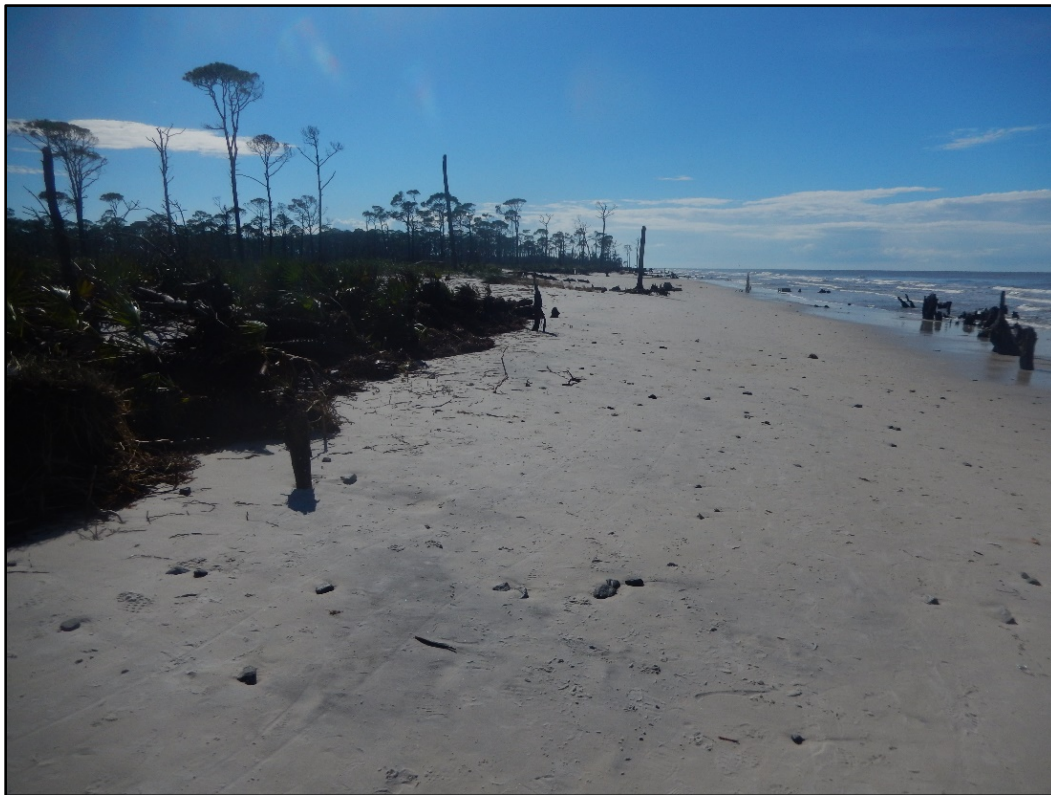
Figure 65. Major dune erosion continues along the entire west shoreline of Cape San Blas (R107-R118).

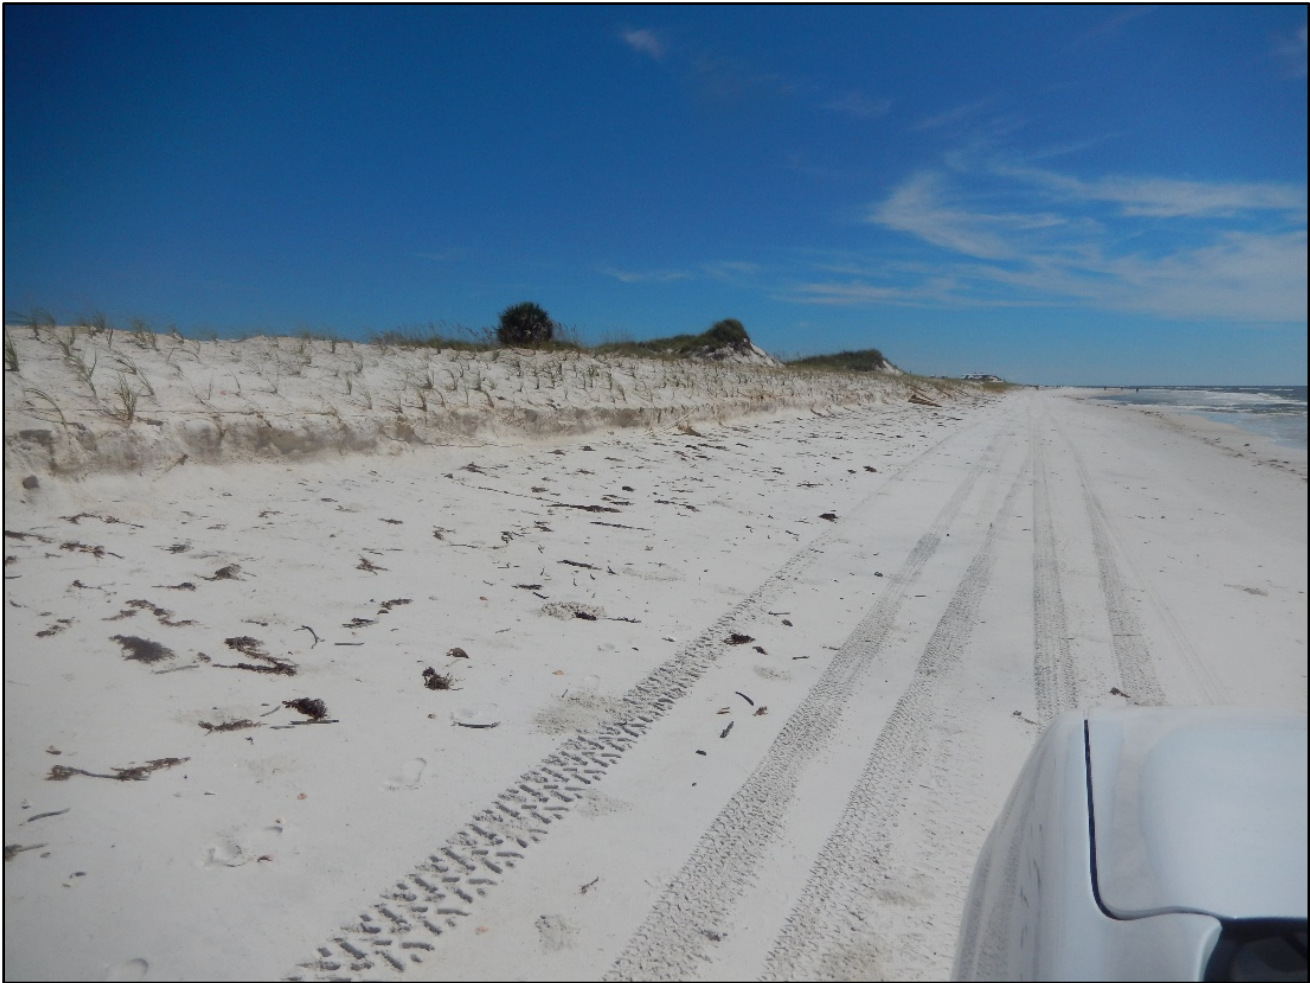
Figure 66. Minor beach and dune erosion at the dune repair section of the Hurricane Michael (2018) inlet breakthrough in the St. Joseph Peninsula State Park (R71-R72).

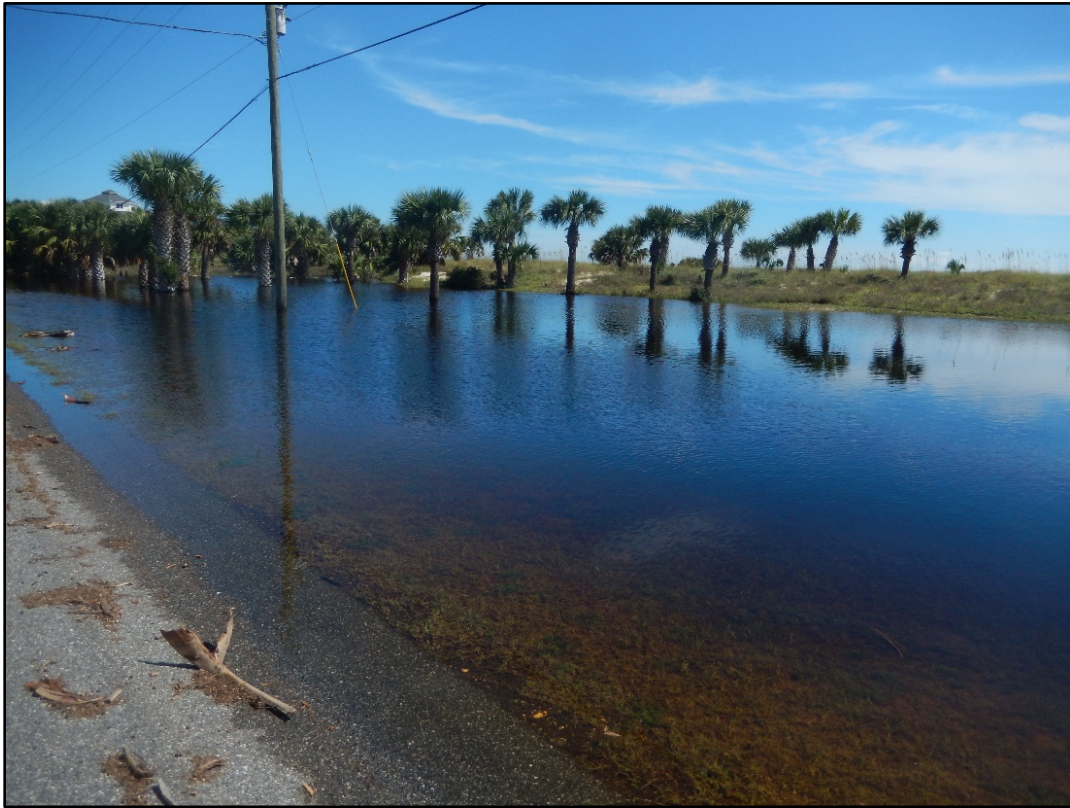
Figure 67. Back dune flooding along Indian Peninsula (R148-R149).
