***Poria Incrassata* Rot:**

Prevention and Control in Buildings

Technical Bulletin No. 1385
U.S. Department of Agriculture
Forest Service

Technical Bulletin No. 1385

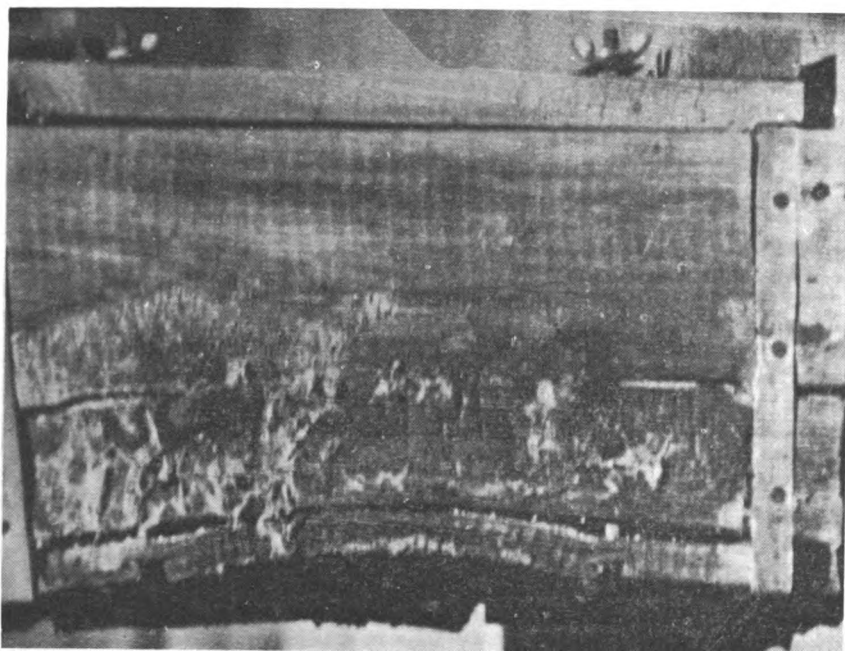
F-512968

In recent years the fungus was found attacking ammunition boxes stored on the ground in pine woods in Mississippi (49) (fig. 2). It was isolated from a dead Virginia pine near a woods site where the soil had been artificially inoculated (14), from a bridge timber near Gainesville, Fla., and from test stakes in Wisconsin and Mississippi (17).

Figure 2.—Ammunition box decayed by *Poria incrassata*.

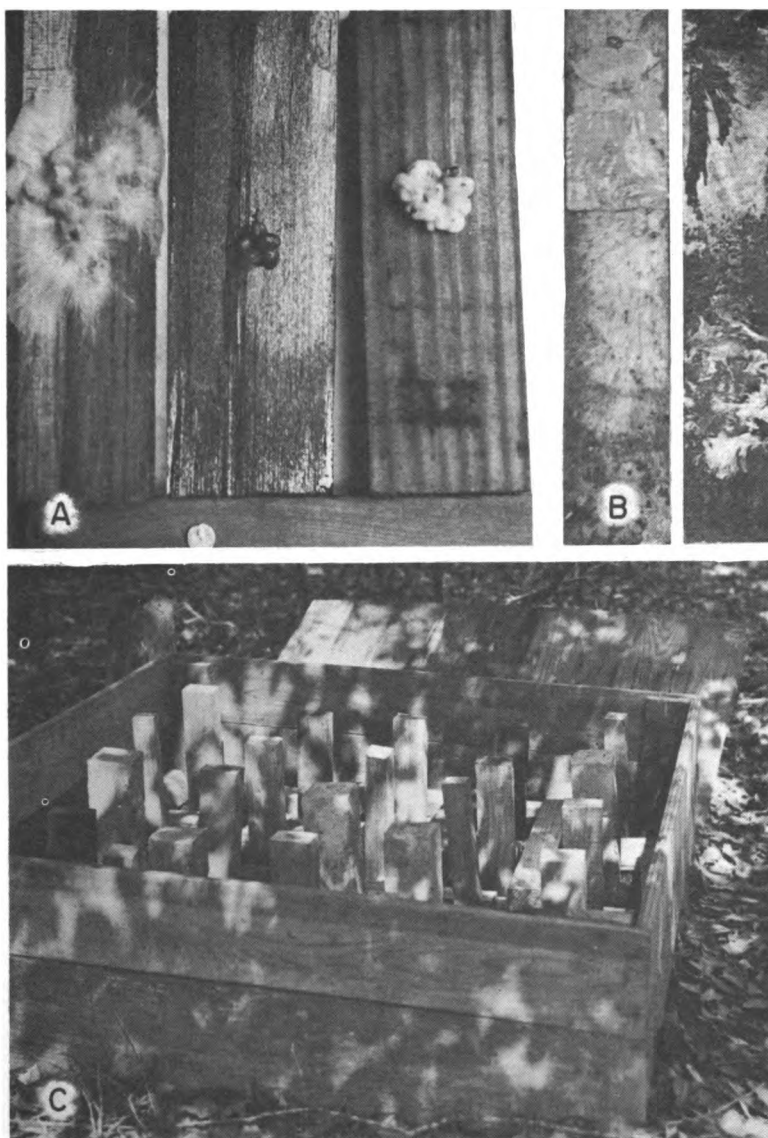
F-512974, 512976, 512975

For the laboratory phase, three pieces of each wood (0.5 by 1.5 by 3 inches) were placed on end in 0.5 inch of sterile water in individual glass jars and inoculated with *Poria incrassata* growing on wheat kernels. After 5 days' incubation at room temperature the inoculum on the creosoted wood was dead; that on wood treated with the inorganic salt had spread up to 0.9 inch over the wood; that on the untreated wood had covered much of the surface (fig. 3,A). No decay occurred in any of the treated wood over a 2-year period.

For the field phase, five stakes (2 by 3 by 18 inches) of each wood were placed with one-third their length in the soil under hardwood shade and enclosed in a wooden box with a leaky cover to permit rain seepage (fig. 3,C). Five 4- by 4-inch concrete posts were used to determine if the fungus would spread over concrete. Pine chips were scattered over the soil as feeder blocks, and a few pieces of test wood were laid horizontally on them. The plot was then inoculated with *Poria incrassata* growing on wheat kernels.

Thus creosote, even though giving complete protection against decay, did not prevent spread of mycelial fans and rhizomorphs over the surface. The decay in the salt-treated wood may have followed leaching. Usually this preservative is not recommended for use in soil contact in areas of high rainfall.

The amount of surface mycelial growth on the aboveground parts of stakes was small, even though decay extended to the top of the untreated pine and cypress stakes. The mycelial development shown in figure 3 occurred on the undersides of samples resting on the feeder chips. This restricted surface growth is further evidence of the sensitivity of *Poria incrassata* to drying.

Figure 3.—*Poria incrassata* on treated wood and untreated cypress heartwood. *A*, Growth on southern pine after 5 days in culture jars: *left*, untreated; *center*, pressure-creosoted; *right*, pressure-treated with fluorochrome-arsenate-phenol. *B*, Mycelium on untreated cypress heartwood *left* and creosoted pine *right* after 8 months in the field plot shown in *C*. *C*, Enclosed field plot (with cover removed) of stakes in artificially inoculated soil.

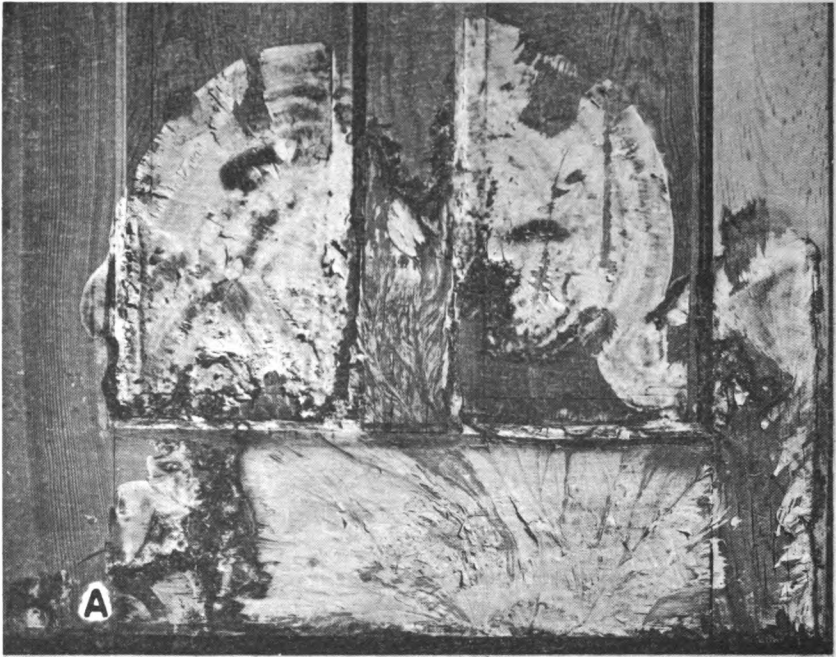
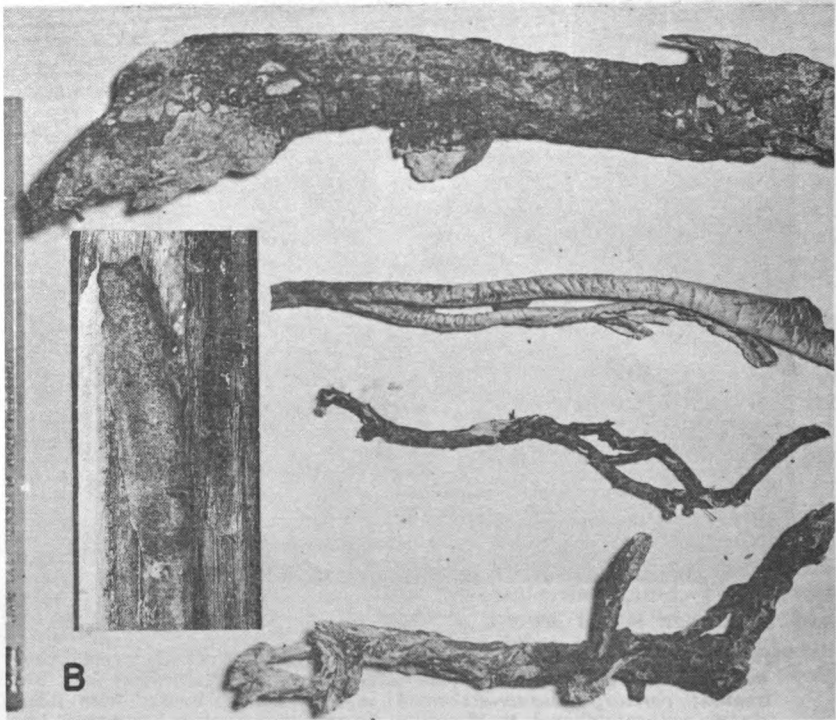
M-52236 F, F-512970, M-30236 F

Irregular vine like rhizomorphs branching in the soil or extending to some other constant supply of water may appear on foundations, framing, or the underside of flooring (fig. 4,B). They are dirty white, sometimes with a yellow tinge, or with age brown to black. They commonly are $\frac{1}{4}$ - to $\frac{1}{2}$ -inch wide but sometimes reach 2 inches. They have a dense outer layer and a porous interior containing enormous hyphae that probably act as water-conducting tubes (fig. 7). Rhizomorphs may be inside brick walls with loose mortar or inside hollow blocks, or may be absent. If they are lacking, the mycelial fans appear to assume the function of conducting water. Fans tend to develop mycelial strands resembling incipient rhizomorphs.

Figure 4.—*A*, Large mycelial fan of *Poria incrassata* that developed between two doors in storage. *B*, Water-carrying rhizomorphs removed from a foundation; inset shows sporophore on a decayed beam.

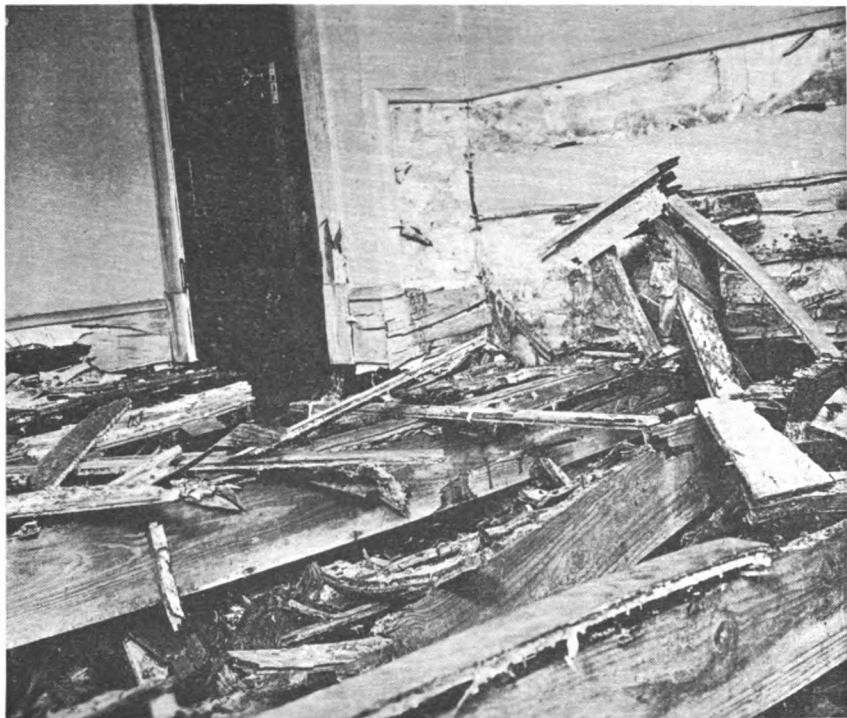
When wood with intermediate to final decay is dried, it usually shrinks severely (fig. 5). For this reason, dry weather may cause wide cracks to open between flooring boards (fig. 6). Such cracks, or depressed areas in painted woodwork, may be the first evidence of infection.

M-19037 F
Figure 5.—Framing, flooring, joists, and trim of house decayed by *Poria incrassata*.

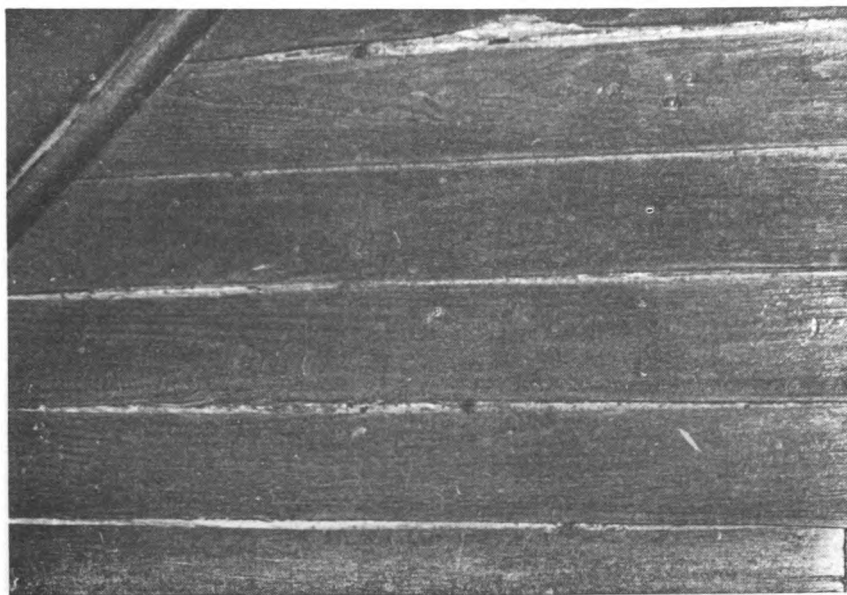
F-512969
Figure 6.—During dry weather, shrinkage cracks in floors often outline extent of attack by *Poria incrassata*.

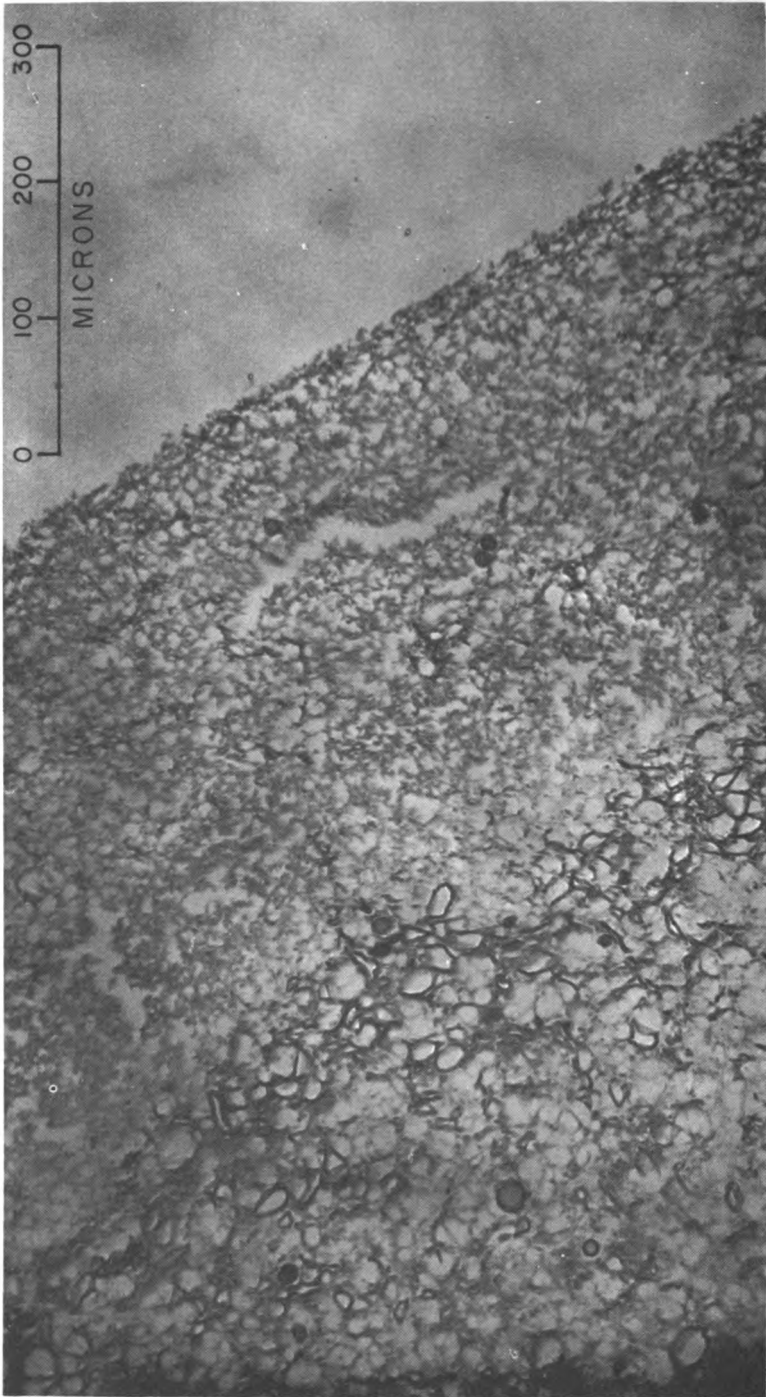
F-519973

Figure 7.—Section through a rhizomorph, showing dense rind and porous interior with giant hyphae for conducting water.

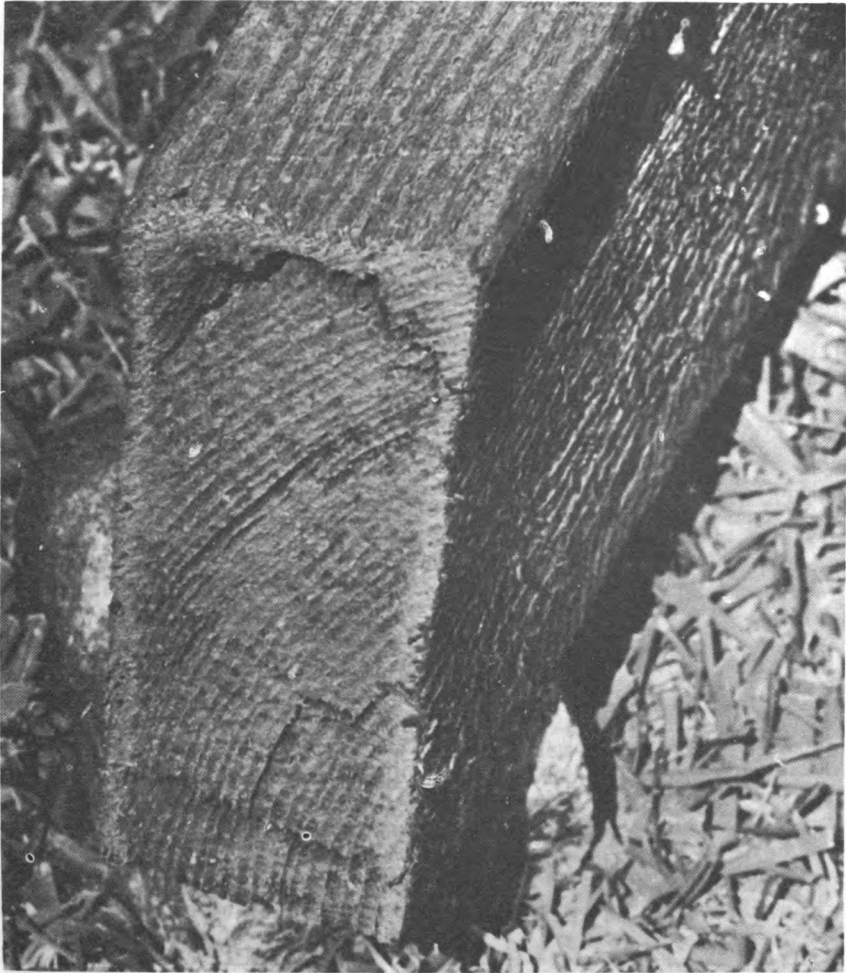
F-512971

Figure 8.—Joist rotted by *Poria incrassata* in a dry crawl space; a sound shell of wood remains.
