Public Meeting – August 21, 2021

# Historic Route 66 State Park Bridge Rehabilitation

# Existing Bridge Profile

*Highway 66 Bridge over Meramac River between Eureka and St. Louis, Mo.*

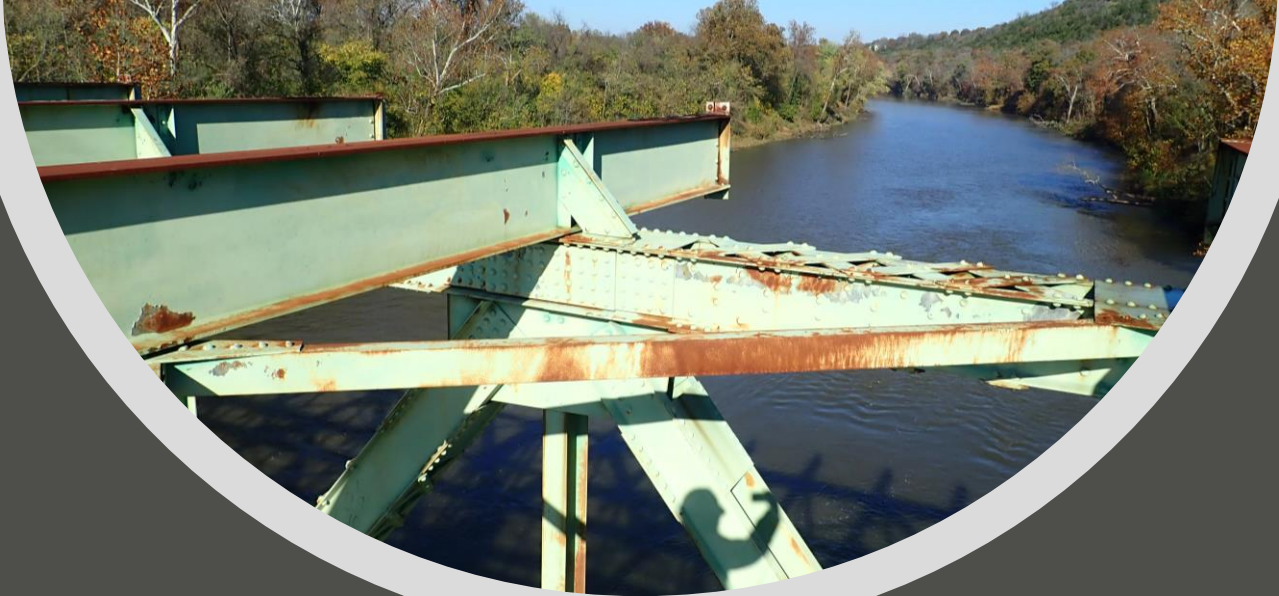
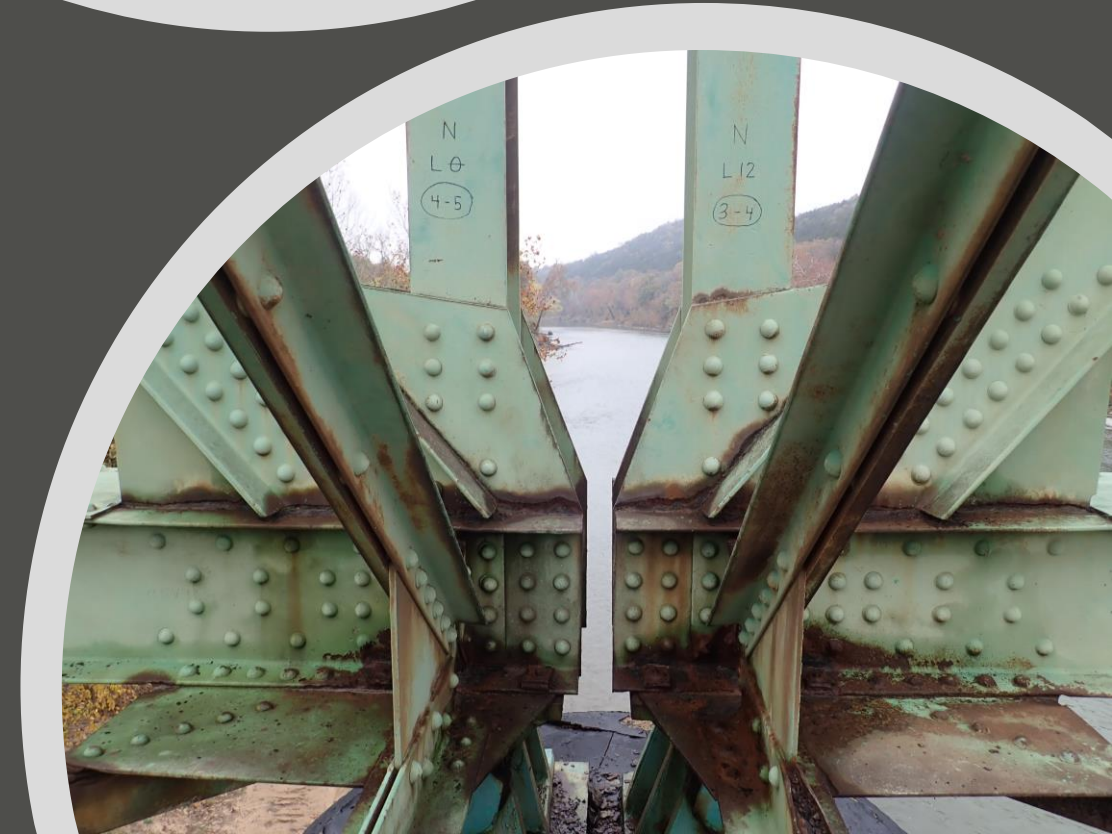
# Main Truss Spans

## CDG Inspection Findings

### Floorbeams

### Ends of Trusses

### Interior Truss Sections

- Remove and replace select plates and bracing members
- Remove and replace limited rivets

### Bearings

- Remove and replace

- Remove and replace vertical cross frames and top/bottom lateral bracing
- Cut-off ends of bottom chord and end diagonals and replace in-kind
- Remove and replace top chord and end vertical member in-kind

- Remove and replace rocker bearings
- Rehab or remove and replace fixed bearings

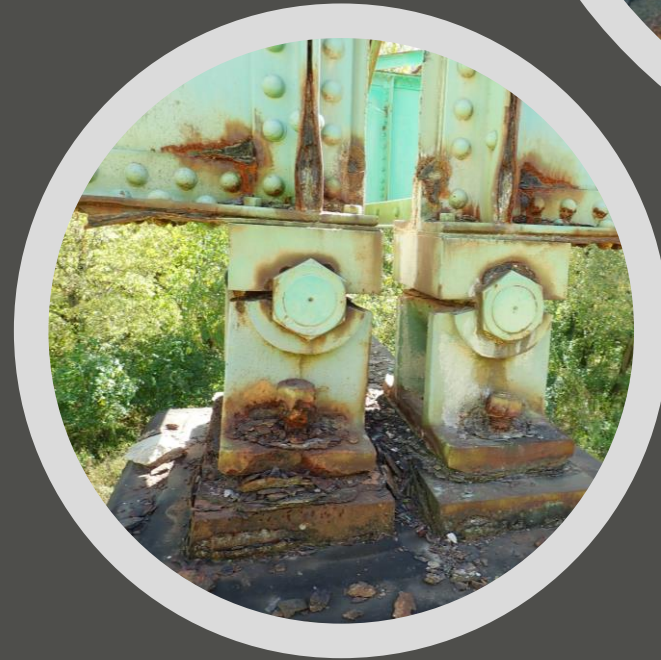
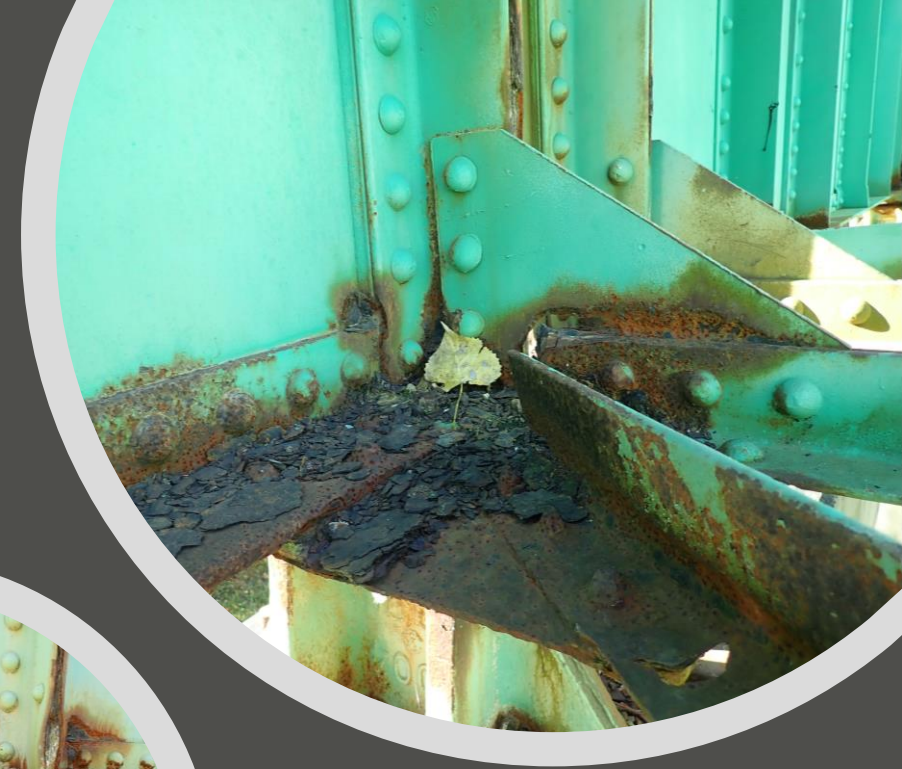
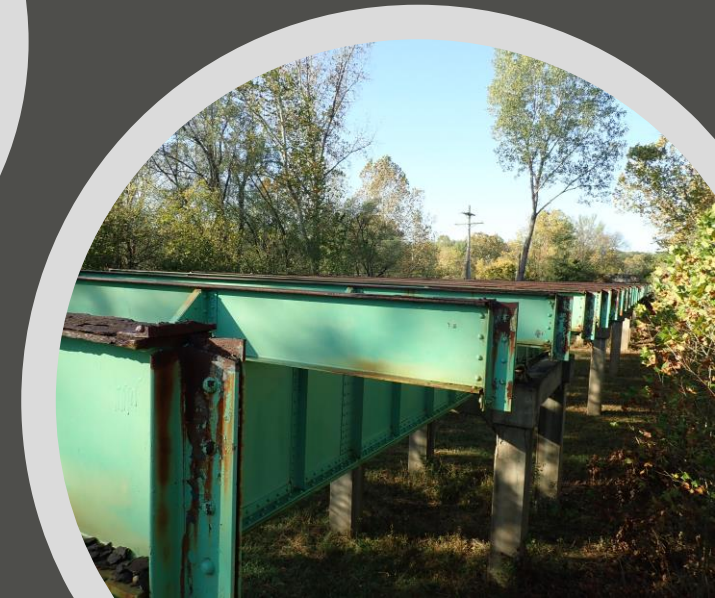
# Approach Spans CDG Inspection Findings

## Floorbeams

## Ends of Approach Spans

## Interior Approach Span Sections

## Bearings

- Remove and replace

- Remove and replace vertical cross frames and top/bottom lateral bracing

- Remove and replace select plates and bracing members
- Remove and replace limited rivets

- Remove and replace rocker bearings

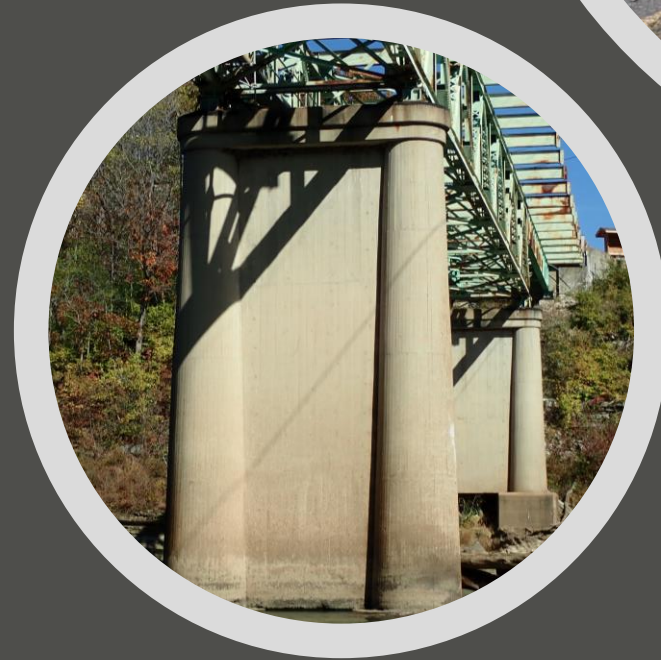
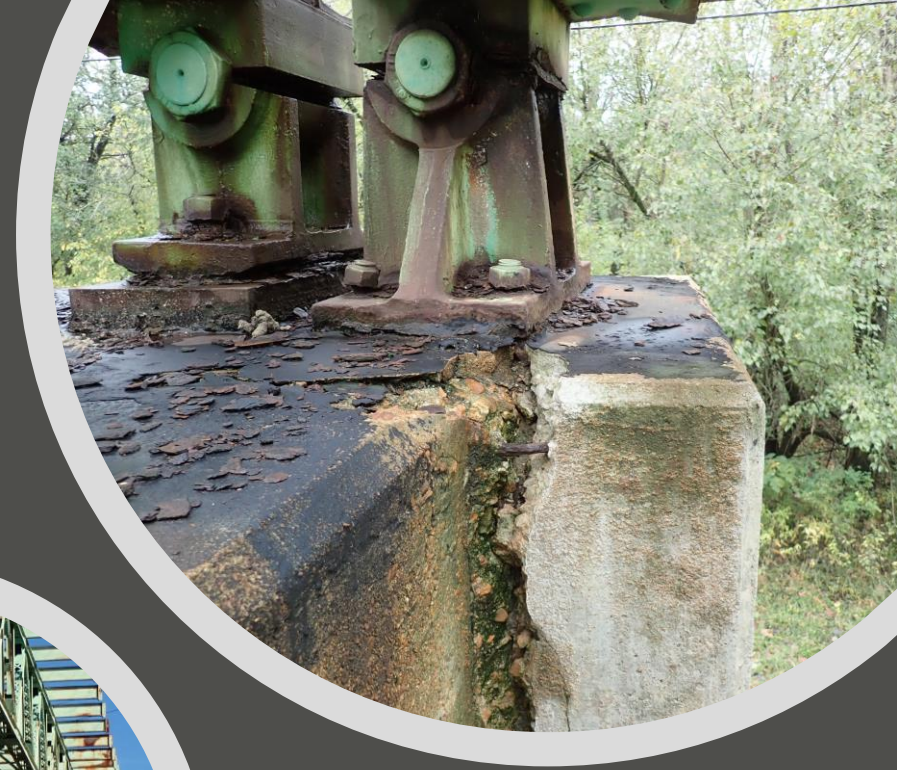
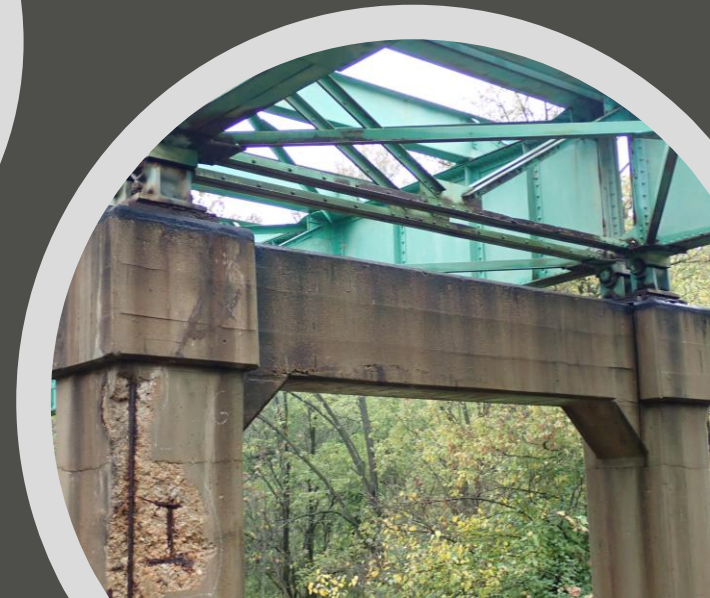
# Substructure CDG Inspection Findings

## Approach Span Bents

- Repair extensive concrete and rebar deterioration

## Three (3) Truss Span River Bents

- Repair minor concrete and rebar deterioration

## Approach Span Bents (Bent 8B)

- Possible need for emergency repairs on west-side approach spans – loss of bearing support
