# National Transportation Safety Board

## Railroad Accident Brief

### Derailment and Subsequent Collision of Two Metro-North Passenger Trains

<b>Accident No.:</b>	DCA13MR003
<b>Location:</b>	Bridgeport, Connecticut
<b>Date:</b>	May 17, 2013
<b>Time:</b>	6:01 p.m. eastern daylight time
<b>Railroad:</b>	Metro-North Railroad
<b>Property damage:</b>	\$18.5 million
<b>Injuries:</b>	65
<b>Fatalities:</b>	0
<b>Type of accident:</b>	Collision

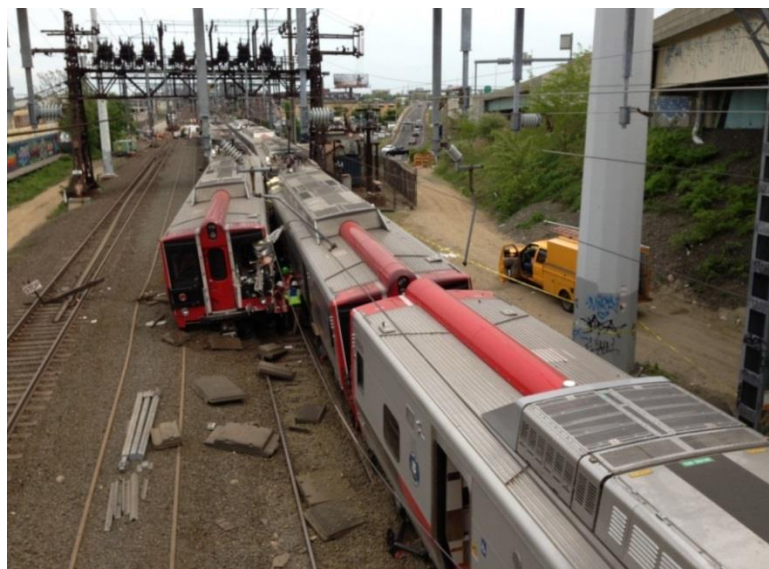
On Friday, May 17, 2013, at 6:01 p.m. eastern daylight time, eastbound Metro-North Railroad (Metro-North) passenger train 1548, which had departed Grand Central Terminal (GCT), New York, New York, headed toward New Haven, Connecticut, derailed from main track 4 at milepost (MP) 53.25 on the New Haven Line Subdivision 7. The derailed train was then struck by westbound Metro-North passenger train 1581, which had departed New Haven, Connecticut, bound for GCT. As a result of the collision, at least 65 persons were injured. Metro-North estimated about 250 passengers were on each train at the time of the accident. (See figure 1.)

Figure 1. Metro-North passenger trains: 1548 (right) and 1581 (left).

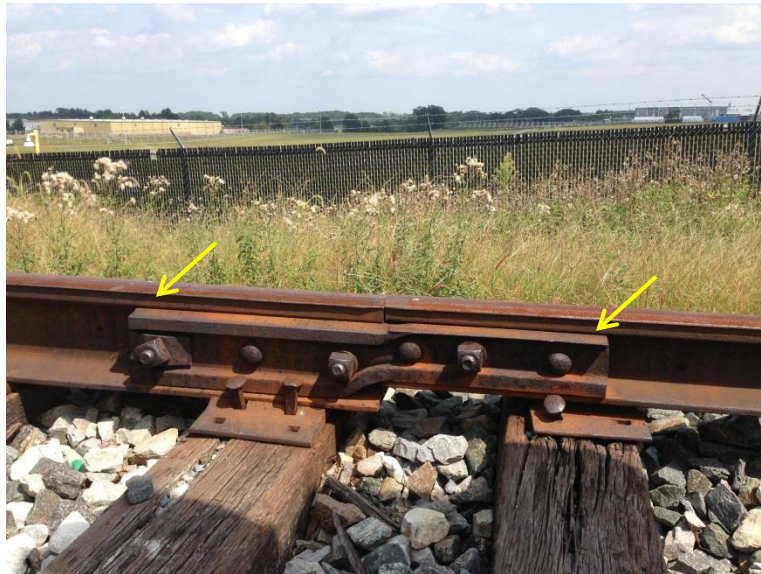
At the point of derailment, investigators found a pair of broken compromise joint bars on the north rail of main track 4. Compromise joint bars are used to join two rails of different sizes by compensating for the different heights of the two rail heads. (See figure 2.) The compromise joint was two separate bars that were bolted to the webs of the two rails. The two rails were

**Figure 2. Photograph of an exemplar compromise joint bar denoted by arrows (not Metro-North).**

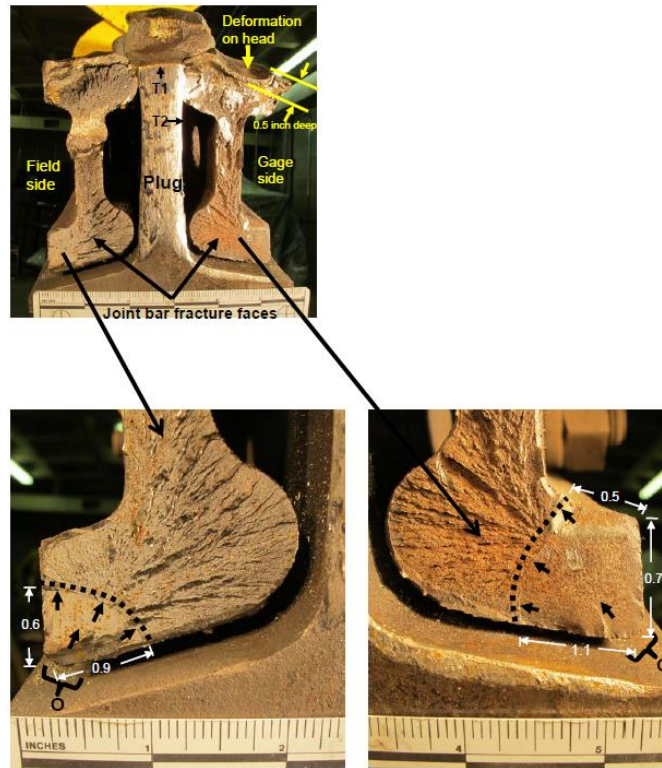
The broken compromise joint bars were examined at the accident scene by NTSB investigators and in the NTSB Materials Laboratory in Washington, DC. The examination found that the gage side bar, which is the bar closest to the center line of the track, exhibited crack arrest marks indicative of fatigue cracking. The fatigue cracks emanated from multiple origins at the bottom of the bar. The compromise joint bar on the field side, which is the bar opposite the gage side, also contained a fatigue crack originating at the bottom of the bar. (See figure 3.) The fatigue propagation extended partially through the middle portions of the compromise joint bars.

**Figure 3. Fractured pair of compromise joint bars and rail showing the east fracture face (top photo) and close-up photographs of the leg portions of the compromise joint bars (bottom photo). A fatigue crack emanated from the lower corner of each leg portion of the compromise joint bars in the areas indicated by brackets “O.”**

By measuring the exposed portions of the fatigue cracks, investigators determined that the gage side bar, which had the largest and oldest fatigue crack, was the first bar to break. The exposed portions of fatigue cracks on the field side bar were smaller; this finding indicated that it was the second bar to break.

Investigators also measured the joined rails to determine whether the rail head running surfaces were properly matched. By design, the compromise joint bars create a 0.1875-inch difference at the base of the rails by raising the smaller rail. This action aligns and levels the rail head running surfaces. However, in this case, the 131-pound rail was worn. The running surface of the 131-pound rail was lower than that of the 136-pound rail; with a vertical rail end mismatch at the joint of about 0.3 inch. A mismatch of this magnitude should have been noticeable by sound and feel when traversed by an inspector in a hi-rail inspection vehicle. This mismatch also would have been noticeable to a trained inspector who walked the track. Federal Railroad Administration (FRA) regulations at Title 49 *Code of Federal Regulations* 213.115, “Rail End Mismatch,” allow no more than a 0.125-inch mismatch on the tread (that is, head) of the rail end for a class 4 track.<sup>2</sup>

On May 15, 2013, 2 days before the accident, the last track inspection in the area of the derailment was performed from main track 2 by Metro-North track inspectors in a hi-rail vehicle.<sup>3</sup> The inspectors documented a “joint with hanging ties” (that is, insufficient ballast support) and “pumping under load” (that is, vertical deflection) at the location of the derailment on main track 4.<sup>4</sup> No corrective action was documented in the report. During an on-scene examination of the derailment area, NTSB investigators found conditions consistent with deflection under the joint. The NTSB investigators determined the combination of the rail-head mismatch and the vertical deflection under the joint caused the compromise joint bars to fail from fatigue cracking.

The NTSB determined that the probable cause of the derailment was an undetected broken pair of compromise joint bars on the north rail of track 4 on the Metro-North Railroad New Haven subdivision at milepost 53.25 resulting from: (1) the lack of a comprehensive track maintenance program that prioritized the inspection findings to schedule proper corrective maintenance; (2) the regulatory exemption for high-density commuter railroads from the requirement to traverse the tracks they inspect; and (3) Metro-North's decisions to defer scheduled track maintenance.

Revise the Track Safety Standards specified in Title 49 *Code of Federal Regulations* 213.233(b)(3), removing the exemption for high-density commuter railroads and requiring all railroads to comply with these requirements: (1) to traverse each main track by vehicle or inspect each main track on foot at least once every 2 weeks, and (2) to traverse and inspect each siding, either by a vehicle or on foot, at least once every month.

Revise your track inspection program to include requirements (1) to traverse each main track by vehicle or inspect each main track on foot at least once every 2 weeks, and (2) to traverse and inspect each siding, either by vehicle or on foot, at least once every month.<sup>6</sup>
