Report on the investigation of
the capsized and foundering of the fishing vessel

JMT (M99)

resulting in two fatalities

3.8nm off Rame Head, English Channel

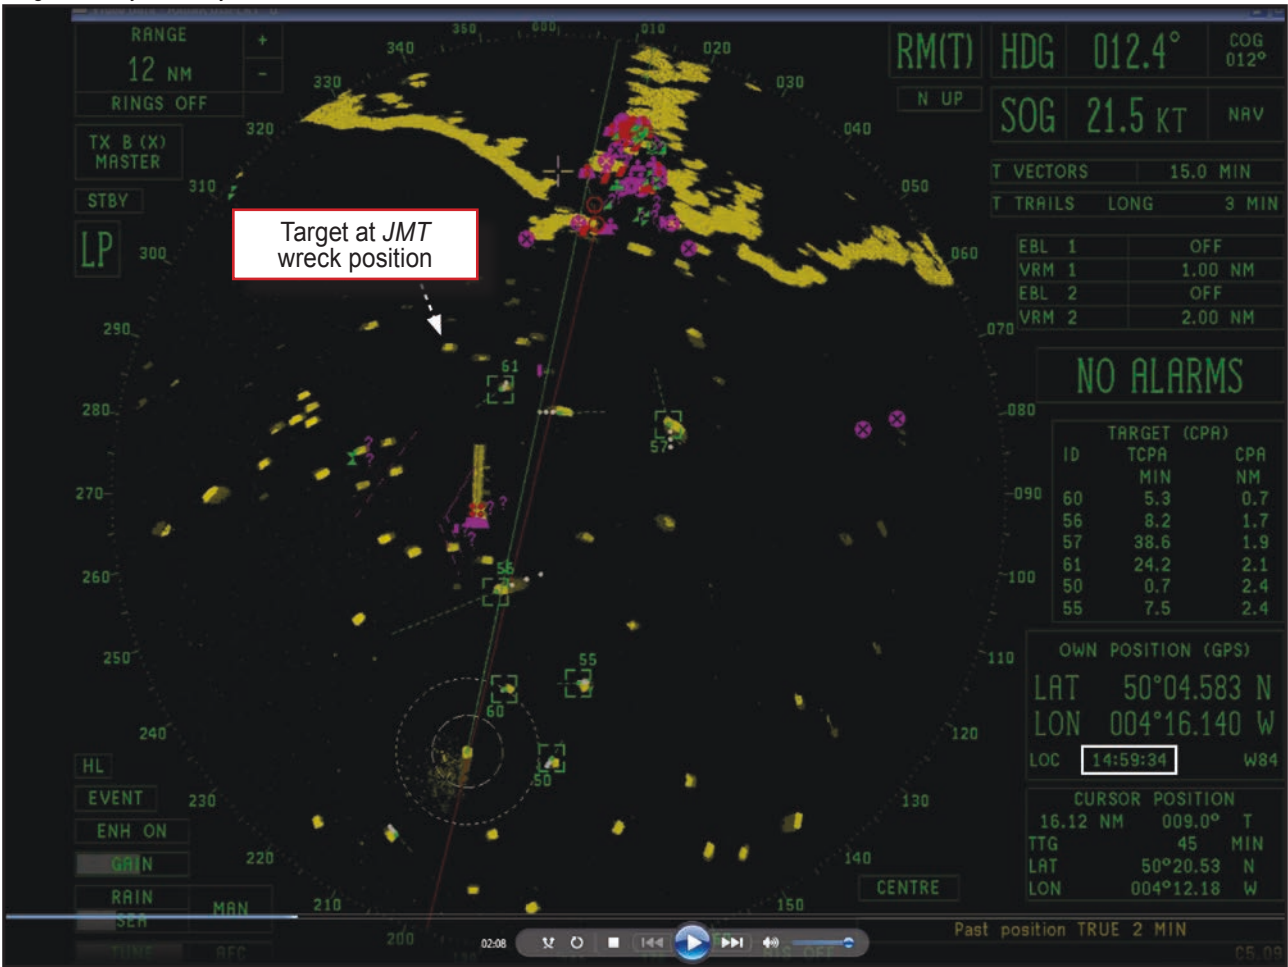
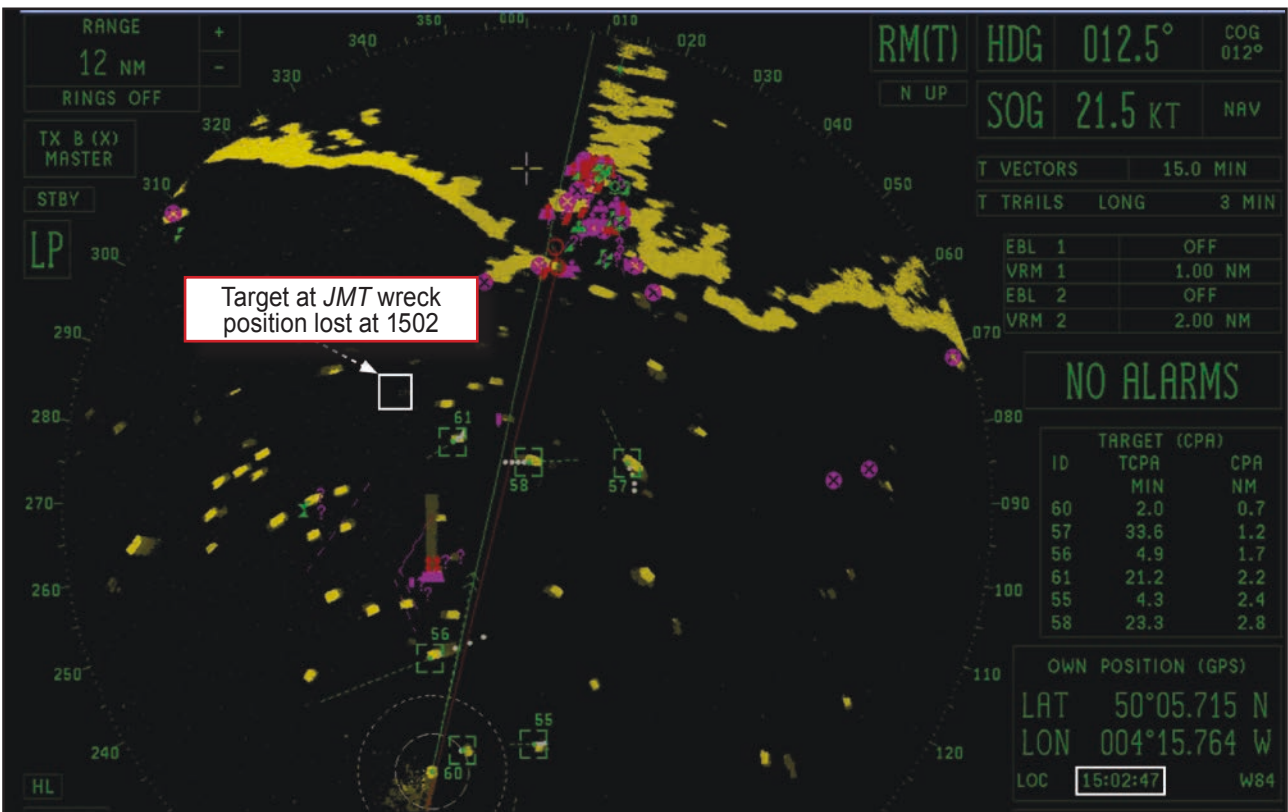
Figure 3: Pont Aven radar screen shot at 1459

Figure 4: Pont Aven radar screen shot at 1502

The VDR data from *Pont Aven* (**Figures 3 and 4**) indicates that *JMT* foundered at, or shortly after, 1501 on 9 July 2015. The positions of the vessel's scallop dredges (**Figure 19**) show that *JMT* was not towing at the time.

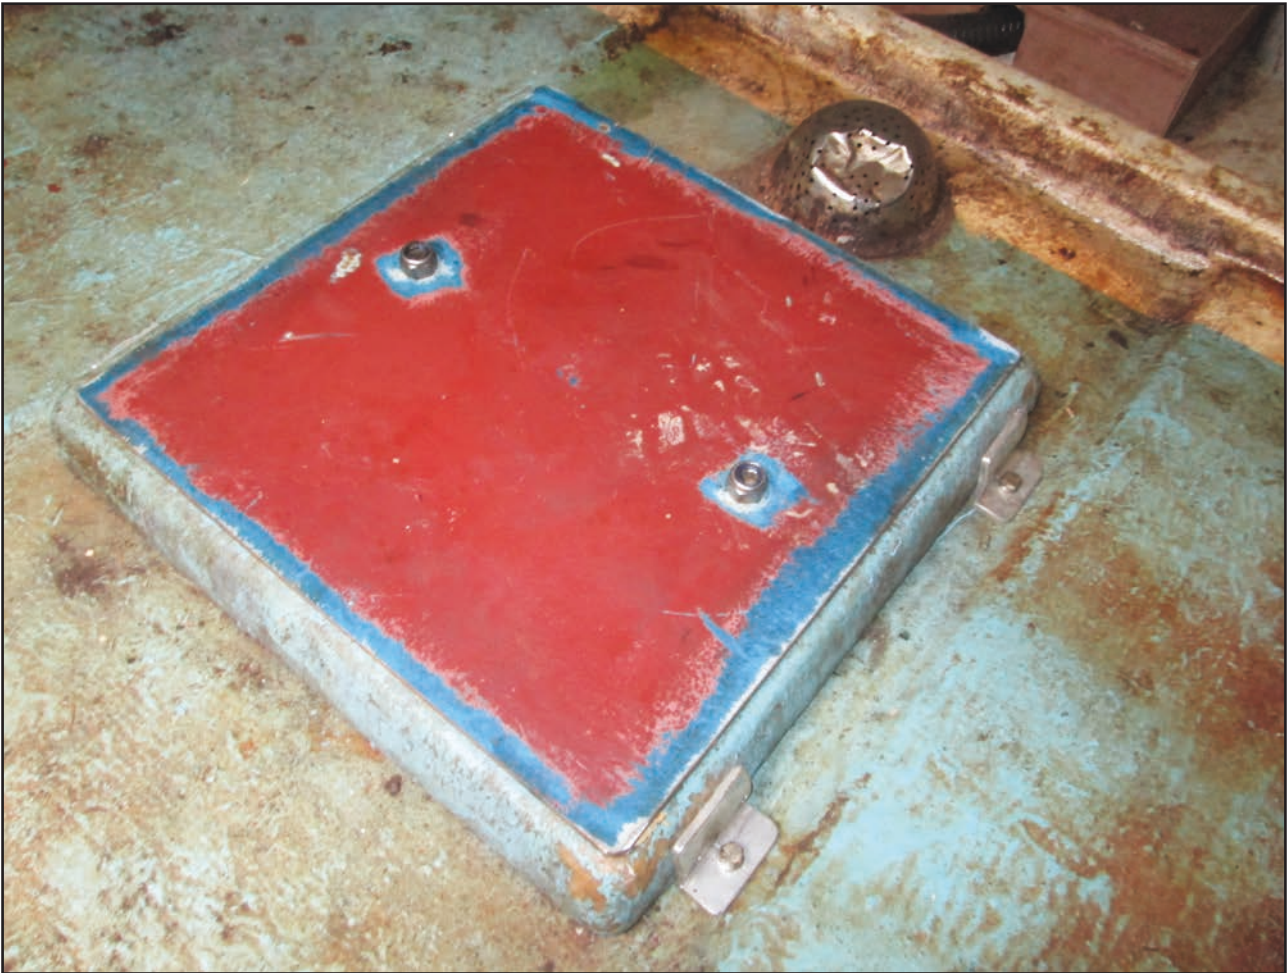
Figure 9: Shaft inspection hatch in *JMT*'s fish hold floor

- The relocation of the engine room access from inside the wheelhouse to a side casing door (**Figure 8**).
- The removal of the shelter on the port side.
- The addition of a collision bulkhead.
- The shaft inspection hatch in the fish hold was secured (**Figure 9**).

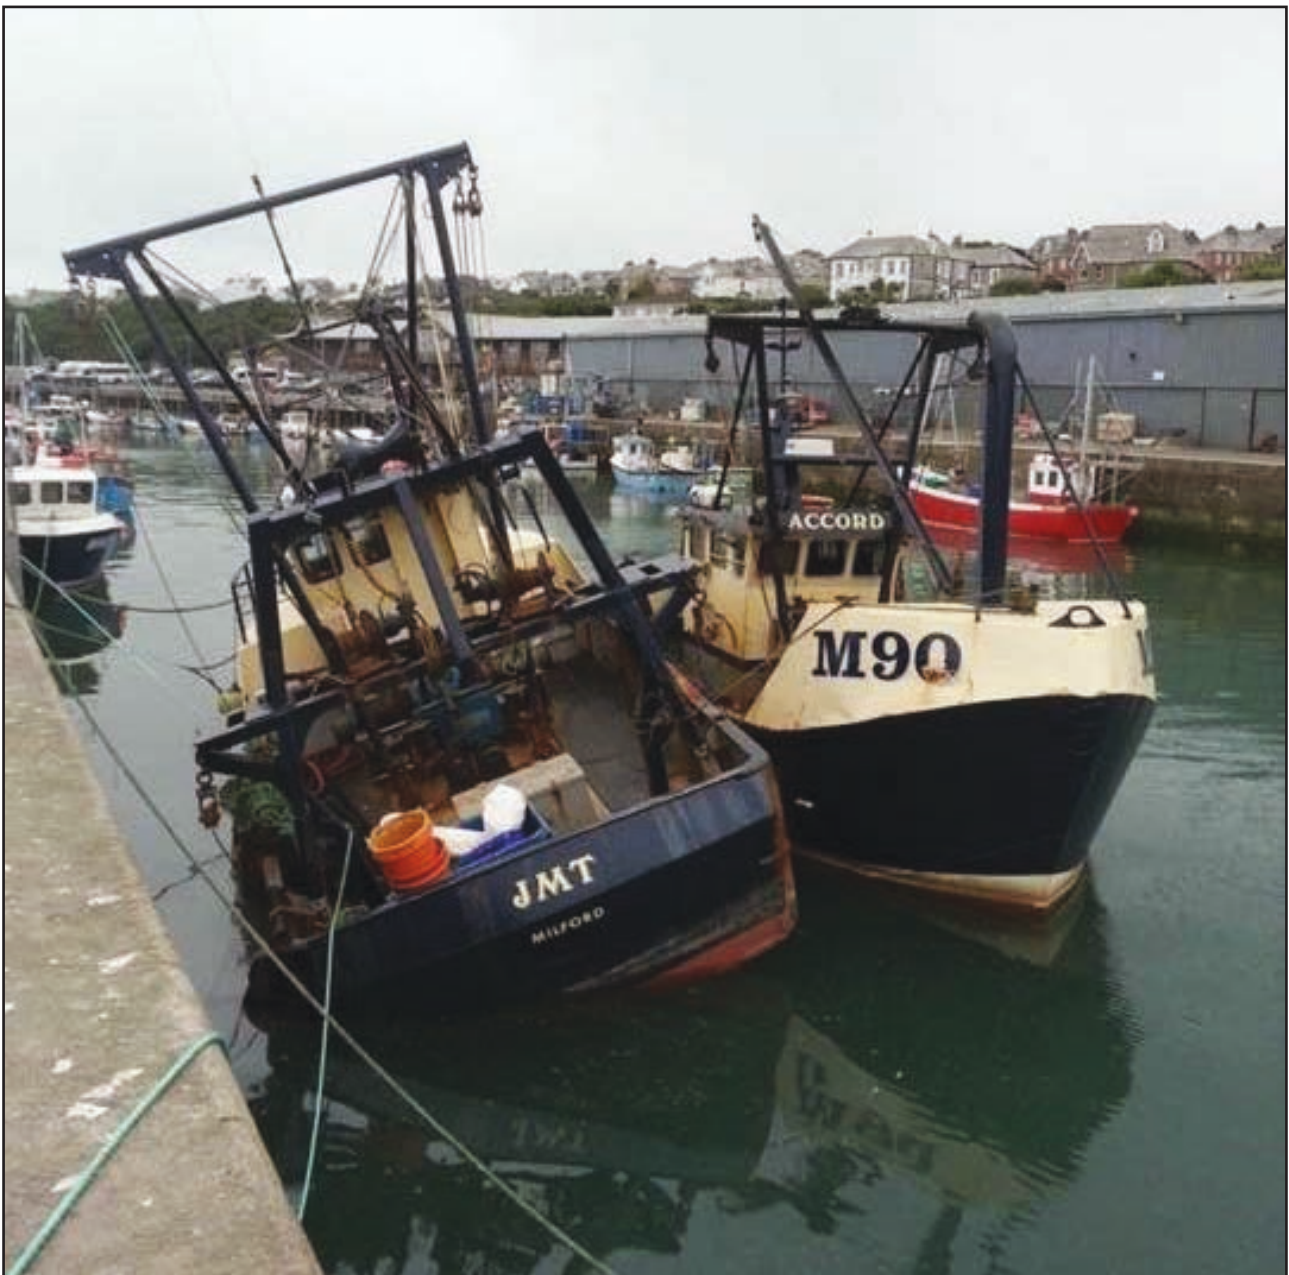
Figure 17: *JMT* listing in Padstow harbour (Summer 2014)

In July 2014, the harbourmaster in Padstow, Cornwall, became concerned about *JMT*'s angle of list (**Figures 17 and 18**) and how 'tender'⁸ the vessel appeared to be when it was manoeuvring inside the harbour. *JMT*'s skipper advised the harbourmaster that the list and apparent lack of stability were due to the fact that the vessel had lost one set of its scallop dredges. The harbourmaster requested that *JMT* was not moved inside the harbour until the vessel had scallop dredges on both sides.

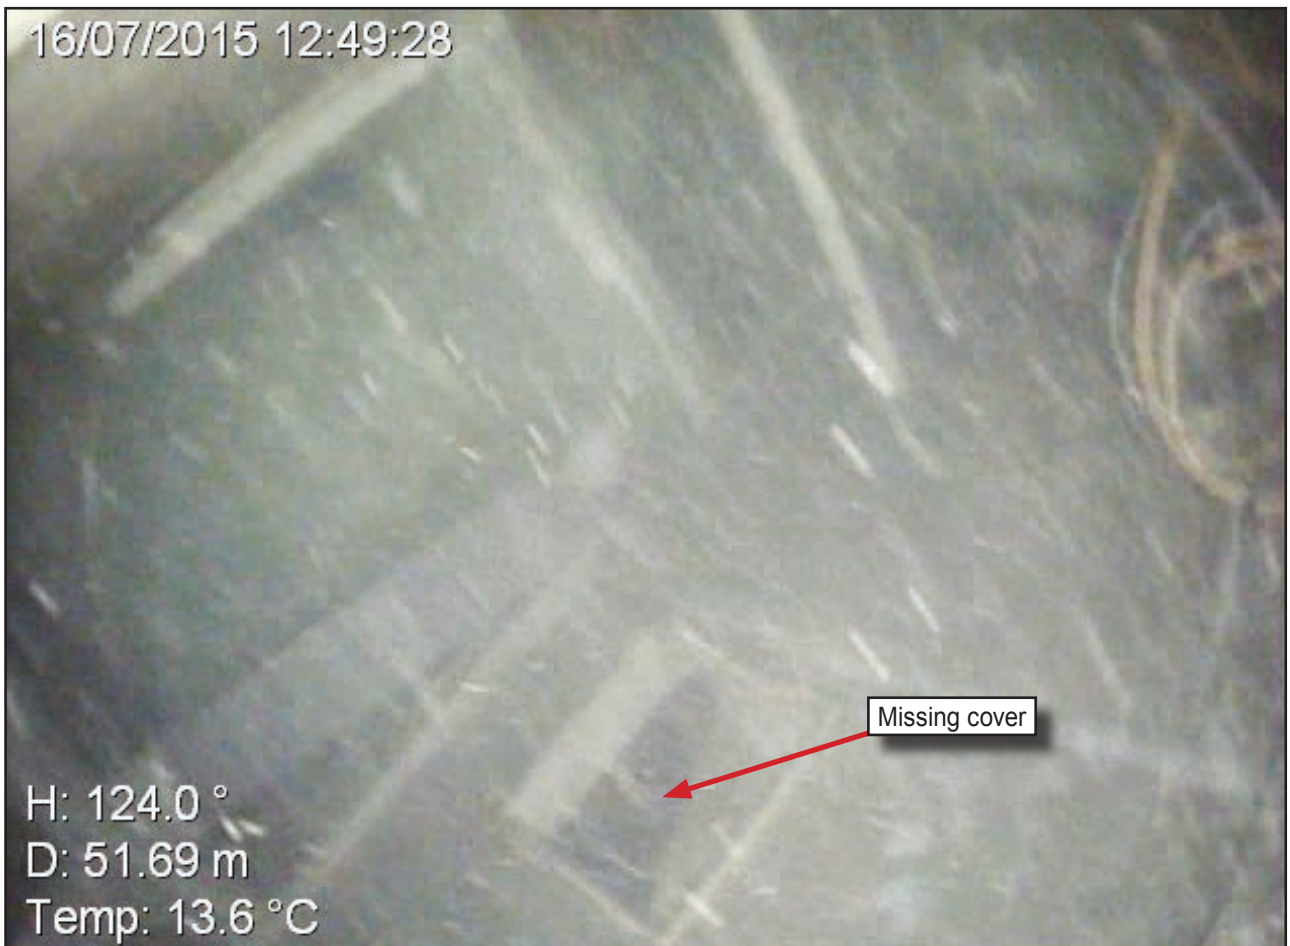
Figure 22: Missing shaft inspection hatch cover

On 16 July 2015, Plymouth University conducted a remotely operated vehicle (ROV) survey of *JMT* on behalf of the Devon and Cornwall Police. The survey's aims were to positively identify the vessel and to locate the missing skipper. The skipper was not found but the survey identified that the engine gear lever was in the 'ahead' position and that the engine throttle lever was fully forward (minimum speed) (**Figure 21**), there were no bags of scallops in the fish hold and that the cover to the shaft inspection hatch was missing (**Figure 22**).

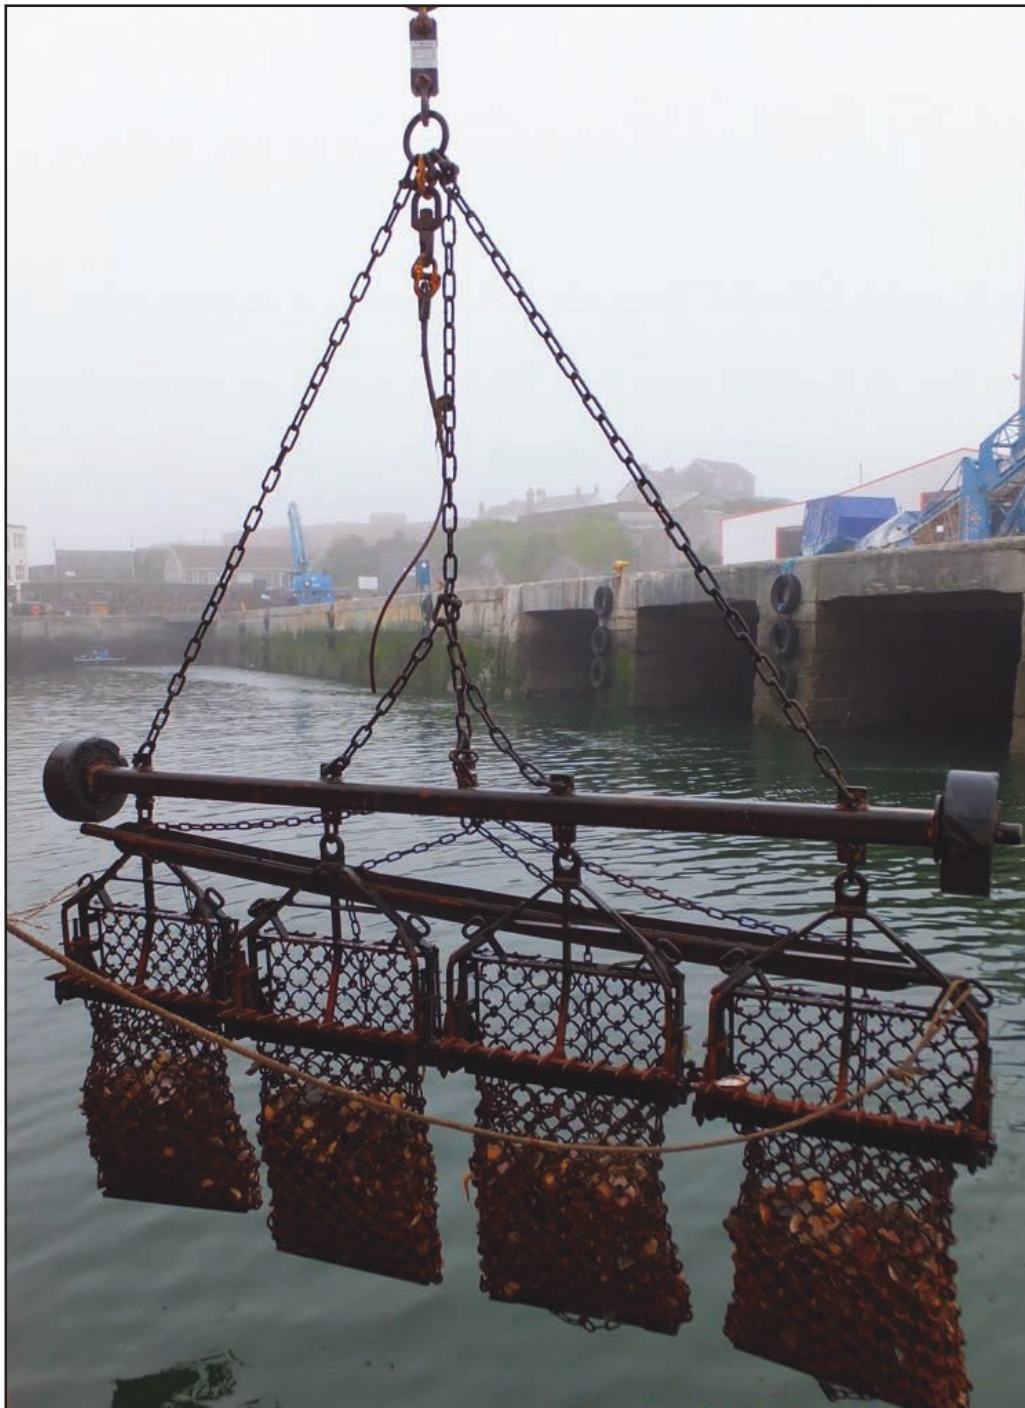
Figure 23: *JMT*'s port side scallop dredges being weighed

The ROV searched an area extending to a radius of 100m from the wreck. It was also used to remove the port side scallop dredges with their contents. The port side scallop gear and its contents were landed ashore and was found to weigh 1144kg (**Figure 23**).

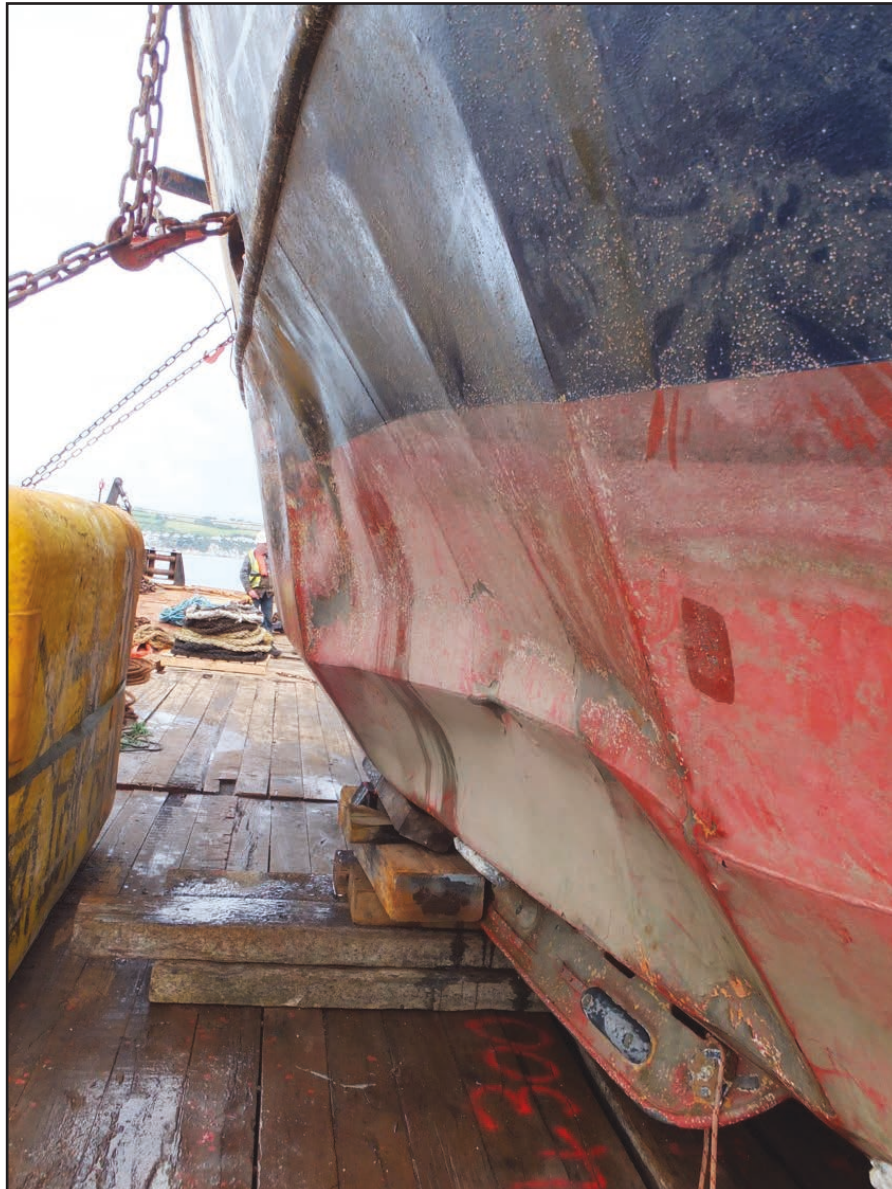
Figure 26: Implosion damage to *JMT*'s starboard side

- Significant implosion damage to both port and starboard wing fuel tanks (**Figures 26 and 27**).
- A 1m split on the welded joint in way of the engine room/fish hold port side bulkhead (**Figure 28**) that was consistent with the implosion damage to the port fuel tank.

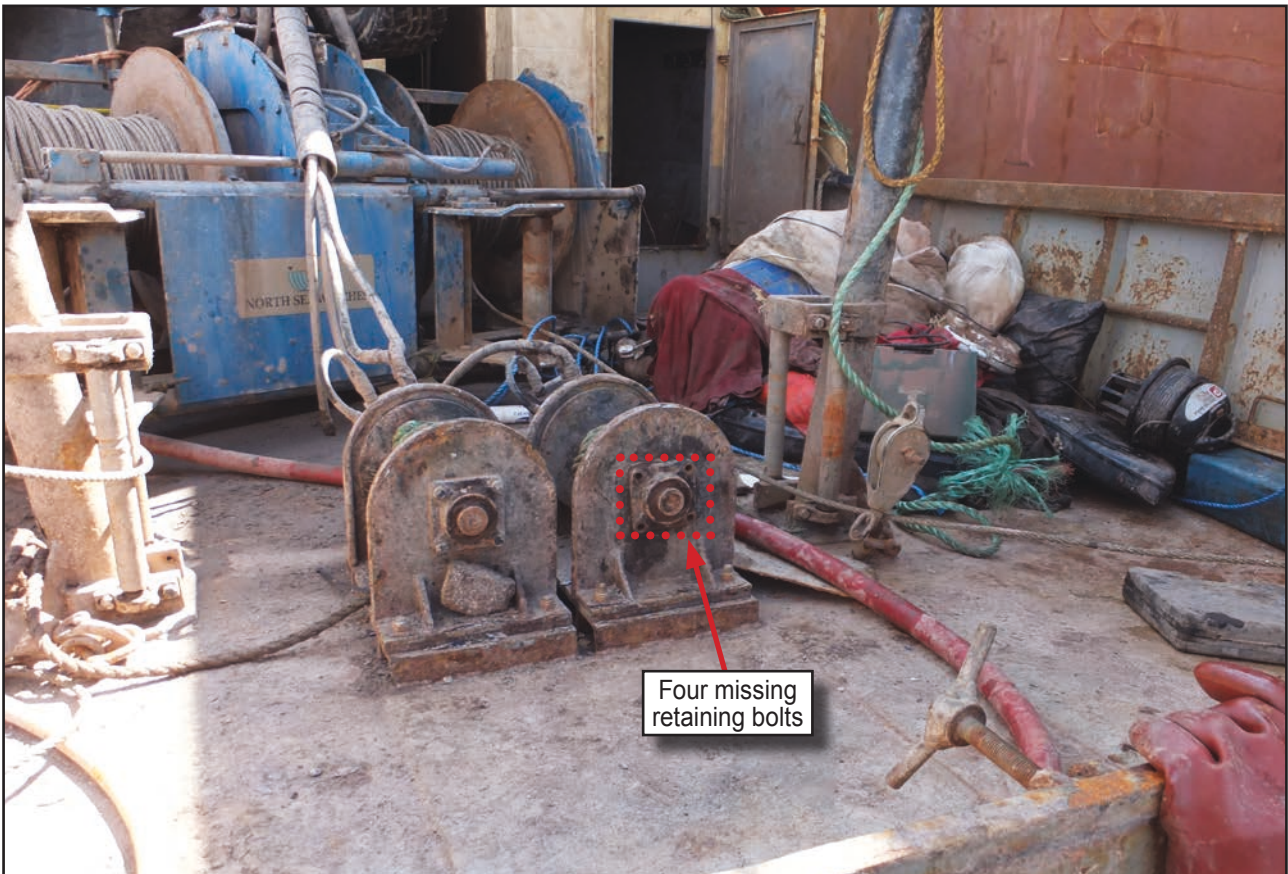
Figure 30: JMT's 'pull down' winches showing missing retaining bolts

- The skipper's mobile phone was plugged into a charging socket in the wheelhouse.
- Four retaining bolts were missing from the starboard hydraulic 'pull-down' winch (**Figure 30**).

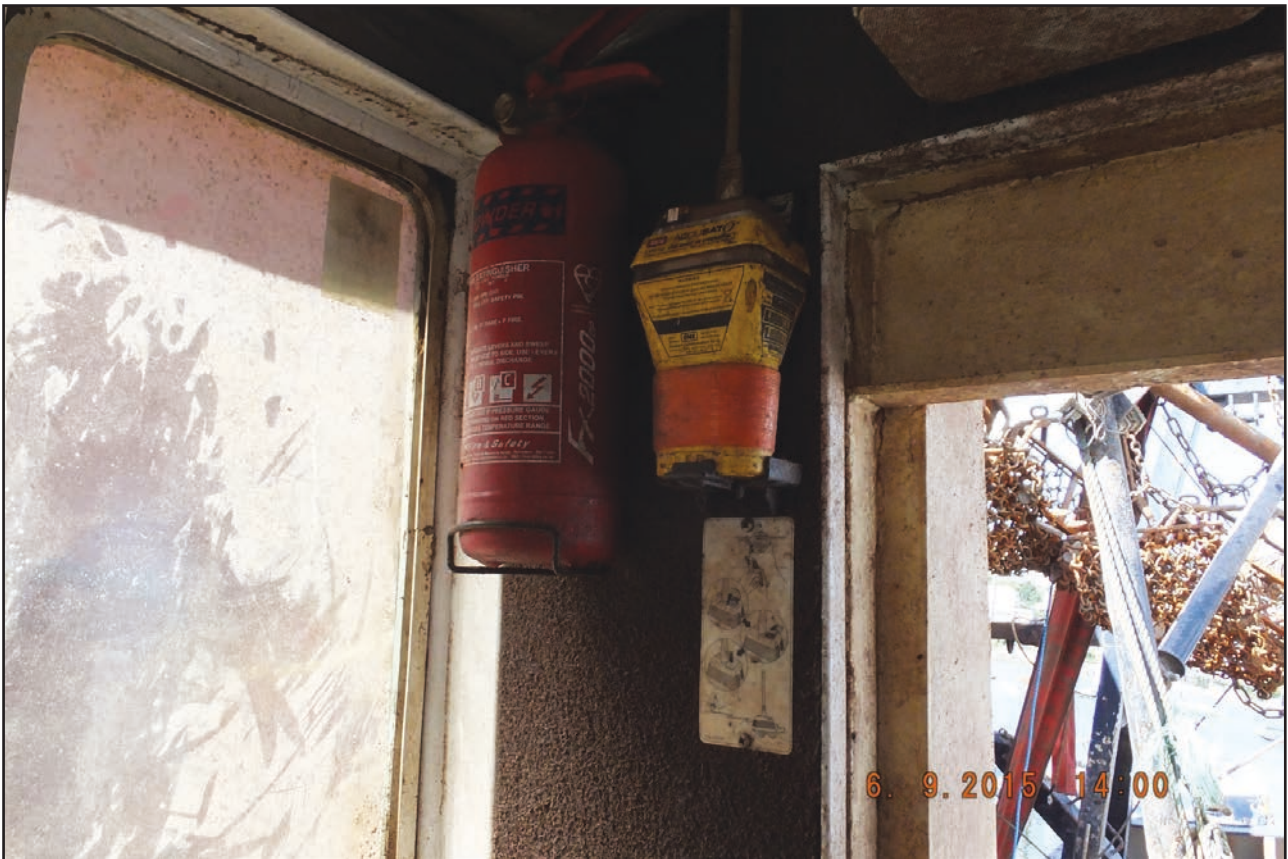
Figure 31: *JMT*'s EPIRB located on the wheelhouse bulkhead

- The EPIRB was fastened in its bracket in the wheelhouse (**Figure 31**).
