MARINE SAFETY ALERT

Safety Alert 01-18

A Delayed Repair Can Bite You in the Derriere **Performing prompt maintenance is critical!**

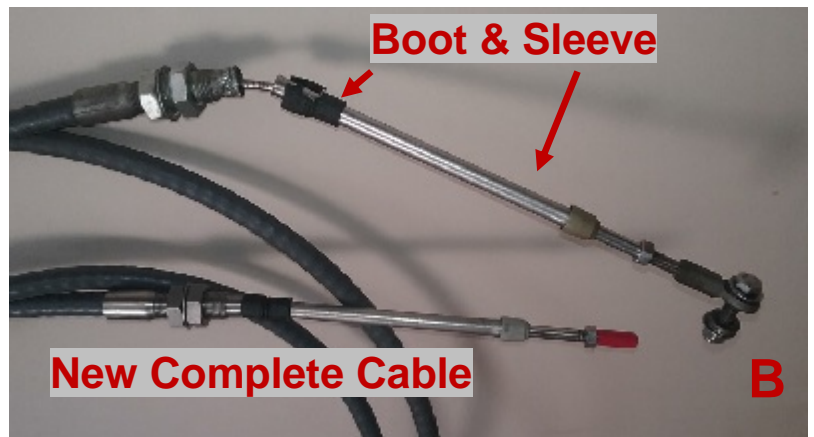
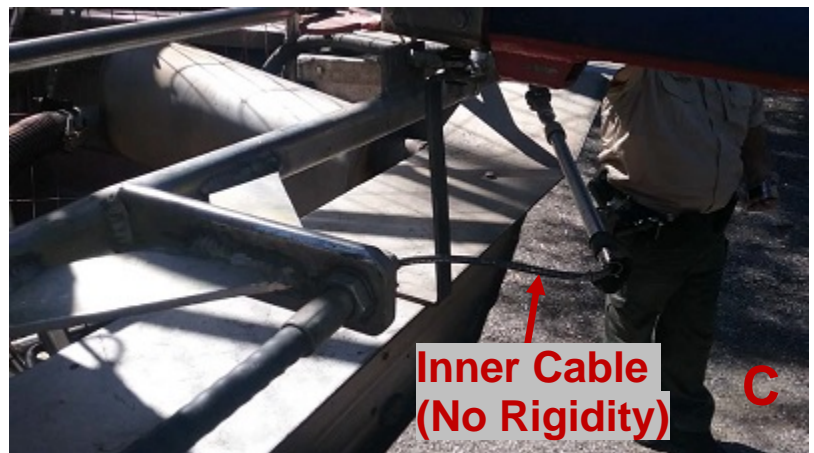
Over time, the crimped connection can become deformed due to the stresses occurring at the joint. Ultimately, in this case, the parts separated and the end of the cable lost its linear rigidity, putting slack into the control cable and causing a loss of control of the steering foils. (Image C) In this instance, the rubber boot covering the joint was found to be damaged and there appeared to be tool marks at the location of the joint. It's likely that in the past the joint was held compressed together by the use of Vice-grip type pliers. The person who may have placed the Vice-grips on the connections failed to recognize the potential risk of a loss of steering should the connection fail. It was not proper to make repairs in this instance and the cable should have been completely replaced.

- To develop an operational paradigm where maintenance and repair items are evaluated carefully, recognizing the potentials risks associated with their operation should the repair or maintenance item not be properly performed or achieved in a timely manner.
- **For airboat operators specifically:** Owners and operators of airboats that use flexible type steering control cables are reminded of the need to thoroughly inspect cables before use, including areas under the dust boots. Due to the forces encountered on airboat applications, owners are also encouraged to ensure these cables are properly maintained and to immediately replace a worn cable. Owners are discouraged from attempting to repair a factory crimp.

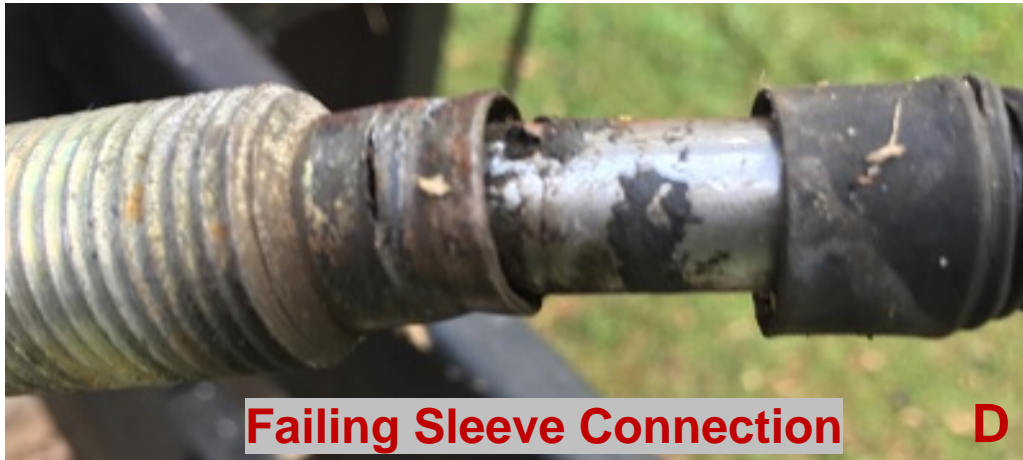
The following image shows a Morse/Teleflex/Cablecraft "type" push-pull control cable assembly sleeve connection point that was fatigued and had begun to fail.
