**MARINE ACCIDENT
INVESTIGATION BRANCH**

SAFETY DIGEST

**Lessons from Marine
Accident Reports
1/2018**

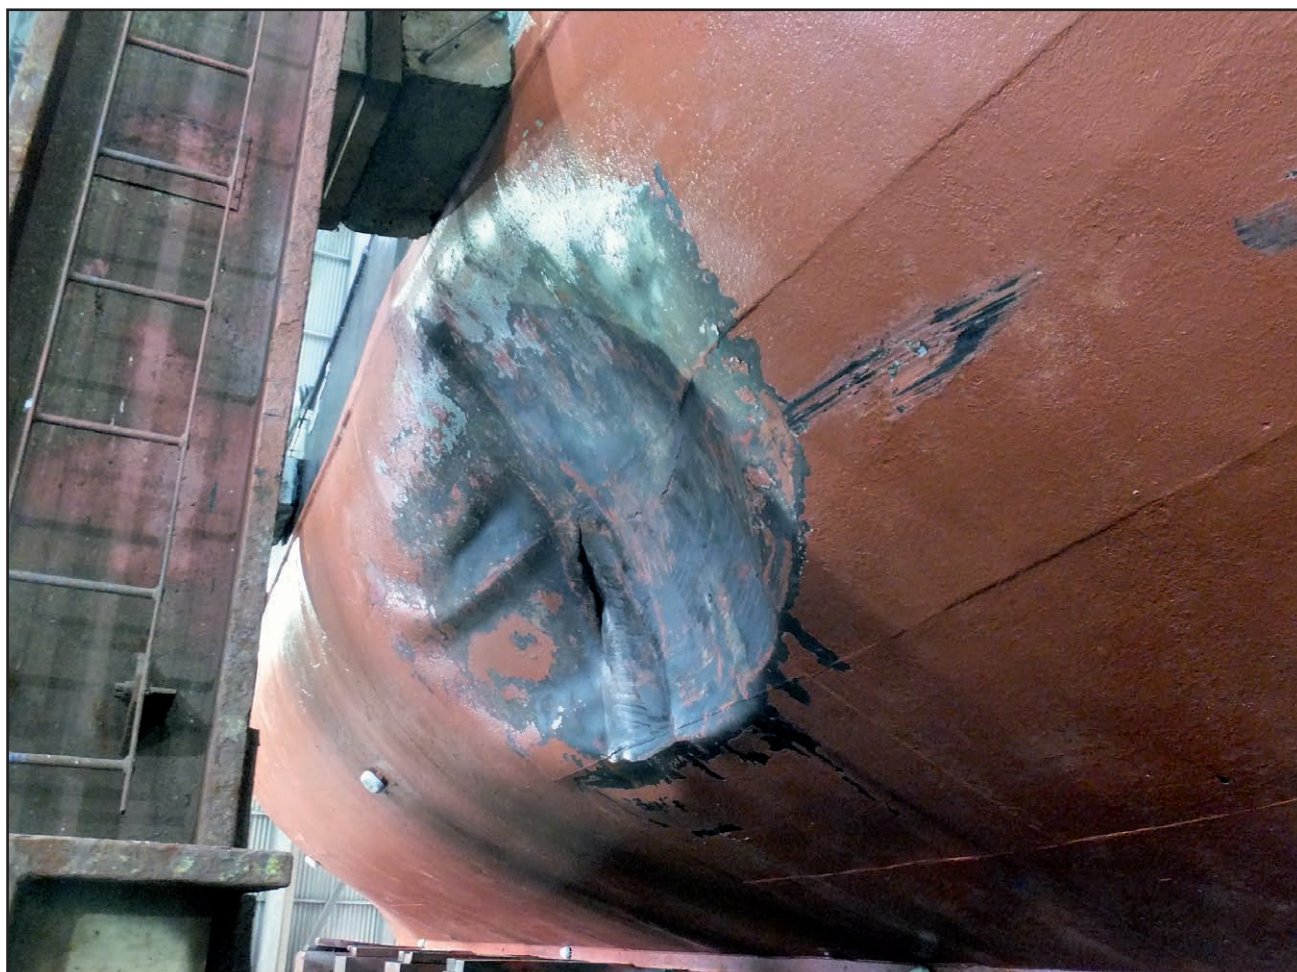
The bunker barge suffered a large indentation below the waterline where it was struck by the cargo ship's bulbous bow (see figure). There was also significant flooding of the vessel, the main engine seized and there was some pollution from leaking fuel cargo.

Figure: Indentation in the bunker barge's hull caused by the cargo ship's bulbous bow

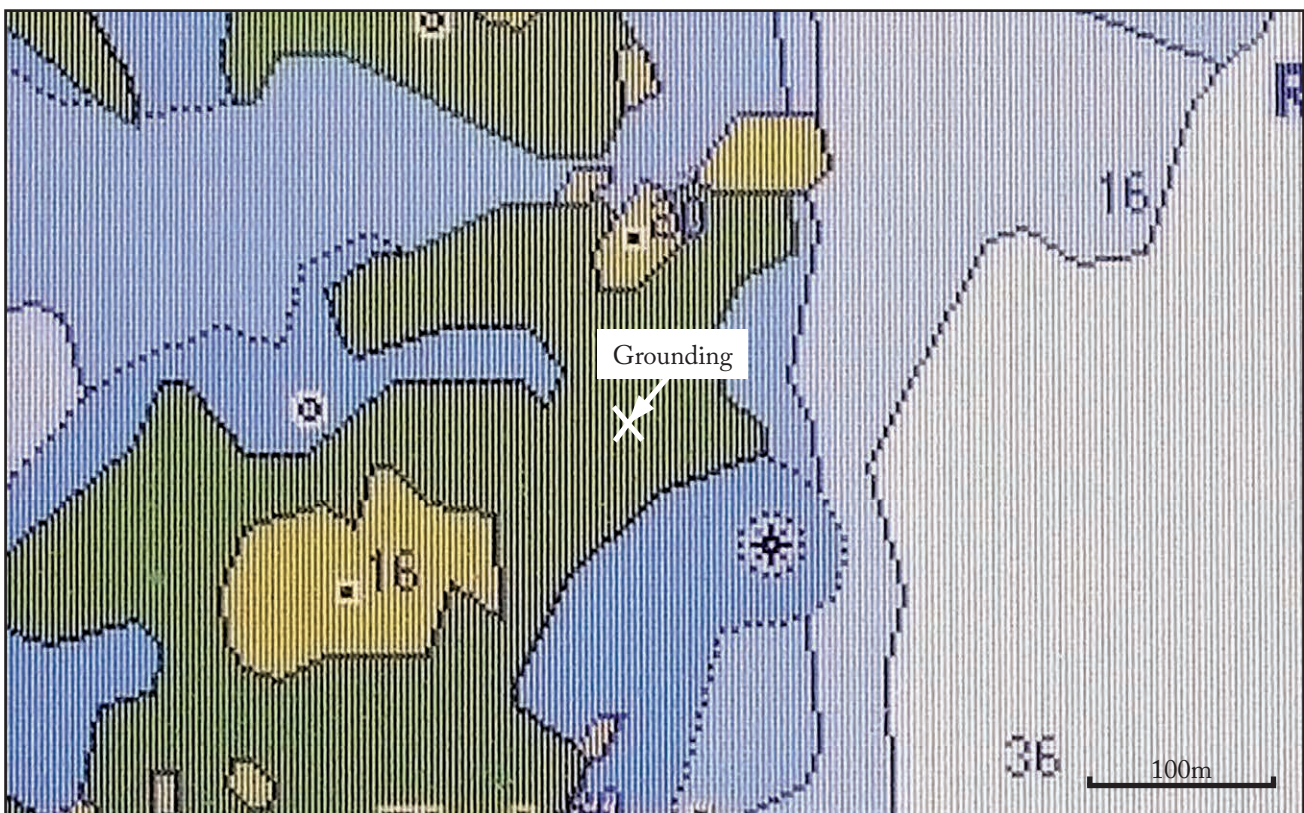
Figure: The grounding location on the intertidal area of the chart where no drying heights were shown

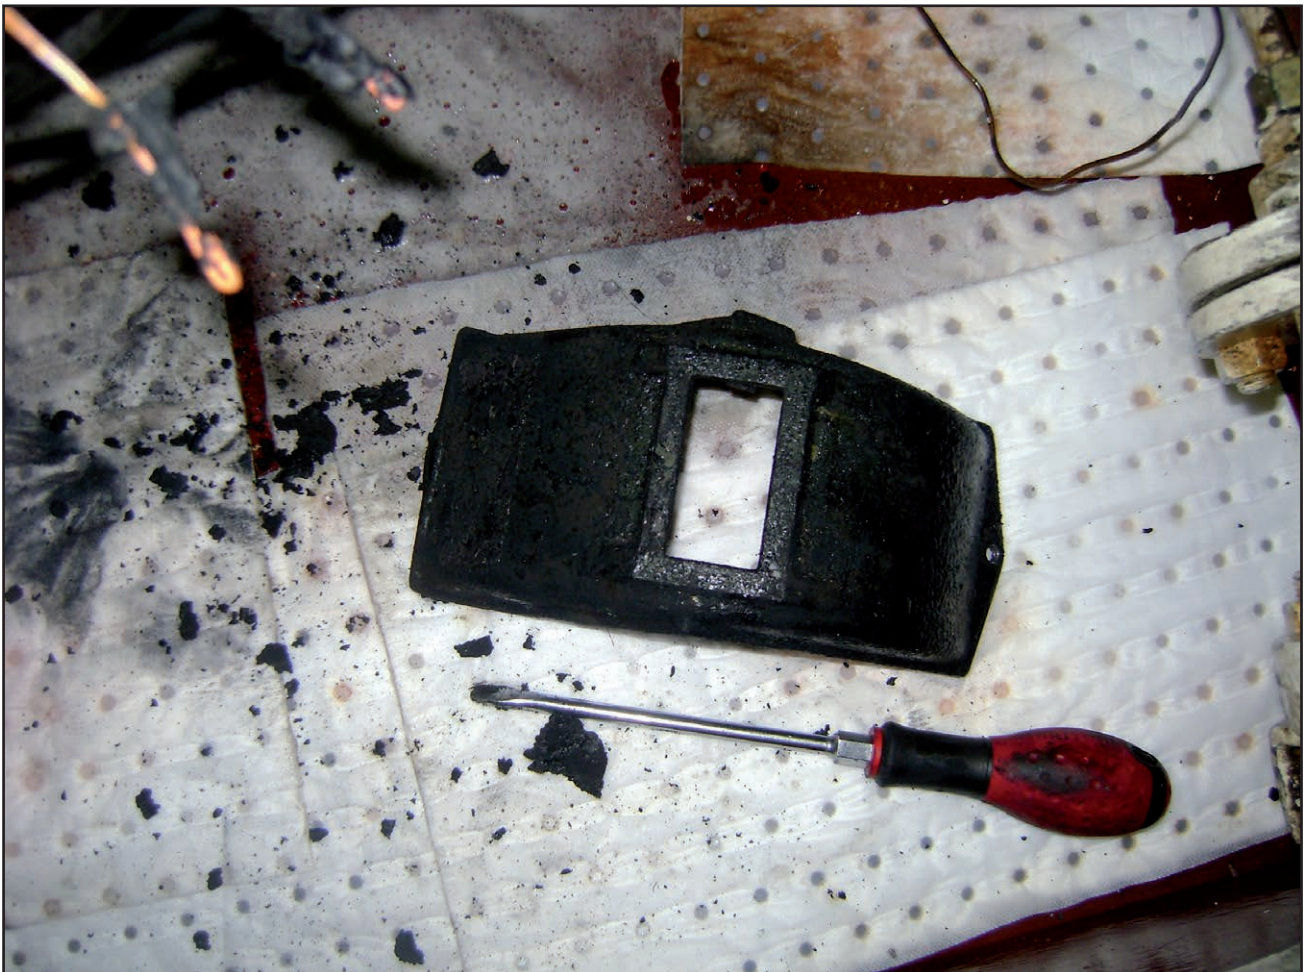
Figure 1: The burner unit's melted sight glass

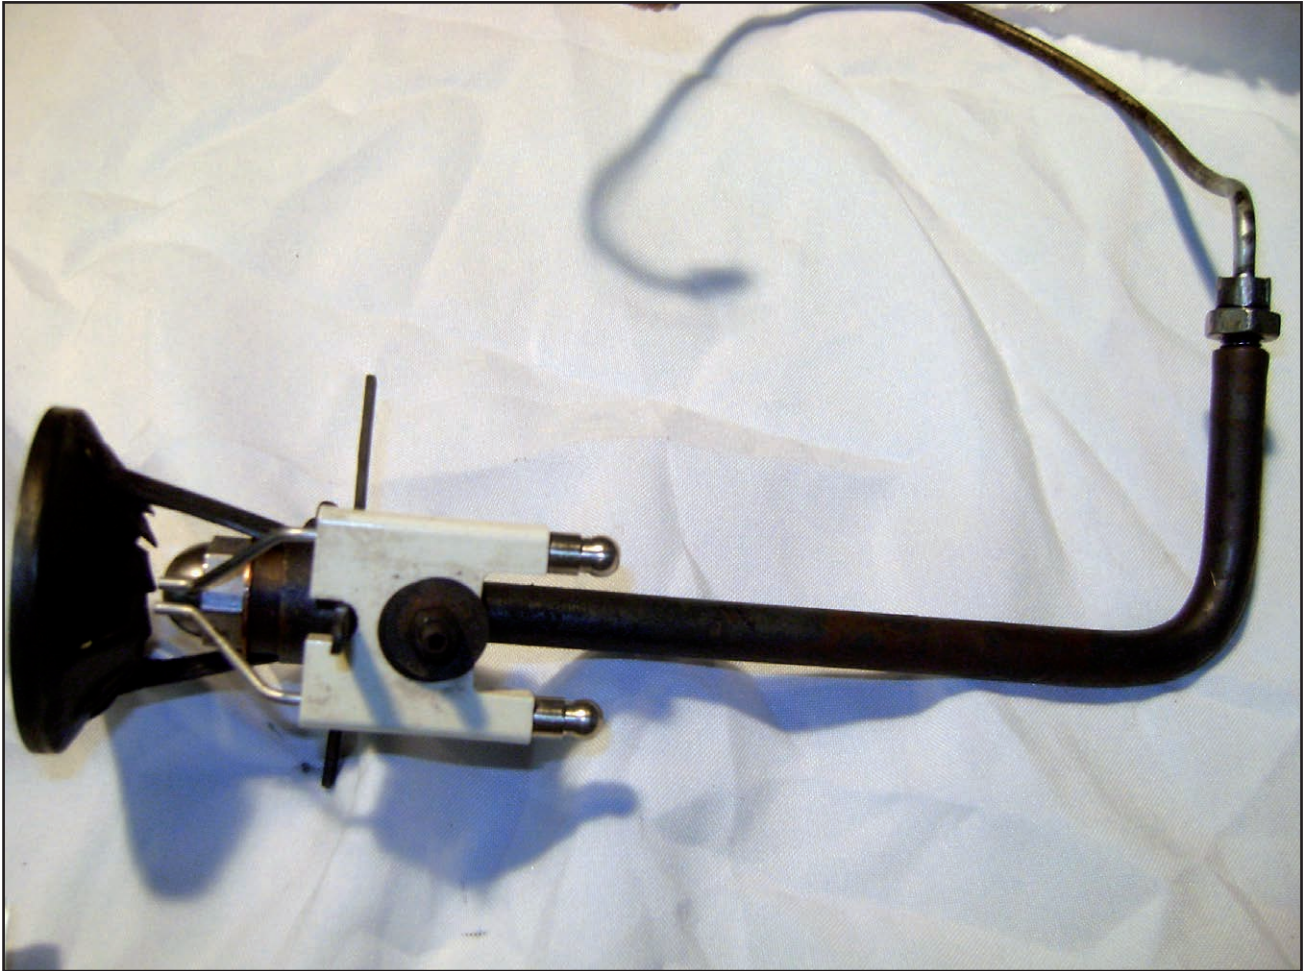
When the boiler was examined, the engineers found that the internal fuel supply pipe to the burner nozzle (Figure 2) was leaking at a compression fitting. When the pipe was removed, one of its compression fittings was found to be worn and damaged to the point it could no longer provide a seal against the fuel pressure. Fortunately, in this case, the consequences of the fire were not serious. However, boiler explosions, including those resulting in fatalities, have occurred when there has been fuel leakage into a boiler furnace.

Figure 2: The leaking internal fuel supply pipe to the burner nozzle

1. Regular inspections of the boiler burner unit required the routine removal and refitting of the fuel supply pipe. This provided the opportunity for the condition of the pipe fittings to be assessed. However, as in this case, it also introduced the risk of damaging the seals. All work carried out to the fuel pipework and compression fittings should be closely inspected before being fitted; a zero tolerance on wear and damage will help minimize the risk of fuel leakage and the subsequent introduction of a fire danger.

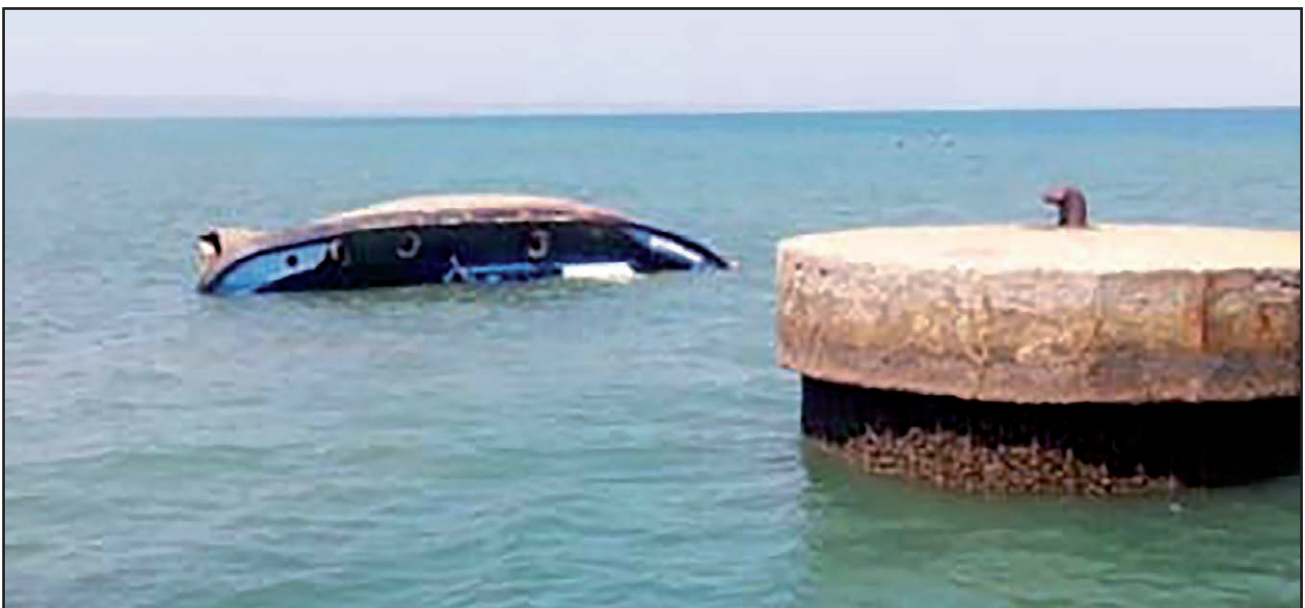
The tug was connected to the ship's port quarter to help pull its stern off the berth. During the manoeuvre, the prevailing wind and tidal conditions caused the ship to move towards an outlying mooring dolphin. To avoid striking it, the ship's master briefly increased ahead speed to 5kts, during which time the tug girted and capsized.

Figure 2: The capsized tug

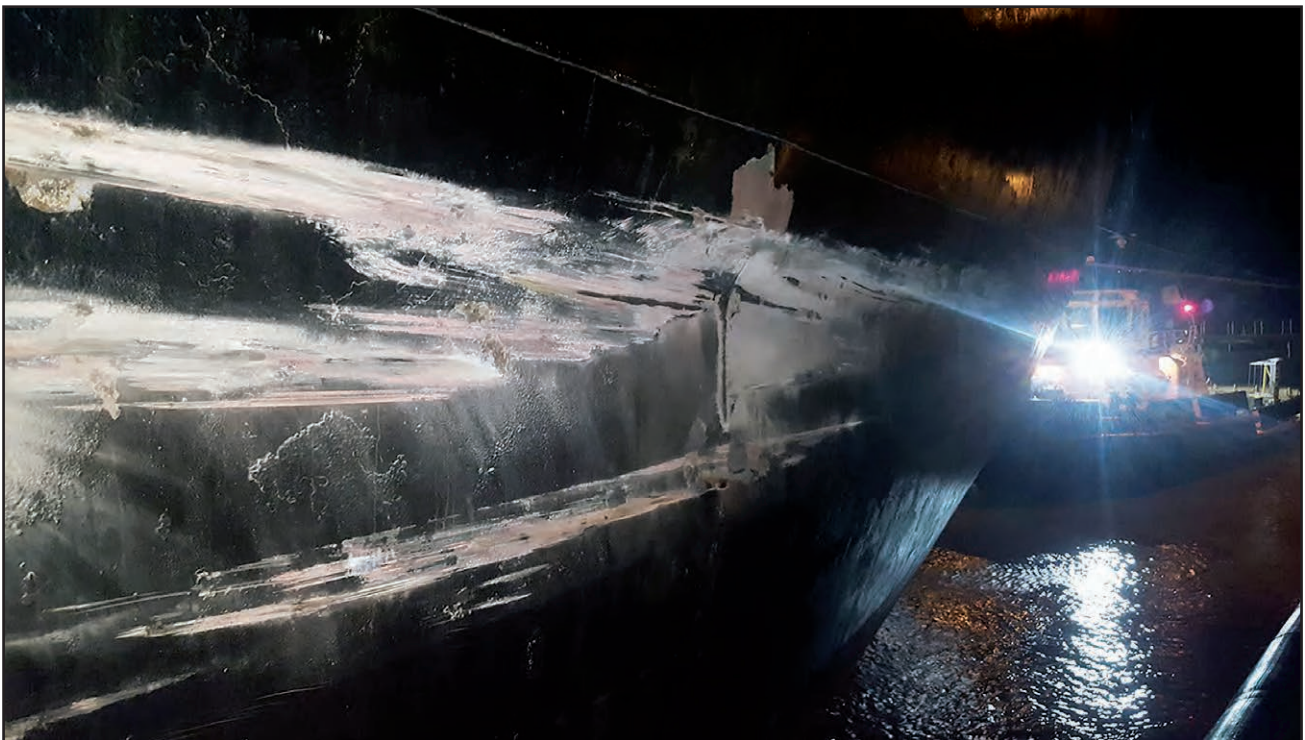
The pilot ordered full astern, and the tug that was helping with alignment moved quickly in an attempt to counter the resulting ship's swing to starboard. However, the ship's port quarter contacted a pier leading up to the lock entrance, causing damage to the ship's port side (Figure 1).

Figure 1: Damage to ship's port side

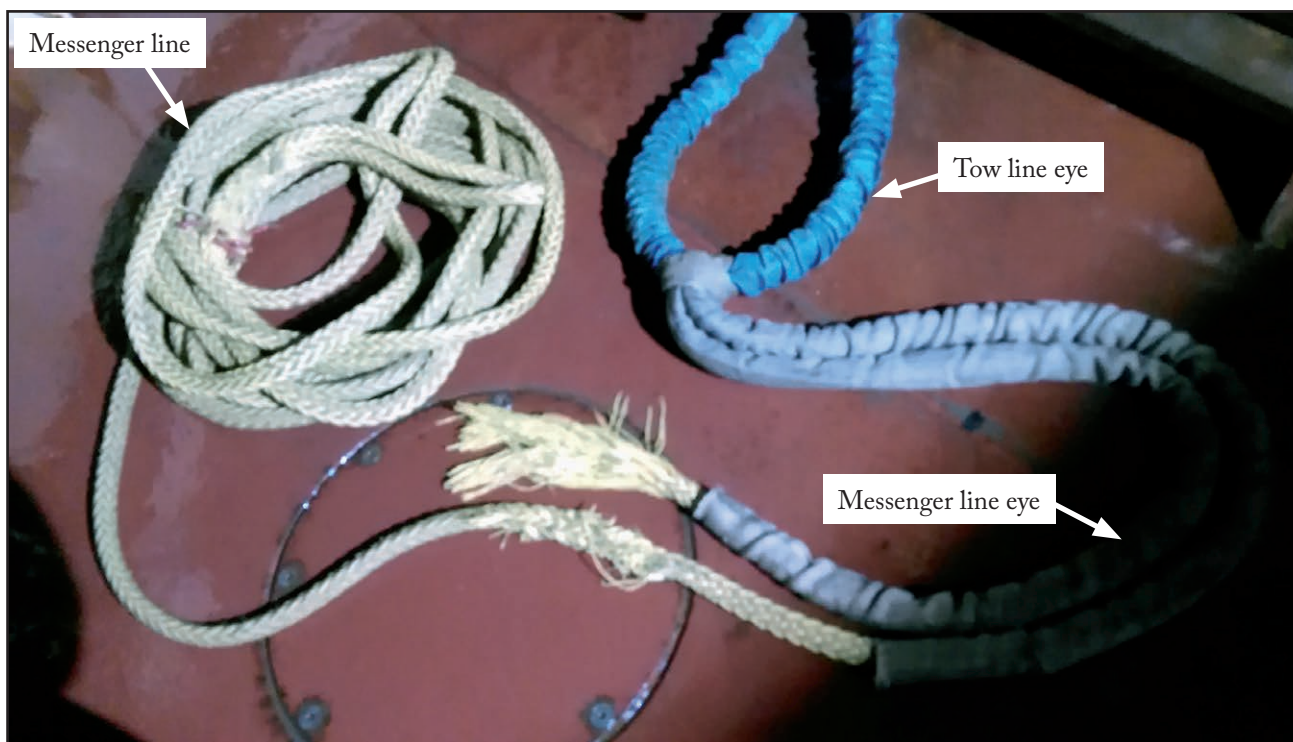
The tug recovered the parted line back on board. The messenger rope's eye, which was connected to the eye of the main towline, had parted (Figure 2). The crew on the bulk carrier's aft mooring deck had mistakenly placed the eye of the messenger rope rather than that of the towline over a bitt to make the towline fast.

Figure 2: Parted messenger line eye

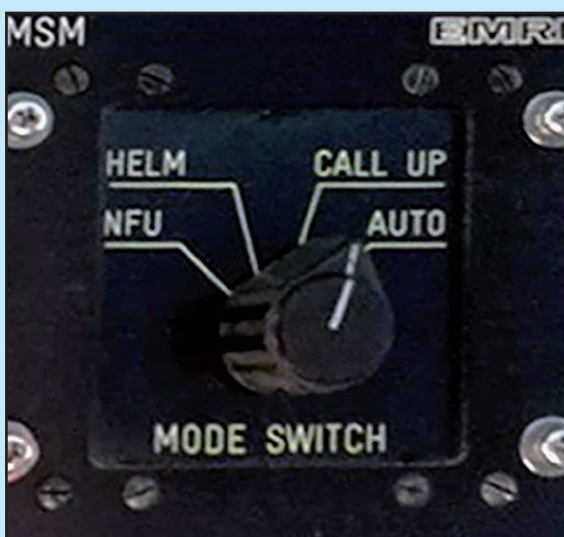
1. The steering mode selector switch at the centreline helm console had four settings: 'auto', 'helm', 'call up' and 'nfu'¹ (Figure 1). The normal procedure when changing from autopilot to manual steering was to change the selector switch setting from 'auto' to 'call up'. The 'call up' setting allowed the vessel to be steered manually from the centreline helm console, and when a selector button was pressed on the bridge wing, to then be steered from the bridge wing. On this occasion, the selector switch was inadvertently changed to the 'helm' setting, which allowed manual steering from the centreline helm console only.

Figure 1: Steering mode selector switch

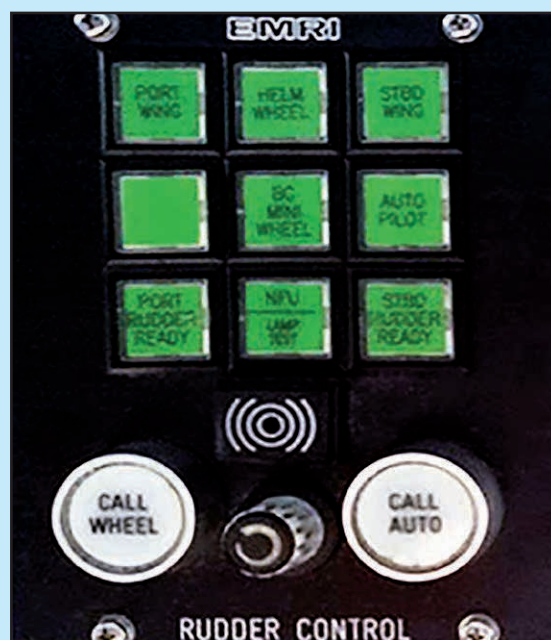
The bridge team no longer recognised the value provided by the indicator light panel.

Figure 2: Helm control station indicator light panel

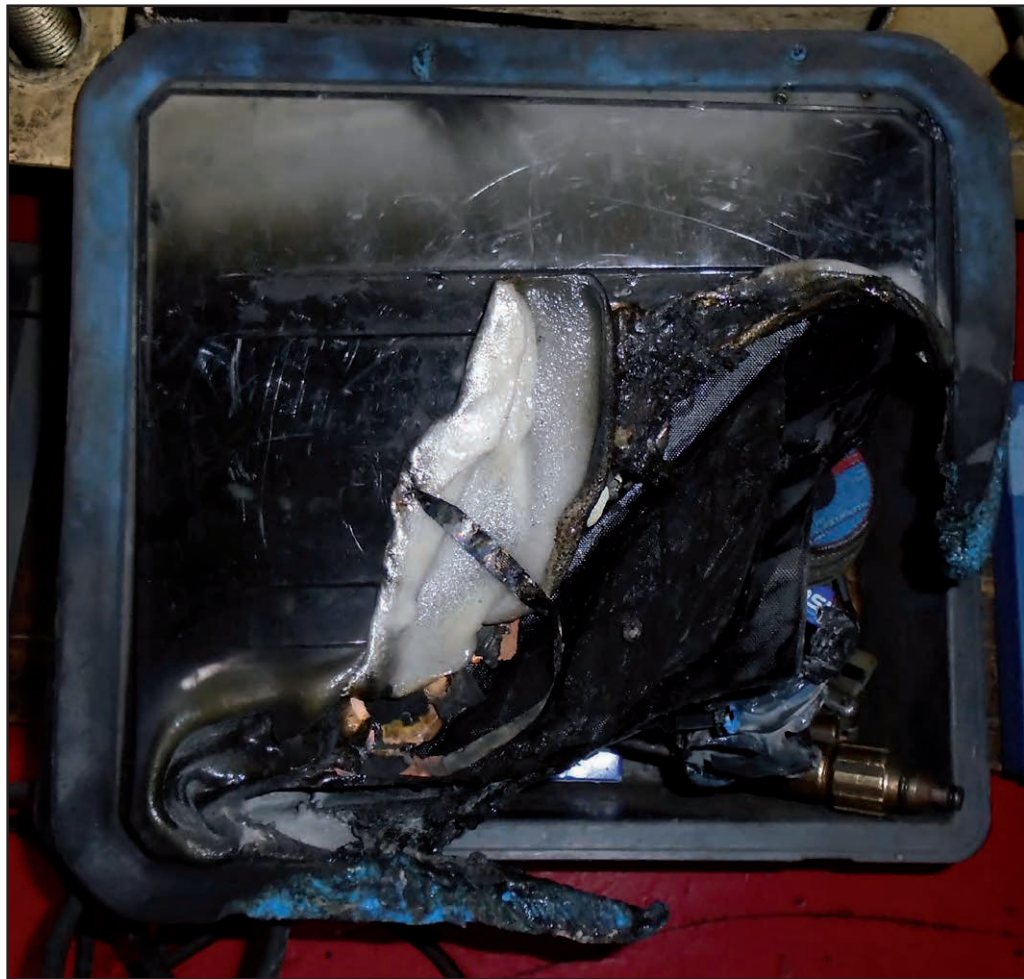
Investigations revealed that a portable light unit, used earlier in the day, had been left at the bottom of the boiler and that sparks from the cutting process had caused the unit to ignite. The contractors had reacted quickly and had extinguished the fire using fire-fighting equipment that had been located close to the work-site as part of the PTW requirements.

Figure 2: Damaged light unit

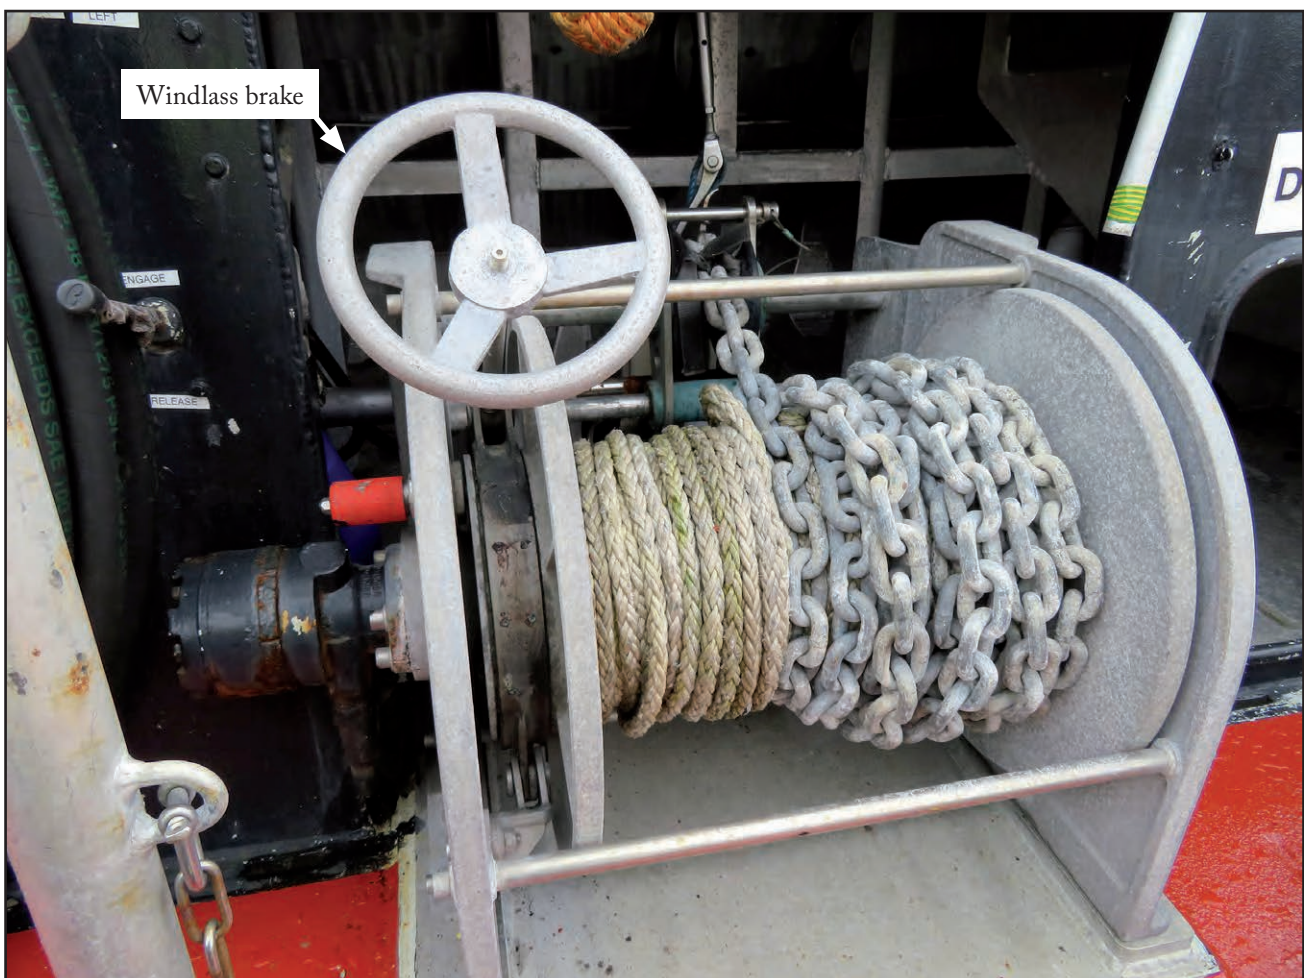
About 4 hours later, the low fuel pressure alarm on the starboard engine sounded. In response, the master ordered his crewman to prepare the anchor for letting go. As the crewman arrived on the forecastle, the engine stopped and the order was given to let go the anchor. However, when the crewman released the windlass the anchor failed to 'free fall' (see figure).

Figure: The windlass and brake

2. One of the most significant safety issues identified in this incident was the crew's inability to anchor the vessel in an emergency. The post-incident inspection by the anchor windlass manufacturer revealed that the aluminium windlass bearings were clogged with dirt and, although it could still be operated under power, the debris prevented the anchor being 'let go' in the 'free fall' mode. A subsequent fleet-wide inspection revealed a similar defect in other vessels. This issue had not been previously exposed by either class or regulatory inspection. Following its investigations, the vessel operator introduced a planned maintenance routine that required weekly fresh water wash down of the windlass, anchor 'free fall' mode tests and an annual overhaul.

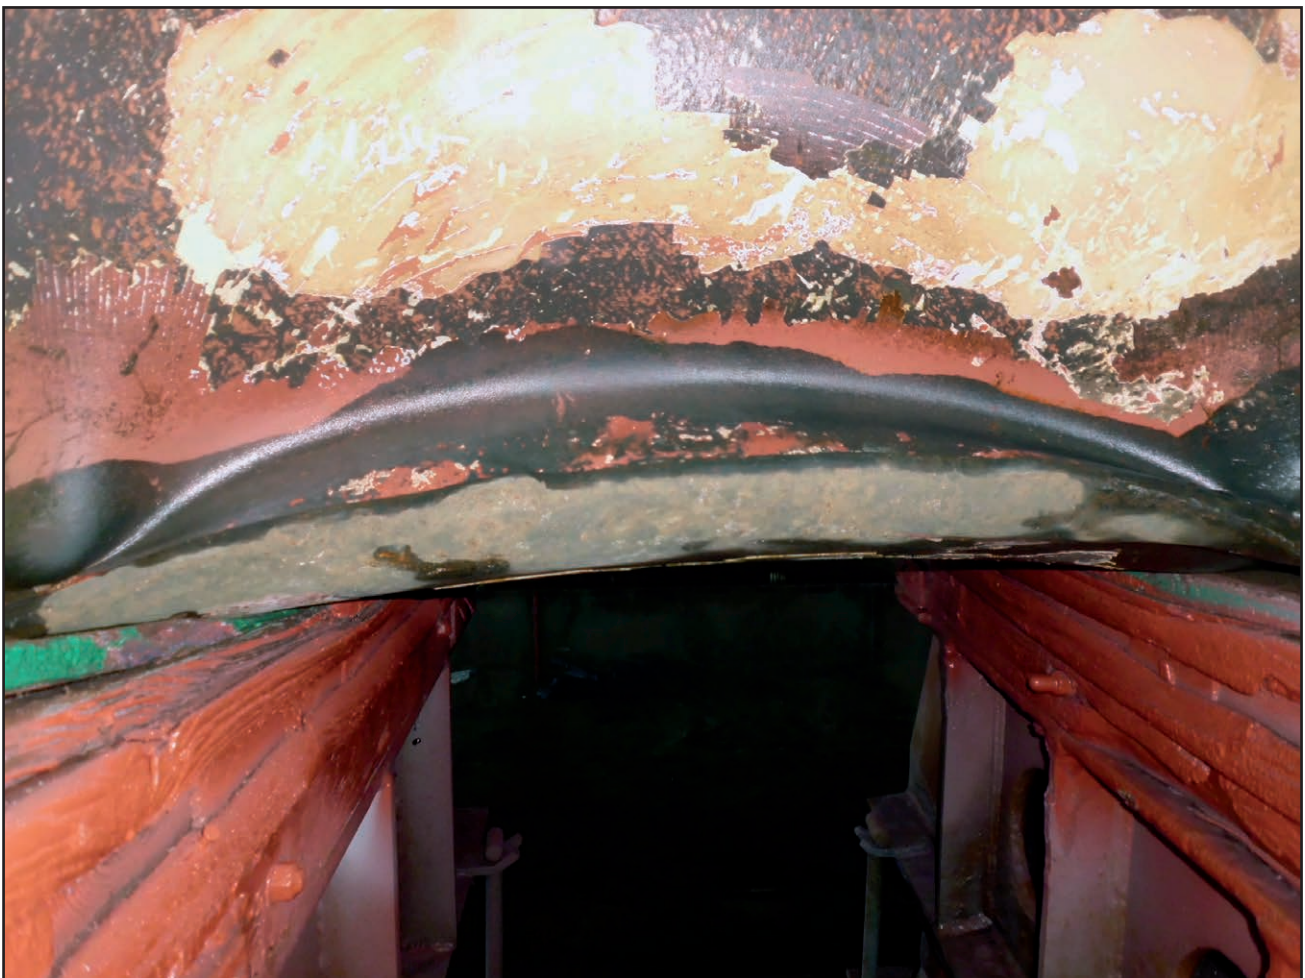
Figure: Hull indentation

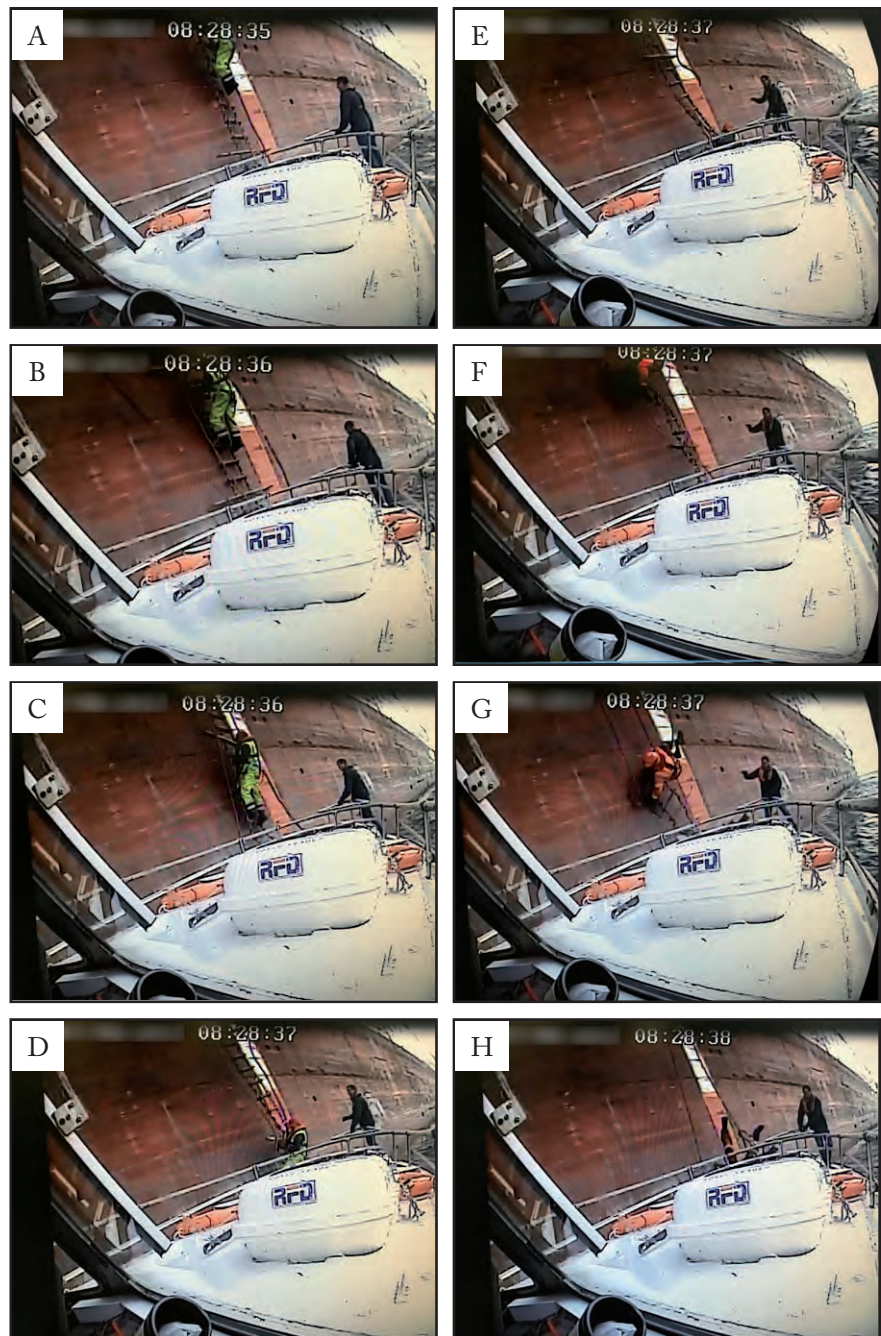
The three technicians proceeded to walk down the accommodation ladder to the top of the pilot ladder. With the pilot boat in position alongside the ship's side, the first technician began to descend the pilot ladder. The first technician was about 1.5m from the pilot boat's deck when the second technician stepped onto the pilot ladder. The pilot ladder immediately failed. Both of the ladder side ropes parted, and both technicians fell approximately 1.5m and 7m respectively (Figure 1). Both were subsequently taken to hospital by ambulance, but fortunately neither sustained serious injuries.

Figure 1: Stills from CCTV showing failure sequence

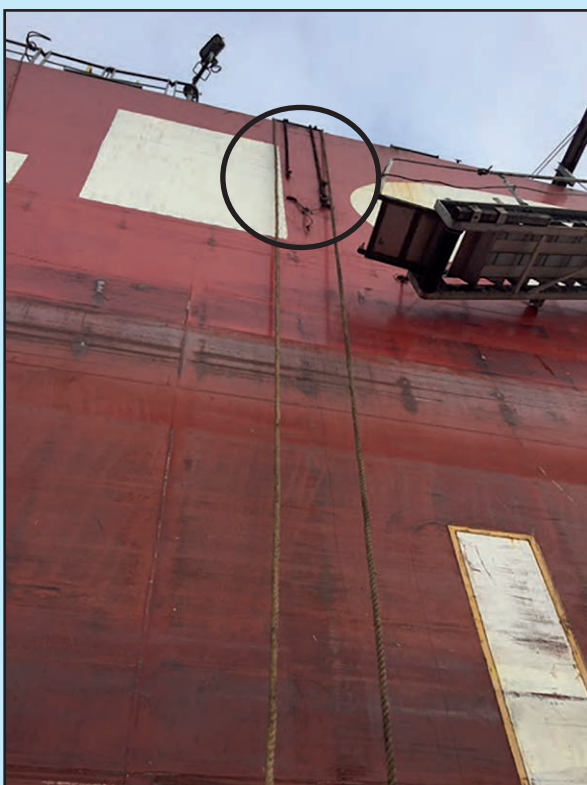
The pilot ladder that had failed was only 15 months old. An internal investigation by the company found that the pilot ladder side ropes had failed through exposure to salt deposits and sunlight (Figure 2), which the ship's crew had not identified.

Figure 2: Ladder rigged position, showing broken section

In this case, the relatively new pilot ladder had not been properly maintained and stowed, and deterioration to the pilot ladder side ropes had not been identified. Do not store ladders on an open deck where the ropes are exposed to contaminants or elements that can degrade the ropes (Figure 3). After use, ladders should ideally be hung up clear of the deck

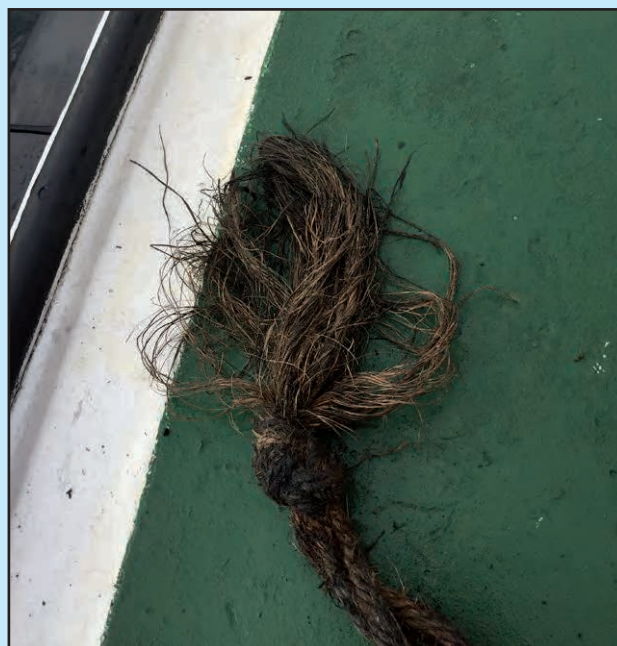
Figure 3: Ladder side rope showing contamination

and stored wherever possible in a clean, dry environment. They must also be protected from oil, chemicals, paint, or any other source of contamination that could affect their strength.

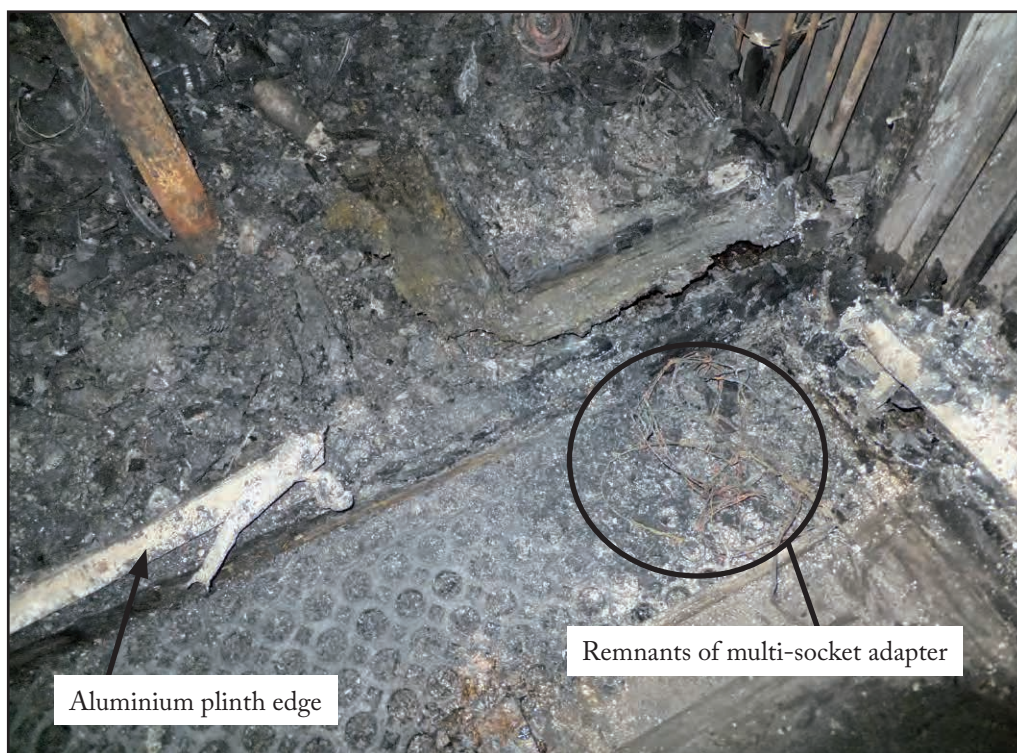
Figure 2: Remnants of multi-socket adapter

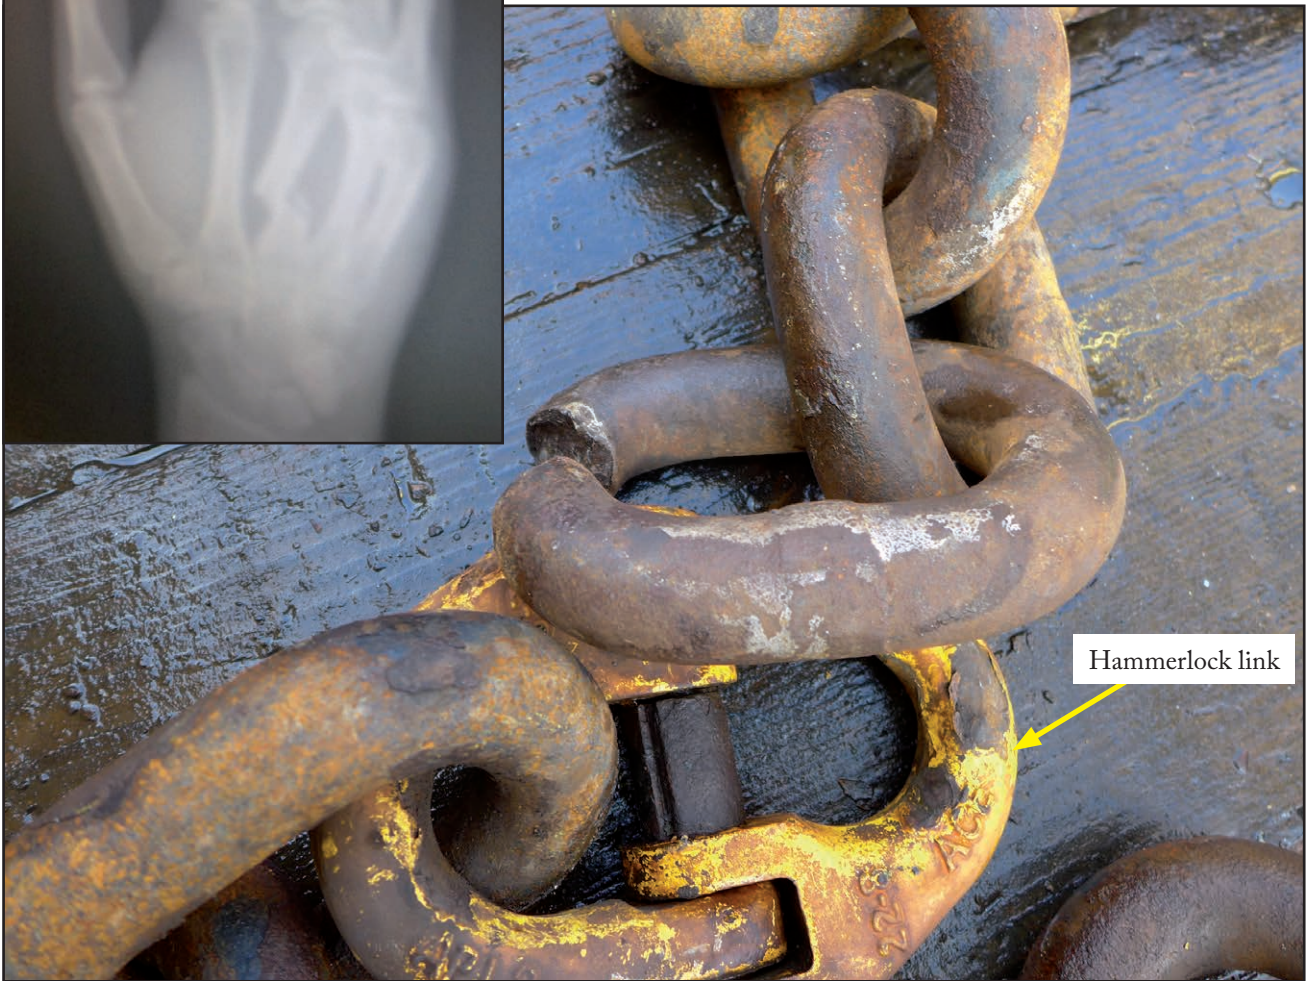
The accident was caused by the failure of a length of chain from which the block was suspended. One end of the chain was attached to a quick release wire and the other end was looped through the block and fastened onto itself with a hammerlock link (Figure 3). However, the two chain links joined by the hammerlock were not in the same plane, forcing them together under load, causing a twisting force (Figure 3). The starboard side chain had been linked without introducing such a twist and showed no signs of failure.

Figure 3: The twisted chain

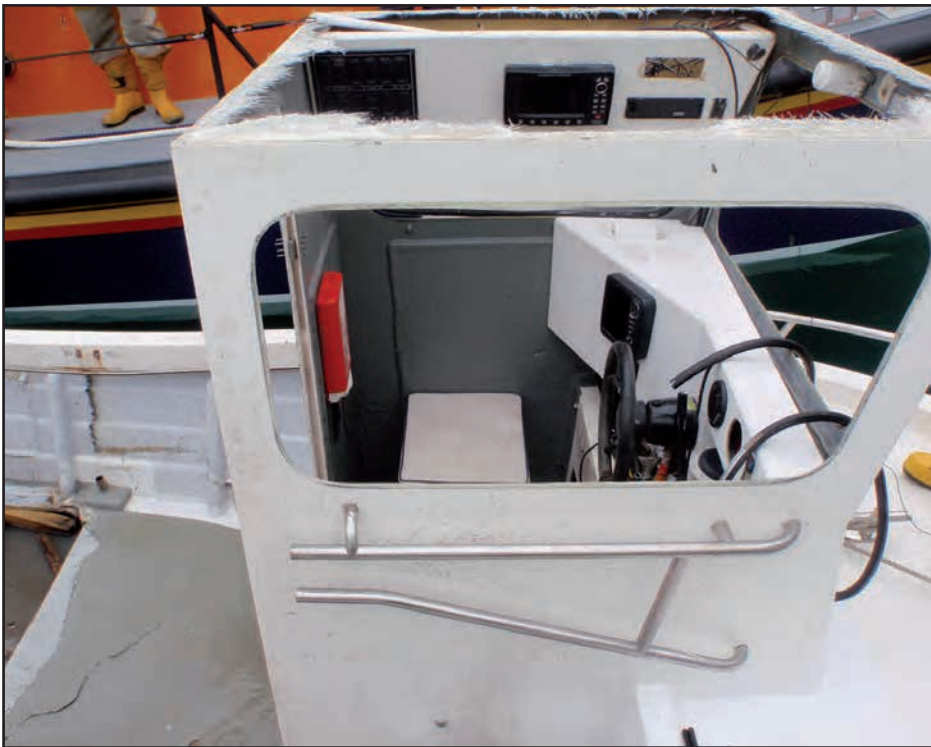
Figure 1: Wheelhouse with missing roof and windows

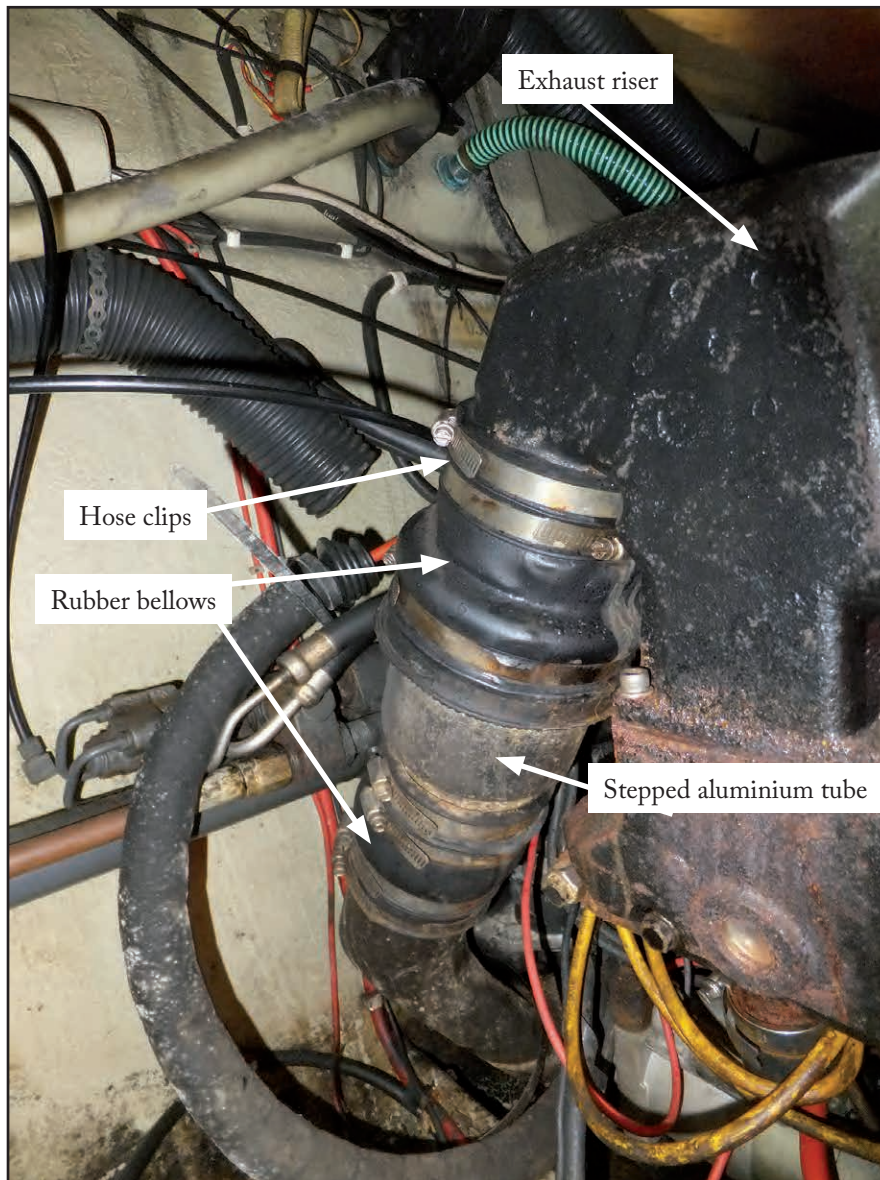
On examination, it was determined that at least two of the flexible rubber bellows of the boat's wet exhaust system were leaking, allowing water and exhaust gas into the boat (Figure 2).

Figure 2: Exhaust riser and rubber bellows

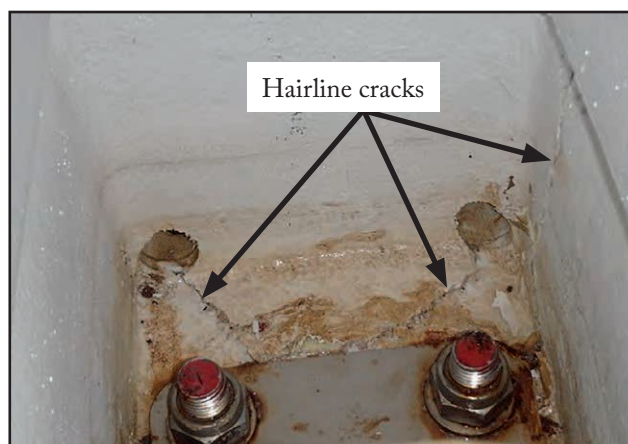
Figure 1: Hairline cracks around the yacht's keel bolts

During the night, the skipper started hearing a clunking sound each time the boat rolled and assessed it to be movement of the keel; a significant development that led to the decision to abandon the boat. When the merchant vessel arrived on scene, the skipper drove the yacht alongside and the crew transferred to the safety of the ship (Figure 2). The yacht was then cut free, with a hull valve left open in order that it would flood and sink.

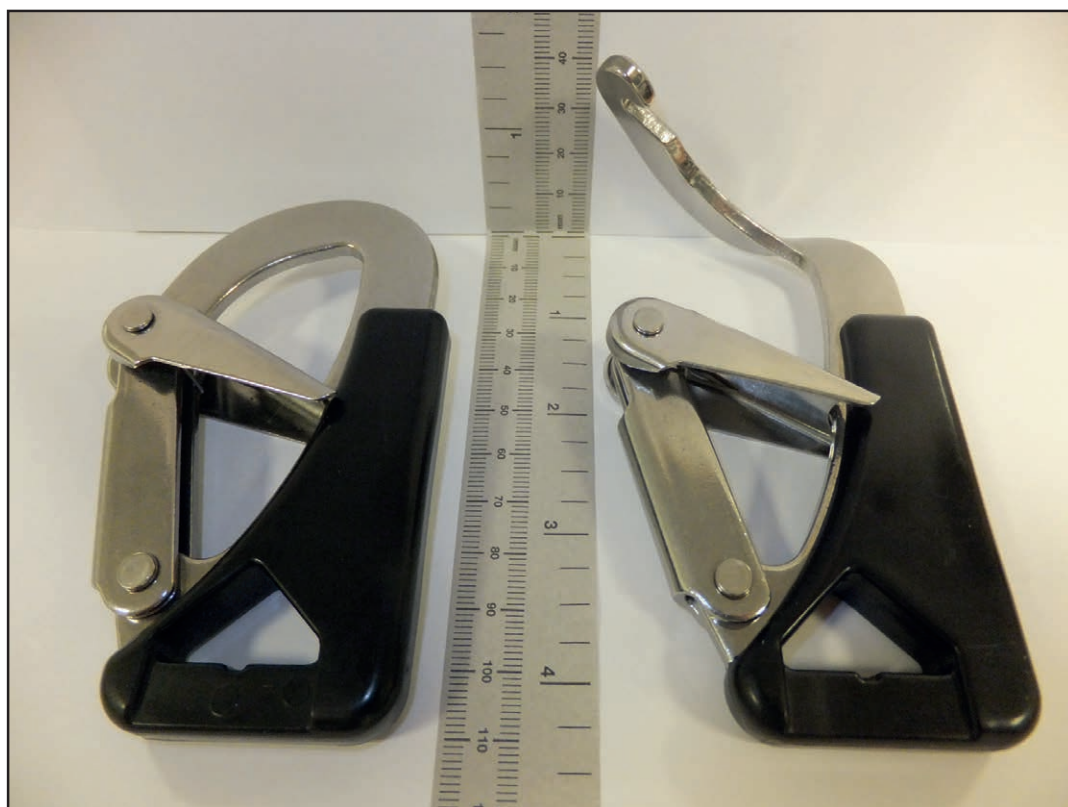
Figure 2: Example of a tether hook and a tether hook after lateral loading
