**Lessons from Marine
Accident Reports
2/2018**

SAFETY DIGEST
Lessons from Marine Accident Reports
No 2/2018

October 2018

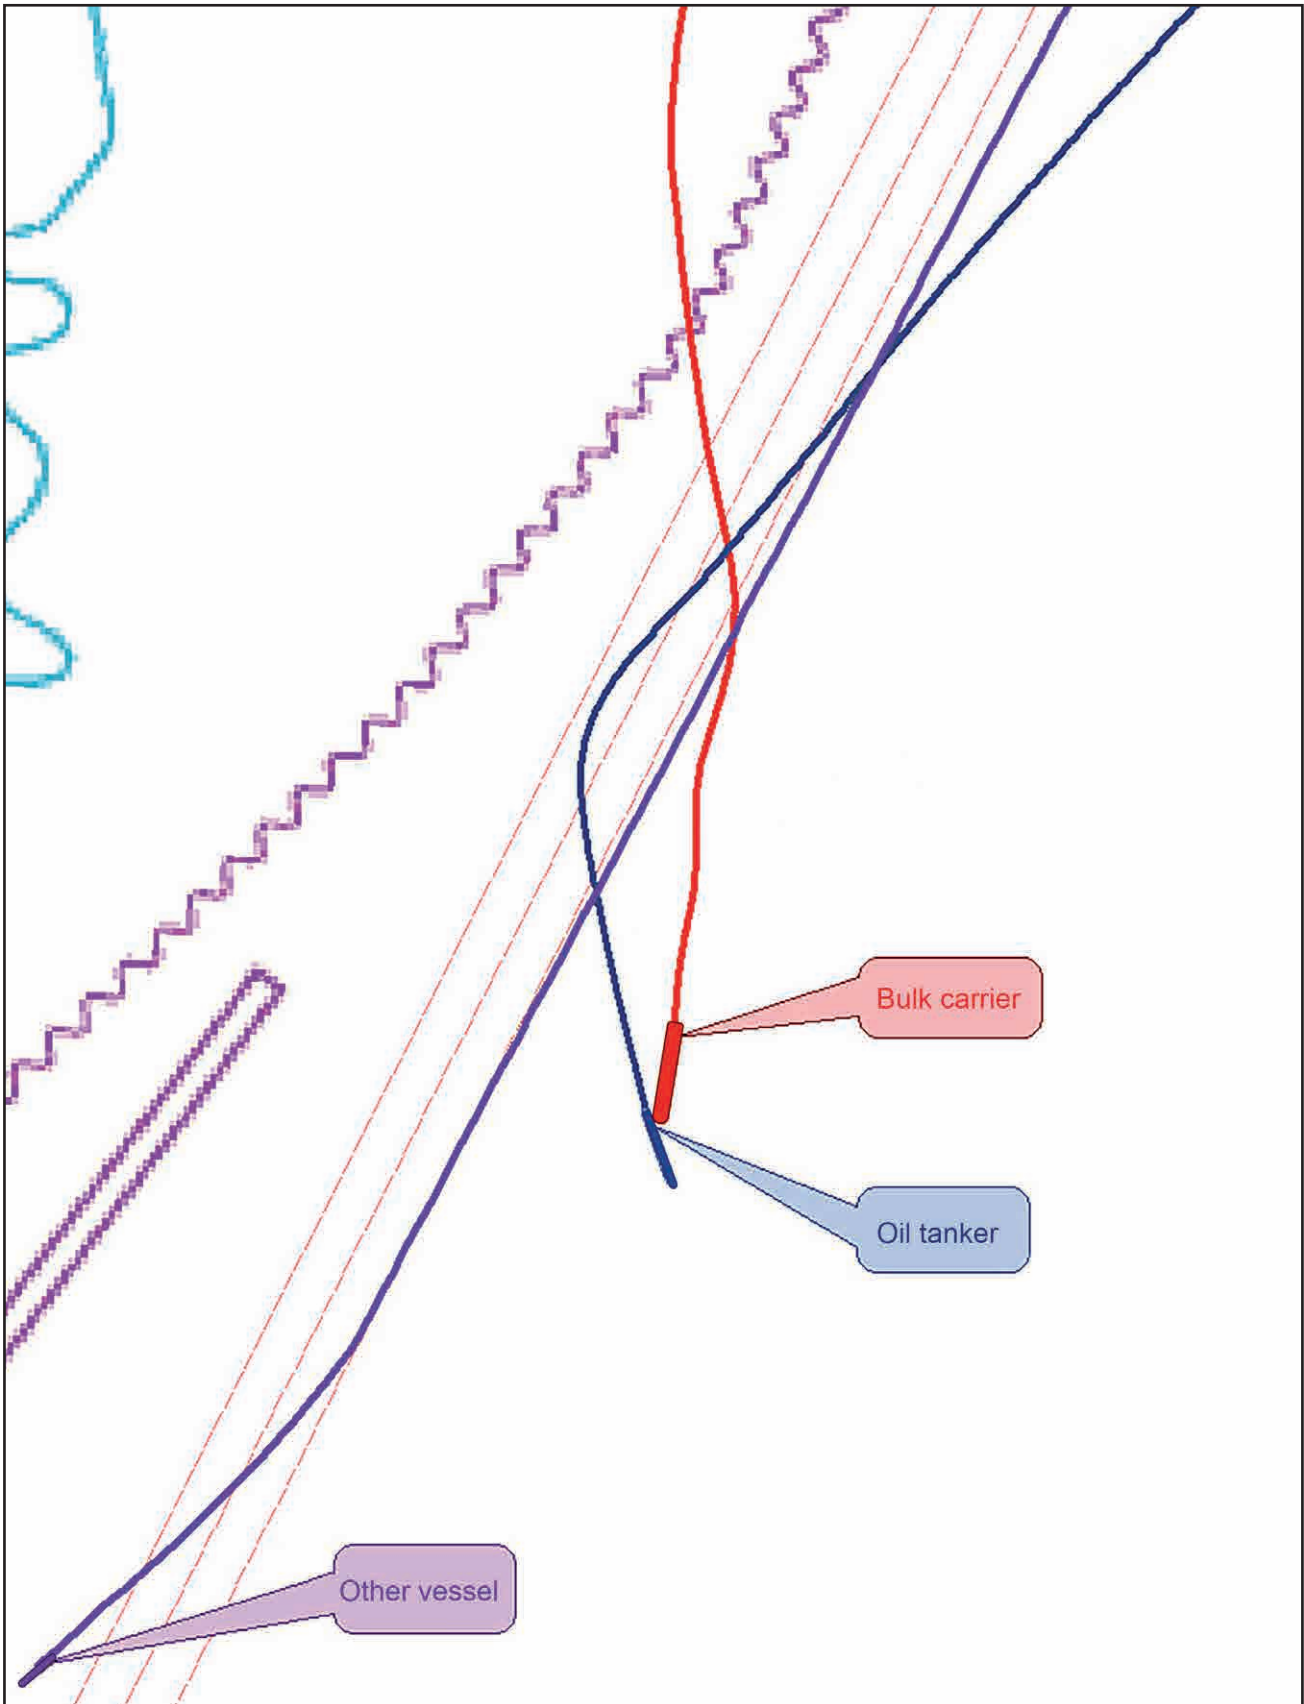
The bulk carrier's master was alarmed to see the oil tanker alter to port across his bow at such close range. Unsure of what to do, and thinking that he had been instructed to pass to port, the bulk carrier's master made a series of helm movements in a vain attempt to avoid a collision. However, due to the proximity of the vessels (see figure) there was nothing that could be done to avoid the accident. Both vessels were severely damaged but there were no injuries and no pollution.

Figure: Tracks of the vessels leading up to the collision

1. Communications should improve understanding; they should not muddy the waters. In this case, the conversation was carried out in neither party's native language, and confusion arose when an assumed action was not verified. The use of standard marine communication protocol might have enabled the information to be passed in a clear manner.
2. Manoeuvring should only be carried out once you are fully aware of what is around you. Assumptions should not be made, and checking sea room ahead and astern is not only good practice but it should also be common sense.
3. Good bridge team management is a vital tool in any navigational situation. Ensure that every member of the team is aware of the plan, their role in it, and that they are empowered to monitor the actions of others in the team.

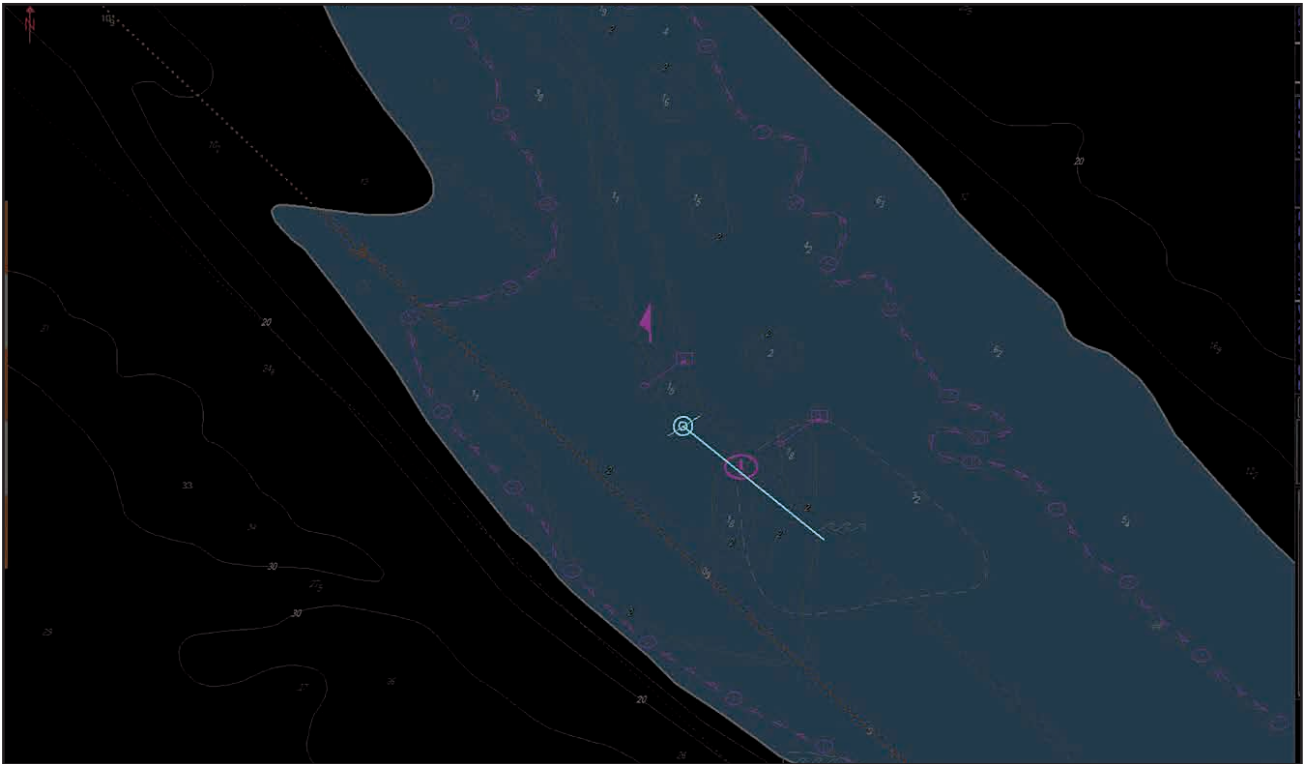
Subsequent inspection of the ECDIS indicated that the system's 'safety frame' or 'look ahead' was inactive and that its audible alarm had been disabled. Consequently, no alarm was generated when the vessel passed over the safety contour (10m) (Figure 2).

Figure 2: Reconstruction of ECDIS display (zoomed in and 'all')

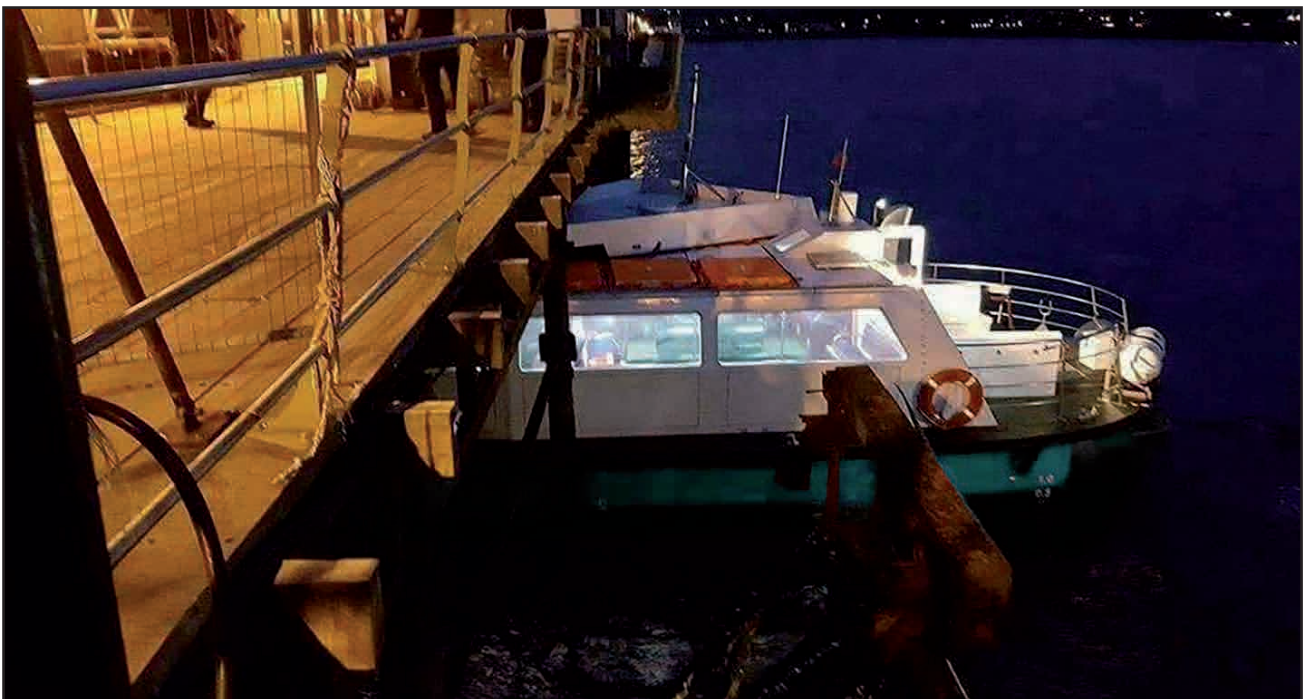
The wheelhouse of a small water jet propelled passenger ferry was severely damaged when the ferry overshot its intended berth and ran under a pier (Figure 1). The skipper suffered minor abrasions from the impact but the two other crewmen and the 15 passengers escaped injury.

Figure 1: Vessel wedged under pier

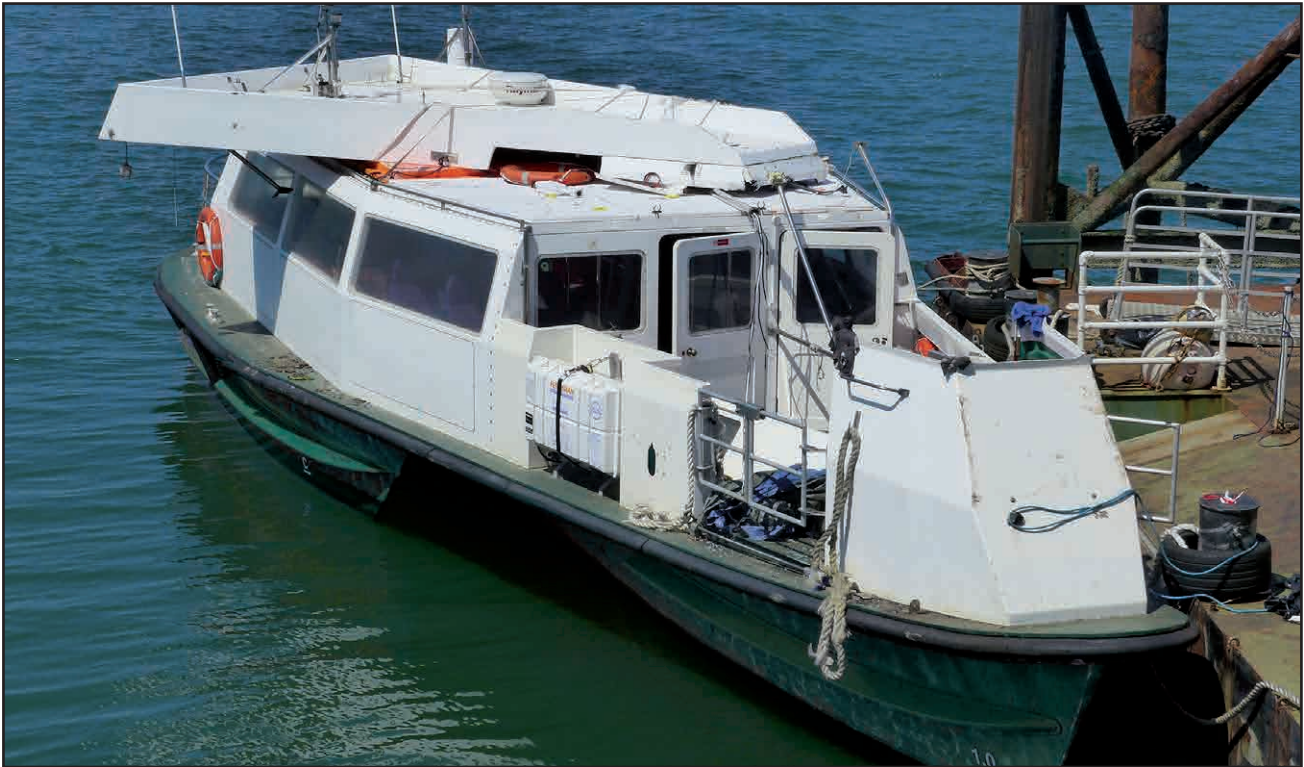
The force of the collision demolished the wheelhouse (Figure 2) and covered the skipper in debris. None of the passengers were injured as they had remained seated as instructed during a safety brief given before departure. Following the collision with the pier, the passengers donned lifejackets and the skipper used a hand-held VHF radio to inform the local VTS that the ferry was wedged (Figure 2). Nearby vessels arrived quickly to evacuate the passengers and the crew ashore.

Figure 2: Ferry post-collision showing the demolished wheelhouse

2. By their nature, ferry operations are routine and the procedures and practices for arrival, departure, berthing and unberthing may hardly vary. However, the approaches to some berths have few abort options and allow little time or sea room to recover from a mechanical malfunction, a lapse, or an error of judgment. The dangers associated with routine tasks are difficult to avoid, but no matter how familiar or competent a skipper might be, asking 'what if?' before each berthing can prompt a greater consideration of the manoeuvre and the potential effects of the environmental conditions.

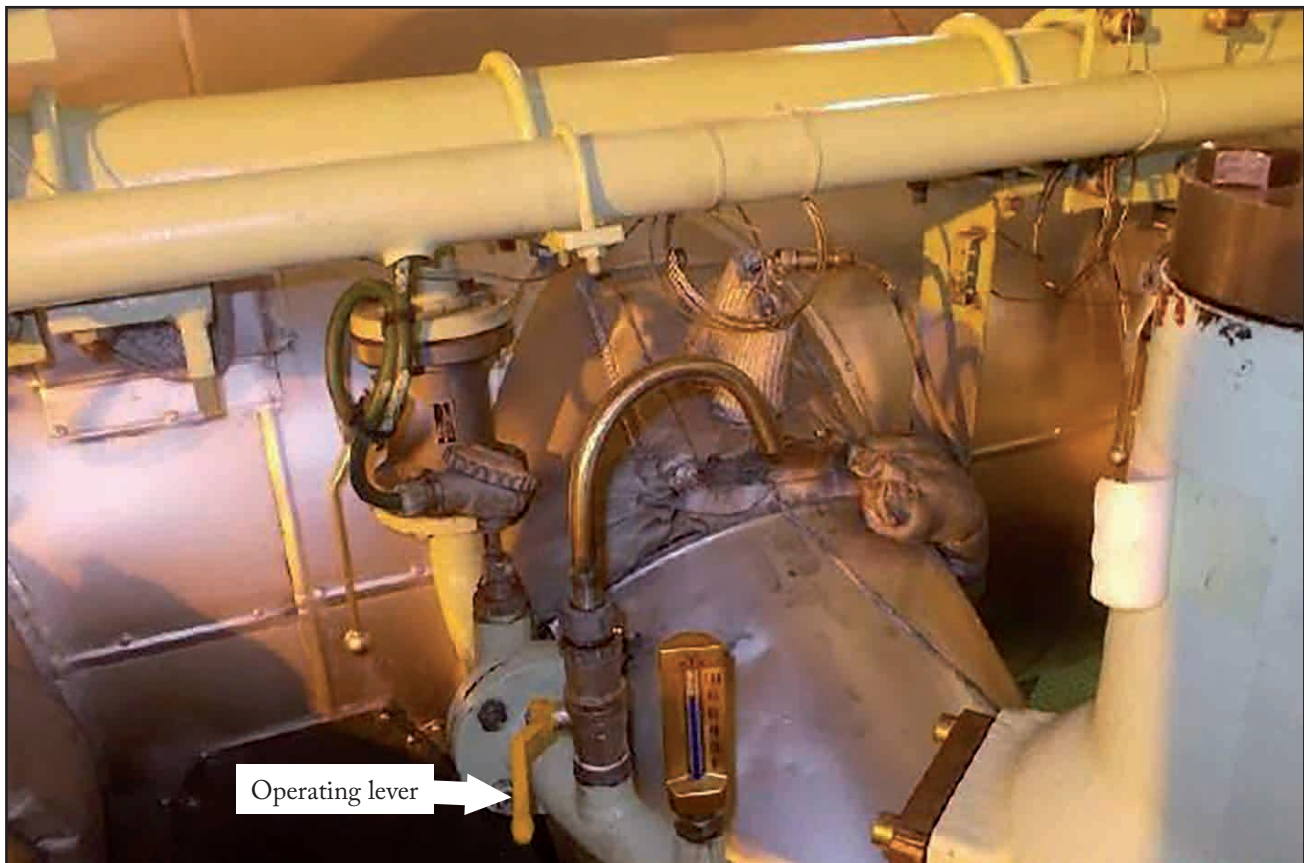
Figure 2: Vent valve operating lever

Following the accident, the company took immediate action to remove the vent valve operating levers on all its vessels with similar engines. This was a temporary measure until proper securing or blanking arrangements could be put in place.

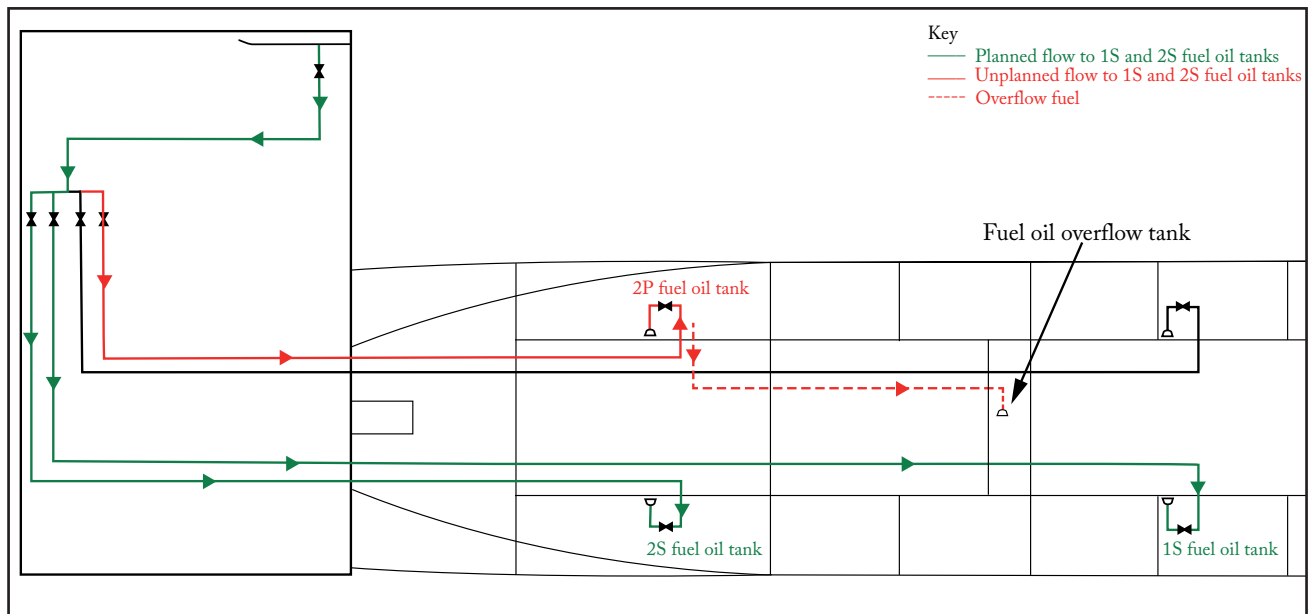
It was subsequently discovered that two valves aligned to another fuel tank were not fully closed. One valve was jammed with some debris and the other not fully tightened, which allowed fuel to flow into a tank that was already 80% full, eventually causing it to overflow.

Figure: Illustration to show the flow of fuel oil at the time of bunkering

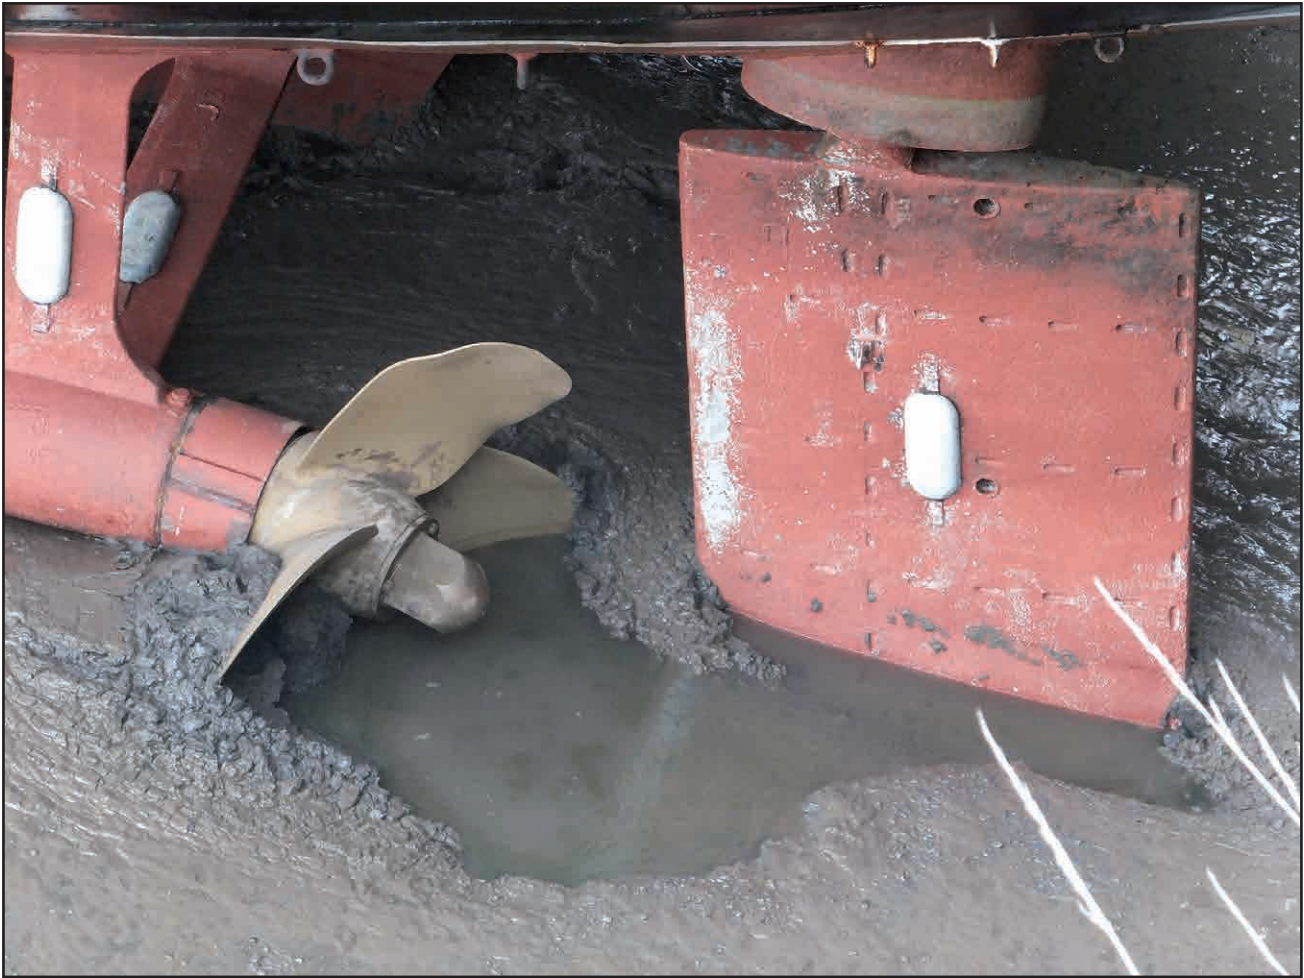
The ferry had run over the submerged remains of a mooring dolphin, which was the northerly-most of several charted derelict dolphins on the eastern side of the approach to the lock (Figure 1). The ferry's port propeller, shaft, stern seal and rudder were damaged by the contact (Figure 2).

Figure 2: Damaged propeller and rudder

2. Navigating by eye in a narrow channel is common practice, but it can be misleading - even in familiar waters. Therefore, when passing close to underwater hazards or shoal water, the use of more accurate navigation systems, such as electronic charts, provides good assurance.

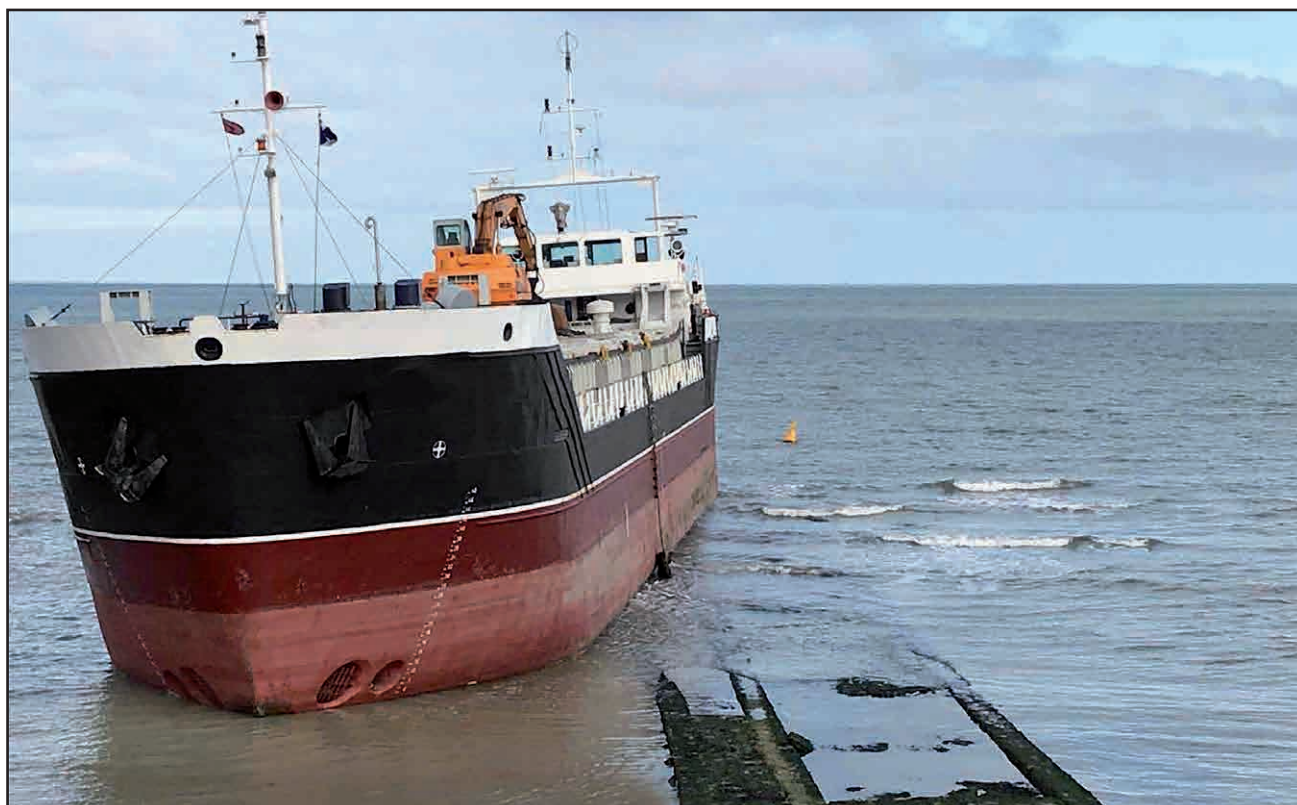
As the ship continued to head to the south, the VTSO soon became concerned that it was closing the shore, and repeatedly advised the chief officer to alter course. However, although the chief officer acknowledged the VTSO's warnings, he took no action. It was dark, and the chief officer had become overwhelmed by the situation and had lost track of the ship's position. The ship grounded at a speed of 7kts on a falling tide and remained high and dry for 12 hours (see figure).

Figure: The cargo ship aground

1. In exposed anchorages prone to high winds or strong tidal streams, a ship can remain safely at anchor only as long as there is sufficient scope on the cable and the anchor continues to hold. Therefore, deciding how much cable to use has to be based on the actual and forecast weather conditions, and the predicted tidal stream and tidal range; not simply on what has worked before. Anchoring is definitely not a one size fits all operation.

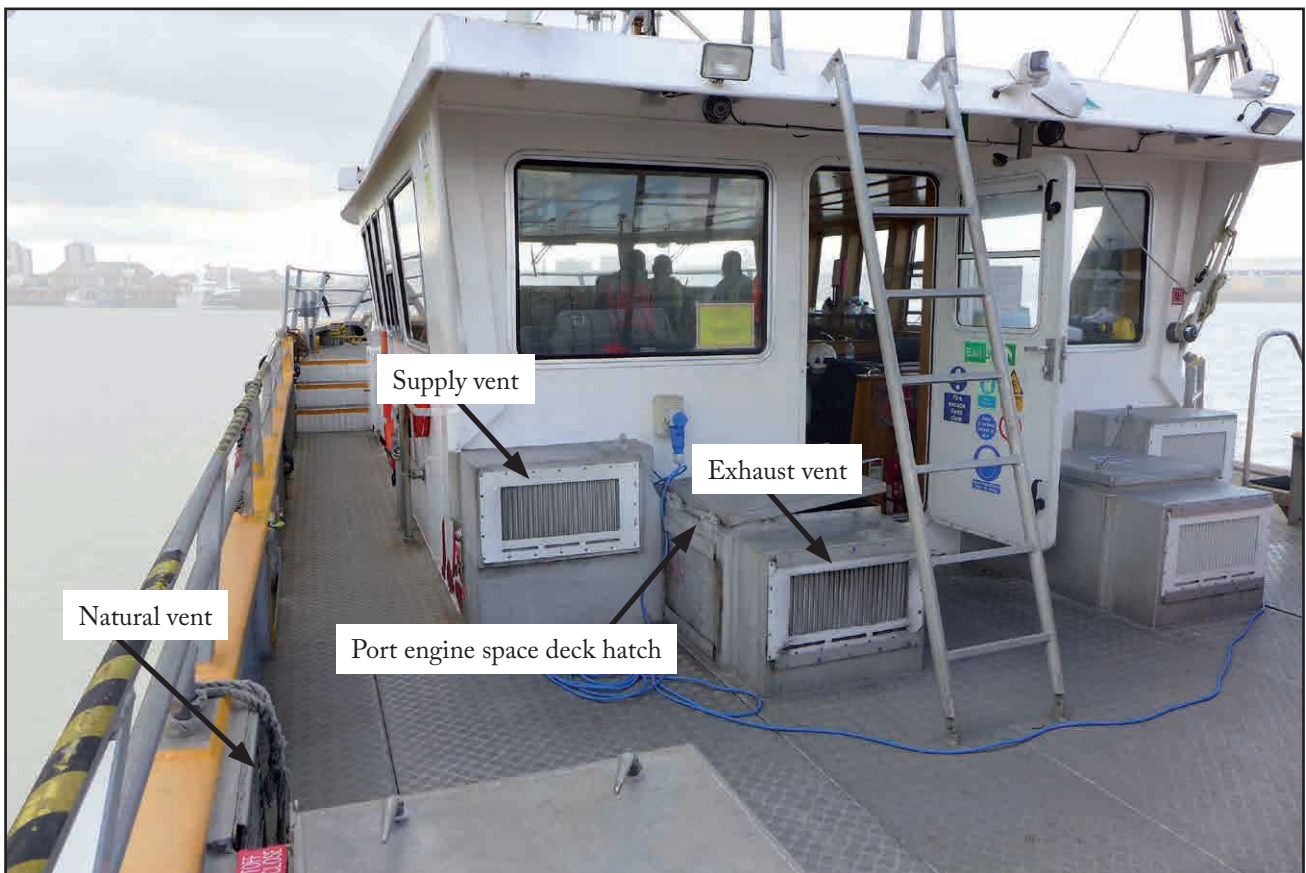
Within 2 minutes of the port engine failure, the crewman had closed the flap on the engine space's supply vent on the aft deck (Figure 1), and activated the fire extinguishing system. The extinguishing medium filled the port engine space, obscuring the flames from view on the CCTV, and a white gaseous cloud billowed from the port engine space's natural air vent (Figure 2). Meanwhile, the technicians mustered on the foredeck and the skipper broadcast a "Mayday" via VHF radio. In response, other crew transfer vessels in the immediate vicinity closed to assist.

Figure 1: Aft deck

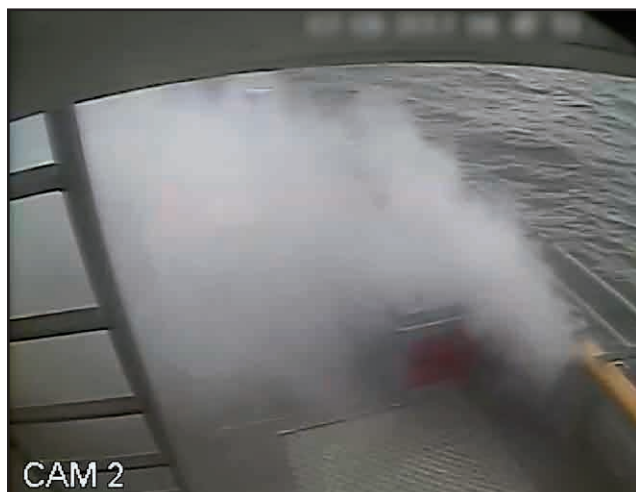
Minutes later, the CCTV showed that the smoke in the port engine space had cleared and flames were burning across the engine's top. The fire was short-lived and within minutes had extinguished, partly due to the smothering effect of shutting the engine space vents but also because there was no more combustible material to burn.

Figure 2: Fire extinguishing powder billowing from the natural air vent

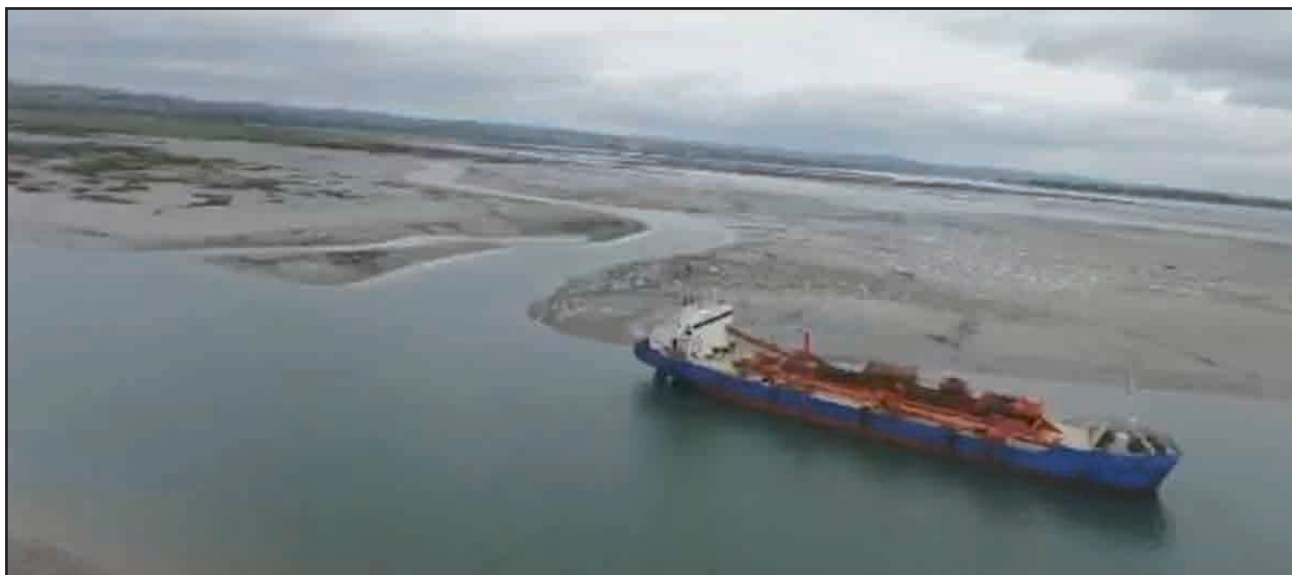
In response to the loss of control, the master reduced speed and attempted to steer the ship using the bow thruster. The master then repeated the procedure for transferring steering control between the consoles, which resulted in regaining control of the rudder from the centreline. However, the recovery of steering control came too late to prevent the dredger grounding gently at about 2kts on the mud bank opposite the berth and a short distance downstream (Figures 1 and 2). The dredger was undamaged and refloated at the next high water.

Figure 2: The dredger aground on the bank opposite the berth

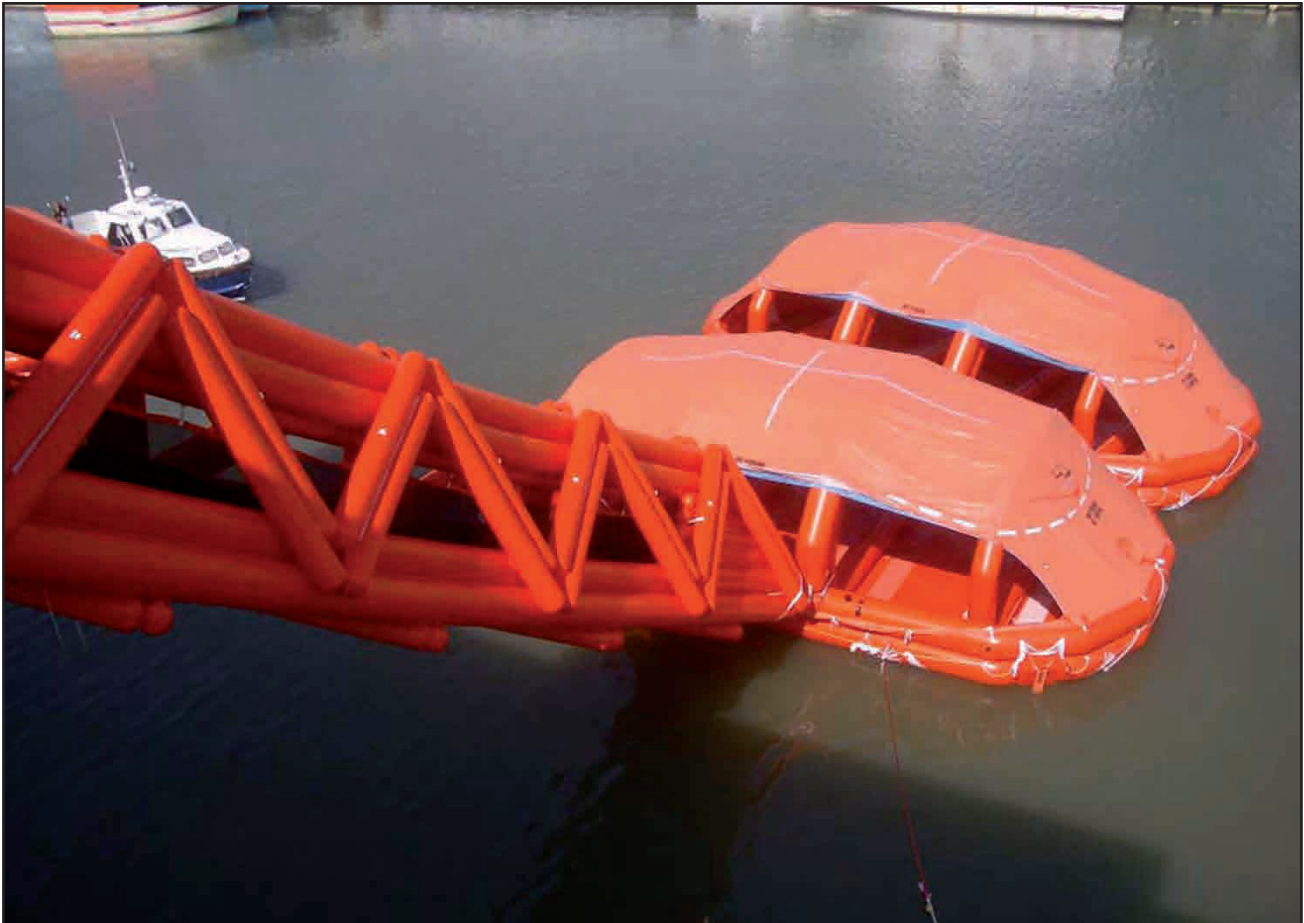
As the third test subject began his descent, pressure applied through one elbow, lifted him up, further reducing friction and causing a rapid increase in speed. As the subject entered the raft his feet became entangled in an overlap between the coir mats, causing him to flip forward and fall face-down into the raft. The force of his body turning against his trapped feet resulted in a fractured ankle.

Figure 1: Deployed MES

2. The MES design concept was to accommodate mass evacuation of passengers wearing normal clothing. While 'normal clothing' will have varying coefficients of friction, the survival suits being tested were known to have a low coefficient of friction. The late decision by the owners to supplement the statutory deployment with an in-house trial did not allow sufficient time to fully assess all of the hazards involved. Furthermore, they did not fully take into account the experiences of ship's staff relating to previous accidents.

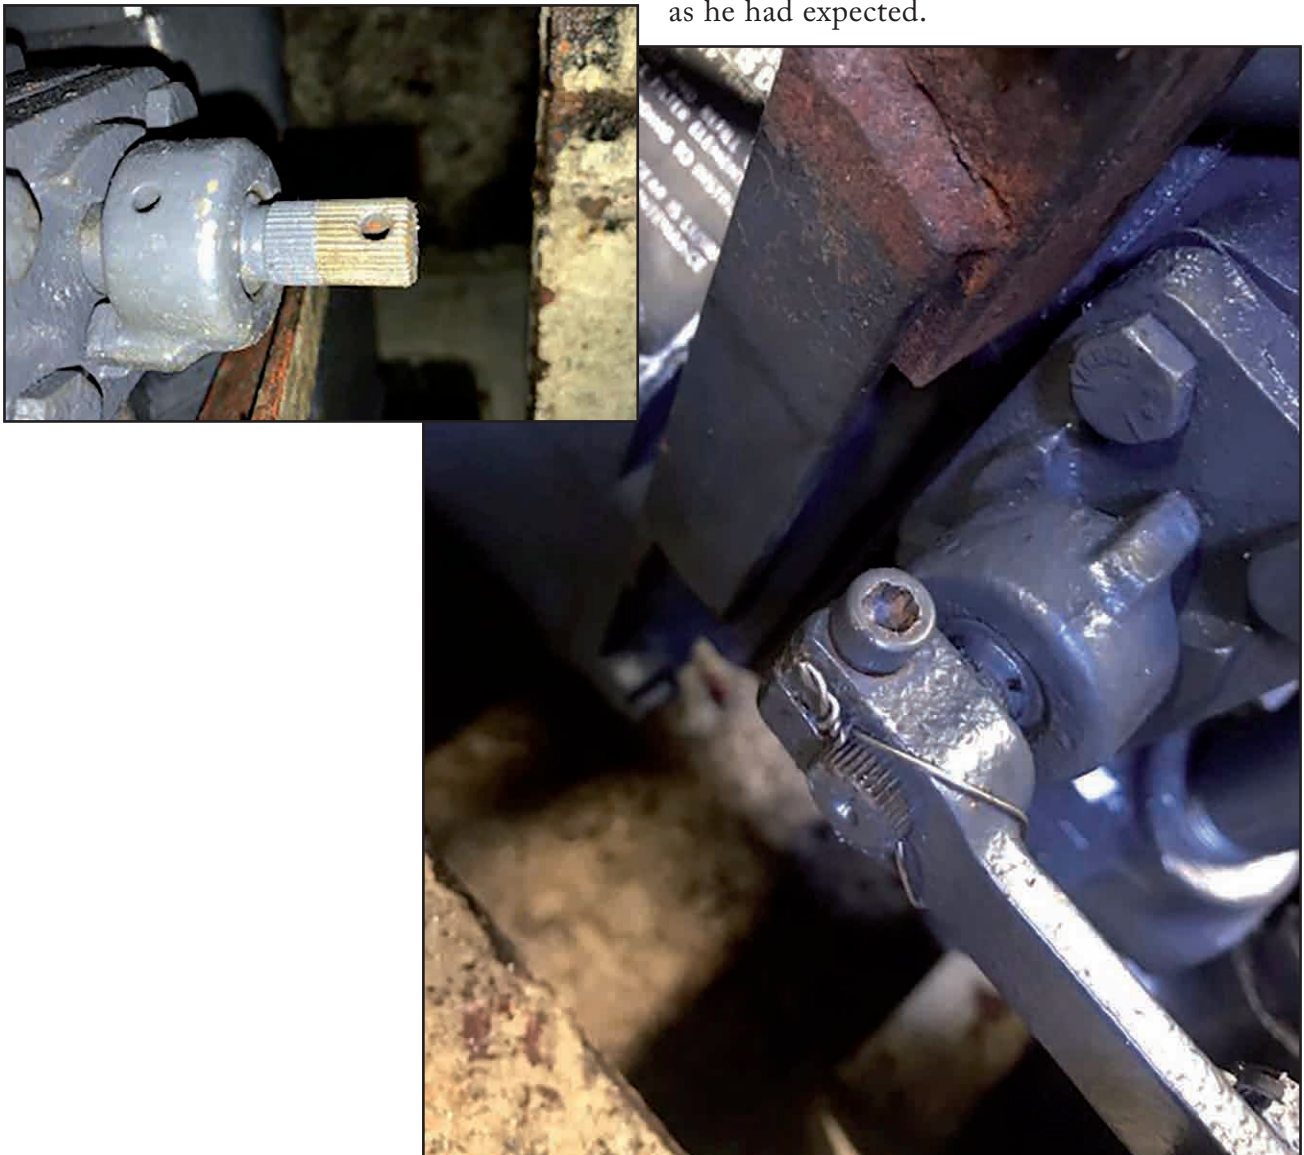
An inspection by a local engineering company discovered that the linkage between the starboard engine gearbox and the gear shift mechanism had disconnected, so the crew were unable to alter the direction of drive (Figure 1). The port engine, having reversed, applied reverse thrust while the starboard engine continued to apply ahead thrust. This caused the vessel to swing to port and make contact with the pier. Unfortunately, the console with the remote controls for the engines did not have any indications for propeller direction (Figure 2) so the master was unable to understand why the vessel was not responding as he had expected.

Figure 1: Gear shift mechanism linkage (inset: linkage disconnected in service)

1. Mechanical linkages are prone to detach or fail, especially when used repeatedly. Check and tighten them as required. Where possible, use self-locking nuts and split pins to prevent such incidents.
2. Simple instruments or gauges in the wheelhouse showing the running direction and speed of rotation of the propellers can provide immediate feedback to the person manoeuvring the vessel.
3. If you have twin screw propulsion, include the loss of one engine in your risk assessment and consider how you may be able to recover from such a situation in an emergency.

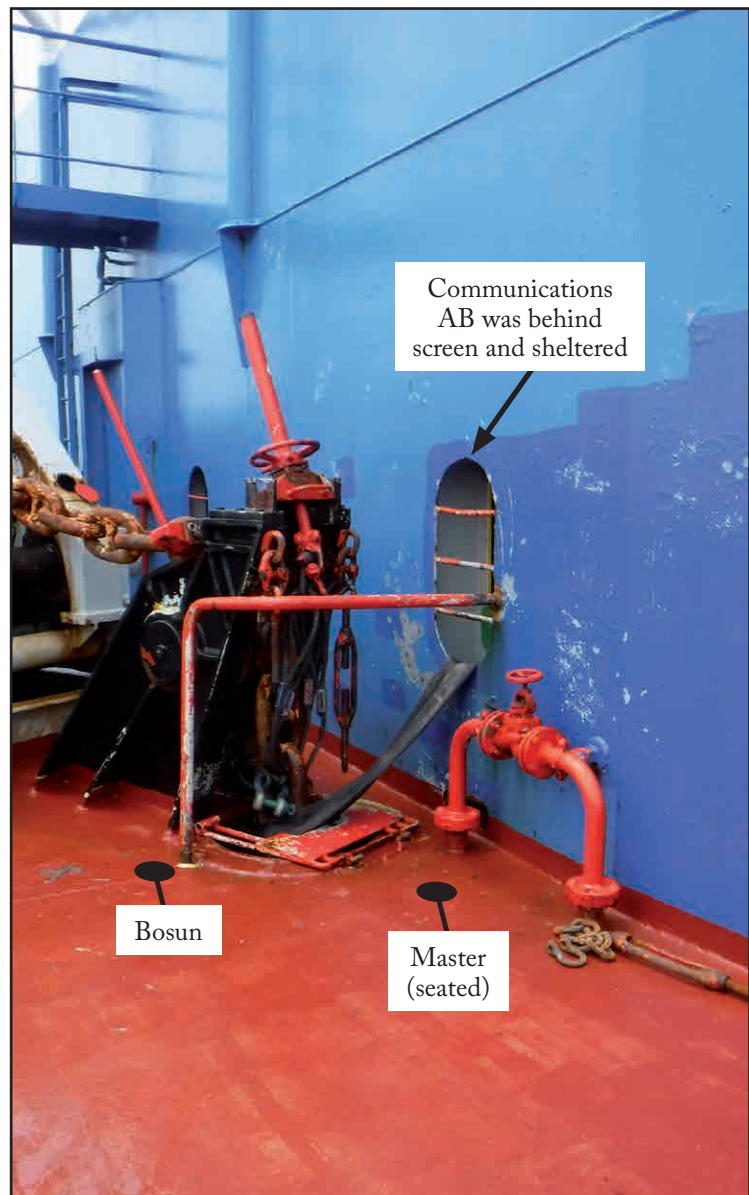
As the master and bosun started working next to the port anchor cable (see figure), the vessel pitched into a very large wave, which resulted in a full bore of water rushing violently up the port hawse pipe. The master was thrown back by the force of the water and struck in the face by the loose hawse pipe cover. The master sustained

Figure: Fore deck area around the port hawse pipe showing the locations of the crew at the time of the accident

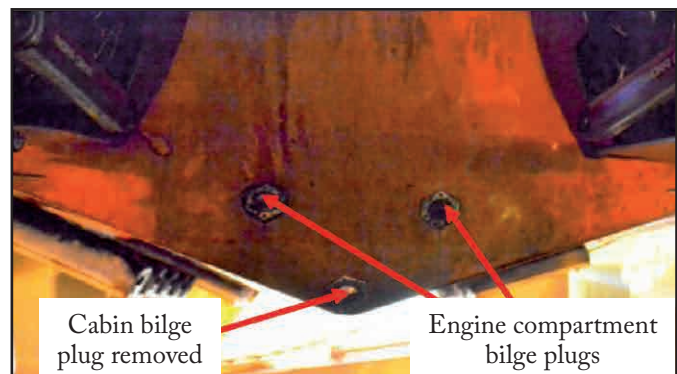
The owners of the ERV carried out an extensive investigation and tests, and concluded that the most likely cause of the accident was that the three drain plugs on the hull of the daughter craft were not in place when it was launched (see figure). The automatic bilge pump had worked correctly, but it did not have a running light indication. The tests conducted with identical daughter craft demonstrated that all the bilge pumps operated together could cope with the ingress of water from three open drain plugs. Subsequently, the company blanked off the drain plugs of all the daughter craft in its fleet.

Figure: Plugs on the hull of the ERV

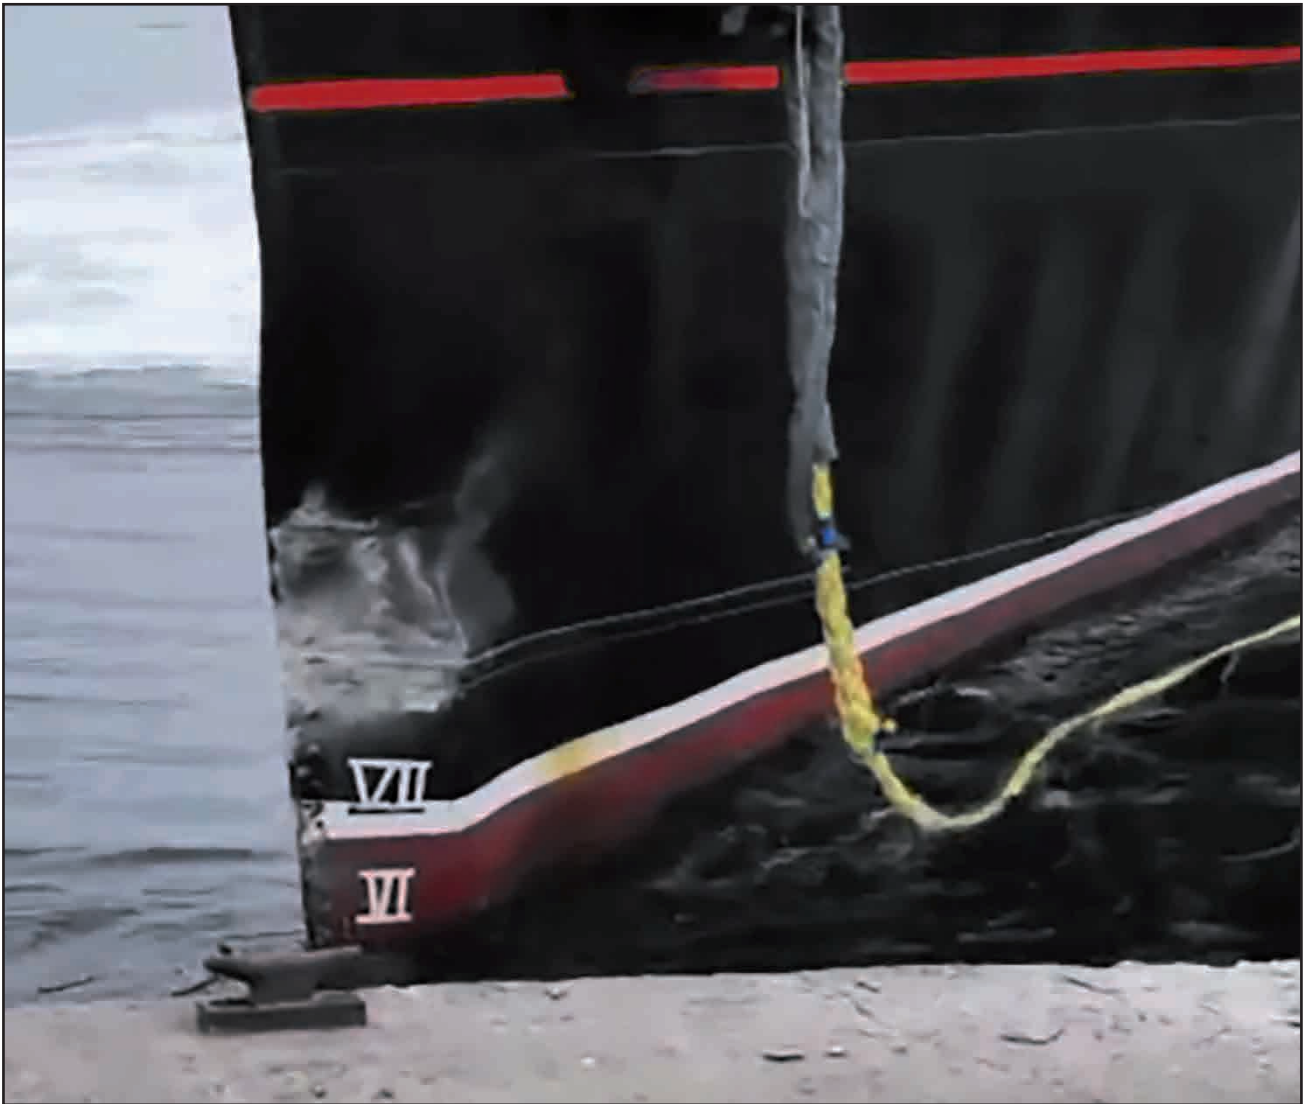
Figure 3: Damage to the bow post collision

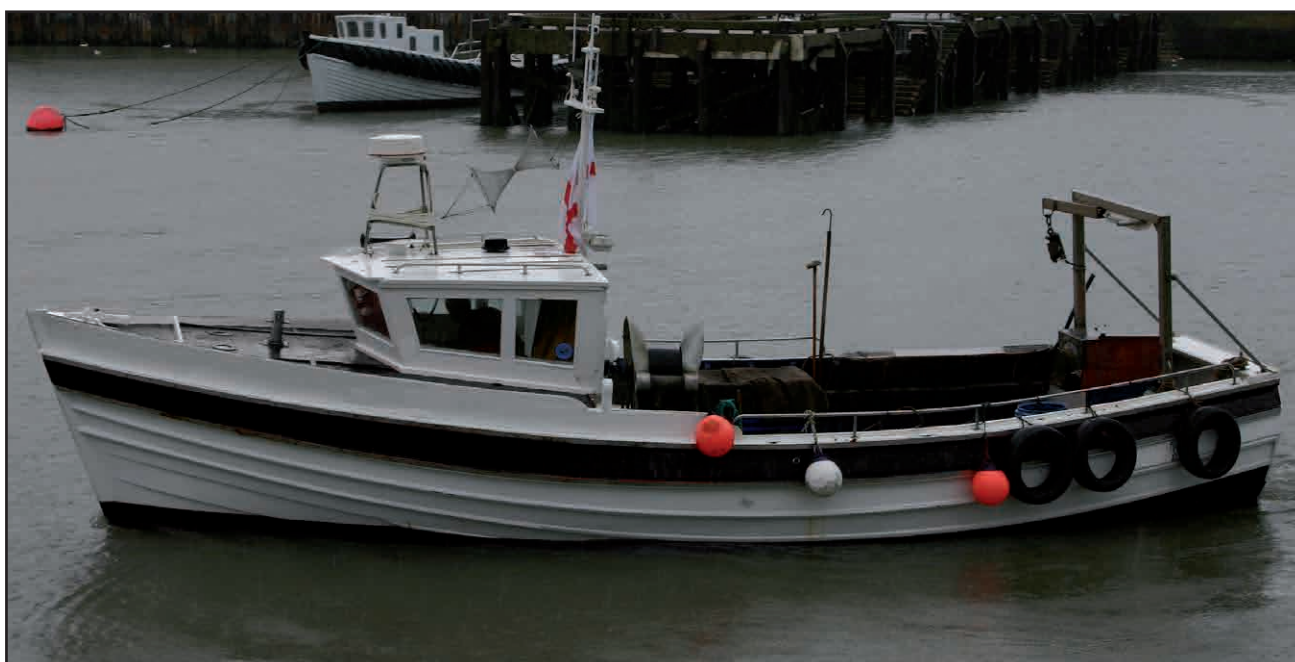
Throughout the morning's fishing, the bilges of the boat had remained dry. The flooding was sudden and was observed to come from the forward part of the boat, and was most likely due to a sprung hull plank. Although the boat was fitted with an electric bilge pump that was started straight away by the skipper, the volume of incoming water soon overwhelmed it and the boat sank.

Figure: The wooden clinker-built fishing vessel

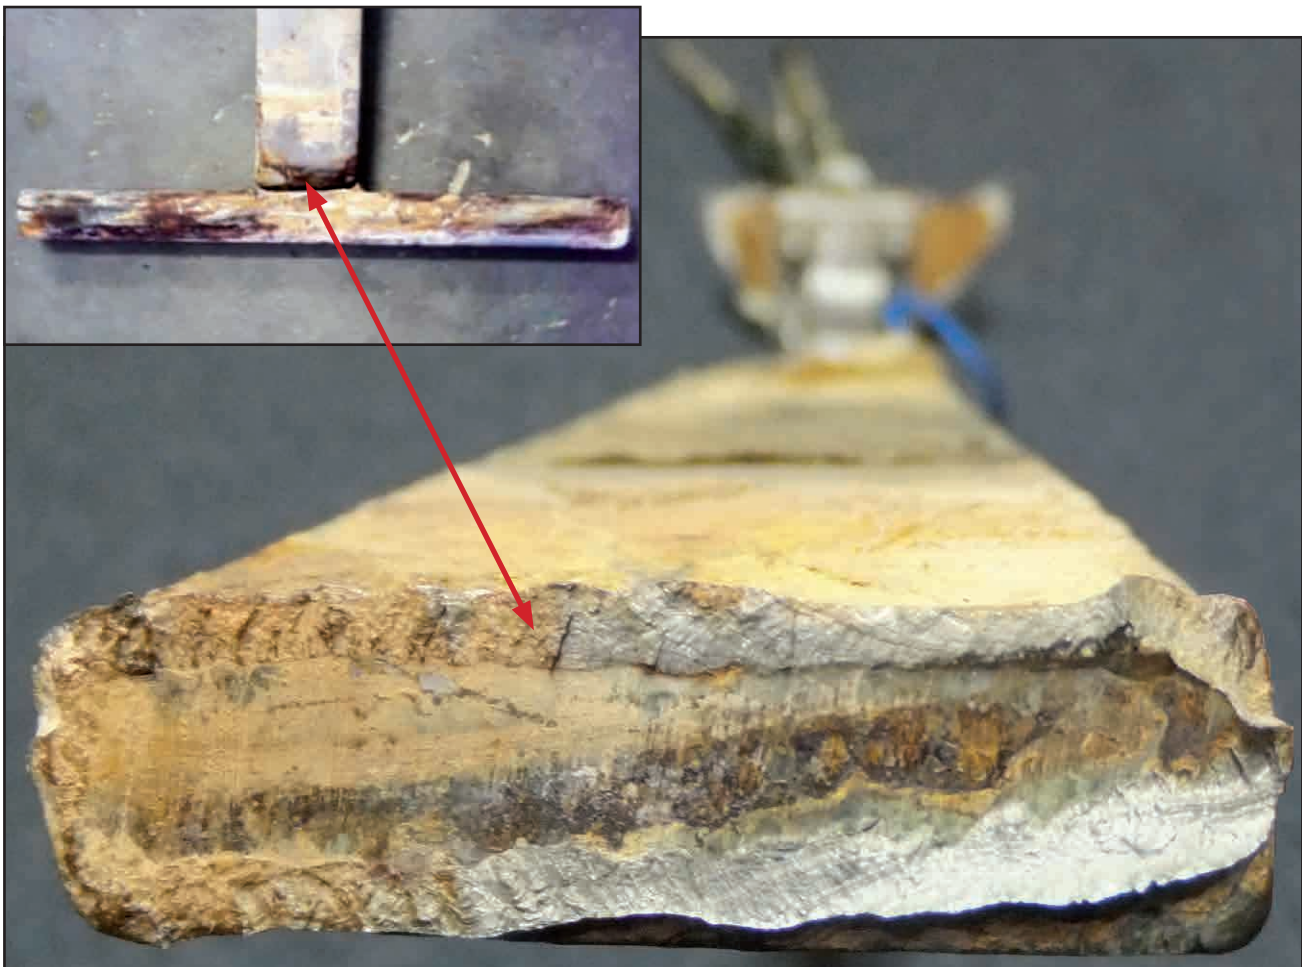
This boat had been in commercial ownership for a number of years and had covered a lot of miles. The cyclic loading on the tie bar would therefore have been high, and ultimately led to the failure of the welded joint.

Figure 3: Tie bar fracture close up (inset: the overall tie bar)
