**Lessons from Marine
Accident Reports
2/2018**

SAFETY DIGEST
Lessons from Marine Accident Reports
No 2/2018

October 2018

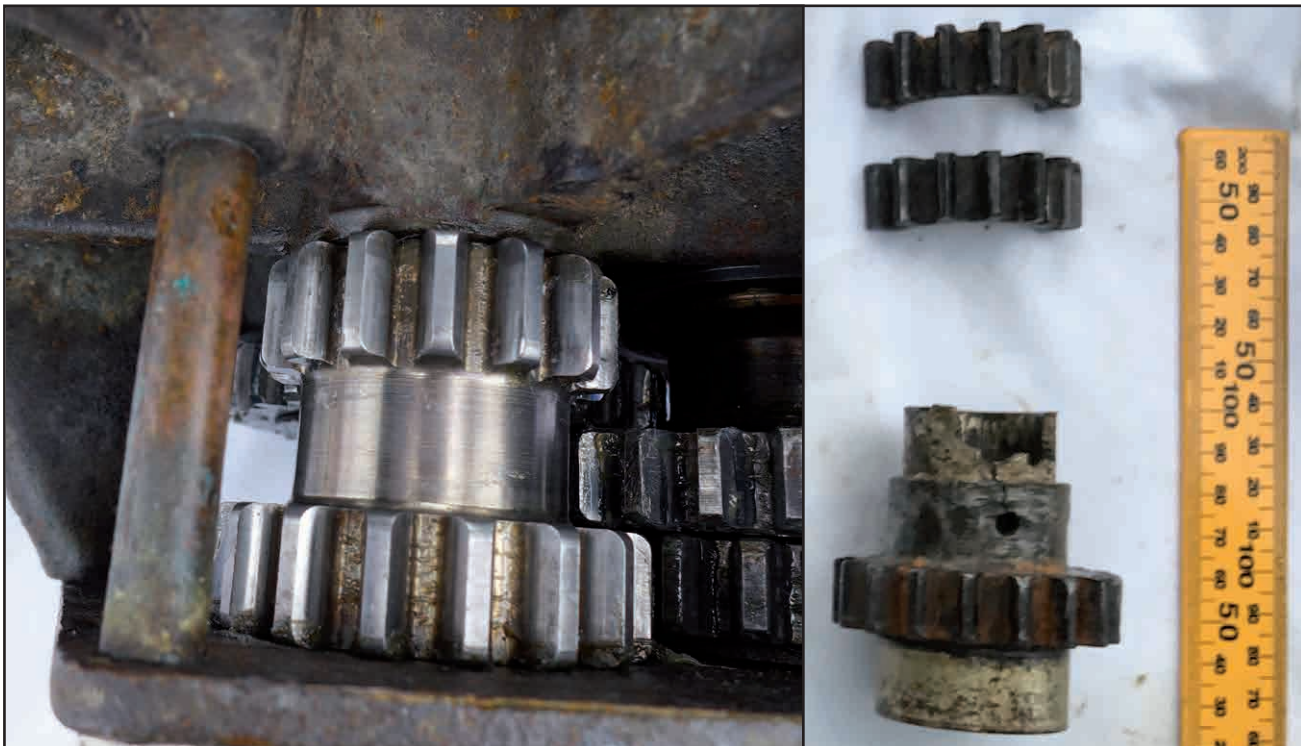
The failed pinion was formed of two parts, whereas the same component on the port side winch was a single part (Figure 2). The coffee-grinders were assessed to be original to the vessel and there was no paperwork to support or explain their installation, maintenance or any repairs.

Figure 2: Port and starboard side winch pinions

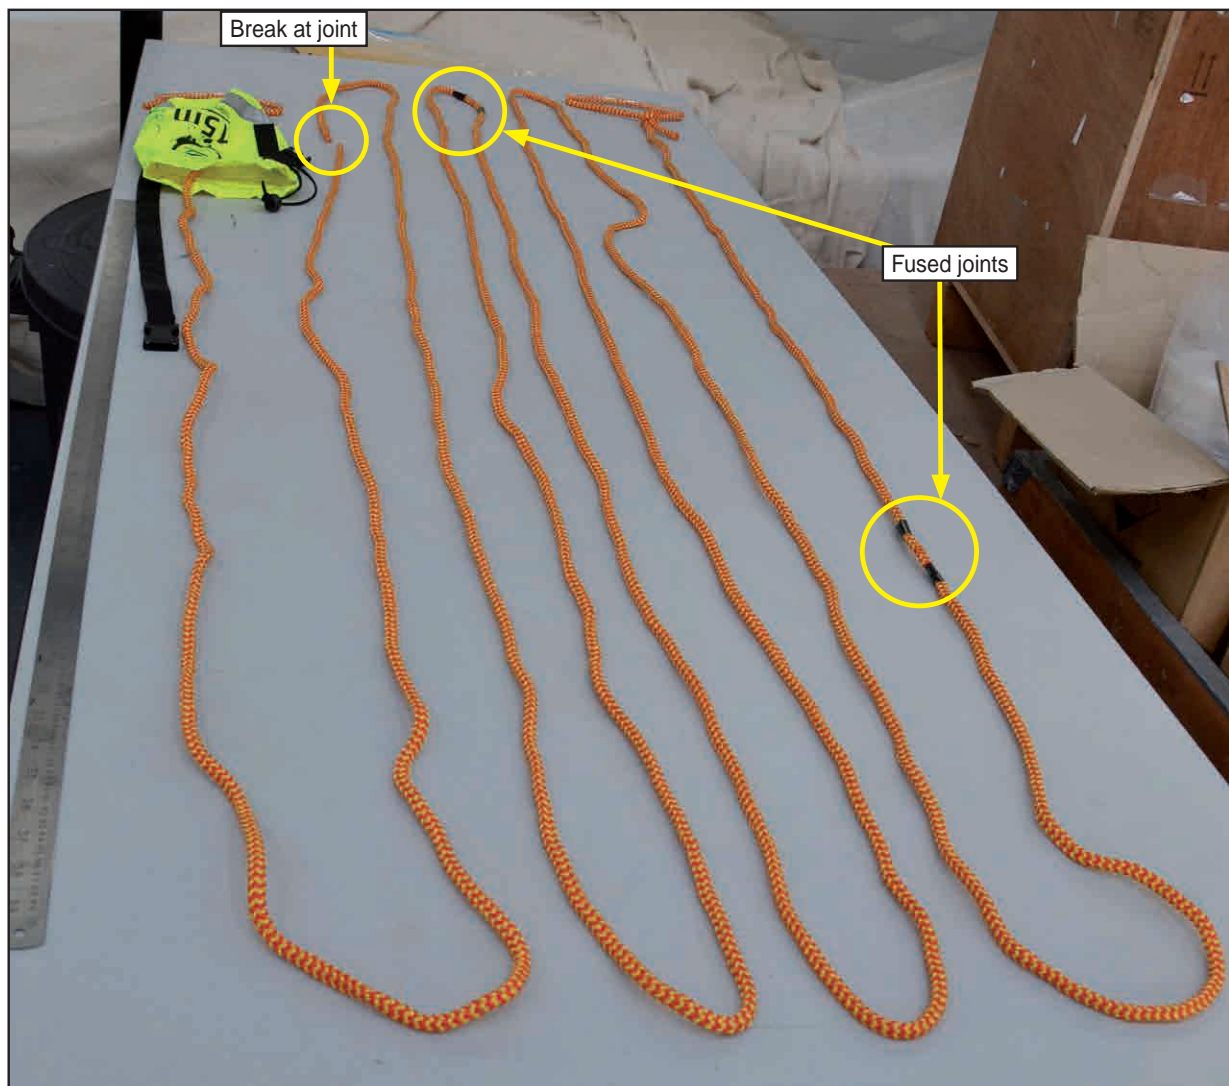
On inspection, the defective RIBER throw bag rescue lines identified by Warrington Rowing Club were found to have been made up of sections of polypropylene rope fused together, which broke easily at the joint when put under tension. One line was constructed of two sections of rope fused together, the other was constructed of four sections of rope, resulting in three fused joints in its 15m length (**Figure 3**). Intact and joined sections of one of the defective rescue lines were tested to determine the line's minimum breaking load. The intact section failed at 256 kgf (kilogramme force) and the joined sections failed between 19 and 23 kgf.

Figure 3: 15m rescue line with three joints

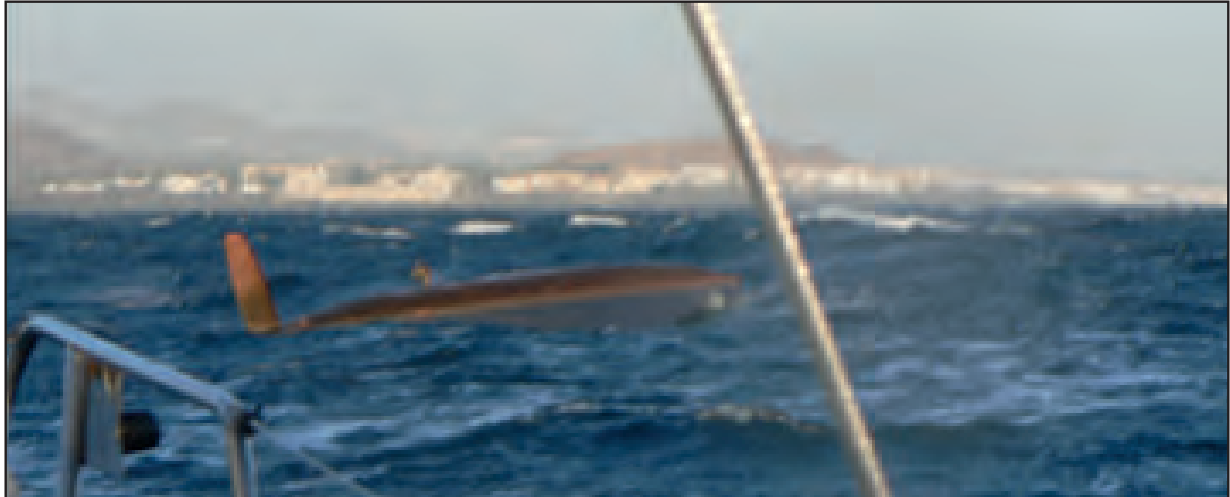
The MAIB is investigating the keel failure and capsizing of the UK registered commercial yacht *Tyger of London* (**Figure 1**) while on passage from La Gomera to Tenerife, on 7 December 2017. The five persons on board were rescued from the water by the crew of a nearby yacht.

Figure 1: *Tyger of London* post-capsize

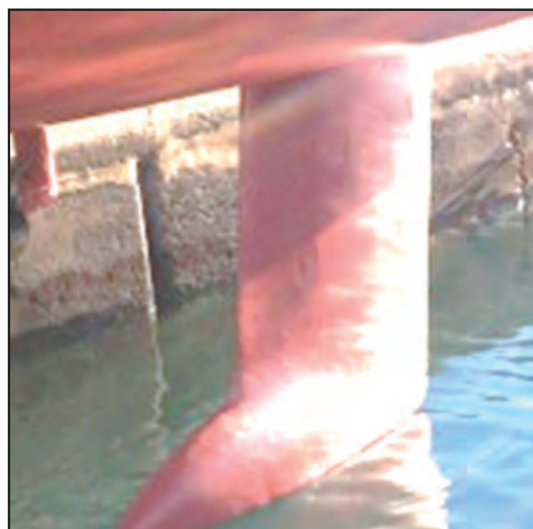
Tyger of London was fitted with the 'shallow draught, lead keel', which is the subject of this safety bulletin.

Figure 2b: Shallow draught, lead keel, fitted to *Tyger of London*, subject of this safety bulletin

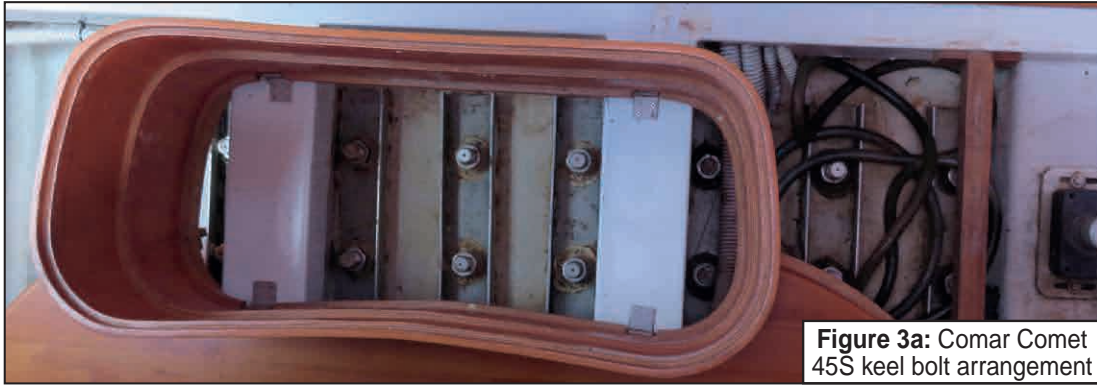
Figure 3a: Comar Comet 45S keel bolt arrangement

- To note that the securing bolts within the bilge of their boats, for this type of shallow draught lead keel, connect the top plate to the hull. The condition and tightness of these keel securing bolts do not indicate the true condition of the keel's internal frame structure.
- To arrange for an out of water inspection of their vessel by a suitably qualified yacht surveyor at the earliest opportunity if the yacht has grounded, been heavily used, or if they have any concern whatsoever as to the condition of the keel, noting the difficulty of inspection of the junction between lead keel and top plate.
