Report on the investigation into
the capsize and foundering of the fishing vessel
Solstice (PH199)
resulting in one fatality
approximately 7 miles south of Plymouth, England

26 September 2017

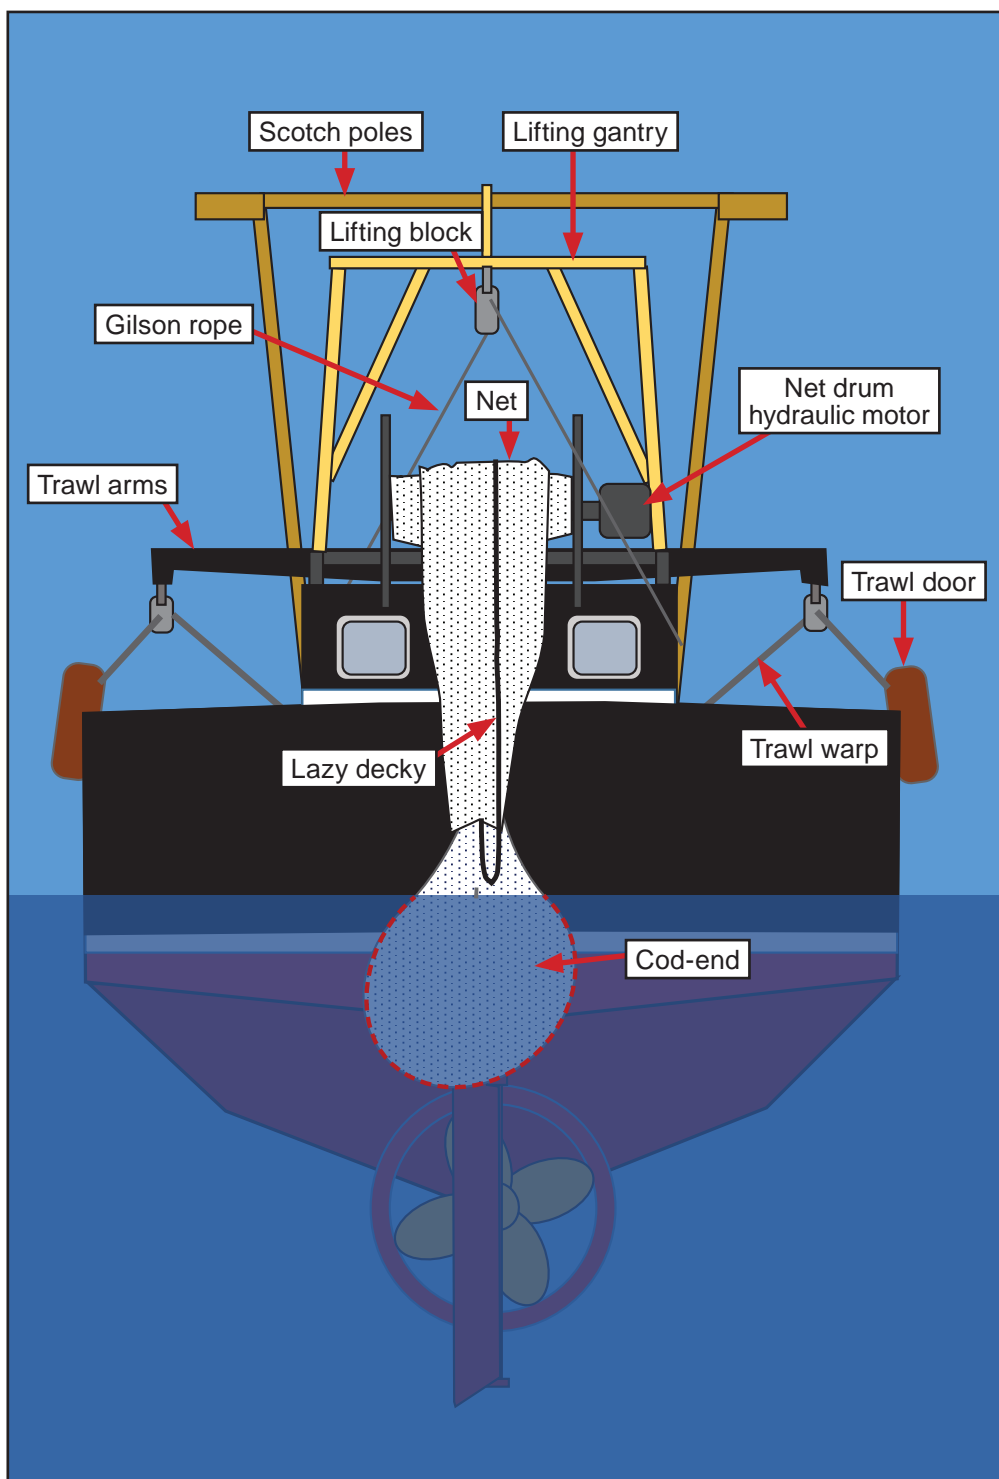
Figure 4: Recovery of cod-end – view from astern

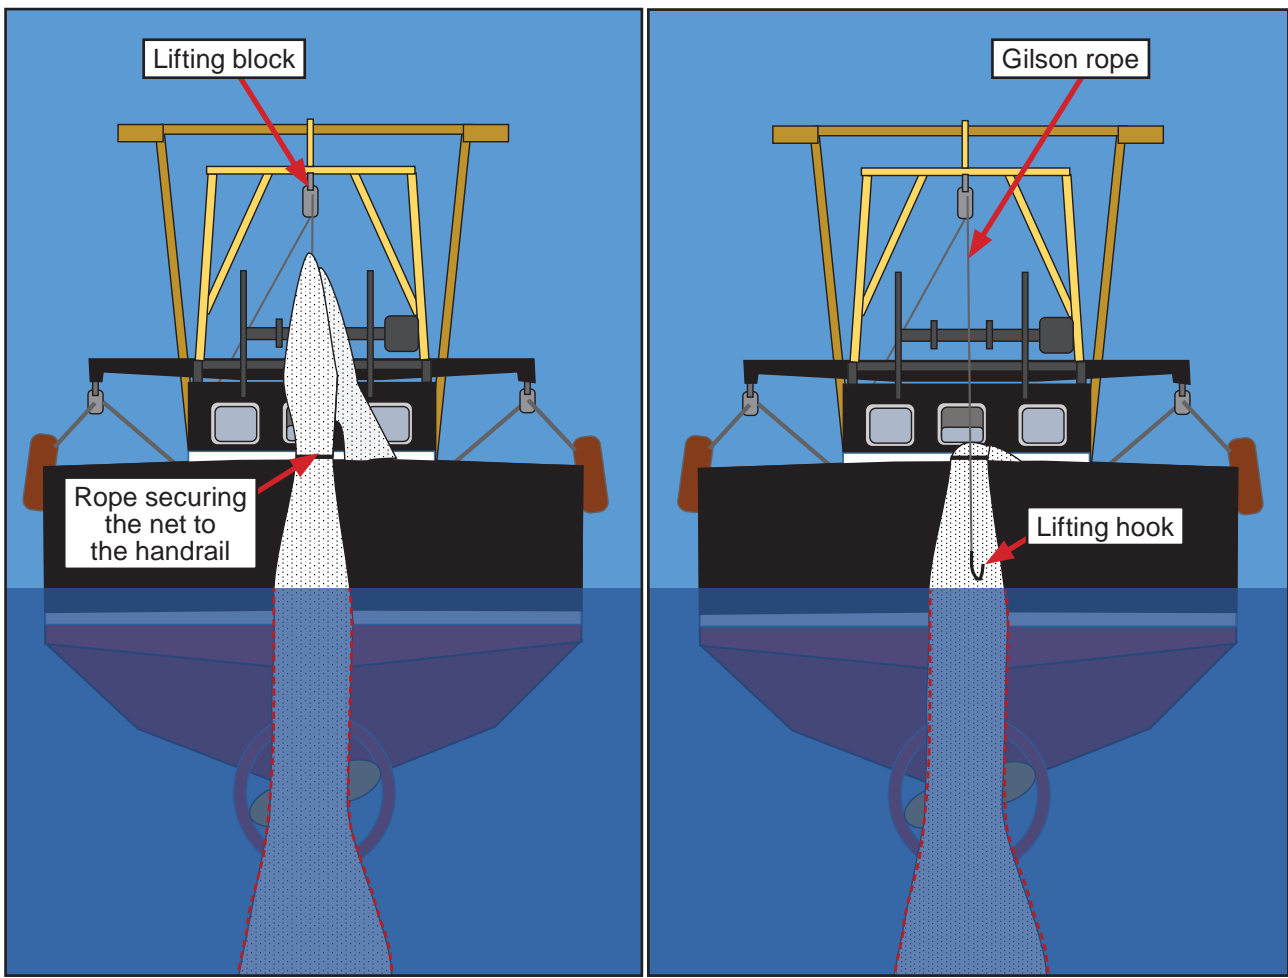
Tony and the skipper visually inspected the net drum and concluded that its hydraulic motor or gearbox had probably failed. Realising that they could not repair the net drum, Tony decided to attach a hook to the gilson rope and use the main deck winch to haul in the net and land the catch.

Figure 5: Recovery of net following net drum failure – view from astern

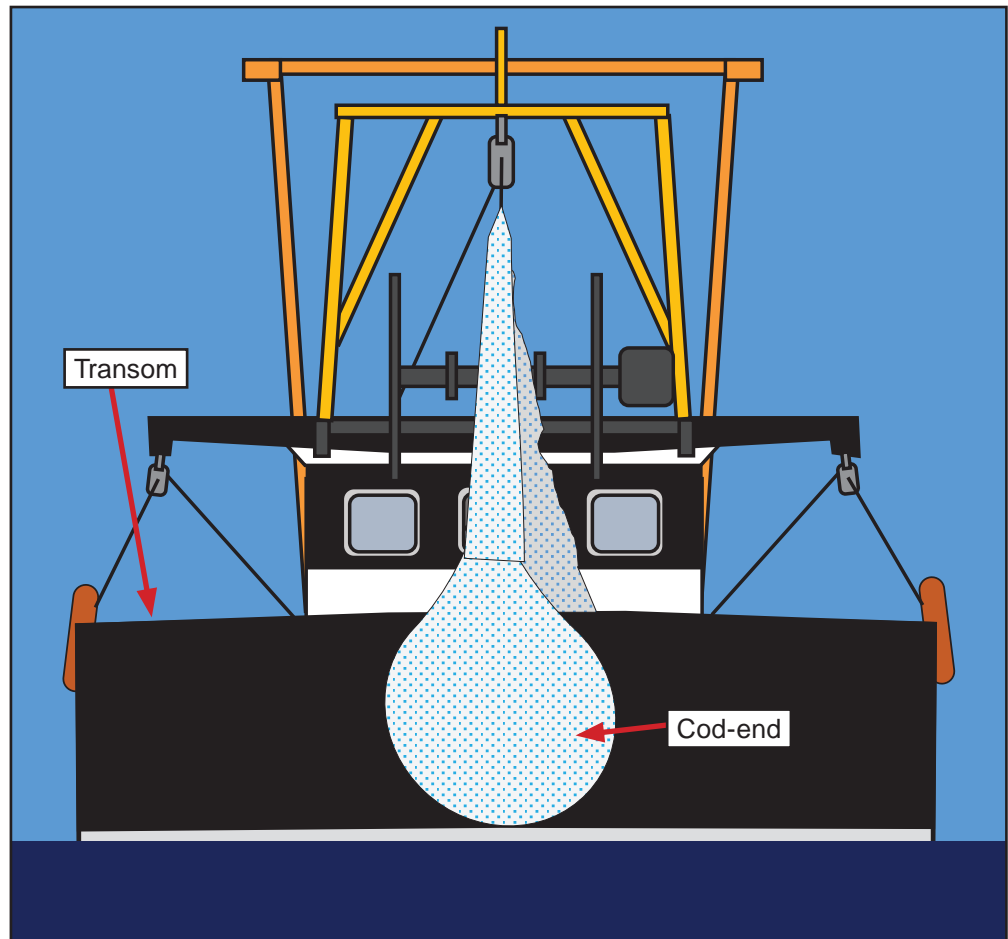
At about 1930, the cod-end was lifted clear of the water (**Figure 6**); it was full of fish, sand and moss. With the weight of the catch suspended from the gantry block, *Solstice* started to roll more heavily and the cod-end began to roll along the top of the transom. As the vessel rolled to port, the gilson rope and net slipped over the net drum cheek⁸ plate. As the cod-end swung further from the centreline it caused *Solstice* to list heavily to port (**Figure 7**).

Figure 6: Cod-end out of the water, resting on the transom – view from astern

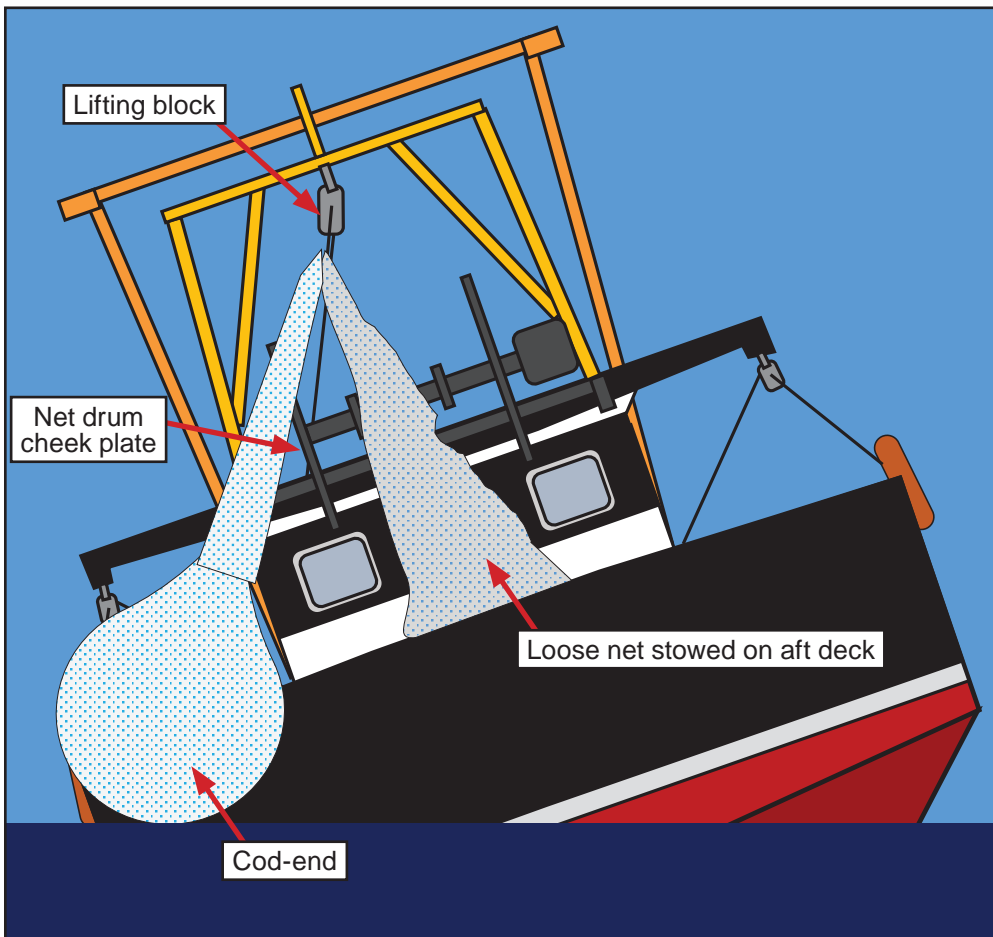
Figure 7: Cod-end on port quarter, heavy list to port as cod-end rolled across the transom – view from astern

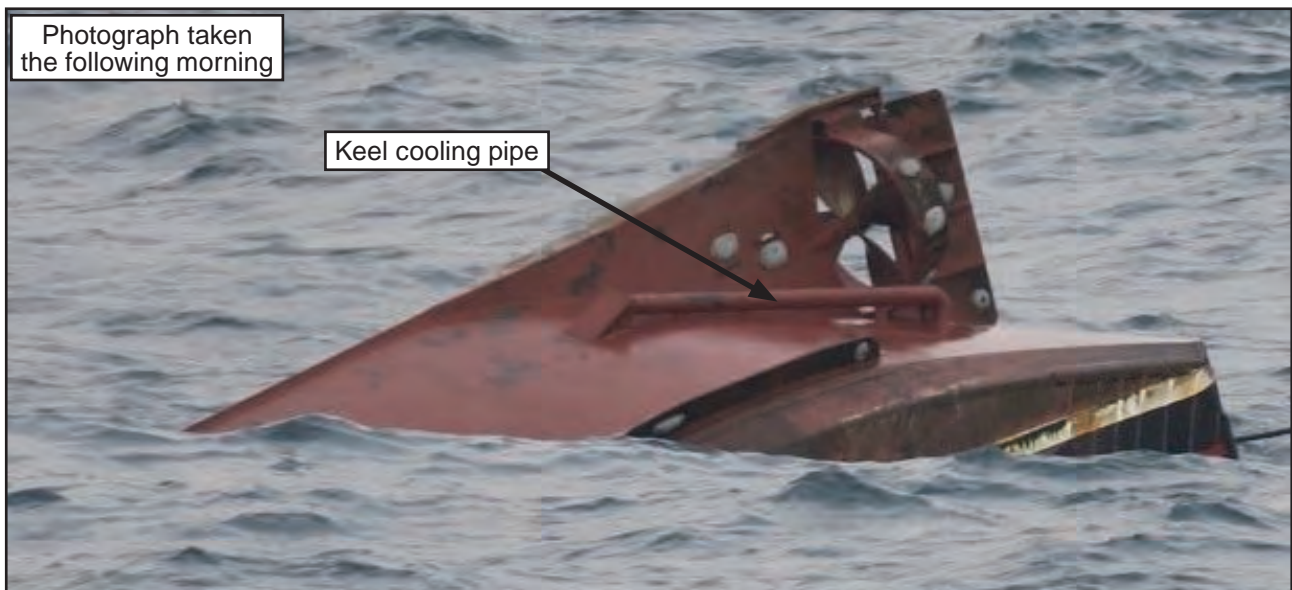
Solstice remained afloat with its upturned hull protruding out of the water (**Figure 8**). The crewman helped the skipper swim to *Solstice*'s hull and using the exposed scupper drains and engine cooling pipes, he climbed out of the water onto the upturned hull. He then took off his waterproof leggings and used them to help pull the skipper out of the water. Without any means of raising an alarm, the two men lay against the engine's keel cooling pipe for warmth.

Figure 8: Upturned hull floating on surface

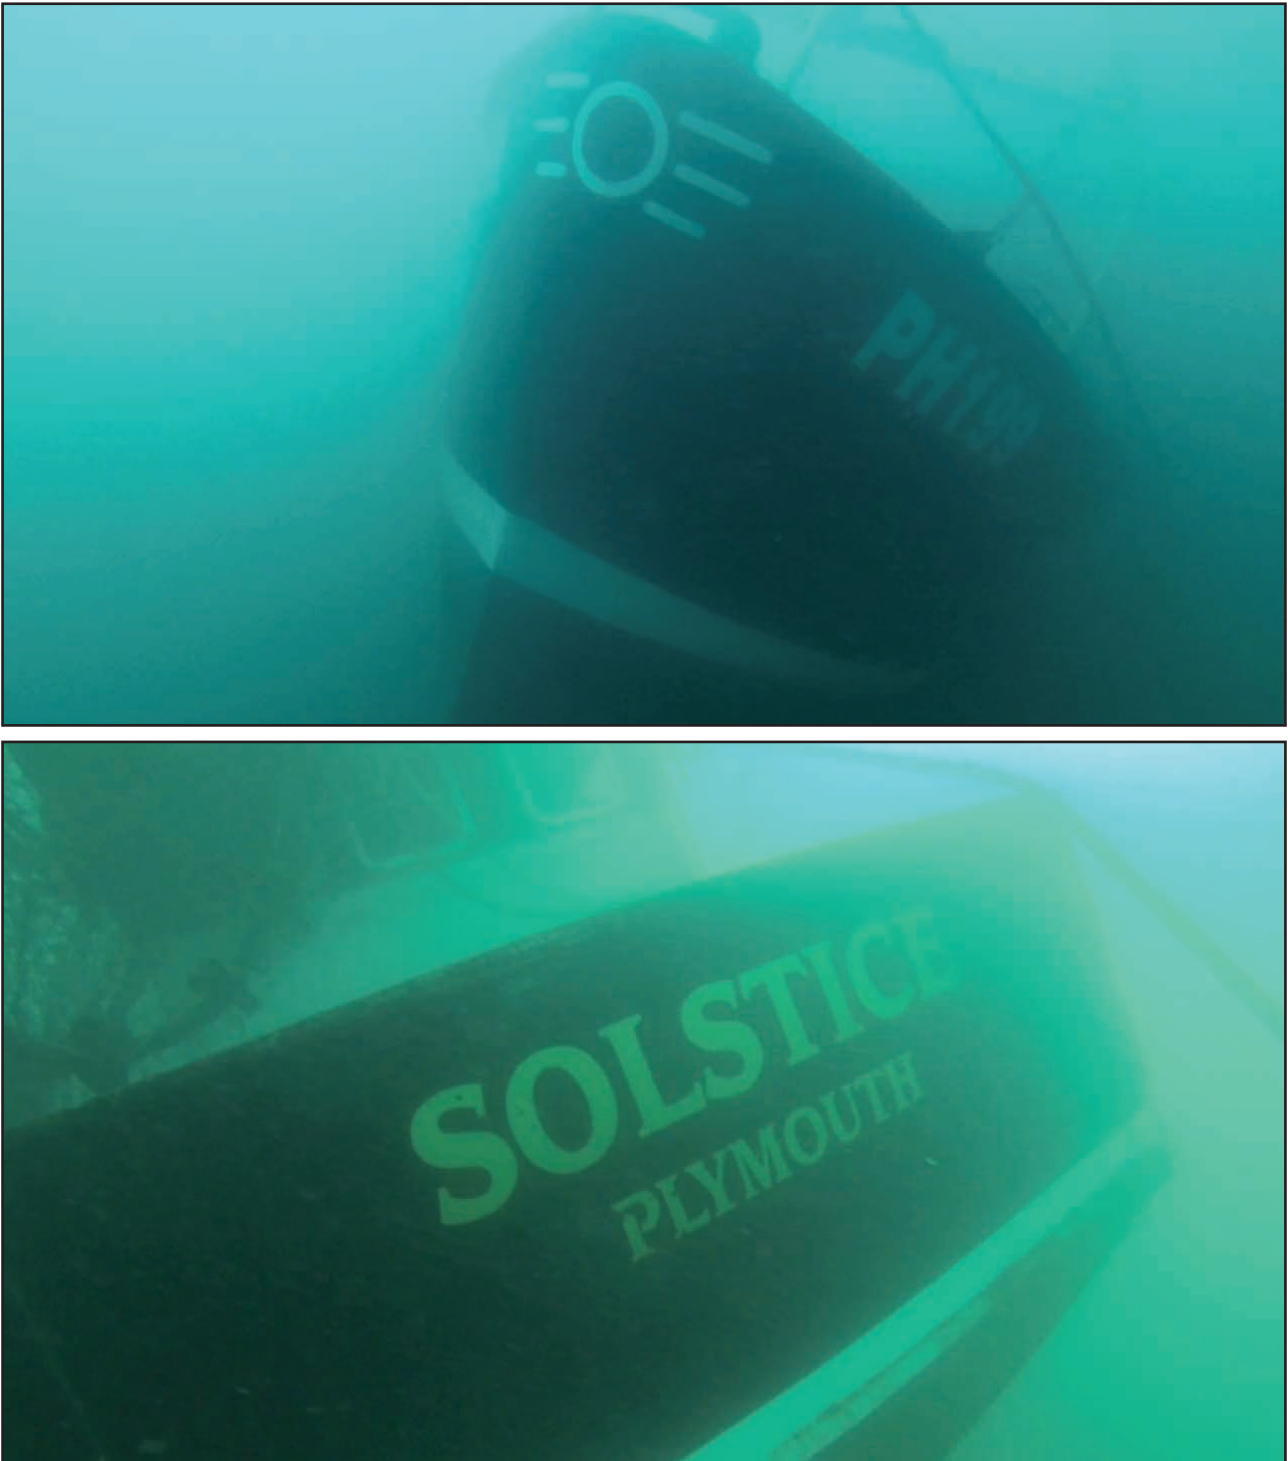
- *Solstice* was lying upright on the seabed at a depth of 26m (**Figure 20**).
- Its hull was intact.

Figure 20: *Solstice* wreck lying upright in 26m of water

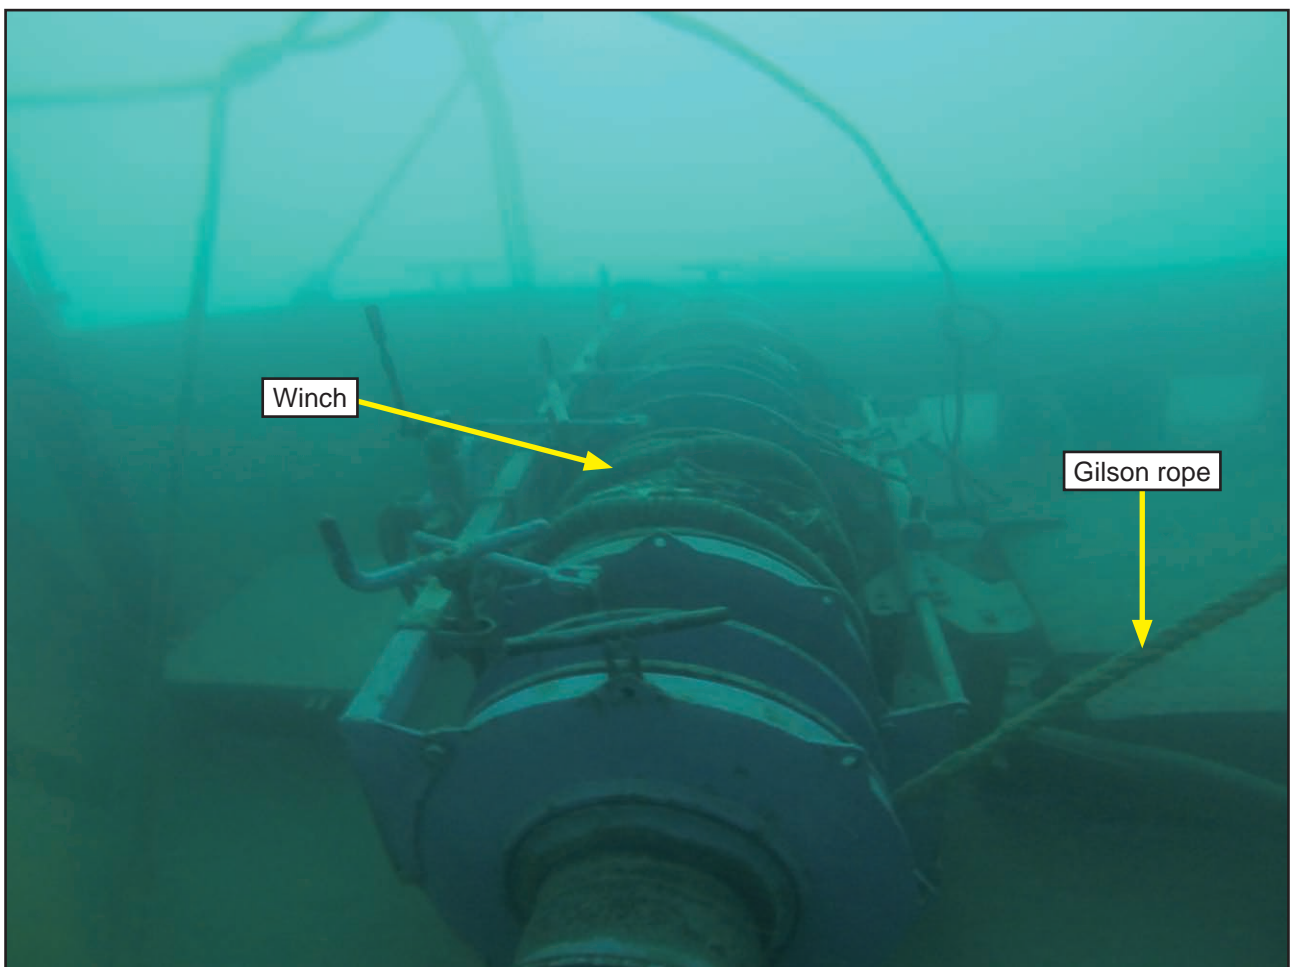
- The gilson rope used to haul the net out of the water was 24mm diameter and was connected to the outer drum on the port side of the forward winch (**Figure 21**). The rope was rove through a block on the port side of the scotch poles to the lifting block at the top of the aft gantry.
- The forward store deck hatch was closed and secured in position by one of its two locking dogs.
- The fish hold hatch cover was in the closed position but was not locked shut.
- The wheelhouse controls (**Figure 22**) indicated that:
 - the forward winch was clutched in;
 - the propeller was de-clutched; and
 - the engine was operating at above idle speed.
- The starboard lifebuoy was still in its cradle (**Figure 23**).
- The aft deck freeing ports were closed and wedged shut (**Figure 24**).
- The mid and forward deck freeing ports were open.

Figure 21: Wreck showing winch and gilson rope

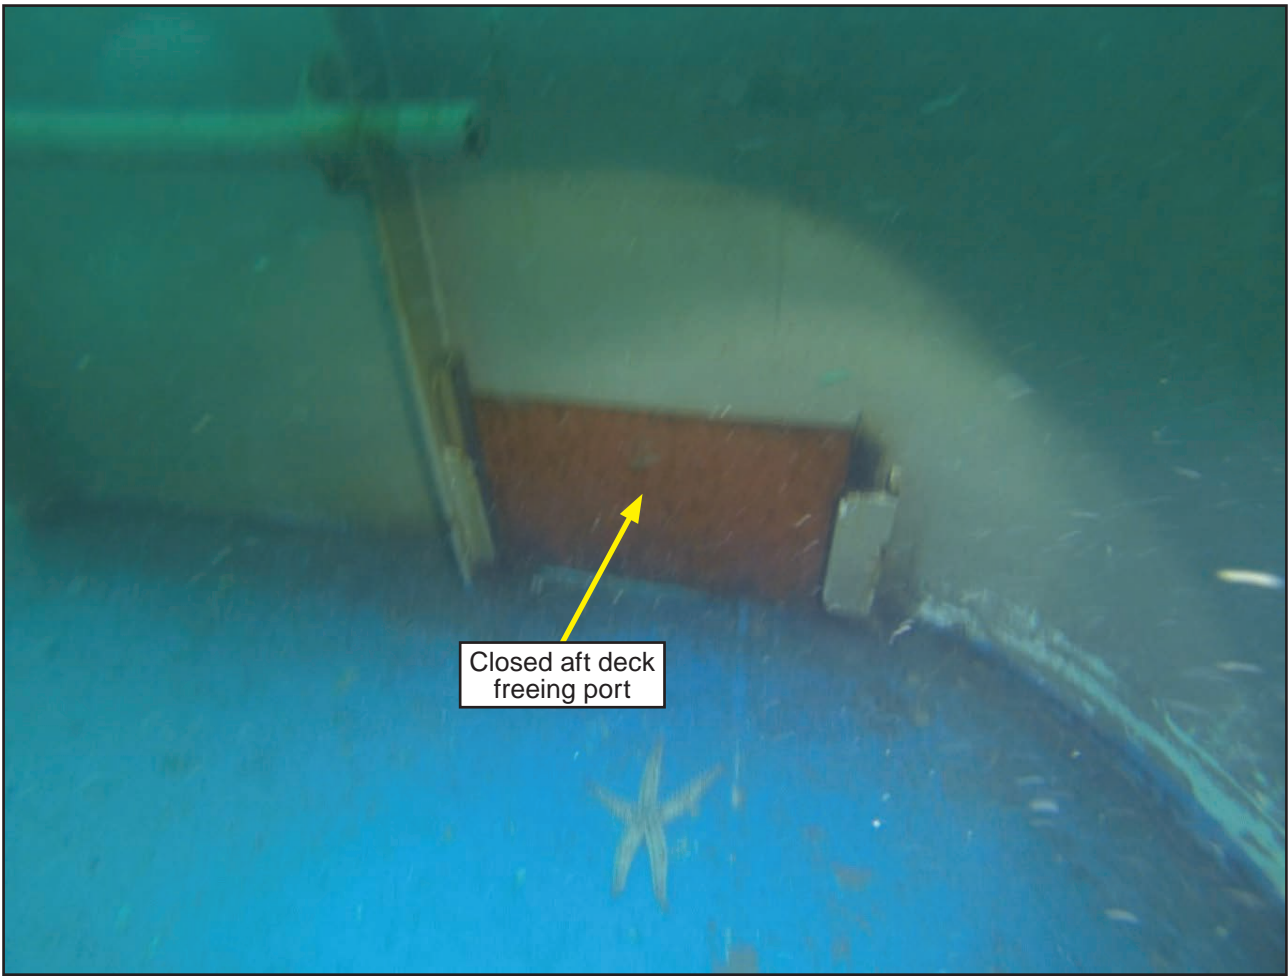
Figure 24: Aft freeing ports, closed and wedged shut

The wreck dive survey identified that the freeing ports on *Solstice's* aft deck had been wedged shut (**Figure 24**). The crew's reasoning for this was understandable as water on the aft deck would have been more problematic to the crew because that was their working area. Furthermore, the likelihood of the aft deck freeing ports being immersed would have been higher when stern trawling. This was because the trawl arms were positioned higher than the hinged dredge warp outriggers, which would have caused the vessel to trim further by the stern and therefore reduce the freeboard aft (**Figure 35**).

It is unlikely that the blockage of the aft freeing ports was a significant factor in this case, given the proximity of *Solstice's* other freeing ports. Nevertheless, any trapped water would have contributed to the capsize.

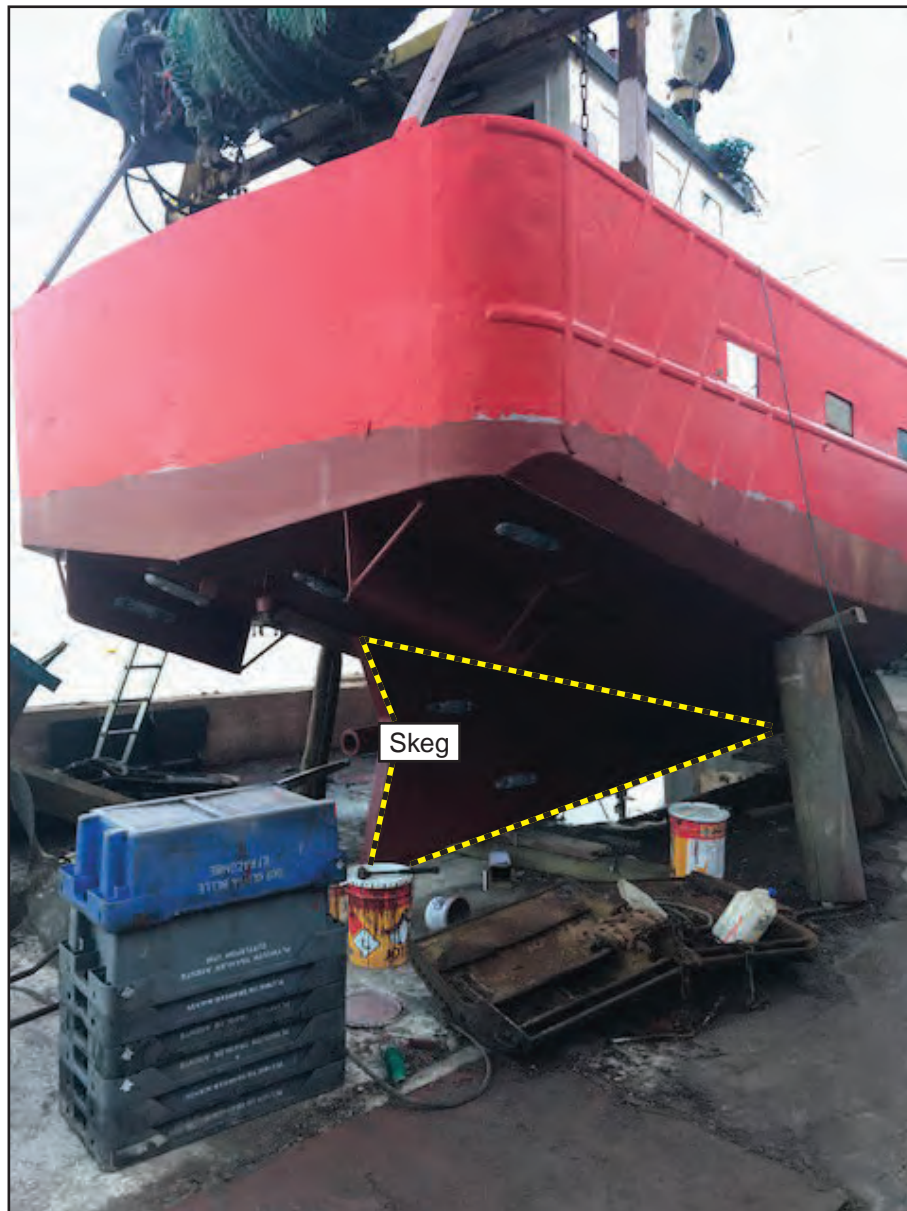
On 29 September 2017, a fishing vessel with an identical hull design (**Figure 25**) and similar rigging to *Solstice* was roll and heel tested by the MCA at the port of Brixham. The vessel was predominantly engaged as a stern trawler and recovered its catch over the stern.

Figure 25: Similar vessel with identical hull design

The roll test identified that the vessel met the requirements for the ‘depart port’ condition and met the freeboard standards¹⁷, but was deficient when measured against the Heel Test standard.

The report noted that the results did not take account of the type of fishing being undertaken or the loads “seen” by the axis of the net drum or gantry when hauling. The measurements also did not consider the ability of the hull form to provide sufficient reserve buoyancy or stability.

Following the roll test, the vessel owner made several alterations to reduce weight high up. The MCA surveyor recommended the vessel owner to seek additional advice to verify the loadings and limits to the working of fishing gear aft.

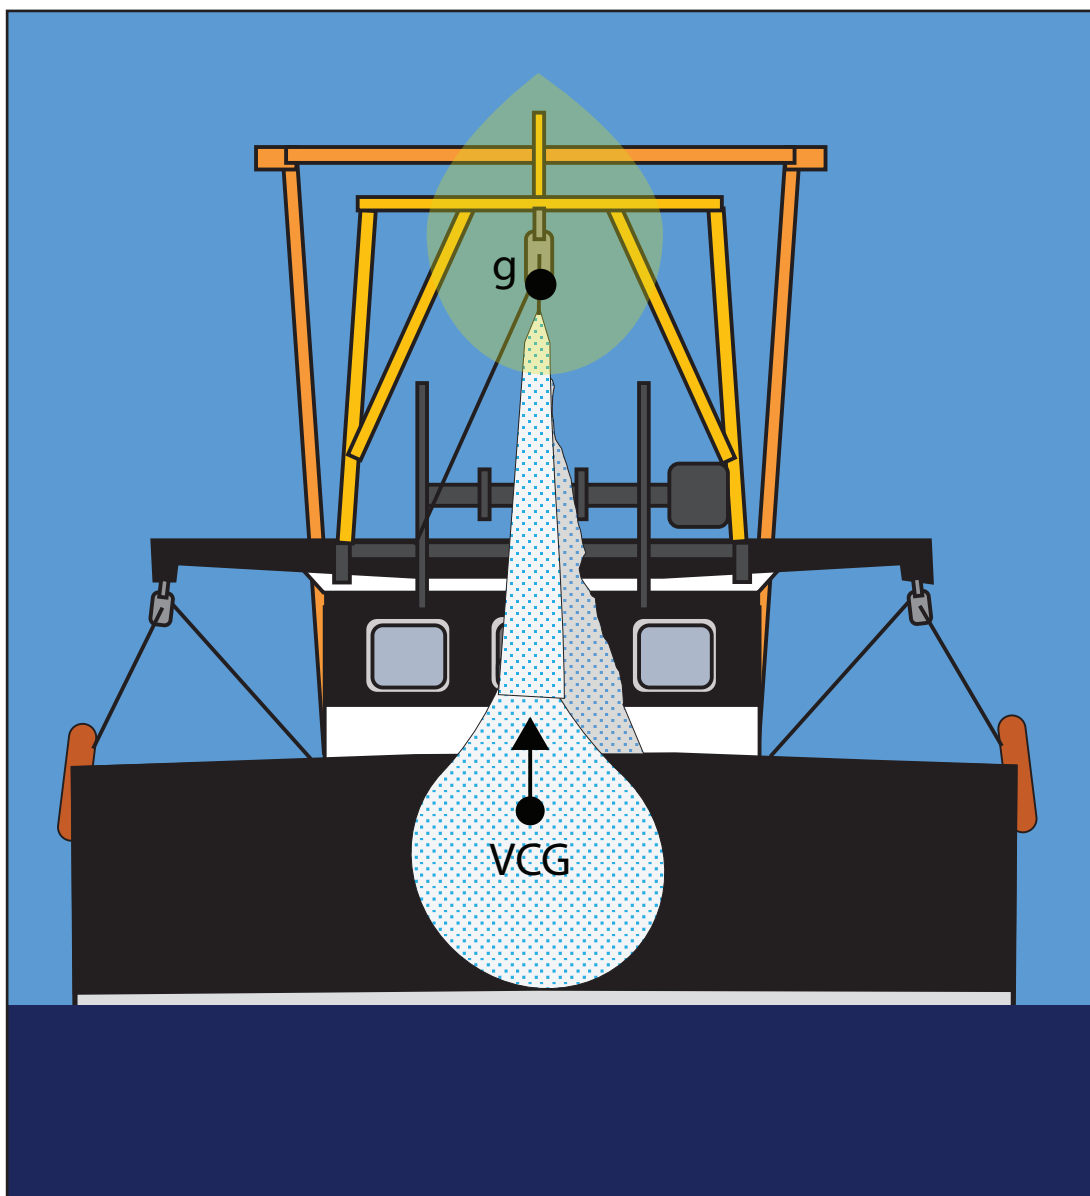
The weight in the net alone would have significantly reduced the vessel's freeboard aft and therefore affected its stability. Using the lifting block rigged at the top of the gantry magnified the problem because the weight of any object acts through the point of suspension. As soon as the cod-end was lifted clear of the water, its VCG and the effect of its full weight would have shifted to the top of the gantry block (**Figure 32**). This would have caused *Solstice's* VCG to move even further upwards, making the vessel dangerously unstable.

Figure 32: Effect on vessel stability when lifting a weight from a high point

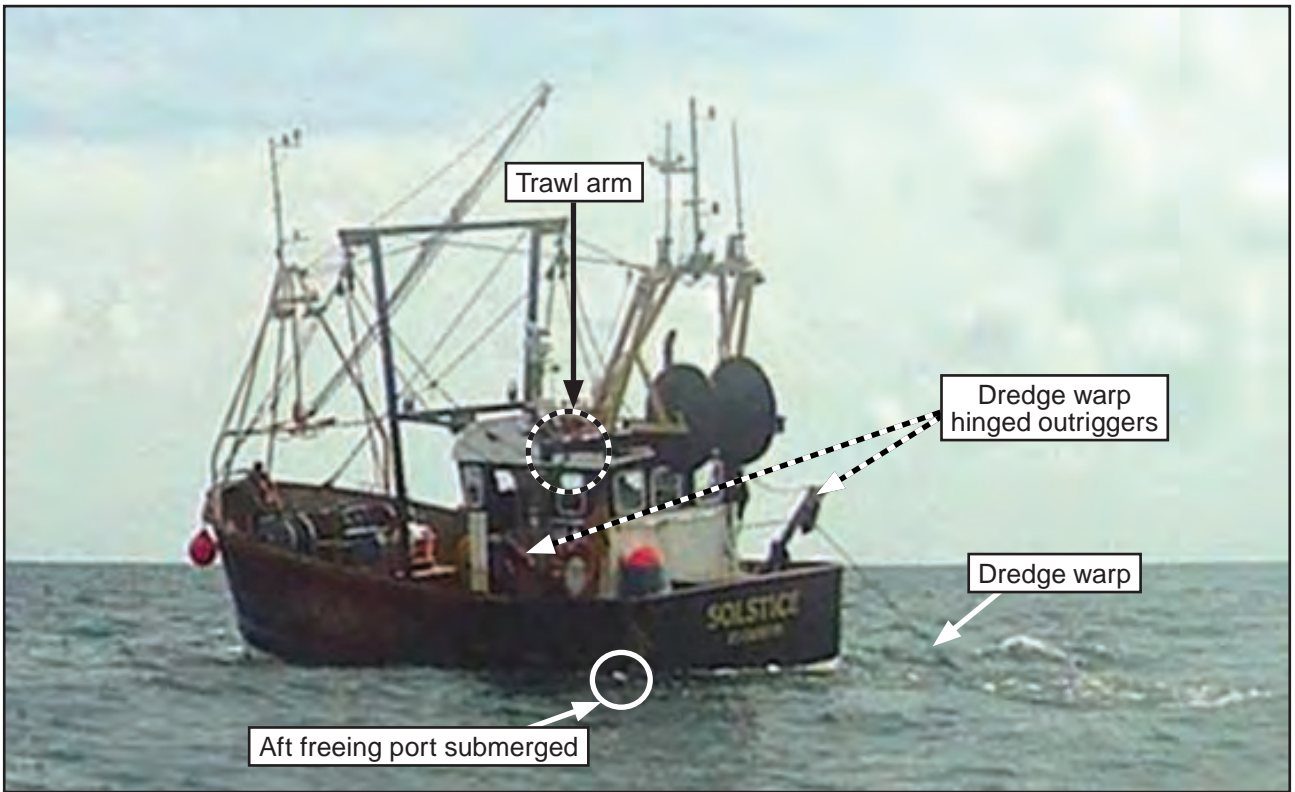
Figure 33: *Solstice* trimmed by the stern and heeling to port

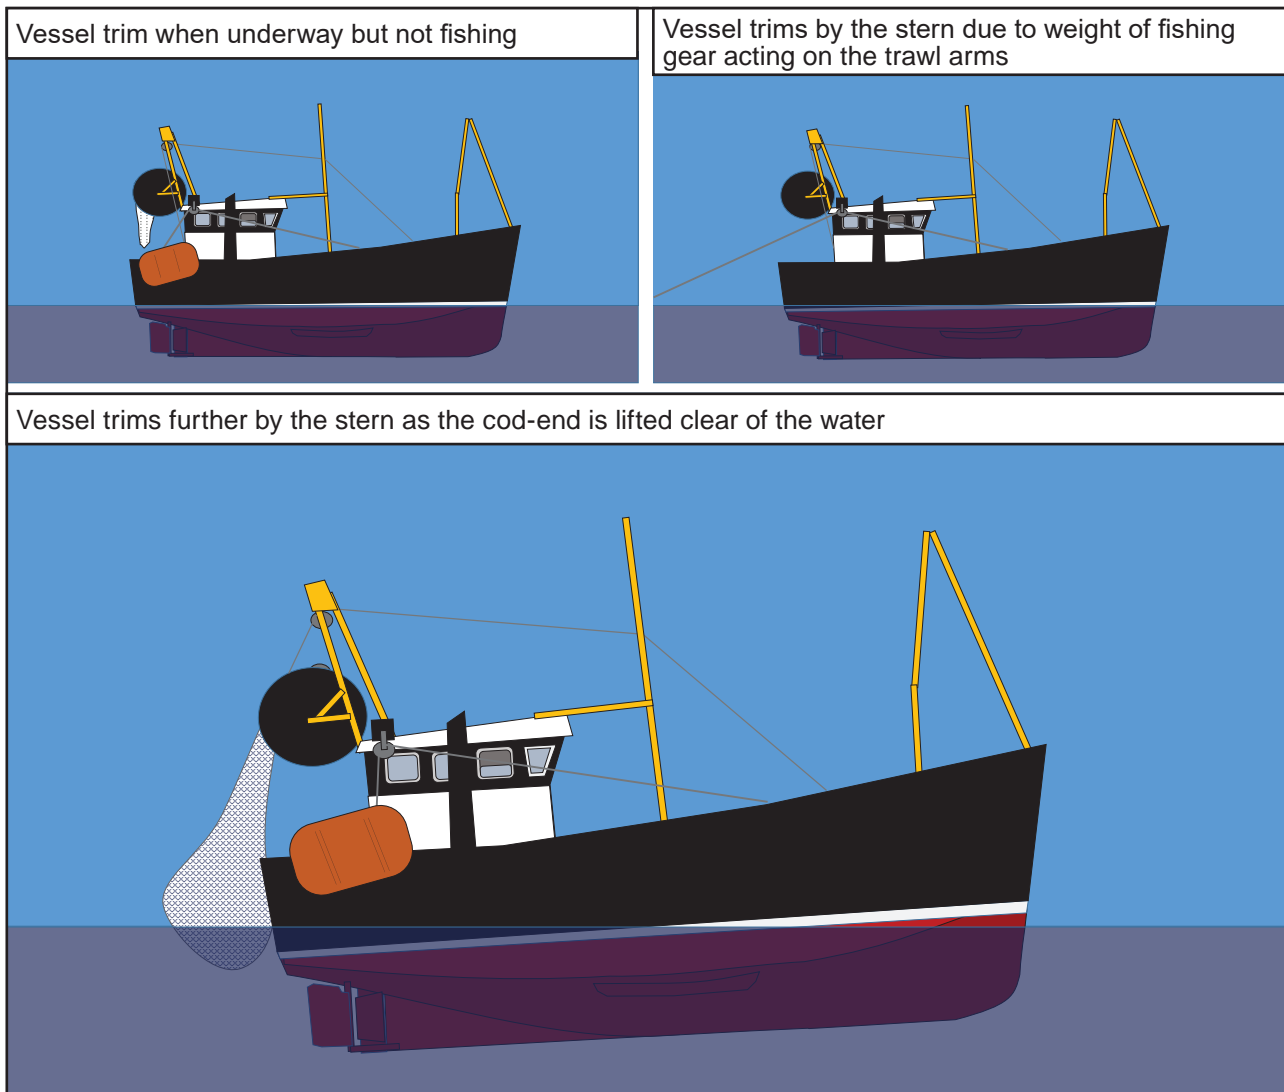
Figure 35: Large change of trim when lifting a weight at the stern

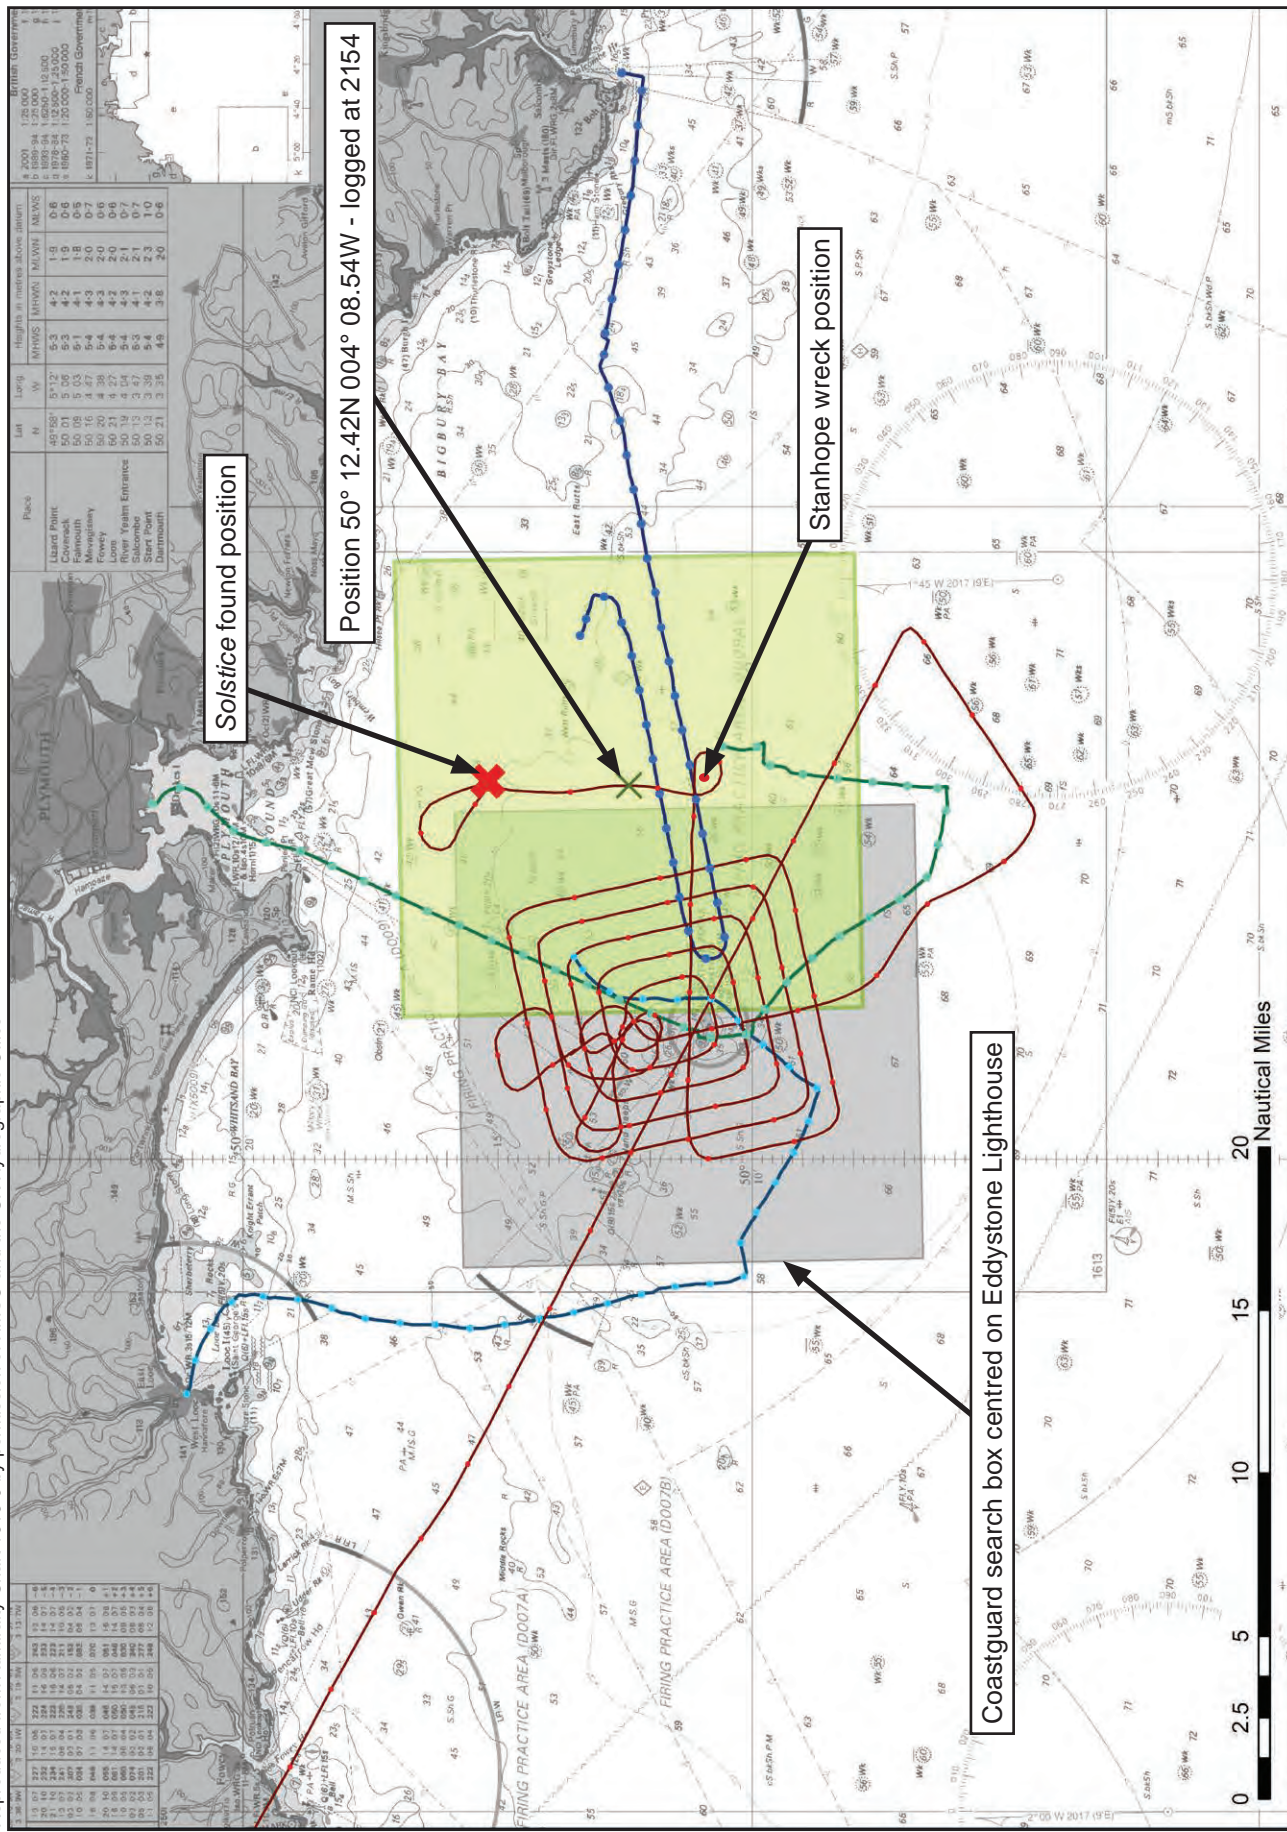
When the lifeboats were launched, and the SAR helicopter tasked, the SMC did not have a detailed plan, so the Eddystone Lighthouse was used as the centre point of the search. This was because the numerous sightings reported by local fishermen (**Figure 28**) were not chronologically logged or charted, and therefore no one had a clear overview of the situation.

Figure 36: Coastguard search box centred on Eddystone Lighthouse
