Report on the investigation of the  
capsize of the fishing vessel  
***Laura Jane (SE80)***  
with the loss of one life  
in Plymouth Sound  
on 7 May 2018

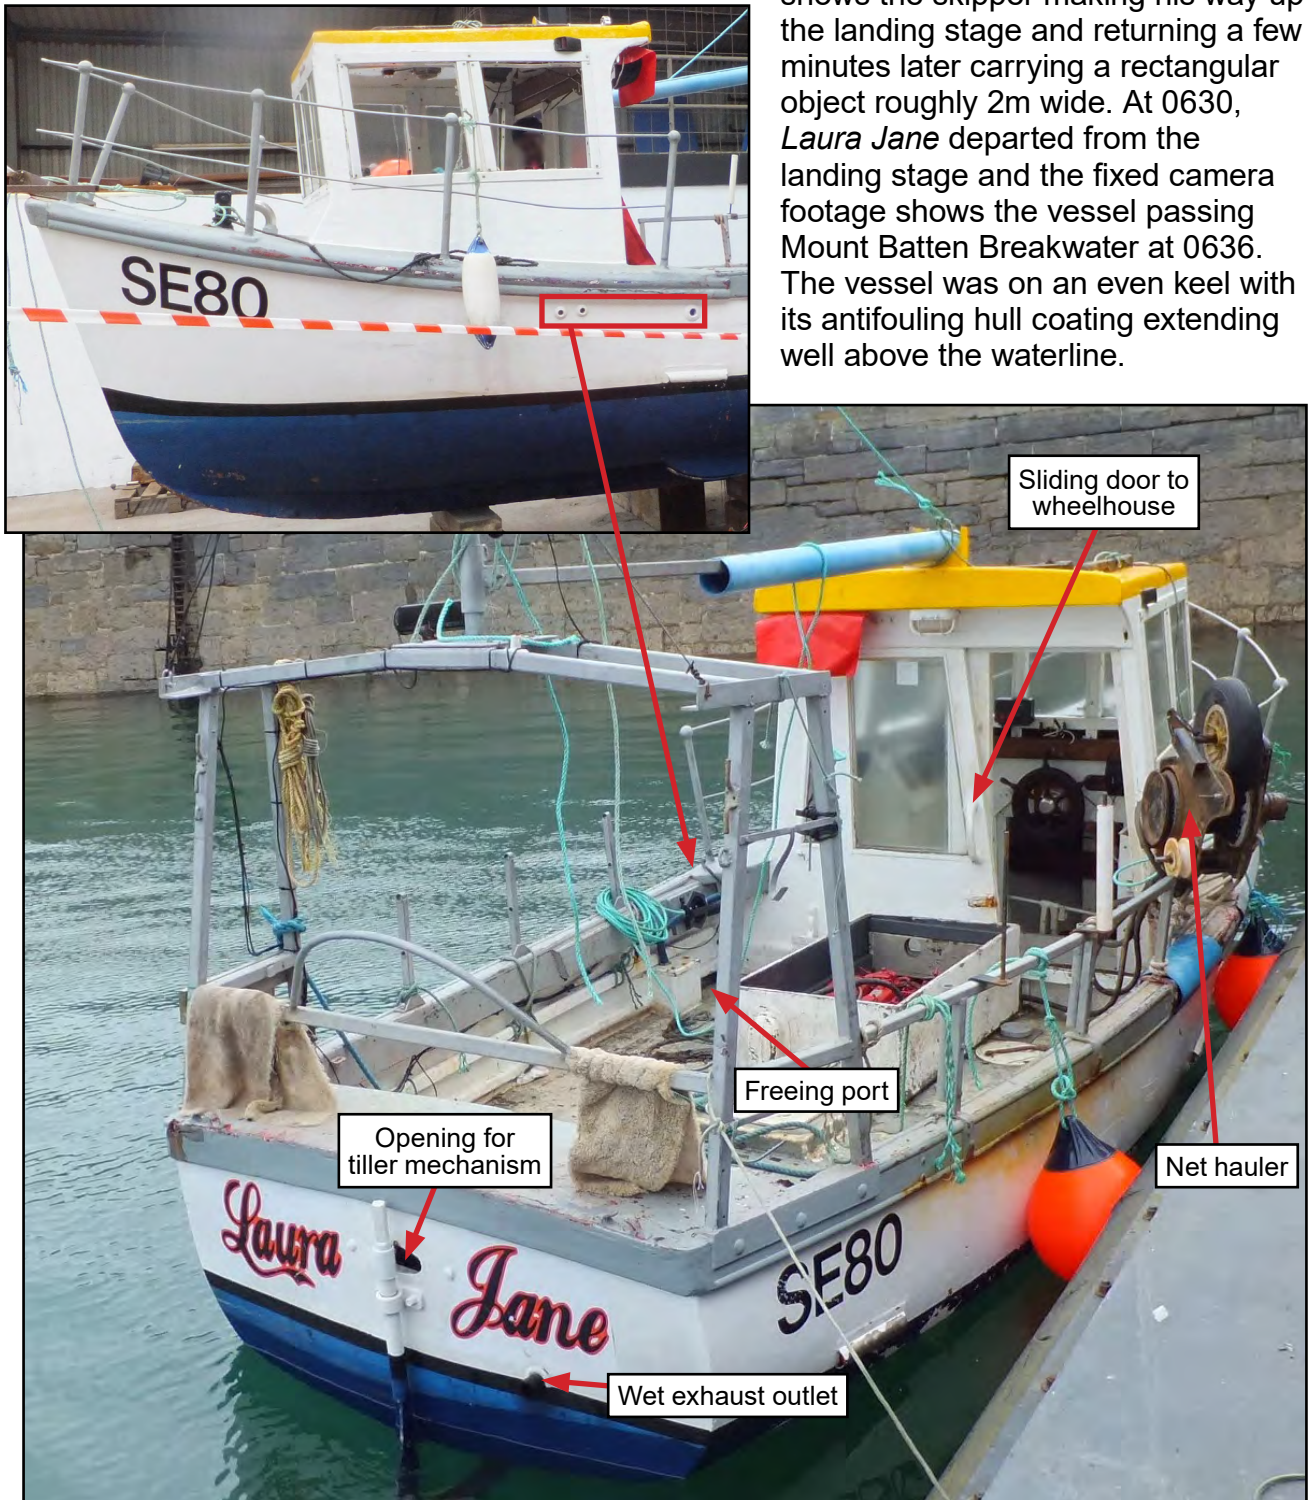
Figure 1: *Laura Jane* (inset: bilge overboard discharges)

The vessel had two electrically-driven bilge pumps, both of which took suction from the wheelhouse and could be switched to automatic or manual running. In addition, a hand-operated bilge pump, with its suction near the aft end of the engine, was fitted on the port side on deck. There was no bilge alarm in the aft part of the vessel. The overboard discharges for all the bilge pumps was on the port side of the hull. The engine cooling water was discharged at the transom through a wet exhaust system (**Figure 1**).

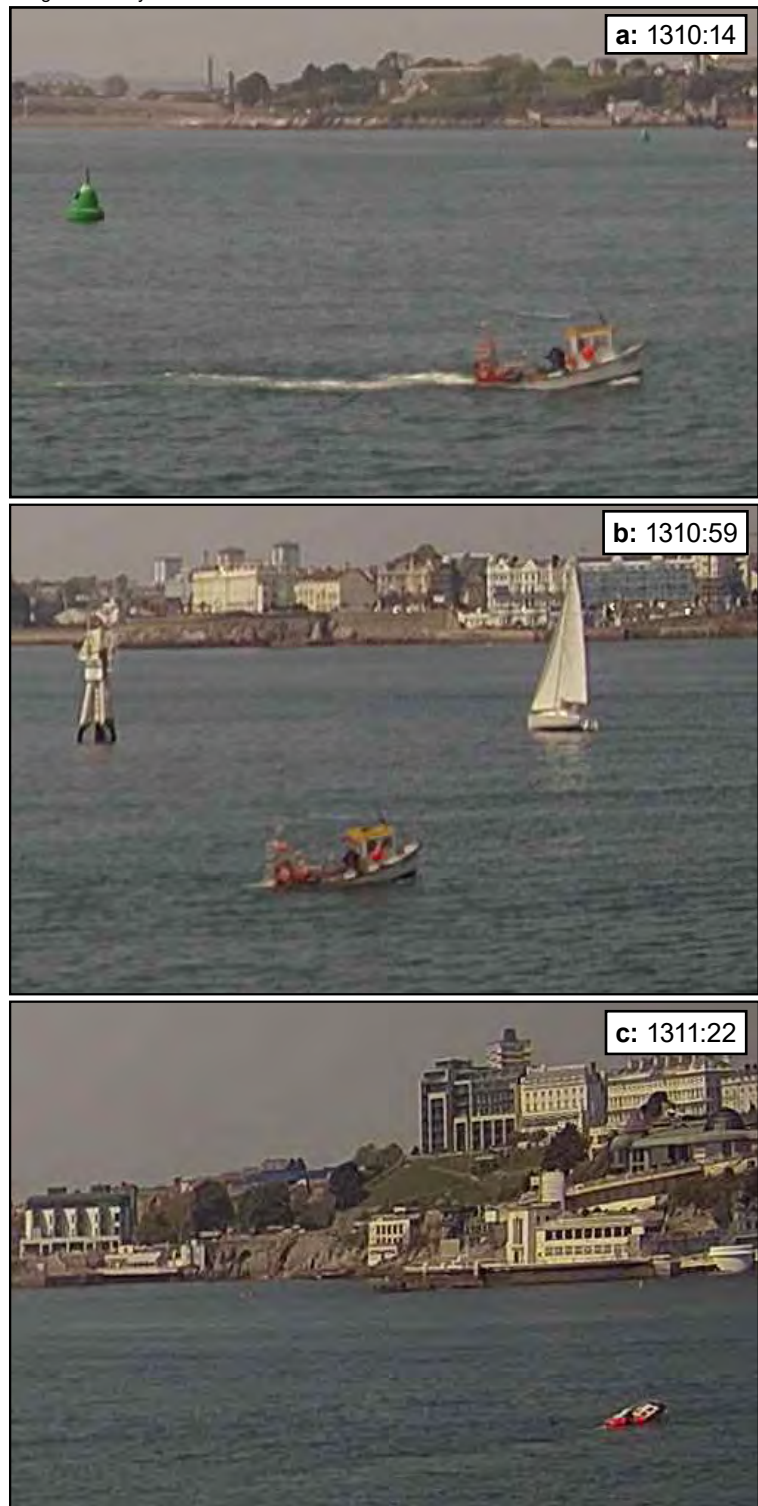
**Figure 3a, b and c:** The capsize

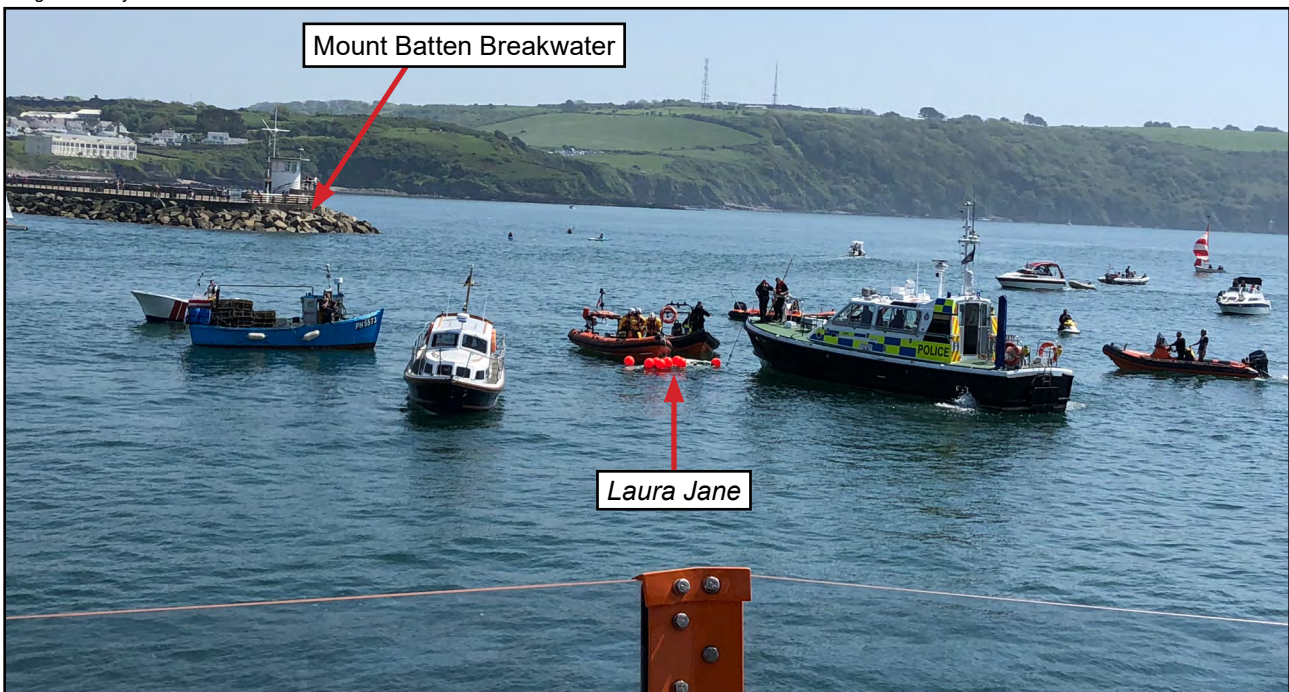
**Figure 4:** Scene shortly after capsized

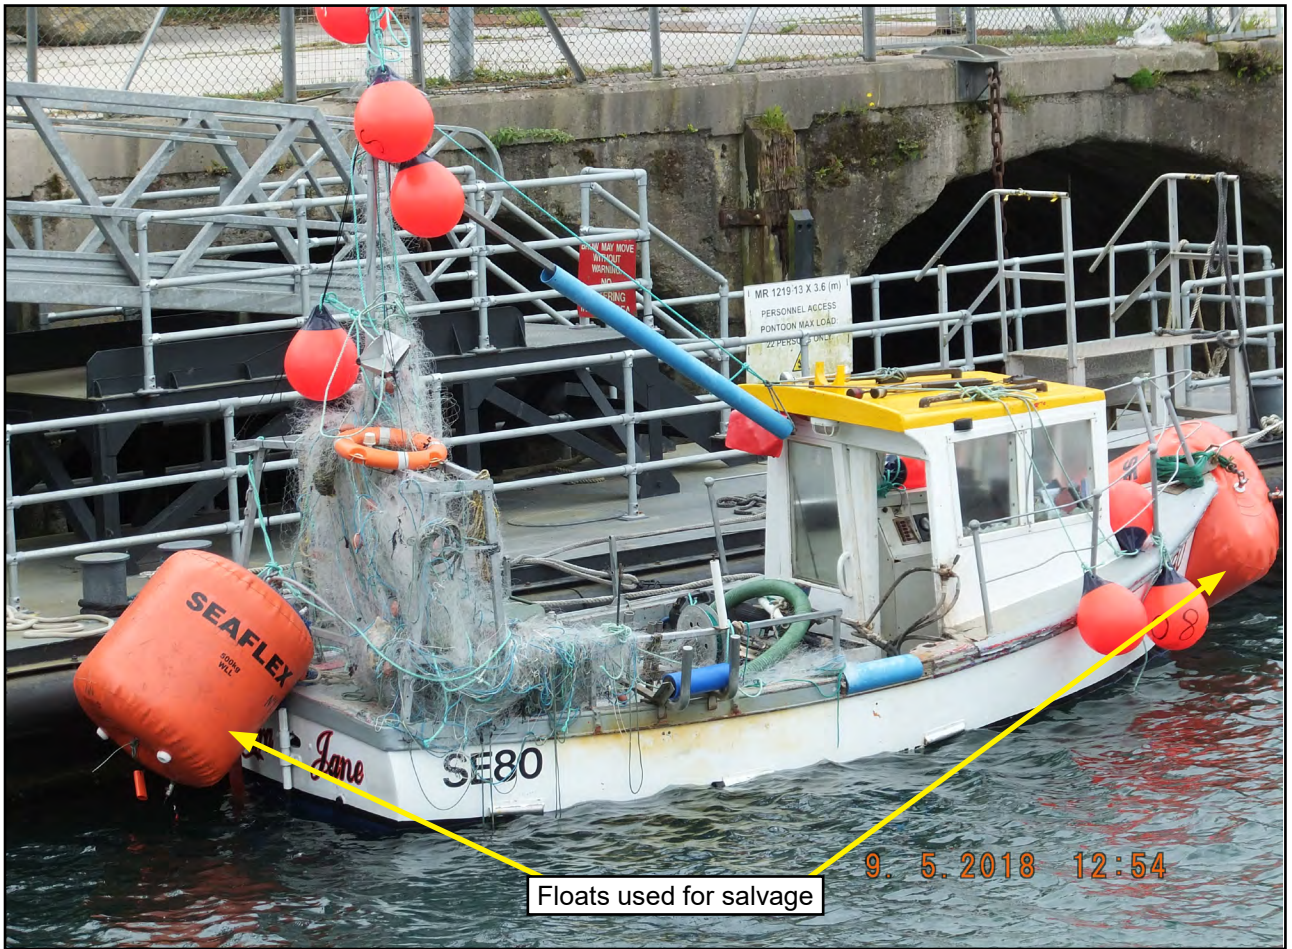
where MAIB inspectors and Maritime and Coastguard Agency (MCA) surveyors attended. All wheelhouse windows, except the one that was broken during the rescue attempt, were found intact (**Figure 6**).

Figure 6: *Laura Jane* at Millbay Docks after recovery

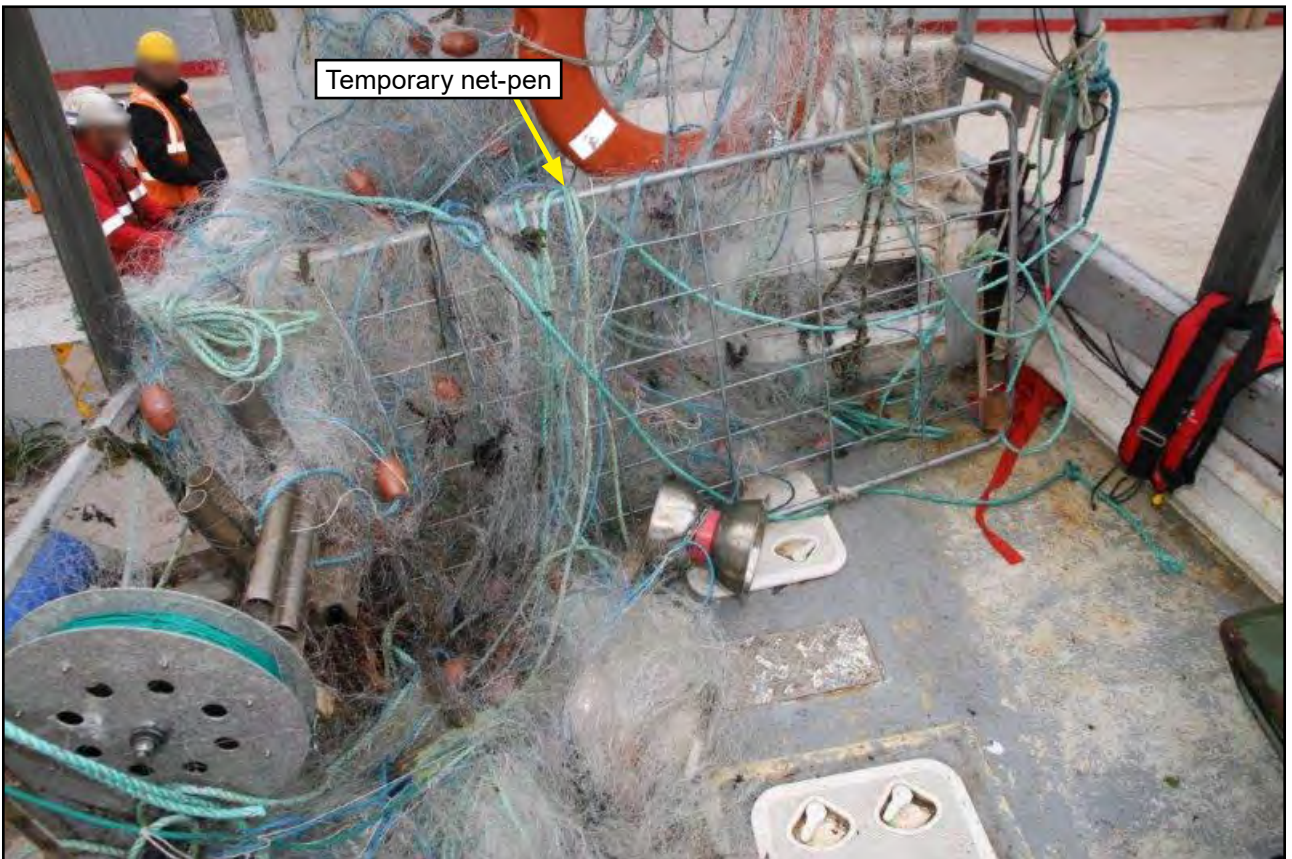
Nine marker buoys were found tied to the vessel, and five jumbled up gill nets and their associated chain weights were found at the vessel's stern, where a temporary pen had been constructed using a rectangular frame (**Figure 7a**). The nets and weights were estimated to weigh approximately 300kg (**Figure 7b**). Two 20-litre jerry cans of diesel were found on board in addition to around 30 litres of diesel in the fuel tank. Solid ballast, in the form of four blocks of steel, each weighing 25kg, were located on board, three in the aft section next to the fuel tank and one in the storage section forward of the wheelhouse.

Figure 7a: Temporary net-pen

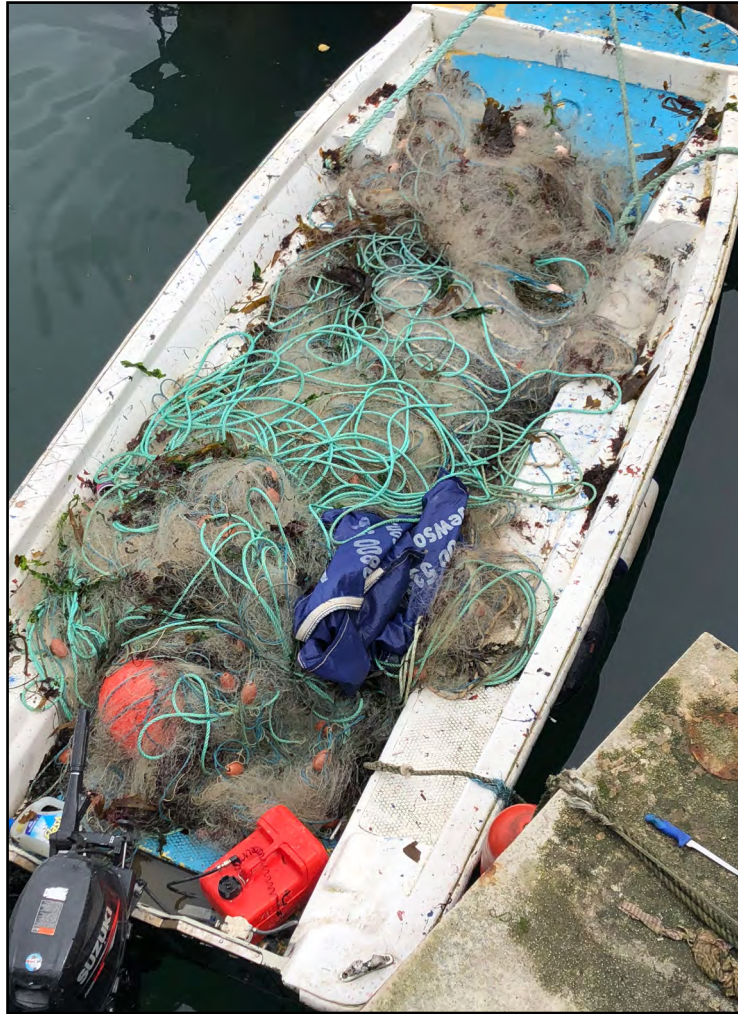
Figure 7b: Nets recovered from *Laura Jane*

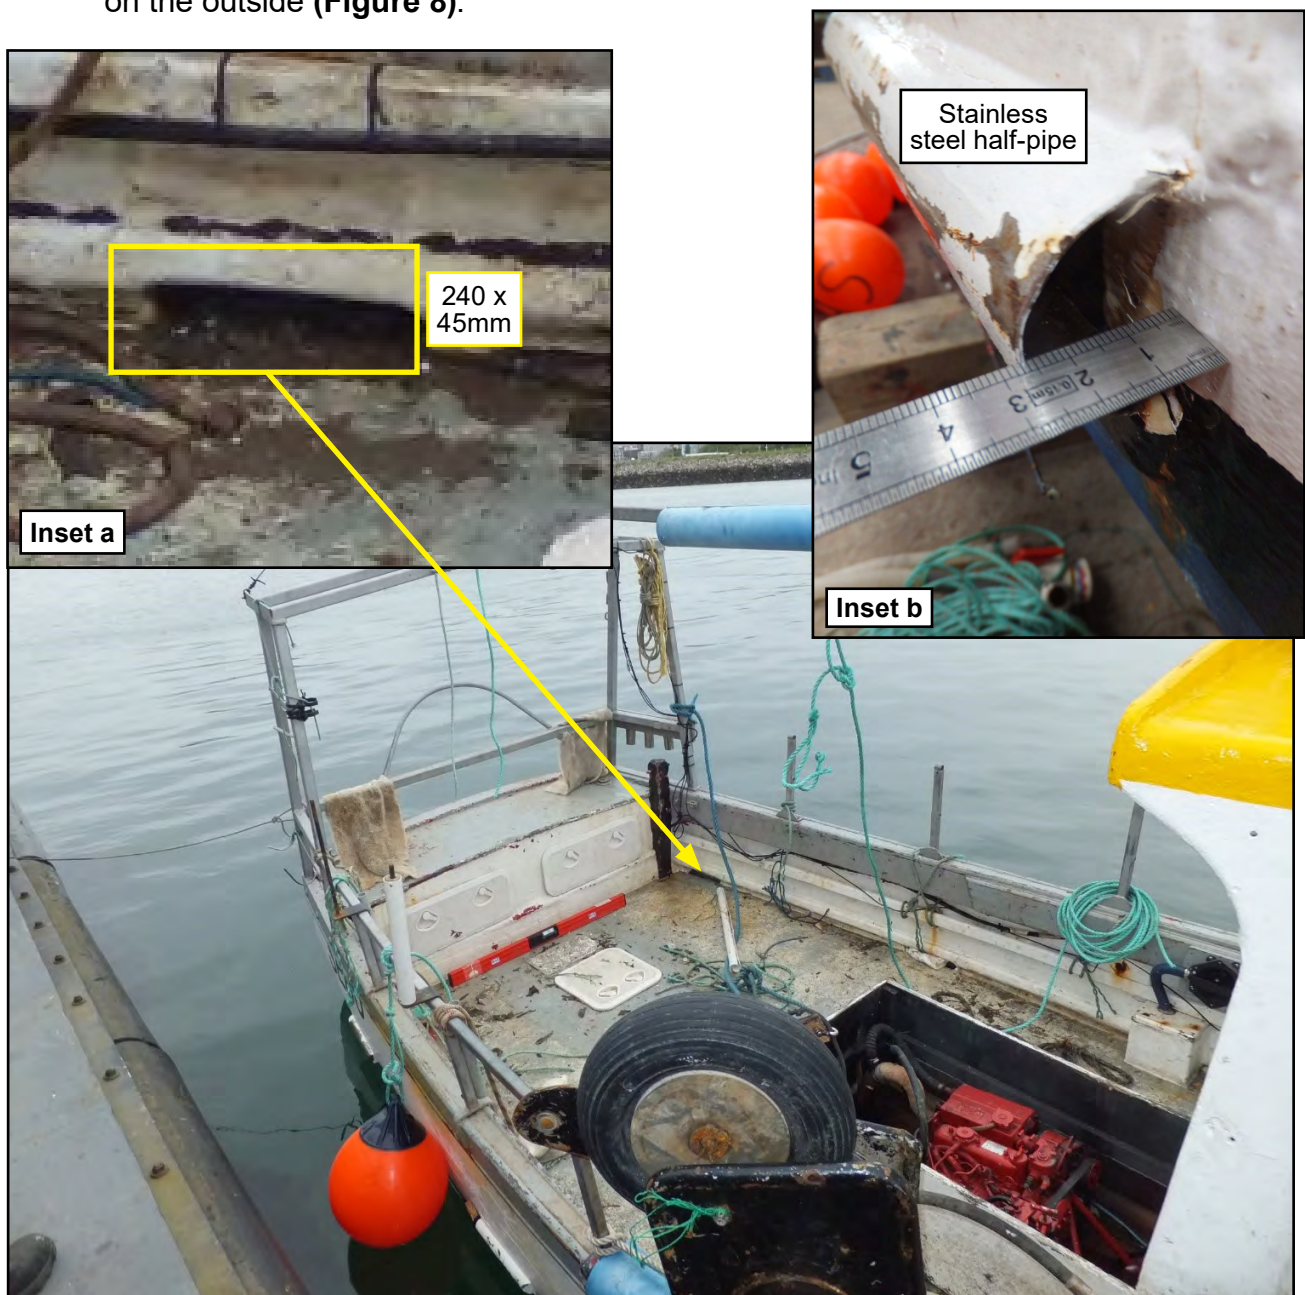
Built in 1980, *Laura Jane* was a glass reinforced plastic gill netter/potter of 6.0 metres registered length. The vessel had a net hauler on the starboard side behind the wheelhouse. It had a storage space forward of the wheelhouse and was fitted with a sealed deck with buoyancy spaces below. Six freeing ports were cut into the hull above the sealed deck, three on either side, with stainless steel half-pipes fitted on the outside (**Figure 8**).

**Figure 8:** Freeing ports (inset a: enlarged view and inset b: stainless steel half-pipe fitted on the hull outside)

The vessel's two forward freeing ports were found to be completely blocked off and painted over, while the midships and aft freeing ports had been plugged at the forward end of the half-pipes. Freeboard measurements were taken on both sides in line with the freeing ports. The minimum freeboards were at the midships area, with 85mm from the waterline to the lowest freeing port opening. At that point, the measurement from the waterline to the top of the gunwale was 565mm.

There was no statutory requirement for *Laura Jane* to comply with the SFCS, which required decked vessels <15m LOA to have freeing ports with a minimum area of freeing ports on each side of not less than 3% of the bulwark area on that side. Although *Laura Jane*'s minimum internal freeing port area on each side was only approximately 2.5% of the bulwark area on that side, it is concluded that the MCA surveyor considered them to be fit for purpose, irrespective of the constriction imposed by the stainless steel half pipes fitted to the hull.

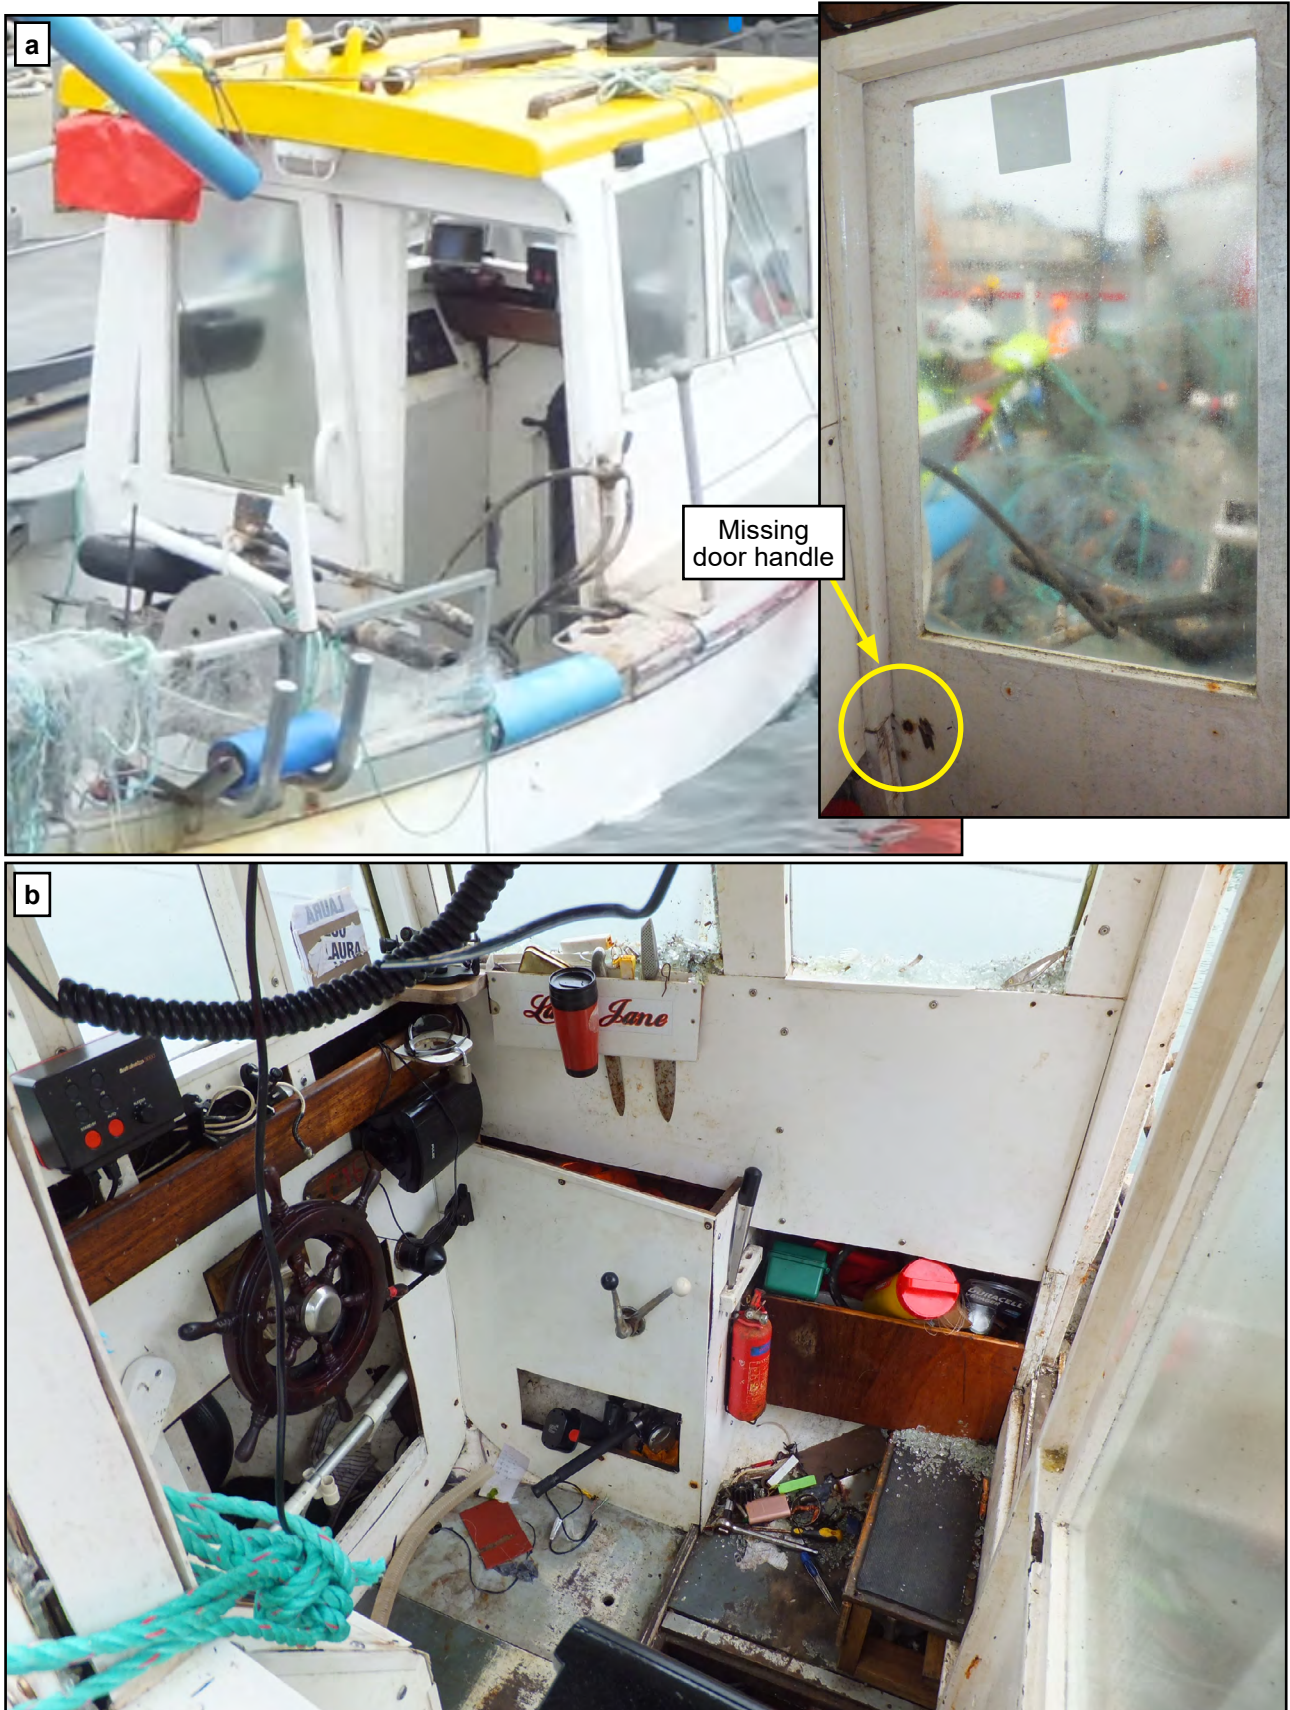
*Laura Jane's* wheelhouse had sealed glass windows (**Figure 9a**). The inside handle of the wheelhouse door was missing (**Inset**). It could not be established when the door handle was removed. There was a fire extinguisher next to the steering wheel and a large box of tools stored in a niche next to the wheel and engine controls. The wheelhouse was equipped with a very high frequency radio, GPS receiver and plotters for fish finding (**Figure 9b**).

**Figure 9a and b: Wheelhouse (inset: missing door handle)**

The skipper did not escape from the wheelhouse as *Laura Jane* capsized, probably due to the unsecured sliding wheelhouse door closing as the vessel increasingly heeled to starboard. The door had no handle in the inside, which would have made it almost impossible for the skipper to raise the door sufficiently for him to escape. It is also possible that he succumbed to cold water shock as sea water rushed into the wheelhouse. Rescuers were unable to extract the skipper in sufficient time to save him due to fears that breaching the wheelhouse windows would cause the vessel to sink.

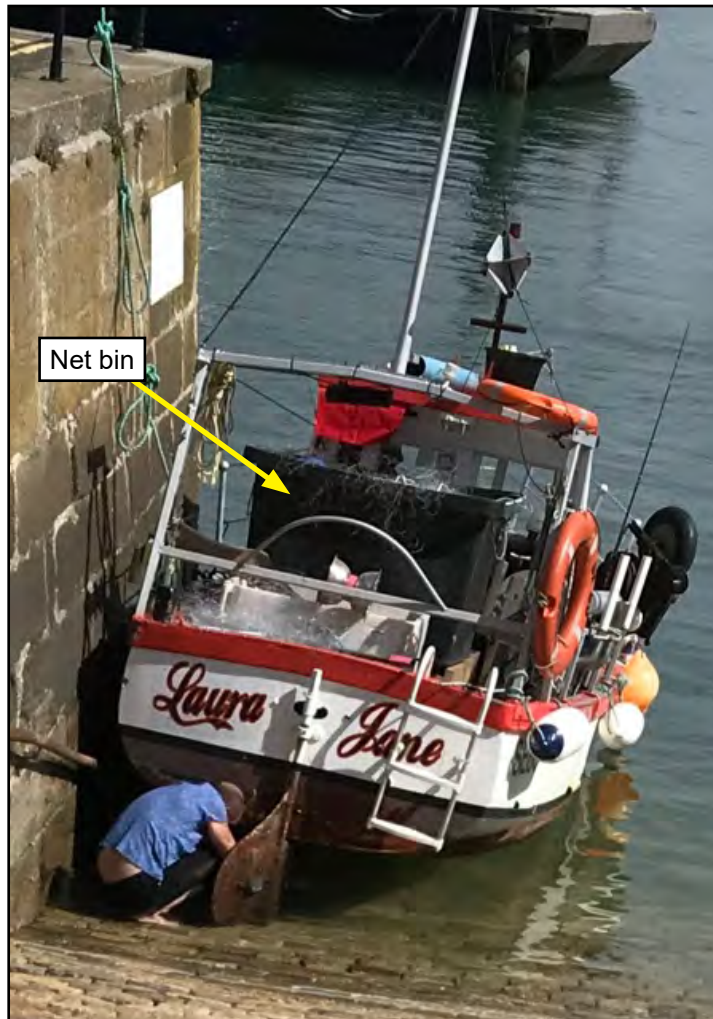
Additionally, it was reported that the current owner had instructed the skipper to carry no more than two nets at a time. It was further reported that the DP for the passenger vessels belonging to *Laura Jane*'s owner had asked the skipper to reduce the size of the two net bins he routinely used (**Figure 11**).

**Figure 11:** Large net bin carried on board  
(photograph taken on 8 April 2018)

It is evident that *Laura Jane*'s skipper had previously used large net bins to stow the fishing gear on board *Laura Jane* (**Figure 11**). Following the owner's reported instruction not to carry more than two nets at a time, and the DP's reported instruction to reduce the size of the net bins, it is uncertain whether the skipper recognised the importance of doing so. He had replaced the net bins with a rectangular frame to form a temporary pen at the vessel's stern, and it is concluded that this was the rectangular object he carried on board before departing the Barbican landing stage on the morning of the accident.
