National Transportation Safety Board

Marine Accident Brief

Engine Room Fire on Board Towing Vessel *Leland Speakes*

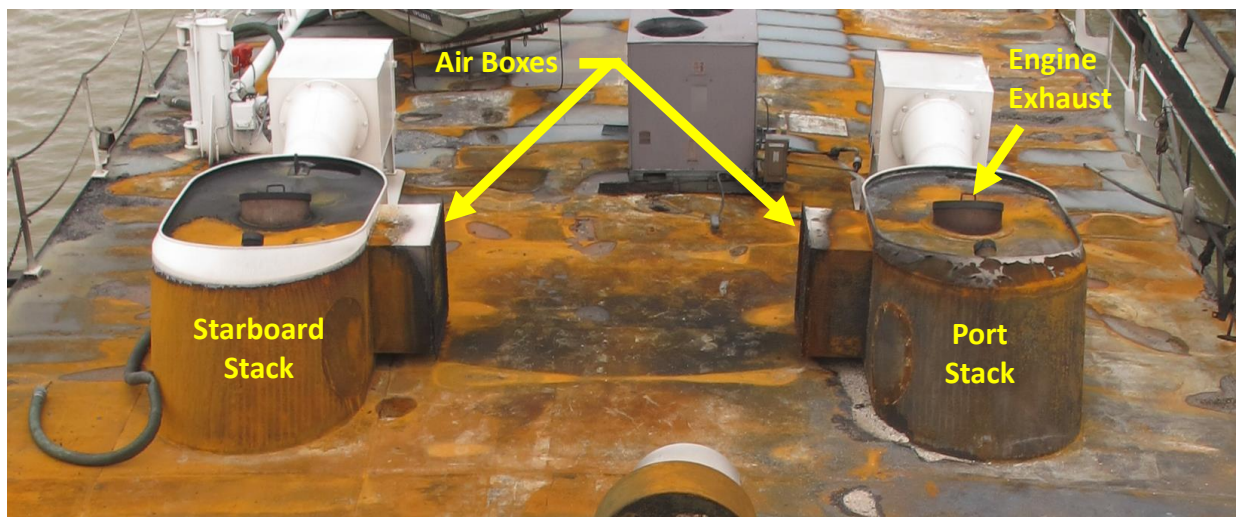
In the wheelhouse, the captain first noticed a reduction in engine noise and looked aft, where he saw black smoke and flames shooting out of the port stack air box (engine room exhaust vent), followed by flames and smoke from the starboard stack air box. Crewmembers said that within a couple minutes, the port side of the engine room, including the area around the main deck door area, was engulfed in flames.

Looking aft at stacks and air boxes post-fire.

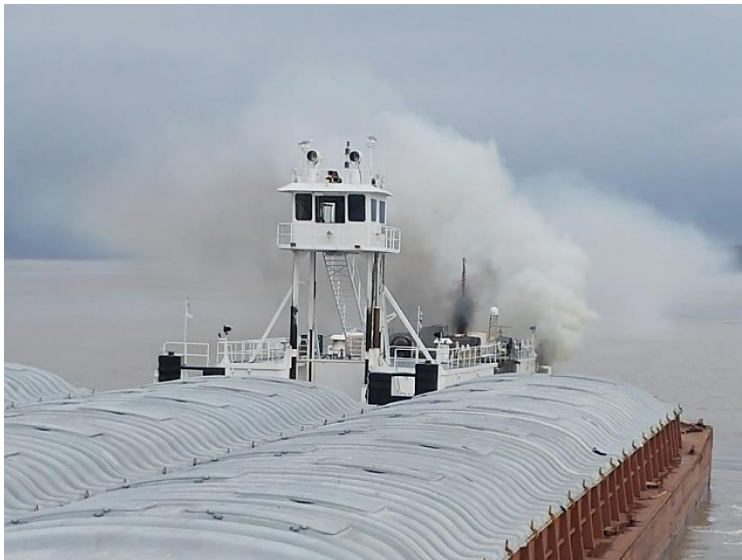
Towboat *Leland Speakes* on fire after abandonment. (Photo courtesy of Leslie Jenkins, Jantran Inc.)

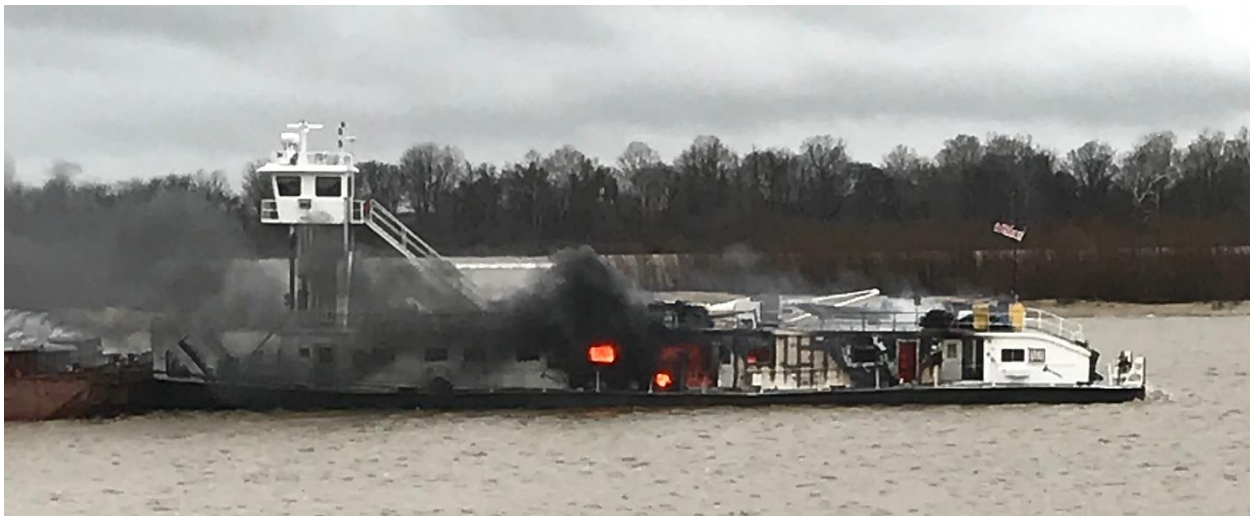
As a result of the fire, all main deck house and interior spaces were damaged, distorted, or destroyed, except for the steering room and portions of a deck locker. All machinery, electrical components, and accessories in the lower engine room and shaft alley suffered heat damage. The port main engine sustained severe damage to its engine block, crankshaft, and piston components.

Leland Speakes on fire and abandoned at 1249. (Photo courtesy of Leslie Jenkins, Jantran Inc.)

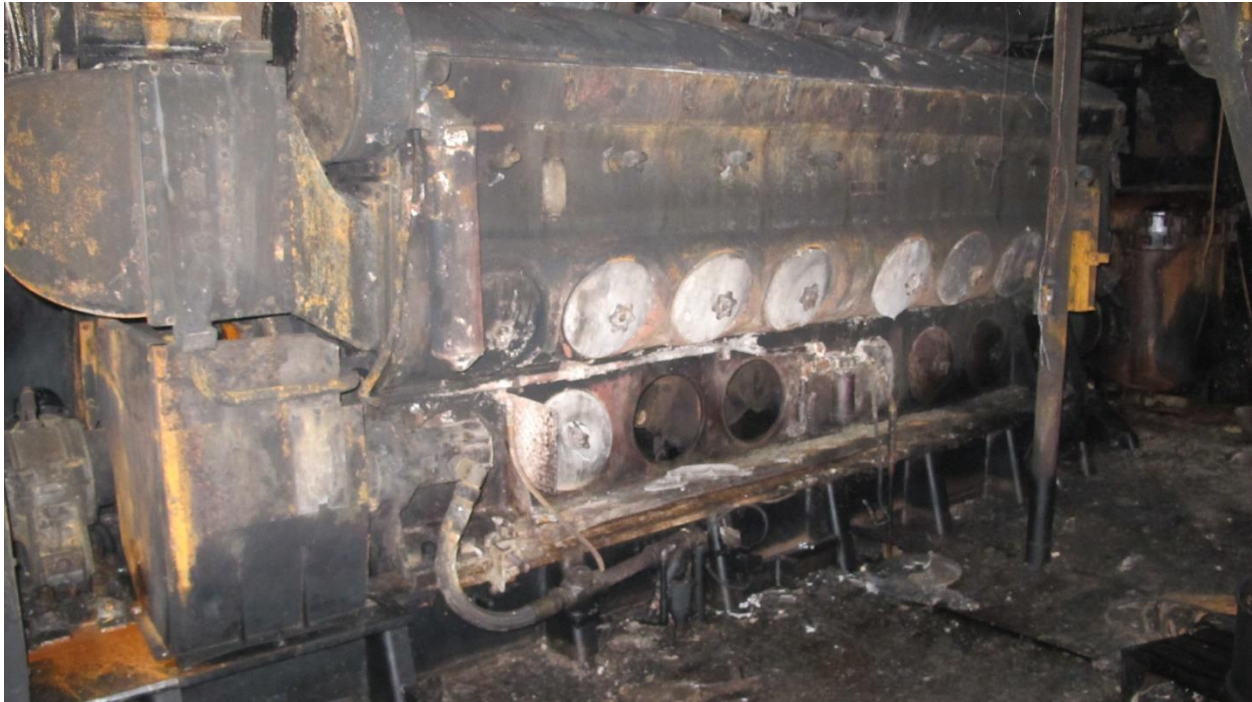
Following the accident, investigators examined the engine room and found the outboard (port side) of the port main engine crankcase severely damaged at cylinder no. 8. They also found a piston and connecting rod outside the engine on the deck plate.

A postaccident survey report concluded that the fire resulted from a failure inside the port main engine:

“... the cap securing both No. 16 and No. 8 connecting rods to the crankshaft failed, which propelled the No. 8 piston and rod through the opposite crankcase inspection port. Given the absence of the piston, all fuel injected into the No. 8 cylinder flowed into the crankcase which apparently, due to friction caused by the failure had reached temperatures capable of igniting the fuel and/or oil in the vicinity.”

Postaccident photo of the inboard side of *Leland Speakes*' port main engine at the lower engine room level.

The fire was determined to be caused by a mechanical failure of the port main engine when piston rod connecting caps failed and components breeched the crankcase, resulting in subsequent ignition of fuel and lube oil off the hot engine. Before the failure, the vessel was proceeding at about 80 percent of engine load and no vessel navigation systems or engine problems were noted by the crew. The engine was overhauled about 14 months before the accident, in accordance with Jantran procedures, which included operator torque procedures and checks in addition to the manufacturer's guidance to ensure proper torquing of engine components.

The National Transportation Safety Board determines that the probable cause of the engine room fire on board the *Leland Speakes* was a catastrophic failure and crankcase breach of the port main engine resulting from failure of the caps that secured two piston connecting rods to the crankshaft. Contributing to the severity of the fire was the vessel's lack of a fixed fire-extinguishing system for the engine room and lack of redundant fire pumps.
