MARINE ACCIDENT  
INVESTIGATION BRANCH

# **SAFETY DIGEST**

**Lessons from Marine  
Accident Reports  
2/2019**

October 2019

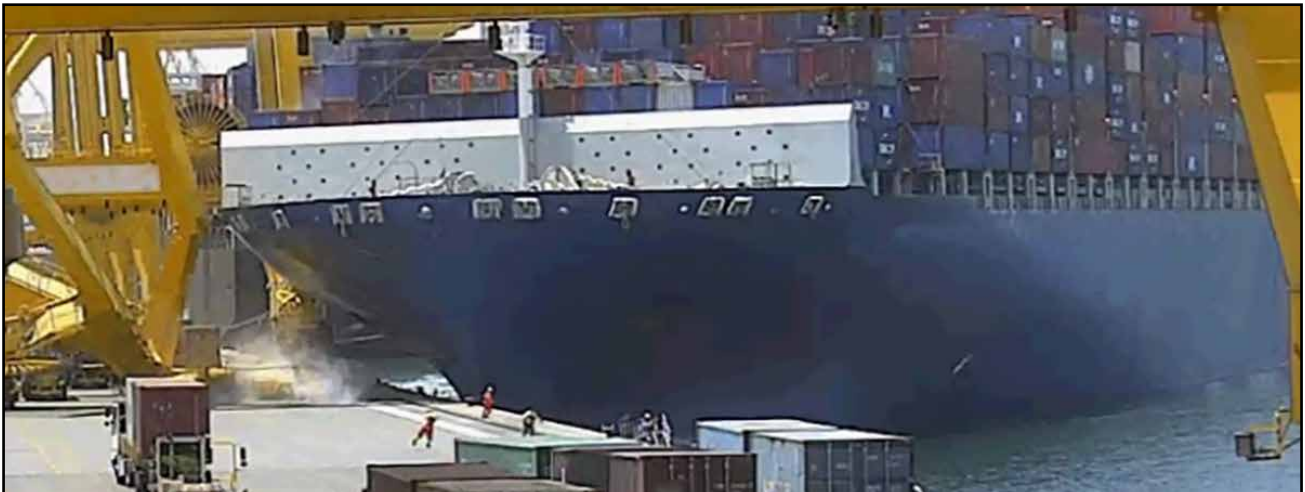
The contact caused significant damage to the container vessel and the shore infrastructure, including two cranes collapsing. Ten port staff were injured.

Figure: The container ship's bow making contact with a crane

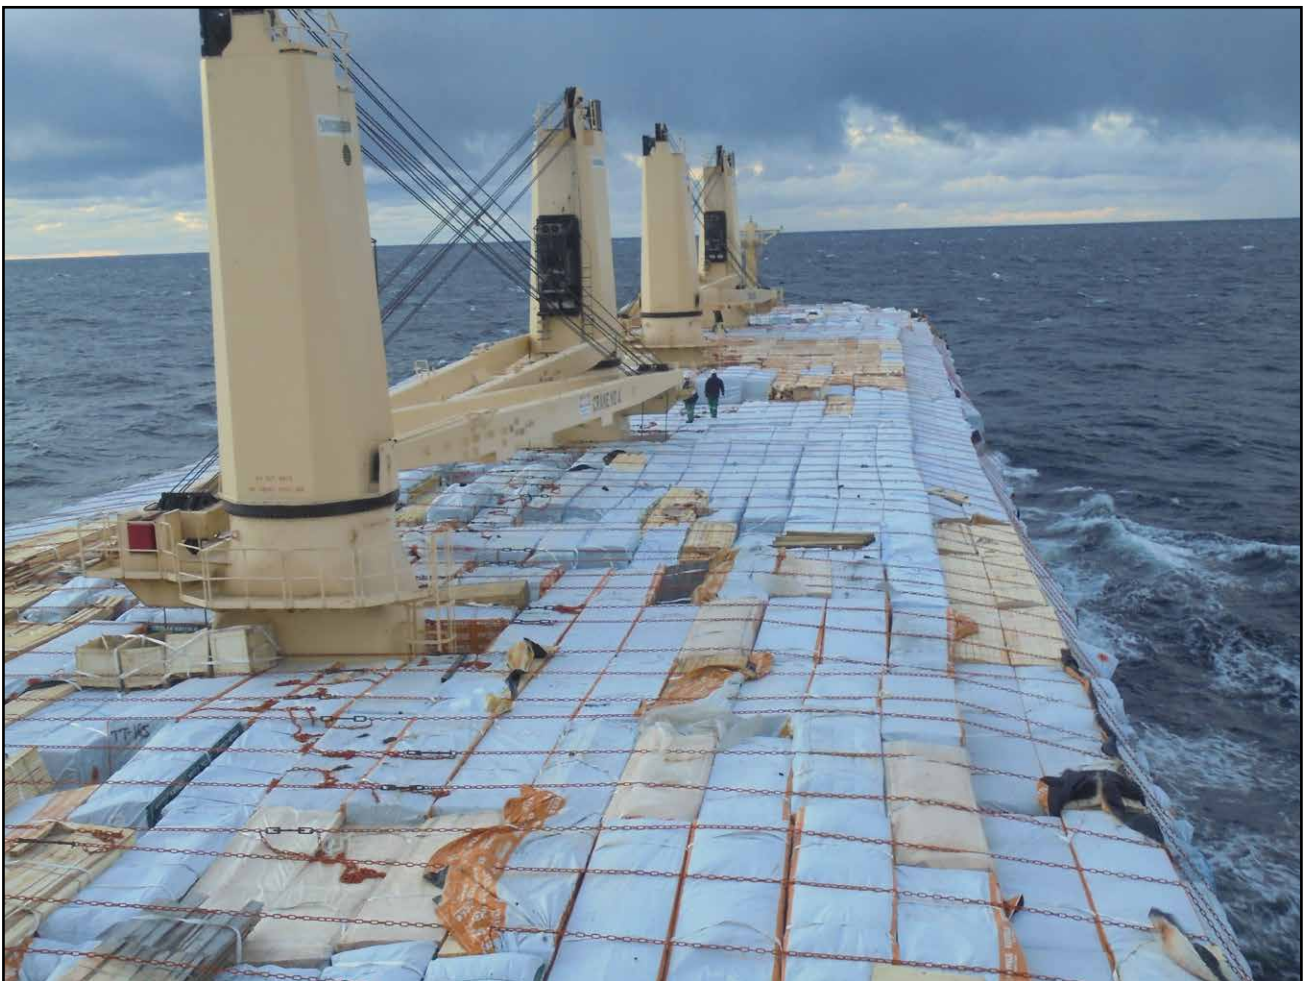
Figure 1: Timber deck cargo secured with top-over lashings at sea

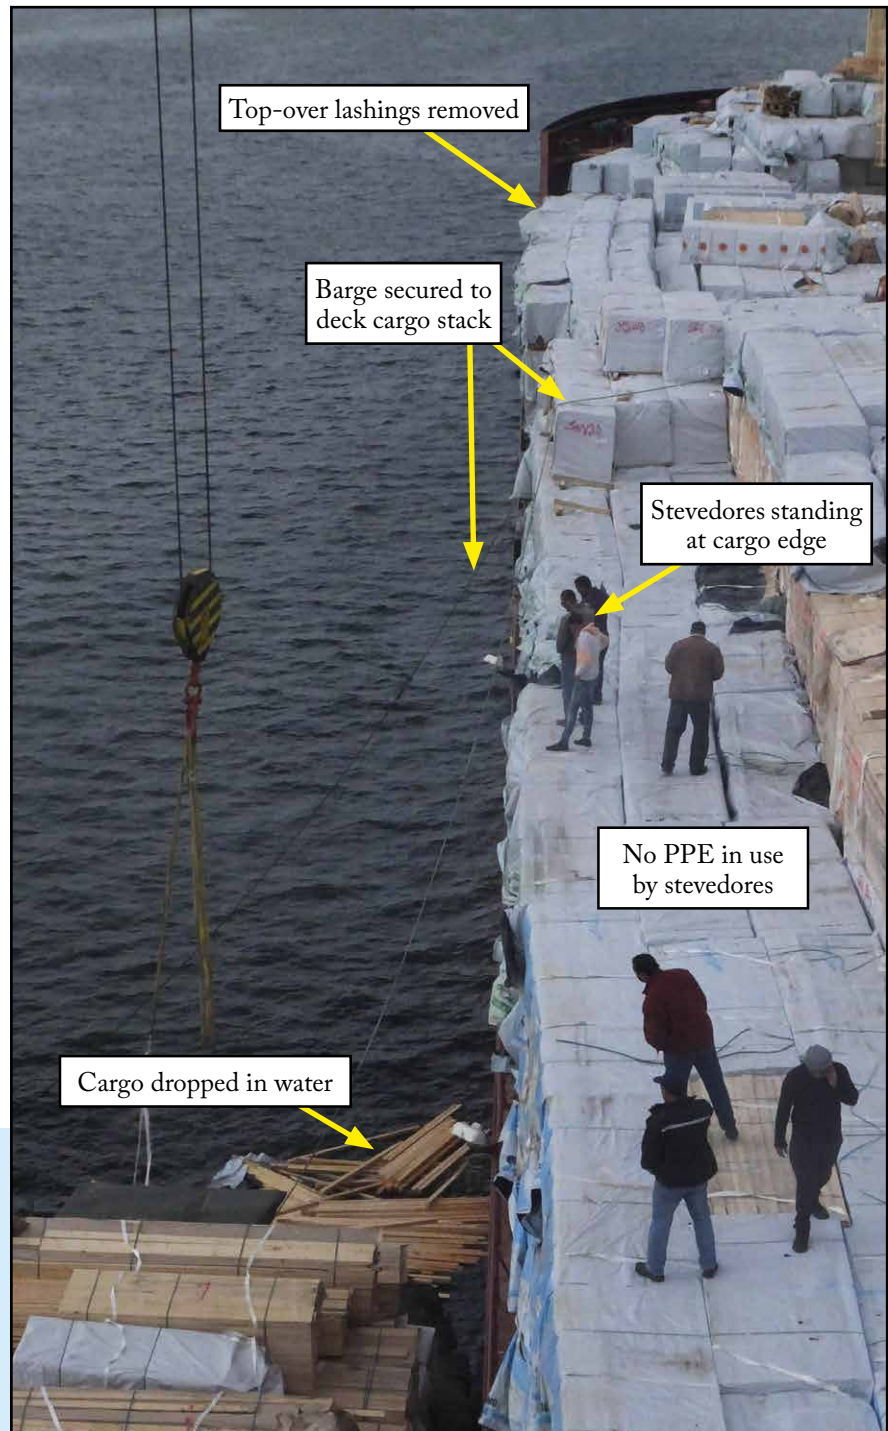
During discharge operations the bosun was conducting security rounds, which involved walking over the deck cargo. The stack of deck cargo that he was standing on collapsed, and he fell with the timber into a barge. Despite being administered first-aid, the bosun did not survive the fall.

Figure 2: Unsecured deck cargo during discharge

1. Although it was a very hazardous working environment, the risks had not been properly assessed. Safe access over deck cargo using ladders and catwalks needs to be provided. Alternative methods of monitoring security, such as the use of CCTV cameras, can also be considered.
2. Vessel crews should challenge poor stevedoring practices. During this discharge operation, the vessel's crew had witnessed a series of poor safety practices by stevedores, including barges being

secured to the cargo, cargo being dropped, stevedores not wearing PPE and cranes being used to lift personnel. When a vessel's crew witness significant safety shortcomings of this nature, proactive engagement with the stevedoring supervisor is necessary to ensure safe working practices are in place for everyone.

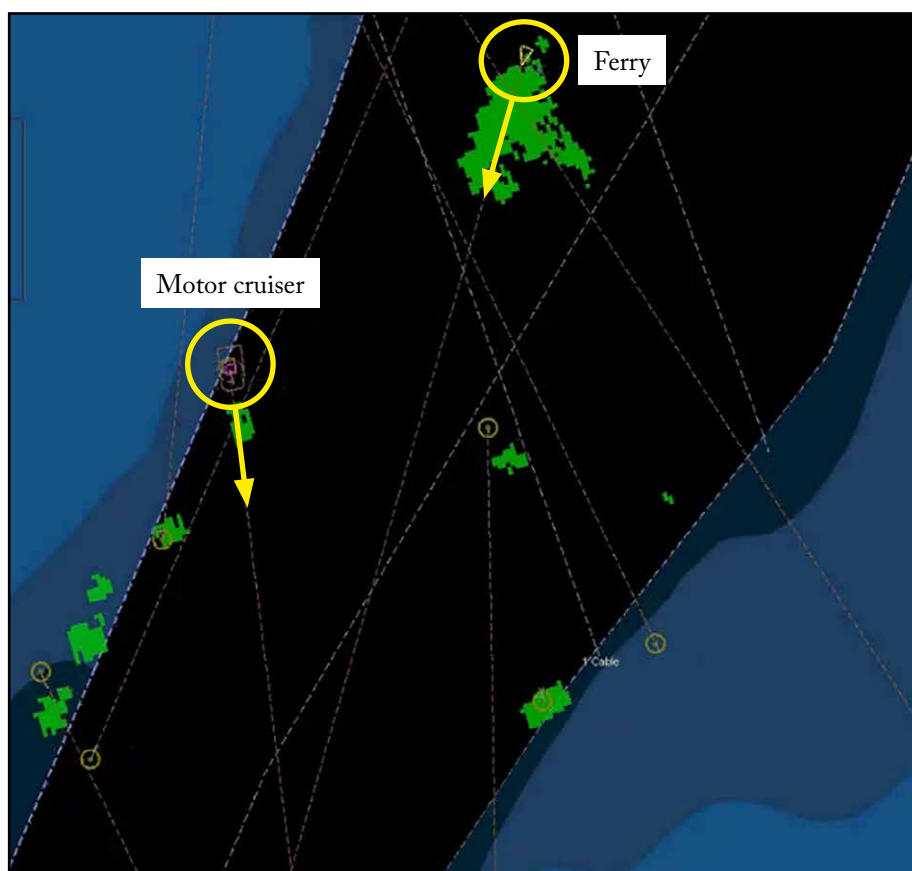
The master and chief officer did not see a motor cruiser with four persons on board that had just entered the channel (Figure 1). The motor cruiser was within 365m off the ferry's starboard bow, heading south at just over 7kts. It was obscured by the sun and might also have been 'wooded' by the bridge window frames. The motor cruiser's owner/driver had a very limited knowledge of the collision regulations and local guidance. He usually went much faster and generally overtook other vessels, and he did not see the ferry because he was looking directly ahead.

Figure 1: Motor cruiser entering the channel

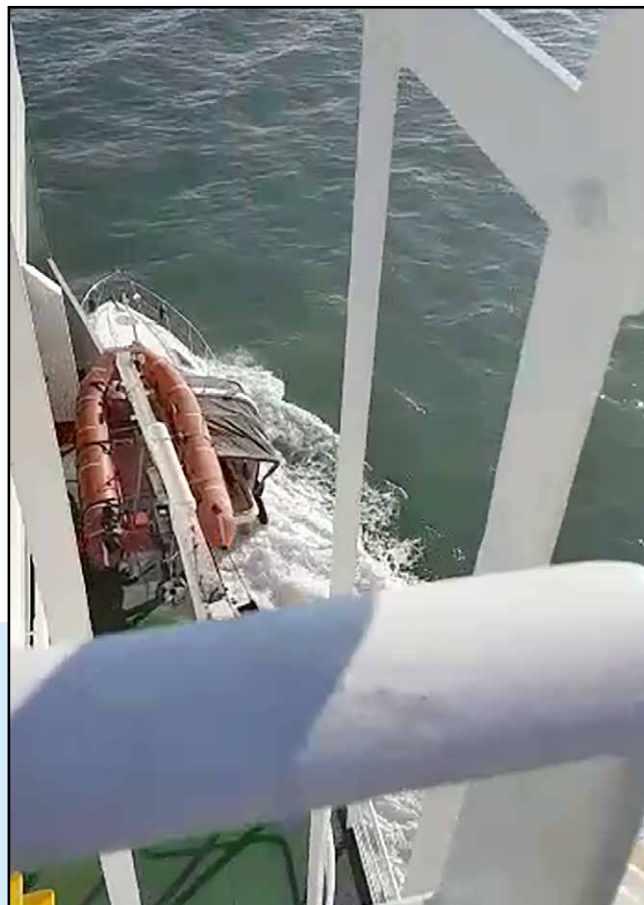
Soon after, the ferry started to alter course to the south as planned. As it did so, it collided with the motor cruiser, which remained pinned against the ferry's bow (Figure 2) for almost 20 seconds before it fell away. The motor cruiser was swamped, and its engines stopped. Fortunately, there were no injuries and, although badly damaged, the motor cruiser was able to make its way alongside on one engine. Meanwhile, the ferry's bridge team remained unaware of the collision until prompted by passenger reports, which were verified by a review of CCTV recordings about 30 minutes later when the ferry was secured on its linkspan.

Figure 2: Motor cruiser pinned against the ferry's bow

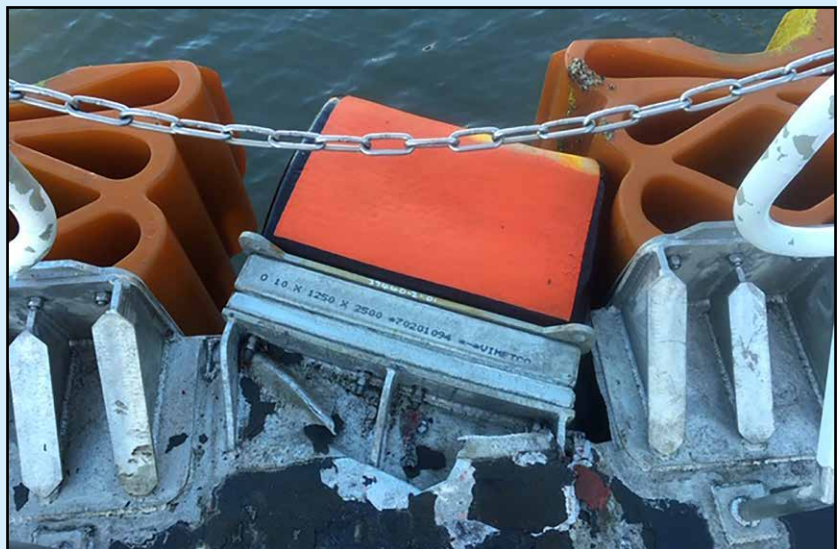
A twin-screw, aluminium-hulled crew transfer vessel was approaching a wind turbine tower. The skipper placed both engine control levers to astern to slow the vessel down, with a plan to nudge up against the turbine to facilitate the transfer of personnel. However, the vessel did not reduce speed and made heavy contact with the tower before the skipper could take any avoiding action. The bow fendering of the vessel was damaged (see figure) and one of the crew was injured after falling over on impact.

An inspection of the engine control system by the manufacturer found that the pitch control rod on the starboard controllable pitch propeller system was stuck. When the skipper had selected astern propulsion, the starboard shaft did not respond. Although the port shaft was functioning normally, the defect on the starboard system was sufficient to cause the heavy contact.

Figure: Damage to the crew transfer vessel's bow fendering

2. Ensure that manufacturers' recommended maintenance routines are in place for all equipment, and that there is sufficient time in the schedule for maintenance. The analysis of this system determined that the starboard control rod had not been greased properly. Greasing of components

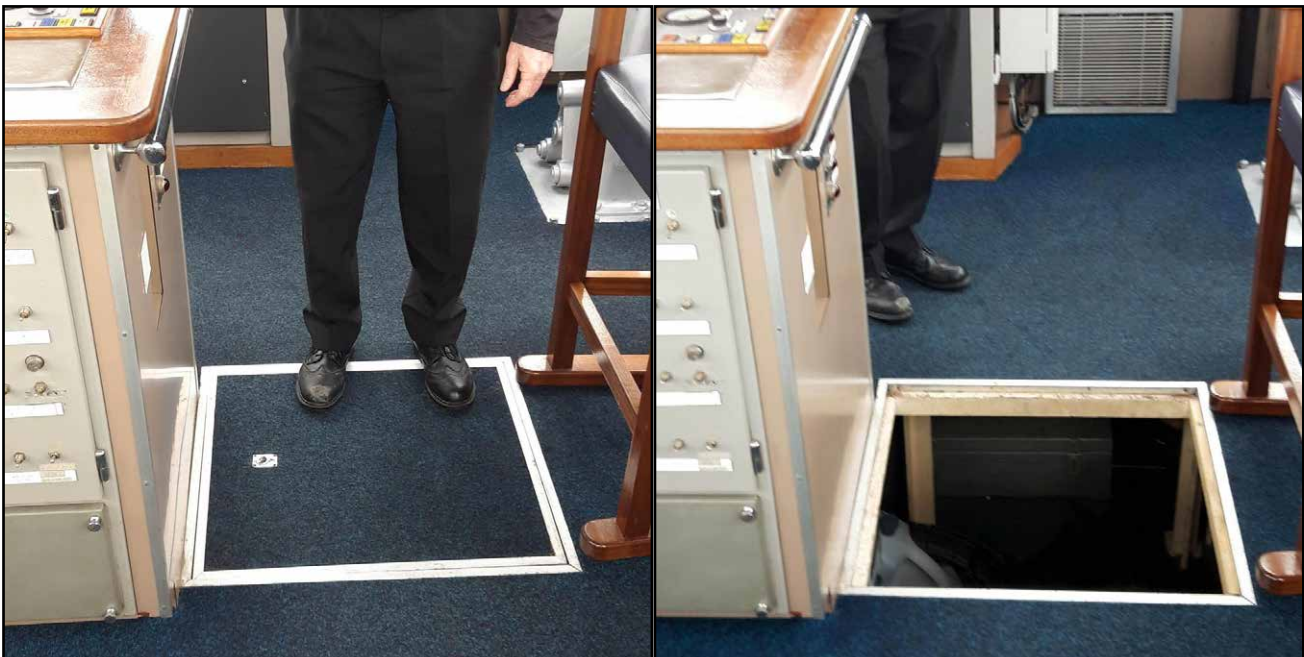
When the tug's master and crew embarked, the AB from the other tug explained that there were contractors on board, but gave no further details. The master went to the wheelhouse to complete some paperwork and was badly injured when he accidentally fell through the unguarded hatchway into the space below.

Figure: The wheelhouse access hatch shut and access hatch open

1. Any openings in the deck should be guarded by suitable barriers. These barriers should remain in place until all work has been completed and the opening has been shut and secured. An appropriate risk assessment should be carried out before any work commences. Such a risk assessment would have identified the hazard in opening a deck hatch and would have helped identify suitable control measures to protect the health and safety of the contractors and the crew.

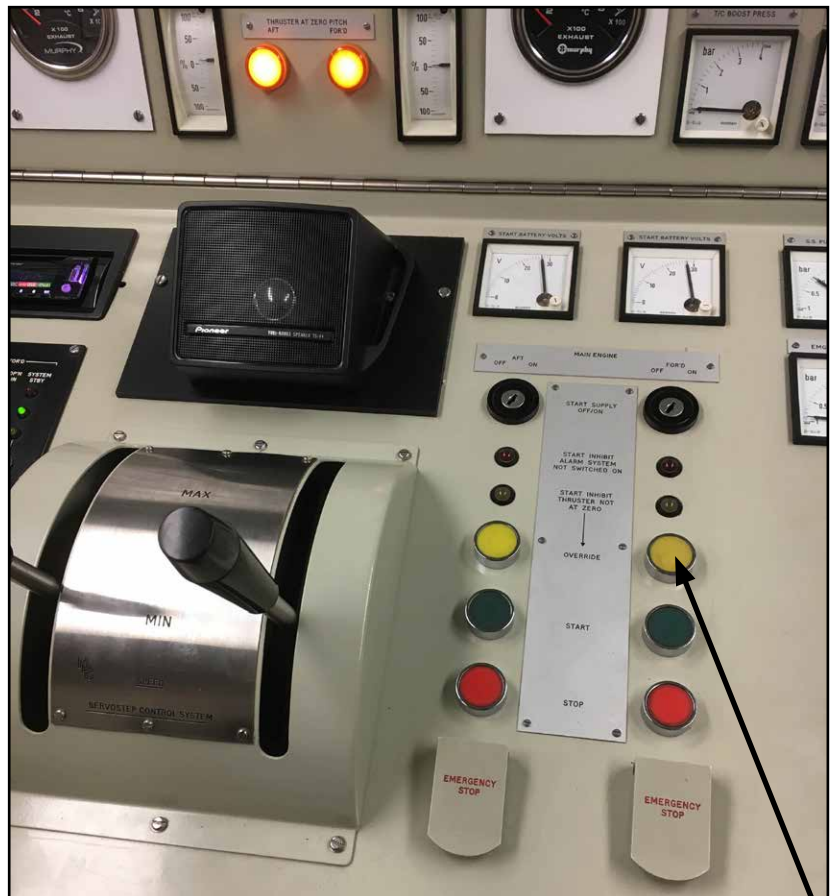
Start interlock override button

Investigation found that the aft propulsion unit had stopped due to a fault in its shutdown system. It also found that the crew were unfamiliar with the vessel's controls, the onboard technical information was unclear on the operation of the propulsion system in reversionary modes, and the vessel's emergency drills did not include machinery breakdowns.

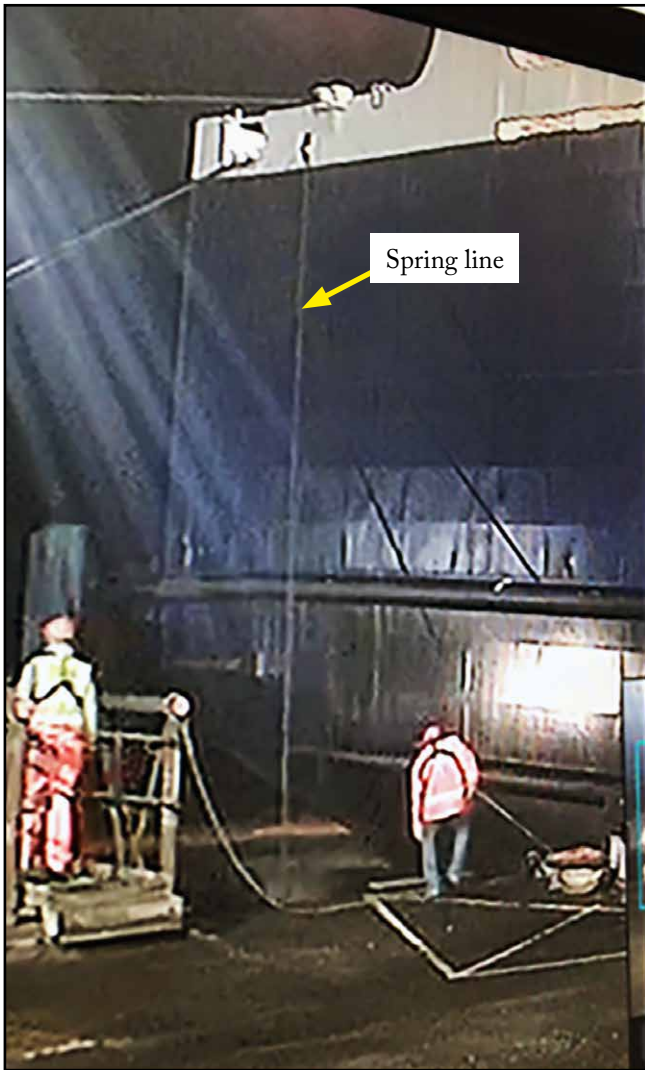
Figure 1: Spring line vertical and slack as linesman picks up messenger

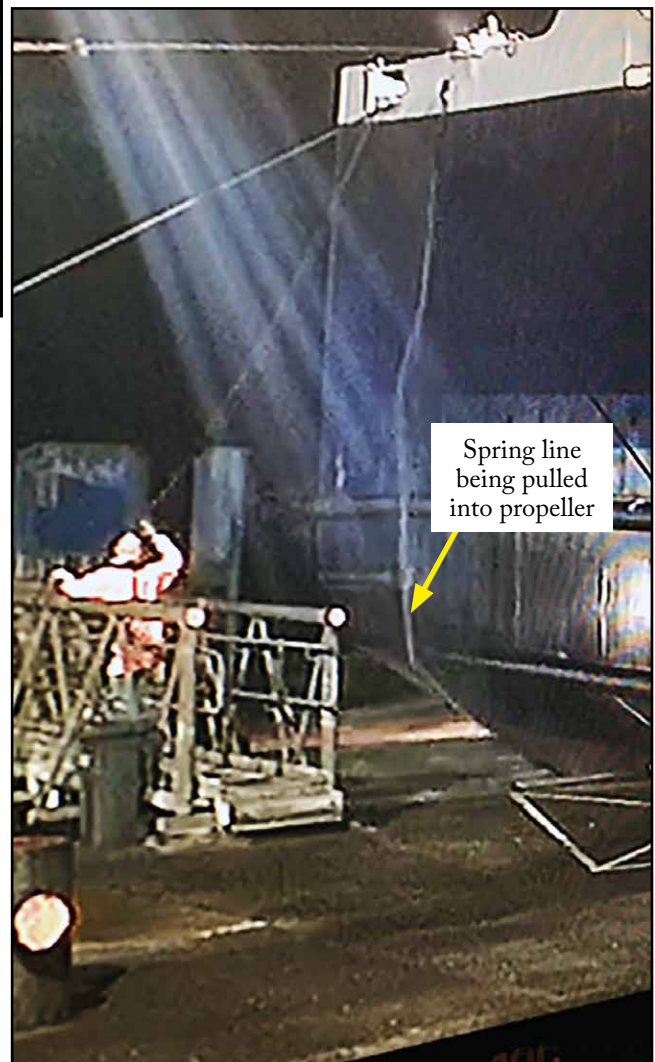
There were no injuries either to shore or ship’s personnel. The ferry sailed without the master being aware that the incident had occurred, but was forced to return to port due to vibration caused by the rope being tangled around the propeller shaft. Divers were able to remove the rope and there was no damage to the vessel.

Figure 2: Spring line becomes entangled in propeller

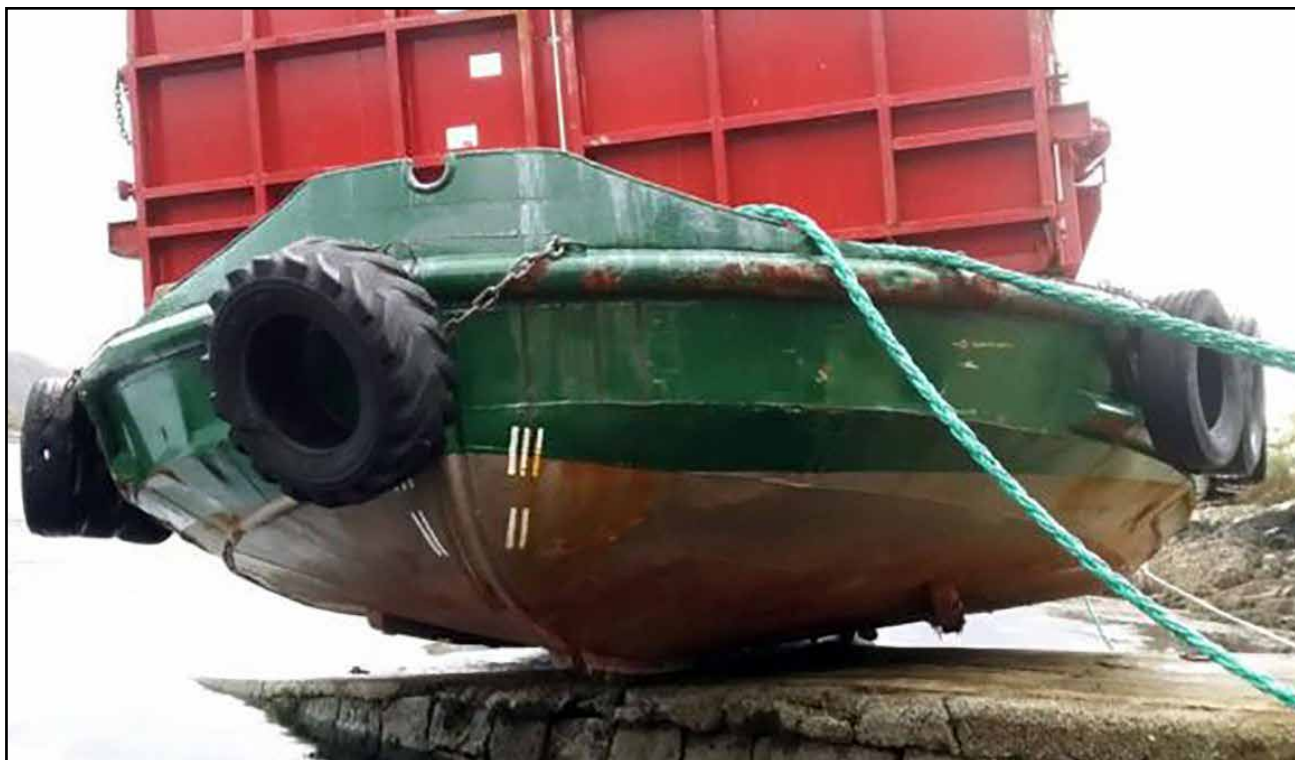
Figure 2: The ferry balanced on the slipway at low water

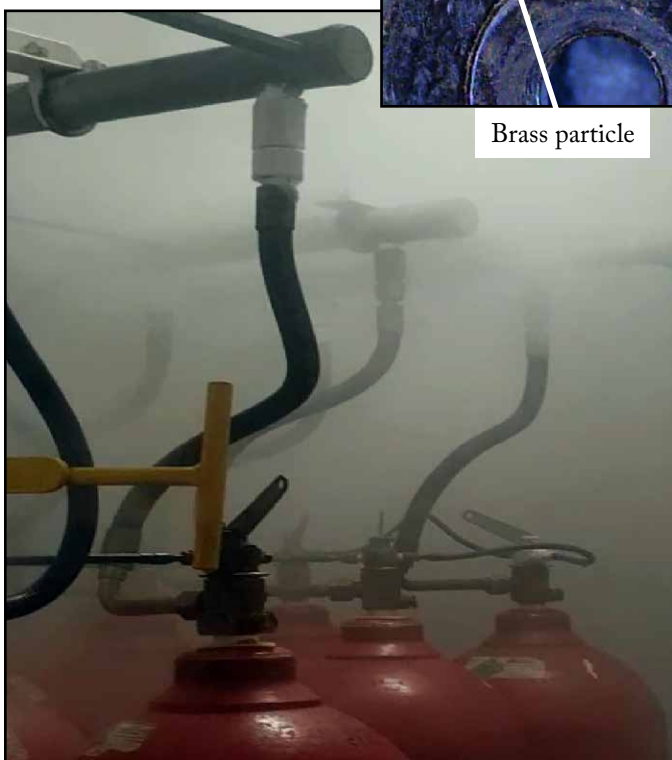
When an engineer approached the CO<sub>2</sub> room he heard a loud hissing noise. On opening the door, he found that one of the cylinder outlets had frosted up around the junction of the flexible outlet hose and the main gas manifold, and a white cloud was forming in the space (Figure 1). The main control valve to the engine room remained closed and no gas had been released into the engine room.

Figure 1: CO<sub>2</sub> leakage (inset: brass particles embedded in cylinder valve seat causing it to leak)

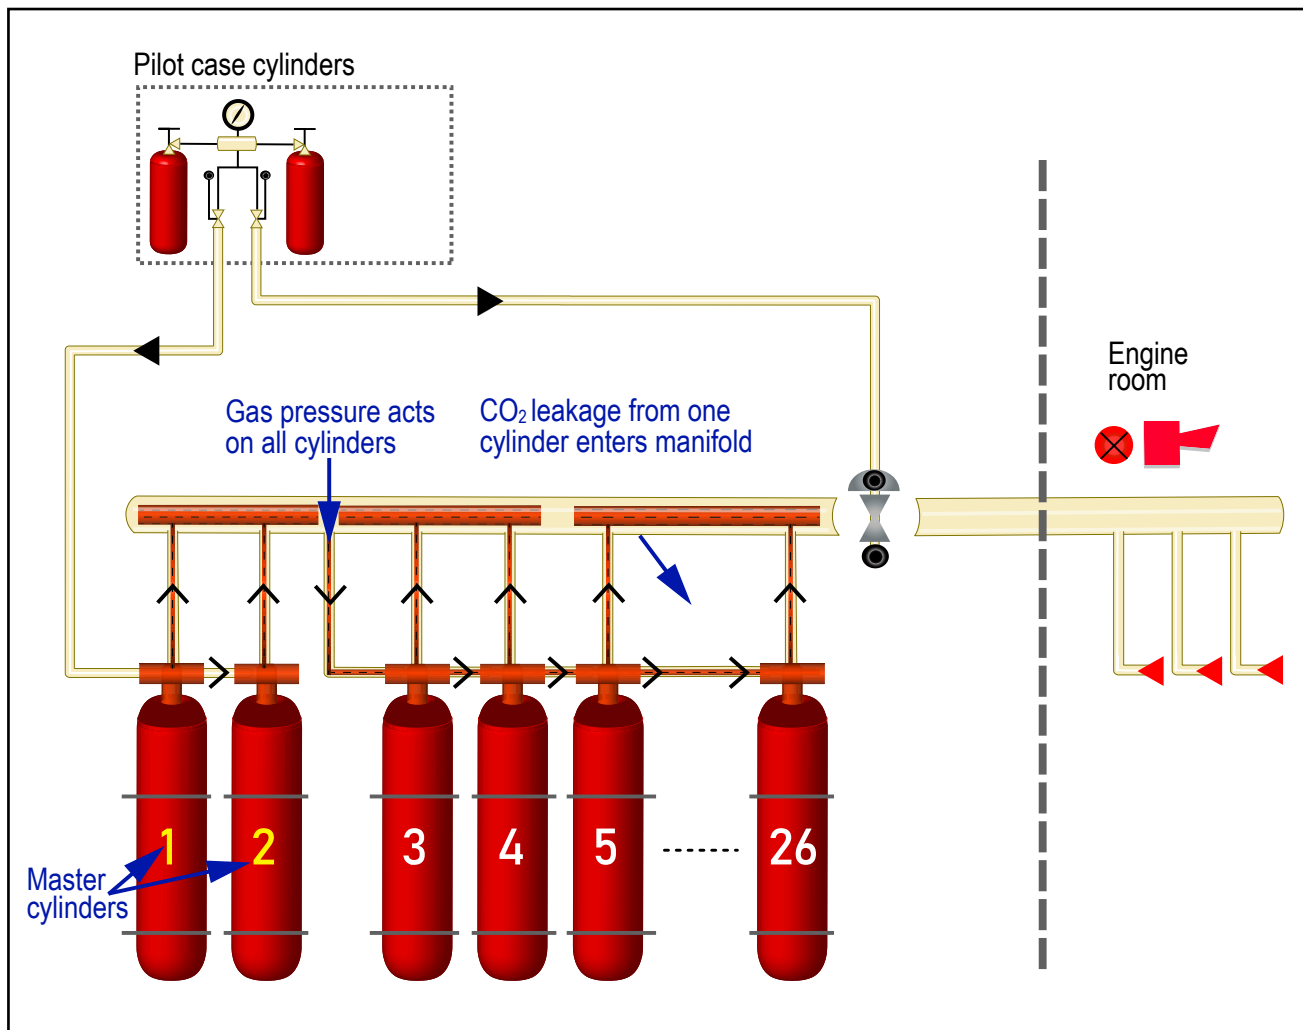
- The main manifold had been pressurised, most probably as a result of a leaking discharge valve on one of the cylinders.
- When the pressure in the main manifold rose above 4.5 bar the release mechanism was activated, causing the entire system (except for the two master cylinders) to discharge (Figure 2 – schematic reproduced).

- The main manifold pressure alarm, which should have alerted the crew at a very early stage to the leakage into the manifold, was damaged and did not function as intended.

- The manifold was not fitted with any vent valves that would release any minor gas leakage into the manifold before it led to a build-up of pressure, although these were available from the cylinder valve manufacturer.

- During servicing the service supplier would typically apply service air from the ship's compressed air reservoirs to the manifold instead of using dry air or nitrogen as recommended.

Figure 2: CO<sub>2</sub> system showing how leakage of one cylinder caused the entire system to be discharged

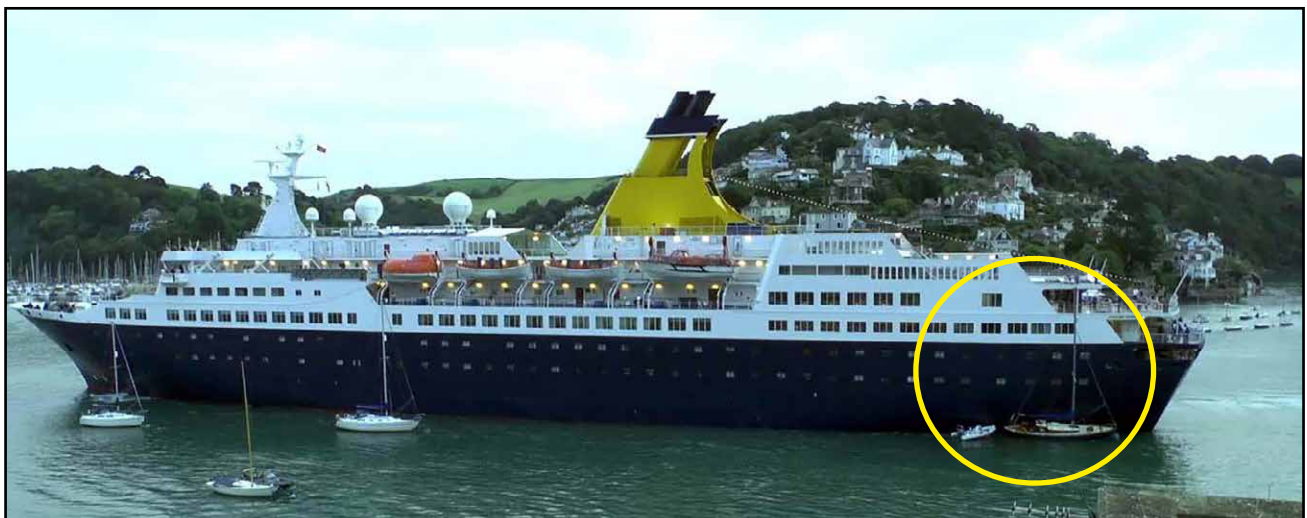
Damage to the yachts was superficial. The position of the yacht's moorings, which reduced the width of the navigable channel by 30%, had not been shared with the cruise ship's manager during the initial planning of the visit, or with the master during the master/pilot exchange.

Figure: Cruise ship colliding with moored yachts (circled)

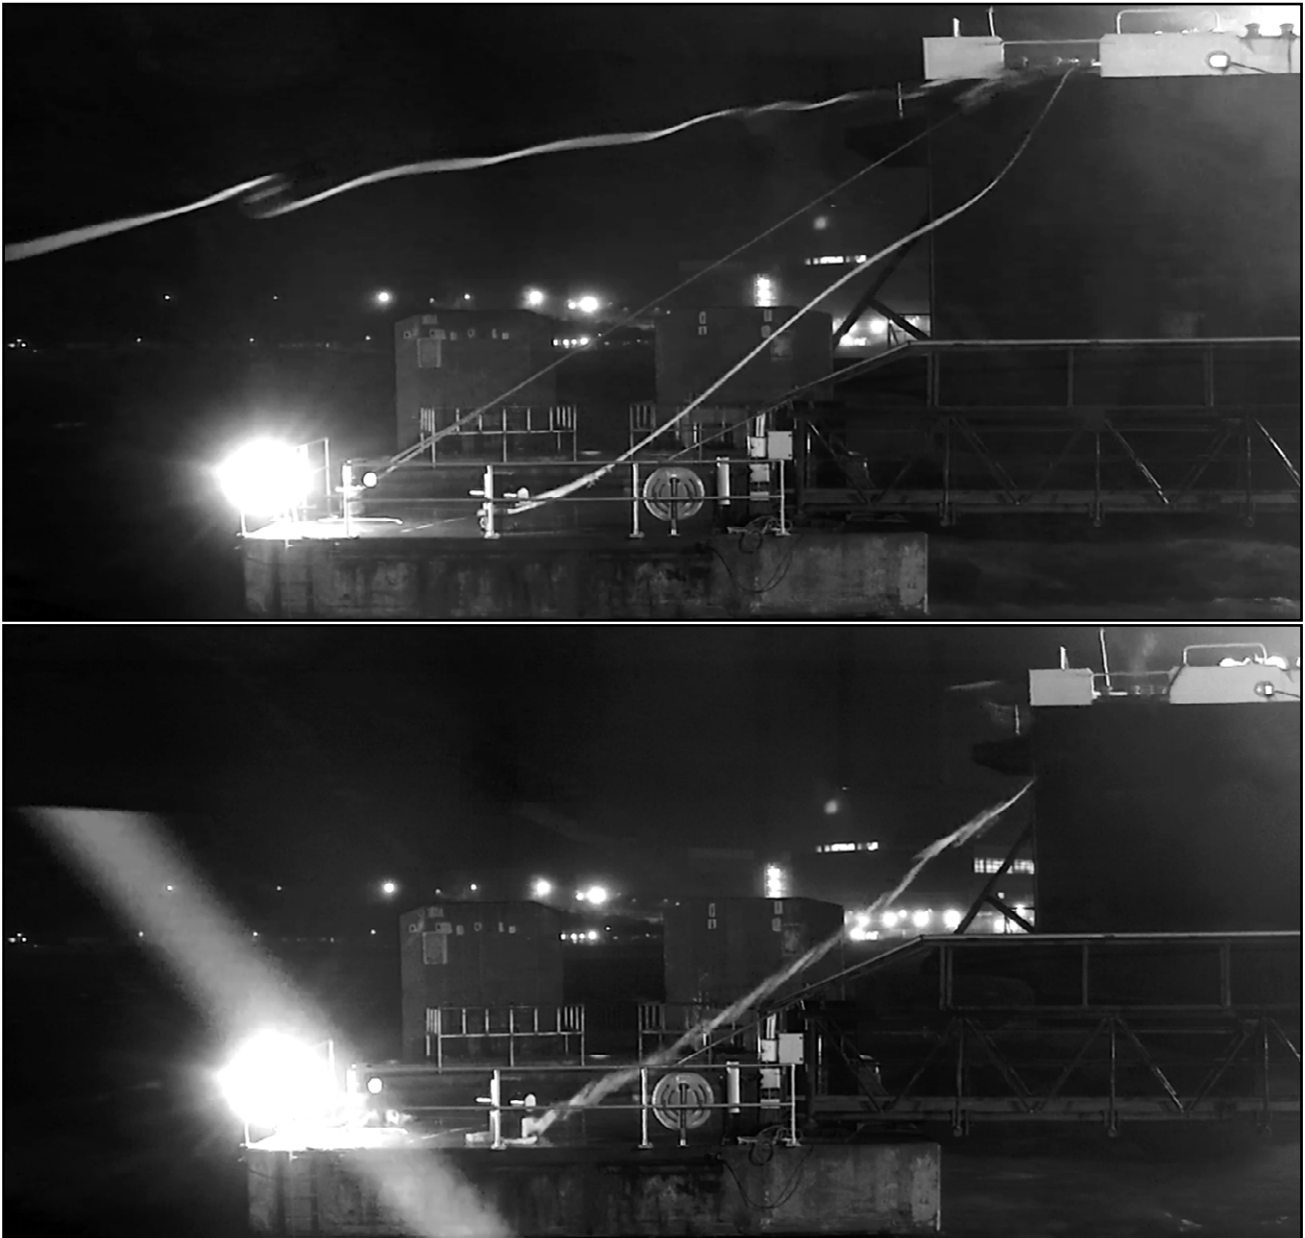
In the early hours of the morning the wind increased as forecast and a gust of 56kts was recorded on board; at the same time the stern lines parted in quick succession due to the extreme force of the wind (Figure 1). The ferry's stern started to swing away from the

Figure 1: CCTV imagery of the ferry's stern lines parting during the storm

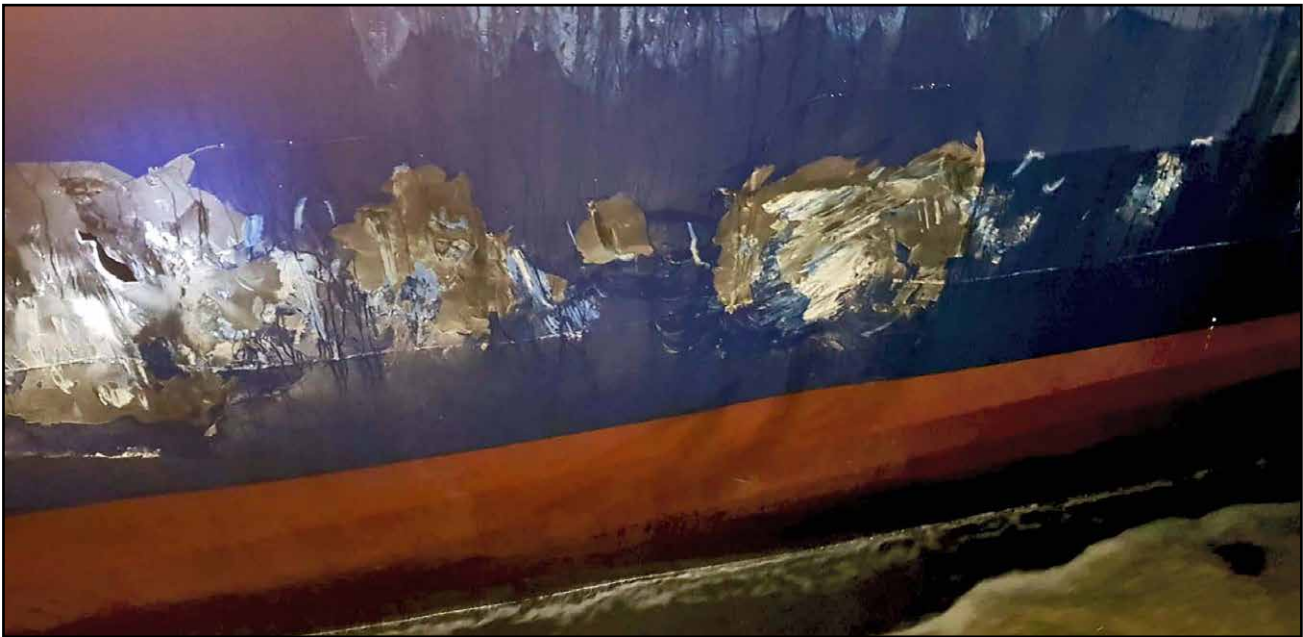
Figure 2: Detail of hull damage to the ferry's port side after impact with the adjacent quay wall

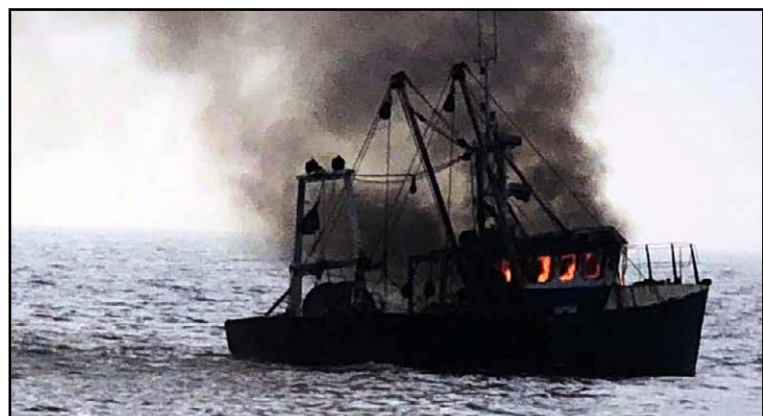
Figure 2: Wheelhouse engulfed in flames

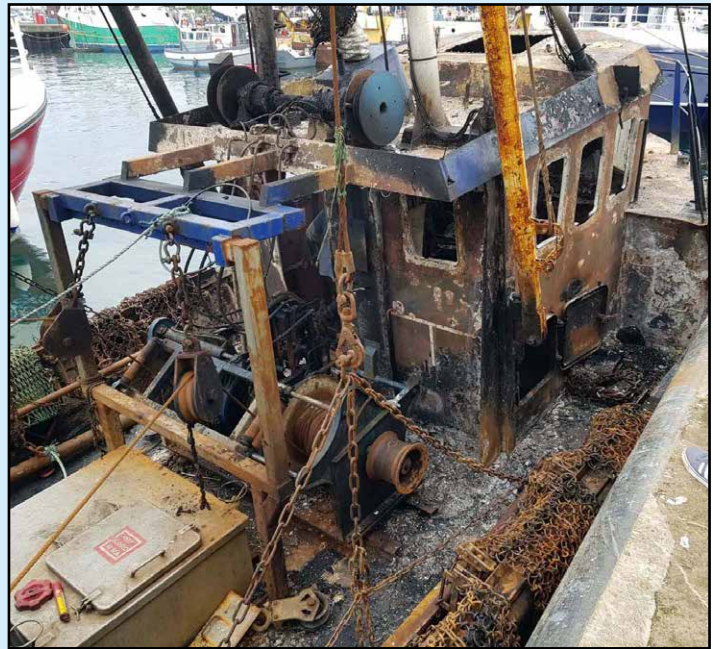
Once in the liferaft, the skipper used the VHF radio to make a "Mayday" call. After receiving no immediate reply, he used his mobile phone to call 999 and asked for the coastguard. Having linked the EPIRB alert to the vessel, the RNLI all-weather and inshore lifeboats quickly arrived on scene and the skipper was recovered ashore, shocked but unhurt. The fire eventually burned out and the fishing vessel was towed back into port, where it was confirmed a total loss (Figure 3).

Figure 3: The burnt out vessel

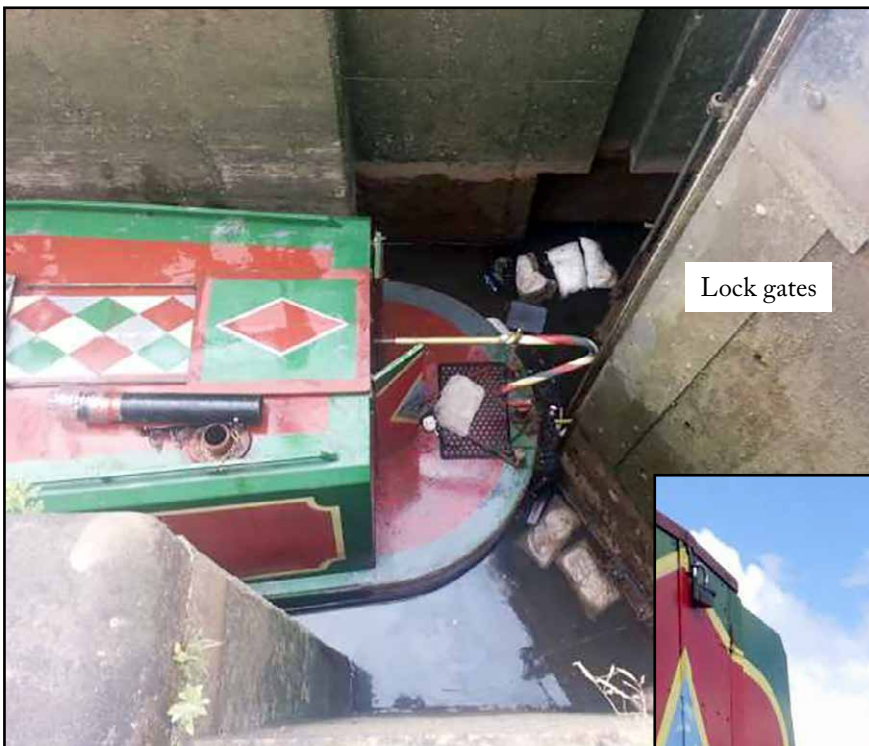
An investigation by the waterway authority established that the boat rudder had become trapped in the mitre of the gates and had prevented the stern from floating freely (Figure 2). The stern button fender was compressed and did not prevent the rudder from becoming entrapped (Figure 3).

Figure 2: Rudder trapped in lock gates

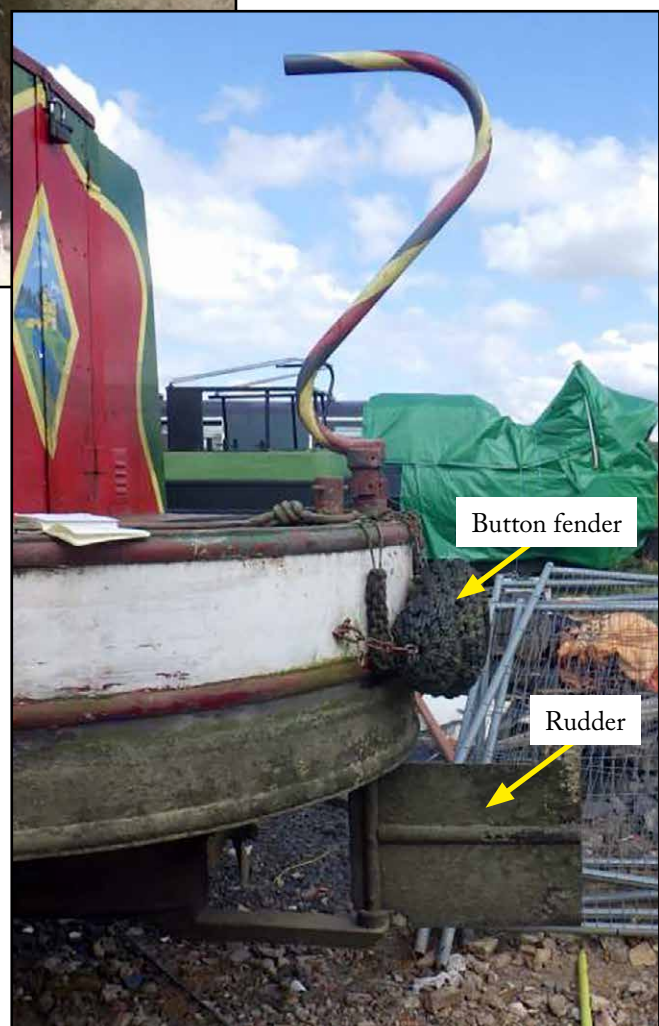
Figure 3: Rudder and compressed button fender

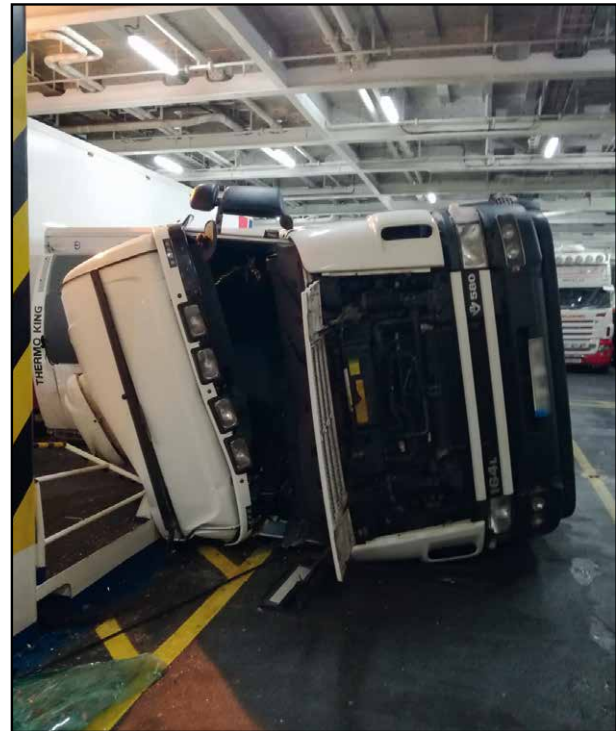
**Figure 2:** Truck toppled over

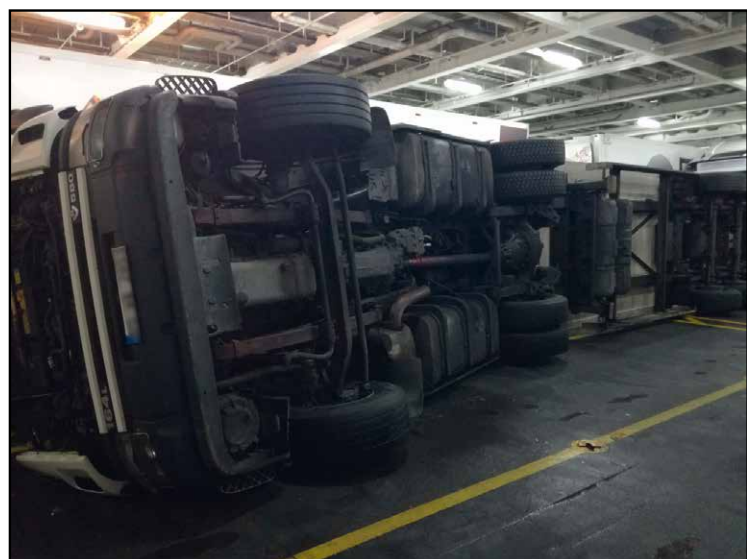
**Figure 3:** Truck toppled over on main deck

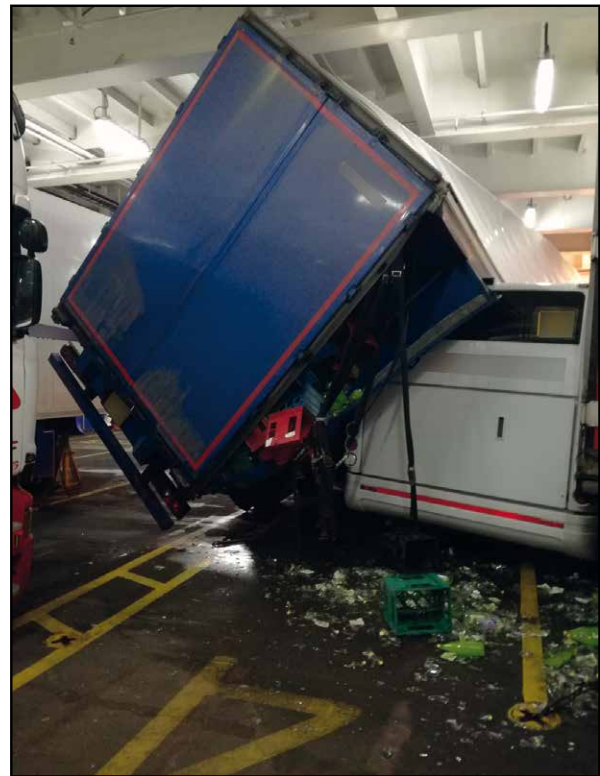
Figure 4: Damaged truck and mini bus

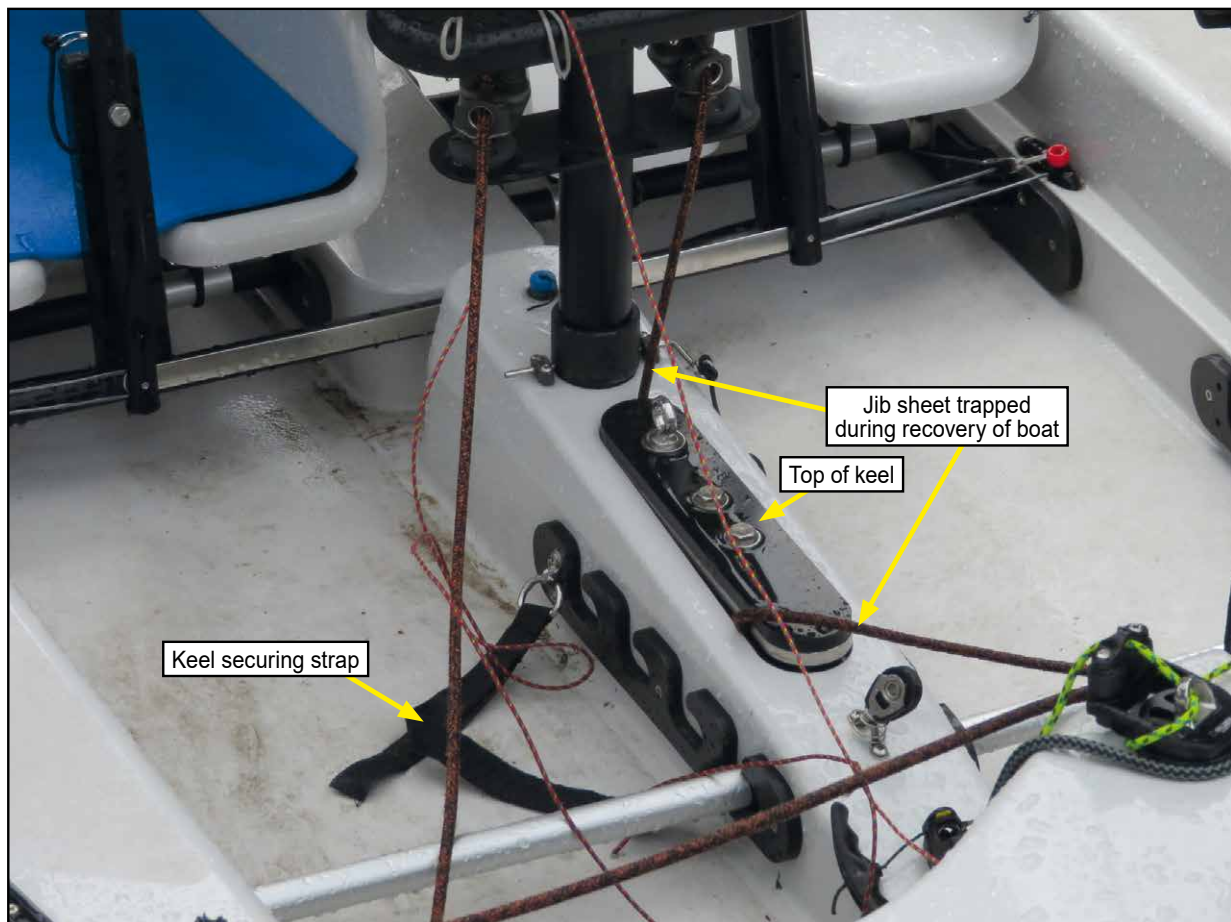
**Figure 1:** Showing top of the keel with the restraint not in place

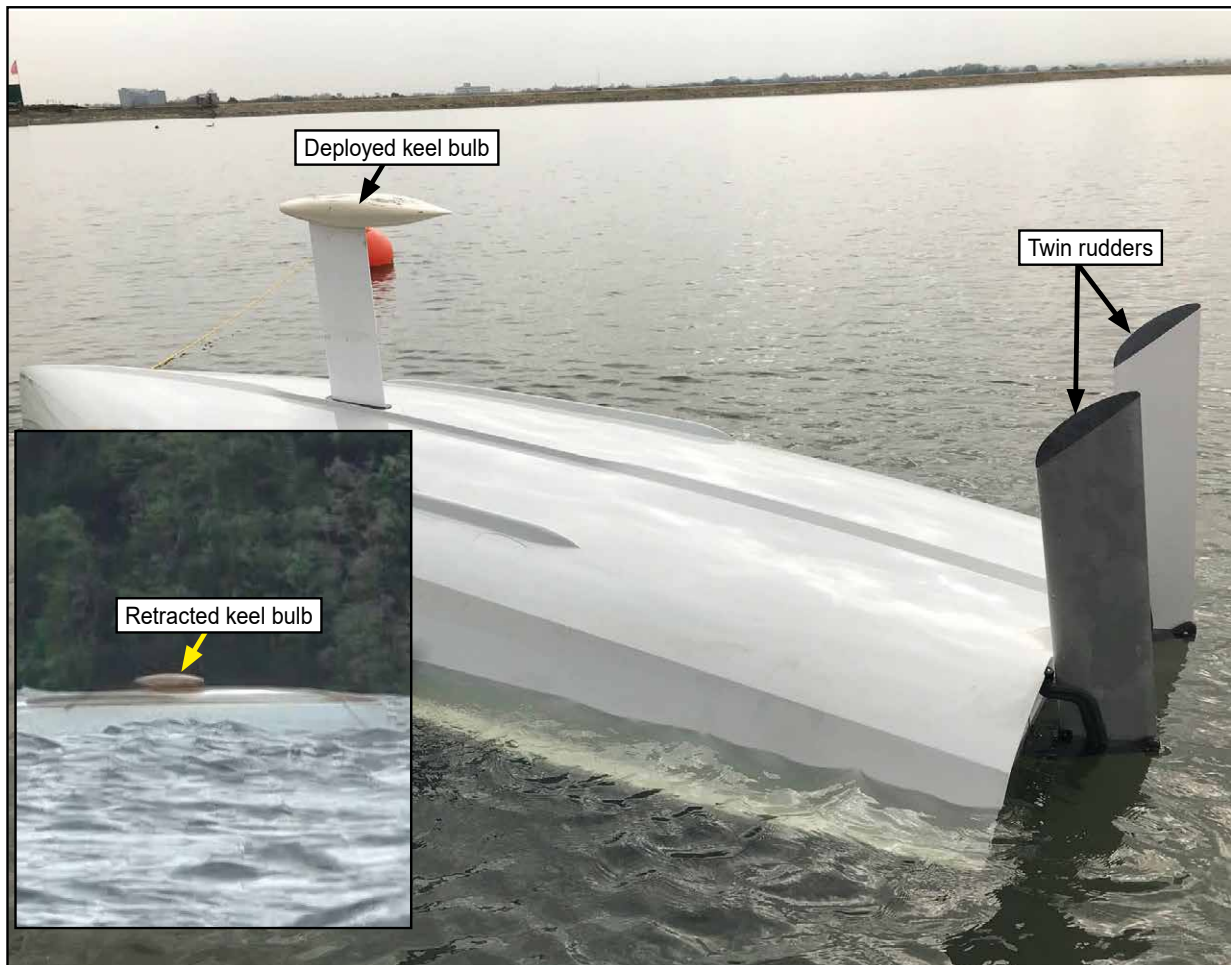
**Figure 2:** Inverted boat with a fully deployed keel bulb (Inset: the keel bulb hard up against the inverted hull)
