Fatal man overboard from the single-handed creel boat *Sea Mist* (BF918) Macduff, Scotland 27 March 2019

SUMMARY

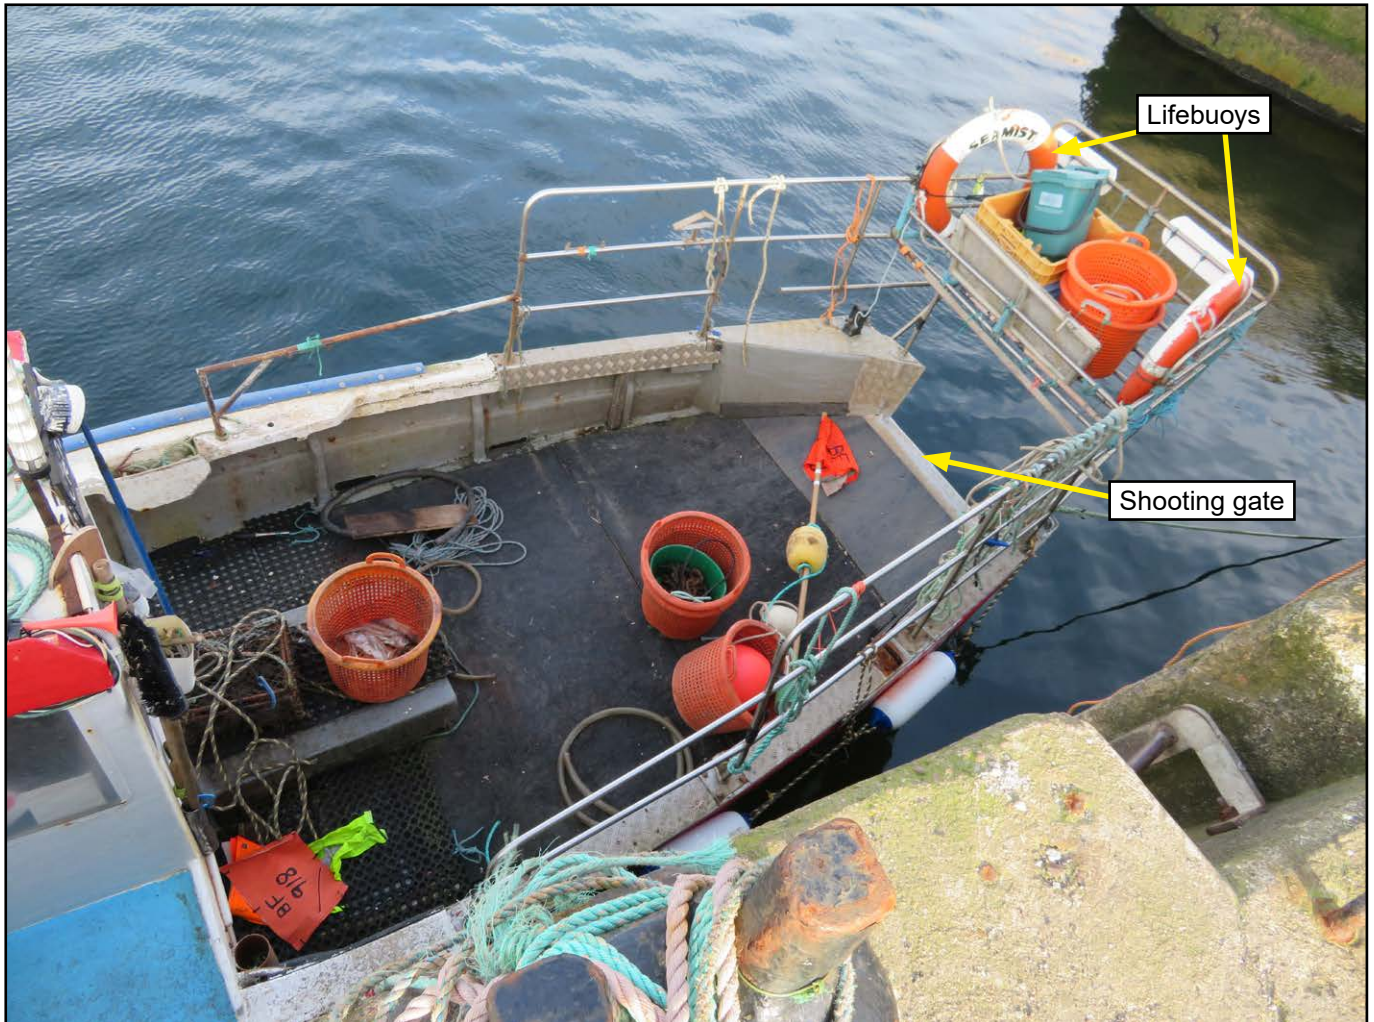
Figure 2: Position of lifebuoys

Sea Mist was a UK registered 5.65m fishing boat with a hydraulic hauler on its starboard side. It had a shooting gate located on its stern, which measured 85cm wide at deck level and 78cm high (**Figure 2**).

The lifesaving equipment carried on board included two lifebuoys located inboard on the aft railing (**Figure 2**) and a solid-filled (inherently buoyant) PFD for emergency use. There were also two 150N auto-inflate PFDs on board for use when working on deck (**Figure 3a**), both of which were found on board after the accident. There were serrated knives in sheaths in two locations on the working deck (**Figure 3b**).

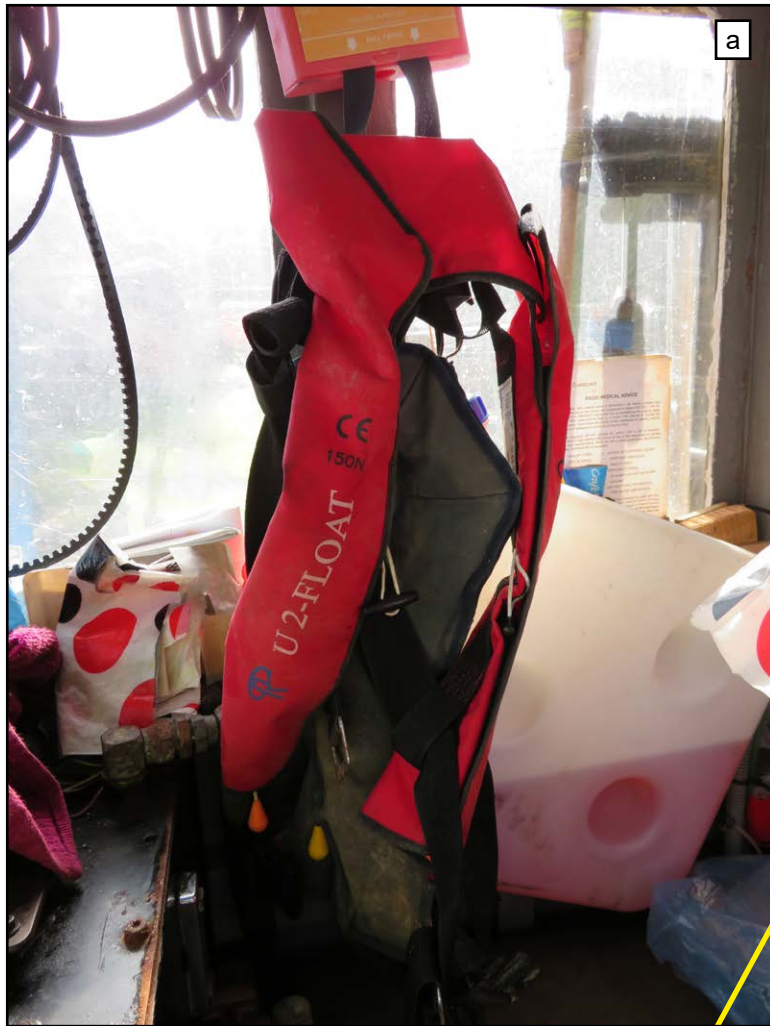
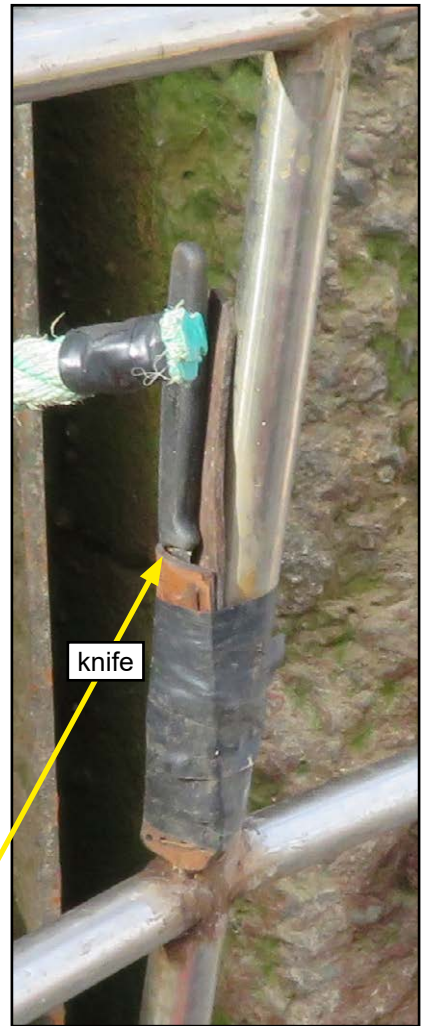
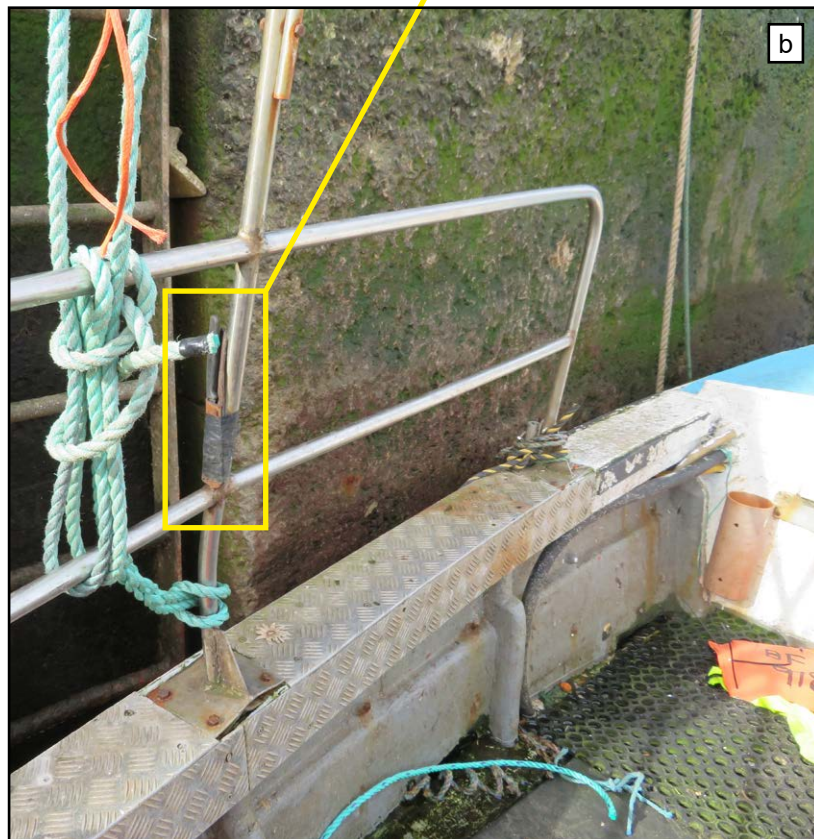
Figure 3: Skipper's personal flotation device and knife stowage on deck

The skipper had completed the mandatory fishing vessel safety awareness training in February 2015. He always carried a knife and was known to regularly wear his auto-inflation PFD when fishing.

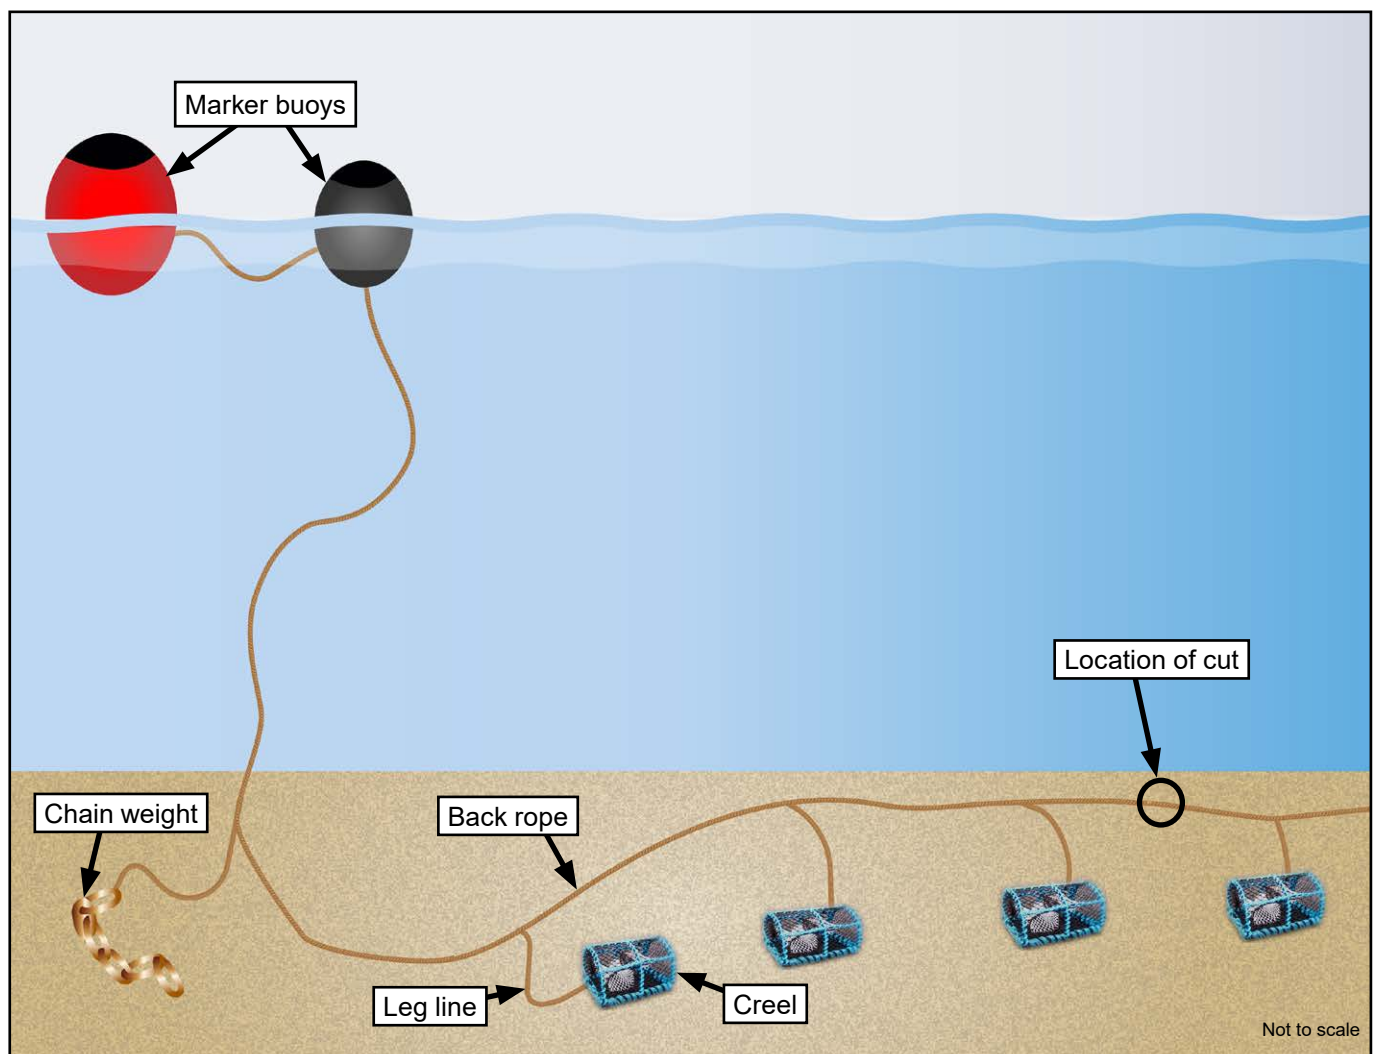
Figure 4: Leader

Each leader had a flagged float that displayed *Sea Mist's* fishing number at one end and two buoys at the other. The back rope had weights at either end and the creels were attached along its length at various distances by leg lines (**Figure 4**). The creels were stowed on the deck end-on to the stern (**Figure 5**) to minimise the risk of the larger creels jamming in the shooting door.

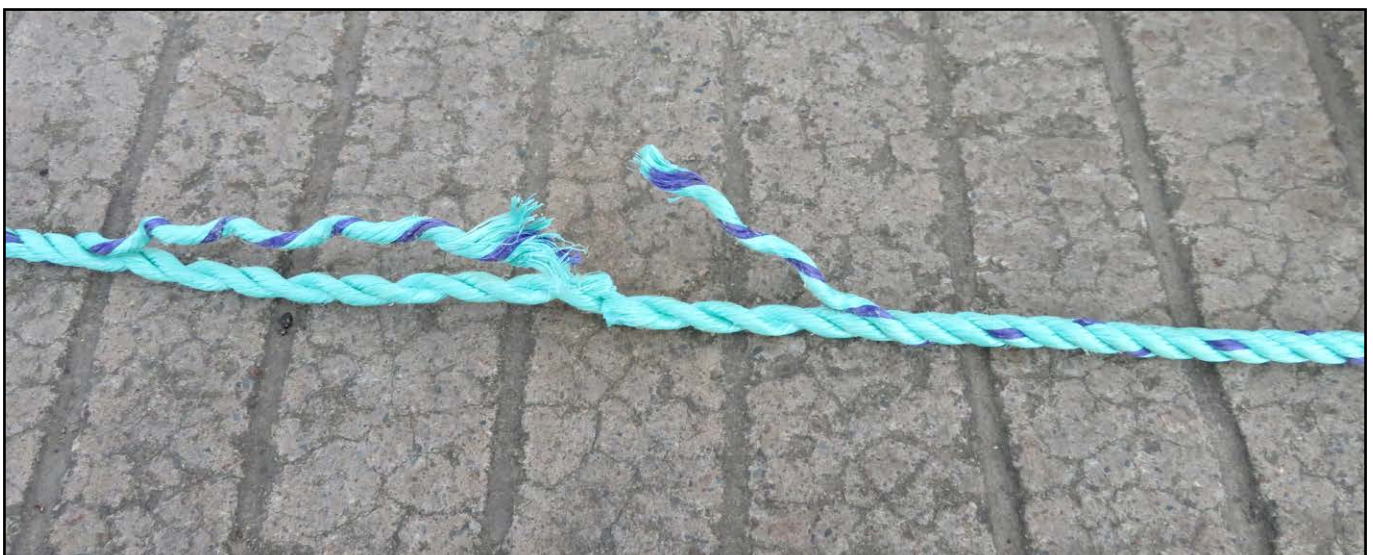
Figure 6: The cut in the back rope

Following the accident, the leader was inspected and a cut in the back rope was discovered between the fourth and fifth creels (**Figure 6**). This section of the leader was sent to an independent specialist to examine the cut. The specialist's report stated that:

Visual and digital microscopy examination confirm that the rope has been mechanically damaged with a sharp edge indicative of a knife. There is no evidence of crushed or distorted strands or filaments adjacent to the damage that might indicate that the rope had been caught or snagged in a clamp or other mechanical type of hinge. There is also no evidence of heat or chemical damage to the rope.

Examination of the ends of the fiber filaments has shown a large proportion to have either a flat or angled shape with a lip. These are all known damage profiles for a sharp cut being made by a knife but there is also evidence of some tearing of the filaments which may be indicative of the knife being pulled across the fibers in an attempted slashing cut or possibly of a serrated edge of a blade being used. [sic]

It was evident from the cut in the leader's back rope, that *Sea Mist's* skipper fought hard to free himself, though it is unknown whether he attempted to cut the rope before or after he entered the water.

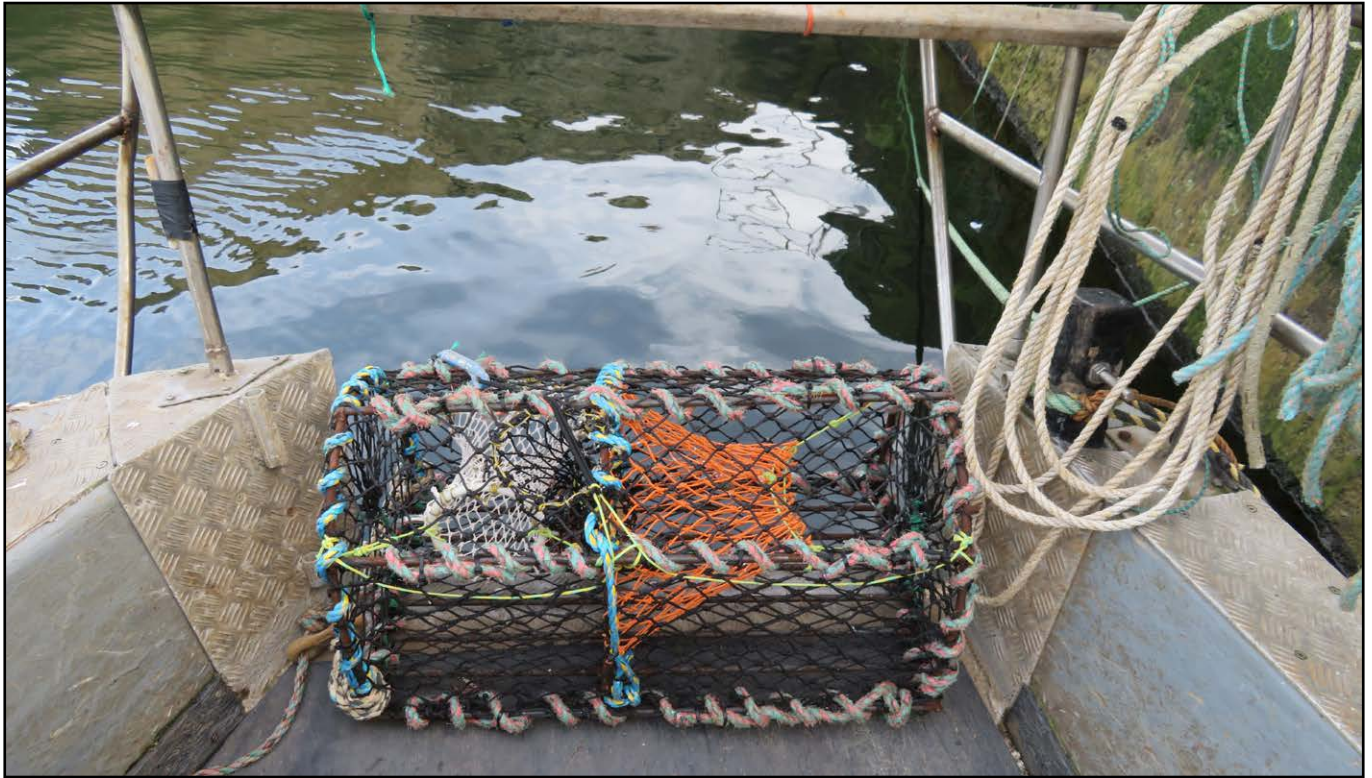
Figure 7: Creel jammed in shooting gate

The most likely reason for the skipper to return to the deck was to release a snagged or jammed creel or group of creels. At 78cm x 42cm, creels two, three and five were the largest creels on the leader and were therefore the most likely to snag in the shooting gate opening (**Figure 7**). Whatever his reason for returning to the deck, the evidence indicates that his boot became entangled in the back rope, and he was pulled overboard as the creels continued to shoot.

Despite the recent publication of improved safety guidance, the frequency of serious and fatal accidents involving single-handed fishermen shows no sign of reducing. In this case, had *Sea Mist's* layout included a physical barrier separating crew from the ropes, the skipper would have been able to place himself in a safe position when he returned to the deck during the shooting operation.
