National Transportation Safety Board

Marine Accident Brief

Fire Aboard and Subsequent Sinking of Fishing Vessel *Ariel*

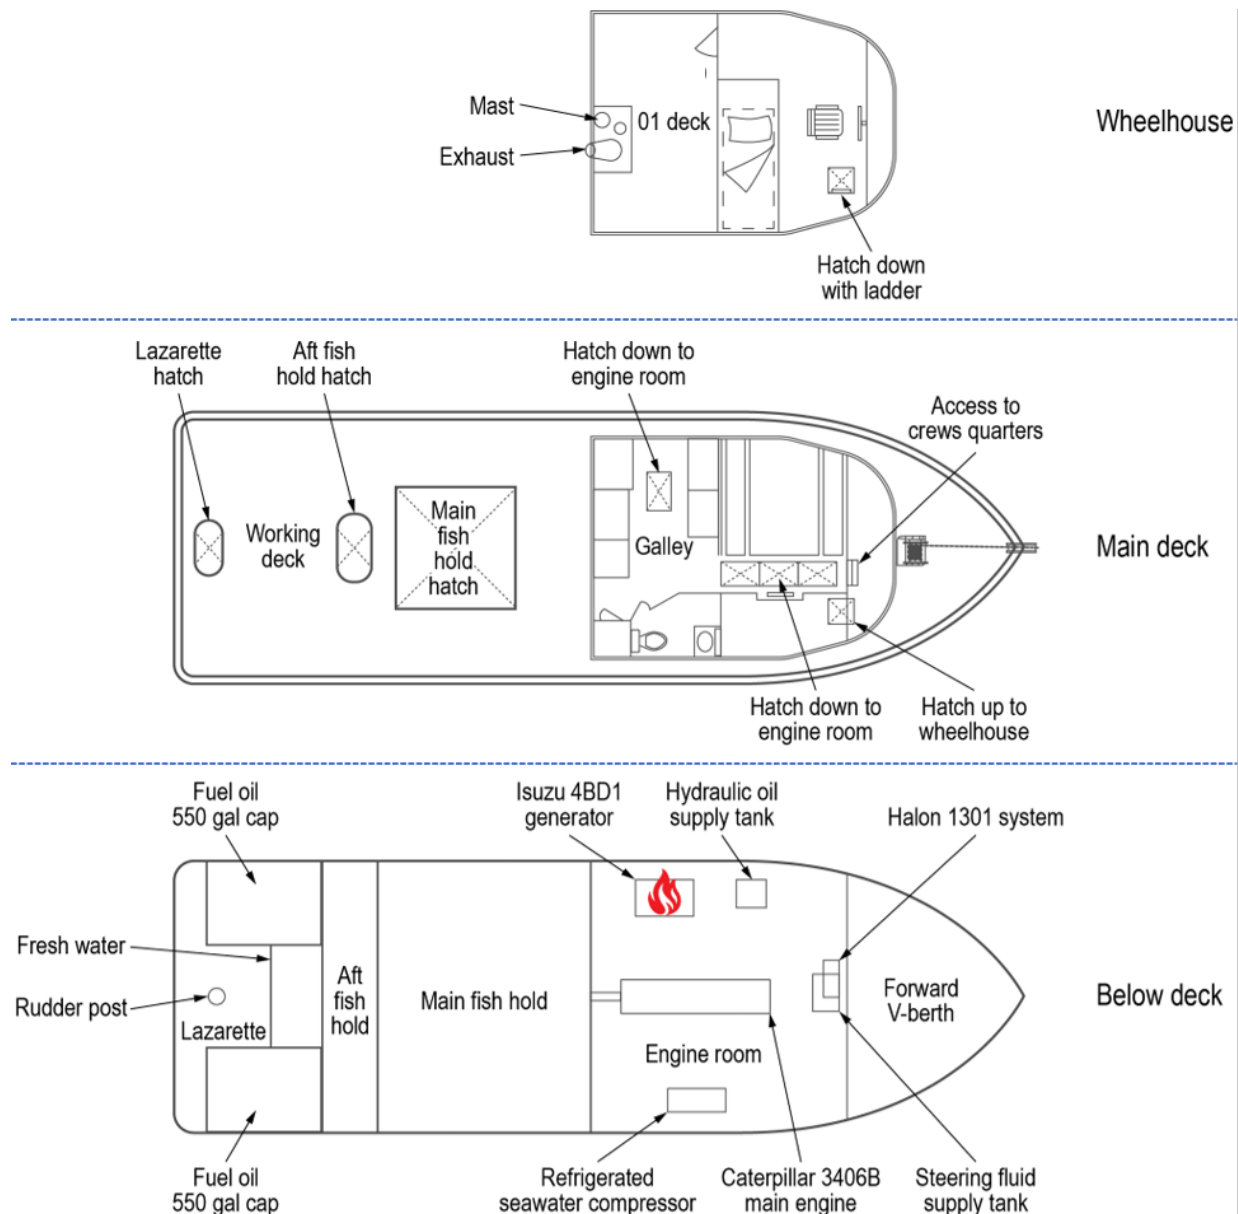
In the early evening on August 26, the *Ariel* had completed fishing and was transiting Sheep Bay at 5.5 knots (about 75% power) en route to a tender in the adjacent inlet. The captain was at the helm in the wheelhouse located above the vessel's cabin. According to the captain, the main fish hold, located just aft of the engine room, was full of fish, and the aft hold, located behind the main hold, was empty. About 1830, the engineer was in the cabin when he smelled smoke. He opened the main hatch to the engine room to investigate and saw flames in the vicinity of the generator. He alerted the captain and the crew and grabbed a fire extinguisher to fight the fire.

General arrangement of the *Ariel*, with the area where the fire was first reported indicated by the red flame icon.

The fluctuating rpm of the diesel engine generator observed by the captain just after the fire was discovered was likely the result of fuel starvation, which suggests that the fuel line to the generator's engine was breached. The fuel hoses that ran between the manifold, fuel filter, and generator met Coast Guard material specifications; however, over time a hose could have become worn from contact, its connections could have loosened through vibration, or it could have otherwise failed, allowing fuel to leak into the engine room. Leaking fuel or fuel vapor may have then come into contact with a hot surface, igniting the fire.

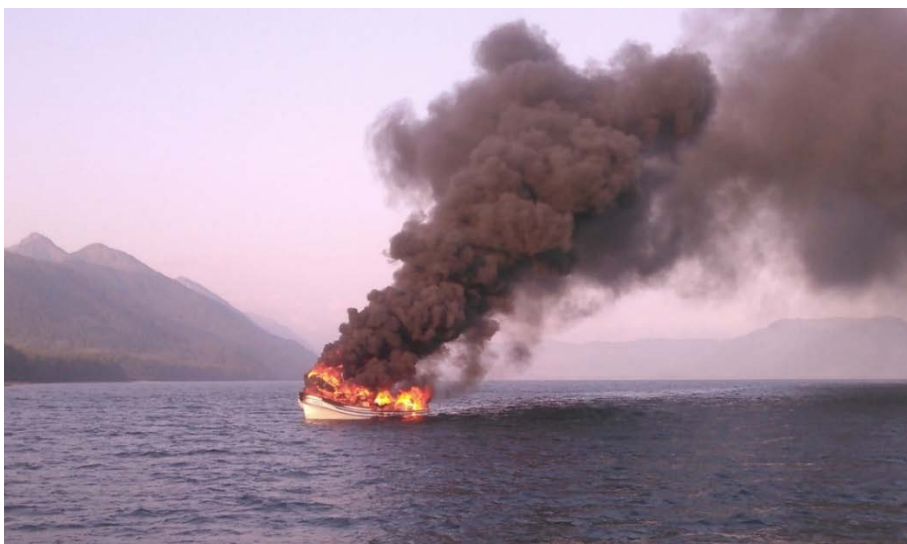
***Ariel* on fire at 1912, prior to sinking in Sheep Bay. (Source: US Coast Guard)**

Nearby fishing vessels that had heard the captain's distress call began arriving at the location of the accident and picked up the crew in the skiff. The *Ariel* continued to burn for several hours and sank at 2335 in 275 feet of water.

Based on crewmember accounts, the Halon fixed fire-extinguishing system on the *Ariel* activated and appeared to reduce the fire, but the fire rekindled and eventually consumed the vessel. To work effectively, fixed fire-extinguishing systems require a minimum concentration of firefighting agent to either halt the chemical reaction producing the fire, displace oxygen feeding the fire, or effect a combination of both. The fixed-open louvers on the inlets to the *Ariel*'s engine room ventilation ducts prevented the space from being sealed off, and thus the discharged Halon was allowed to escape, and new air was introduced to the fire. The engineer's attempt to seal off the ventilation inlet louvers using available materials was commendable but likely too late to prevent the spread of the fire.

Fixed fire-extinguishing systems in engineering and other hazardous spaces require a minimum concentration of extinguishing agent to either halt the chemical reaction producing the fire, displace the oxygen feeding the fire, or effect a combination of both. To ensure the effectiveness of the system and prevent the reintroduction of oxygen to the space, ventilation inlets should be designed or modified to be closed remotely or covered.
