The capsizing of fishing vessel *Anna-Marie II* (WK 875) Brora, East Scotland resulting in one fatality 23 September 2019

SUMMARY

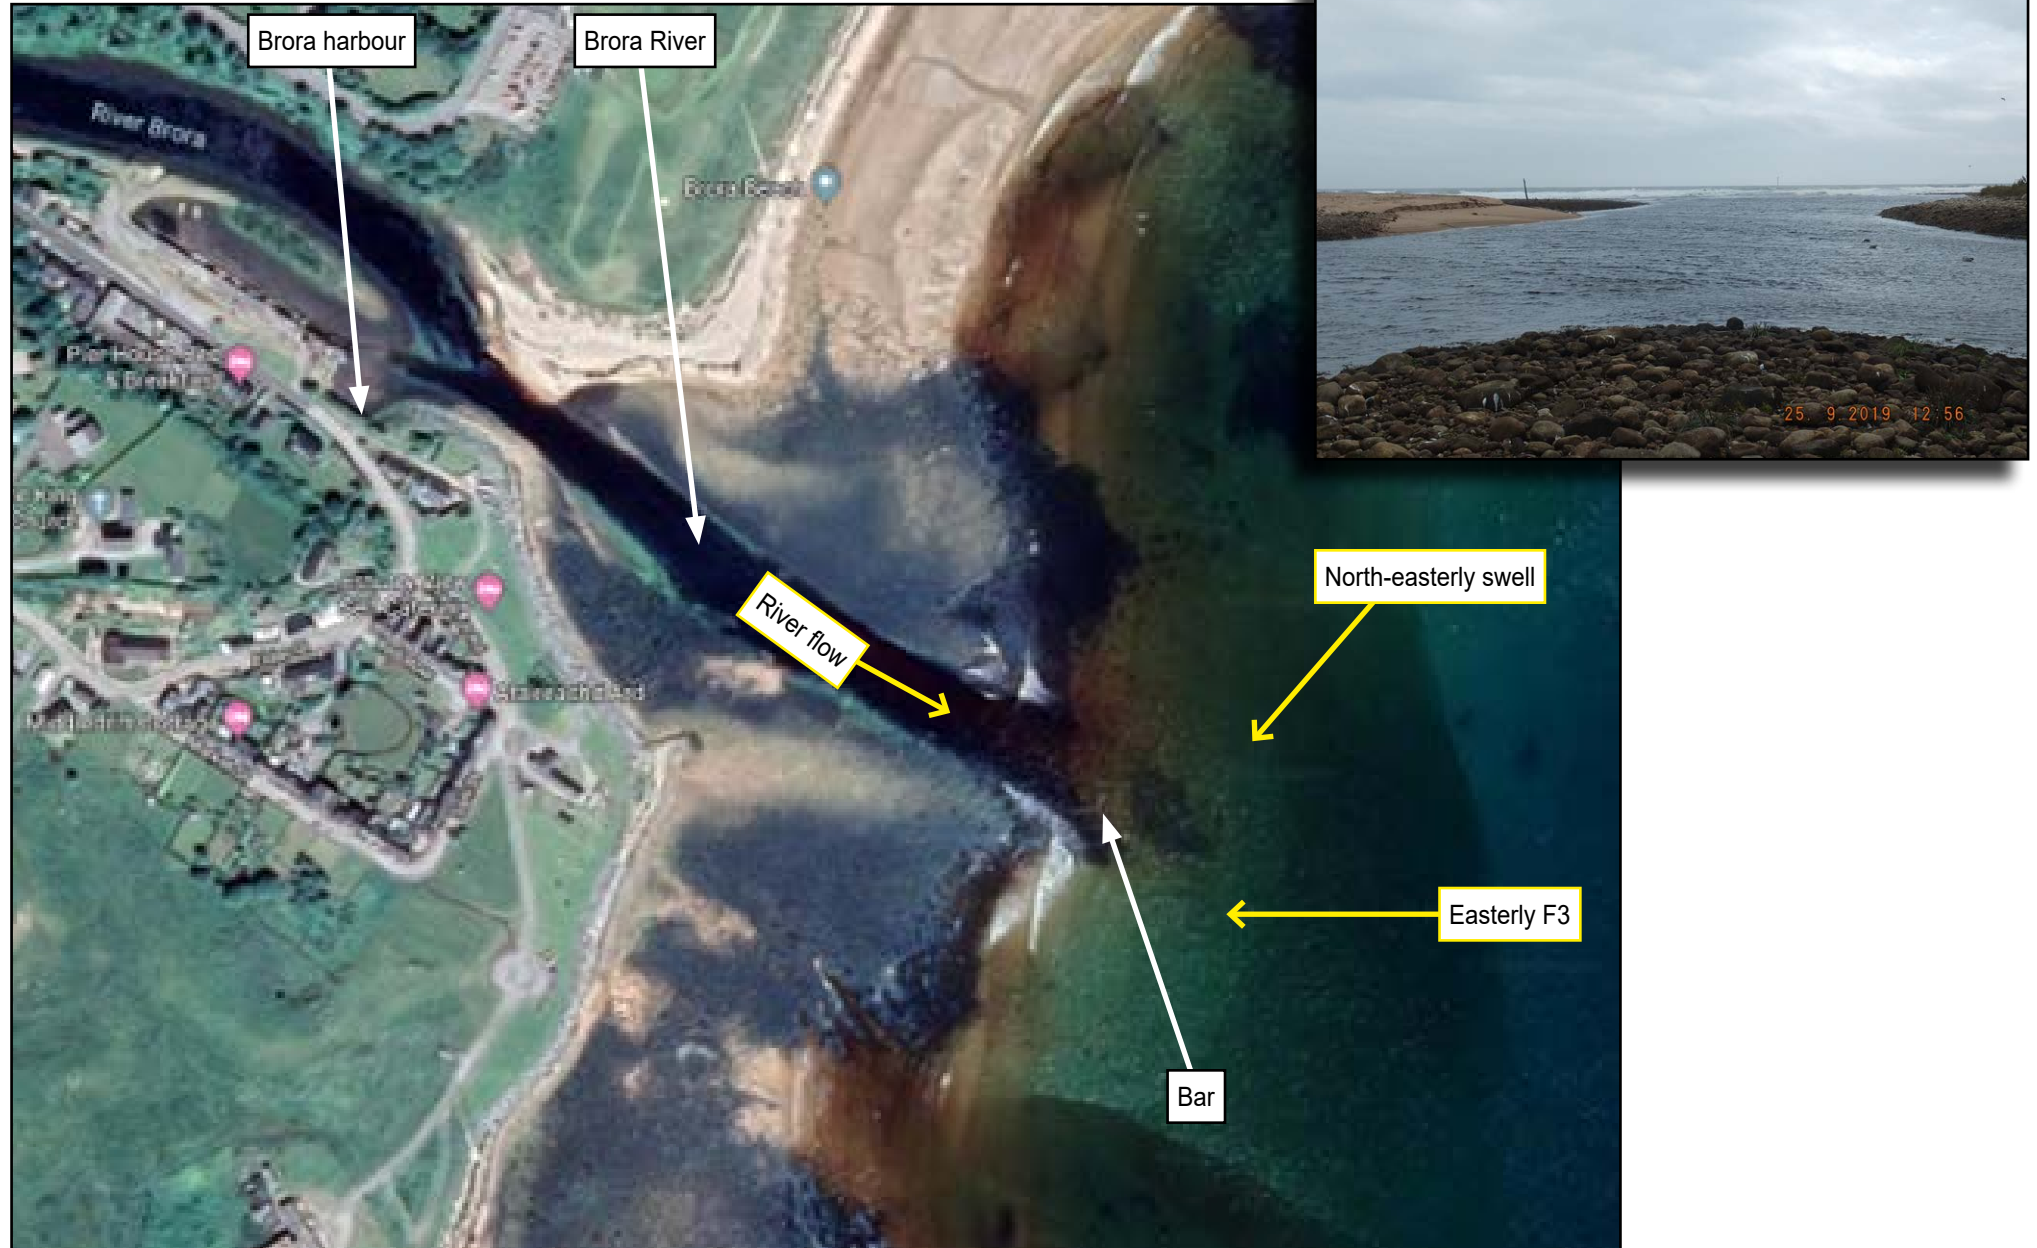
The skipper steered *Anna-Marie II* westward towards the Brora river entrance (**Figure 2**) and waited for three sets of waves to pass before starting his run into the river in the following seas. At this time the crewman was looking to the rear of the vessel from just outside the wheelhouse. Once they were committed to entering the river, an unexpected large wave caught *Anna-Marie II* from astern, causing the vessel to broach; turning it to starboard and heeling it to port, beam on to the waves. A second wave then hit the vessel, rolling it further to port, causing it to capsize and invert (**Figure 3**). The crewman was initially trapped under the hull, but after 10 to 15 seconds he was able to free himself. When he surfaced he could not see his father in the water so decided to head for shore.

Figure 2: Satellite image of Brora river entrance (inset: looking from Brora harbour towards the river entrance)

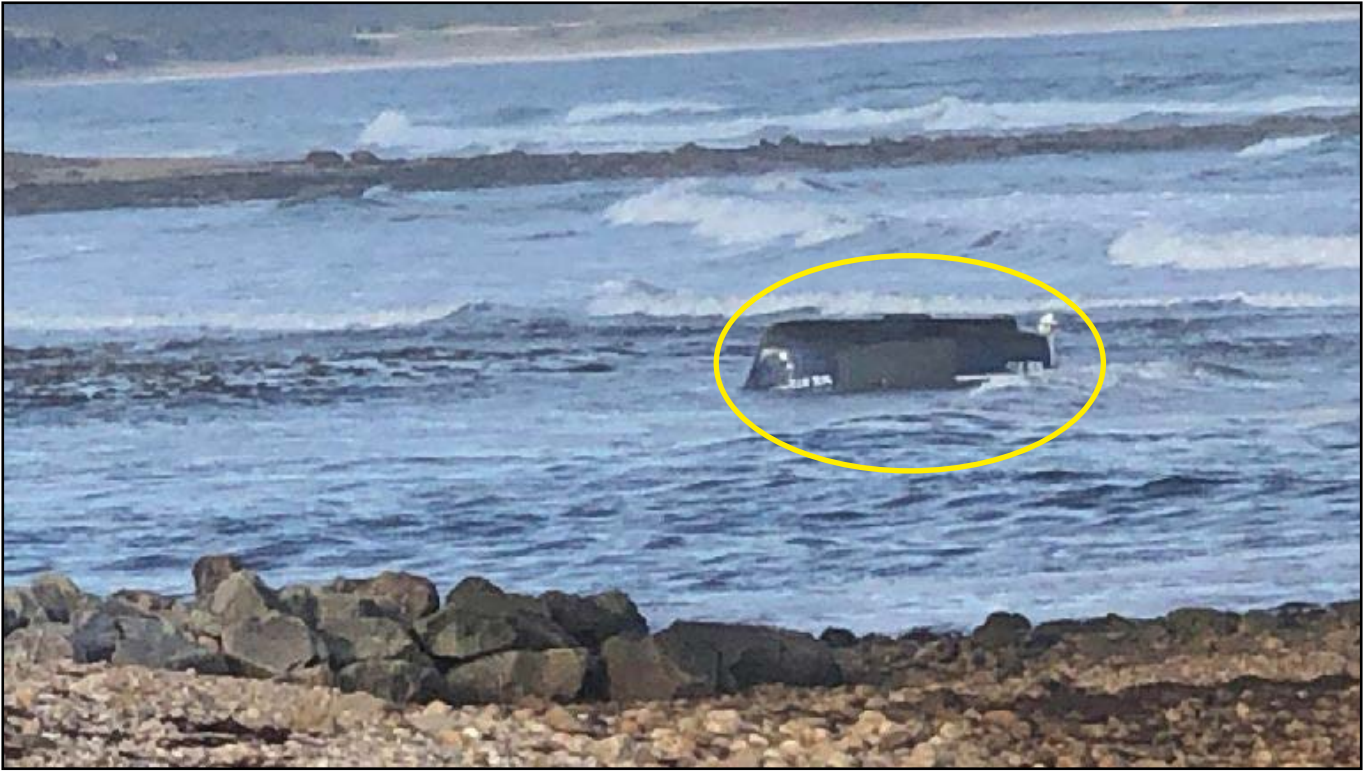
Figure 3: *Anna-Marie II's* upturned hull

- *Anna-Marie II* capsized and inverted because the size and steepness of the waves encountered were too great and the vessel had insufficient stability to resist the heeling moment.

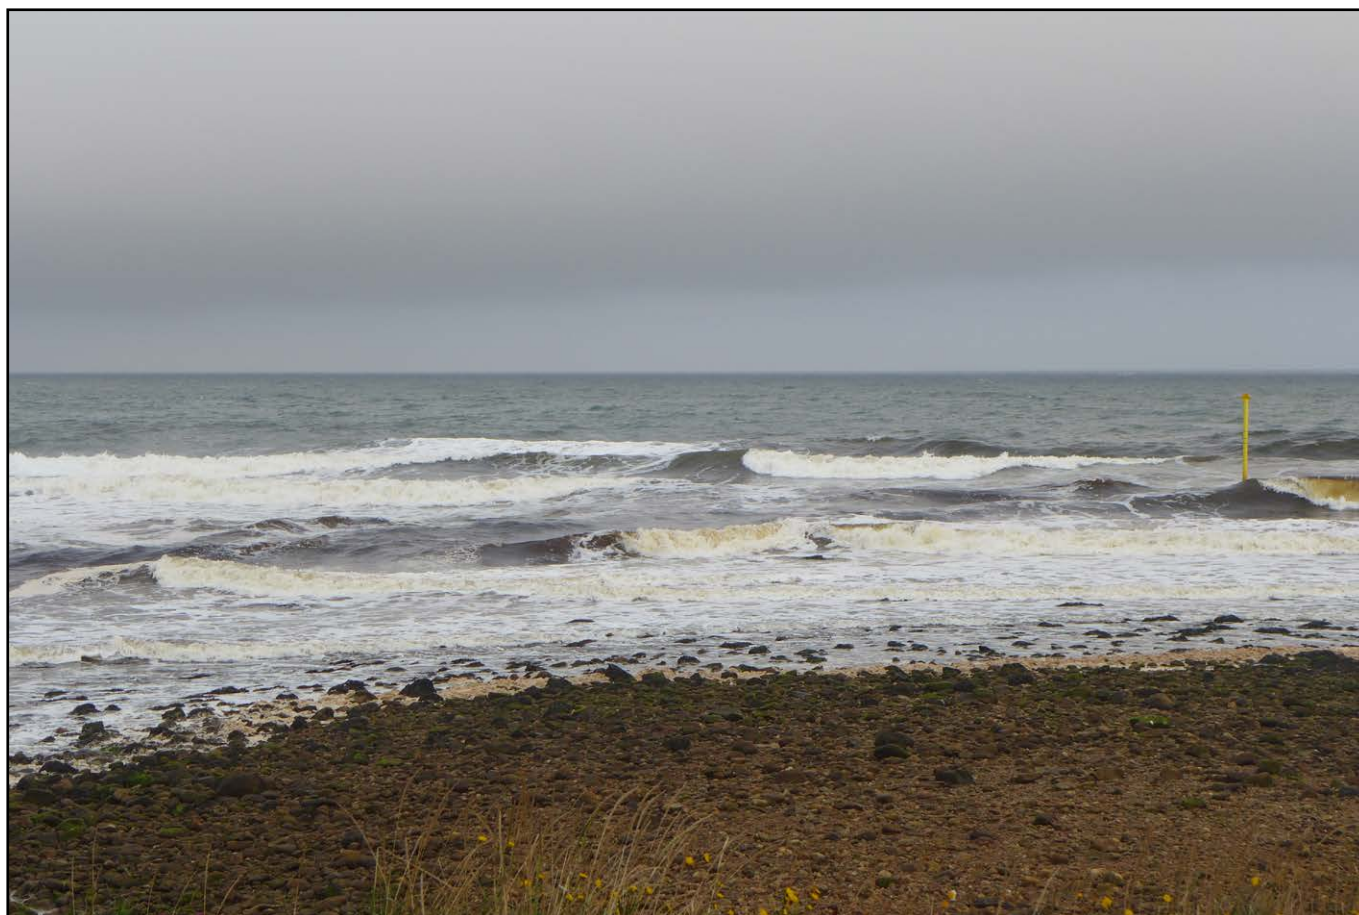
The bar⁵ at the entrance to the Brora river is known to generate waves (**Figure 6**). These are most significant at low water, when the bar can only be crossed by vessels with a very shallow draught. As occurred on the day of the accident, the local fishermen kept in touch by VHF radio and would often discuss the sea conditions. If already at sea and conditions at Brora were judged too bad to attempt entering the harbour, the local fishermen would typically divert to alternative harbours at Helmsdale (about 6.5nm from Brora) or Portmahomack (about 8nm from Brora).

Figure 6: Waves over the bar at Brora river entrance

⁵ A bar is a raised area of the seabed that can occur at the entrances to rivers, causing rough conditions as waves from sea increase in size in the shallower water at the same time as meeting the outward flow of the river.
