INFORMATION SERVICE BULLETIN

Volume 21/Number 2 September 1999
Page 1 of 2

SIDEWALL INDENTATIONS IN RADIAL TIRES

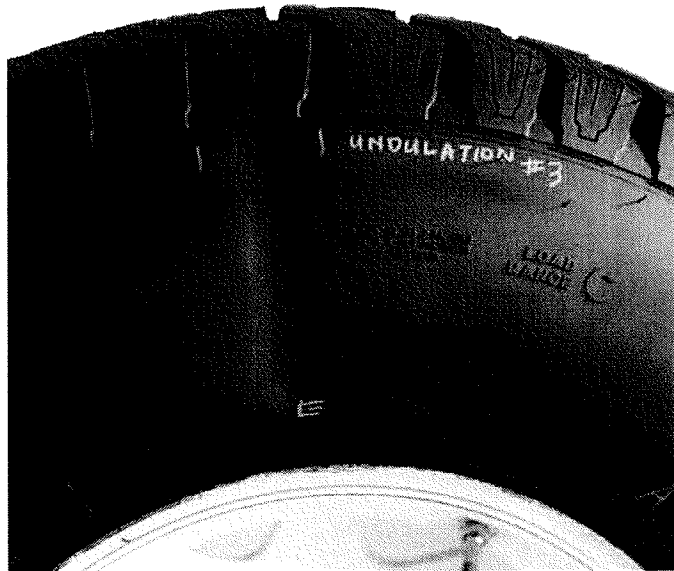
The condition, sometimes referred to as sidewall undulations, is a common characteristic of radial tire construction (see photo). These indentations are more noticeable in larger/wider radial-ply tire sizes and become more visible with higher inflation pressures.

In a radial tire the body ply cords run straight across the tire from bead to bead. Because of the "straight across" constructions, the joining of the ply material creates a narrow overlap of ply cords in the radial direction at each junction. These overlapped ply cords slightly restrict the natural expansion of the sidewall when inflated. This results in an indentation. Since all radial tires contain belts, which restrict the tread and keep it flat, only the sidewalls are indented.

Sidewall indentations are purely a visual characteristic and will not affect the performance of the tire. If bulges, rather than indentations, appear on the sidewall or if there is any question concerning the sidewall appearance, the tire should be removed from service. A knowledgeable tire dealer or the manufacturer's representative should be contacted.
