AIRCRAFT ACCIDENT REPORT

**WESTERN HELICOPTERS, INC.,
BELL UH-1B, N87701
VALENCIA, CALIFORNIA
JULY 23, 1982**

NTSB/AAR-84/14

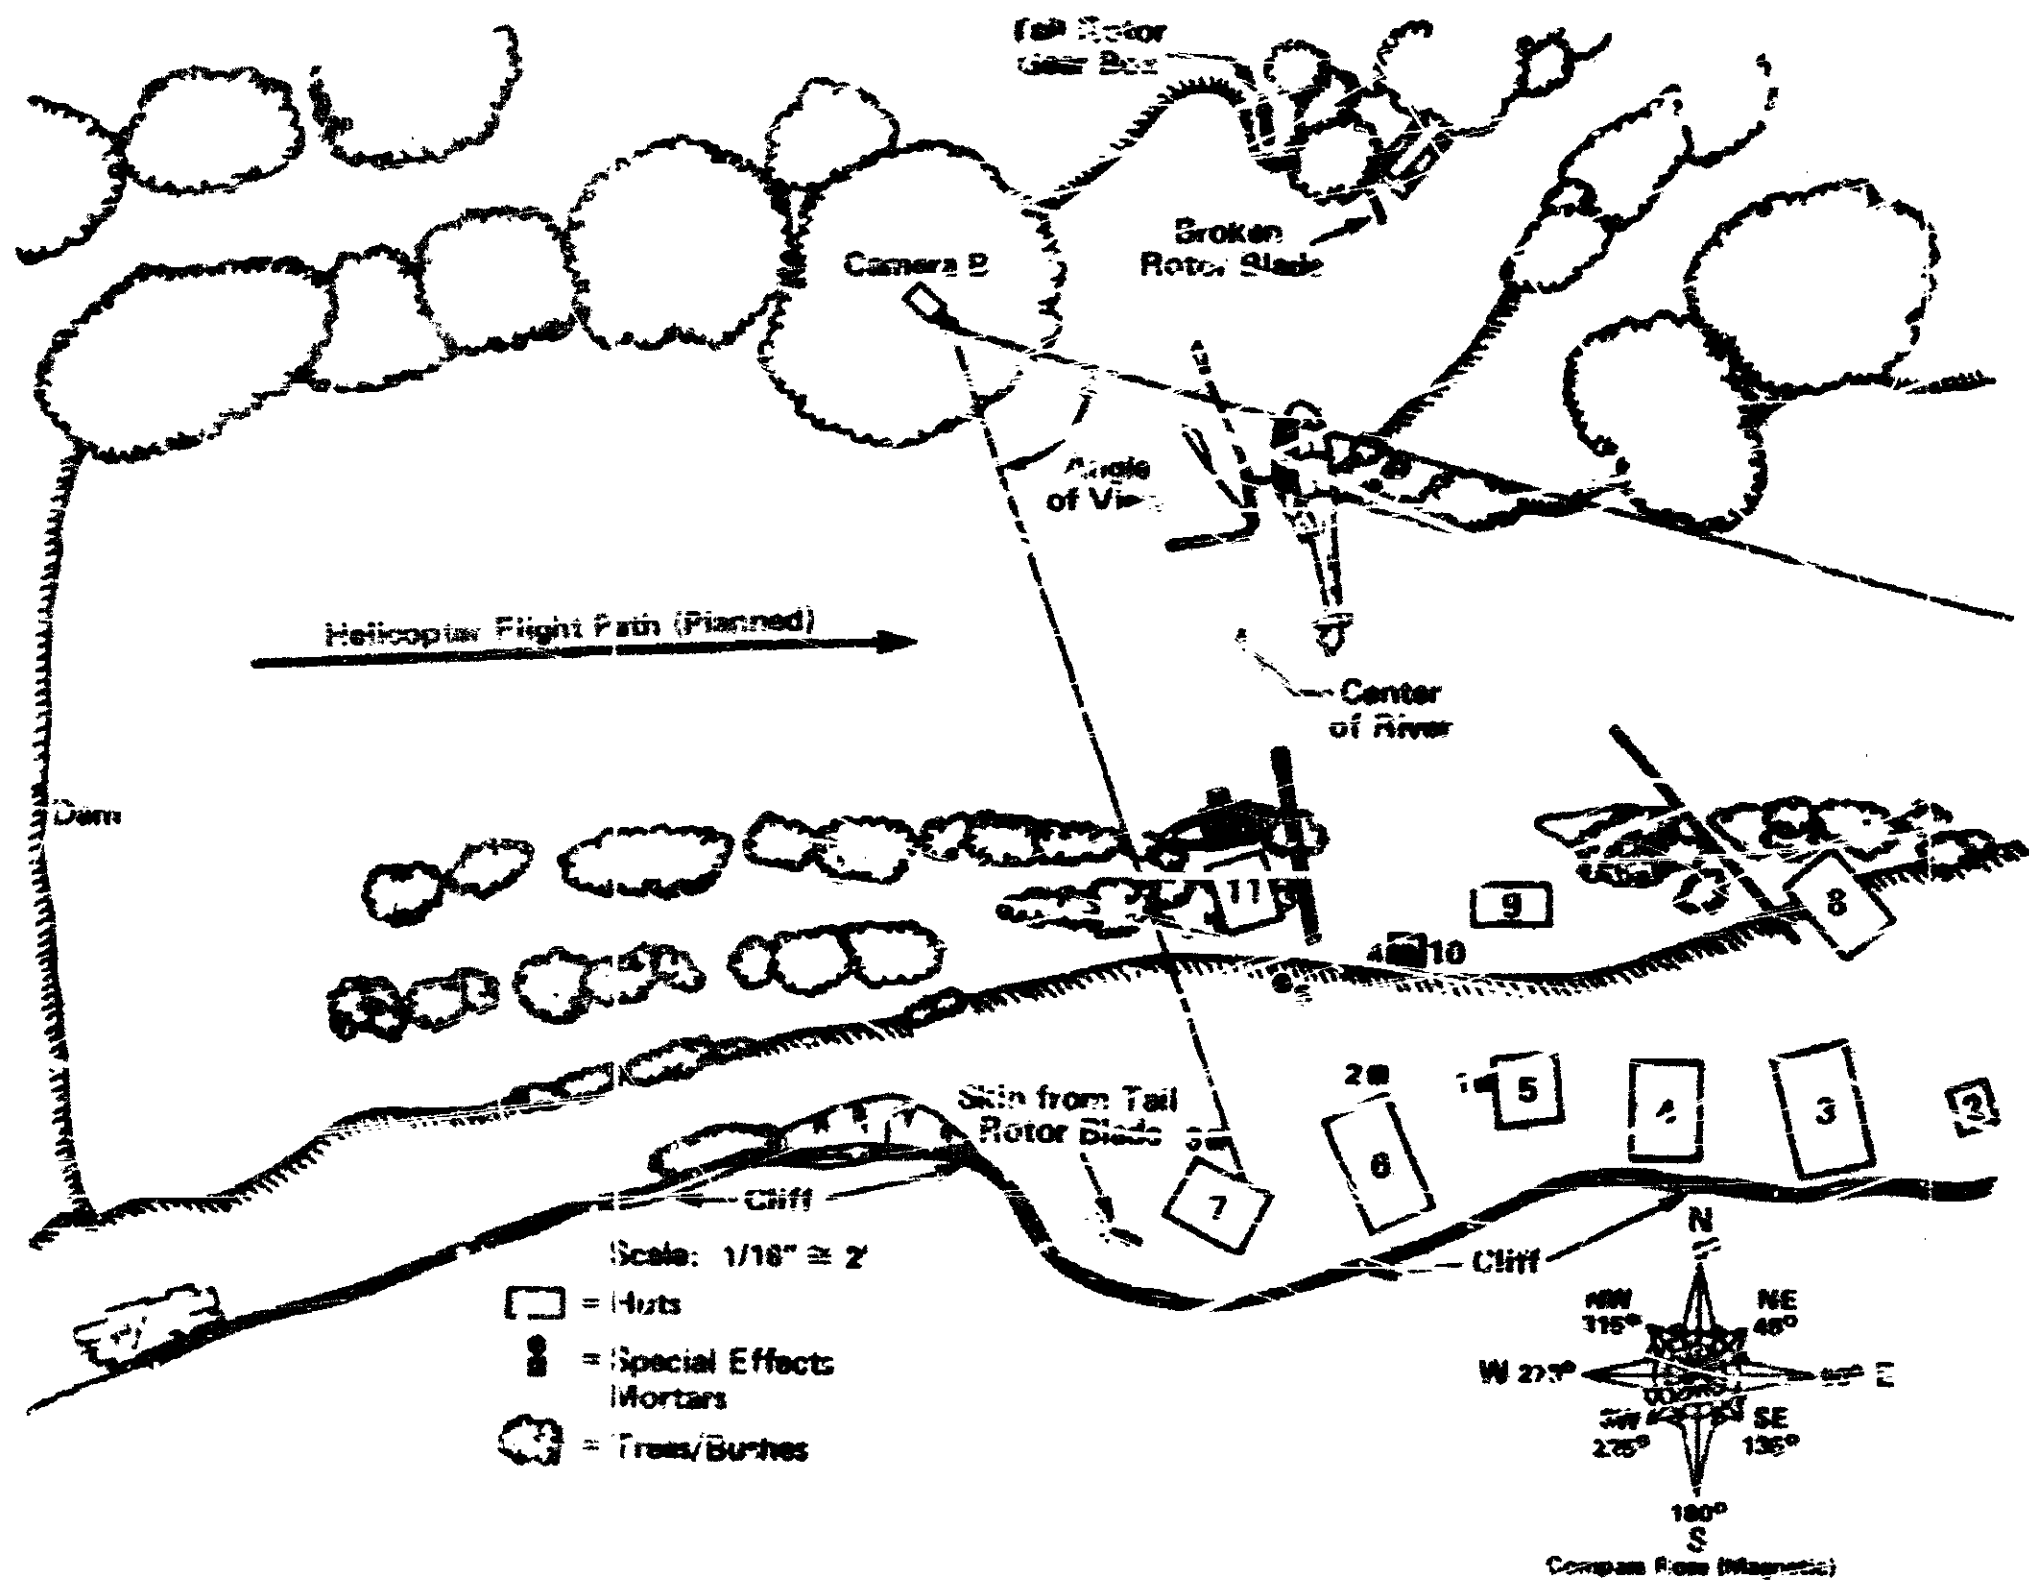
Figure 1.—Accident site.

The helicopter came to rest on its left side on a magnetic heading of 345°. The helicopter's structure, flight controls, and rotating assemblies, except the tail rotor assembly, remained intact. The main rotor mast assembly, including the main rotor blades and their associated components, were heavily damaged as a result of impact. Damage to the main rotor blades was consistent with the damage which would be expected if the blades were rotating at impact. The preimpact integrity of the main rotor flight control system was established; all of the damage to the main rotor flight control system was determined to be the result of impact. There was no evidence of any pre-existing malfunction or failure.

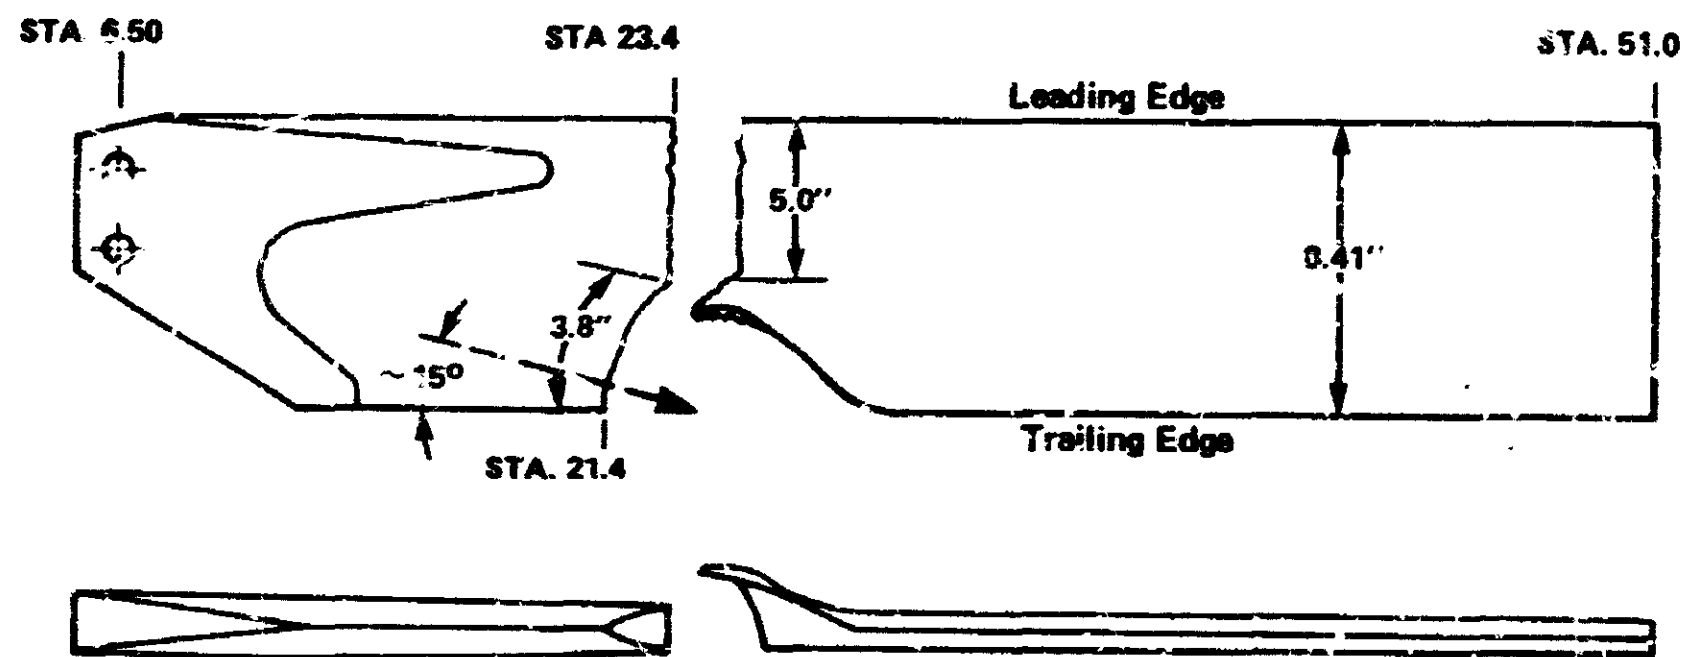
Figure 2.—Blade damage.

The tail rotor 90° gearbox, with one intact blade and the butt portion of the other blade attached to the hub assembly, was found about 41 feet north of the main wreckage. Tail rotor blade, serial No. A3-84197, had separated 18 1/4 inches outboard of its butt end. The outboard portion of the blade was found about 21 feet southwest of the tail rotor 90° gearbox. The broken tail rotor blade exhibited a semicircular indentation about 3 1/2 inches deep on its trailing edge; the indentation spanned the fracture line in the blade. (See figure 2.) The left side of the blade had two rectangular punctures just aft of its leading edge. Foreign particles were found on both fracture surfaces of the blade. Tail rotor blade serial No. A3-84104 remained attached to the hub assembly. About 33 1/4 inches of the blade skin was missing; the skin was found behind hut No. 7. (See figure 1.) Visual examination of the skin disclosed extensive curling at the butt end and extensive heat damage. Also, particles of a rubbery substance with wood embedded were found on the right side of the skin.

A foreign object impacted the tail rotor blade trailing edge approximately 18.25 to 22.3 inches (463.55 - 566.42 mm) from the butt end. The impact of the foreign object deformed the aft 4 inches of the tail rotor blade trailing edge at station 25. This deformation created an out-of-track condition of the tail rotor blade that may have resulted in the separation of the 90° gearbox and blades from the aircraft.

The separated portion of one tail rotor blade was found 21 feet away from the tail rotor gearbox to which the blade hub with the mating fracture surface was still attached. A matching semicircular indentation existed on the trailing edges of both portions of the fractured tail rotor blade. The matching indentations are conclusive evidence that the blade was struck by an object before the blade fractured, and that the fracture may have been precipitated by the damage inflicted by the object or by vibrational forces caused by the resulting imbalance in the tail rotor system.
