APPLICATION OF THE TRIPOD METHOD FOR HUMAN FACTOR ANALYSIS ON THE EXAMPLE OF M/F JAN HEWELIUSZ CAPSIZING

Zbigniew Szozda, Maritime University of Szczecin; Poland; szozda@am.szczecin.pl

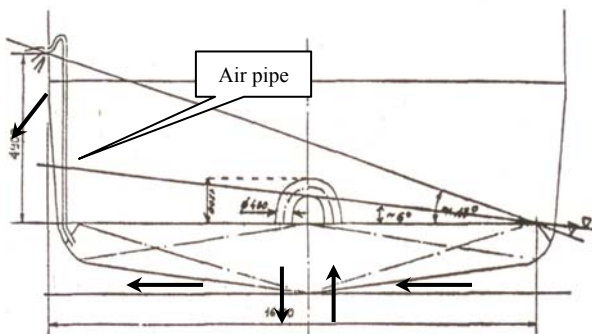
- A. Events which took place long time before the capsizing but had strong impact on the disaster:
 1. The inclining test (in the shipyard) was performed not reliable.
 2. Faulty construction of 3 DB BT allowing the ballast water to outflow the ship. When the ship was heeled more than 17 degrees the water run gravitationally from the upper tank

through the pipe, lower tank and the air pipe out the ship. It was not possible to control this outflow. This construction is shown in the figure 2 and is recognised as a latent failure.

Figure 2. Construction of No 3 Double Bottom Ballast Tanks. The latent failure.

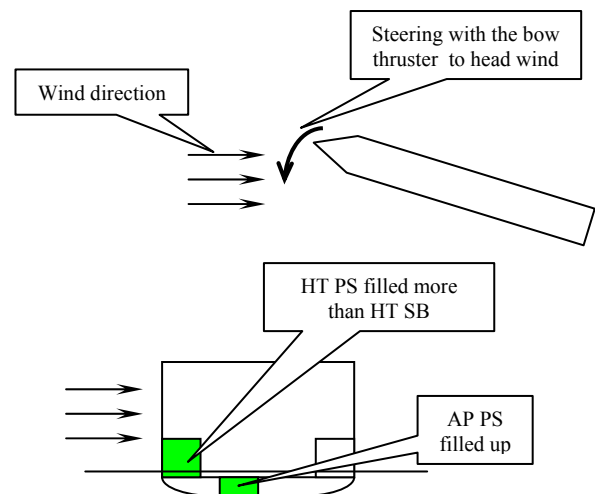
The change of the ship course and its effect on the angle of heel is shown in figures 3 and 4. Unintended change of the course could be a result of lower wind speed at the moment when the crew steered the ship to the head wind.

Figure 3. The situation before changing the course. The angle of the heel ~ 0 degrees.

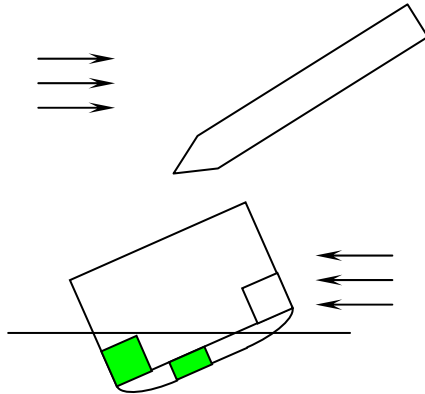
11. Low speed of the ship.
12. Unintended change of the ship course in relation to wind direction.
13. The change of the ship course in relation to the wind direction with low speed in unsymmetrical loading condition resulted with the angle of heel about 30 degrees. It was impossible to change the course by bow (barrier No 5). There was no attempt at change the course by aft. The angle of heel caused increasing unsymmetrical mass distribution in 3 DB BT (ballast water outflow) and 10 HT (shift of the water). It was possible cargo shift to Port Side caused by increasing angle of heel. The crack in the aft door could cause flooding of the train deck (bulkhead deck) including the ladder way to the engine room. All mentioned events caused increase of the angle of heel and finally capsizing of the ship in quasi static way in about half an hour from changing the course.

It is recognised that after occurrence of this event the process leading to capsize was not possible to be stopped by the crew using the measures available on board in these conditions.

Figure 4. The situation after changing the course. The angle of the heel ~ 30 degrees.

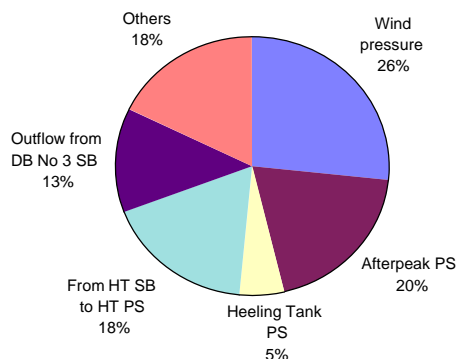
Percentage of heeling moments capsizing the ship is shown in the figure 5. It is clear that measured wind (mean speed 59 knots) could not capsize the ship with calculated stability characteristics.

Figure 5. Percentage of heeling moments capsizing the ship.

- 100 % in the figure 5 means a static external heeling moment necessary to capsize the ship.
- “Afterpeak PS and Heeling Tank PS” are the result of the event number 10.
- “Outflow from DB No 3 SB” and “From HT SB to HT PS” are the result of events number 2 and 3.
- “Others” might contain such events like shifting of the cargo to PS or flooding of the main deck. It is not possible to calculate these values separately.

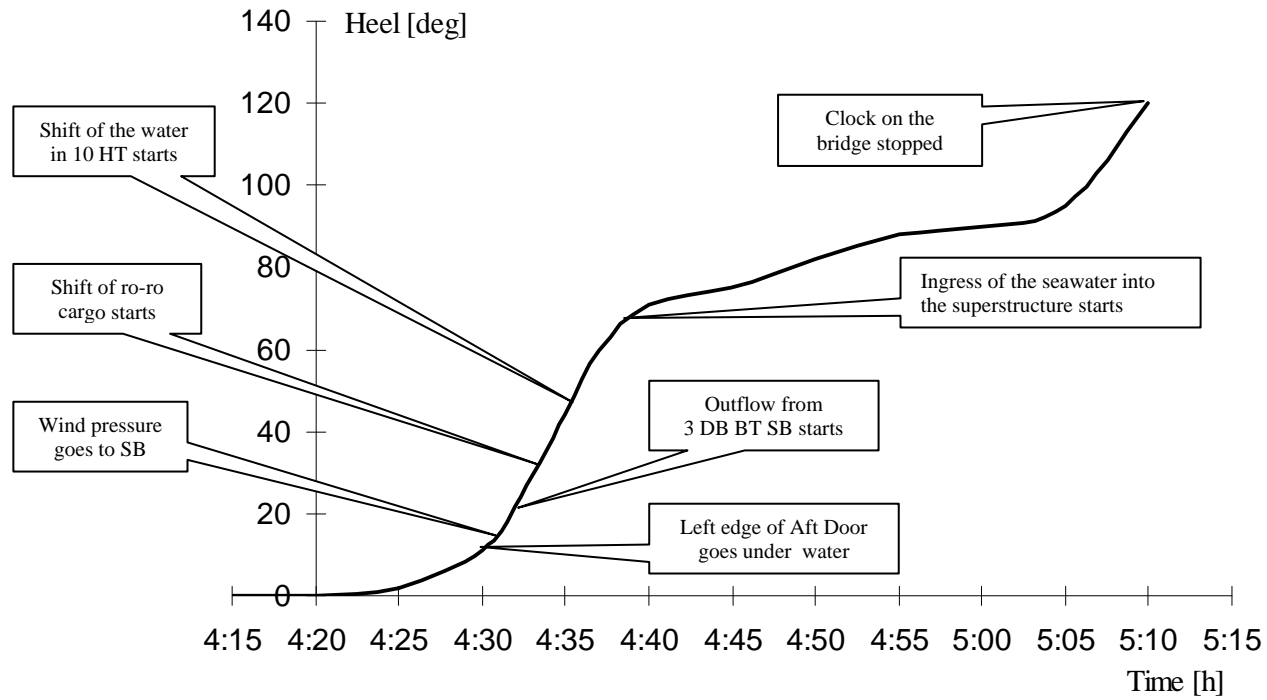
Figure 6 shows increasing heel (quasi static) versus time and successive events causing increase of the heel when activated.

Figure 6. Quasi static heel of the ship versus time

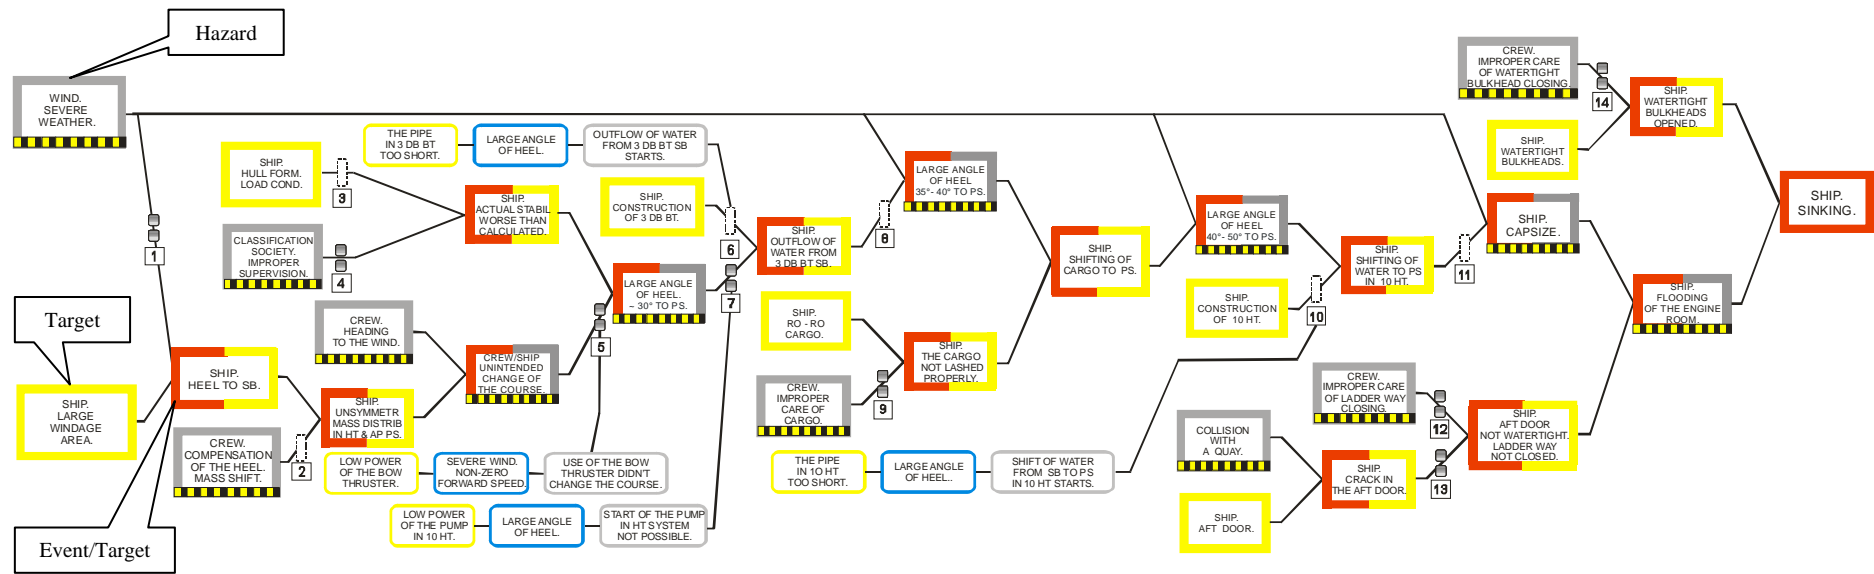
The diagram containing a number of triple blocks (Hazard, Target and Event) identified during the investigation of the capsizing is shown in the figure 7. This figure exemplifies the TRIPOD path of this accident and present in the form of “trios” the most possible capsizing scenario. The examination of the scenario identified a number of different barriers which should stop the sequence of events leading to capsizing of the ship provided the design and operation were free of human errors. The Table 1 contains 14 breached barriers: 8 existing and 6 missing. The nature of all barriers is classified as human factor. The barriers are divided into 3 groups: lack of regulations, design and operation.

Figure 7. TRIPOD path of m/f Jan Heweliusz capsizing.
