1. Tanks damaged due to vacuumPages 1- 2

1. Tanks damaged due to vacuum**Case 1**

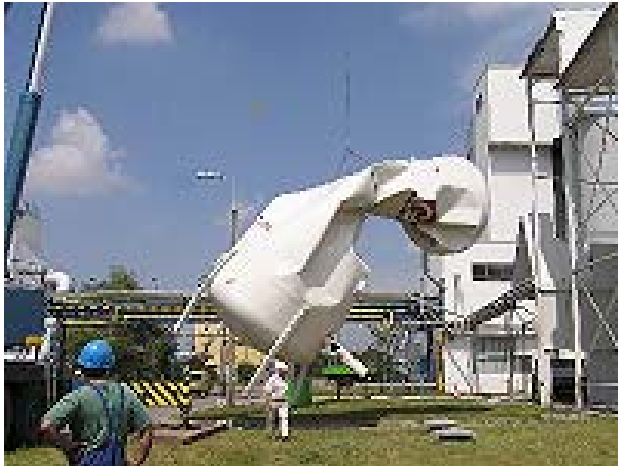
**Picture no1**

An oxygen buffer vessel was connected between the oxygen PSA plant (pressure swing adsorption) and the inlet of the oxygen compressor. The production capacity of the plant decreased but the compressor continued to run causing a vacuum in the tank and consequently the tank was destroyed.

The tank was designed for a min. pressure of 900 mbar(a). The installation was equipped with the following safety devices to prevent vacuum in the tank or to protect it from damage:

- The PSA plant had high and low outlet pressure switches and the vessel had a low pressure switch. These switches were connected to the same PLC (programmable logic controller) and on activation should stop the compressor. The PLC failed at the accident.

- The compressor had a low pressure switch on the inlet. The set minimum pressure was based on the protection of the compressor and was 0.15 bar(a) – much lower than the allowed minimum pressure in the vessel.
- The vessel had a bursting disc to protect against vacuum but the design bursting pressure of the disc was lower than the minimum allowed pressure of the tank.

- Safety instrumented functions should be hard wired. If this is not feasible and PLC is used, the failure of the PLC shall be considered at the design risk assessment.
- During commissioning of a plant all safety critical functions (such as the bursting disc) should be checked for compliance with design specifications.
- The risk of tank implosion will be eliminated if the tank was designed for the pressure of 0 bar(a).

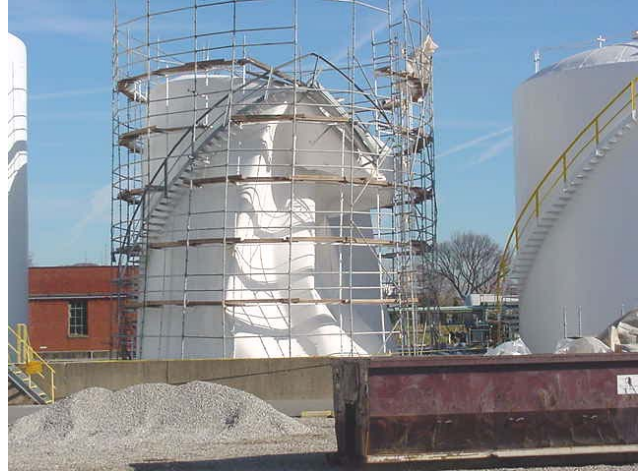
Picture no.2

A storage tank was going to be painted and therefore painting preparation included a scaffolding elevation as well as a protection with plastic covers of some parts of the tank, including the vent valve. The painters forgot to remove the plastic bag on the vent valve after painting. When liquid was withdrawn from the tank, the plastic cover was sucked into the vent pipe blocking the air flow and causing a vacuum in the tank. The tank then collapsed as can be seen on picture no. 2.

For some, it is hard to believe that the plastic over the vent pipe is stronger than the steel tank under the vacuum conditions that are created when withdrawing product out of the tank. Seeing is believing!

- Covering the vent pipe during tank painting is standard practice; leaving it covered when withdrawing product from the tank is not.
- This is an expensive, embarrassing mistake that is entirely preventable by adherence to good procedures and good communications between operations and maintenance.
- This sort of event nearly always results in total destruction of the tank. It is generally not cost effective to repair tanks with damage of this extent.
