Extract from The United Kingdom Merchant Shipping (Accident Reporting and Investigation) Regulations 2012 – Regulation 5:

© Crown copyright, 2018

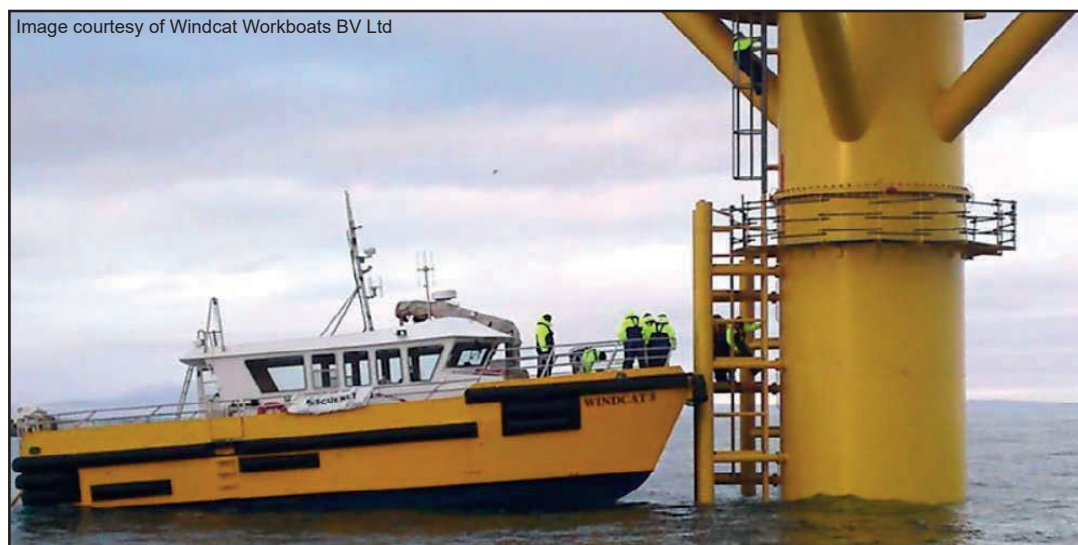
A recommendation has been made to *Windcat 8*'s owner, Windcat Workboats BV Ltd, which is aimed at improving its crews' reactions to engine alarms and engine space fires.

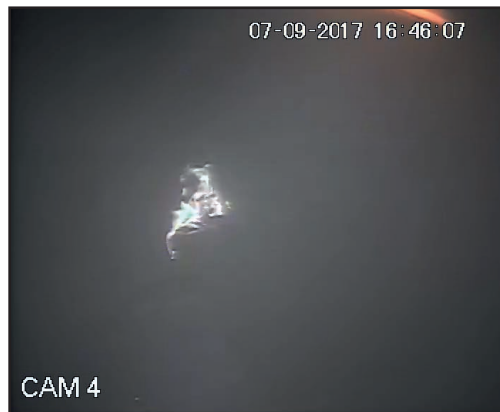
Figure 5a: Fire on engine top

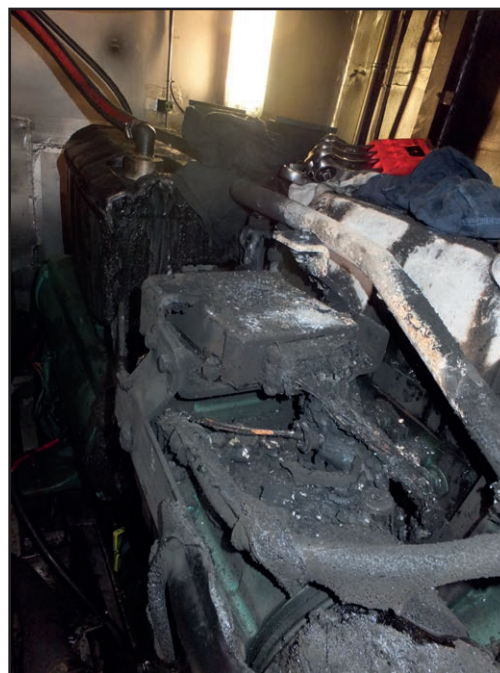
Figure 5b: Fire damage to port engine

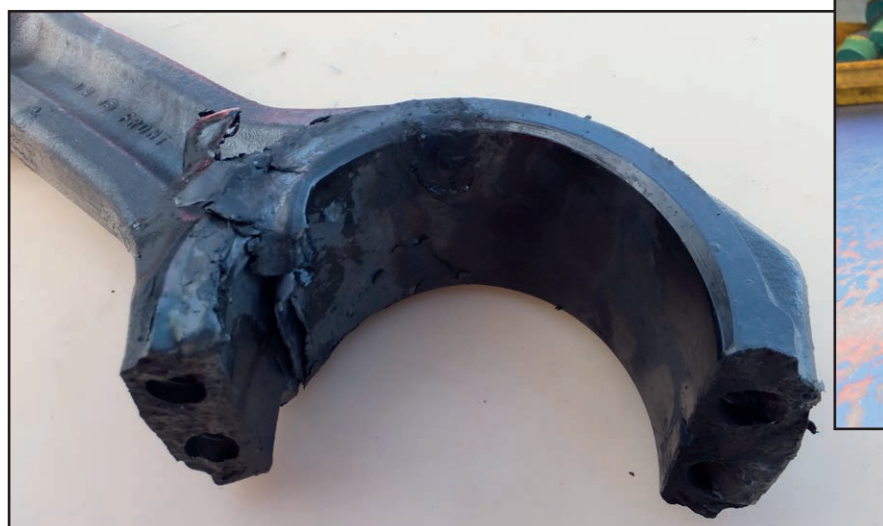
Figure 6: Heat damage to No.6 piston connecting rod

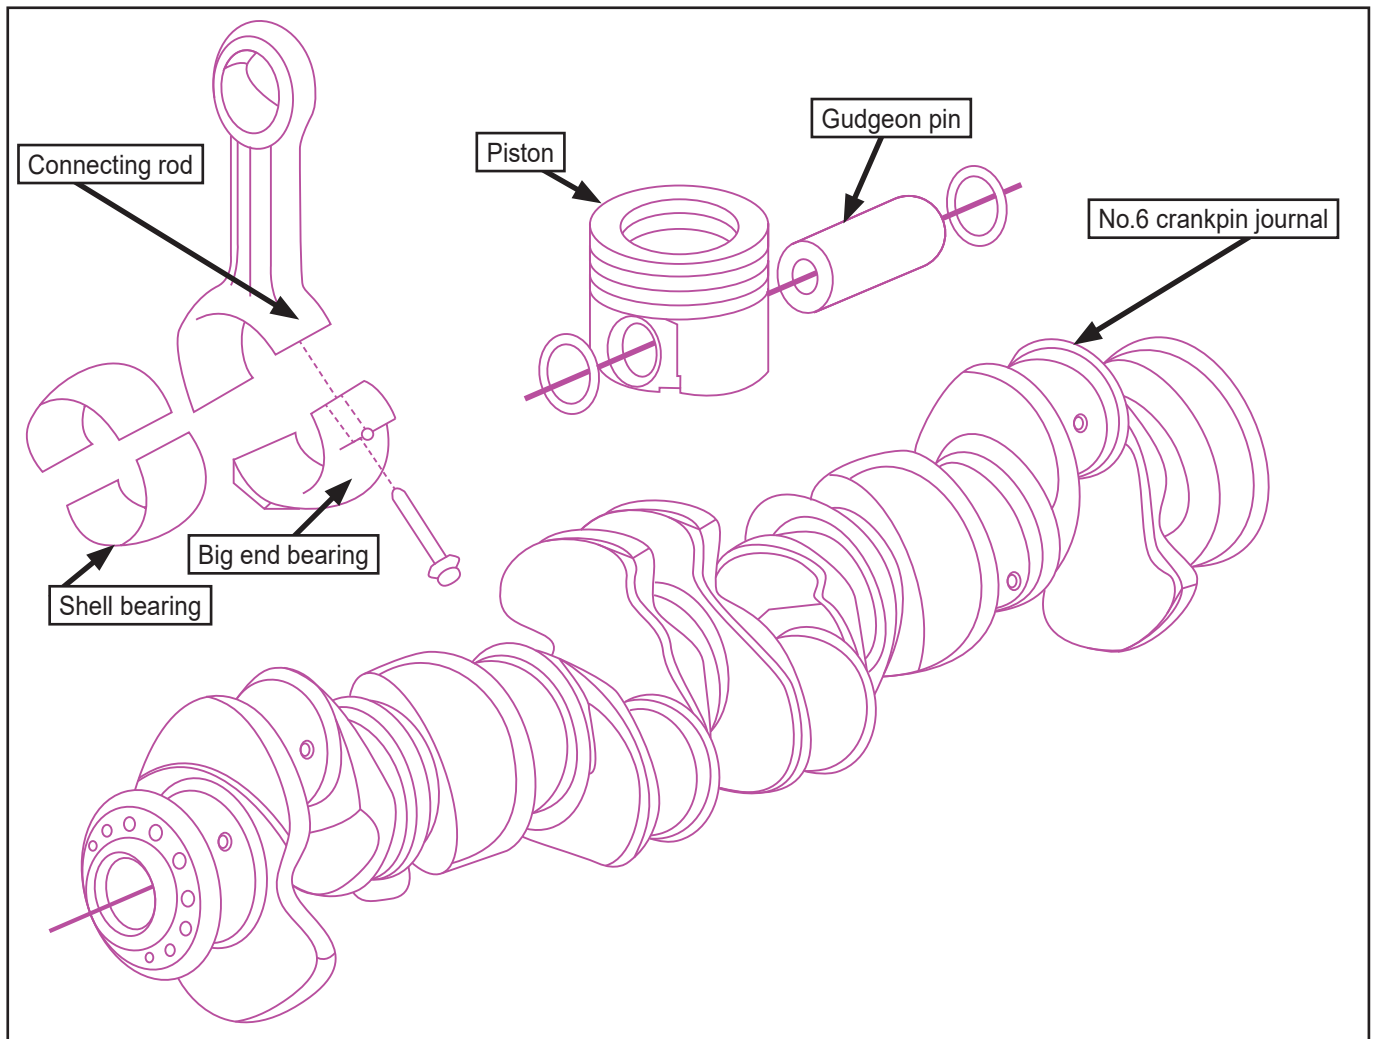
Figure 7: Schematic of crankshaft assembly
