Distributed Fiber Optic Sensing for Deep Foundation and Soil Vertical Strain Monitoring

Yeskoo, Richard Andrew

Doctor of Philosophy

University of California, Berkeley

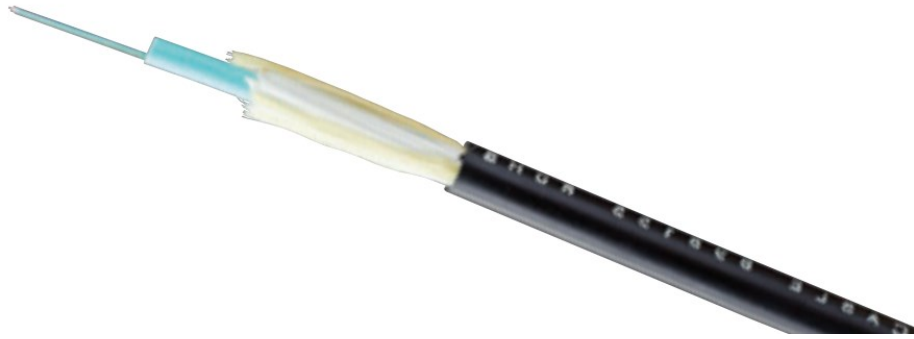
Figure 3-2: Photo of Belden 8 mm thermal cable (photo credit: Belden Optical Fiber Catalog)

The cable is a non-armored, loose tube cable with four single mode fibers in a gel-filled tube. The tube is then wrapped in a fiberglass yarn and coated with a polyethylene jacket. The gel provides a physical strain break in the cable design, preventing externally applied strains on the outer jacket from being transferred to the optical cables within. Although each cable contains four fibers, only one fiber was utilized in the temperature monitoring. The main functional parameters of the cable are listed in Table 3-1.

The distributed temperate cable chosen for this research is an 8 mm diameter standard outdoor telecommunications cable manufactured by Belden, part number FSSC002N0. A schematic cross section of the cable is shown in Figure 3-1 and a photo of the cable is shown in Figure 3-2.

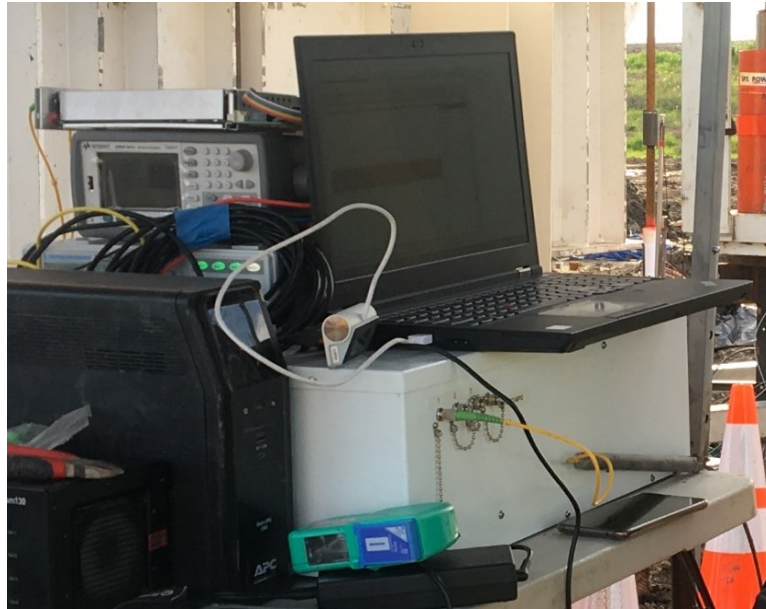
Figure 3-8: ALICIA fiber optic analyzer during load test

The ALICIA fiber optic analyzer (see Figure 3-8) is a research-based analyzer, first developed in Professor Kenichi Soga’s research group at the University of Cambridge in 2015. It is a single ended system; only connecting to one end of the sensing fiber optic installation. While the system approach relies on the same Brillouin scattering based distributed sensing as the Omnisens analyzer, most closely mimicking it in BOTDR mode, the unique ALICIA system architecture uses digital methods for signal processing rather than the analog frequency sweeping method of the Omnisens analyzer. This results in much faster data acquisition speed, with readings taken in 1-2 seconds as opposed to 5 minutes. The system has an effective spatial resolution of 1 m with a sampling interval of 0.02 m. Being a research-based system, the system

design requires the use of separate components in addition to a control laptop to function, rather than the integrated single box employed by the Omnisens analyzer.

A second generation of the research box was developed and deployed for the levee monitoring project presented in Section 5.2, incorporating several improvements into the original ALICIA design and integrating them into a single box.

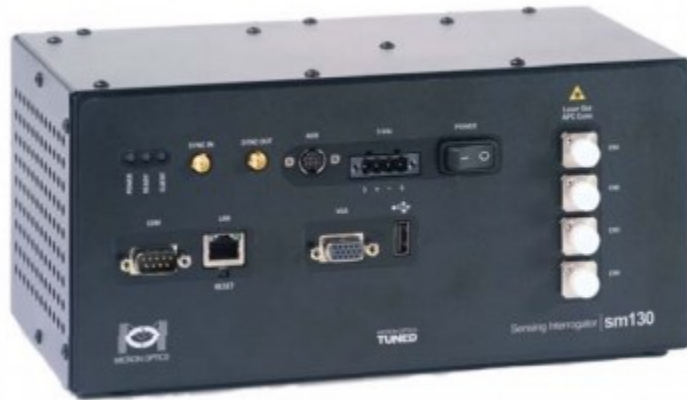
Figure 3-9: Micron Optics SM130 FBG interrogator (photo credit: Micron Optics)

The Micron Optics SM130 (Figure 3-9) is an FBG optical interrogator, capable of simultaneously reading up to four channels of FBG strands. Each channel is individually calibrated with the manufacturer-provided central frequency for all the FBG sensing nodes in the string. The interrogator then uses these calibration factors to calculate the frequency shift, which is then converted into differential strain. The control software tracks the peak frequency of each grating continuously during monitoring at a maximum scanning frequency of 2 KHz. For this project, data was saved at a 1 second frequency during monitoring. The wavelength accuracy of the analyzer is 1 pm, which for the strain sensitivity of the FBGS cable, corresponds to a strain resolution of 0.8 $\mu\epsilon$.

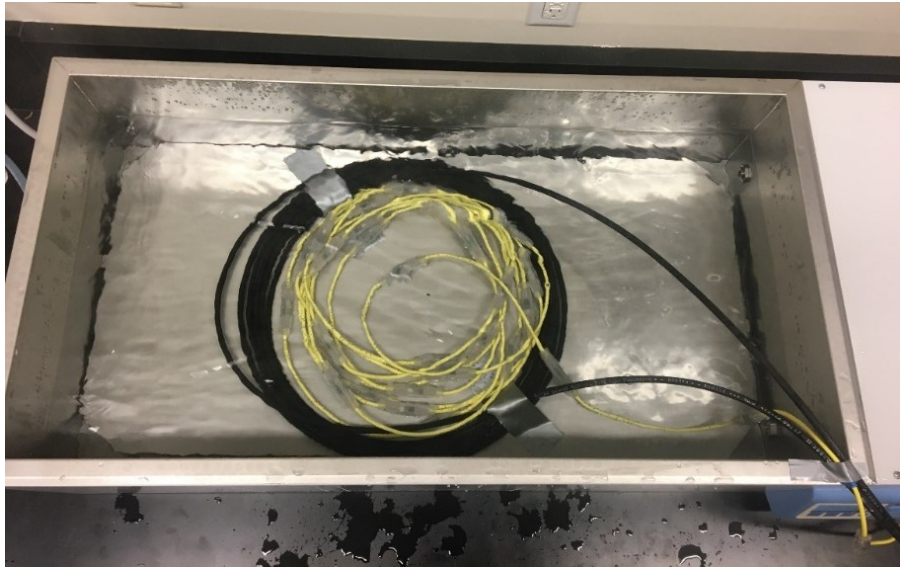
Figure 3-11: Photograph of the cable configuration within the water bath.

Within the water bath, the two cable types were coiled in loops of approximately 10 inches in radius in the center of the bath, as shown in Figure 3-11. The cables were taped to the bottom tray of the bath to prevent flotation and keep the cables fully submerged during the test. A series of baseline readings were taken using the fiber optic analyzer to confirm that no significant bending strain was imparted on the fiber optic thermal cable. The cables exited the water bath at a small cutout in the lid, where they were routed to the respective reading systems, as shown in Figure 3-12.

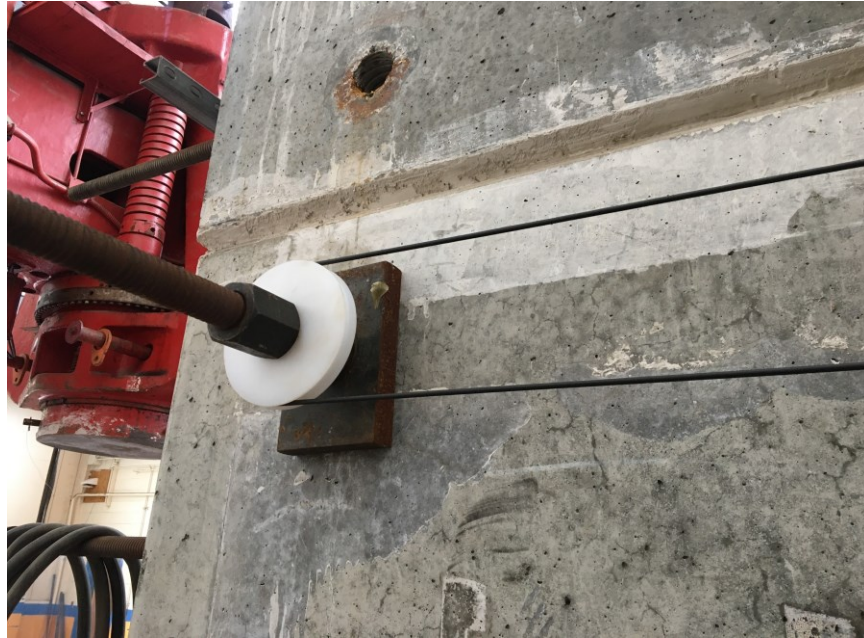
Figure 3-16: Photo of Loop 2 (long loop) pulley mounted on strong wall

The pulleys, as shown in Figure 3-16, were selected to be made of a low friction material to allow the cable to rotate around the pulley axis freely. The pulleys were 6" in diameter; chosen based on the center-to-center clamp spacing as well as ensuring a large enough curvature to prevent the risk of signal loss or breakage in the fiber optic cable during testing. The pulleys had a circular cross-section channel $\sim\frac{1}{4}$ " deep to route the cable within. The pulleys were mounted vertically using a threaded rod in the anchor holes in the first and last blocks of the strong wall. The clamps and pulley heights were selected to have the cable arms as close to horizontal as possible. Nuts were installed on the threaded rod to prevent the pulleys from moving along the bar, although a small gap was left between the nuts and pulleys to allow free rotation of the pulley on the bar.

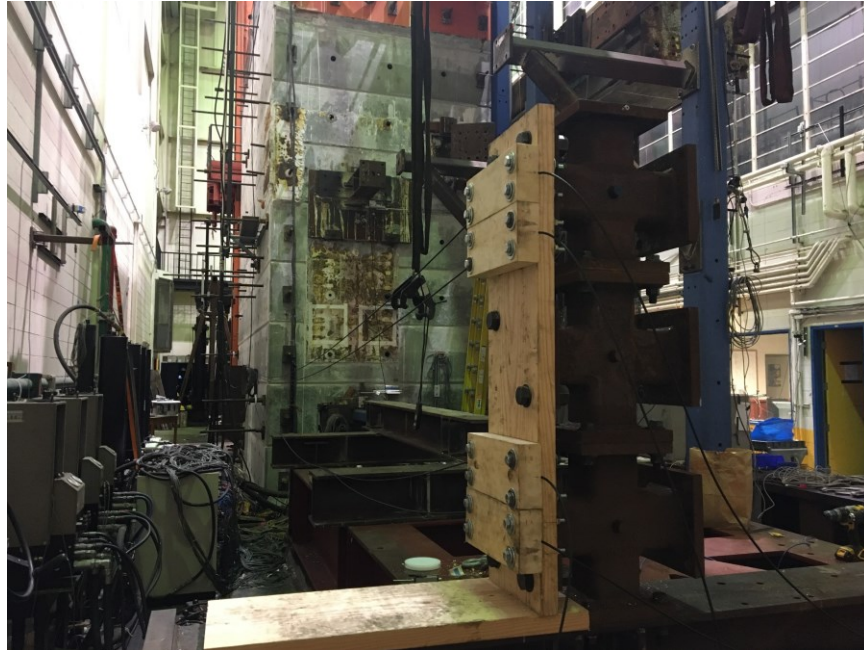
Figure 3-17: Photo of wood clamp setup at far corner of 1D shake table

Each clamping mechanism was made of two separate pieces of wood (see Figure 3-17). The first was a vertical length of 2x12 lumber, connected to a stack of cross steel members that were bolted to a horizontal extension from the shake table. This vertical board provided the clamping face for all four loops. Adhesive discs of 40-grit sandpaper were adhered to the face of the 2x12 along the four cable paths to increase the friction between the wood and the cable. Four 11.25" long wood boards (custom planed lumber 2" x 5") were then bolted to the clamping face of the lumber using 1/2" diameter bolts with fender washers to distribute the clamping load along the board. A triangular channel was cut into the centerline of each board using a table saw with the blade tilted at a 45° angle, then smoothing the lip using a hand plane. Various depths of the channel were tested to maximize the clamping force while avoiding crushing (and potentially damaging) the cable. A final depth of the channel of 3mm (for the 5mm diameter cable) was chosen. The clamping bolts were tightened in an alternating pattern to ensure the clamping force was applied symmetrically. During the tightening of the clamps, the fiber optic cable was pulled taught by hand to remove slack in the system and apply an initial pretension to the cable. The bolts were then tightened to 10 foot-lbs using a torque wrench to ensure an even clamping force between all four boards. Tell-tale marks were made on each cable at the front and rear of the clamp to provide a visual check of any slippage of the cable during the test.

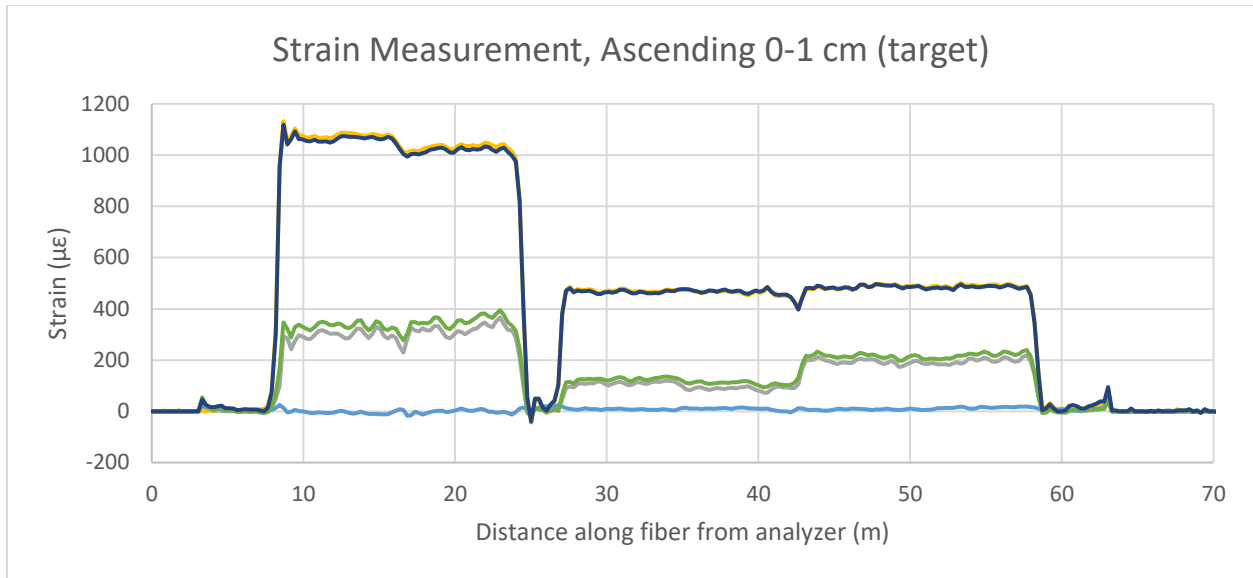
Figure 3-19: Ascending strain measurements, run 1 (grey) and 2 (green)

As shown in Figure 3-19, the higher lines represent the static strain measurements at 10 mm (target) displacement, while the intermediate lines represent the readings taken during the two ramp cycles (run 1 (grey line) and run 2 (green line) in Figure 3-19). It is clear that the intermediate strains do not represent an average (visually halfway) of the applied strains during the ramp cycle, indicating that the reported strain measurements were taken at different times during the 5 minute load. The Brillouin peak frequency values during the two ramp readings from 0 - 10 mm (target) are shown in Figure 3-20. Comparing the order of the Brillouin frequency, from smallest to largest, to the overall percentage of the total applied strain, it can be observed that an increase in the 3 starting frequencies correlate to the magnitude of the strain measurement during the transient reading. Since the strain is increasing linearly, this intuitively supports that the lower frequency portions of the fiber are being interrogated by the analyzer earlier than sections with higher frequency.

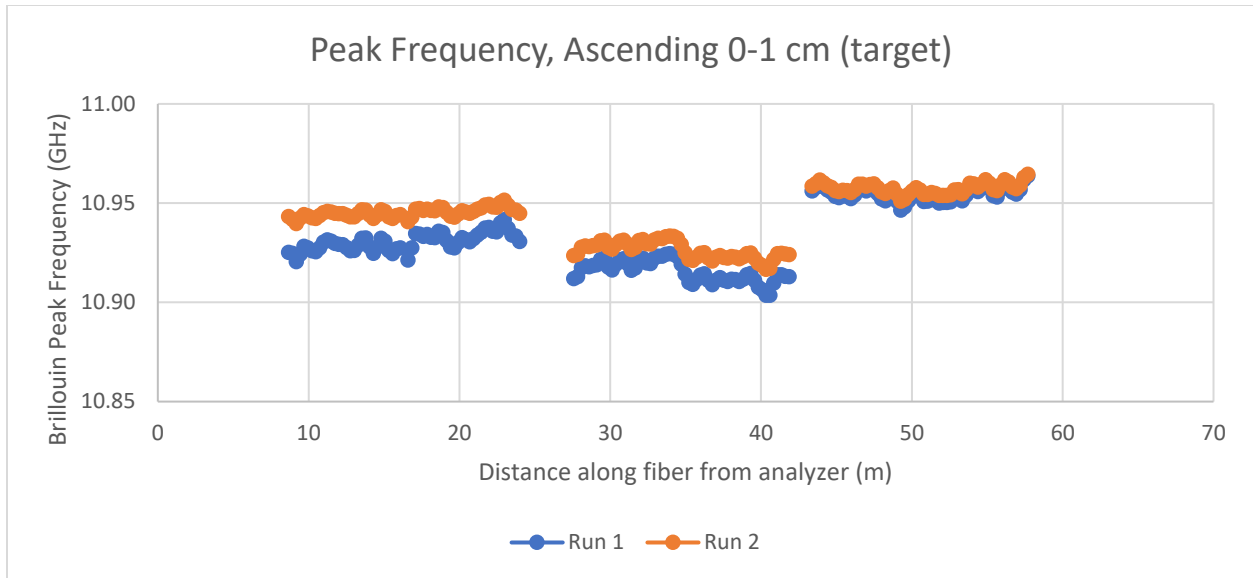
Figure 3-20: Peak frequency during two ascending strain reads

Based upon correspondence with the fiber optic analyzer manufacturer, it is understood that the analyzer sweeps from the bottom of the frequency sensing window to the top in the prescribed measurement step. This would indicate that sections along the fiber where the Brillouin backscatter is at a lower frequency would be read earlier in the read interval than those at a higher frequency. This can be represented visually by plotting the measured strain against the associated frequency, as shown in Figure 3-21, and an approximately linear trend in the data can be observed. The scatter in the data is within the system repeatability of approximately $\pm 20 \mu\epsilon$. The linear trend can become even more evident if we separate the readings from the two loops and add the measured strain values at the 0 and 10 mm (target) displacements, forcing them through the minimum and maximum limits of the frequency sweep window. This is shown in Figure 3-22 for loop 1 and Figure 3-23 for loop 2. The strain readings during the ramp cycle plot linearly depending on their peak frequency between the minimum and maximum window frequency limits and the associated minimum and maximum strain (measured in static readings).

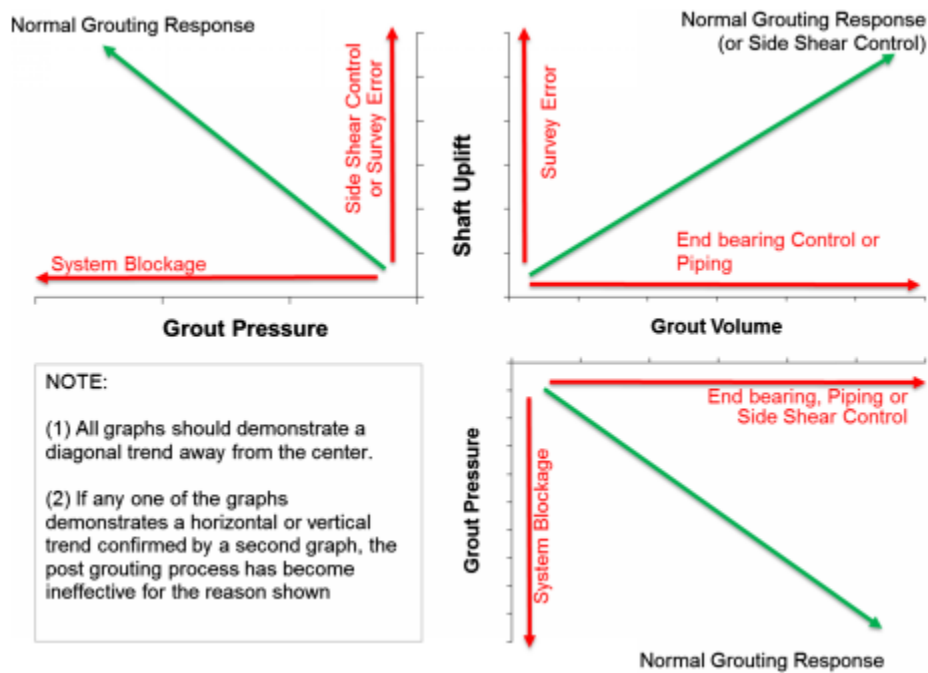
Figure 4-10: Quality assurance plots for post grouting drilled shafts (Winters 2014)

Together, these three criteria provide the basis for monitoring and acceptance during grouting. However, the variable nature of grout delivery at the base of the pile and the potential for blockages to develop during grouting pose the very real risk that grout pressures and flows observed at the surface are not being transmitted to the base as intended. A joint monitoring approach for all three measurements was first proposed by Winters (2014) and has been partially adopted in the US practice, with a combined approach incorporating review of all three in relationship in real-time during grouting. The template for the graphical approach is shown in Figure 4-10.

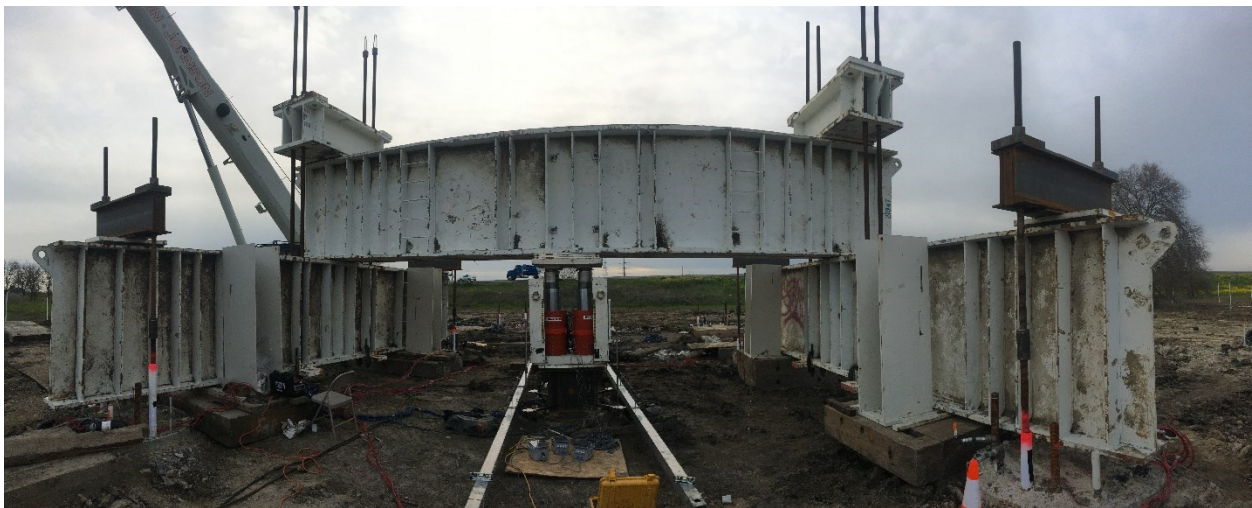
Figure 4-13: Load test frame

After the base grouting was complete, the four test shafts were load tested. The axial loads were imposed on the test pile using four hydraulic jacks, connected to the four surrounding reaction piles through a steel load frame. A photo of the load test frame is shown in Figure 4-13.

Displacement and strain measurements were taken in the manner as described above for base grouting, with additional measurements taken of top displacements of the pile using LVDTs and the hydraulic jack pressure and associated load on the pile were taken during the load test.

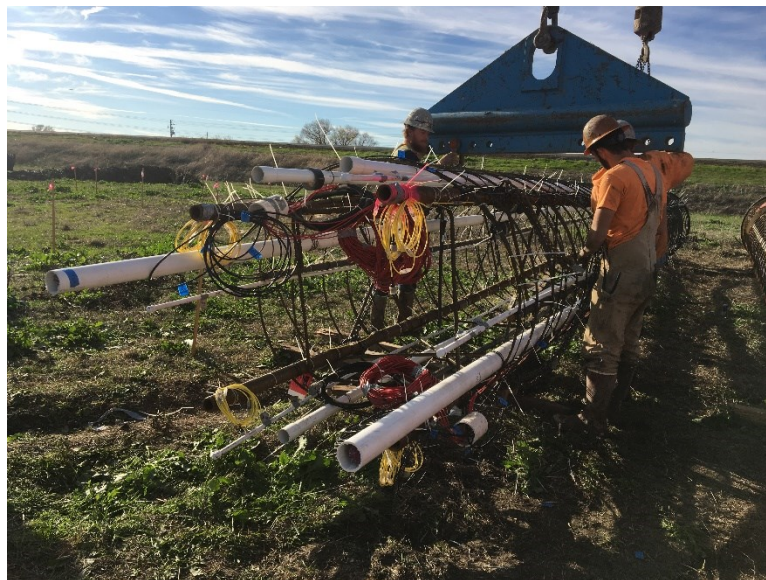
Figure 4-18: All instrumentation wiring installed and coiled; cage prepared for final pick

At the top of the pile, the cable was once again routed inside the cage 2 m below the top horizontal bar. This setup – the vertical “down”, 1.5 circumferential loops, and a vertical “up” – constitutes a single loop, as shown in Figure 4-15. For piles with multiple loops of the same type, 7 m of cable was left between each loop to allow for reconnection in the event of a fiber break within the pile. The installation of all the fiber optic cable on the cage took approximately 2-3 hours after delivery to site with 2 researchers. Figure 4-18 shows the top of a reinforcement cage prepared for lifting into the pile bore with all cabling coiled and secured to the top bars. The fiber optic cable bundles are black, while the red cable are the conventional strain gauges and the yellow cables are the conventional thermal wire.

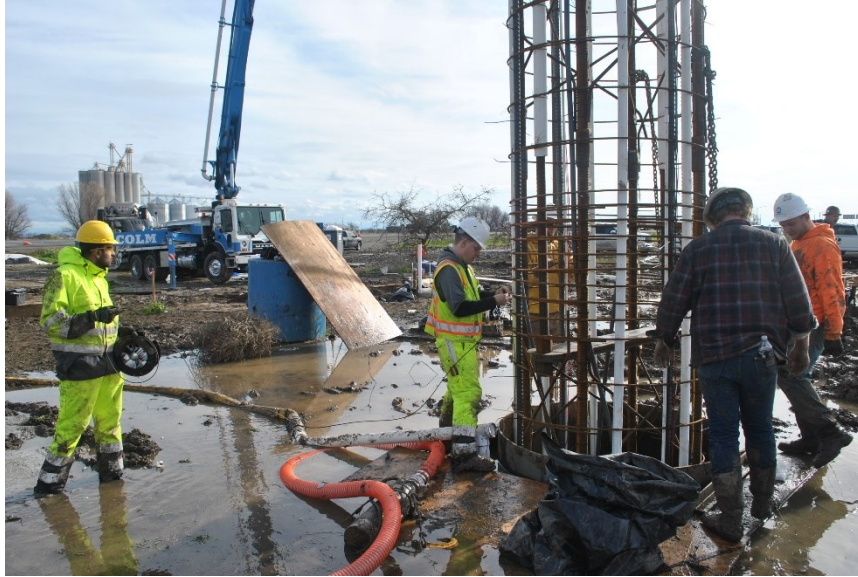
Figure 4-20: Installation of final fiber optic cable vertical during lowering of reinforcement cage

After the cage was lifted vertical and oriented over the pile bore, the coil was detached, and the cable was installed with zip ties along the appropriate vertical bar as the cage was lowered into the bore, as shown in Figure 4-20. This method is the same as how fiber optic cables would be installed on subsequent cages for multi-section piles.

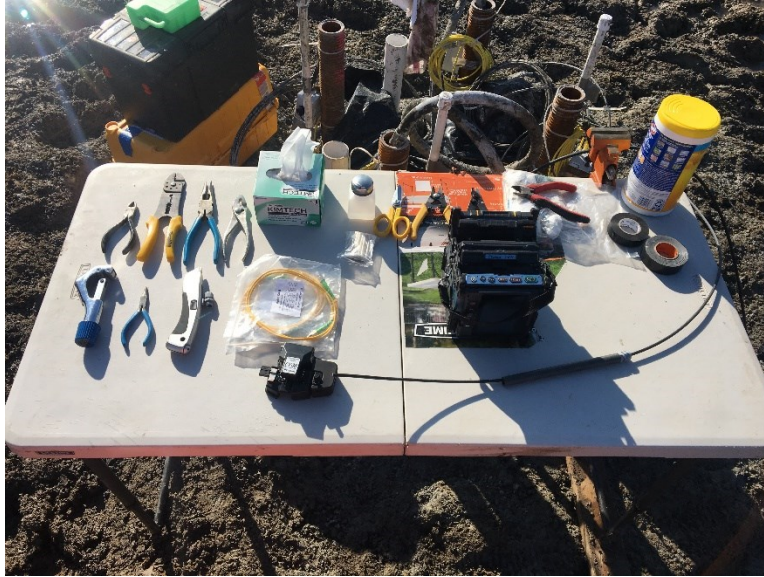
Figure 4-21: Photo of the field setup and tools used for splicing fiber optic cables from the piles

At the completion of the pile concreting, the temperature and strain cables were spliced together and FC connectors were connected to the remaining 2 free ends. A photo of the field setup for splicing the fiber optic cables after the piles were installed is shown in Figure 4-21. The field setup was laid out on a portable folding table. Disinfecting wipes were used to carefully clean the cable ends of mud and dirt, as well as wipe down the table. The tools on the left of the table were used to remove the outer layers of the fiber optic cables include a pipe cutter, cable snips, wide and needle nose pliers, a matte knife, and wire strippers. The yellow-handled tools in the upper center part of the table were used to prepare the fiber core – stripping any protective coating and buffer to expose the core. The core was cleaned with a sterile wipe wetted with alcohol (center top, left). The core was cleaved (center bottom, left), then installed in the holder within the splicer (center, right). The process was repeated for the other section of fiber which was being spliced.

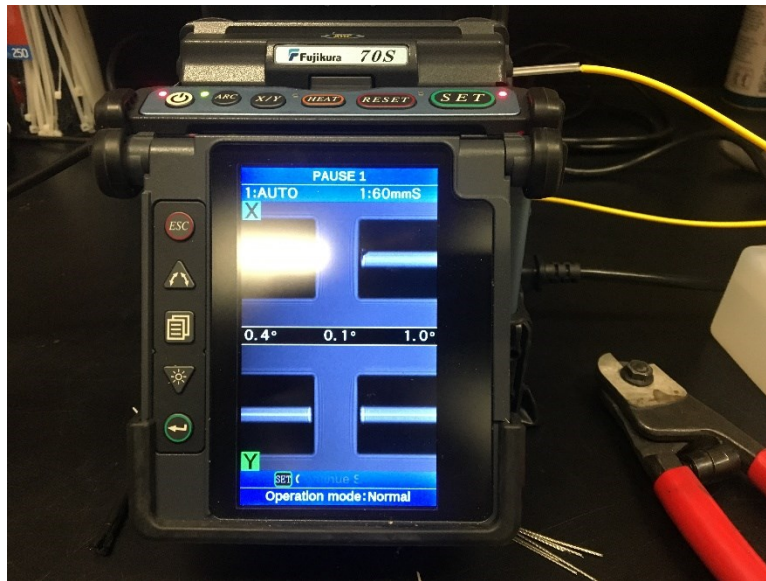
Figure 4-23: Fujikura fusion splicer, joining strain cable (left) and FC patch cable (right)

The splicing process entails carefully removing the protective sheathing around the fiber optic strand, cleaving the end of the fiber optic cable to a 90° face, splicing the two cable cores together using a fiber optic fusion splicer, and securing a protective sheath around the completed splice. A photo of a splice between the strain cable and an FC connector patch cable is shown in Figure 4-23. This photo was taken of a splice performed in the lab between the Nanzee 5 mm cable and an FC connector patch cable. The image on the screen shows a close-

up view of the two fiber optic cores which are aligned and measured for squareness of the cut. Any incompatibility of the angle of the two cuts will result in an error from the splicer and the fiber would have to be recut.

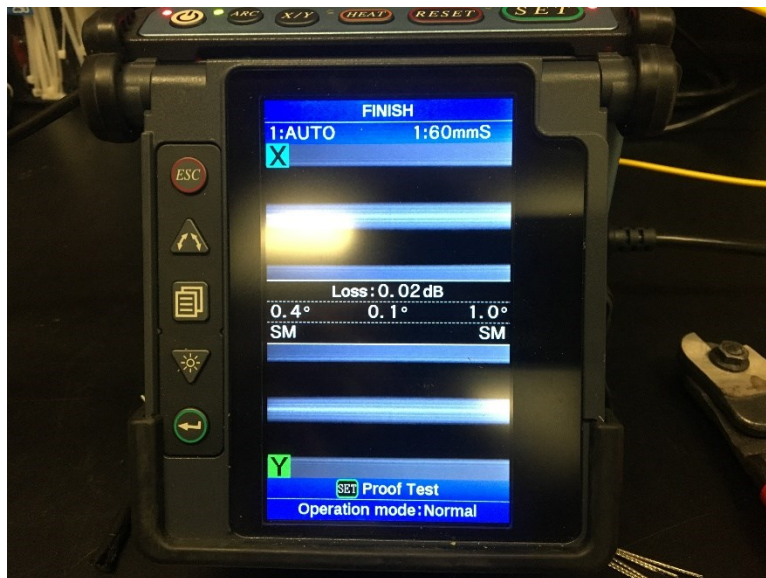
Figure 4-24: Photo of completed splice between strain cable (left) and FC patch cable (right)

The maximum optical loss for each splice was set at 0.1 dB – any splice over this value would be cut and repeated. A photo of the same cable shown in Figure 4-23 after the splice is completed is shown in Figure 4-20.

Following the completion of the splice, continuity was confirmed through all connections using an Optical Time Domain Reflectometer (OTDR) testing device. This allows for testing of both the

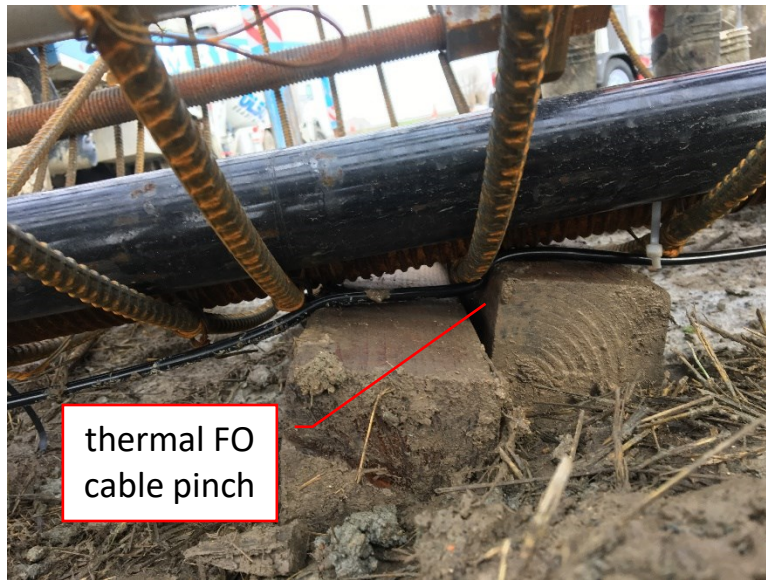
Figure 4-26: Thermal fiber optic cable pinched under reinforcement during handling prior to installation

None of the installed distributed fibers were broken during installation, including a section of temperature cable that was pinched between the reinforcement and cribbing during handling of the cage prior to picking. A photo of the kink in the cable is shown in Figure 4-26. After the cage was repositioned, an integrity test was performed on the cable using the OTDR which showed no breakage or loss at the pinch point.

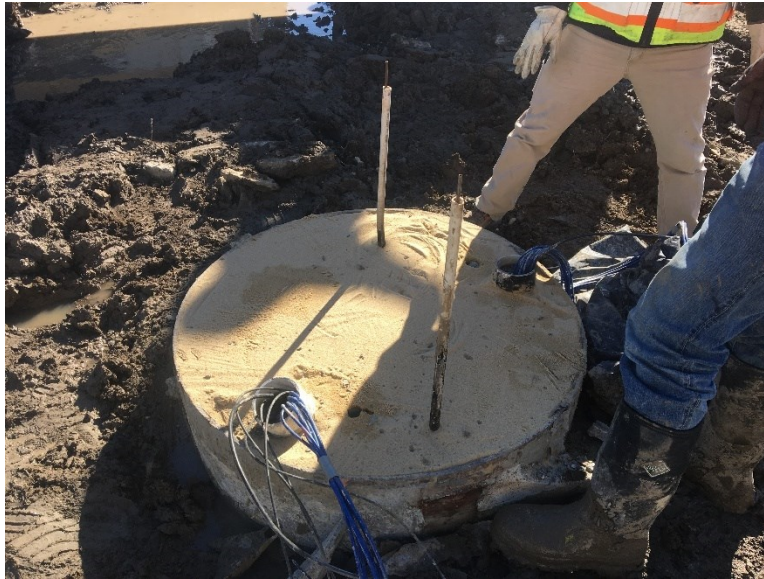
Figure 4-195: Sand bed preparation of test pile prior to load test

unexpected during post grouting and was observed in the open- and closed-type delivery systems, special care was taken during the pile preparation and seating during the load test process to ensure the applied load was uniform. This preparation included cutting the pile and casing level, as determined by survey, as well as placement of a sand bed and steel loading plate to equally distribute the load on the pile. A photo of the sand bed preparation is shown in Figure 4-195.

Due to the attention and effort in preparing and seating the loading jacks to be uniform and perpendicular to the pile face, the applied load was assumed to be aligned with the pile. This assumption is consistent with the standard approach of top-down pile load tests, with best practices dictating a similar level of care and preparation in aligning the applied load with the pile. Large strain variations across the pile are therefore not expected, and strain measurements are often evaluated for validity based on this implicit understanding.

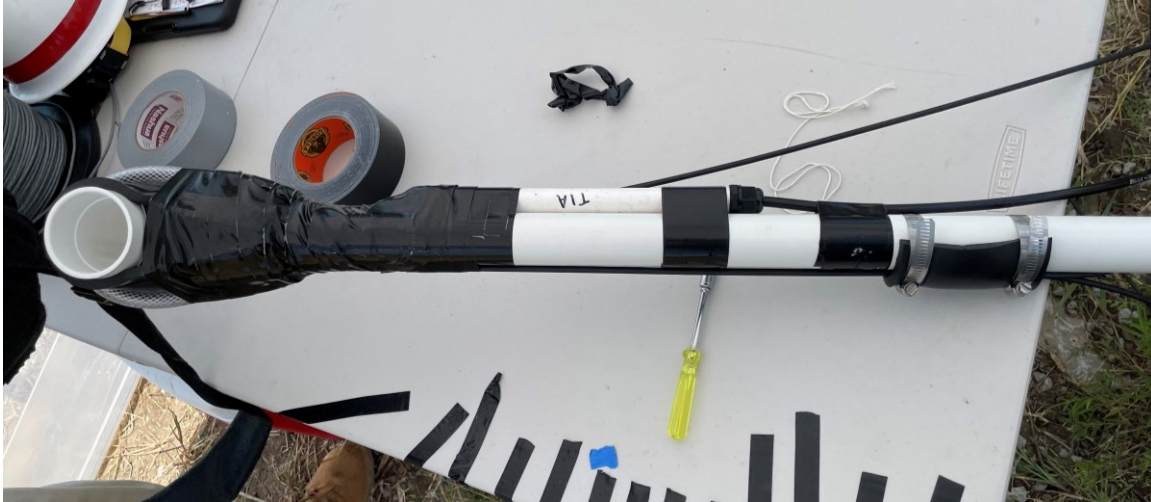
Figure 5-5: Fiber optic cable turnaround detail

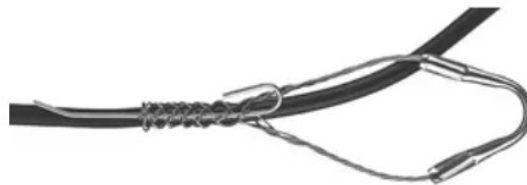
Figure 5-6: Mesh cable clamp used to apply measured pretension to strain cable (photo credit: Hubbel Inc.)

The intended purpose of the fiber optic strain cable was to measure vertical ground deflections, with movements both in uplift as well as settlement. While any uplift would result in an increase in the tension in the embedded strain cable, settlements of a large magnitude could result in the cable going slack within the grout column and no longer reporting accurate strain measurements. To prevent this case, a calibrated pretension was applied to the strain cable in each borehole to maintain the cable in tension during potential settlement that develops during the monitoring period. This approach had been used on previous vertical fiber optic soil deployments, with the additional step taken on this project of measuring the imposed pretension force on the cable. A metal mesh cable grip was used to grasp the strain cable to apply the calibrated tension firmly. A photo of the metal grip installed on the cable is shown in Figure 5-6. A grip design, which is attached using a removable metal bar, was chosen as to allow the grip to be attached at an intermediate point along the cable, rather than being threaded from one end of the cable as in a closed-grip design.

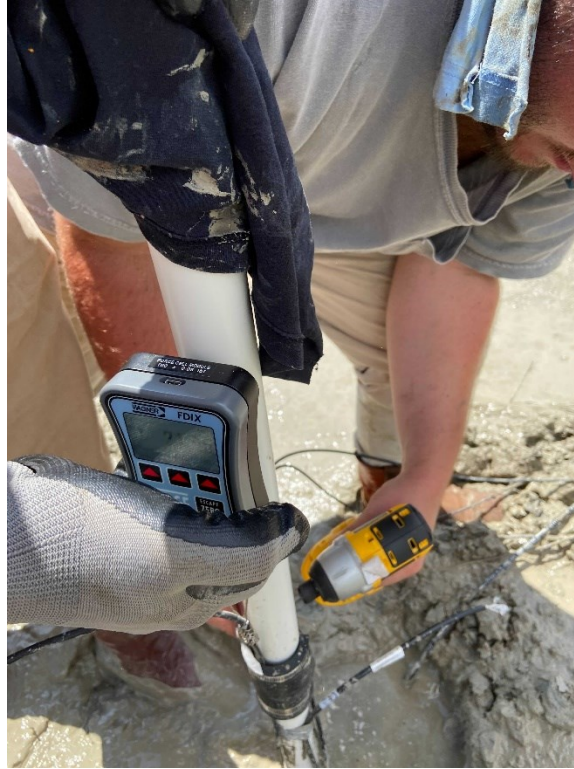
Figure 5-7: Handheld pretension of strain cable during Phase I installation

The pretension force was applied to the strain cable by pulling up on the mesh clamp attached to the cable. Once the target tension force of 50 pounds was achieved, two metal pipe clamps were tightened around the tremie pipe and strain cable to lock the tension force within the cable during the curing of the grout column. These clamps were then removed once the grout had reached a sufficient cure strength to grasp the strain cable. The applied tension was measured using a digital force gauge called the Force One FDIX, manufactured by Wagner Instruments. The force gauge had a load hook that was attached to the loop on the cable clamp grasping the strain cable. During the Phase I installation, the tension was applied by hand by pulling upwards on the force gauge while a second researcher tightened a pair of clamps to hold the tension during curing. A photo of the force gauge and the tightening clamps is shown in Figure 5-7.

It was found during the Phase I installation that it was difficult to maintain a constant force by hand. During the second installation, a ratchet strap attached to the top of the tremie pipe was used to apply a constant force to the strain cable prior to locking off. A photo of this modified setup is presented in Figure 5-8.

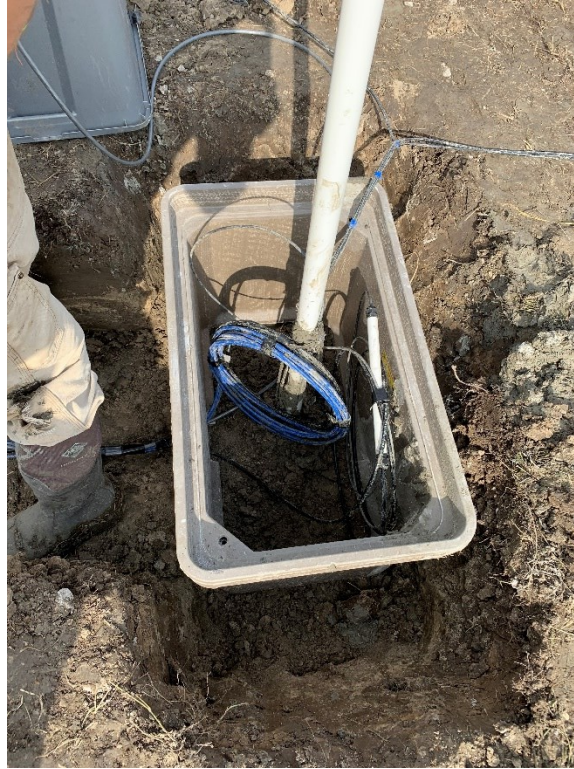
Figure 5-9: Enclosure vault used to protect the cable at the top of each borehole array

Each borehole location was completed using a rectangular traffic-rated vault box to house and protect the excess cable and ground-level splice connections for the duration of the project. Entry slots for the cable to enter and exit each box from the connecting trenches were cut into the side skirts, and the box was buried flush with the surrounding ground. The cable at each borehole was neatly coiled together to allow access for potential future modifications to the system, such as splicing in additional cable or bypassing a borehole network in the event of damage to the downhole section. A photo of the enclosure configuration is shown in Figure 5-9.

Once the grout had cured, the clamps holding the applied pretension on the strain cables were removed. The tremie pipe stick-up was trimmed below the lip of the enclosure to allow the lid to be installed. This final step concluded the installation procedure for each of the borehole fiber optic arrays.

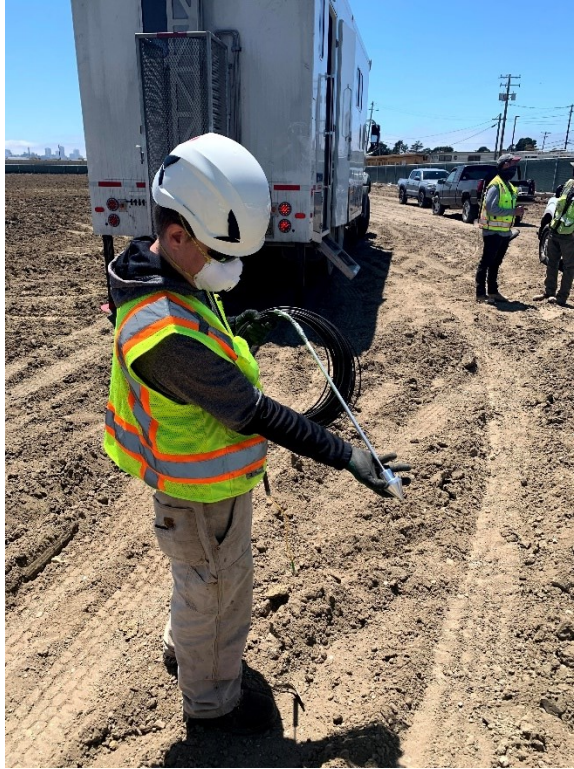
Figure 5-31: Prepared fiber optic cable and dummy CPT tip

One of the main goals of the field trial was to develop and test a method of installing the fiber optic cable via CPT, rather than the previously adopted deployments in conventional geotechnical boreholes. This new method would offer the benefit of significantly reducing the time and cost associated with installation of a fiber optic extensometer, especially when compared to the more involved installation and assembly of a conventional multi-point borehole extensometer. The installation was prepared by first advancing an instrumented CPT, creating both a complete CPT record of the precise location of the fiber optic installation, as well as serving as a pilot hole for the fiber optic cable. Once the instrumented CPT had reached the termination depth, set as a minimum of 9.8 feet (4 times the spatial resolution of the fiber optic analyzer) beyond the bottom of the Young Bay Mud, the cone was extracted from the ground, leaving the hole open. The fiber optic installation had been prepared beforehand by attaching a length of armored strain cable to the center of a sacrificial “dummy” CPT cone, machined out of a block of aluminum. A photo of the prepared fiber optic assembly is shown in Figure 5-31

To begin the installation, the fiber optic cable was threaded through several hollow CPT rods and the excess cable was pulled out, so the dummy cone was seated against the first rod and taped in place to remain secure before the push began. A photo of the dummy cone in place prior to installation is shown in Figure 5-32.

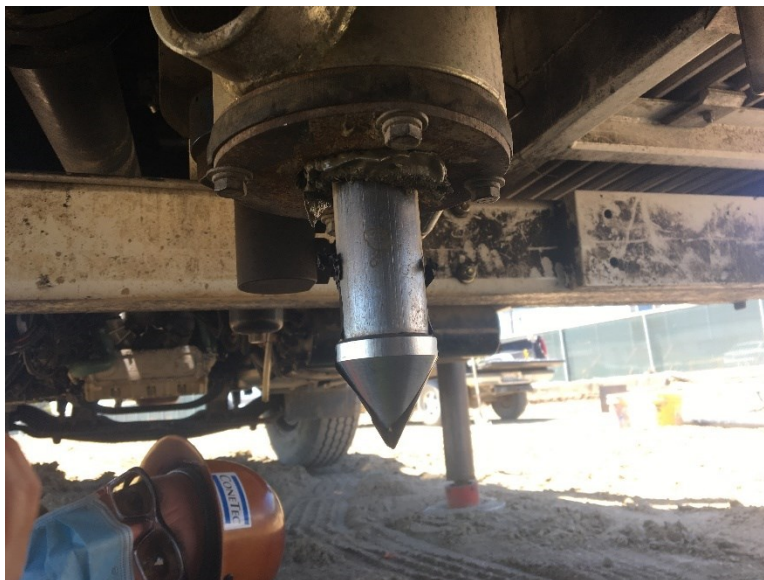
Figure 5-32: Dummy cone taped in place at the bottom of the first CPT rod

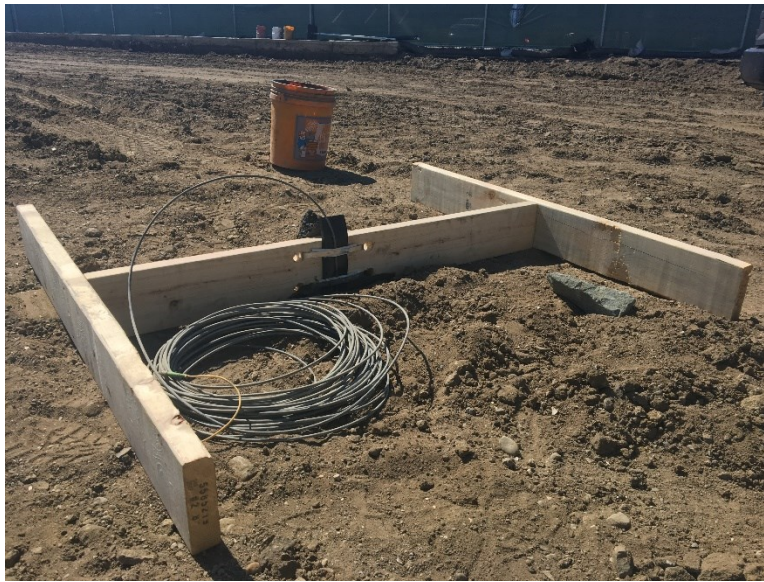
The dummy cone and trailing fiber optic cable was then pushed into the previously opened hole, with the fiber optic cable threaded through the rods as installation progressed. Once the dummy cone reached the bottom of the previously pushed hole, the cone was pushed an additional 2 feet into undisturbed soil to increase the fixity of the tip. A cement-bentonite grout was then poured into the rods as they were extracted, chosen based on the mix for “Grout for Soft Soils” published by Mickelson (2002) to avoid the grout column from being stiffer than the Young Bay Mud. Following full extraction of the rods and topping off the grout, the strain cable was pretensioned to approximately 2000 $\mu\epsilon$ and fixed via clamp to maintain the tension during grout curing. A photo of the completed installation and tension frame is shown in Figure 5-33.

Figure 5-33: Completed fiber optic installation and tension frame, immediately following installation

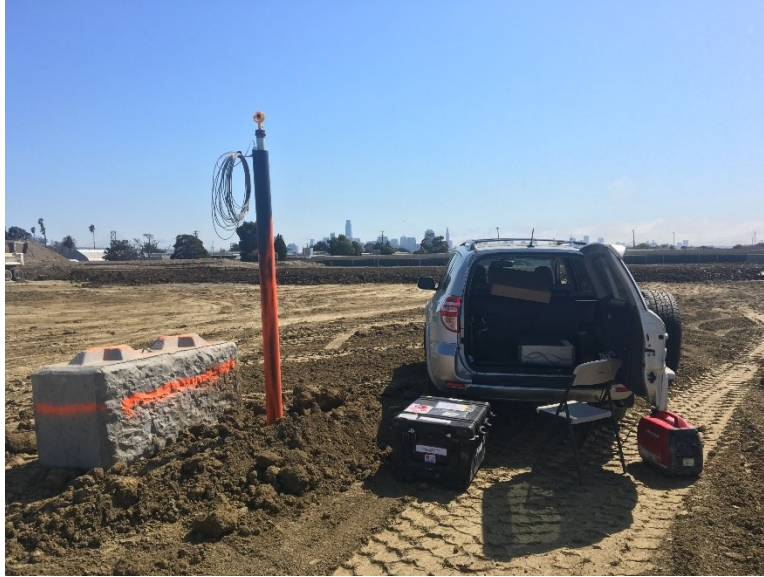
Monitoring of the fiber optic installation was performed using a commercial analyzer operating in the BOTDR mode. The analyzer was configured using a spatial resolution of 0.75 m with a readout spacing of 0.25 m. The manufacturer reports a measurement repeatability of $\pm 20 \mu\epsilon$ (1 standard deviation) at comparable reading settings. A series of 3 initial baseline readings were taken 2 days after the installation, following removal of the tension frame. A photo of the standpipe riser and the fiber optic analyzer is shown in Figure 5-34.

Figure 5-34: Standpipe riser, fiber optic cable, survey reflector, and fiber optic analyzer
