UPGRADING A TERMINAL VAPOUR RECOVERY SYSTEM

Zeeco's vapour recovery systems improved reliability and reduced operating costs at a Zenith facility

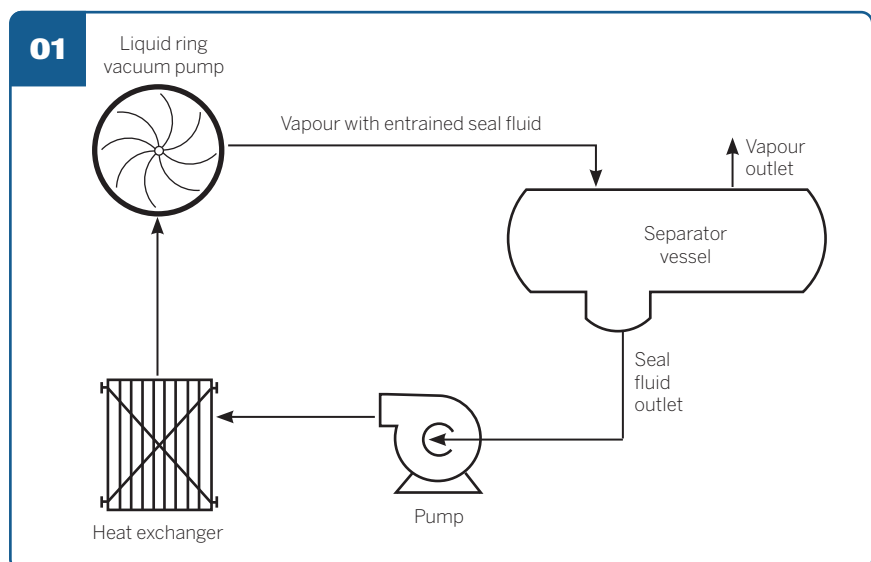
The vapours leaving the vacuum pump will contain some seal fluid requiring them to be routed to a separator unit. The seal fluid from the separator must then be routed back to the vacuum pump. A heat exchanger is also typically required to cool the recovered seal fluid before it can be returned to the vacuum pump (Figure 1).

- 01** LRVP seal fluid loop – equipment replaced by dry screw vacuum pump
- 02** Zephyr combustion unit in service while upgrades on the VRU were completed
- 03** Zenith Energy power usage before and after Zeeco's retrofit

The primary change in Zeeco's upgrade plan was to replace the existing LRVP and its auxiliary equipment with a state-of-the-art dry screw vacuum pump (Figure 1). The dry screw vacuum pump is more efficient and eliminates the need for seal fluid and its associated auxiliary separator vessel, pump, and heat exchanger.

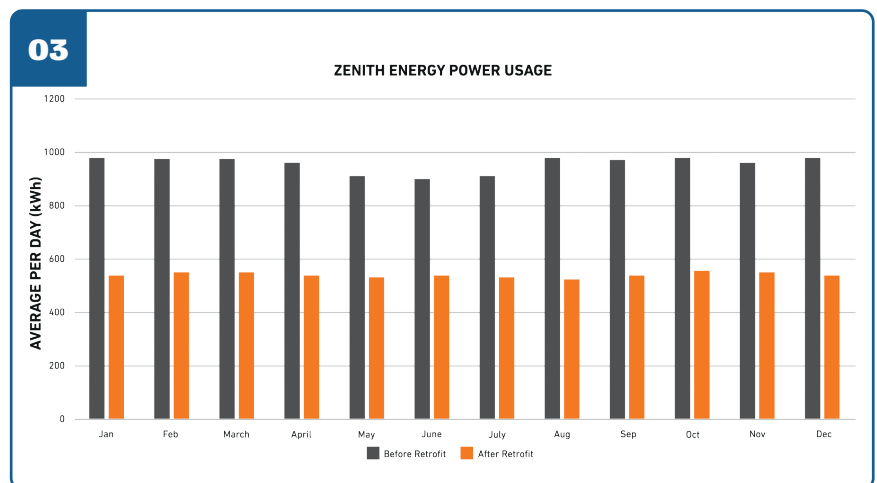
The upgrades to the system resulted in dramatic improvements to the VRU operations, with a higher throughput and increased reliability. The power save mode has also reduced electrical power usage of the VRU by more than 40% (See Figure 3). Emissions levels were also significantly reduced, allowing the unit to already comply with tighter regulations that are expected to be implemented in the future. These improvements are also aligned with current environmental, social, and governance (ESG) criteria. From a financial standpoint, the upgrade was also a success. The return on investment (ROI) for the full retrofit was less than two years.
