## Multisource data integration to investigate one century of evolution for the Agnone landslide (Molise, southern Italy)

**Abstract** Landslides are one of the most relevant geohazards worldwide, causing direct and indirect costs and fatalities. Italy is one of the countries most affected by mass movements, and the Molise region, southern Italy, is known to be susceptible to erosional processes and landslides. In January 2003, a landslide in the municipality of Agnone, in the Colle Lapponi-Piano Ovetta (CL-PO) territory, occurred causing substantial damage to both structures and civil infrastructure. To investigate the evolution of the landslide-affected catchment over approximately one century, different data were taken into account: (i) literature information at the beginning of the twentieth century; (ii) historical sets of aerial optical photographs to analyse the geomorphological evolution from 1945 to 2003; (iii) SAR (Synthetic Aperture Radar) data from the ERS1/2, ENVISAT and COSMO-SkyMed satellites to monitor the displacement from 1992 to 2015; (iv) traditional measurements carried out through geological and geomorphological surveys, inclinometers and GPS campaigns to cha

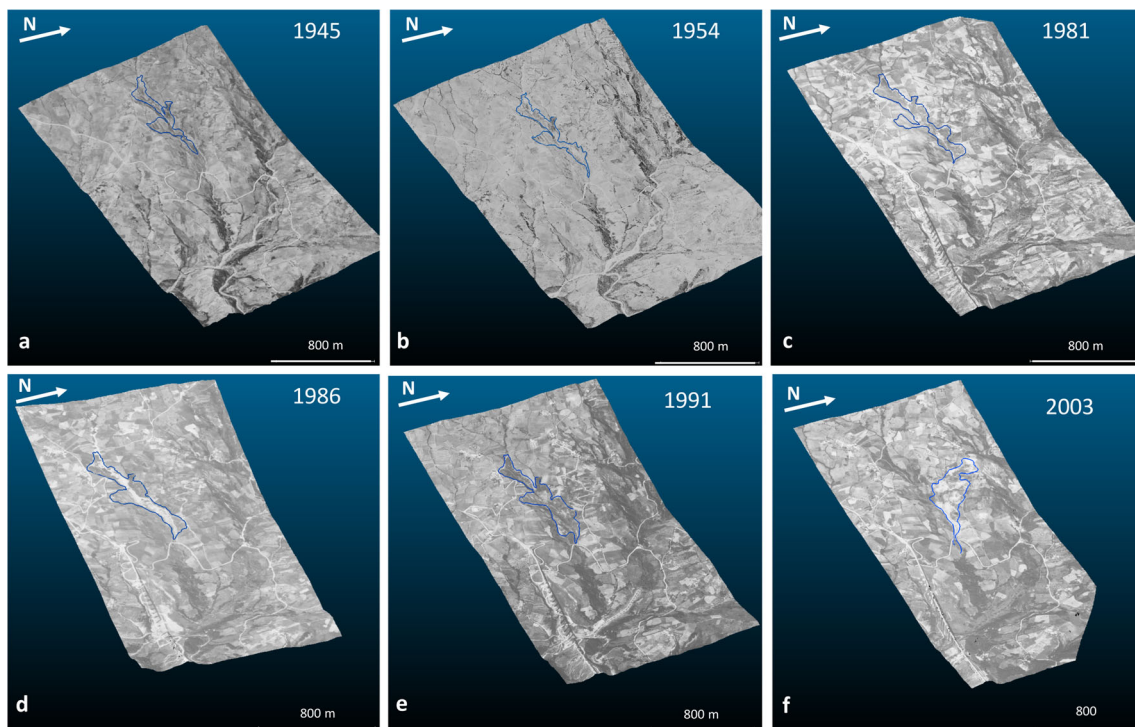
**Fig. 5** 3D reconstruction of the Colle Lapponi-Piano Ovetta landslide-prone area made by a set of historical aerial photographs that date back to 1945 (a), 1954 (b), 1981 (c), 1986 (d), 1991 (e) and 2003 (f). The landslide contour is plotted in blue

the beginning of the twentieth century and the main reactivation in 2003, with no information on the geomorphological evolution of the landslide. The procedure, with dedicated settings for historical photos, was applied to each scenario to extract the respective 3DPC and models. The results were individually analysed zooming and rotating the 3D model to better detect and map the contour of the landslide with respect to the classical stereoscopy by means of the Cloud Compare software. In addition, the resulting 3D reconstruction was integrated in the environmental GIS in order to obtain a better interpretation combined with the available ancillary data, e.g., Aspect and Slope. The first set of photographs refer to 1945 (Fig. 5a), in which an area affected by the landslide was visually recognized at the right flank of the basin damaging the access road to Piano Ovetta. It is difficult to confirm if the phenomenon was an activation or reactivation of an existing old mass movement because previous maps are not available. The contour map based on the analysis of the 3D reconstruction contains a visible area of approximately 0.86 km<sup>2</sup> that features displaced material with an average length and width of approximately 900 and 100 m, respectively.

The subsequent analysis included the set of photos from 1954 (Fig. 5b), in which no additional differences were recognized with respect to the previous set from 1945. In fact, the dimensions of the landslide are comparable to those of the previous reconstruction, and only small changes in the length, up to 1 km, are recognizable.

The flight conducted by the IGM over this territory was repeated in 1981 acquiring five additional photographs. After 25 years, the results are comparable to the previous analysis, with some small differences recognizable only on one side of the main body (Fig. 5c). Some lateral sliding, probably due to water erosion operating on the toe, is distinguishable. In fact, the length of the landslide is similar to that from the previous years. However, the width of the landslides increased due to some lateral slides that enlarged the area involved. An analogous boundary, with less evidence of lateral sliding, can be mapped on the 3D reconstruction of the CL-PO landslide-prone area in the 1986 reconstruction (Fig. 5d).

In the reconstruction of 1991 (Fig. 5e), remedial work conducted between 1986 and 1991 is recognizable (Fig. 6a). These man-made activities are visible as perpendicular white strips across the river along the width of the landslide (into Verrino creek). They consisted of concrete weirs built to avoid the continuous enlargement of the landslide due to span erosion and to control the amount of mobilized material run off. Currently, they are not visible inside the landslide due to the remobilization of material during the 2003 reactivation, but some of them were

The 3D reconstruction made from the 2003 imagery shows the involvement of the left flank of the basin (Fig. 5f). Between January 23rd and 27th, an unusual increase in pore pressures caused by an intense rainfall of more than 200 mm in 72 h (Fig. 7a) occurred, triggering the complex deep-seated mass movement (Calcaterra et al. 2008) consisting of the reactivation of an old dormant landslide. The upper member of the Agnone Flysch was involved in a large roto-translational slide resulting in earth flow (Cruden and Varnes 1996), including an area of approximately 1.21 km<sup>2</sup> that was up to 1 km in length and had an average width of 200 m, which completely altered the local hydrographic network (Fig. 7b).

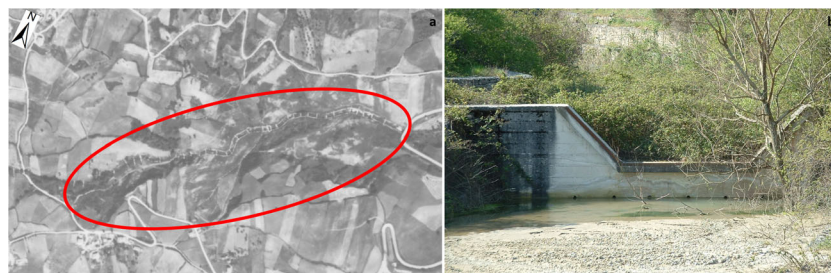
**Fig. 6** Location of the remedial work visible on the historical aerial reconstruction (a); details of the concrete weirs built along the tributary of the Verrino Creek (b)

recognizable in the widespread vegetation close to Verrino creek (Fig. 6b).

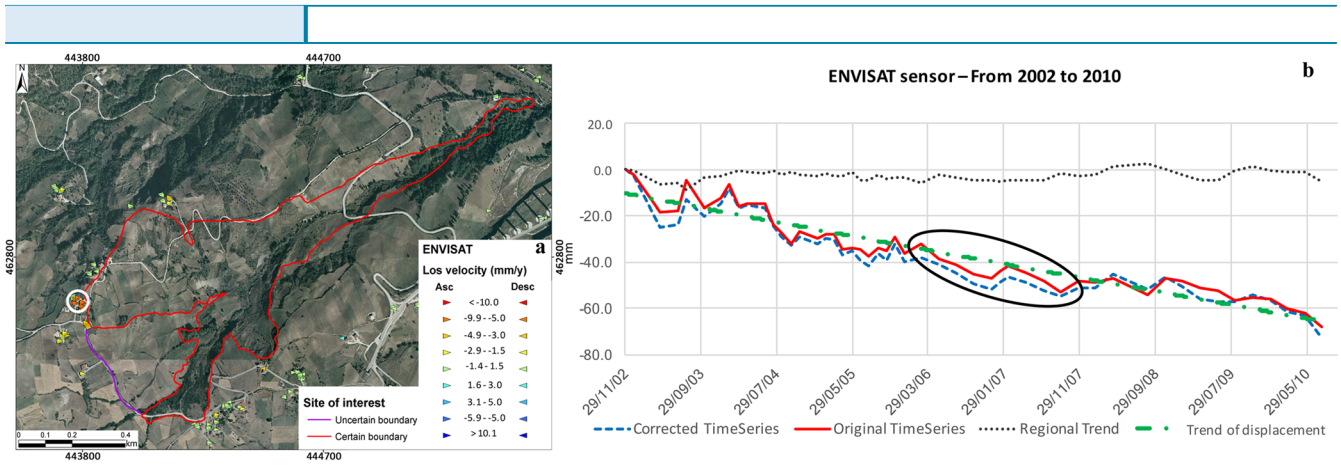
**Fig. 9** a PS distribution in the area of interest of the CL-PO landslide. b Regional trend and original and corrected time series of a PS located on the crown of the landslide. The black ellipsis highlights where the main reactivations occurred

The ENVISAT PS data (2003–2010) are concentrated on the structure located on the crown. The ascending PS data show average velocities between  $-3.0$  and  $-4.9$  mm/year with a peak of  $-7.0$  mm/year, while the descending data are close to the stability range (Fig. 9a). The time series of the ENVISAT data, mainly in descending geometry, are noisy, but the trends of both orbits confirm continuous displacement (green line in Fig. 9b).

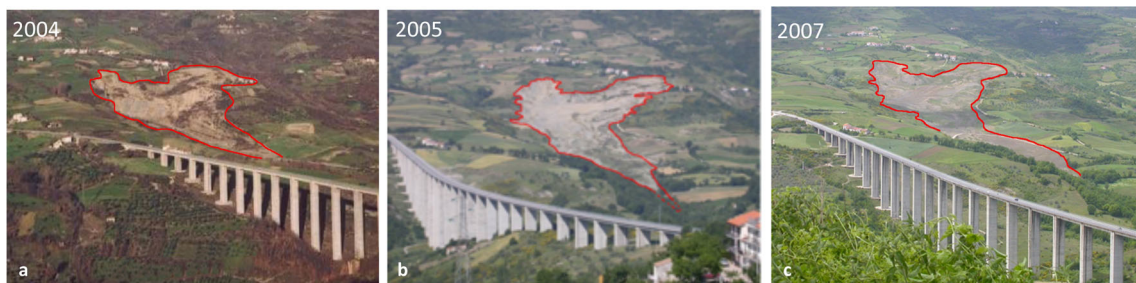
**Fig. 12** Optical photographs in 2004 (a), 2005 (b) and 2007 (c)

The enlargement of the territory involved in the landslide by continued displacement is visually recognizable through optical photographs shot from the same point of view (Fig. 12a–c).

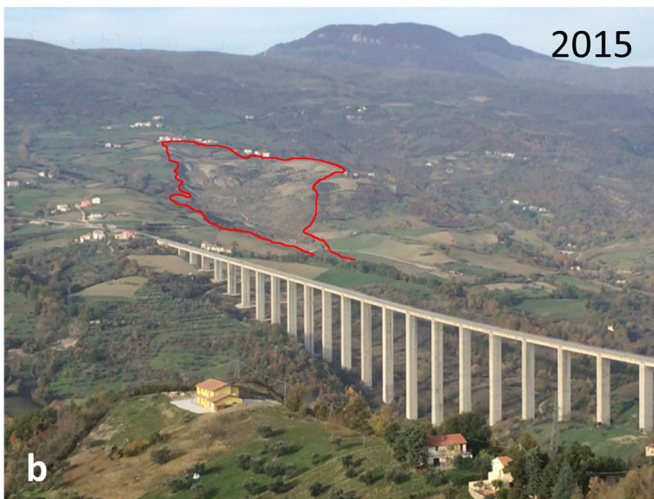
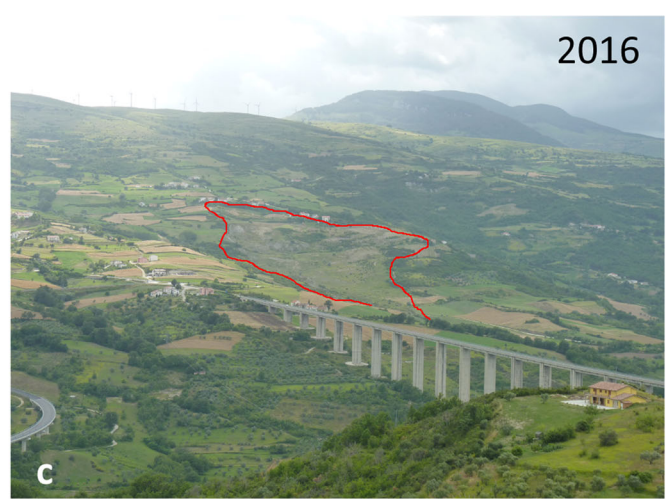
**Fig. 13** Geomorphological maps of the landslide-prone CL-PO area and GPS displacements recorded from 2010 to 2016 (a). Optical photographs of the landslide on November 2015 (b) and July 2016 (c)

and field surveys, was estimated to have approximately 350 m of advancement at the toe and approximately 270 m of retrogression at the head sector, reaching a total length up to 1500 m. The GPS field survey results in order to record the displacement measurements from 2010 to 2016 are visible in Fig. 13a. During the campaign conducted in November 2015 and July 2016, not all benchmarks were found because some of them were destroyed for building the drains or lost because of the continuous displacement affecting the slope. By means of the field surveys, it was possible to design a geomorphological map of the area influenced by the landslide and its surroundings by conducting several geomorphological field campaigns (Fig. 13a) where several old and recent scarp and counterslope shapes were noted.
