Wind and Seismic Effects

Proceedings of the 22nd Joint Meeting

NIST SP 796

PROCEEDINGS OF
THE 22ND JOINT
MEETING OF
THE U.S.-JAPAN
COOPERATIVE PROGRAM
IN NATURAL RESOURCES
PANEL ON WIND AND
SEISMIC EFFECTS

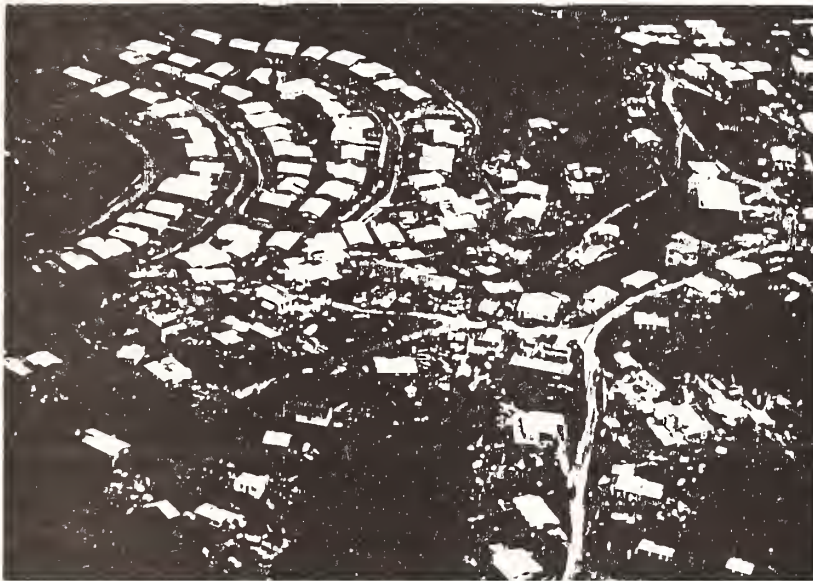
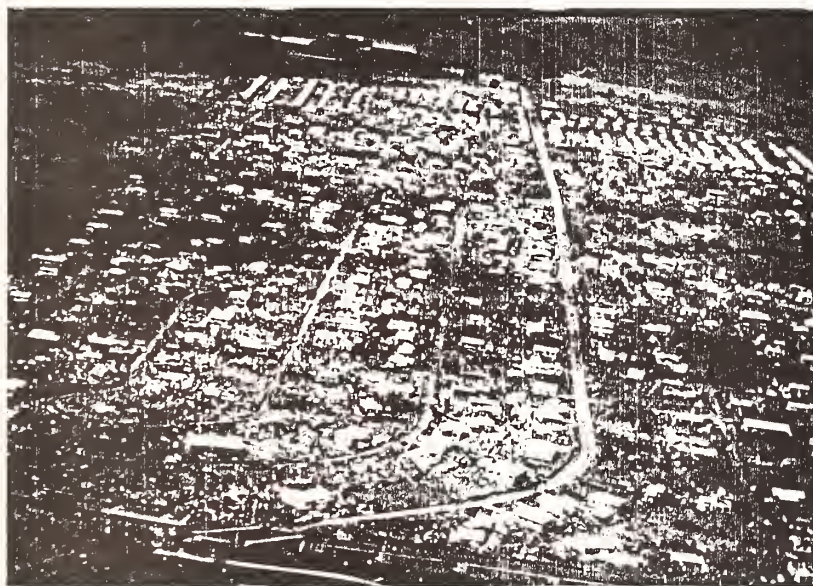
Figure 18a. Apparent microburst damage in 2 residential areas of St. Croix (aerial photos)

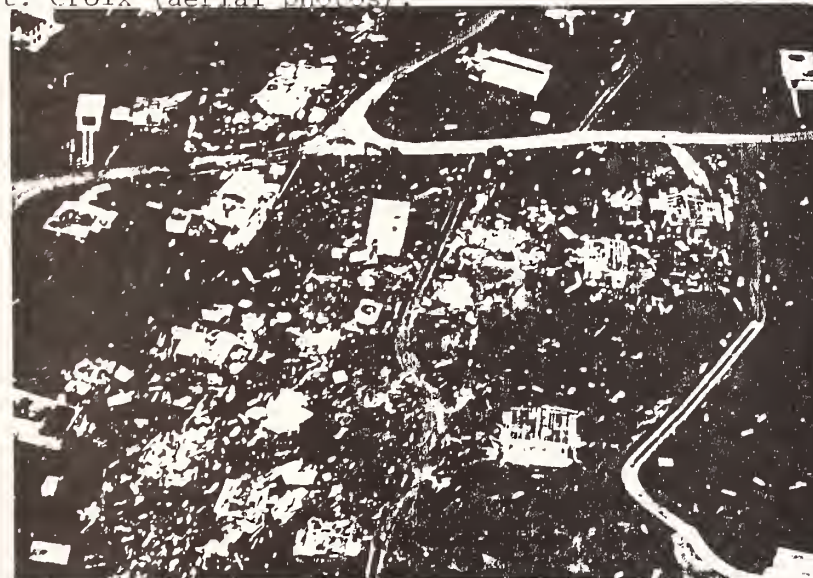
Figure 18b. Close-up aerial photo of microburst damage near north coast, Vieques.

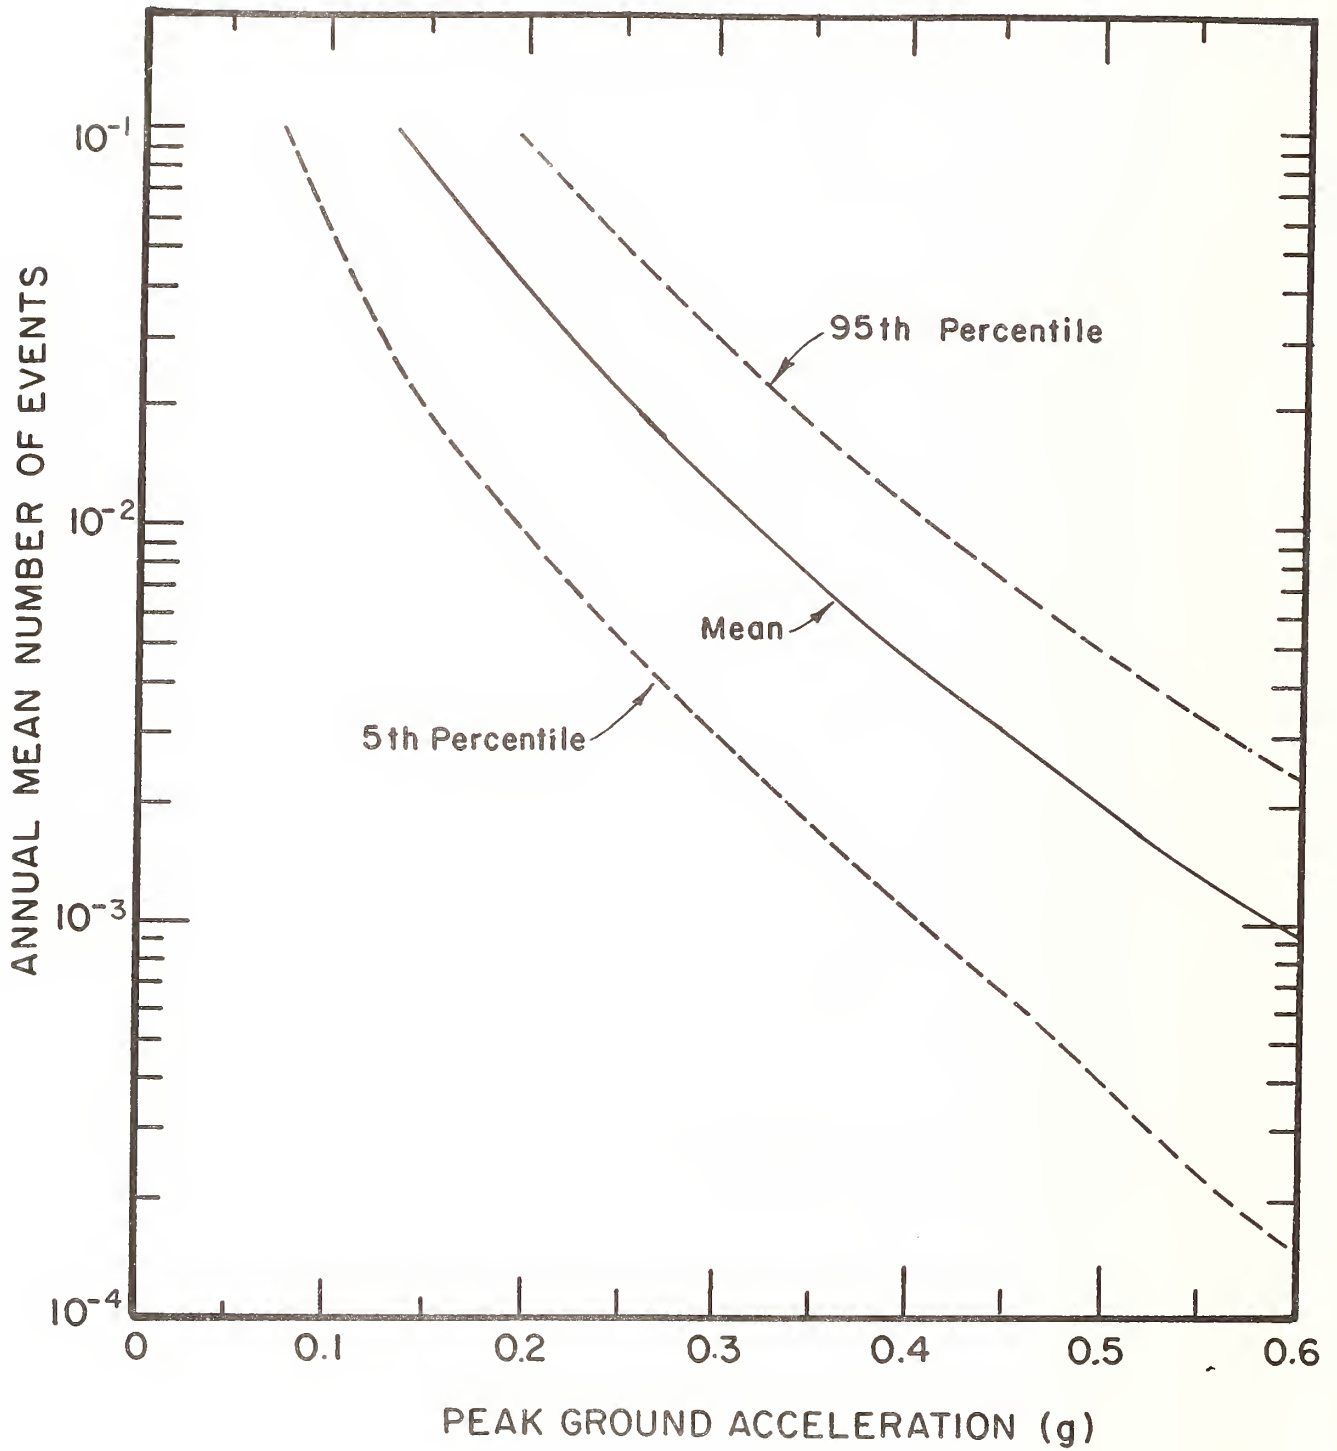
Figure 2a Seismic Hazard Curves for all LLNL site: Peak Ground Acceleration (g).

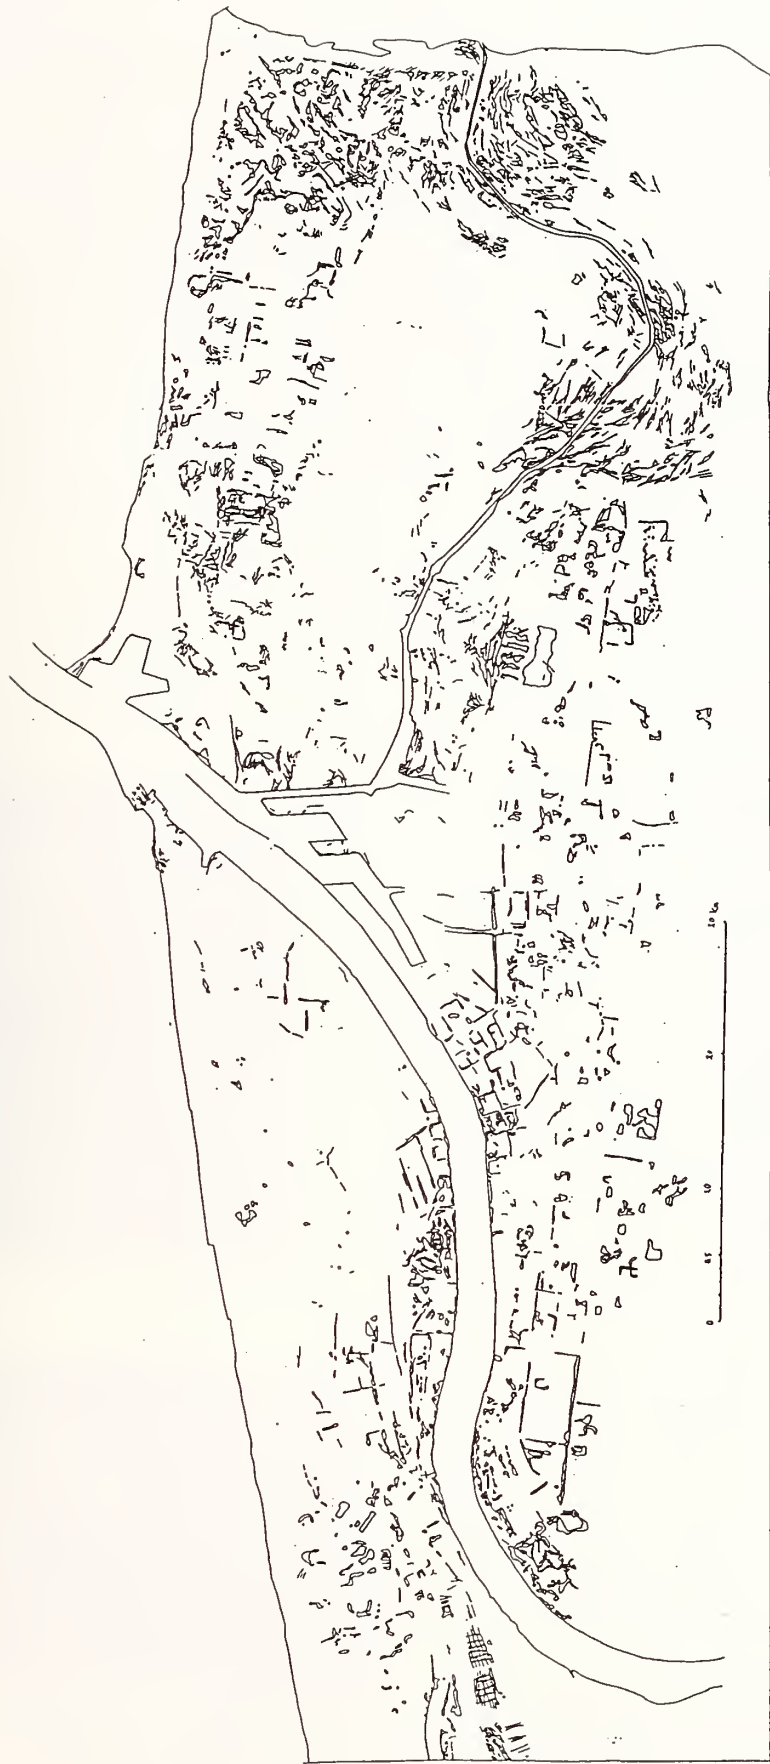
fig.-3 Distribution of cracks and sand boils
Compiled from "Actual condition map on
damages caused by Niigata earthquake at a scale
of 1:10,000"

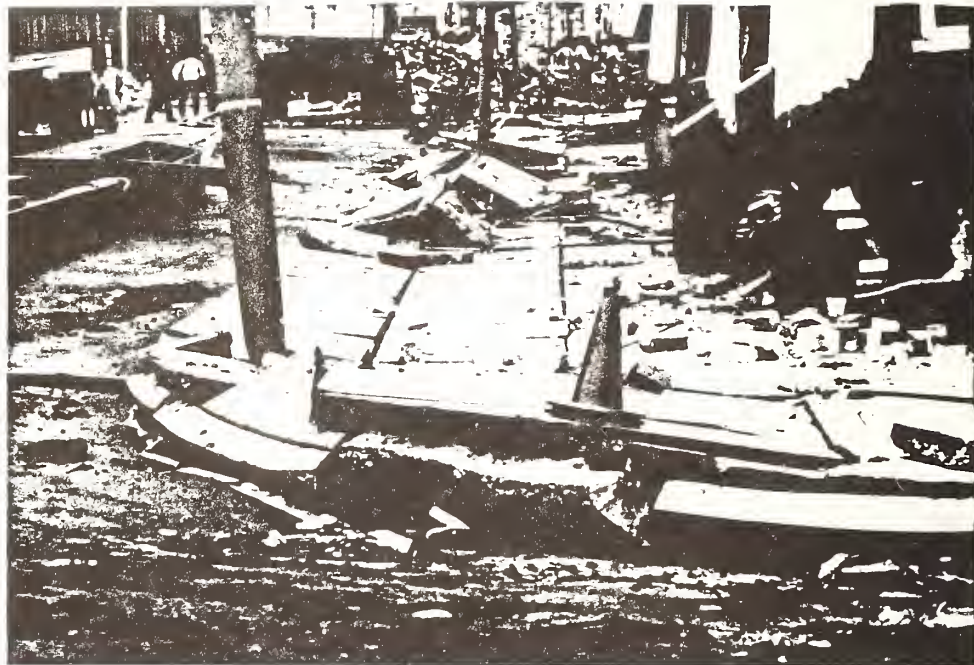
Figure 11. Buckled and broken sidewalks and street pavement resulting from soil liquefaction, in the Marina District.

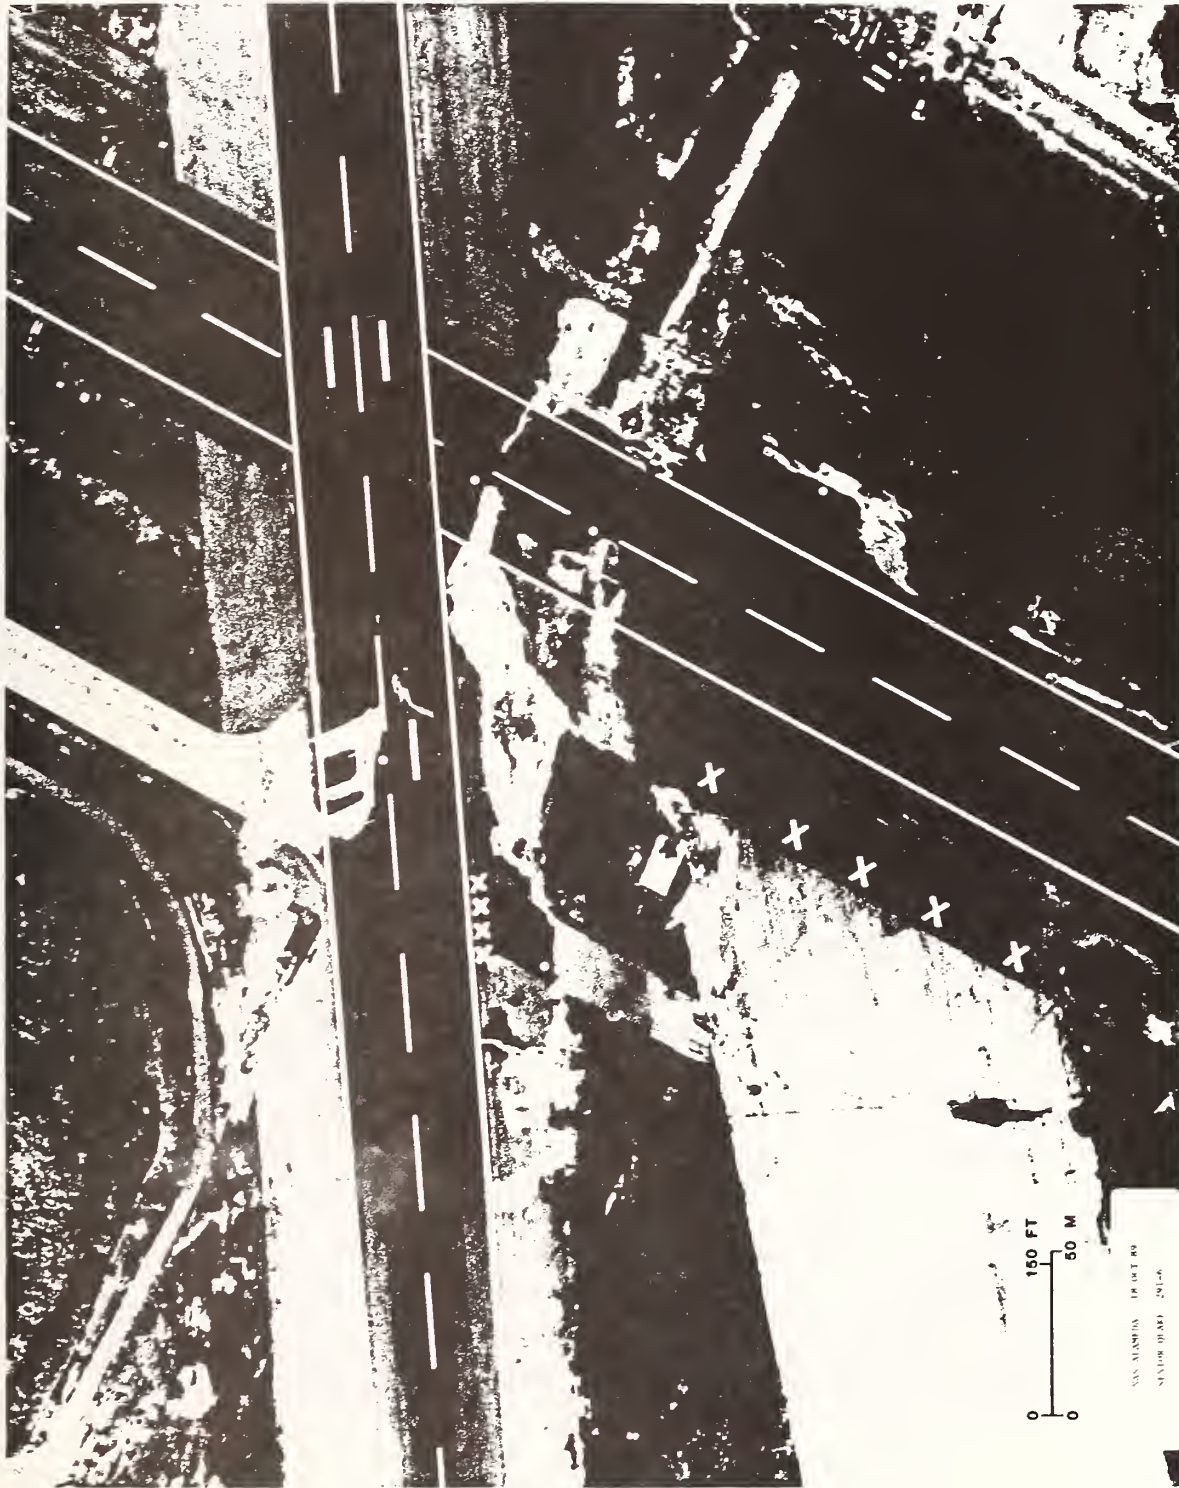
Figure 12. Large-scale soil liquefaction in fill materials at the Alameda Naval Air Station.

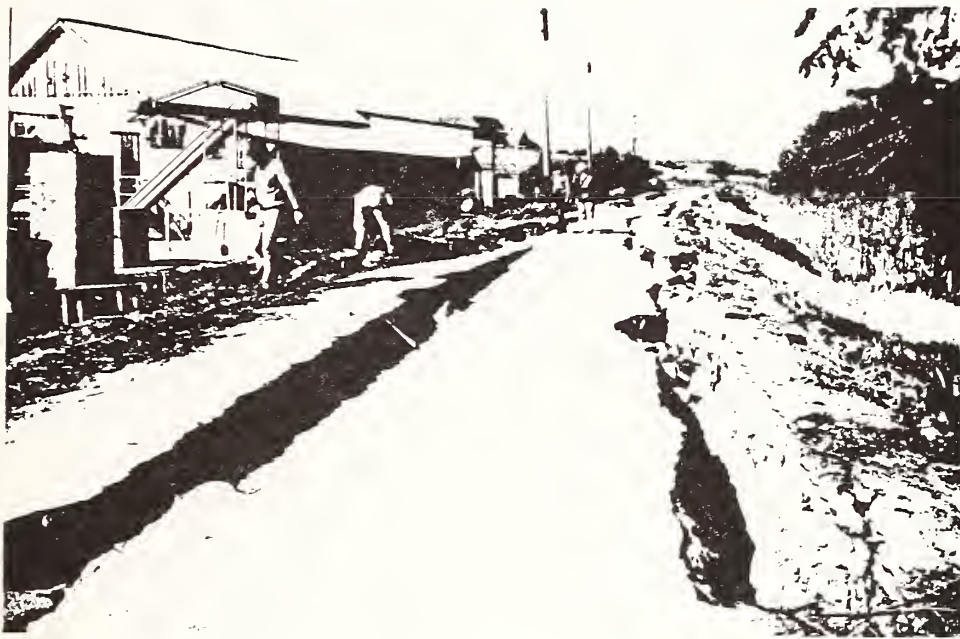
Figure 15. Liquefaction-induced fissures in levee of the Pajaro River, near Watsonville. The fissures were deeper than the height of the levee.

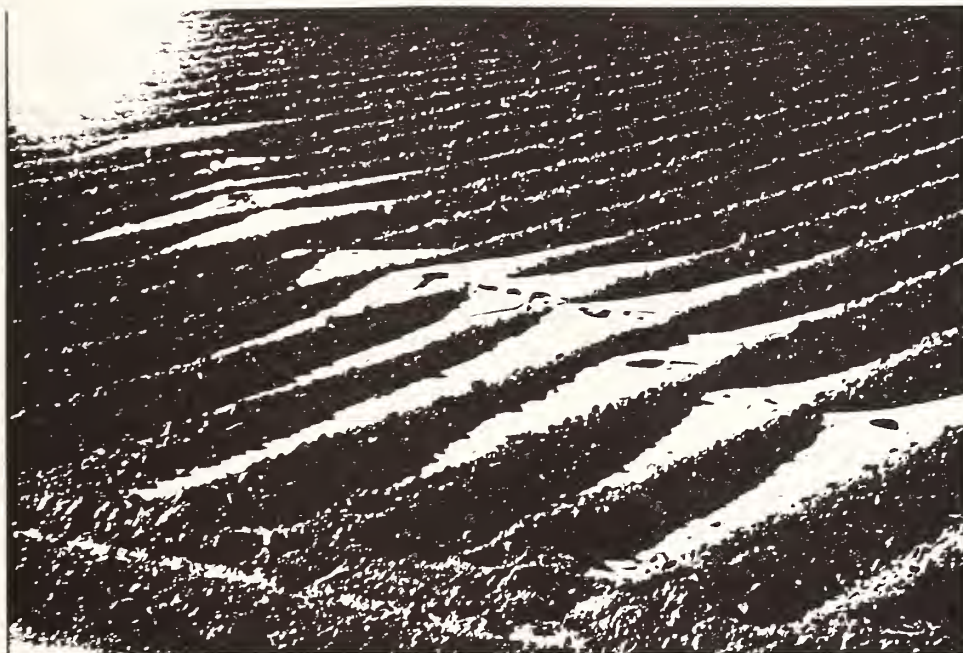
Figure 16. Liquefaction in a field adjacent to the Pajaro River levee near Watsonville. Sand extruded from a linear ground break, with multiple vent holes.

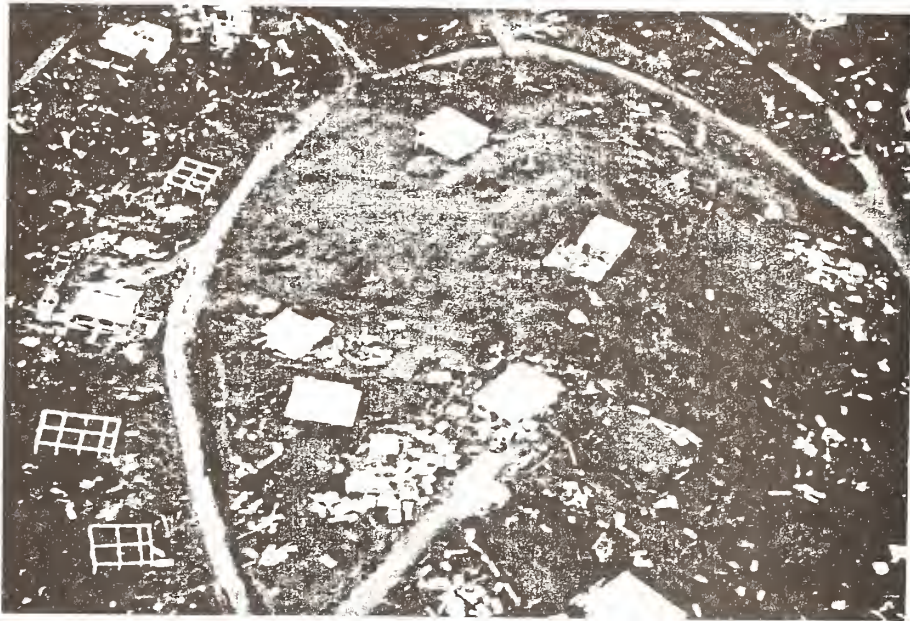
Figure 8. Housing damage on Vieques

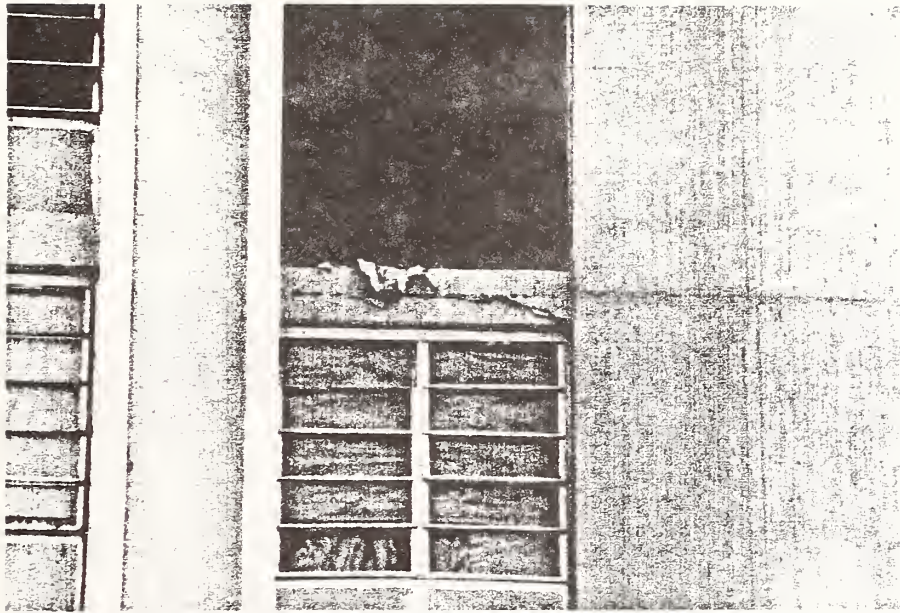
Figure 10. Damaged edge beams, concrete highrise buildings
Fajardo, Puerto Rico

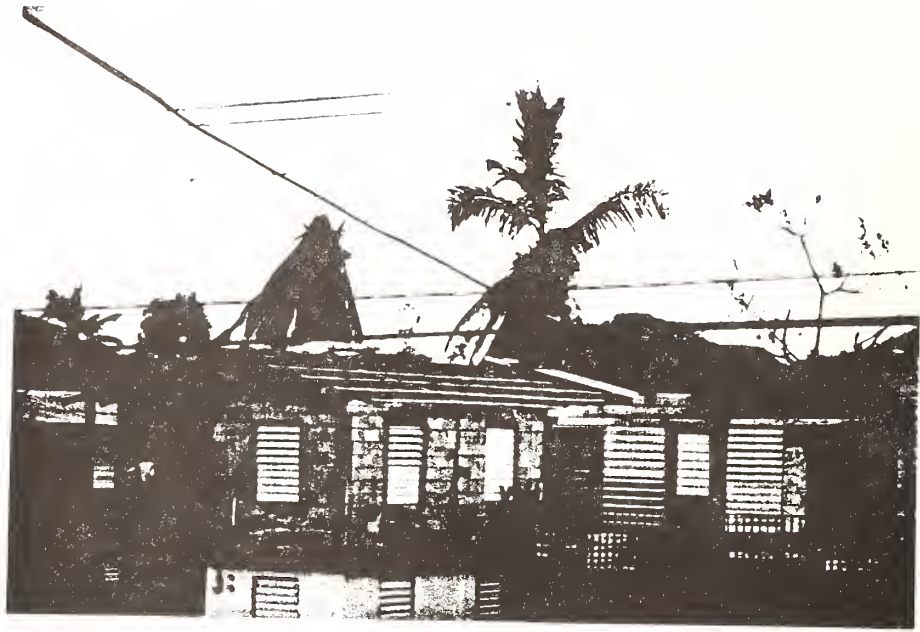
Figure 12. Failed corrugated steel sheet roofing, Puerto Rico

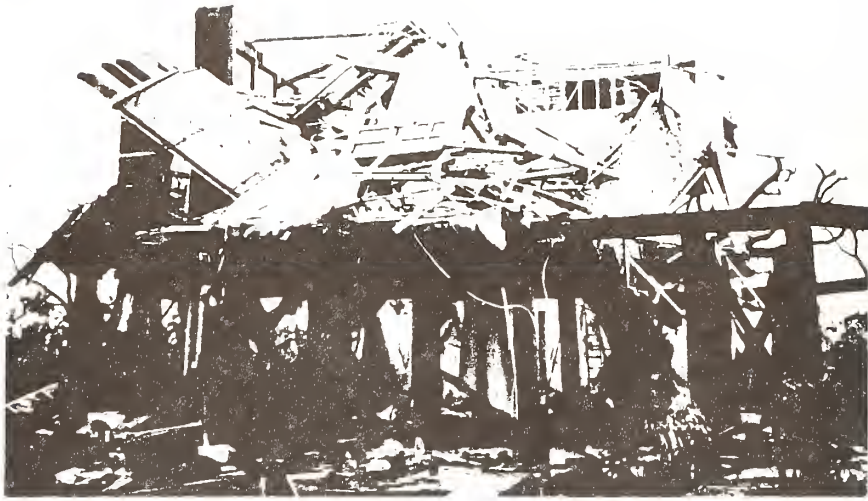
Figure 2. Heavily Damaged House, Bull Bay.

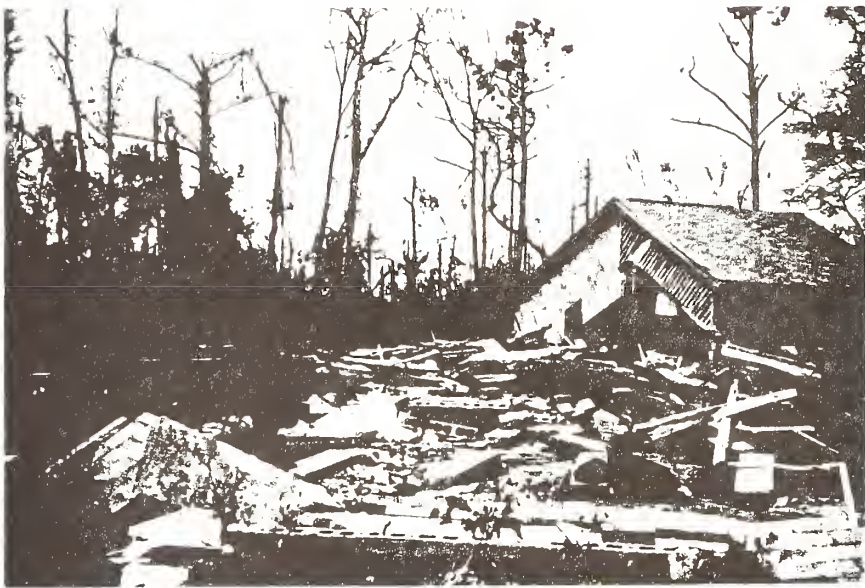
Figure 3. Shear Failure of House, Bull Bay.

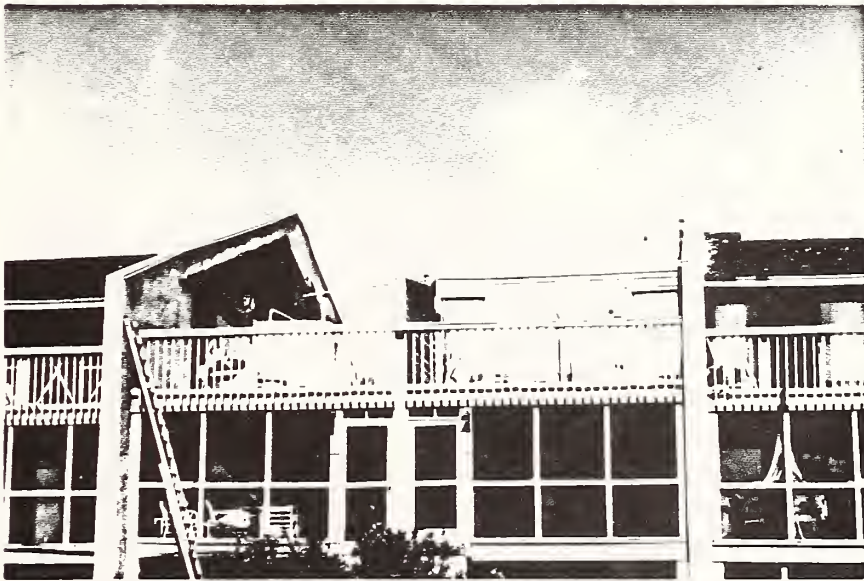
Figure 5. Condominium Roof Failure, Isle of Palms.

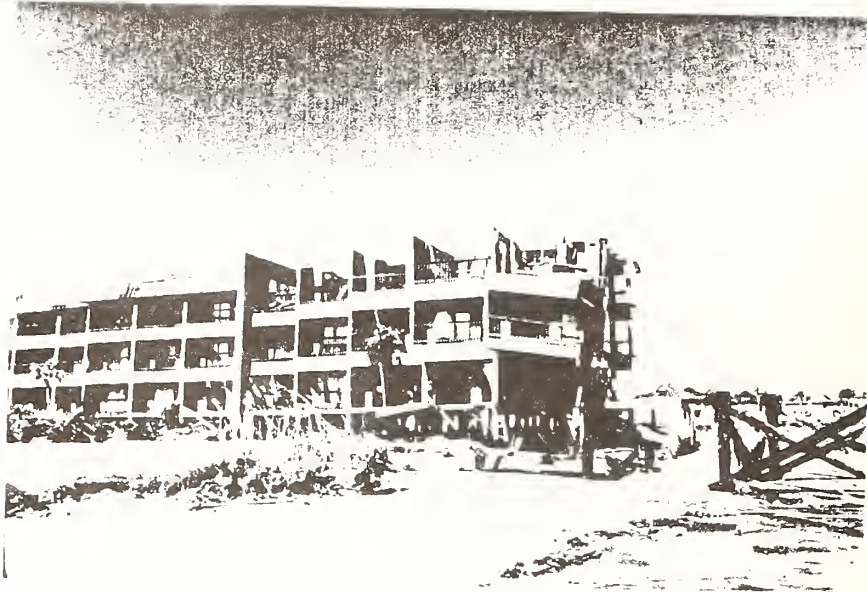
Figure 6. Wind and Surge Damage to Condominium, Isle of Palms.

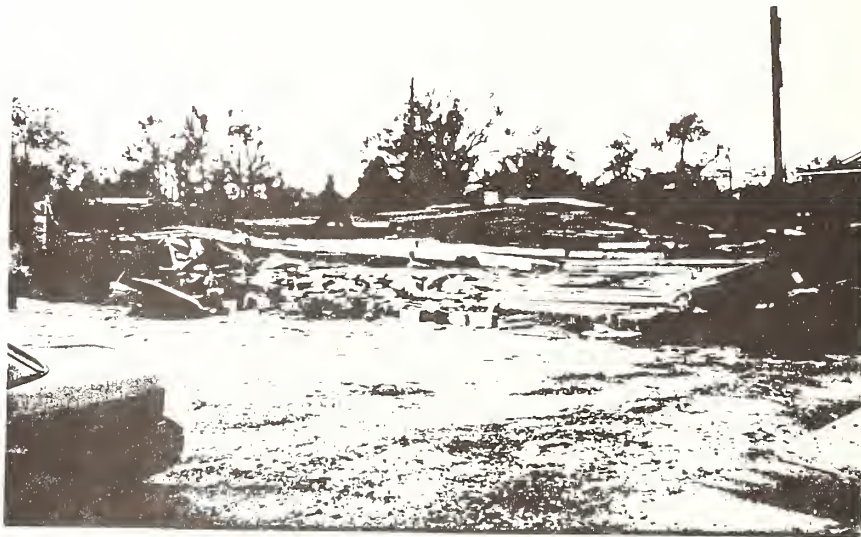
Figure 7. Collapse of Masonry Commercial Structure, North Charleston
