## MONITORING OF THE RIVERBEDS OF RIVERS DNIESTER AND TISZA OF THE CARPATHIAN REGION

Kh. Burshtynska, V. Shevchuk, S. Tretyak, V. Vekliuk

Department of Photogrammetry and Geoinformatics of National University Lviv Polytechnic, Lviv, Ukraine –  
byrsht@polynet.lviv.ua, aspirantvov08@rambler.ru

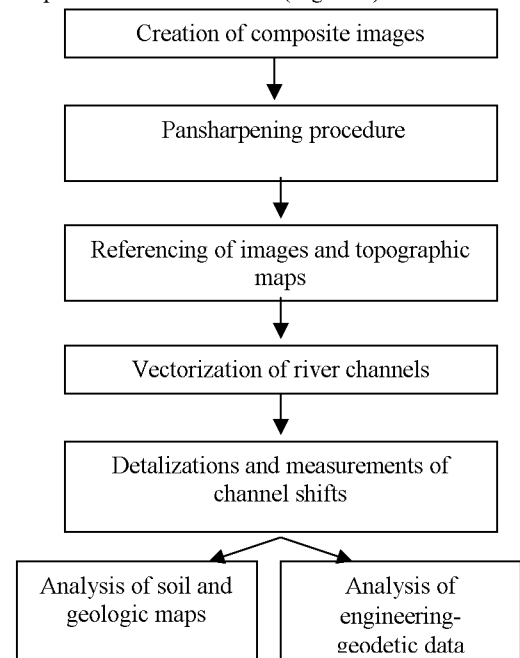
Figure 1. Flowchart of riverbed shifts monitoring for the rivers Dniester and Tisza

In the study we developed the flowchart for monitoring of channel processes of these rivers (Figure 1).

Global tasks relate to the planned shifts of riverbeds; for these tasks space images of middle resolution with easily visible drainage structure are used. For studies related to the determination of high accuracy deformation processes, especially in urban areas, we applied high resolution space images. High precision determination of deformation processes in riverbeds, including changes in topography, are possible through a ground-based geodetic work or field observations. The analysis of geological and soil maps allows to identify rocks, sediments and soils in the places of considerable shifts of the rivers.

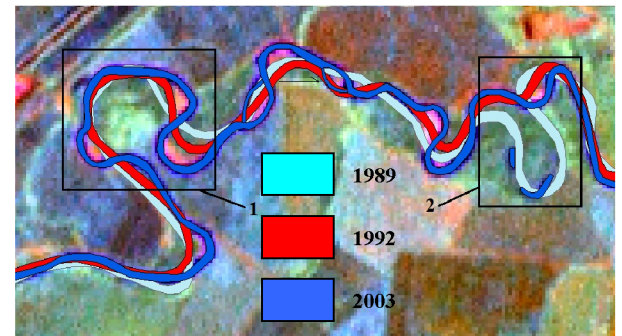
Figure 2. Digitized channels of the Dniester river in different years with the image of Landsat 7

Figure 2 shows the shift of the riverbed according to space images from the satellites Landsat 5 (red color) and Landsat 7 (blue color), as well as 1989 topographic map (azure). Maximum changes have been detected on sections 1 and 2. They reach 85 m in the first section from 1989 to 1992, and

420 m in the second section over the same period. Large curve near railroad tracks is especially dangerous for the environment (section 1).

The changes of riverbeds can be observed even at a relatively small 10 year period (1992 – 2003), indicating instability of the channel and significant impact of flood events. Major floods occurred in the Carpathian region in 1998 and 2001.

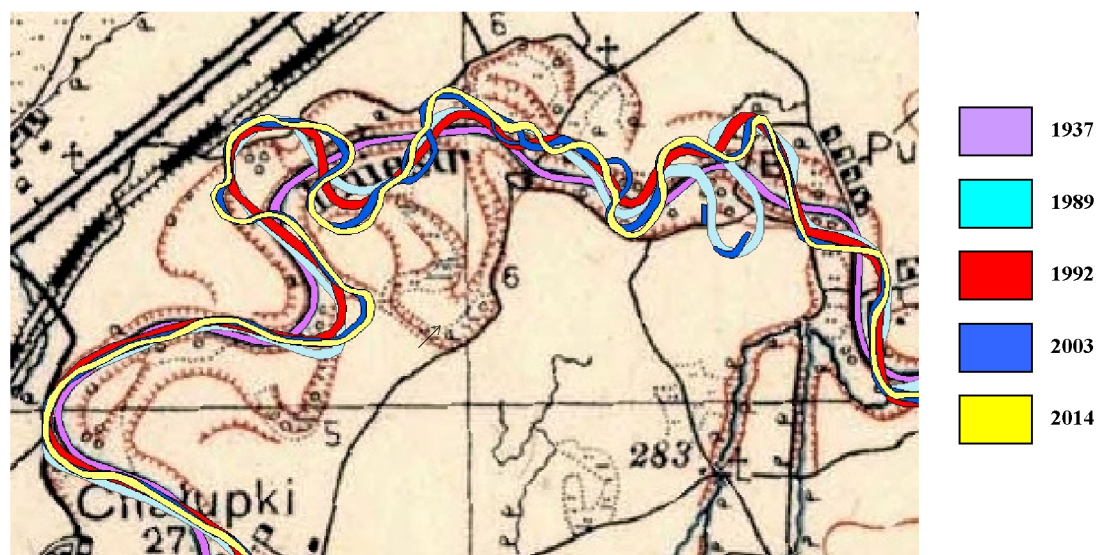
Figure 3. Digitized channels of the river Dniester over different years (from 1937 to 2014)

Analyzing the topographic map of 1937 (Figure 3), we can explain such instability of the riverbed in the studied section by erosion of soils, which is represented by numerous ravines. The same Figure presents the results of analysis of the shift of Dniester's riverbed according to all available materials: the image of riverbed, digitized on the 1937 map, is in purple, and the satellite images of 2014 are in yellow. The type of colors of other images of the riverbed is the same as on Figure 2.

The migration of riverbed to the side of the railway can be observed on section 1. The section 2 shows a significant change of riverbed in 1989 (azure), compared to 1937.

In general, the river is inclined to meandering at the studied sector. Then, in 1992-2014 the river broke through the meander, returned to its original riverbed and left behind an oxbow lake.

The section 1 portrays a systematic deviation of the riverbed to the right, caused by the erosion. Main deviations of the Dniester's riverbed at sections 1, 2 are given on table 2.

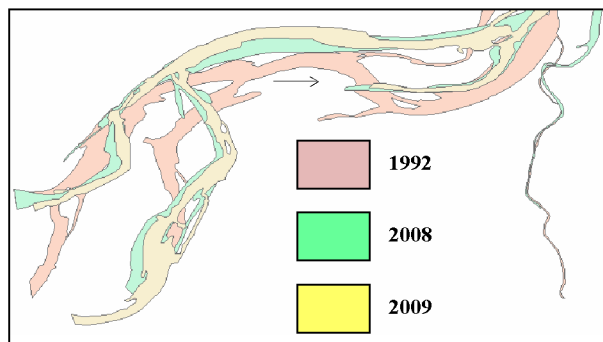
Figure 4. A comparative image of the Stryi river channel according to the topographic plans of 1992, 2008 and space image of 2009

The figure 4 depicts a digitized channel of the river Stryi (its riverbed by the 1992 topographic plan is given in red, by the 2008 topographic plan – in green, and by space image of 2009 – in yellow).

The analysis allows to conclude that in this area the riverbed is weak. Its maximum shifts over 17 years amount to 100-130 m. The change of its configuration is largely due to strong floods and anthropogenic activity. Therefore, considering small angles of the slope of coastal areas (up to 1-2°), we can assume that generally the floods of 1997, 1998, 2001, 2004 and, especially, 2008 caused this phenomenon.

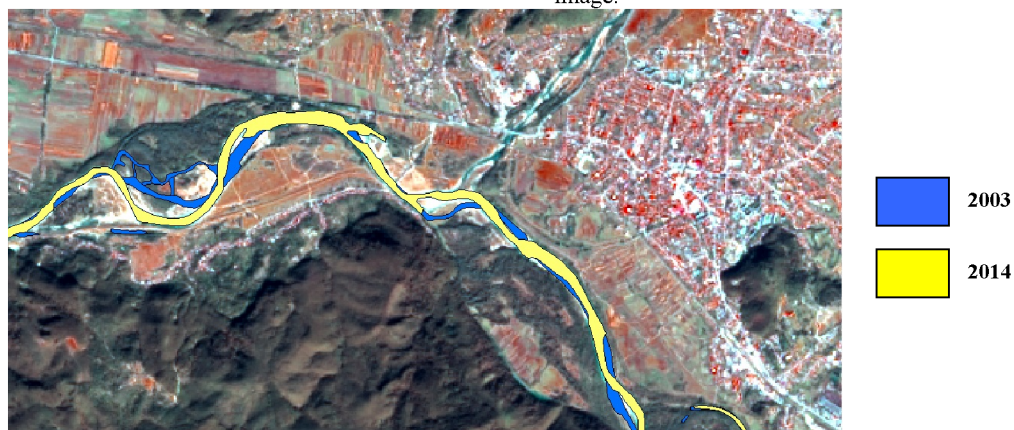
Figure 6. The Tisza's riverbed according to space images by Landsat 5 (blue) and Landsat 8 (yellow)

Even the space images of Tisza's riverbed, obtained from satellites Landsat 5 (2003) and Landsat 8 (2014) over the 11-year period (figure 6), which almost overlap, show a significant migration of riverbed in the north-west part of the image.
