# Detection of collapsed buildings from lidar data due to the 2016 Kumamoto earthquake in Japan

**Abstract.** The 2016 Kumamoto earthquake sequence was triggered by an  $M_w$  6.2 event at 21:26 on 14 April. Approximately 28 h later, at 01:25 on 16 April, an  $M_w$  7.0 event (the mainshock) followed. The epicenters of both events were located near the residential area of Mashiki and affected the region nearby. Due to very strong seismic ground motion, the earthquake produced extensive damage to buildings and infrastructure. In this paper, collapsed buildings were detected using a pair of digital surface models (DSMs), taken before and after the 16 April mainshock by airborne light detection and ranging (lidar) flights. Different methods were evaluated to identify collapsed buildings from the DSMs. The change in average elevation within a building footprint was found to be the most important factor. Finally, the distribution of collapsed buildings in the study area was presented, and the result was consistent with that of a building damage survey performed after the earthquake.

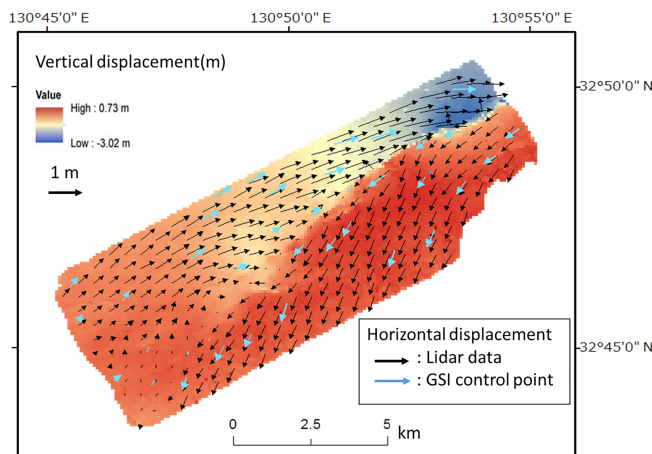
**Figure 2.** Estimated three-dimensional coseismic displacement after the mainshock of the 2016 Kumamoto earthquake. The black arrows and the shaded colors indicate the horizontal and vertical displacements obtained from lidar (Moya et al., 2017). The blue arrows indicate the horizontal displacements at the control points measured by the Geospatial Information Authority of Japan (2016).

The study area is located in the near field of the Kumamoto earthquake sequence where significant permanent ground displacements were produced during the earthquake. A direct comparison of the BDSM and ADSM shows that the building coordinates do not match because the ADSM contains coseismic displacements. Therefore, the ADSM was shifted before detecting the damaged buildings based on the permanent crustal movement calculated by Moya et al. (2017). To do this, an automated procedure for calculating the permanent three-dimensional (3-D) displacement was implemented. The permanent ground displacement was calculated by 100 m grid size and then applied to the ADSM pixels within the grid size. Figure 2 illustrates the calculated permanent ground displacement of the common lidar data area. In the figure, the results of new field measurement carried out in August 2016 for surveying reference points after the Kumamoto earthquake are also shown (Geospatial Information Authority of Japan, 2017). The coseismic displacements estimated from the lidar data show good agreement with the survey results (Fig. 3). In Fig. 2, the causative fault is located in the areas where sudden changes in the direction of the permanent ground displacement are observed. Over the entire study area, a maximum horizontal displacement of approximately 2 m was observed.

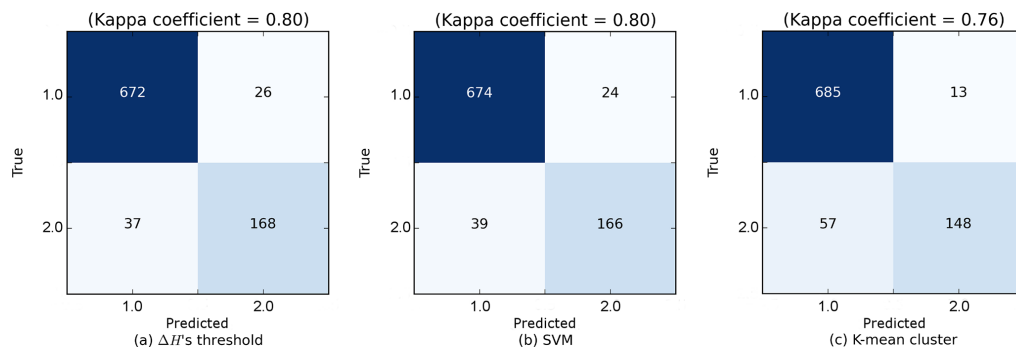
**Figure 13.** Confusion matrix calculated from the comparison of the ground truth data and the predicted damage levels based on the  $\Delta H$  threshold (a), SVM (b), and  $k$ -means clustering (c). Two damage levels, noncollapsed (1.0) and collapsed (2.0), were employed.

distance from each other (Scikit-learn, 2017b). Figure 12 represents the predicted collapsed and noncollapsed buildings using the  $k$ -means clustering method, for which the Cohen's kappa coefficient obtained was 0.76. Figure 13 shows the confusion matrix calculated from the comparison between the ground truth data and the predicted results from the three methods explained above, applying a  $\Delta H$  threshold, SVM, and  $k$ -means clustering. The first two methods show the same level of accuracy, while  $k$ -means clustering shows a lower accuracy.

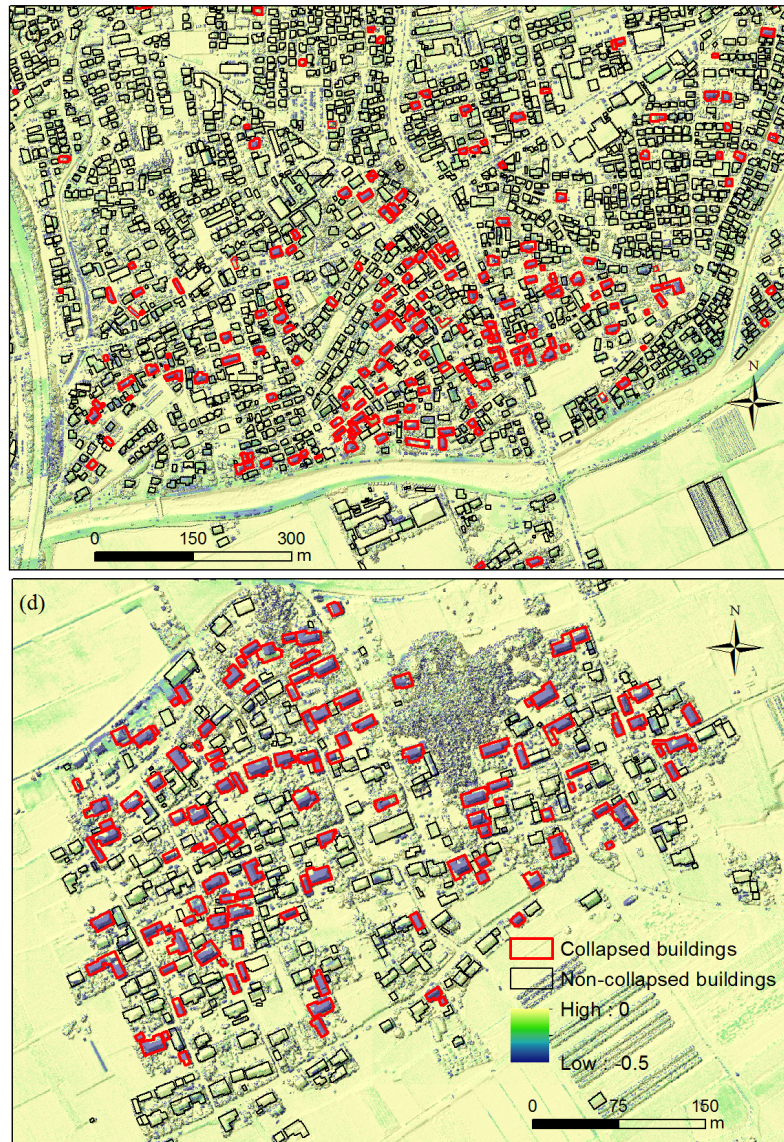
**Figure 15.** Close-up view of areas (c) and (d) in Fig. 14a where collapsed buildings are concentrated. The red and green polygons are the collapsed and noncollapsed buildings estimated using the threshold ( $\Delta H < -0.5$  m).

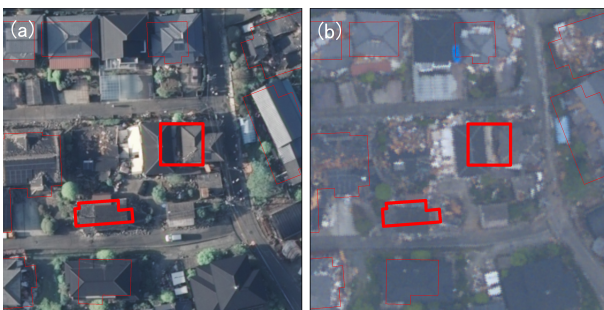
**Figure 16.** (a) Aerial image taken on 15 April; (b) aerial image taken on April 23. The thick red polygons show buildings that collapsed after the foreshock and were detected using the  $\Delta H$  threshold.

It was observed that some buildings that collapsed during the foreshock (14 April event) were also detected by the lidar methods. In order to be detected, the debris of those buildings should be either severely disturbed by the mainshock (16 April event) or removed before the ADSM was

recorded. For instance, Fig. 16 shows two buildings that collapsed during the foreshock (Fig. 16a). However, because the mainshock produced a significant reduction in their elevations (Fig. 16b), it was also detected from the pair of lidar.
