UNITED STATES AIR FORCE
AIRCRAFT ACCIDENT INVESTIGATION
BOARD REPORT

KC-135R, T/N 63-8877

DATE OF ACCIDENT: 3 MAY 2013

SUMMARY OF FACTS AND STATEMENT OF OPINION
KC-135R, T/N 63-8877
3 MAY 2013

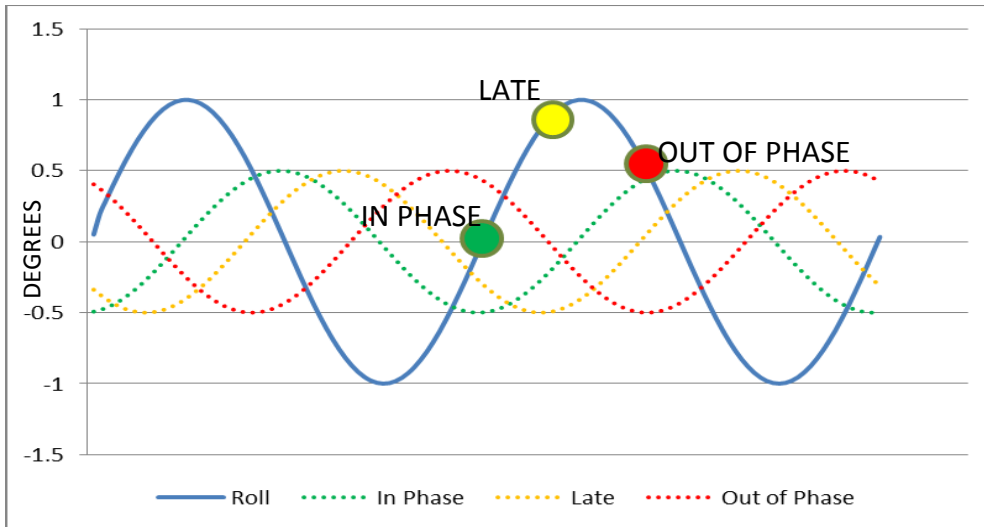
Figure 8. Lateral Input Timing Assessment (Tabs Z-10, EE-9)

Proper dutch roll damping technique is to apply corrective control wheel deflections as the aircraft rolls through wings-level (Tab AA-28 to AA-30). The damping technique described in the Technical Order (T.O.) 1C-135(K)R(II)-1, *KC-135R/T Inflight Data*, Change 12, dated 1 April 2012 (Inflight Manual) is to “stop the rising wing at the desired bank angle with aileron. As the wing stops, center the control wheel and prepare to stop the other wing from rising” (Tab BB-171). Figure 8 below illustrates a properly timed input (green dot), a late input (yellow dot), and an out-of-phase input (red dot). The out-of-phase input occurs after roll has changed direction, and in turn accelerates roll in the opposite direction instead of dampening the roll (Tab BB-171).

Most of the lateral control inputs accomplished by the MCP resemble the example in Figure 8 regarding the in-phase properly timed inputs. As a trend, the roll oscillations of the MA did not get larger with in-phase inputs. The amplitudes of the inputs appear to be greater than that of the roll. When engaged, the autopilot applied late corrections and in turn generated a larger, steeper roll in the opposite direction (Tab EE-9). Once the MP takes control of the MA, the lateral control inputs can no longer be reliably measured due to the FDR constraints and rudder input (Tab EE-4 to EE-5, EE-9).

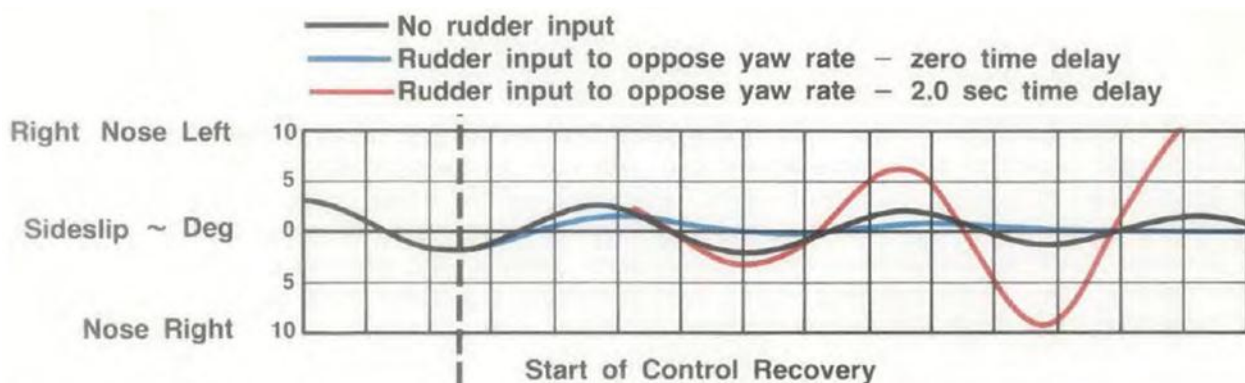
Figure 12. KC-135 Aerodynamic Characteristics Dutch Roll Response (Tab AA-28)

The MP's rudder response in Figure 11 is analogous to the expected response shown in red in Figure 12. The rudder input is nearly zero between 08:47:00Z and 08:47:34Z, and the sideslip oscillates steadily around plus or minus three degrees. From 08:47:34Z until the end of the flight, rudder inputs correspond with increasing sideslip on each cycle. Figure 12 below depicts the same divergent sideslip tendency when rudder input is applied two seconds late (Tabs AA-28, EE-11). The amplitudes of the building sideslip are indicative of undesirable rudder inputs, as shown below in Figure 12 (Tab AA-28).

If the pilot reacts to an abrupt roll onset with a large rudder input in the opposite direction, the pilot can induce large amplitude oscillations. These large amplitude oscillations can generate loads that exceed the limit loads and possibly the ultimate loads, which could result in structural damage (Tab AA-14). Boeing airplanes are capable of sustaining a single control input, but do not account for input reversal or oscillatory inputs (Tab AA-8). The Inflight Manual contains a warning that states, "The sudden reversal of rudder direction at high rudder deflections, due to improper rudder application or abrupt release, can result in overstressing the vertical fin. This condition could be brought about during recovery attempts from a flight condition induced by a lateral control malfunction" (Tab BB-172). Figure 11 depicts an abrupt application and release of the rudder, as well as a rudder reversal in the final 10 seconds (Tab EE-11).

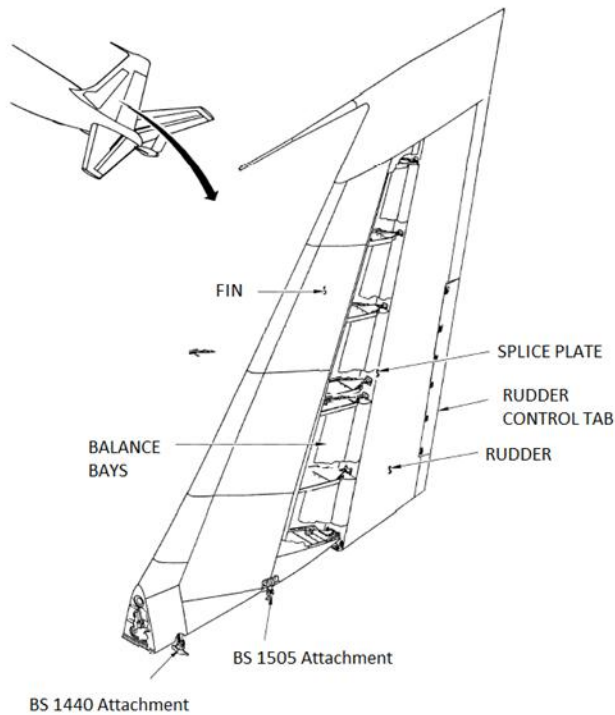
Figure 14. Vertical Stabilizer and Rudder Balance Bays (Tab BB-127, BB-131)

The vertical stabilizer attachment points at Body Station (BS) 1440 and BS 1507, shown in Figure 16, were both intact on the stabilizer side with the pins installed. At BS 1440, the fuselage side fittings had failed just below the fuselage skin (exterior metal sheets of the aircraft's structure) (Tabs J-18, HH-3). At BS 1505, the top of the bulkhead with the complete body side fitting intact was still attached to the vertical stabilizer (Tab J-18).

The vertical stabilizer has a steel splice plate on the left hand side at Fin Station 156 to splice the chord at the aft end of the balance bays (See Figure 14) (Tab J-18). A splice is a joint made in assembly of aircraft components in which all individual parts have to be attached (Tab HH-3). The Fin Station 156 splice plate was deformed to the left and down due to the rudder PCU being torn from the vertical stabilizer as the rudder hinge assemblies and rudder failed (Tab J-86 to J-87). In addition, there was a large rip on the left hand side of the vertical stabilizer where the rudder PCU tore through the skin (Tab J-18). The left and right sides of the vertical stabilizer contained forward to aft skin buckling from the bottom up (Tab J-87). Buckling is an out of plane bending, followed by crushing of material under compressive loads (Tab HH-3).

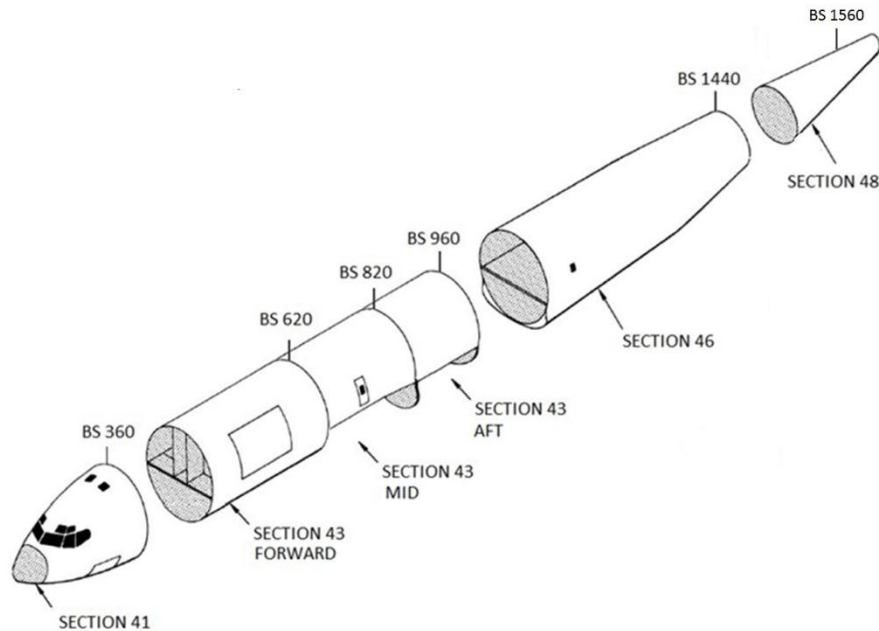
Figure 16. Fuselage Section Breakdown (Tab Z-11)

The MA separated at the Section 46 to Section 48 joint just aft of the BS 1440 bulkhead (Tab J-23). The top of Section 48 remained attached to the vertical stabilizer (Tab J-24). It extended from approximately BS 1440 aft to BS 1560 and spanned multiple stringer bays (Tab J-24, J-85).

Structural failure of the wings and fuselage forward of BS 1440 caused the MA to break into four pieces which included three major fuselage sections and the right hand wing. The forward portion of the fuselage separated just forward of the wing near BS 600 (Section 41 and Section 43 Forward). The fuselage broke just aft of the wings near BS 980 (Section 46). The center portion of the fuselage over the wings and main landing gear wheel wells (Section 43 middle and aft) remained with the center wing and most of the left hand wing. (See Figure 16) In addition, all four engines separated from the wings (Tab J-28).

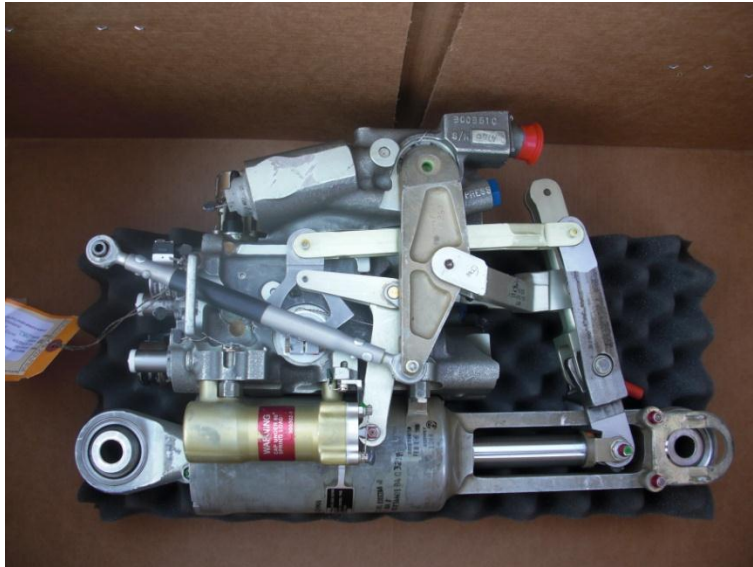
Figure 18. Non-Mishap PCU (Tab Z-10)

The PCU main actuator shaft was broken in the vertical plane after the rudder hinges overloaded and subsequently failed (Tab J-35 to J-36). Failure of PCU linkages also occurred including a broken tablock H-assembly (Tab J-125). The outer fork of the main clevis of the lock lever was bent toward the actuator at the bearing rivet (See Figure 19) (Tab DD-12).

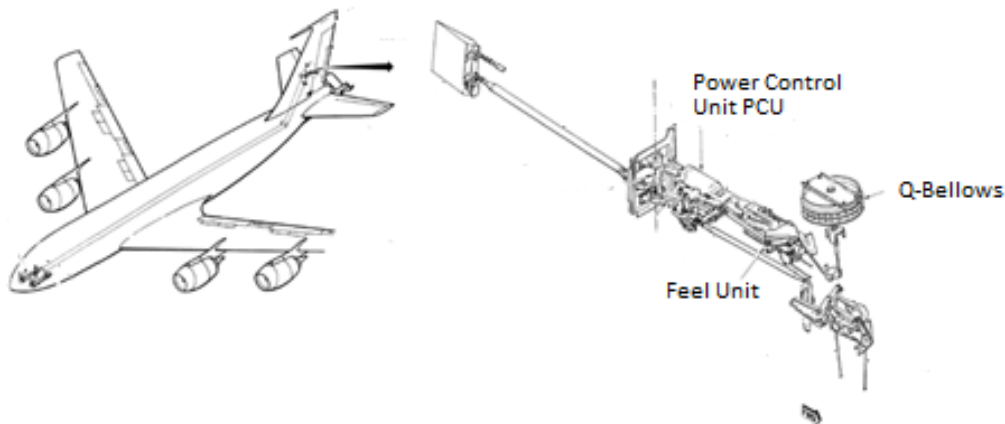
Figure 20. Rudder Control Equipment (Tab BB-47)

Wear in the rudder feel unit could correlate to an input to the rudder PCU to displace the rudder either left or right from the neutral position. Due to increased Q-bellow input at higher airspeeds, the rudder would be displaced further from the neutral position. Additionally, the Q-bellow force will be constant and not induce an oscillating rudder (Tab DD-13). Analysis of FDR data from the MA's previous flight on 2 May 2013 from RAF Mildenhall to the Transit Center at Manas showed the MA's control wheel position appeared to be oriented to the left indicating a tendency for the MA to roll to right (Tab EE-6). Although the MA had a tendency to roll to the right, the flight on 2 May 2013 was uneventful (Tabs V-20.7, EE-6). FDR data indicates the MA experienced this same tendency to roll to the right on the day of the mishap (Tab EE-5). There is no evidence to suggest the wear in the rudder feel unit caused the MA's rudder to oscillate during the mishap flight.
