LONG TERM PERFORMANCE AND DURABILITY OF EPS AS A LIGHTWEIGHT FILLING MATERIAL

Tor Erik Frydenlund¹ and Roald Aabøe²

ABSTRACT

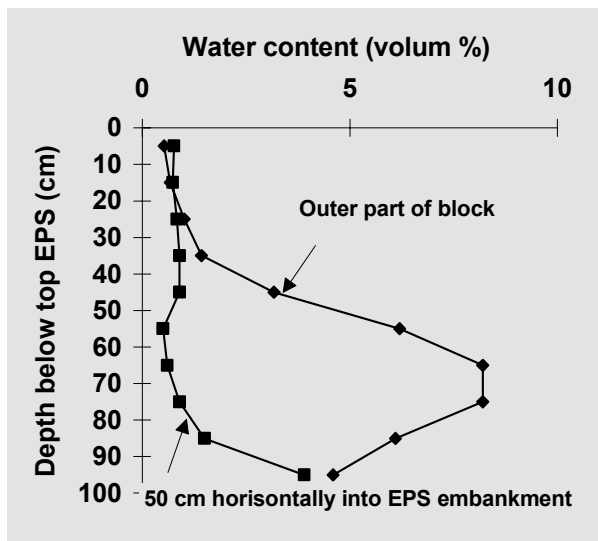
Figure 6. Horizontal gradient of water in EPS.

Furthermore there is hardly any change in the water content with time. Samples retrieved from the outer parts of blocks facing the surrounding soil, may have a higher water content as may be seen from figure 6. But only 500 mm further into the block the water content is again below 1 % by volume. So the average density of drained fills therefore has values of $\rho < 30 \text{ kg/m}^3$. This is well below the specified design value for such fills.

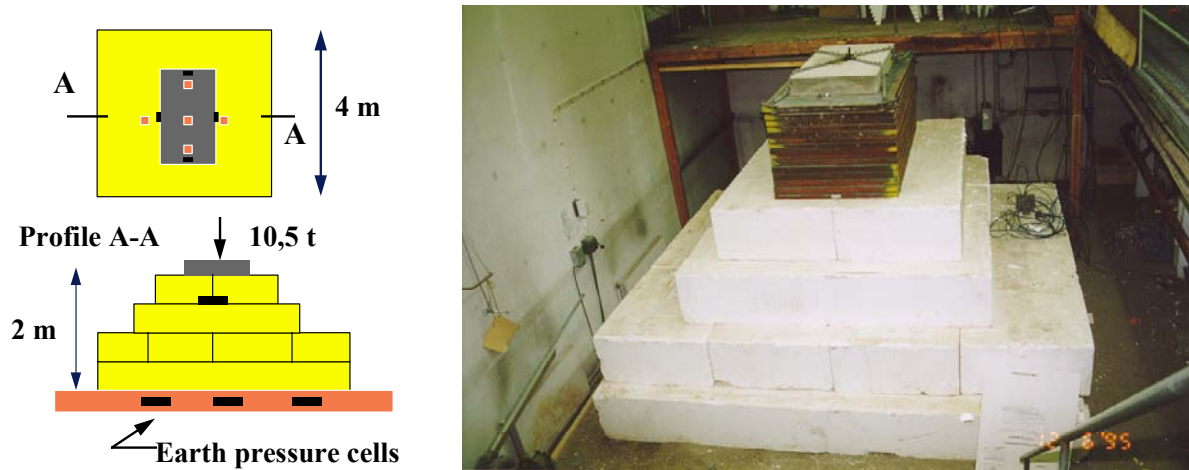
Figure 8. EPS test fill at the Norwegian Road Research Laboratory (now the Road Technology Department).

In a laboratory test at the Norwegian Road Research Laboratory (now the Road Technology Department) a test fill of height 2 m with normal size blocks and a compressive strength $\sigma = 100$ kPa has been loaded to a value of $q_{dw} = 52.5$ kPa and the resulting deformations observed over a period of 3 years (figure 8). The results are shown in fig. 9 together with calculated deformations to be expected according to the theories introduced by Magnan & Serratrice.

As may be seen the observed deformations are only about half of the calculated values and creep deformations with time are also much smaller.

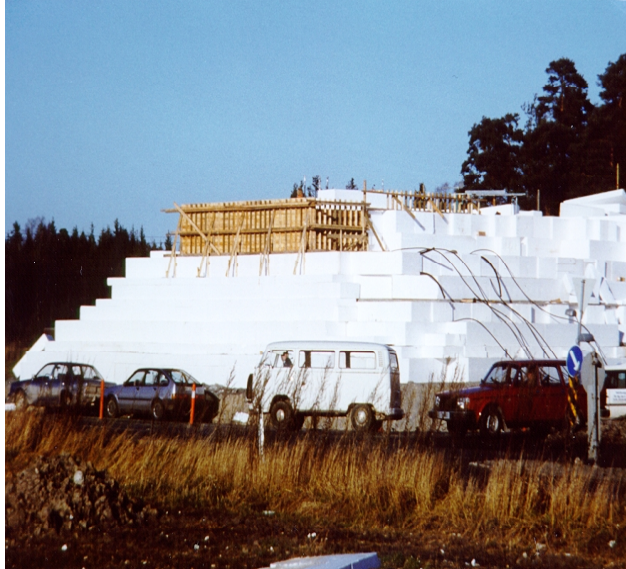
Figure 10. Construction of one abutment on the EPS embankments at Løkkeberg bridge.

Due to low bearing capacity and expected large settlements, light weight fill materials (EPS) were considered in the embankments adjoining the bridge. The project provided an opportunity to place the bridge foundation directly on top of the EPS fills (height 4,5 and 5m) on both sides as an alternative to placing the bridge abutment on piled foundations. Since the bridge was a temporary solution and possible deformations could be adjusted during the period of operation, it was decided to carry out the project as a full scale test.

The bridge is today still in operation 12 years after completion. No signs of cracks or uneven deformation

have been observed. The bridge support has been lifted 30 cm on one side due to subsoil settlements in accordance with the theoretical calculation.

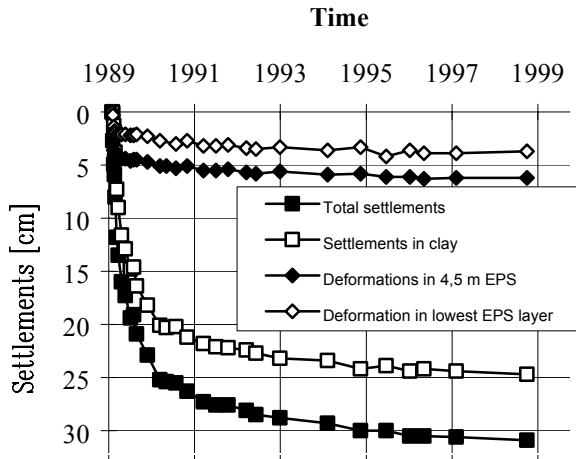
After 12 years in service measurements show only small deformations 6 cm (1,3 % of the EPS height) in the EPS embankment. Most of the deformation occurred during the construction period and only minor creep effects have been measured. Creep deformations as an average and creep deformations for the lowest EPS layer (6,5 % of the layer thickness) are shown in fig. 13 for a period of 10 years.

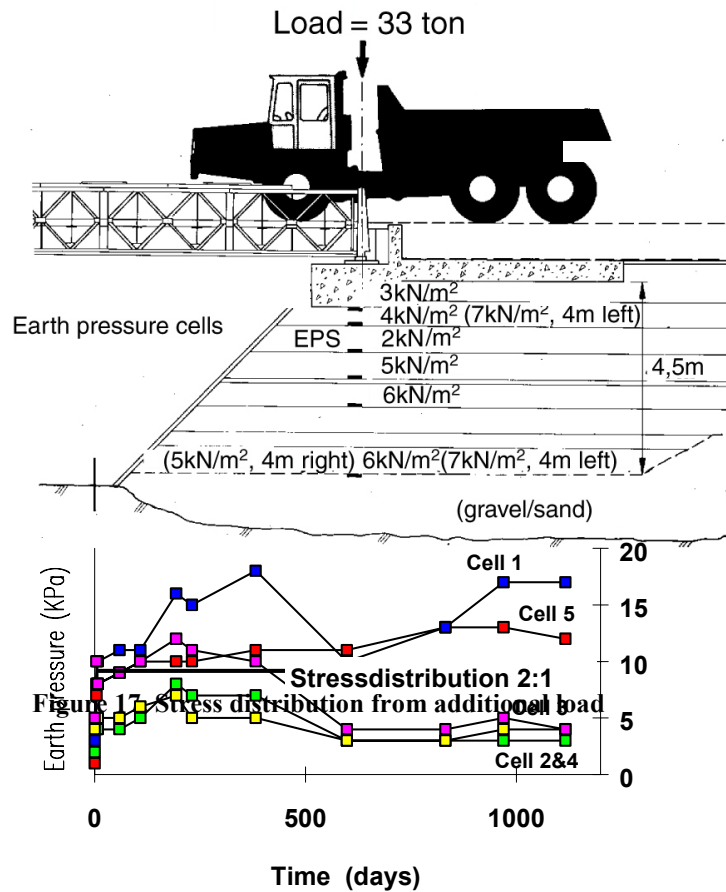
Figure 18. Stress distribution measured in the test hall (fig. 8)

expected. The measured stress increases in the various fill levels with the additional load from the dumper correspond well with the stress distribution without the dumper. The increase in stress levels from the dumper is shown in fig.17. The same tendency to reduced vertical pressure in a zone beneath the abutment was also observed here. After unloading the abutment, the pressure cells immediately returned to the initial stress levels.

Attempts have been made to evaluate the stress distribution in EPS blocks based on stress observations from the test hall experiments and stress observations at the Løkkeberg bridge. Stresses between blocks are of course difficult to measure and the results obtained vary quite a bit. In general measured stresses are, however, relatively low and indicate that the outer perimeter of the stress bulb may lie within a slope with a gradient 2:1 measured from the outer edge of the loading area. However, depending on the stiffness of the loading area and possible load eccentricities, local stress concentrations may occur. In figure 18 the stress level at the bottom of the fill with distribution gradient 2:1 is indicated with a black line and may be compared to the stress levels of cells 2, 3, 4 and 5.

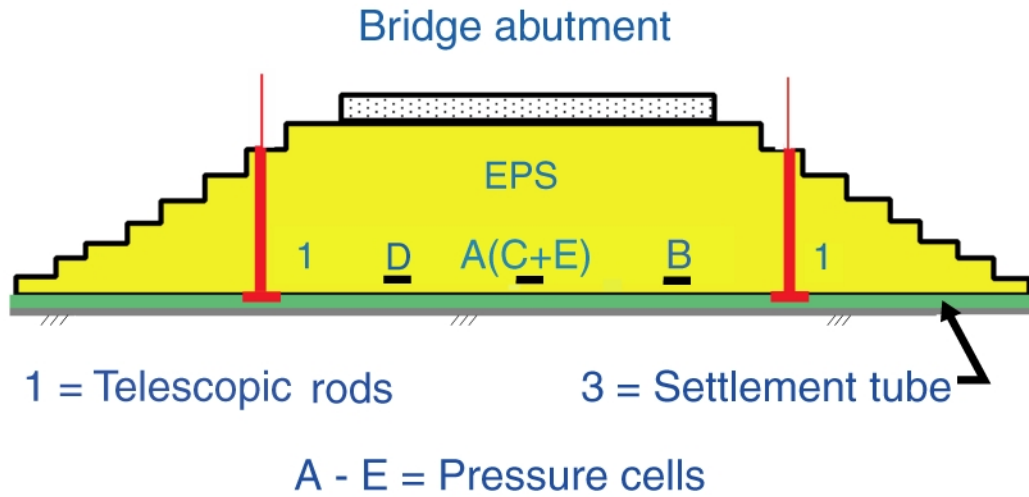
Figure 21. Cross section indicating location of monitoring equipment

In order to monitor the behaviour of the reconstructed bridge both settlement and stress gauges have been installed. The different types of gauges and their locations in relation to the bridge abutment are indicated on the cross section in figure 21. Prior to reconstruction the settlement rates of the adjoining fills were observed to be 100 mm/year and constant. After reconstruction the settlements have nearly been halted as shown on figure 22.
