***Poria Incrassata* Rot:**

Prevention and Control in Buildings

Technical Bulletin No. 1385
U.S. Department of Agriculture
Forest Service

Technical Bulletin No. 1385

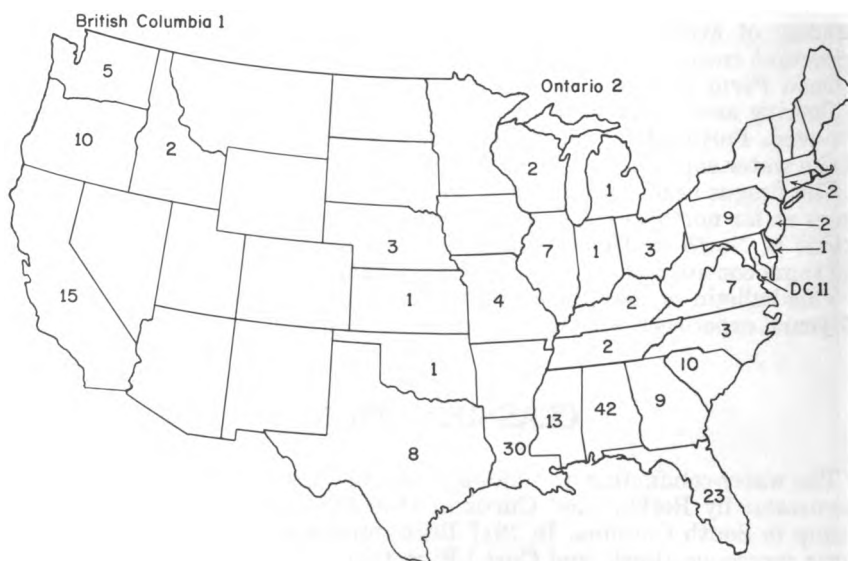
Figure 1 gives the relative prevalence in terms of number of cases reported. The map is based on published accounts, observations by the author, and correspondence with those who have encountered the fungus in buildings or have herbarium material. Most reports are from the Southeastern States.

Figure 1.—Number of occurrences of *Poria incrassata* reported since 1849.
