Report on the investigation of
the capsized and foundering of the fishing vessel

JMT (M99)

resulting in two fatalities

3.8nm off Rame Head, English Channel

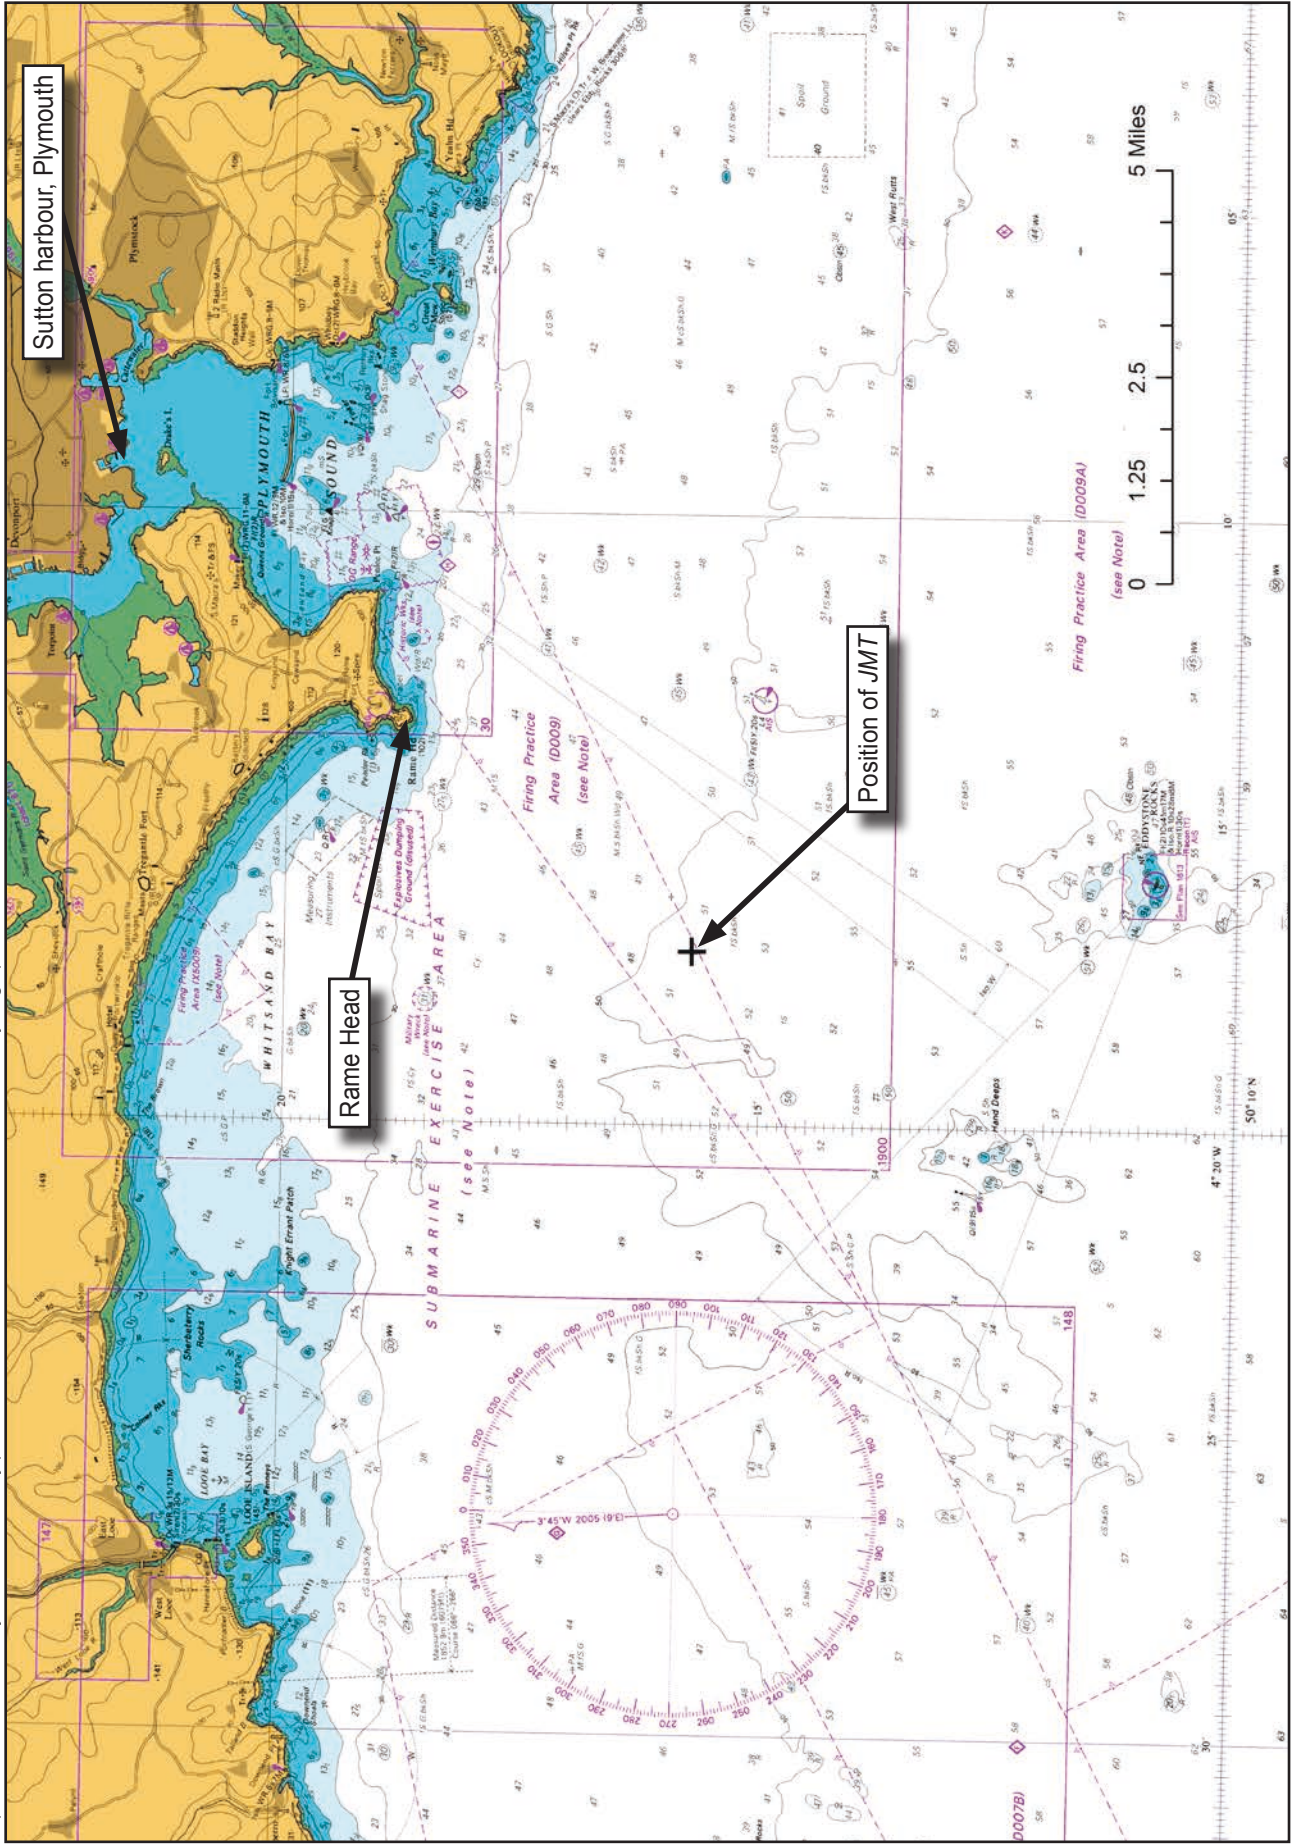
Figure 1: Extract from chart BA 1267 showing the position of the wreck

The lifeboats, helicopter, yachts and local fishing vessels continued to search for *JMT*'s skipper. The wreck of *JMT* was located 3.8nm south-west of Rame Head (**Figure 1**) at a depth of 51m, but Michael Hill was not found.

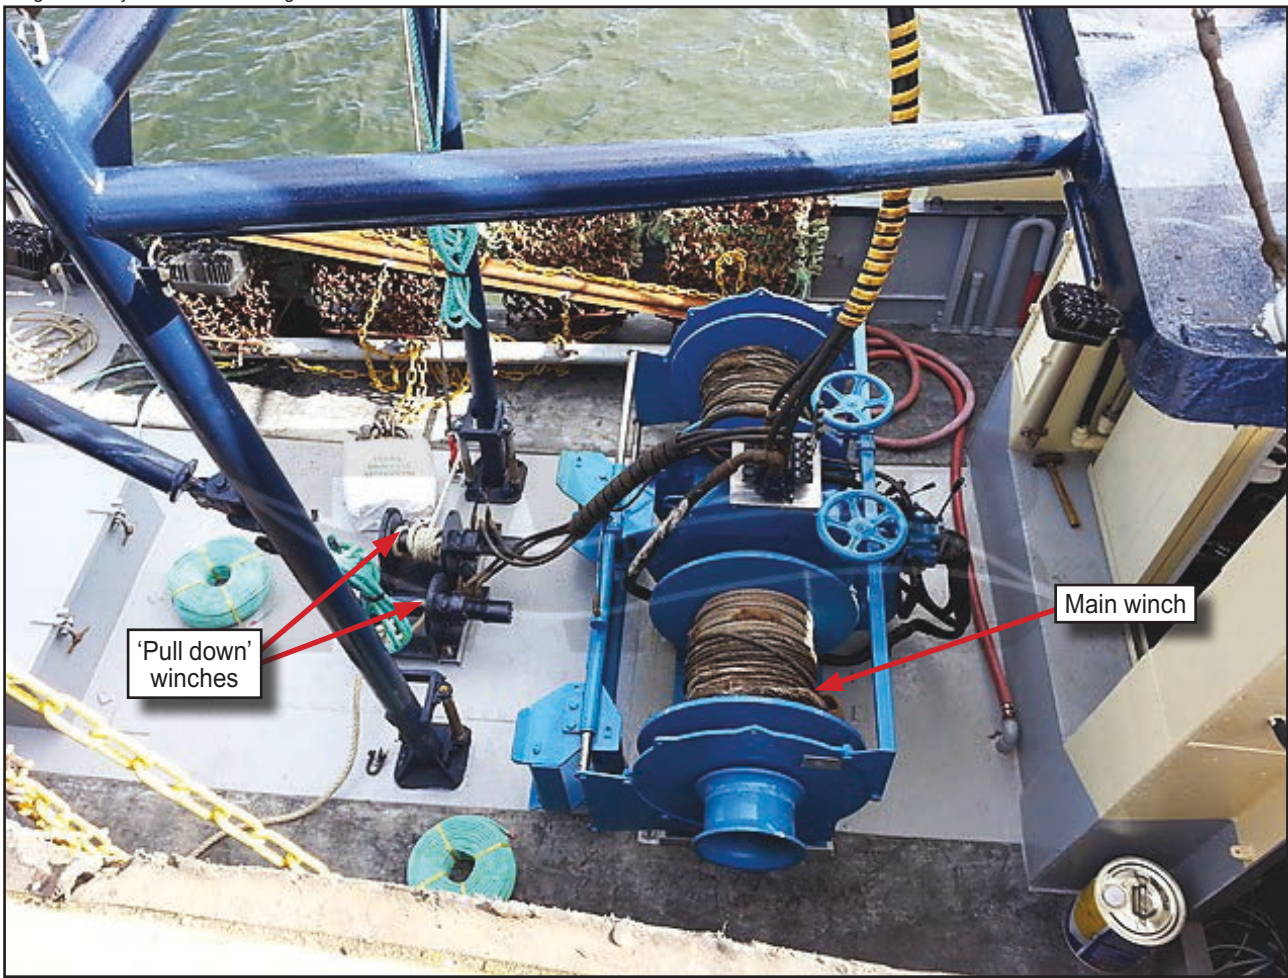
Figure 2: *JMT*'s working deck

During the day, the skipper maintained regular contact with his father by mobile telephone. At about 1430, the skipper informed his father that he had caught 17 bags of scallops and that his target for the day was 25 bags. He also told him that the starboard 'pull-down' winch (**Figure 2**) was not working.

- The skipper's mobile phone was plugged into a charging socket in the wheelhouse.
- Four retaining bolts were missing from the starboard hydraulic 'pull-down' winch (**Figure 30**).

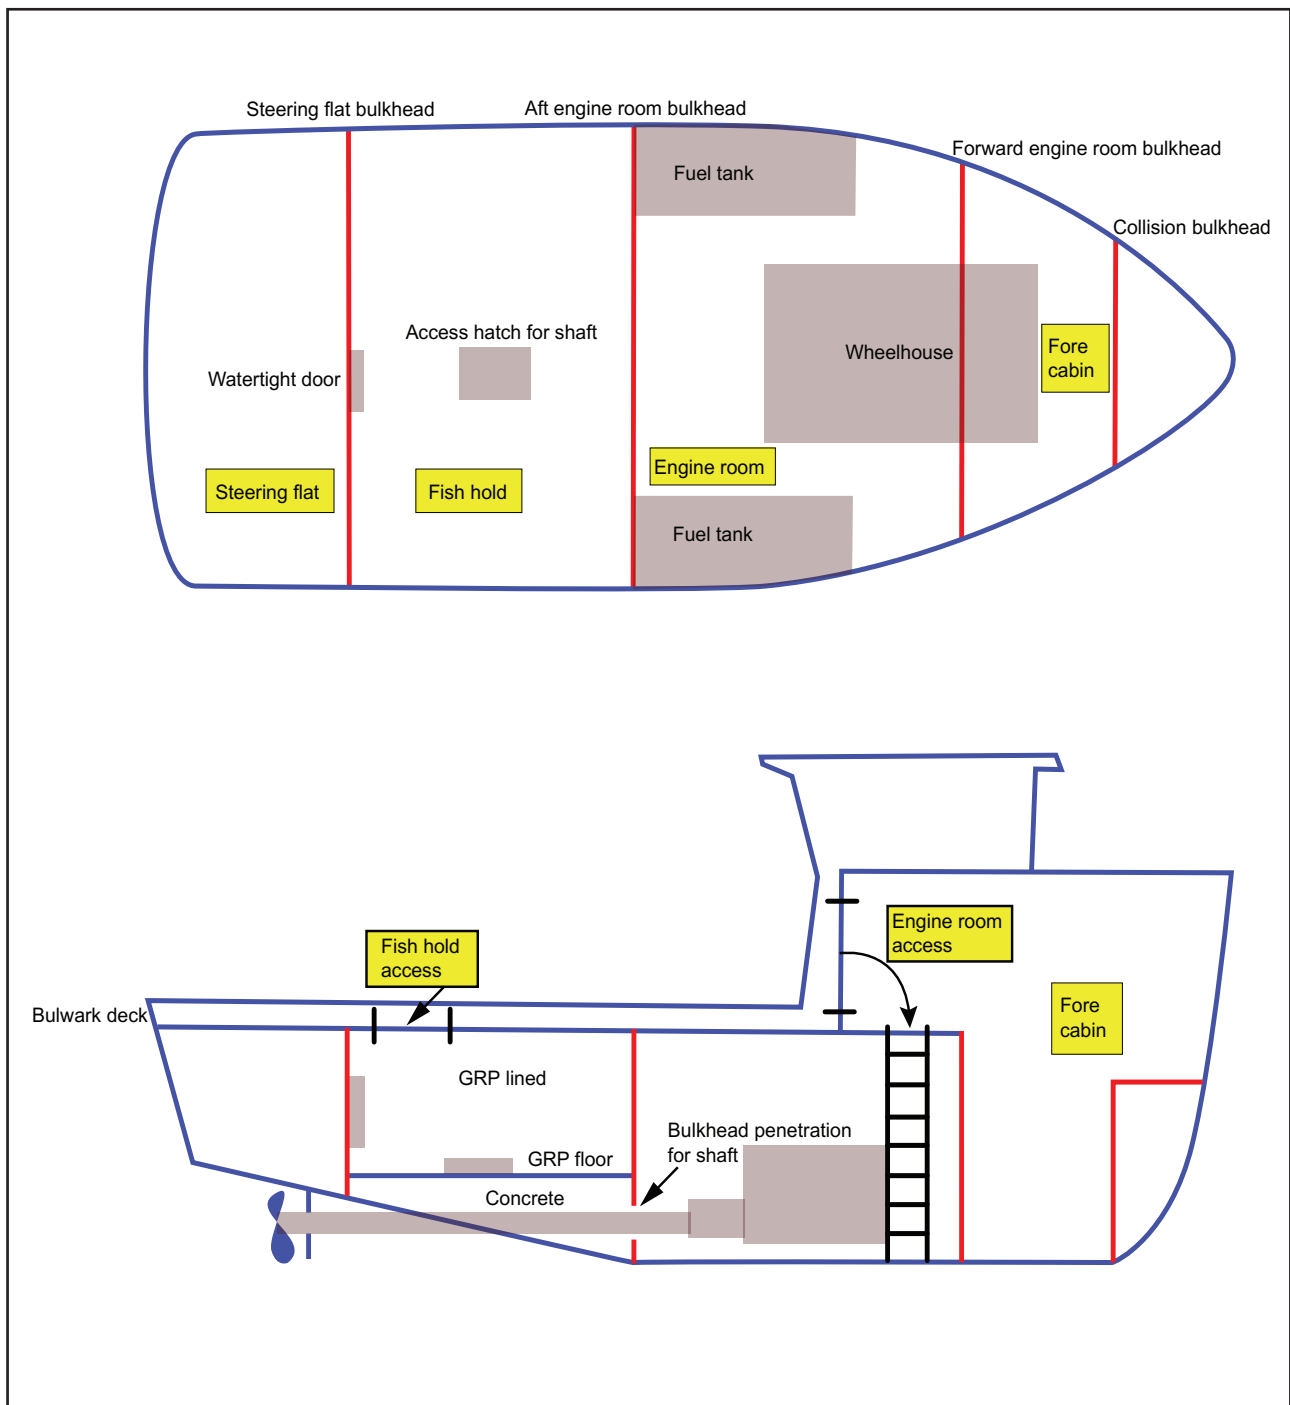
Figure 6: Arrangement of *JMT*'s compartments

JMT had four main below-deck compartments: the fore cabin accommodation, the engine room, the fish hold and the steering flat (**Figure 6**). Access to the accommodation was via a short companionway from the wheelhouse. Access to the engine room was through an opening in the deck of the forward casing. The fish hold, which was lined with glass re-enforced plastic but was not refrigerated, was entered via a hatch located on the aft deck. The steering flat was accessed via a watertight door from the fish hold.

The common bulkheads between the engine room and the accommodation and between the fish hold and the steering flat were watertight. The common bulkhead between the engine room and the fish hold was penetrated by the propeller shaft at bilge level. The shaft was accessed via a hatch on the fish hold's deck.

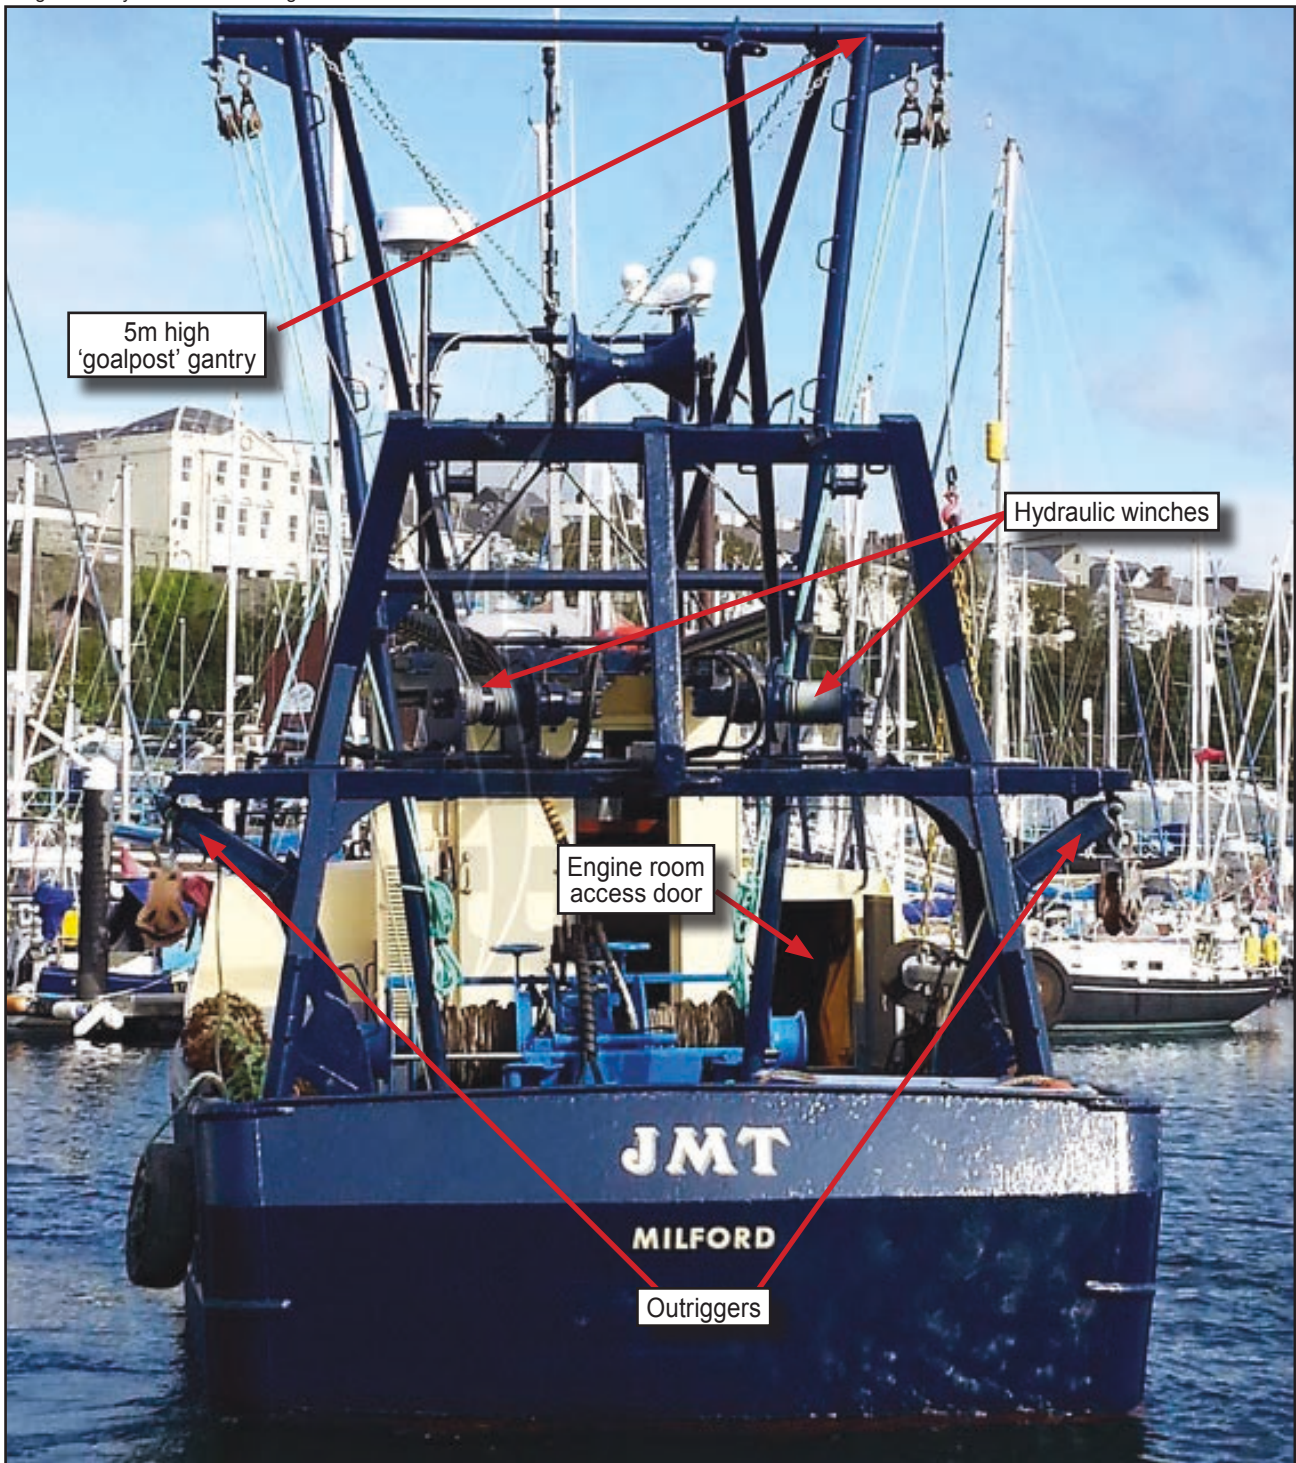
Figure 8: *JMT* post modification in 2013

- The replacement of the trawl winch.
- The replacement of the 'scotch poles' (**Figures 5 and 7**) with a 5m high 'goalpost' gantry (**Figure 8**).
- The addition of two 'pull-down' hydraulic winches on the deck (**Figure 2**) and two hydraulic winches on the aft gantry for lifting the scallop gear (**Figure 8**).
- The addition of 'outriggers' for towing the scallop gear (**Figure 8**).

- The relocation of the engine room access from inside the wheelhouse to a side casing door (**Figure 8**).
- The removal of the shelter on the port side.
- The addition of a collision bulkhead.
- The shaft inspection hatch in the fish hold was secured (**Figure 9**).

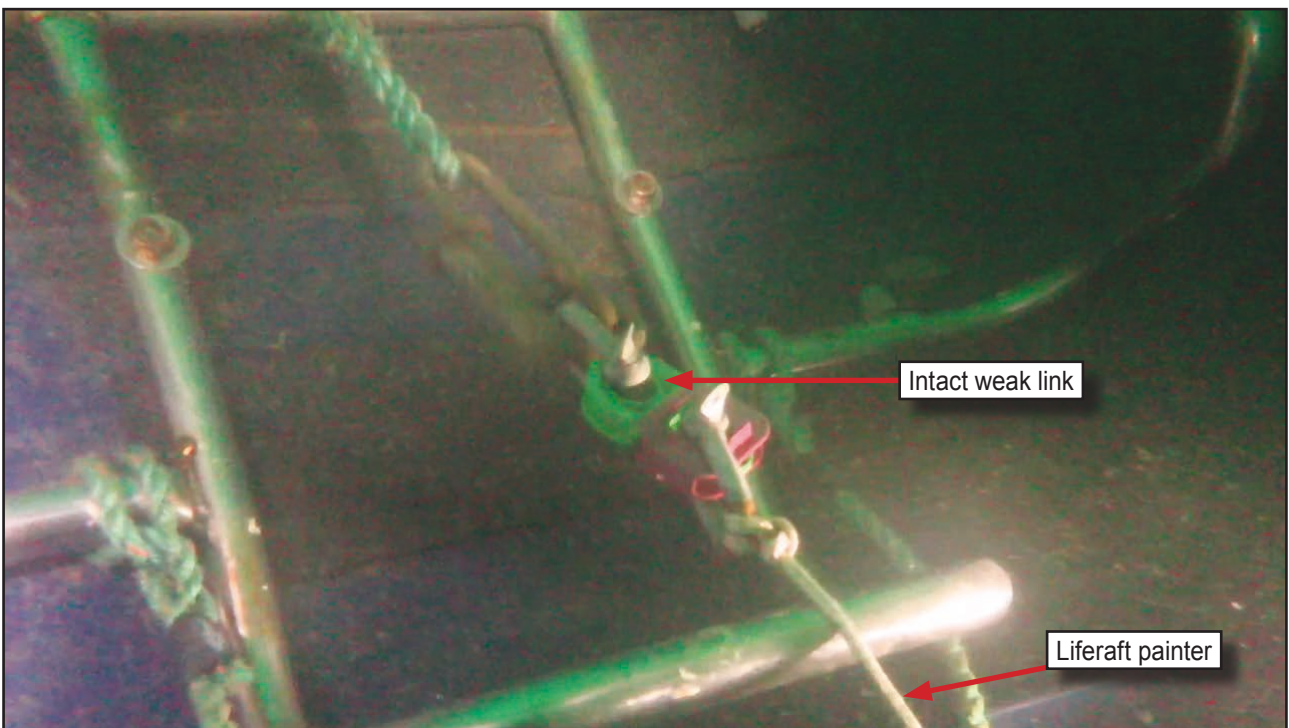
Figure 20: Underwater image of JMT's HRU

- *JMT* was resting on its keel with a 30° list to port at a depth of 51m.
- The port side scallop dredge gear was raised and full of stones, debris and scallops (**Figure 19**).
- The starboard side scallop dredge gear was empty and inverted (**Figure 19**).
- The wheelhouse door, engine room access and fish hold hatch were open.
- A full bag of scallops was on the port side of the aft deck.
- The liferaft's HRU had activated.
- The liferaft was on the seabed off the vessel's port side and was still attached to the vessel by its painter, which was connected to the weak link from the HRU. The weak link was intact (**Figure 20**).
- The two life-rings were missing from the wheelhouse roof.

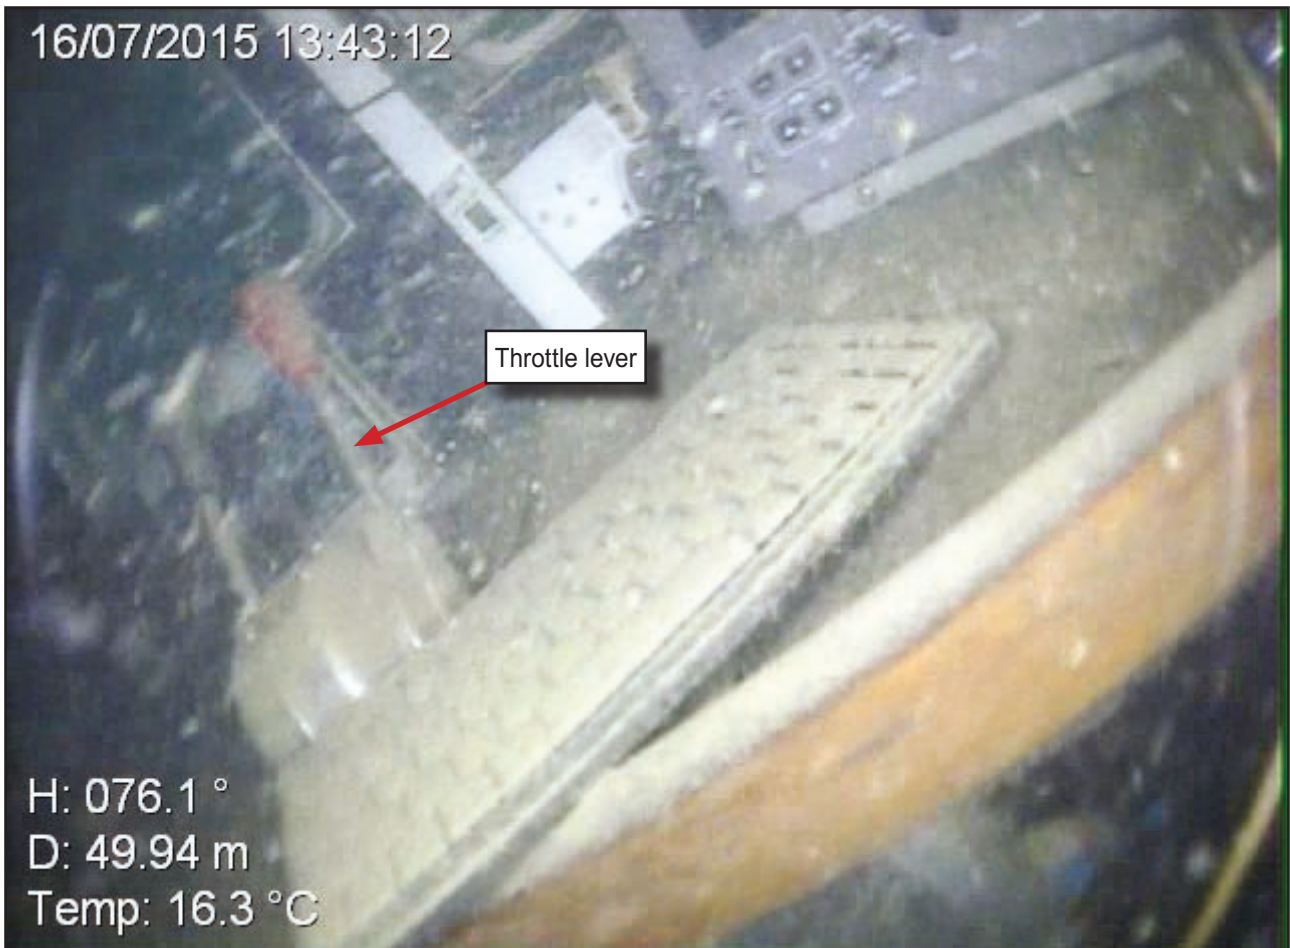
Figure 21: JMT's throttle position

On 16 July 2015, Plymouth University conducted a remotely operated vehicle (ROV) survey of *JMT* on behalf of the Devon and Cornwall Police. The survey's aims were to positively identify the vessel and to locate the missing skipper. The skipper was not found but the survey identified that the engine gear lever was in the 'ahead' position and that the engine throttle lever was fully forward (minimum speed) (**Figure 21**), there were no bags of scallops in the fish hold and that the cover to the shaft inspection hatch was missing (**Figure 22**).

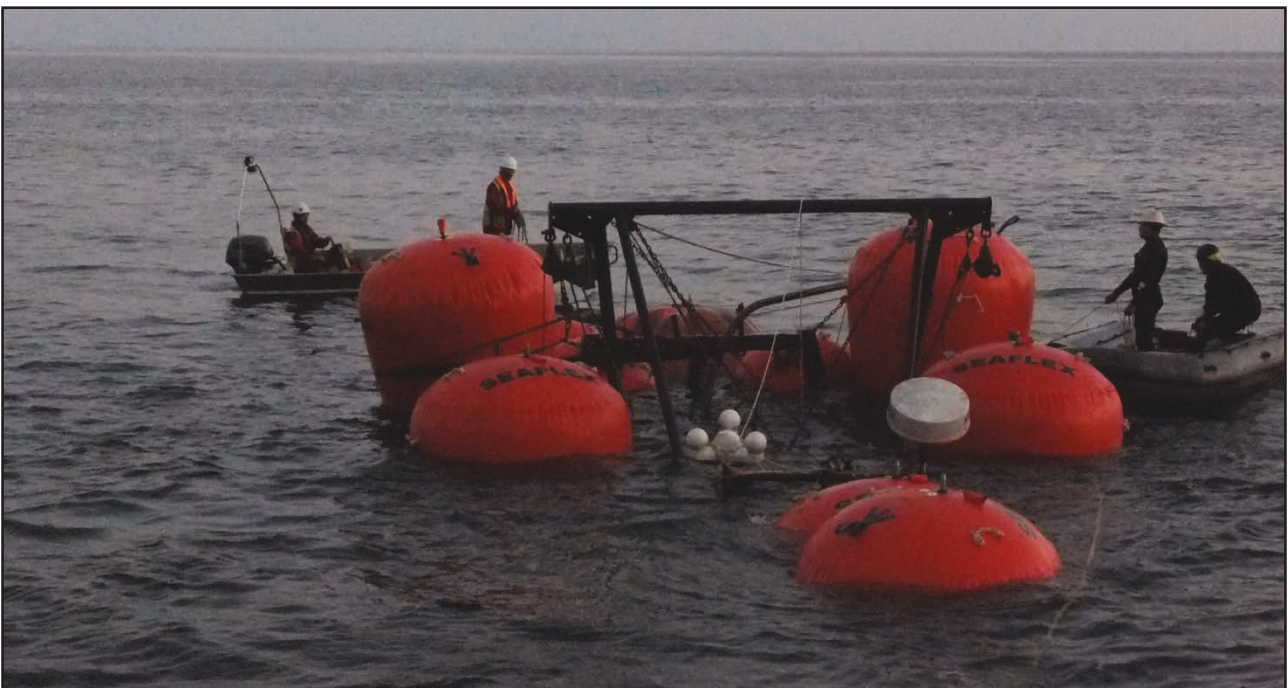
Figure 24: *JMT* supported by airbags

On 17 August 2015, airbags were used to raise *JMT* to the sea surface (**Figure 24**). The vessel was then towed to shallower water and lowered back onto the seabed to enable divers to prepare the vessel for beaching or lifting onto a barge. During two unsuccessful recovery attempts, the airbags being used to lift *JMT* lost buoyancy, causing the vessel to sink to the seabed. No additional hull damage resulted. However, the trawl winch was dislodged from its transverse axis.

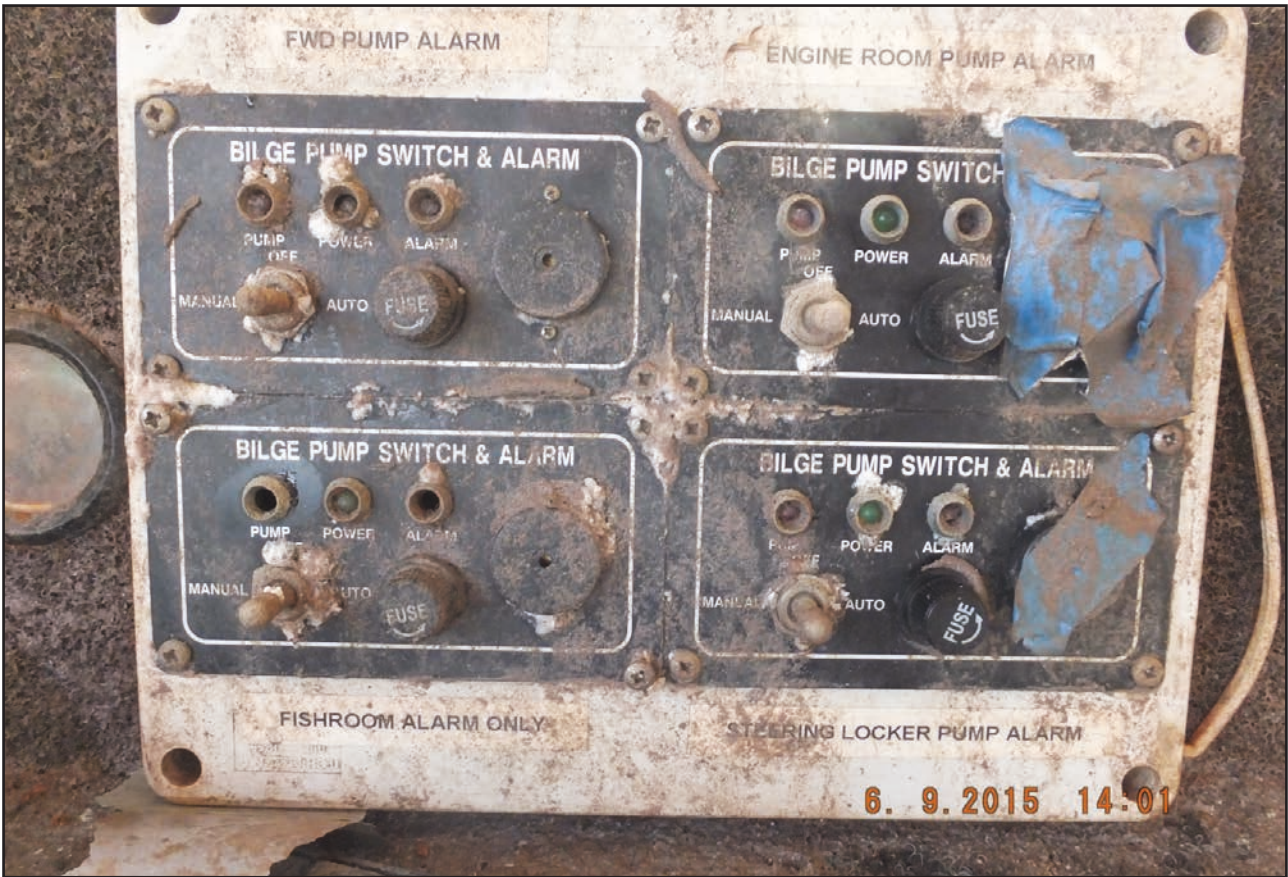
Figure 29: JMT's bilge pump switch panel

- The winch hydraulics were clutched in.
- All of the bilge pump switches were in the 'off' position and the engine room and steering locker audible alarms had been taped over (**Figure 29**).

It is almost certain that the vessel capsized suddenly and without warning. It also probably sank very quickly. The absence of other vessels in the vicinity and of any significant impact damage to *JMT*'s hull indicate that the vessel had not been involved in a collision. Furthermore, that the bilge pumps were not switched on (**Figure 29**) and the vessel was subsequently found to be watertight during the stability assessment, indicates that there had been no progressive flooding.
