MARINE SAFETY ALERT

Safety Alert 01-18

A Delayed Repair Can Bite You in the Derriere **Performing prompt maintenance is critical!**

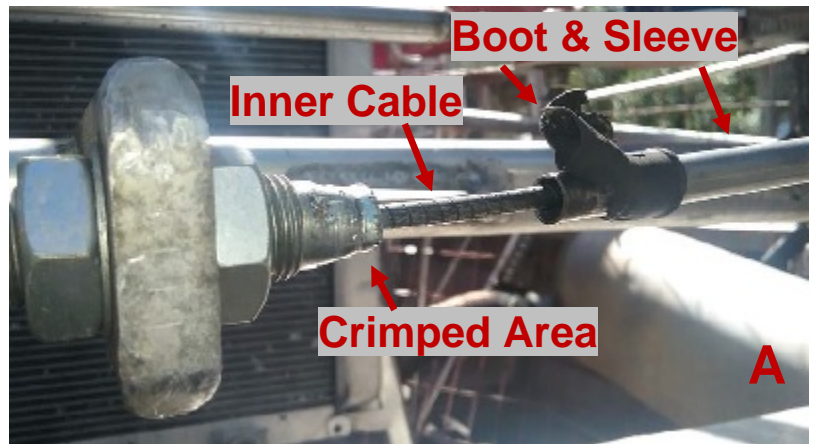
Recently, several passengers onboard a commercial airboat tour were injured when the boat lost steering and hit a tree. Fortunately, there were only a few serious injuries because the boat was not underway at full speed when the accident occurred. This Safety Alert serves as a reminder to vessel owners, operators and those who repair these vessels of the importance of recognizing risks and ensuring proper maintenance and repairs are made to minimize risk.

On some airboats, steering is achieved by directing the flow of (propulsion) fan air across two vertically placed rudder foils. As the foil position is changed the directional thrust acting on the stern of the vessel varies. The foils move in tandem because of a linkage between the two foils. The steering cable is typically only connected to one of them. The end of the body of the steering cable is secured to the vessel and locked in place by two nuts. (Image A) Attached near this fitting is a sleeve which covers the final end of the enclosed cable. The end of the sleeve is bellowed outwards and inserted into the end of the main cable body which is then crimped inward. (Image A) This joint is covered by a rubber boot to prevent dirt and debris from entering into the cable body and interfering with the enclosed cable's movement. The crimped connection allows for some angular movement at the end of the cable.

- To develop an operational paradigm where maintenance and repair items are evaluated carefully, recognizing the potentials risks associated with their operation should the repair or maintenance item not be properly performed or achieved in a timely manner.
- **For airboat operators specifically:** Owners and operators of airboats that use flexible type steering control cables are reminded of the need to thoroughly inspect cables before use, including areas under the dust boots. Due to the forces encountered on airboat applications, owners are also encouraged to ensure these cables are properly maintained and to immediately replace a worn cable. Owners are discouraged from attempting to repair a factory crimp.
