**MARINE ACCIDENT
INVESTIGATION BRANCH**

SAFETY DIGEST

**Lessons from Marine
Accident Reports
1/2018**

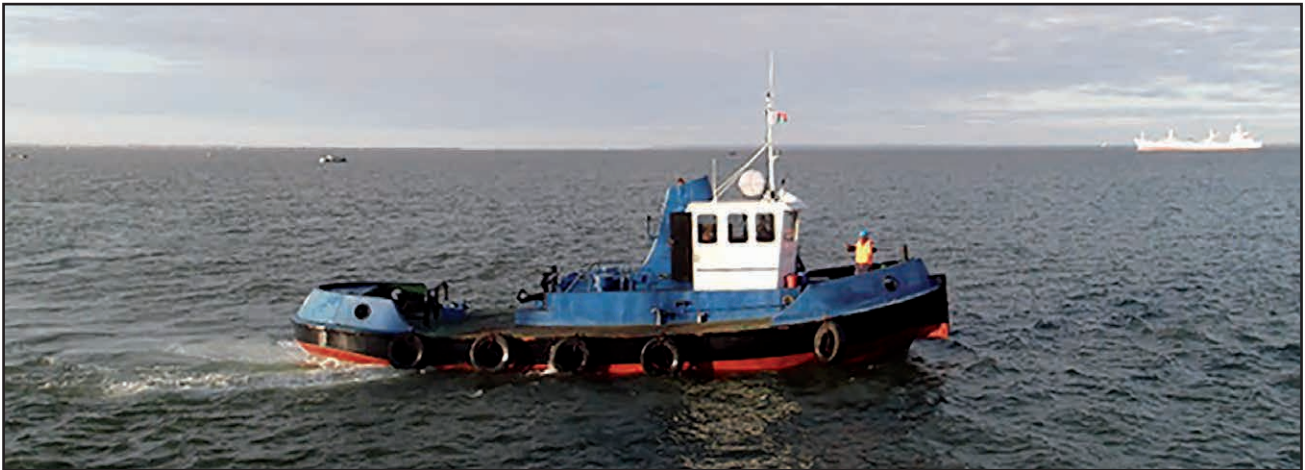
The tug was connected to the ship's port quarter to help pull its stern off the berth. During the manoeuvre, the prevailing wind and tidal conditions caused the ship to move towards an outlying mooring dolphin. To avoid striking it, the ship's master briefly increased ahead speed to 5kts, during which time the tug girted and capsized.

Figure 1: The tug

1. The girting and capsize of tugs is an ever present risk if towing operations are not managed and executed safely.
2. Girting can rapidly lead to a tug capsizing. It occurs when high athwartships towing forces cause a tug to be pulled sideways through the water by the towline. If the tug is unable to manoeuvre out of this position it is likely to capsize. Single screw tugs with a low freeboard are at particular risk of girting.

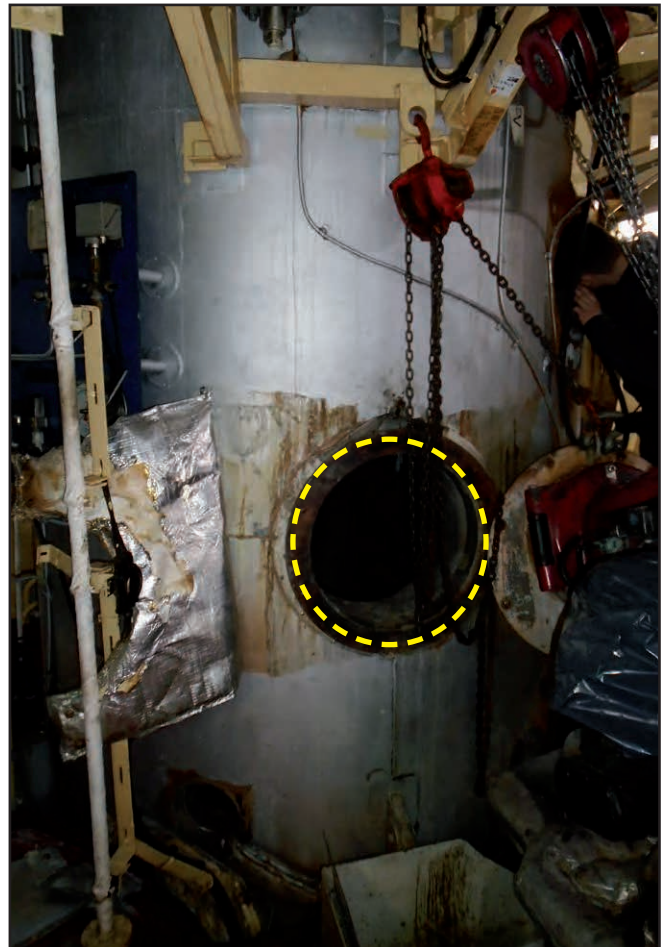
A ro-ro ferry was operating to a normal schedule with contractors on board to conduct repairs to an auxiliary boiler. The work was planned to start during an evening passage. The repairs involved hot work inside the boiler (Figure 1).

Figure 1: Furnace access

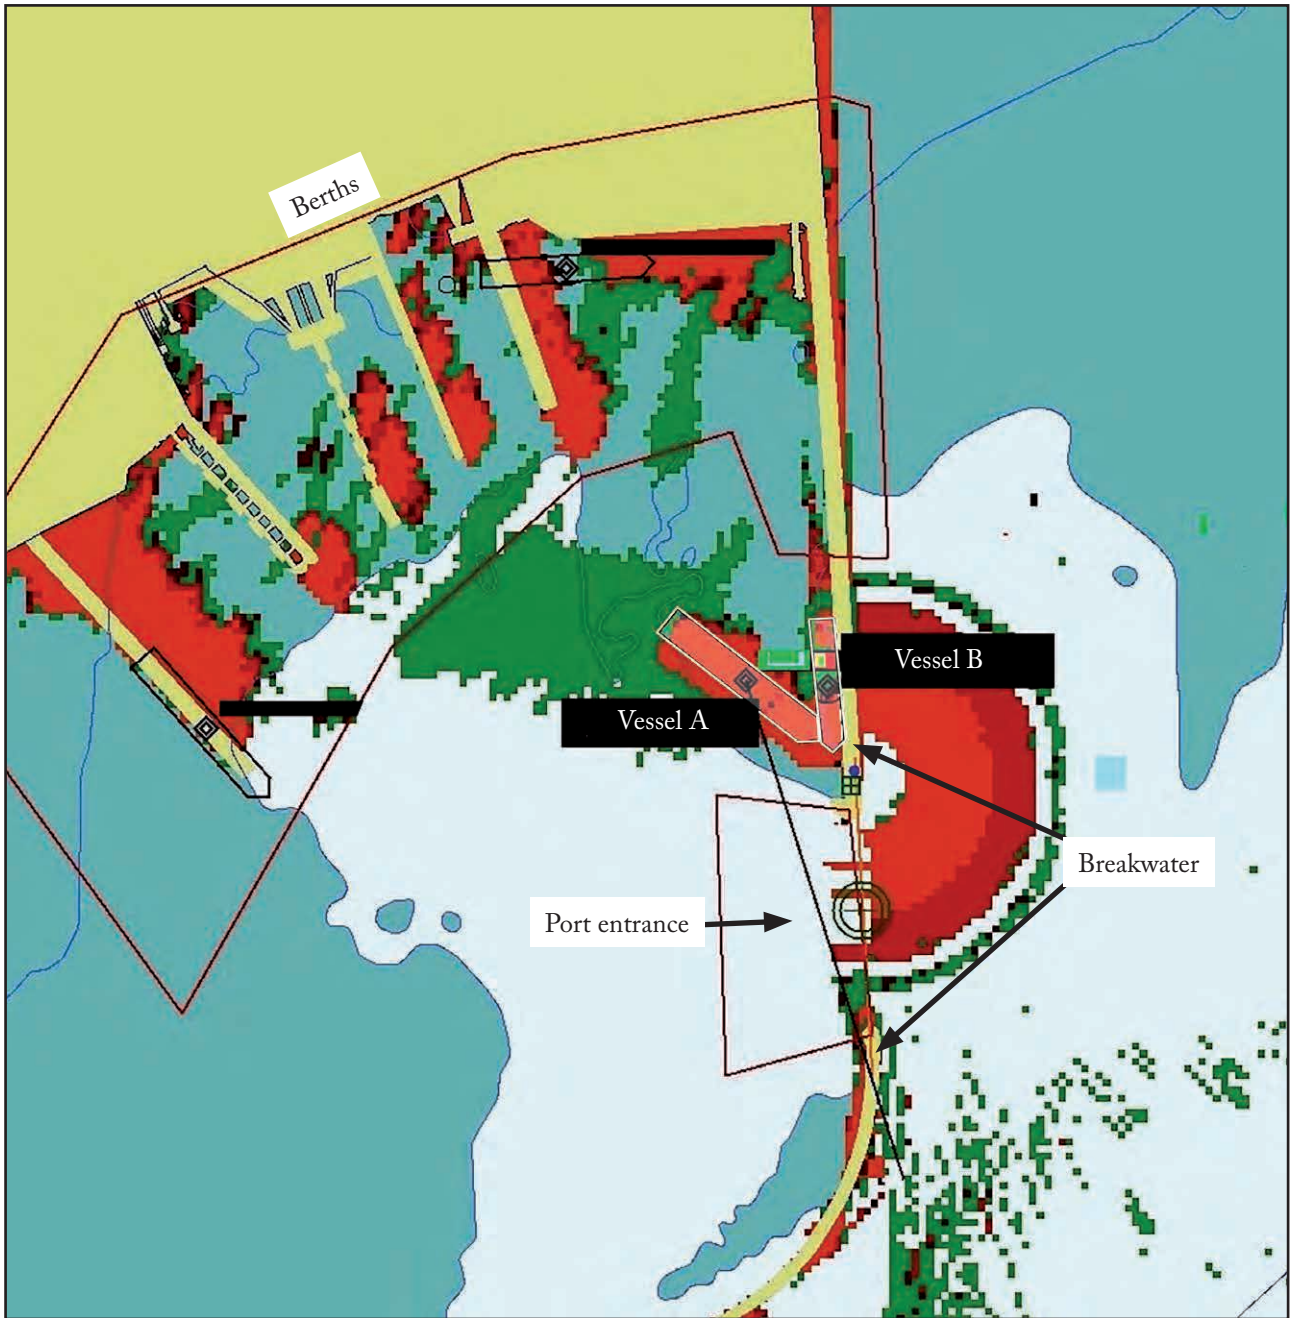
Port control called the ship (see figure - Vessel A) on VHF radio advising of its close proximity to the ship berthed (see figure - Vessel B) on the breakwater ahead. The master activated a pre-recorded message on the public address system instructing passengers and crew to brace for an impending collision. However, the combined effect of the astern propulsion and deployed anchor prevented contact with the ship ahead, but only by 3m.

Figure: Radar picture from port control showing the proximity of the two vessels

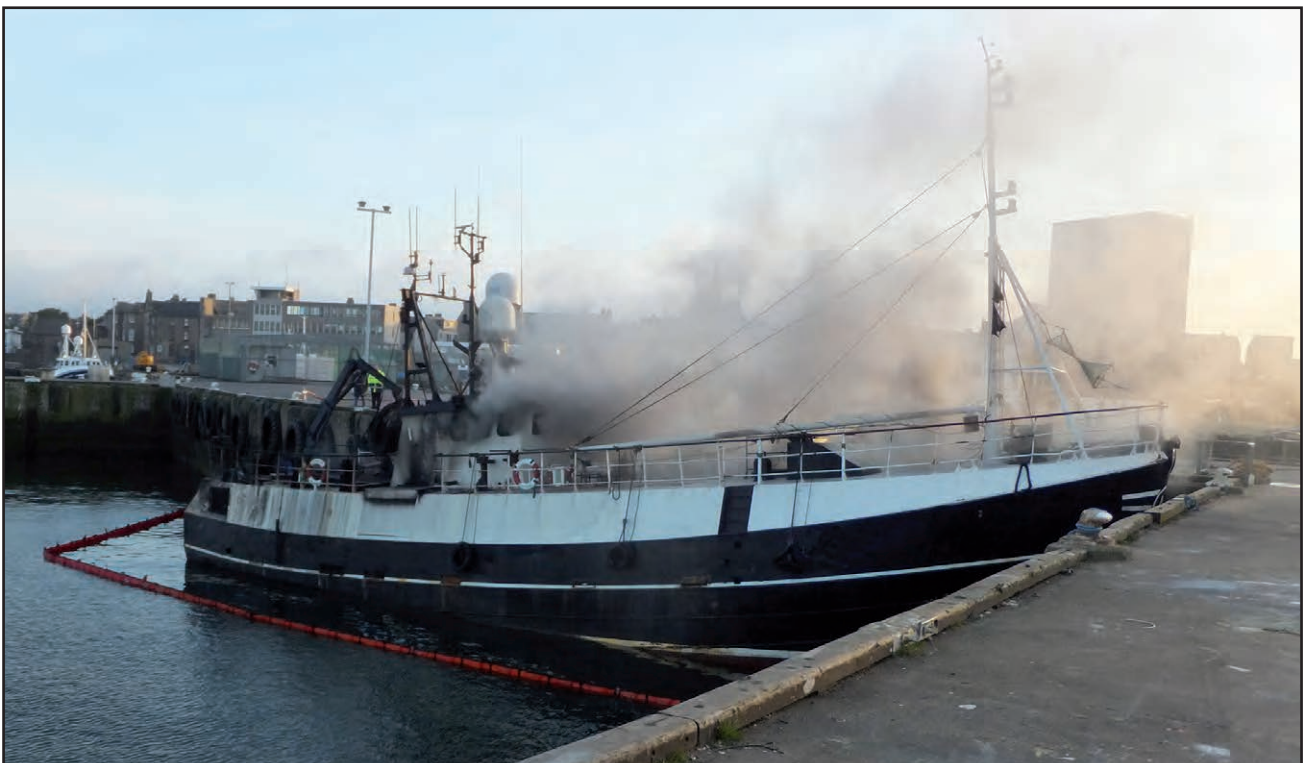
At 0537, with flames emitting from the vessel, the crew of another fishing vessel secured nearby called the emergency services. At 0546, the first fire appliance was on scene and the fire service continued to tackle the blaze until the following day (Figure 1). By this time, the vessel was extensively damaged and it was later declared a constructive total loss.

Figure 1: The fishing vessel on fire

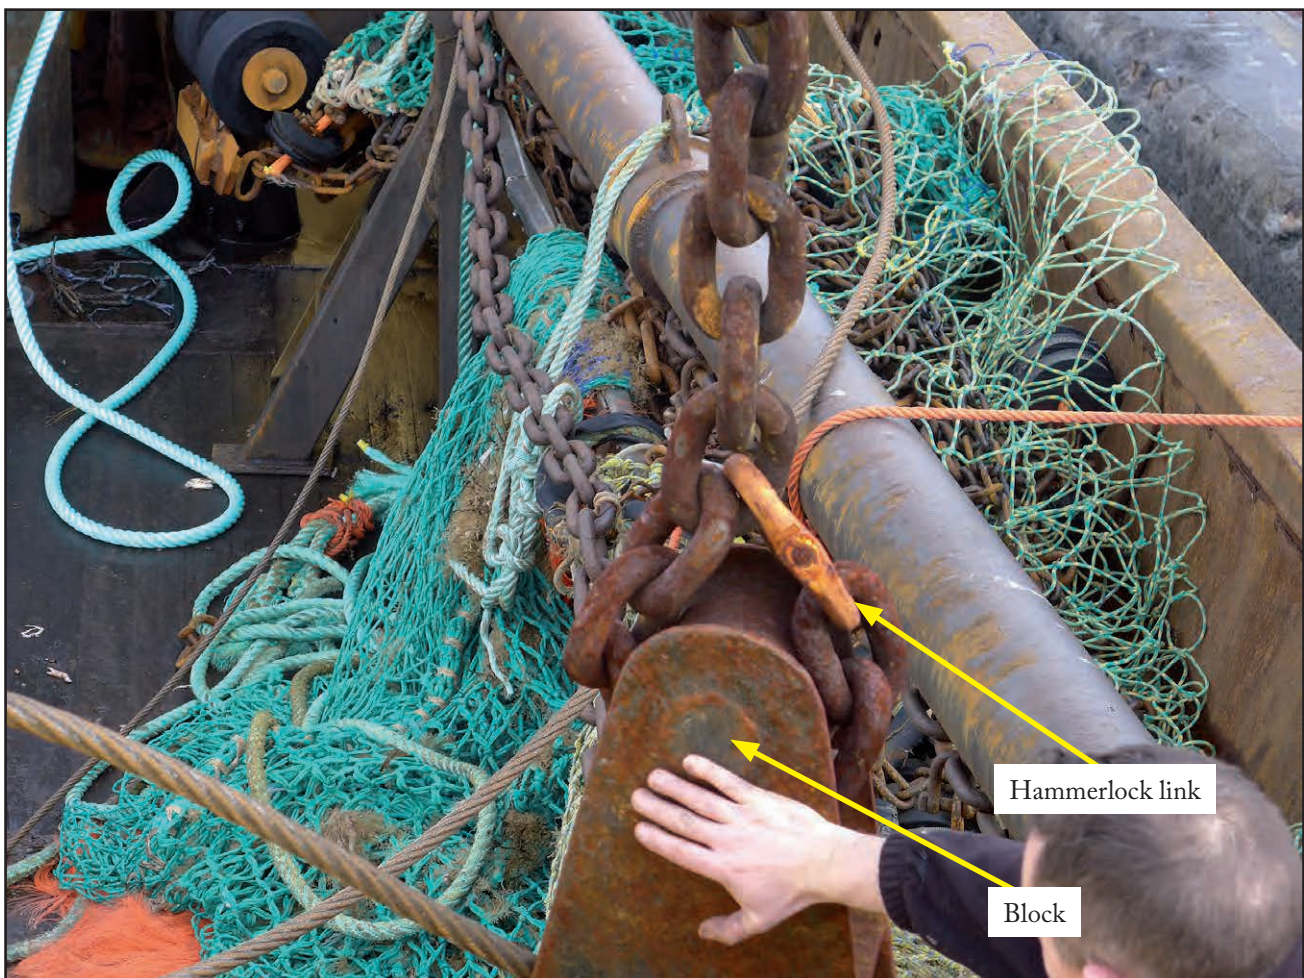
Figure 1: The port tow beam

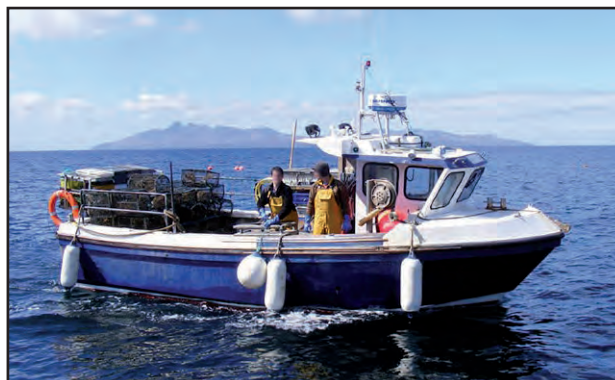
Figure 1: The fishing vessel

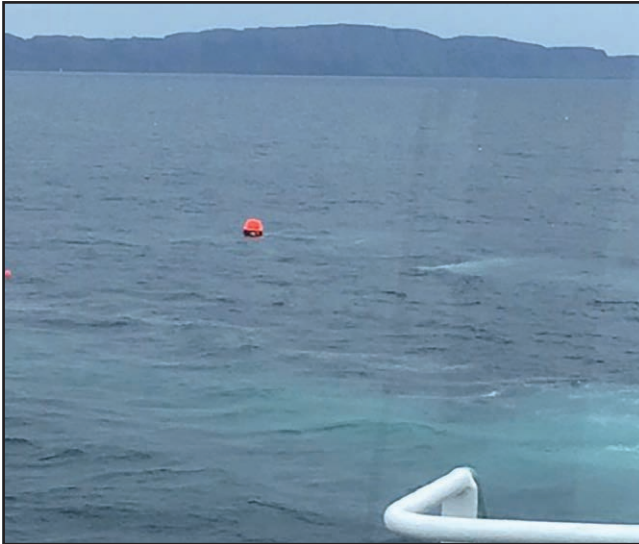
Deciding that his boat could not be saved, the skipper climbed into the liferaft and cast it adrift (Figure 2). A passenger ferry, alerted by the "Mayday" call and tasked by the coastguard, diverted to the scene and launched its fast rescue craft. The ferry's rescue boat crew recovered the skipper from his liferaft and took him back to the ferry, where his condition was assessed. Another nearby fishing vessel picked up the liferaft and stood by the sinking boat (Figure 3) until it sank a few minutes later.

Figure 2: The liferaft

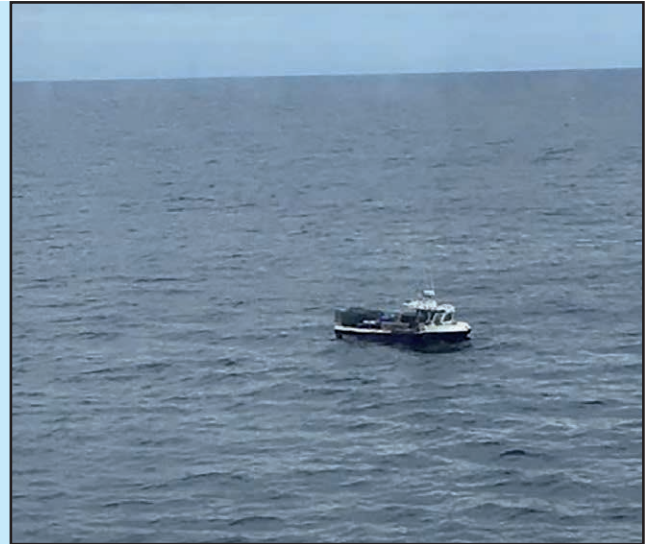
Figure 3: Fishing vessel standing by the sinking boat

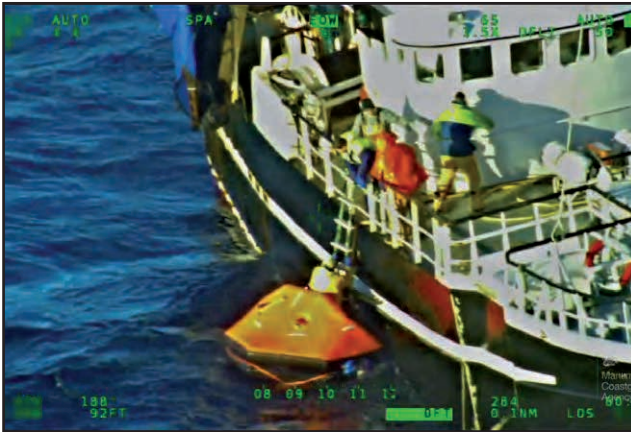
Figure: Recovery of the crew

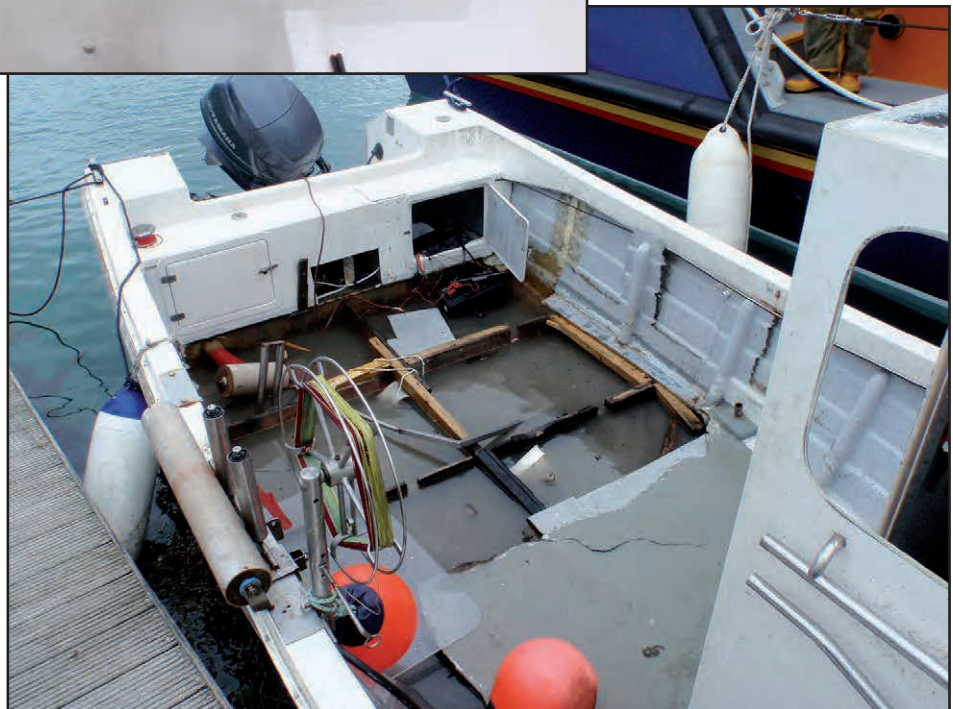
Figure 2: Layout of the vessel

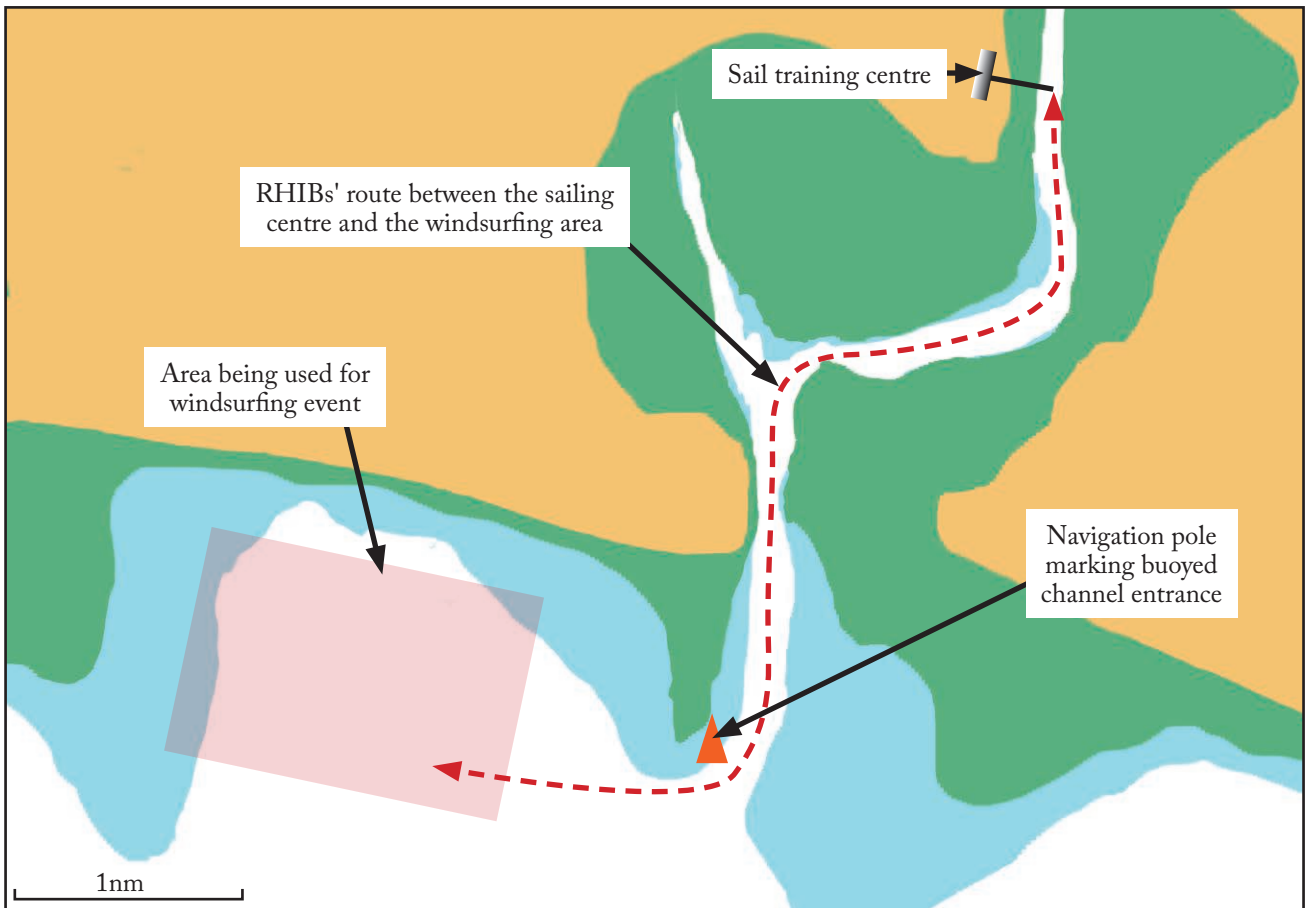
Figure 1: Overview of the area showing the sailing centre, windsurfing area and channel navigation pole

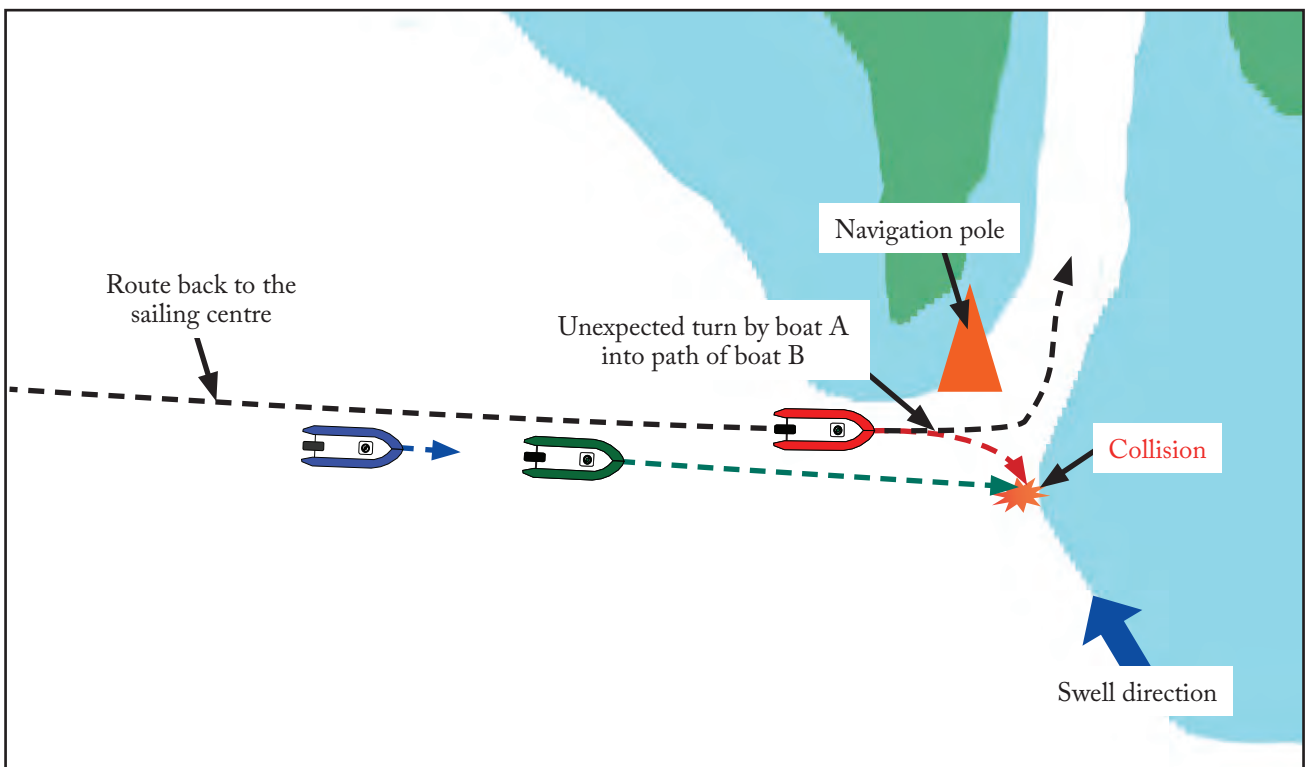
Boat A's manoeuvre brought it directly into the path of boat B, which was still planing at full speed. When the helm of boat B realised what had happened, it was too late to avoid collision (Figure 2) so he pulled the kill cord to stop the engine. Boat B struck boat A violently on its starboard side then rode right over boat A into the sea beyond; all of boat A's four crew were thrown into the water and three were injured, one seriously.

Figure 2: Expected and actual routes of boats A and B leading to collision (not to scale)

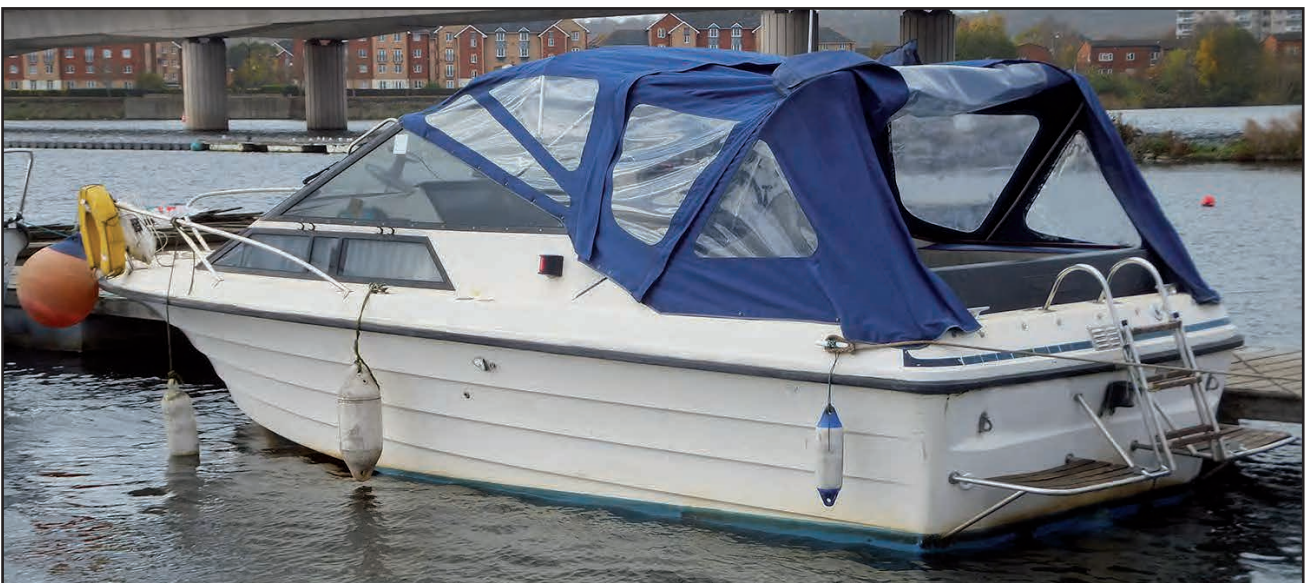
Figure 1: The motor cruiser

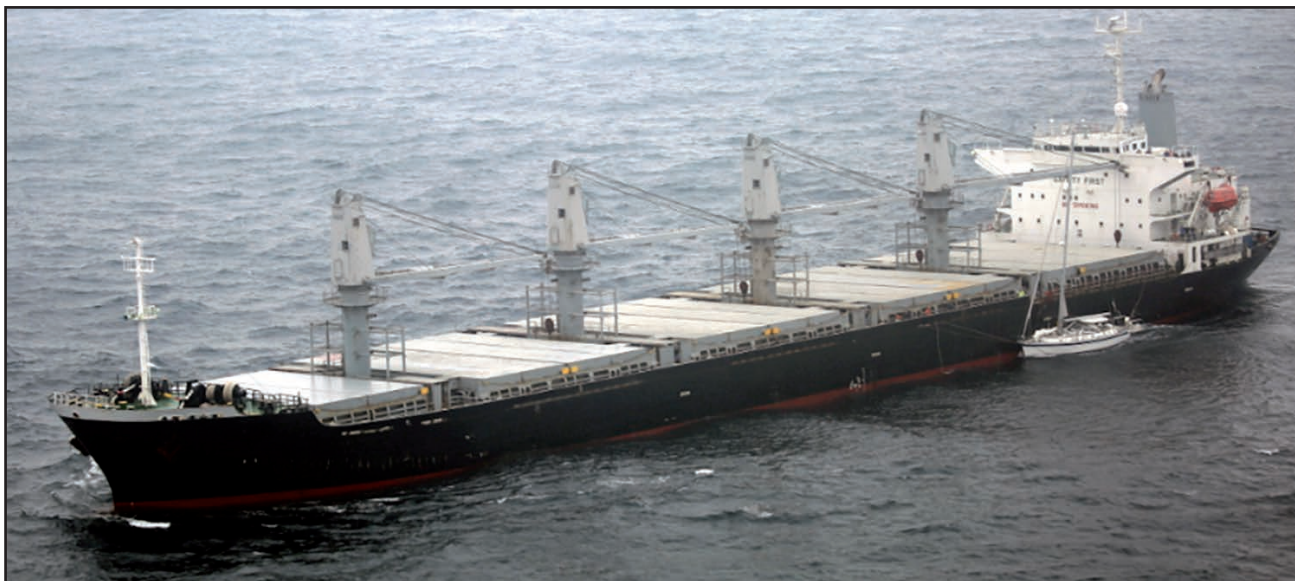
During the night, the skipper started hearing a clunking sound each time the boat rolled and assessed it to be movement of the keel; a significant development that led to the decision to abandon the boat. When the merchant vessel arrived on scene, the skipper drove the yacht alongside and the crew transferred to the safety of the ship (Figure 2). The yacht was then cut free, with a hull valve left open in order that it would flood and sink.

Figure 2: The yacht alongside the rescuing merchant vessel as the crew transferred to safety

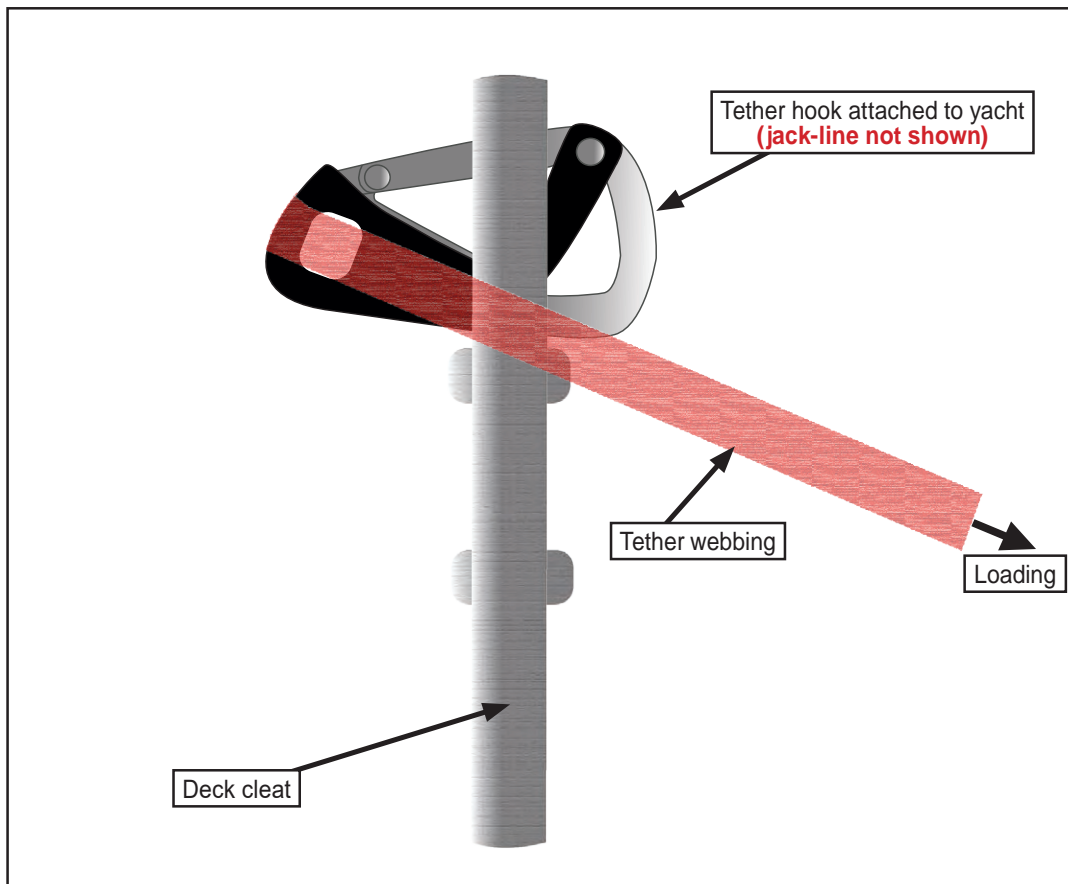
Figure 1: Tether hook under deck cleat

To prevent the strength of a safety harness tether becoming compromised in-service due to lateral loading on the tether hook, the method used to anchor the end of the tether to the vessel should be arranged to ensure that the tether hook cannot become entangled with deck fittings or other equipment.
