**Lessons from Marine
Accident Reports
2/2018**

SAFETY DIGEST
Lessons from Marine Accident Reports
No 2/2018

October 2018

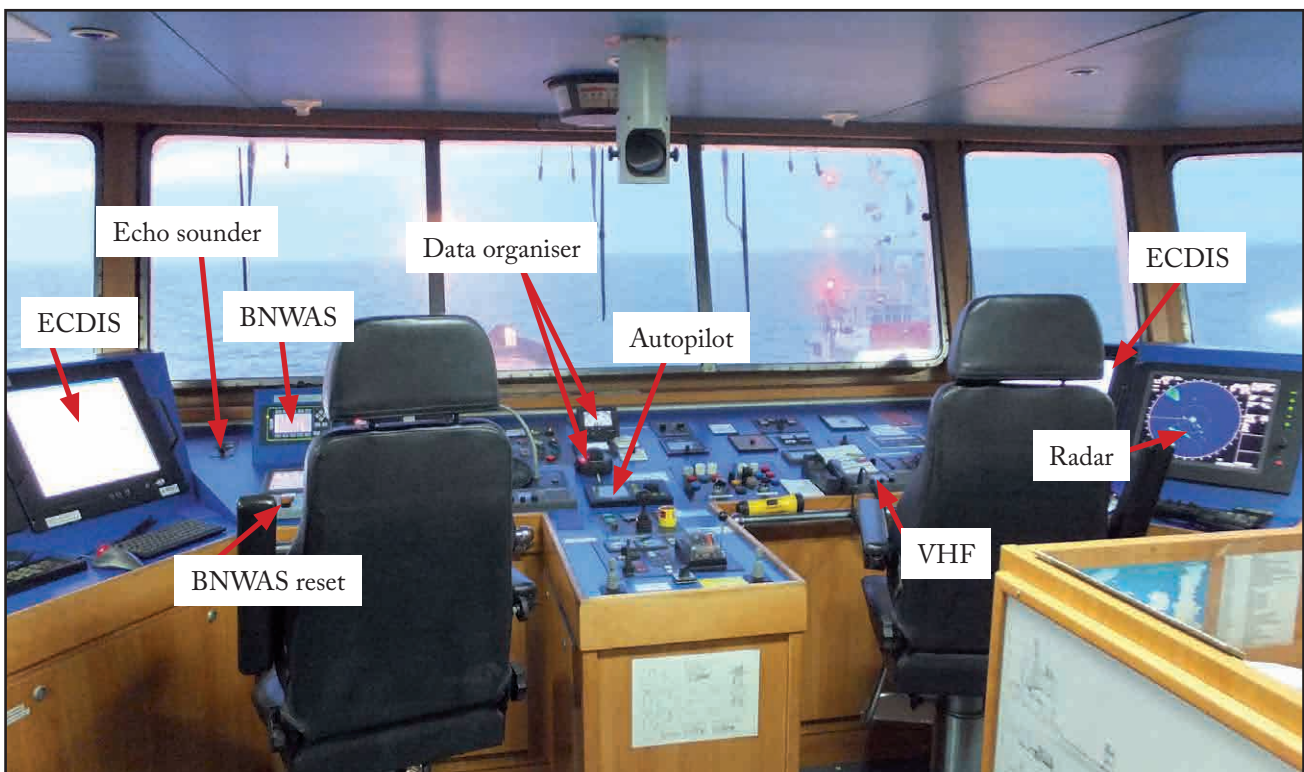
Figure 1: Bridge layout

Subsequent inspection of the ECDIS indicated that the system's 'safety frame' or 'look ahead' was inactive and that its audible alarm had been disabled. Consequently, no alarm was generated when the vessel passed over the safety contour (10m) (Figure 2).

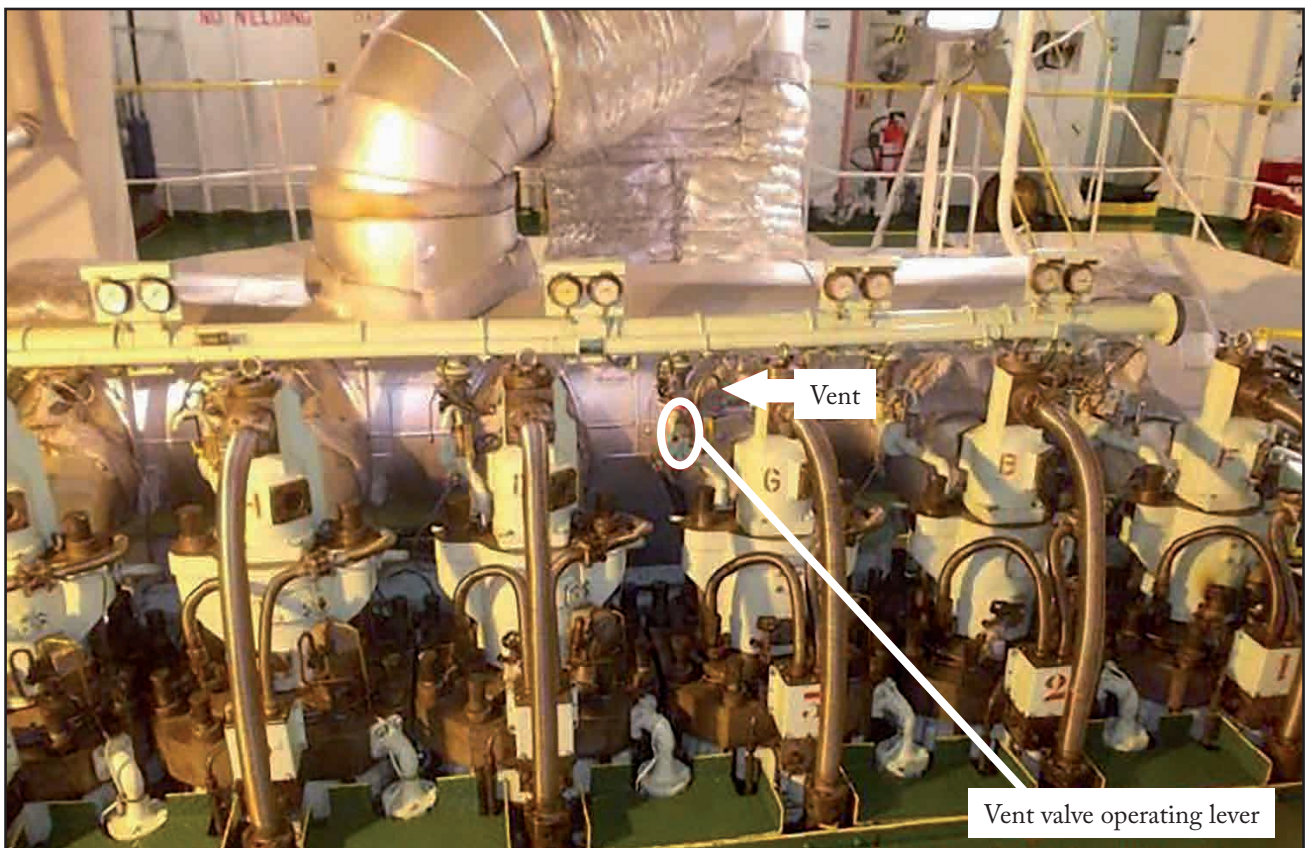
Figure 1: View of main engine cylinder heads

The confined location prevented the second engineer's escape, but the swift actions of the third engineer, who managed to close the valve, saved him from further scalding injuries.

Following the accident, the company took immediate action to remove the vent valve operating levers on all its vessels with similar engines. This was a temporary measure until proper securing or blanking arrangements could be put in place.

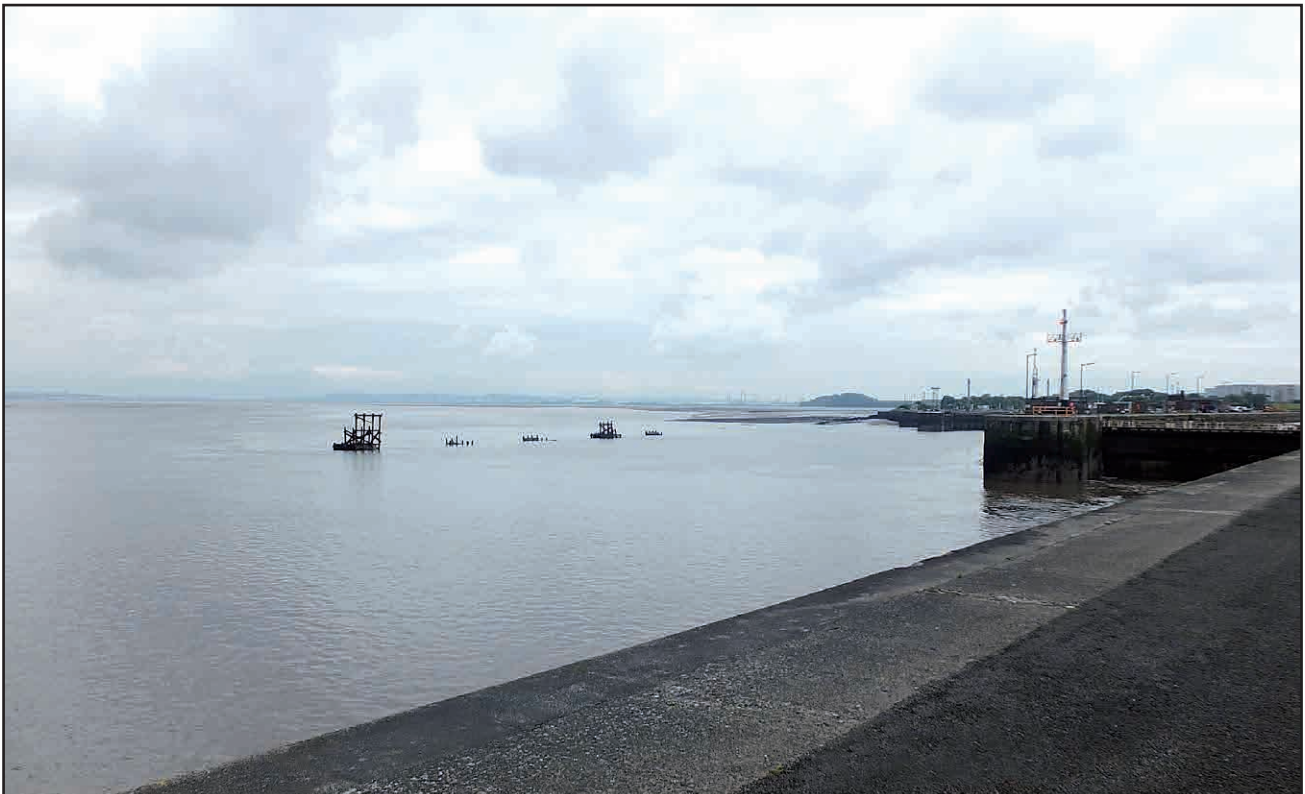
Figure 1: View of exposed dolphins

The ferry had run over the submerged remains of a mooring dolphin, which was the northerly-most of several charted derelict dolphins on the eastern side of the approach to the lock (Figure 1). The ferry's port propeller, shaft, stern seal and rudder were damaged by the contact (Figure 2).

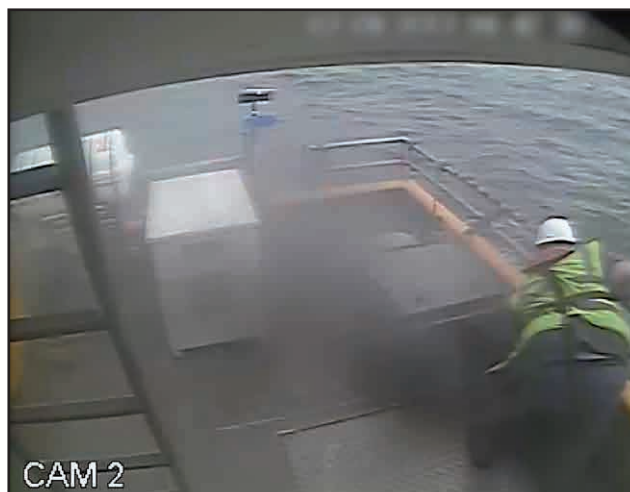
Figure 3: Deckhand shutting off fuel supply

Minutes later, the CCTV showed that the smoke in the port engine space had cleared and flames were burning across the engine's top. The fire was short-lived and within minutes had extinguished, partly due to the smothering effect of shutting the engine space vents but also because there was no more combustible material to burn.

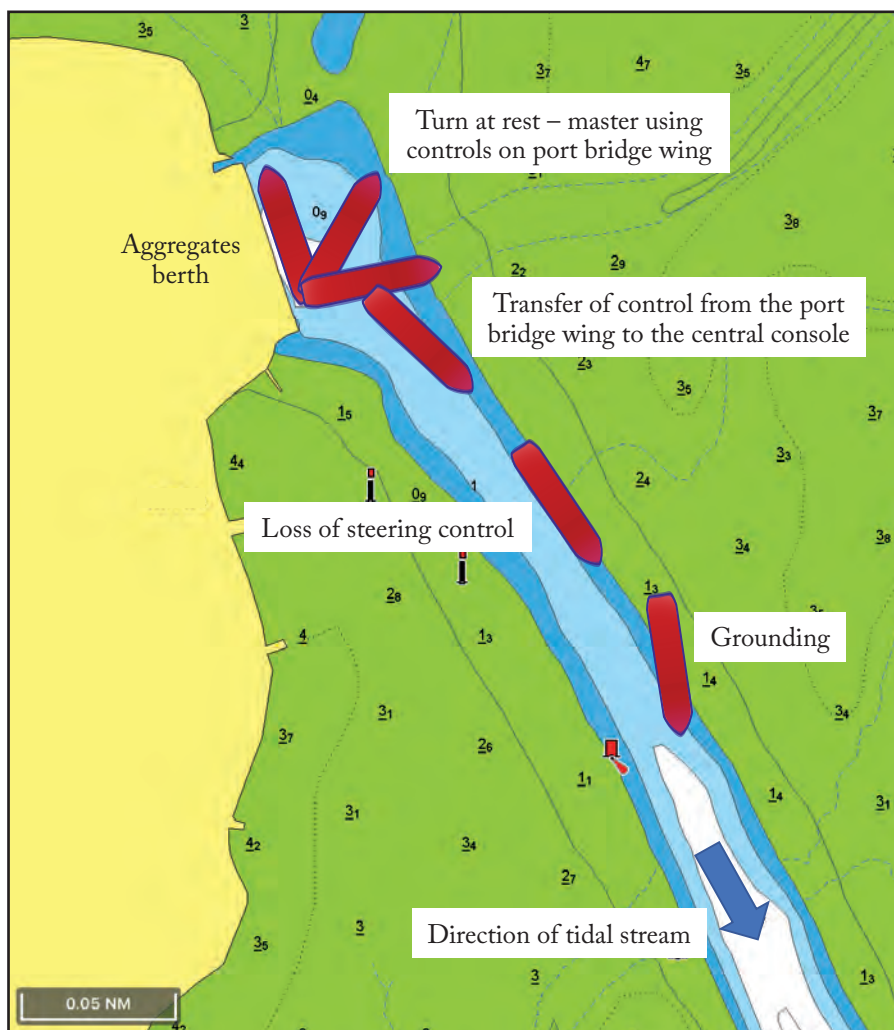
Figure 1: Chart showing the unberthing, turn at rest and grounding position

In response to the loss of control, the master reduced speed and attempted to steer the ship using the bow thruster. The master then repeated the procedure for transferring steering control between the consoles, which resulted in regaining control of the rudder from the centreline. However, the recovery of steering control came too late to prevent the dredger grounding gently at about 2kts on the mud bank opposite the berth and a short distance downstream (Figures 1 and 2). The dredger was undamaged and refloated at the next high water.

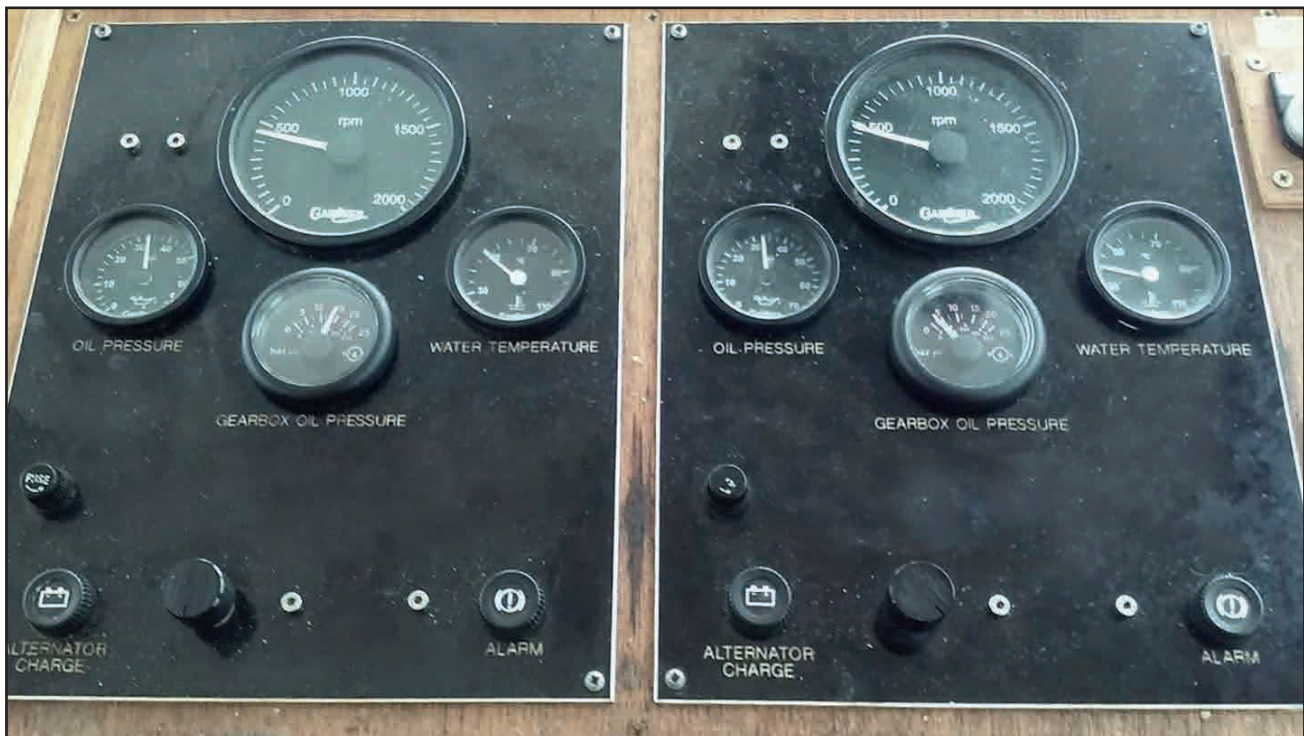
Figure 2: The wheelhouse console

An inspection by a local engineering company discovered that the linkage between the starboard engine gearbox and the gear shift mechanism had disconnected, so the crew were unable to alter the direction of drive (Figure 1). The port engine, having reversed, applied reverse thrust while the starboard engine continued to apply ahead thrust. This caused the vessel to swing to port and make contact with the pier. Unfortunately, the console with the remote controls for the engines did not have any indications for propeller direction (Figure 2) so the master was unable to understand why the vessel was not responding as he had expected.

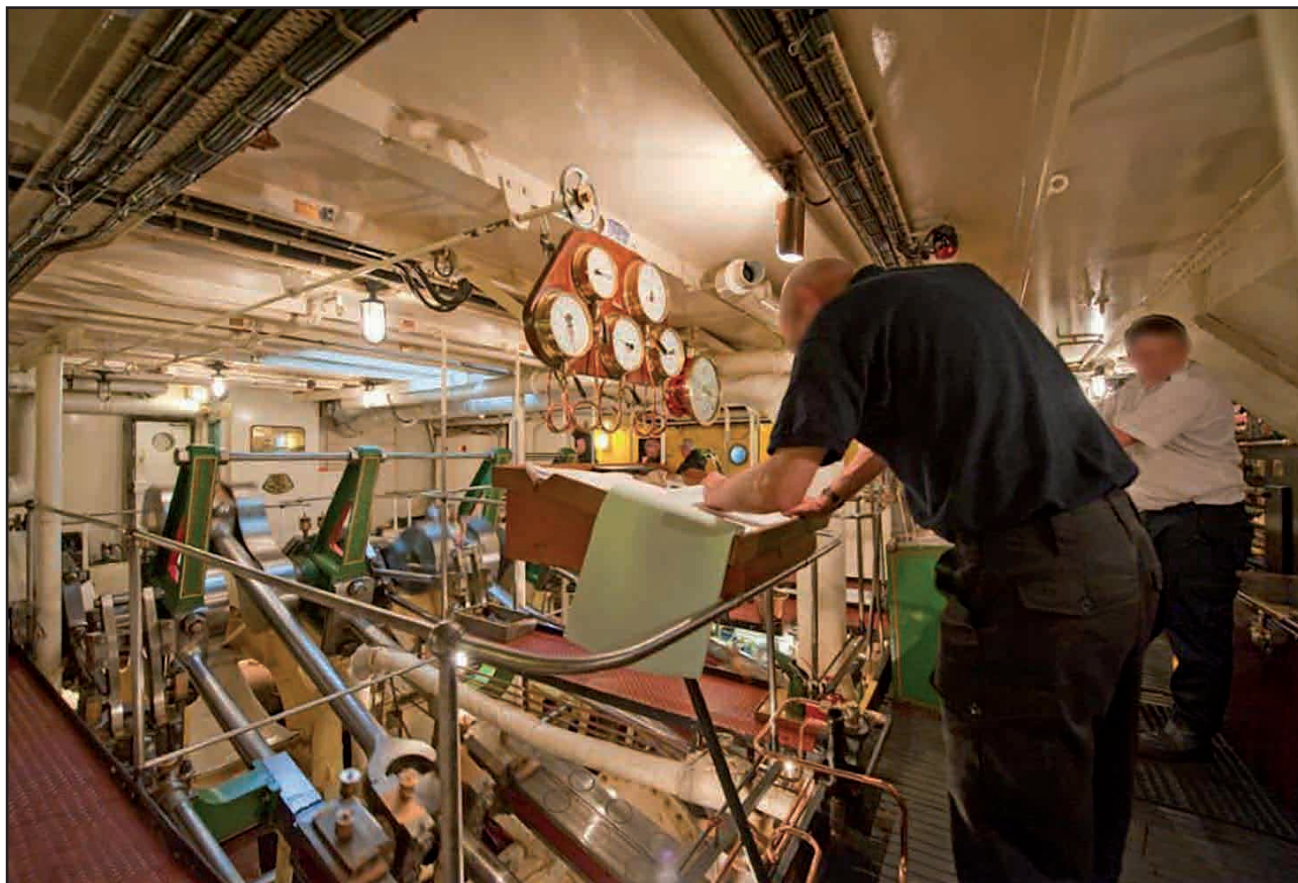
Figure 1: Engine room configuration showing the crew member (left) and chief engineer (right) with the engine telegraph between the two of them

However, the master noted that, rather than moving astern, the vessel was continuing to move ahead. Concerned, he ordered 'double ring full astern' (an emergency order). This had no effect; the vessel continued to move ahead. A further 'double ring full astern' was ordered by the bridge, followed swiftly by 'stop' on the engine telegraph and a third 'double ring full astern'. At the same time, the chief officer tried to contact the engine room using the voice pipe, but without success.

In the engine room, the chief engineer had become distracted while operating the engine controls and was assessing whether a recent

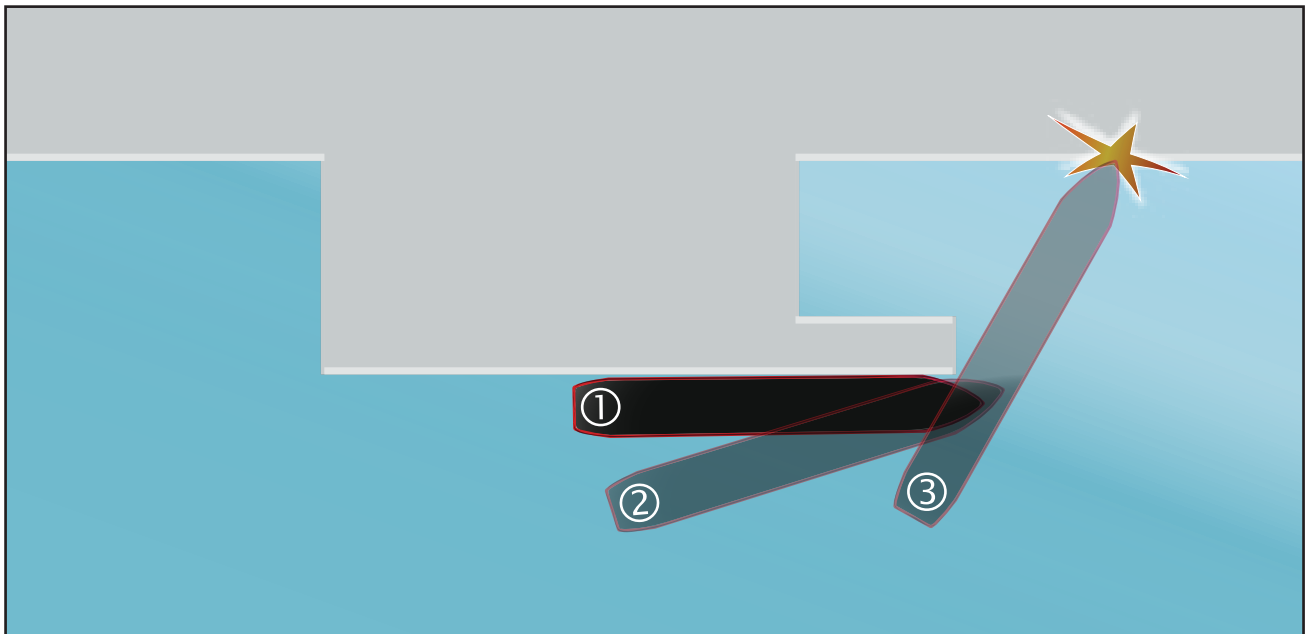
Figure 2: The engines mistakenly put to full ahead rather than full astern cause the ship to strike the quay

The vessel's engines were stopped and the crew inspected the damage. They discovered that although the vessel's watertight integrity had not been compromised, it needed substantial repairs (Figure 3).

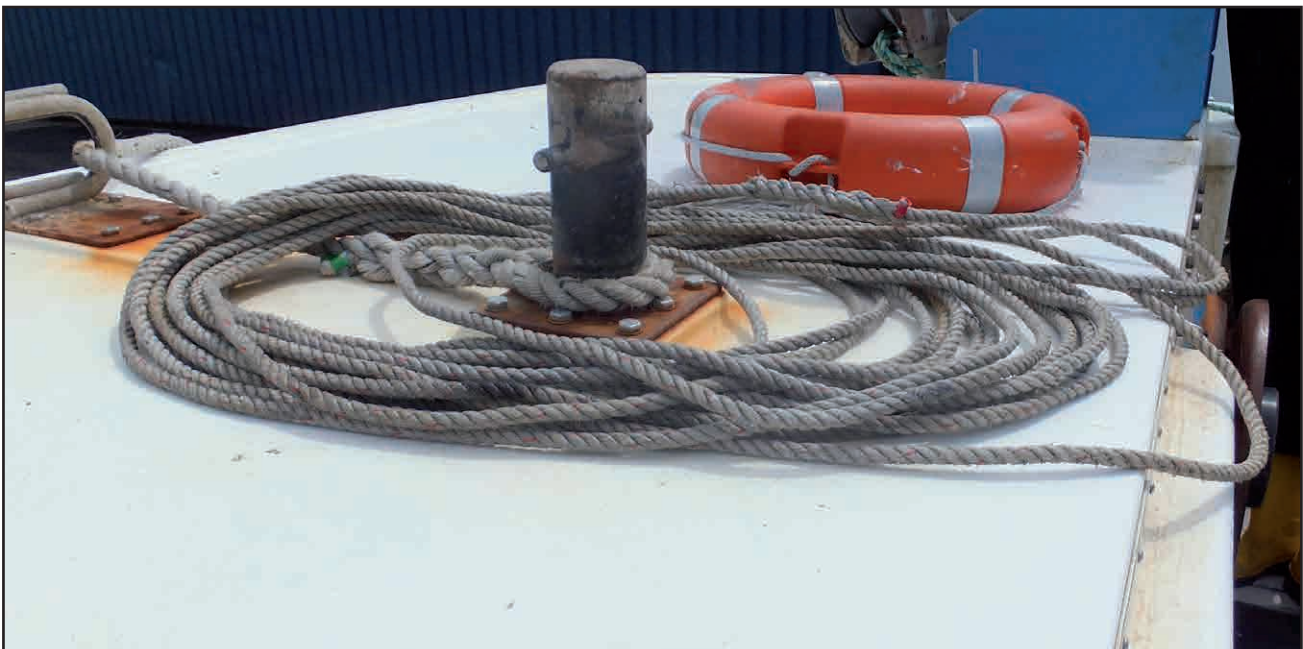
Figure: The lifebuoy and polysteel rope

the vessel close to the deckhand, who was now face-down and motionless. The lifebuoy was again thrown, but the deckhand did not respond. In desperation, the second deckhand jumped into the water to assist, but he too got into difficulty quickly and started to lose his strength. He was not wearing a lifejacket and was being weighed down by the polysteel rope from the lifebuoy, which he had used as a lifeline. The skipper recovered the deckhand who was attempting the rescue; by then, the first deckhand had disappeared from sight.

The lost crewman had possibly been using recreational drugs that were found among his personal effects on board, and he had jumped into the water despite the skipper instructing him not to do so. He and the other deckhand almost certainly suffered from cold water shock following immersion.

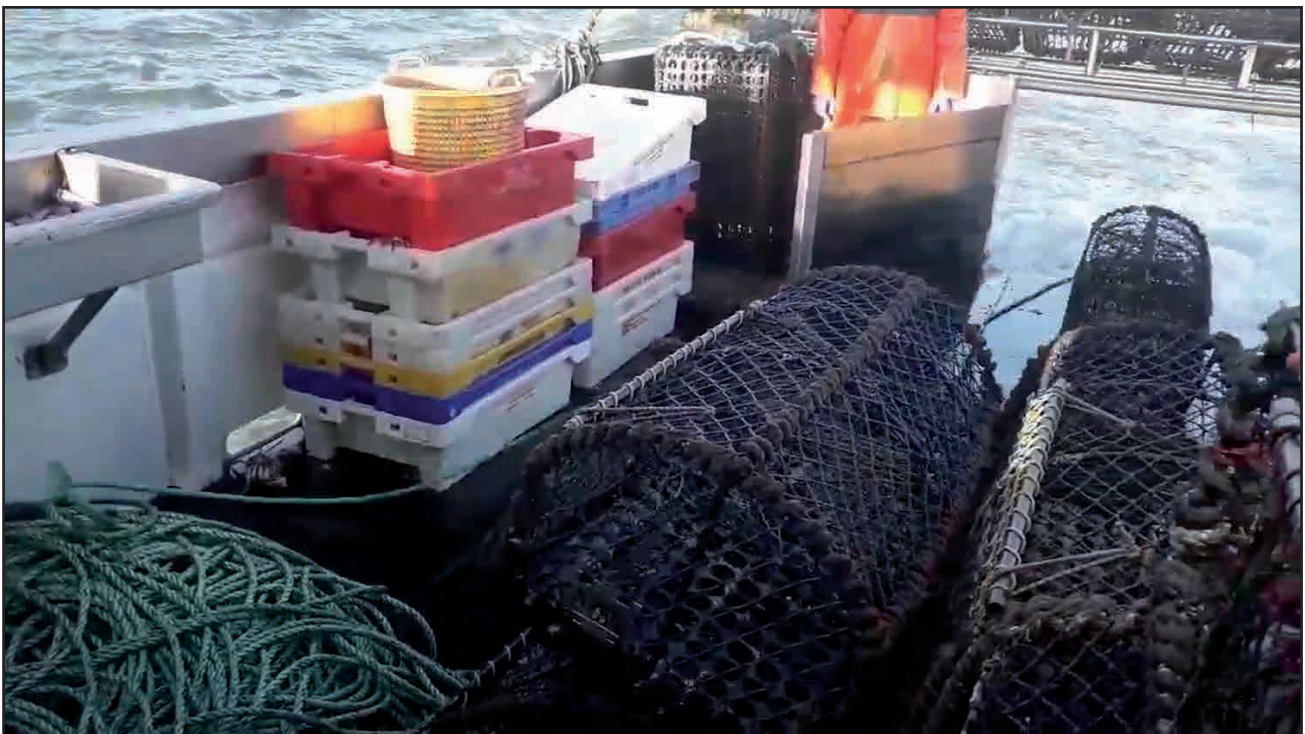
Figure: Typical set-up when shooting pots

When shooting a fleet of pots, the deckhand usually remained in a ‘safe area’ behind pound boards (see figure) until about five or six pots remained on deck. The deckhand could then walk over the relatively clear deck towards the wheelhouse to complete the shooting process by dropping the fleet’s remaining anchor and marker buoy. This time, the deckhand left the ‘safe area’ without apparent reason, and attempted to cross over the running backrope while about 20 pots and their associated lines remained on deck.

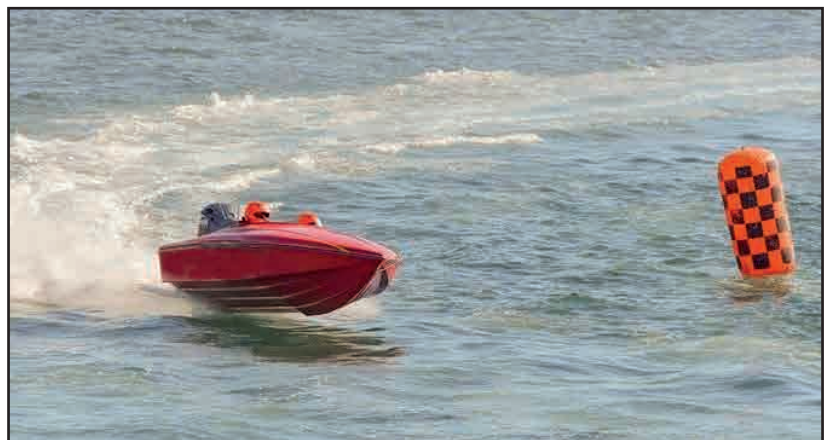
Figure: The racing powerboat (not during the accident)

The driver suffered three broken ribs and was discharged from hospital later that day. The navigator had suffered a very deep laceration to his ankle and, unfortunately, his foot was later amputated.

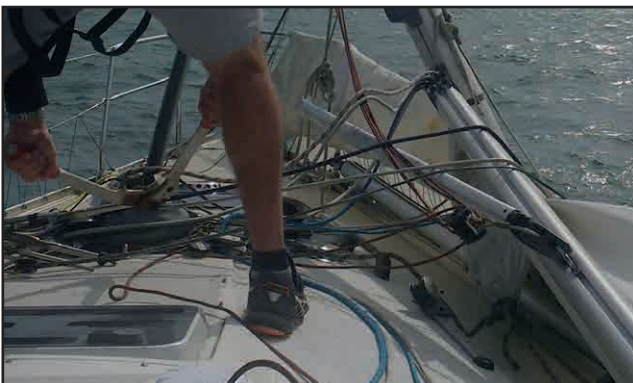
Figure 1: The rigging being cut

The skipper checked the welfare of the students, assessed the damage and informed the coastguard. He then cut the remaining rigging free, dropping it to the seabed, and returned to port under engine power.

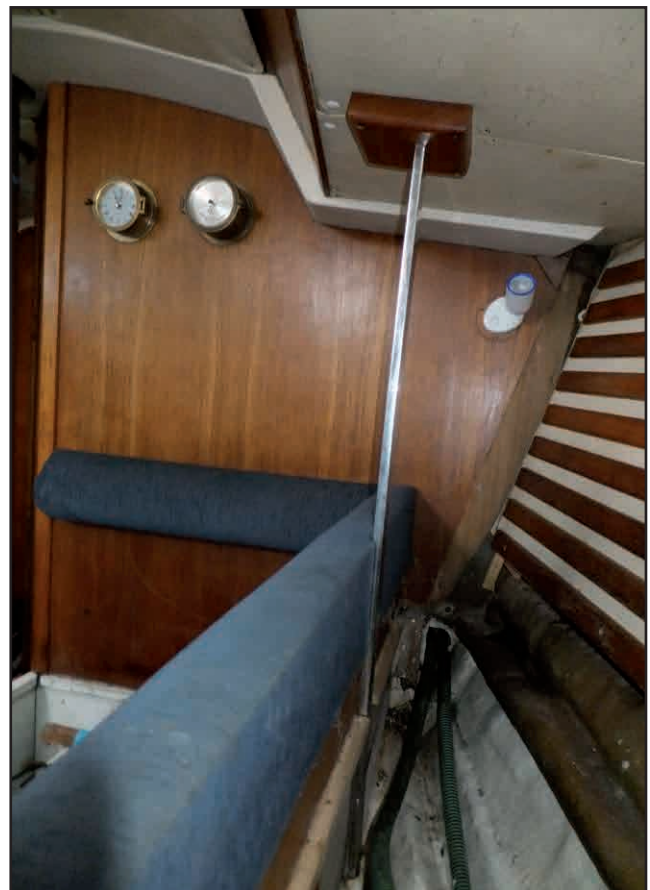
- The weld fracture occurred as a result of cyclic loading
- The weld was not a full penetration weld
- Surface corrosion was found close to the point of failure but was not considered a causal factor.

This boat had been in commercial ownership for a number of years and had covered a lot of miles. The cyclic loading on the tie bar would therefore have been high, and ultimately led to the failure of the welded joint.

Figure 2: The starboard tie bar intact and in-situ

1. This vessel recently had all of its standing rigging renewed; it was not deemed practical to inspect the tie bar securing point as it was inaccessible without removing a significant amount of the internal fixtures. However, owners and surveyors should carefully consider the risk of a failure such as this occurrence given a yacht's age and usage when deciding which critical elements of structure should be examined.

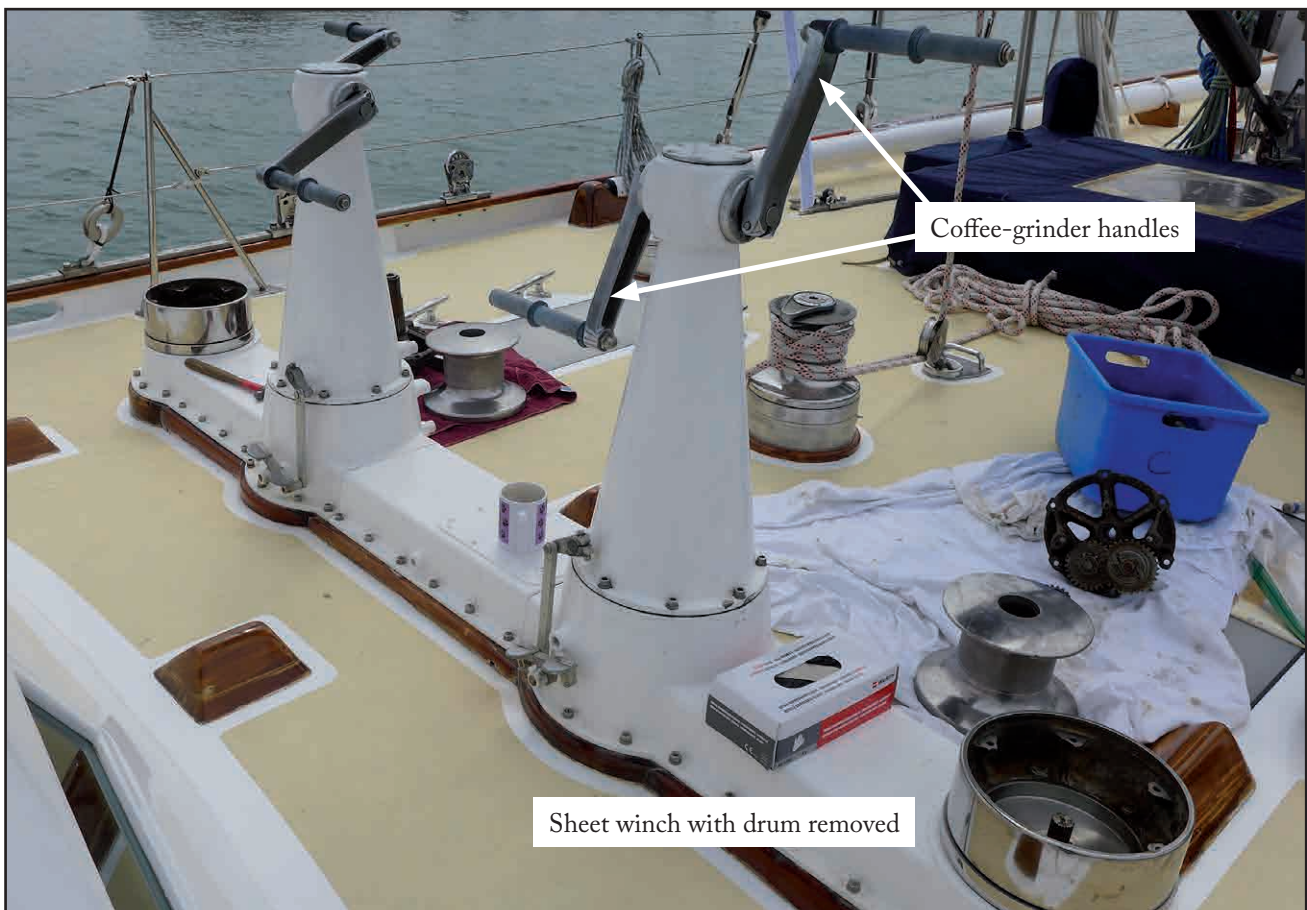
Post-accident examination of the gearing system inside the starboard winch drum identified that a load-bearing pinion on the central spindle had catastrophically failed. This had resulted in the tension in the winch drum being instantly released back up through the pedestal to the handles, causing their violent, hazardous reversal of direction.

Figure 1: Pedestal winch system

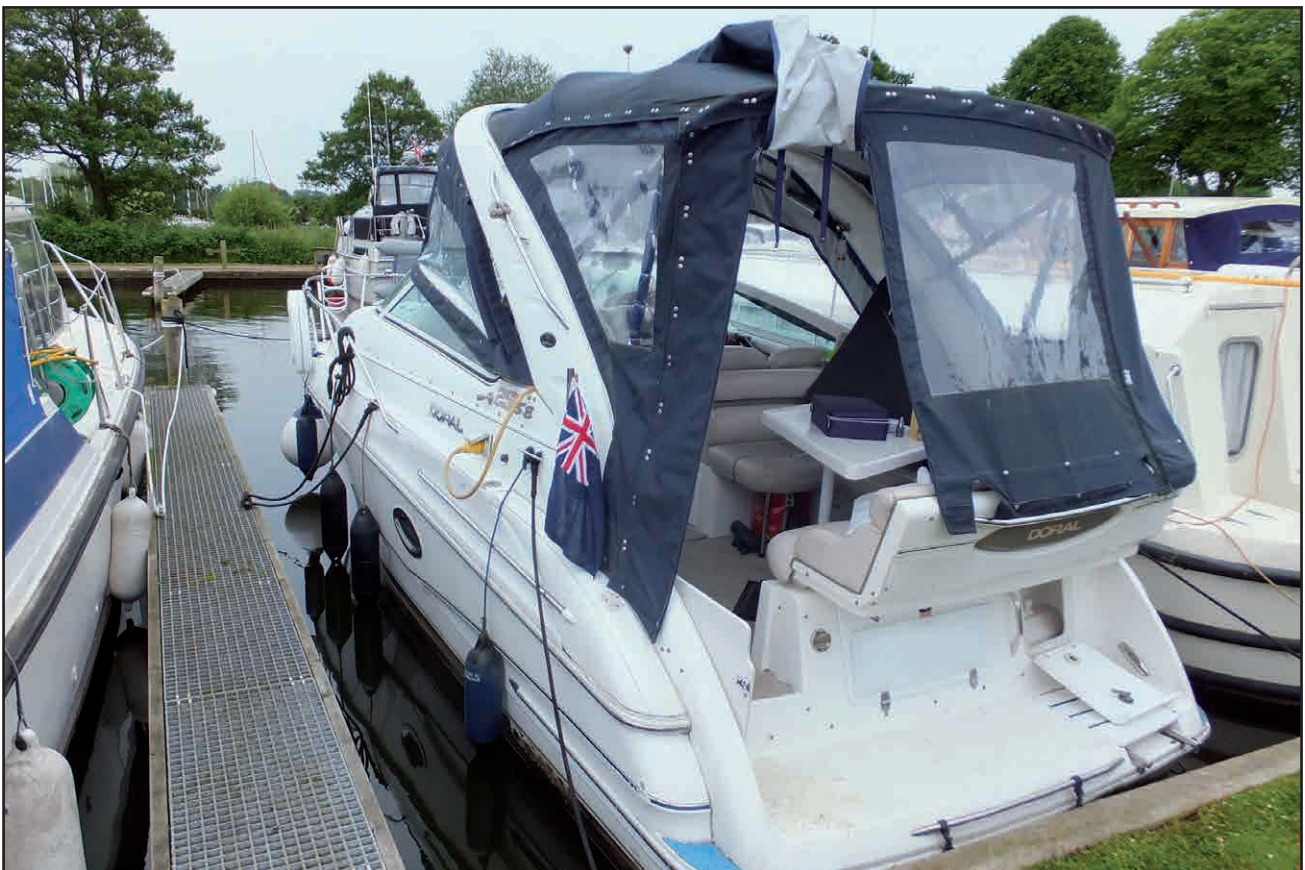
The post-mortem examination showed that the owner and his partner had died of carbon monoxide poisoning.

Figure 1: Configuration of the canvas canopy

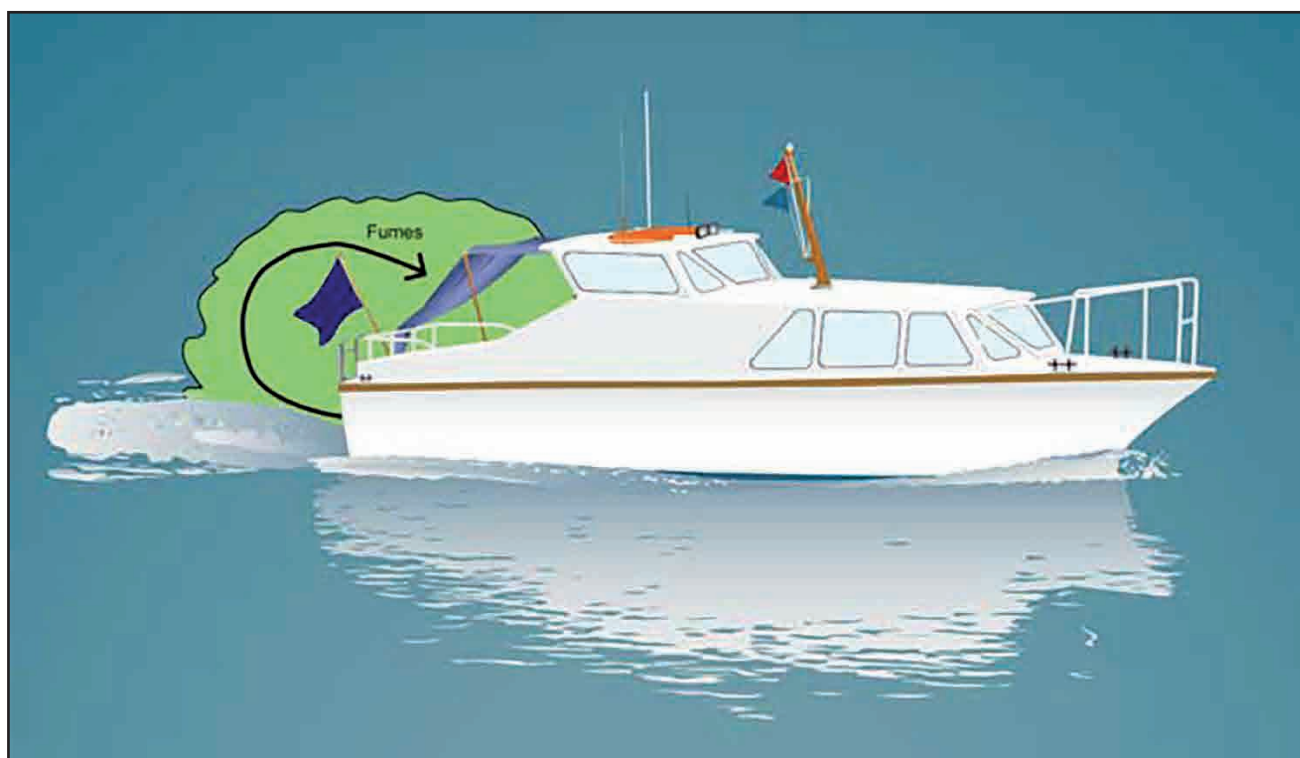
Figure 2: Diagram showing 'station wagon effect'

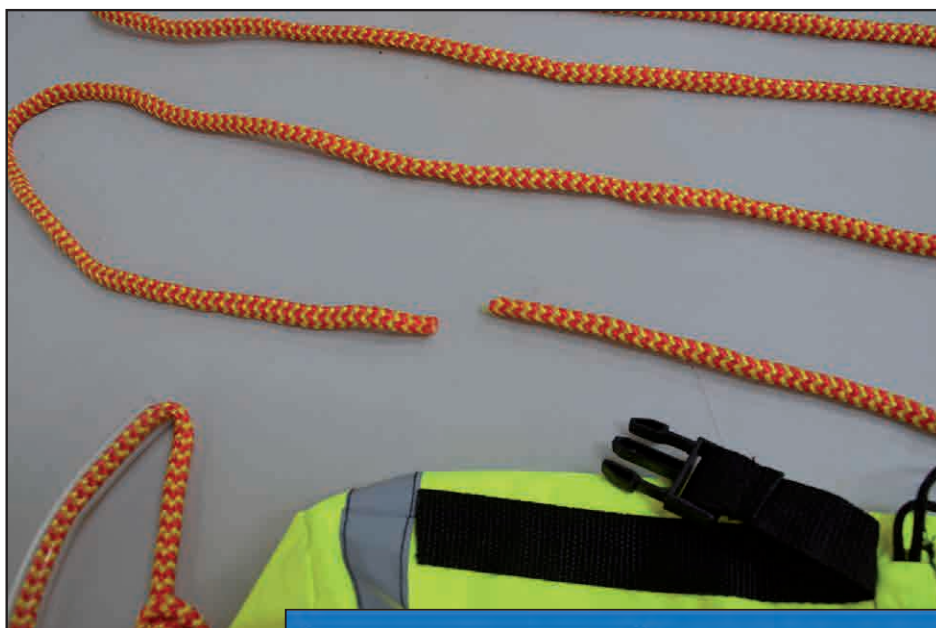
A defective throw bag rescue line was discovered while Warrington Rowing Club was conducting boat capsizing drills for new rowers at Halton Baths in Cheshire, UK. A 15m long polypropylene rescue line in a throw bag, supplied by Riber Products Limited (RIBER), parted (**Figure 1**) while a young person in the water was being pulled to the side of the pool during a simulated rescue. There were no injuries. The rowing club safety advisor subsequently found another throw bag with a defective rescue line that had been purchased from the same supplier. RIBER was informed and the company contacted its customers after identifying a batch of 208 throw bags that could be at risk. A further three defective rescue lines have been identified as a consequence of the customer warning notice posted on Facebook (**Figure 2**).

Figure 1: RIBER 15m throw bag rescue line

On inspection, the defective RIBER throw bag rescue lines identified by Warrington Rowing Club were found to have been made up of sections of polypropylene rope fused together, which broke easily at the joint when put under tension. One line was constructed of two sections of rope fused together, the other was constructed of four sections of rope, resulting in three fused joints in its 15m length (**Figure 3**). Intact and joined sections of one of the defective rescue lines were tested to determine the line's minimum breaking load. The intact section failed at 256 kgf (kilogramme force) and the joined sections failed between 19 and 23 kgf.

Any throw bag rescue lines found to have joins or discontinuities should be removed from service and the original manufacturer /supplier informed.

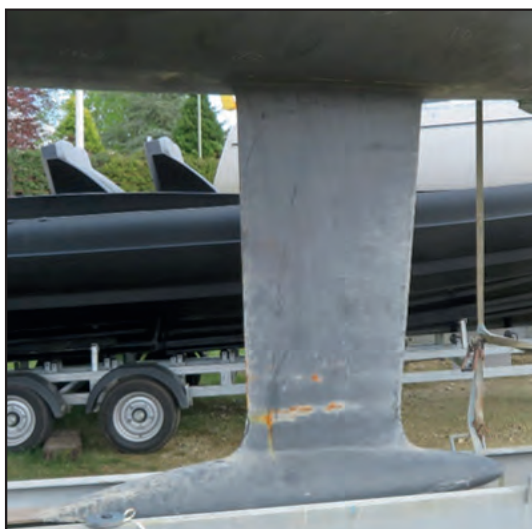
Figure 2a: Deep draught bulb keel not affected by this safety bulletin

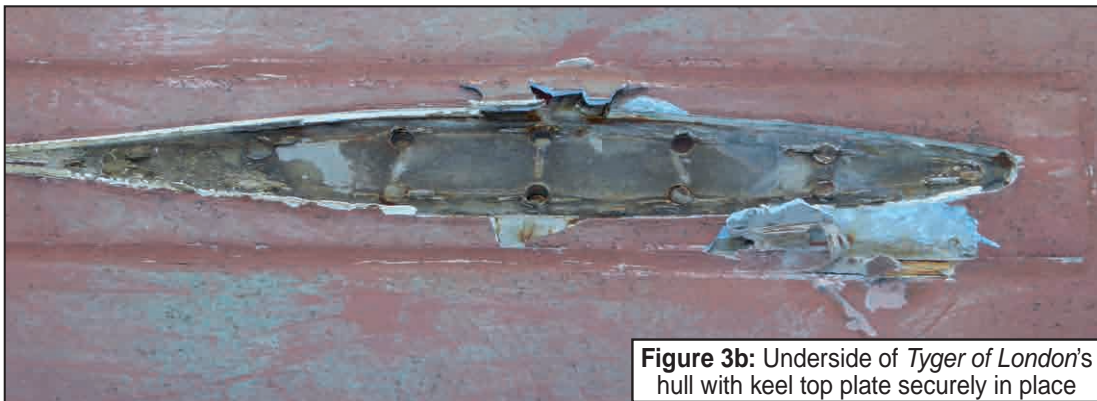
Figure 3b: Underside of *Tyger of London's* hull with keel top plate securely in place

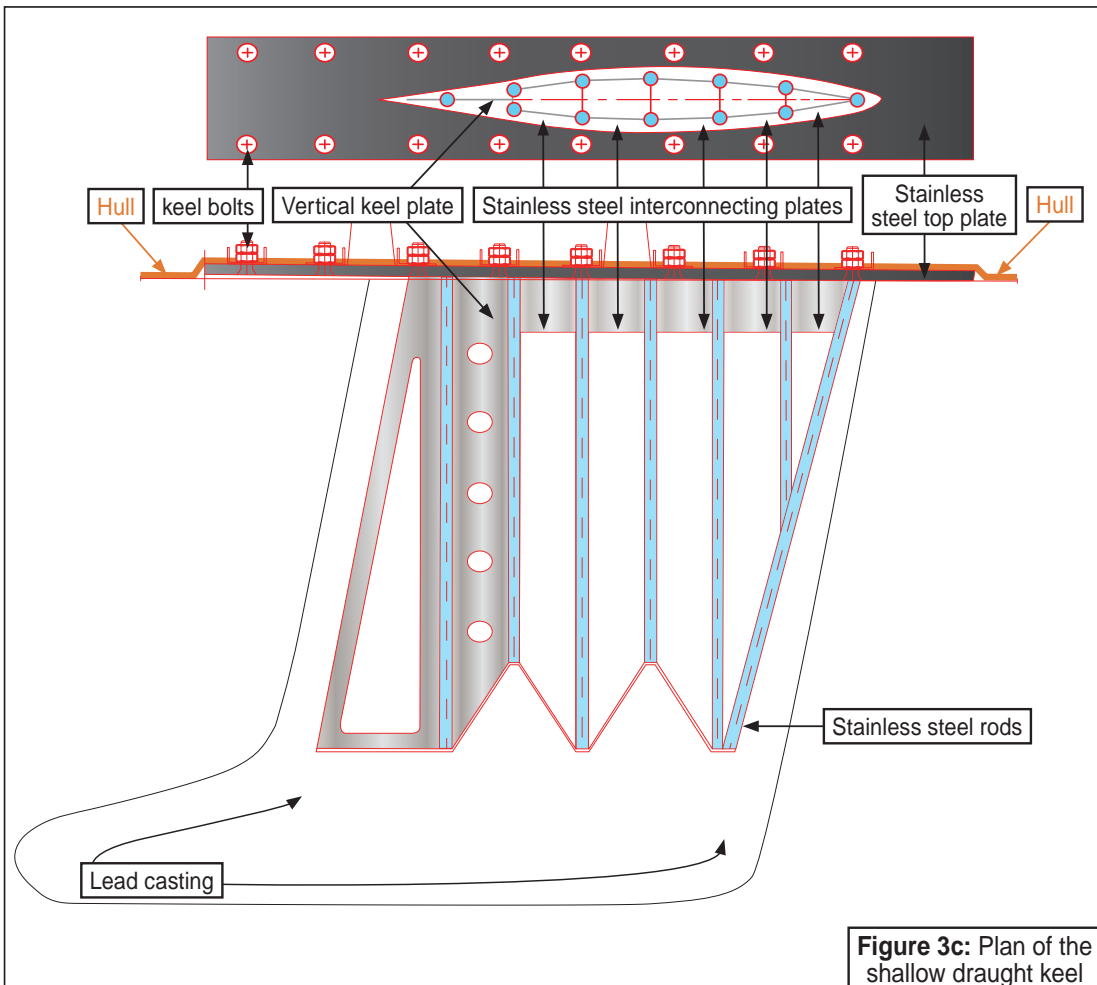
Figure 3c: Plan of the shallow draught keel
