Report on the investigation into
the capsize and foundering of the fishing vessel
Solstice (PH199)
resulting in one fatality
approximately 7 miles south of Plymouth, England

26 September 2017

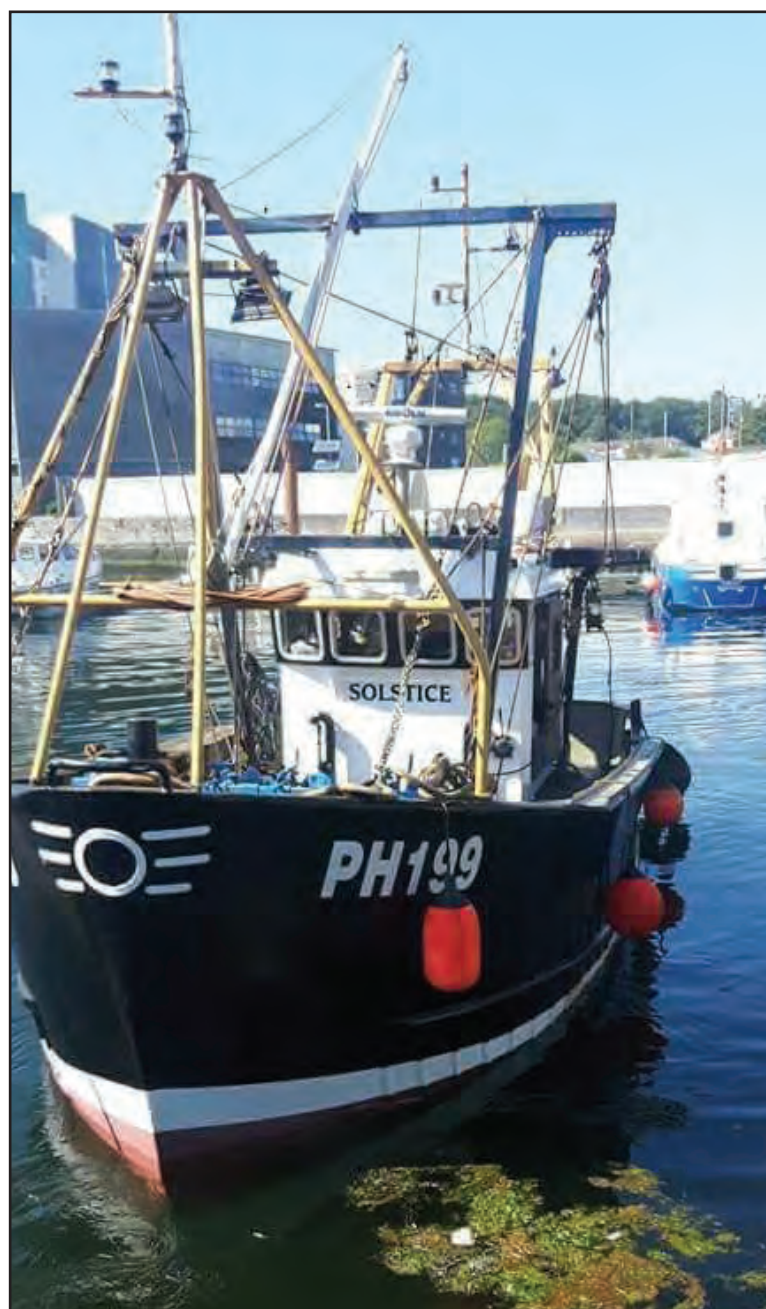
Figure 1: *Solstice*

The 9.9m fishing vessel *Solstice* (**Figure 1**) was equipped to work as either a scallop dredger or a stern trawler. Until September 2017, the vessel's owner, Clive Anthony Jones (Tony), had worked *Solstice* out of Sutton harbour, Plymouth, as a scallop dredger. At the beginning of September, Tony and his son, who was the vessel's permanent skipper, decided to re-rig *Solstice* and trawl for cuttlefish. This was to increase the vessel's earning capacity and reduce the crew's workload.

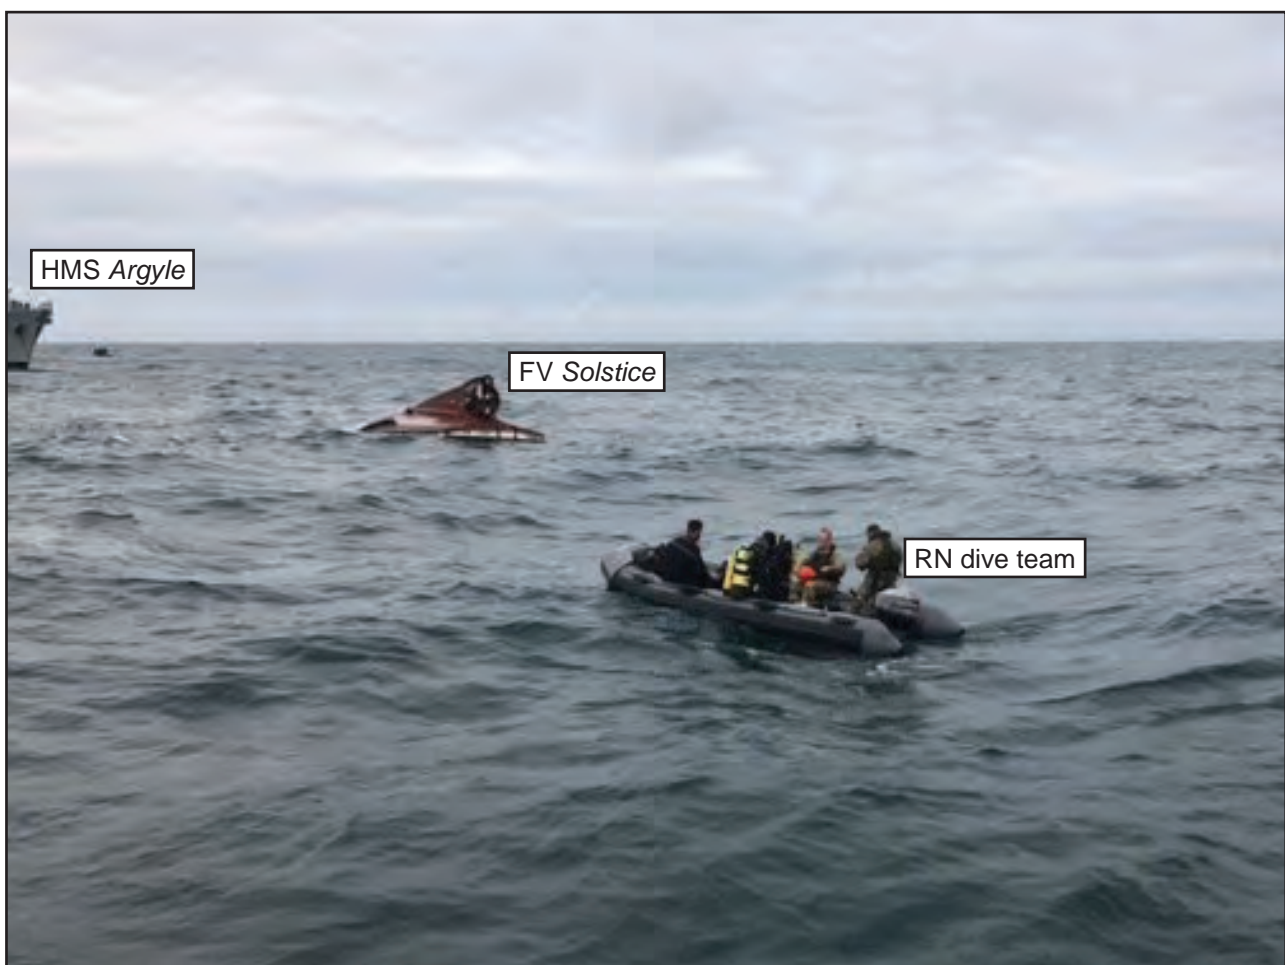
Figure 10: RN dive team preparing to dive on *Solstice*

The Royal Navy (RN) warship HMS *Argyle* was requested to stand-by *Solstice* overnight. At 0830, the Plymouth-based RN dive tender *Datchet* was tasked to attend and assist (**Figure 10**). By that time, *Solstice* had drifted about 1nm from Rame Head and HMS *Argyle*'s crew had connected a towline to the hull to prevent the vessel going aground. At 1020, two RN divers entered the water, and about 8 minutes later they found Tony's body floating against the deck on the port side of *Solstice*'s wheelhouse. He was recovered and taken ashore.

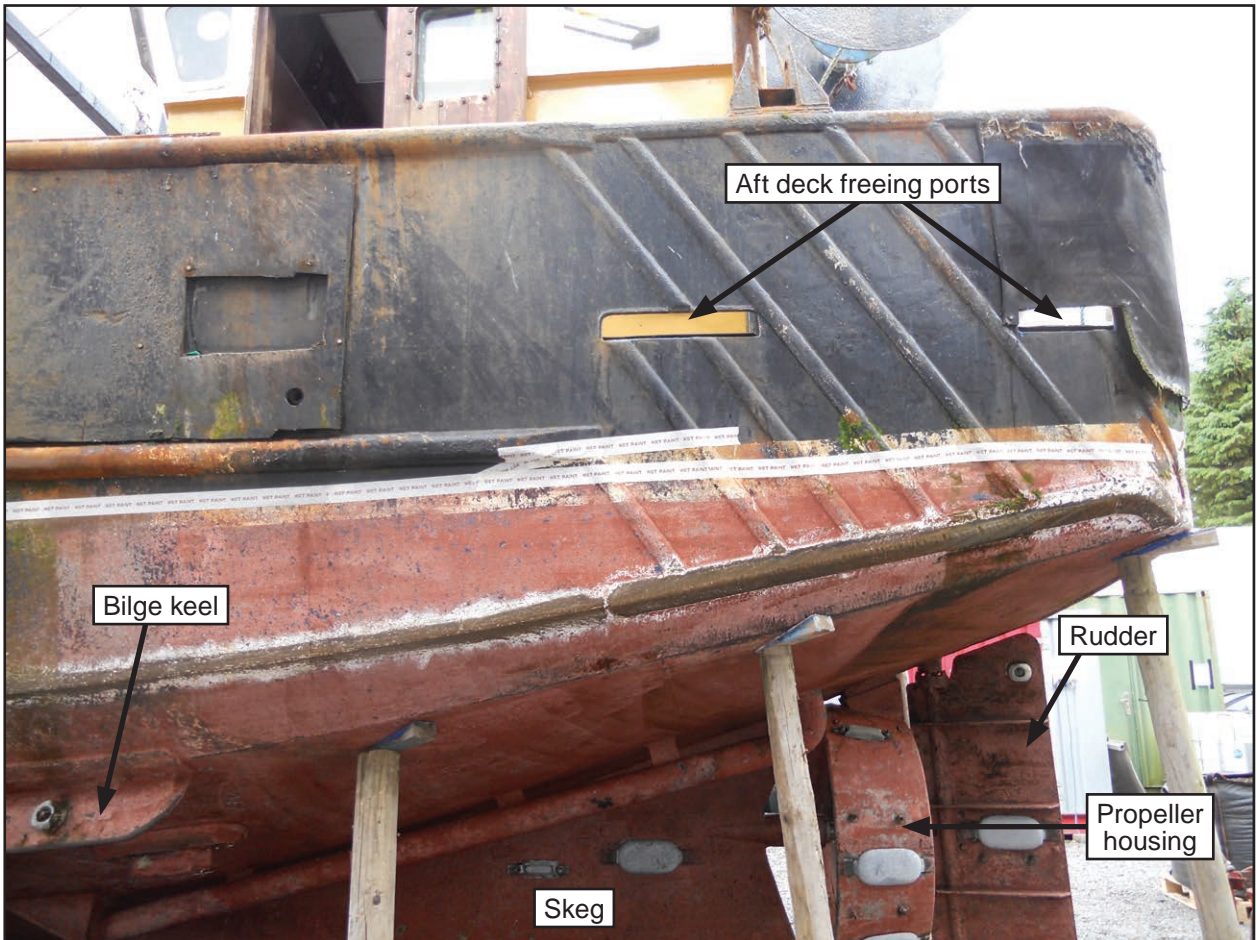
Figure 12: Pre-purchase survey – hull form aft end port side showing aft skleg design

Solstice was built in 2000 at the Offshore Steel Boats shipyard in Barton, Humberside. It had an all steel construction, with an aft wheelhouse, all-round bulwark and a raked and curved transom. It had a conventional single screw propeller and blade-type rudder, and its hull had an aft skeg and was fitted with bilge keels (**Figures 11, 12 and 13**). Below deck from fore to aft was a forward store, insulated fish hold, engine room, full width cabin, and aft peak space that contained the steering gear. Access to the engine room and cabin space was via the wheelhouse, and access to the fish hold and forward store was via hatches on the forward working deck. The wheelhouse door was on the port side.

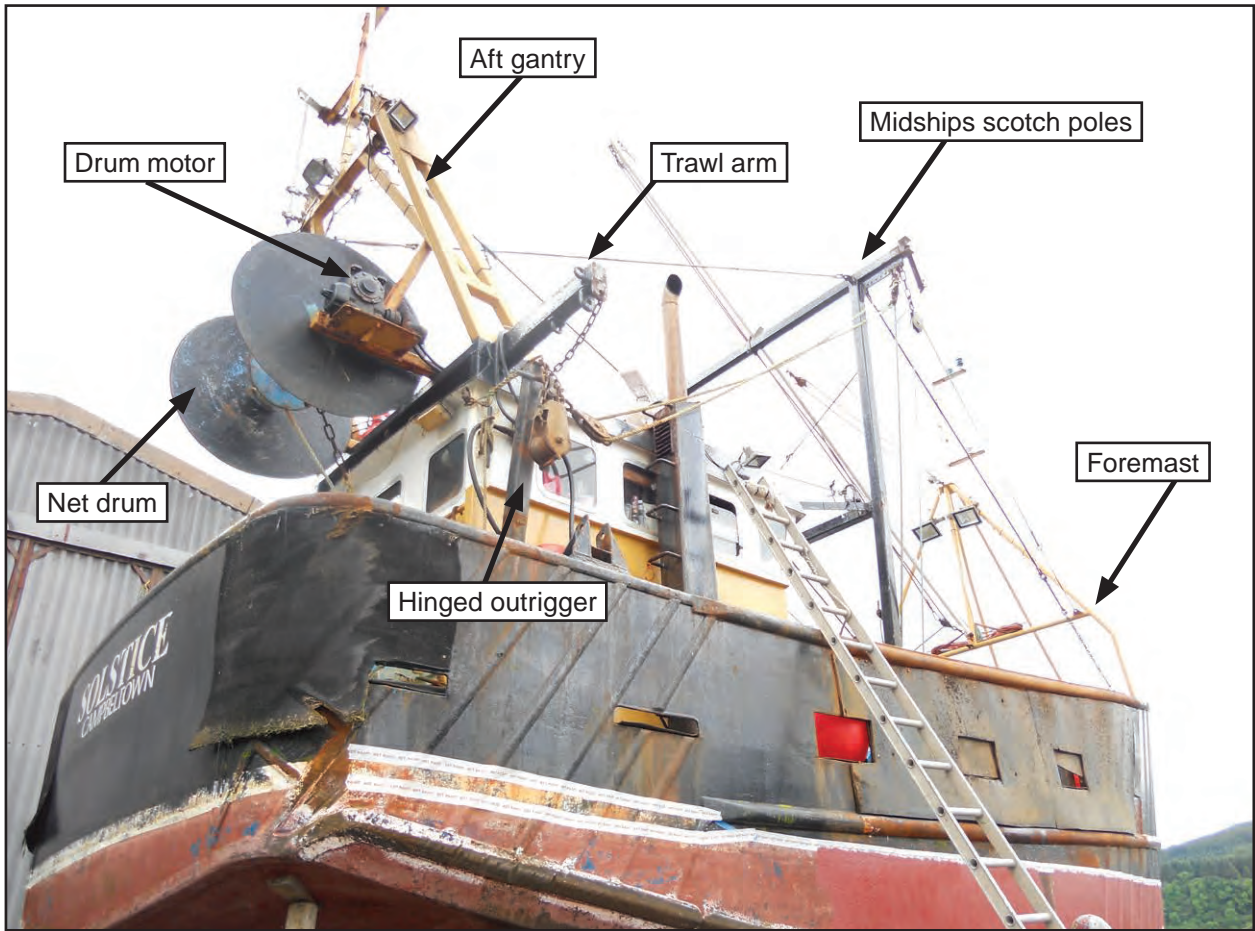
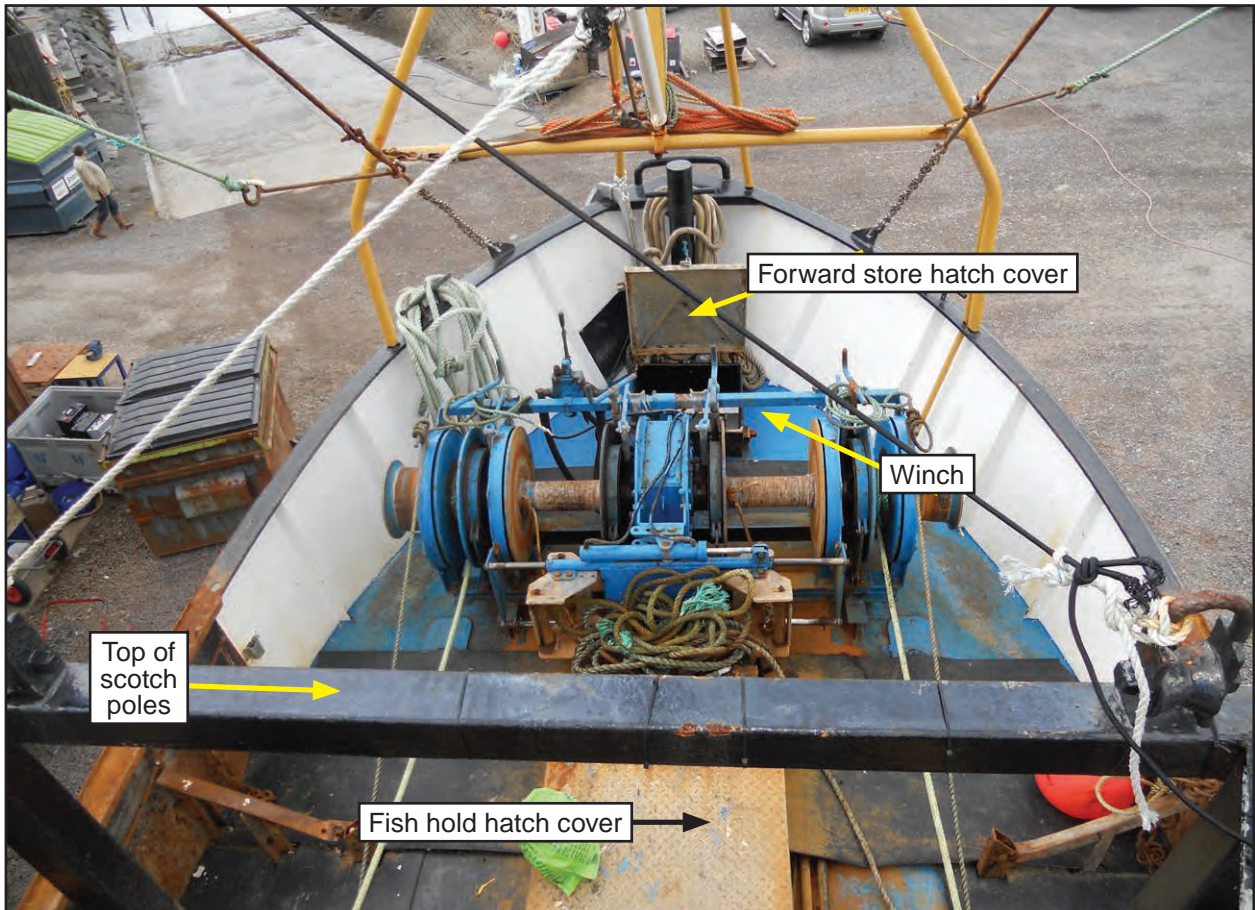
The vessel had a 2t working load limit multi-purpose, four-barrel, double-drum hydraulic winch on the forward deck and a hydraulic net drum on top of the wheelhouse roof. It also had a landing derrick on the foremast, scotch poles amidships, an aft gantry with trawl arms and port and starboard hinged outriggers for scalloping (**Figures 14 and 15**).

Figure 14: Pre-purchase survey – upper structural components

Figure 15: Pre-purchase survey – forward deck from top of wheelhouse

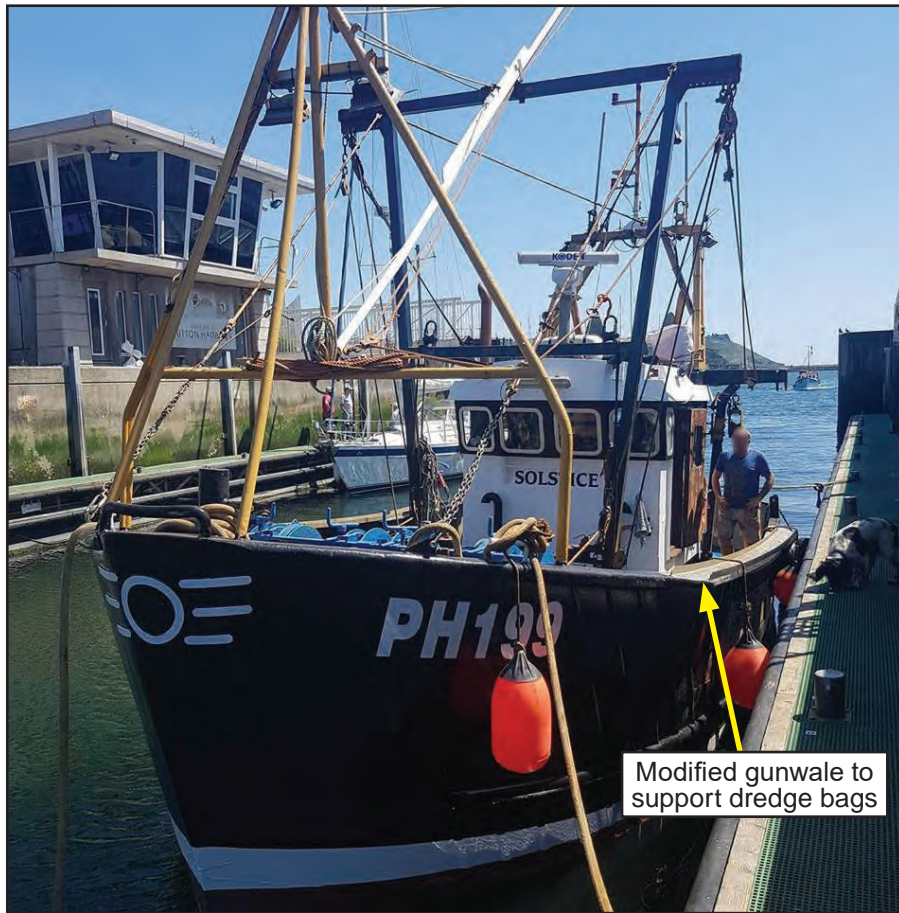
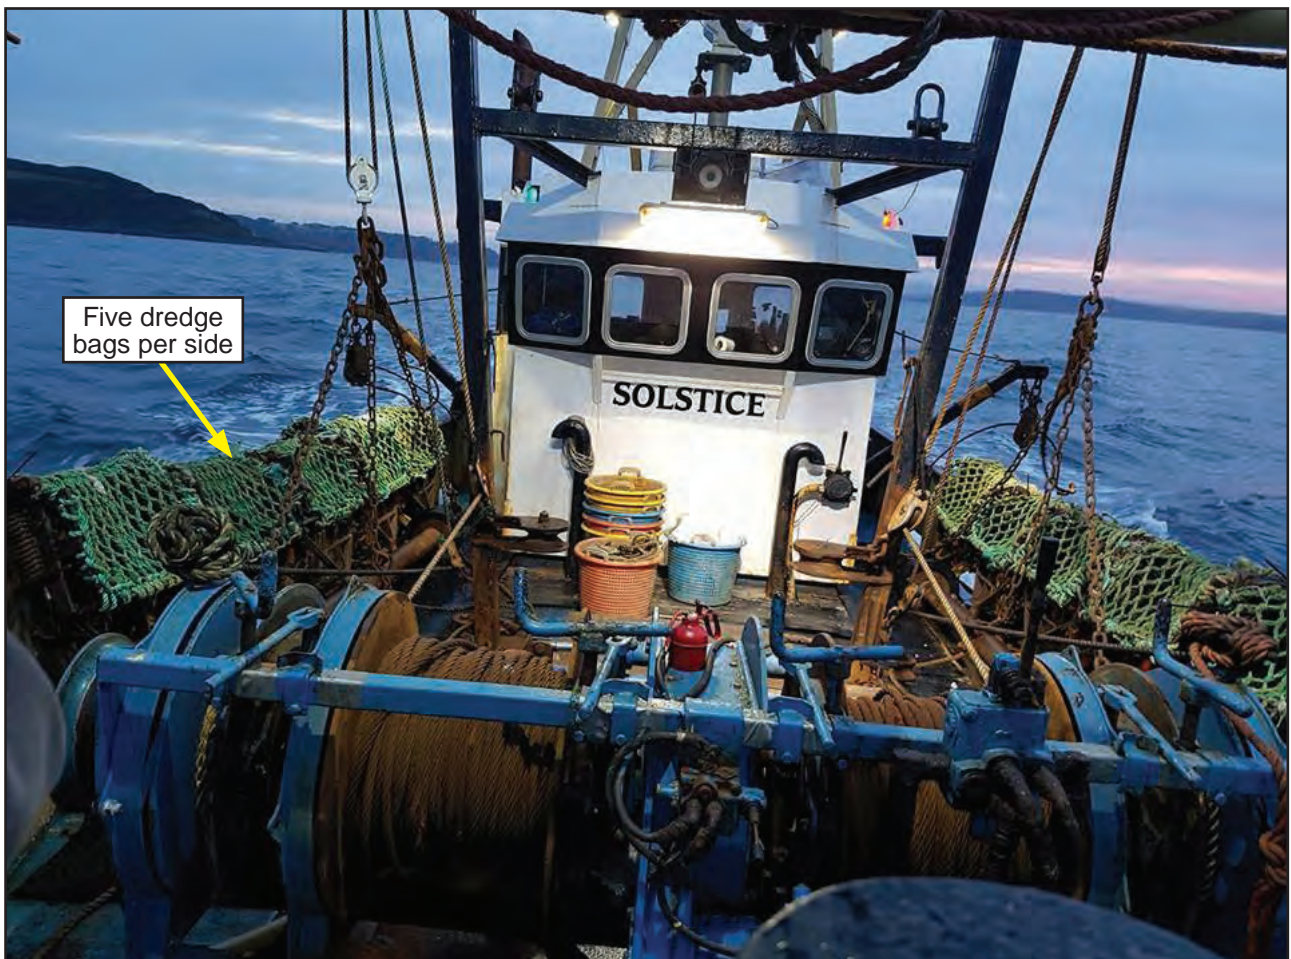
Figure 16: Modifications carried out to *Solstice* in 2017 to improve dredging method

Between 23 May and 18 June 2017, modifications were made to *Solstice*'s bulwarks and dredge gear to improve working methods and increase the vessel's catch. Longer dredge beams with five bags instead of four were fitted and larger steel trays for landing the dredge bags were welded to the top of the forward deck gunwales (**Figure 16**).

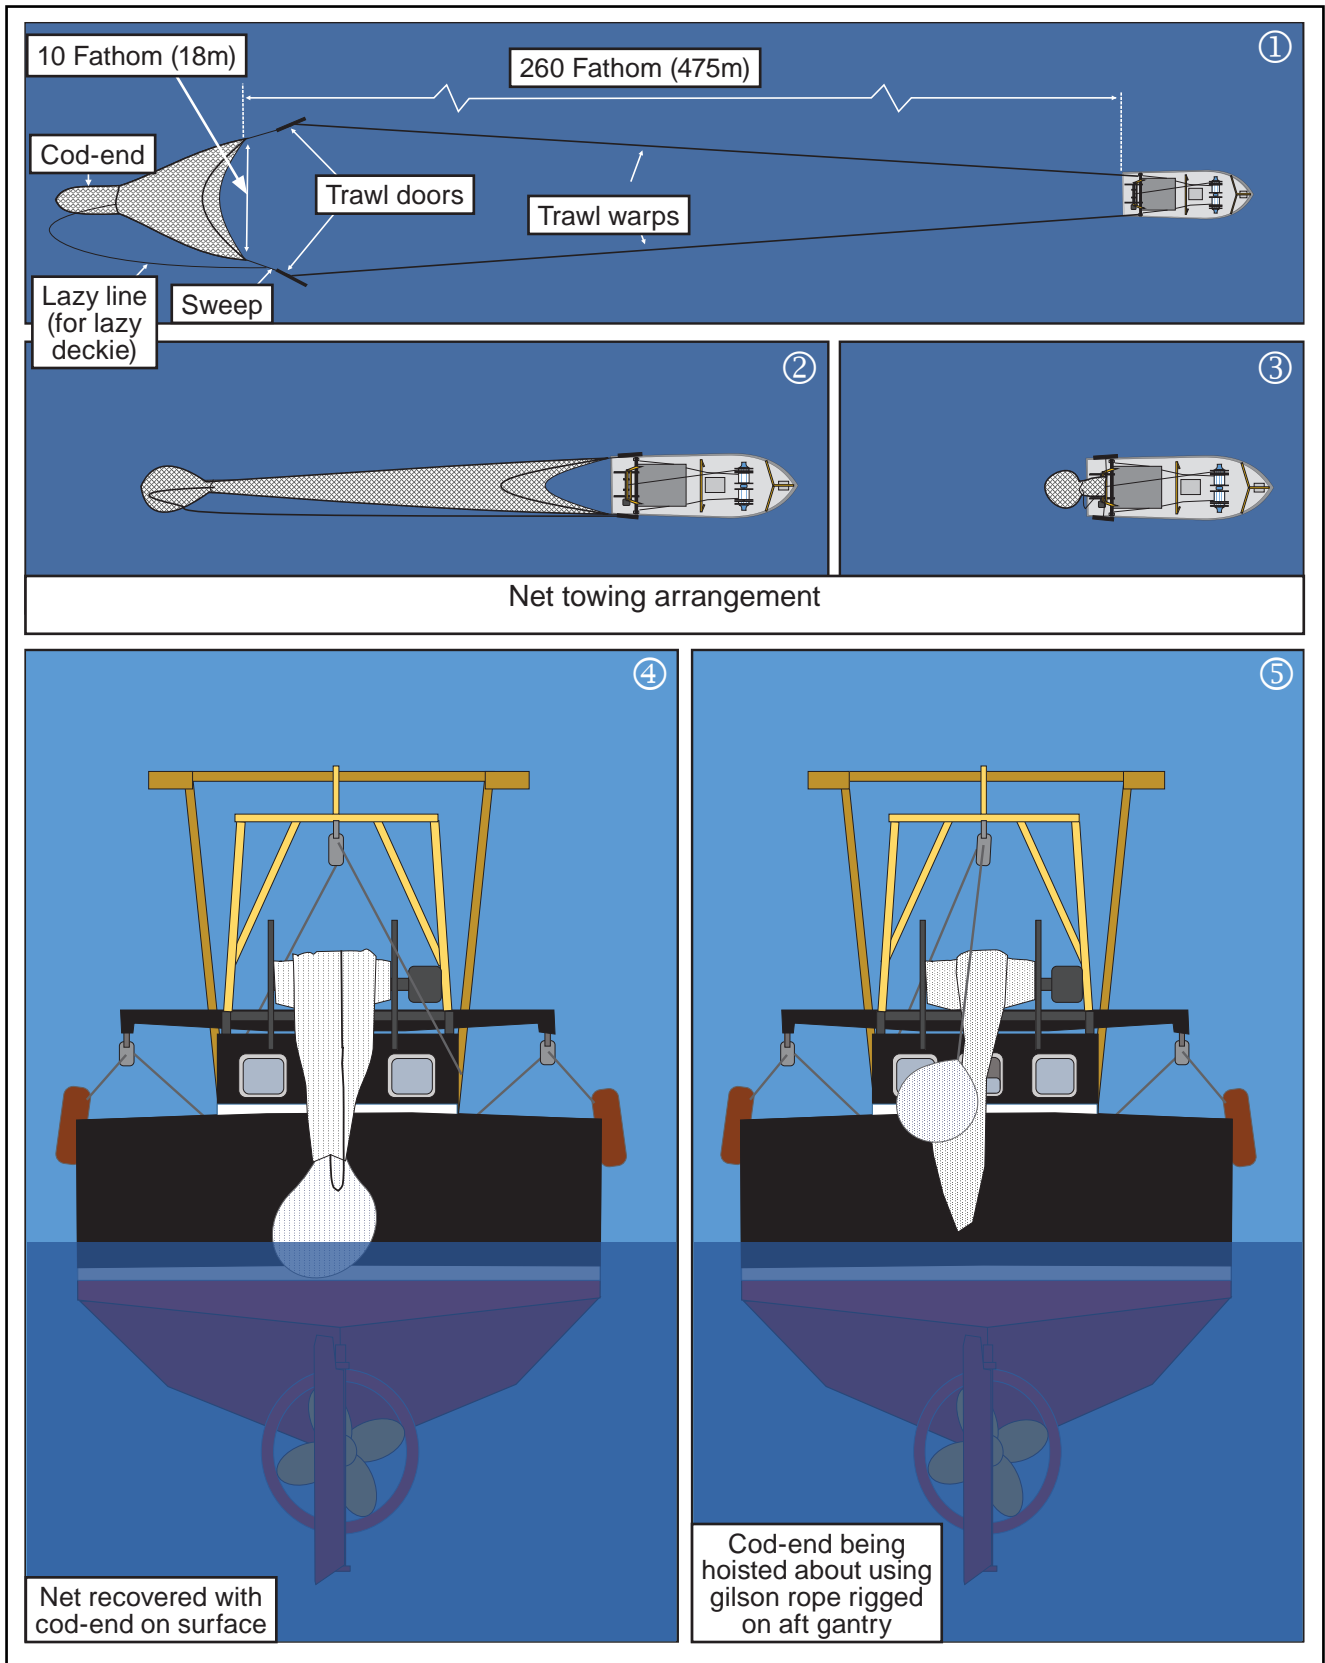
Figure 17: Solstice net towing and catch recovery method

Solstice did not have a written risk assessment or safe system of work for trawling. The method (**Figure 17**) used by Tony to land the catch involved recovering the net over the stern and emptying the cod-end onto the deck area aft of the wheelhouse. To do this, the forward winch was used to haul in the trawl warps and sweeps. Once the trawl doors were secured, the net drum was used to haul the cod-end to the surface. The cod-end was then lifted over the stern deck bulwark using the deck winch and a gilson rope. The gilson rope was rigged through the block at the top of the aft gantry. The cod-end was emptied onto the aft deck between the pound boards (**Figure 18**). Once landed, the catch was processed, boxed up and taken forward to the fish hold.

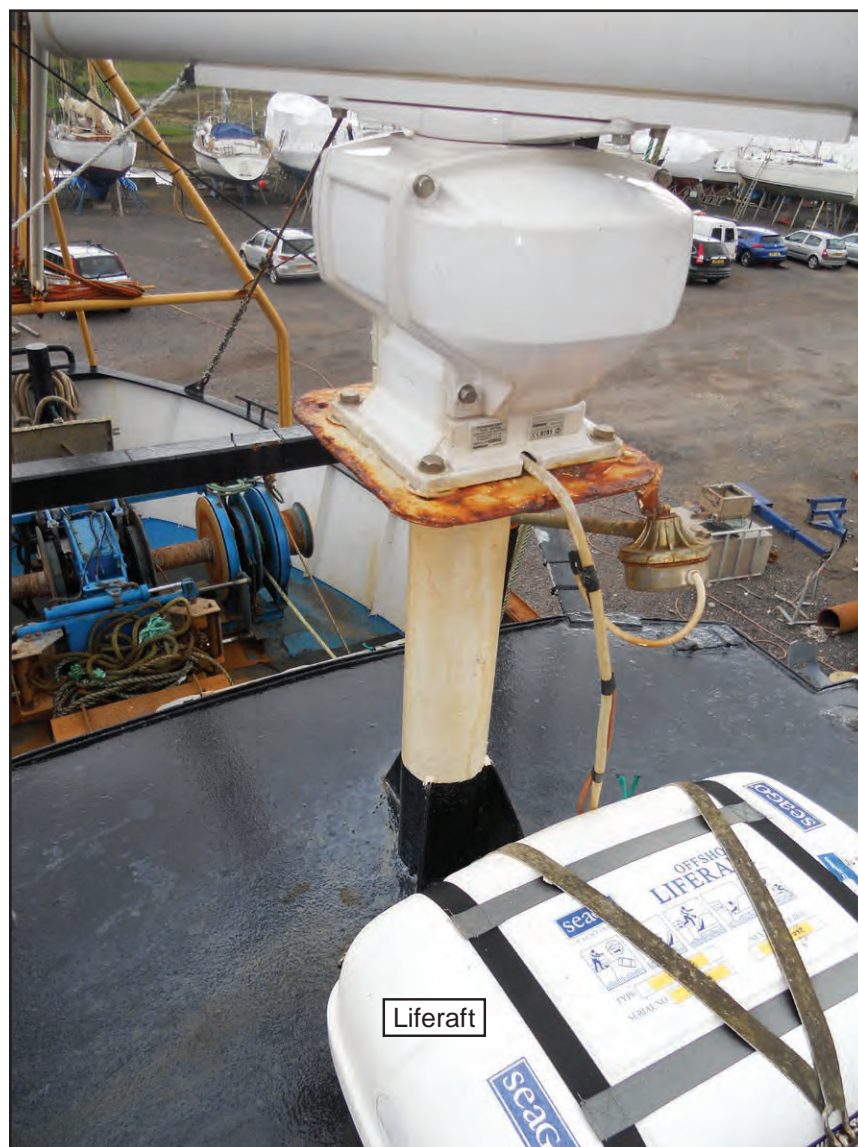
Figure 19: Liferaft on top of wheelhouse

Solstice had two lifebuoys, one each side of the wheelhouse; the starboard lifebuoy had an 18m buoyant line. The vessel also had a four-person *Seago Offshore* liferaft that was stowed in a cradle on top of the wheelhouse roof (**Figure 19**) and secured in place by a hydrostatic release unit (HRU). The liferaft was on board when Tony purchased the boat and was overdue its periodic service (the service due date was May 2017).

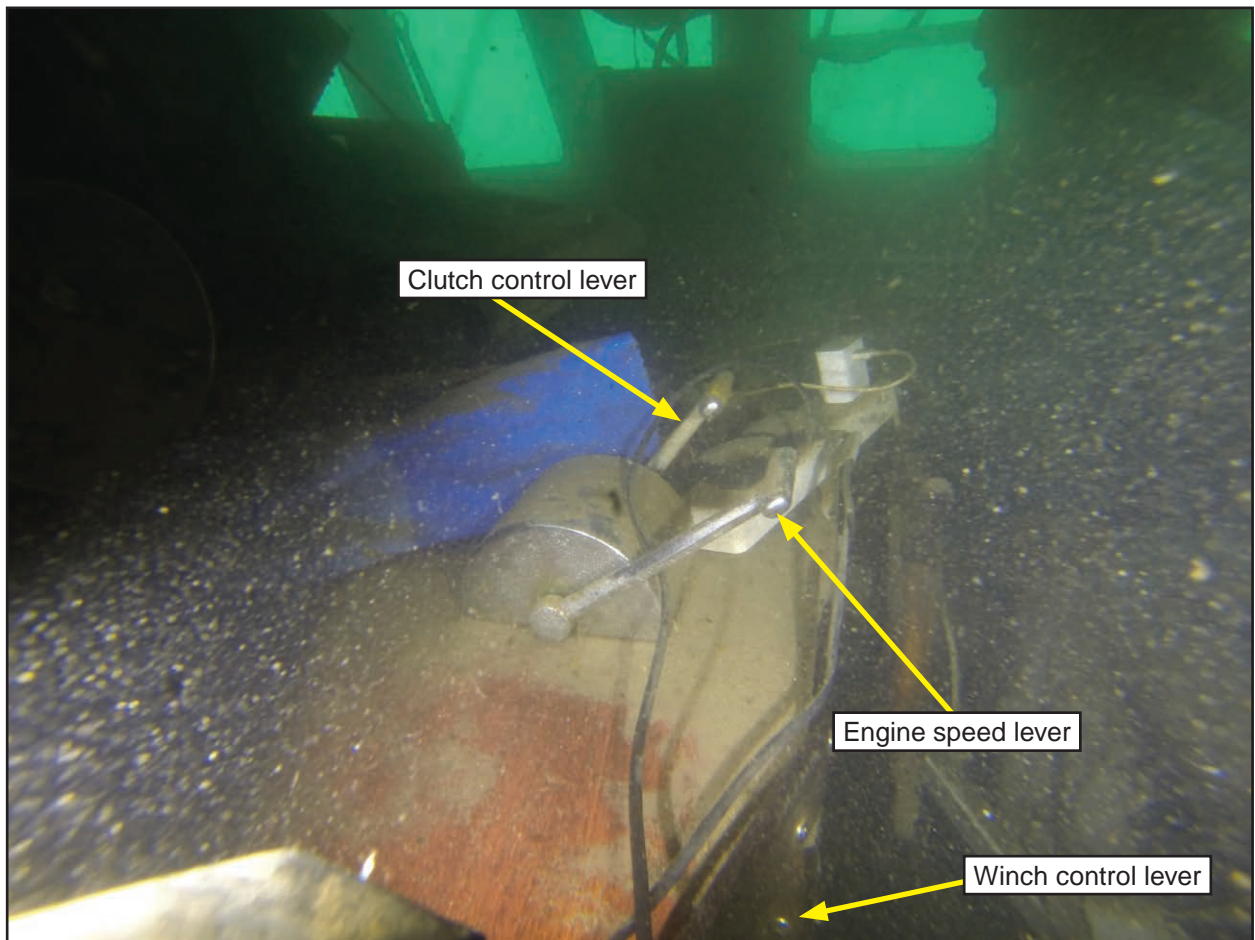
Figure 22: Wreck showing wheelhouse engine control

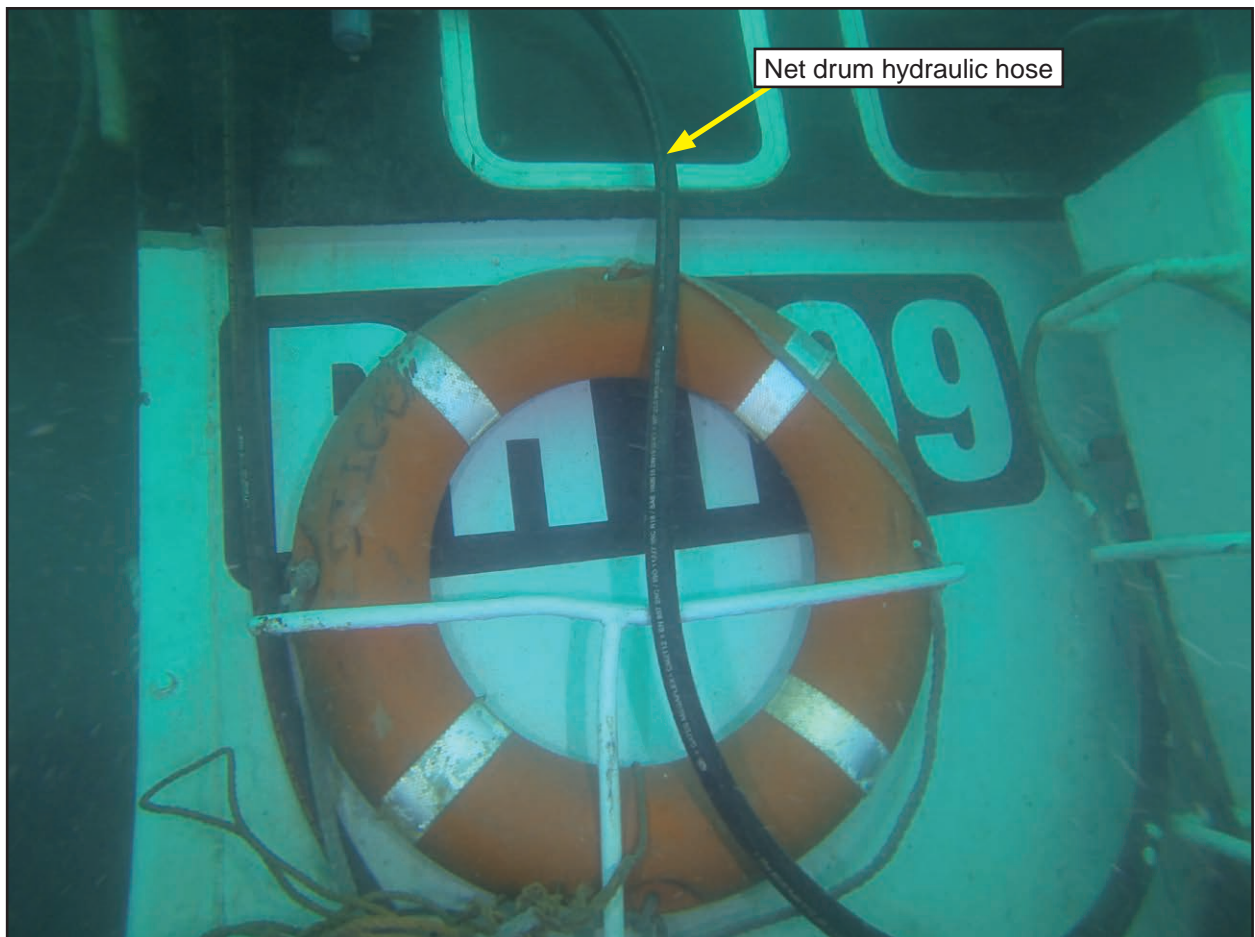
Figure 23: Wreck showing starboard lifebuoy

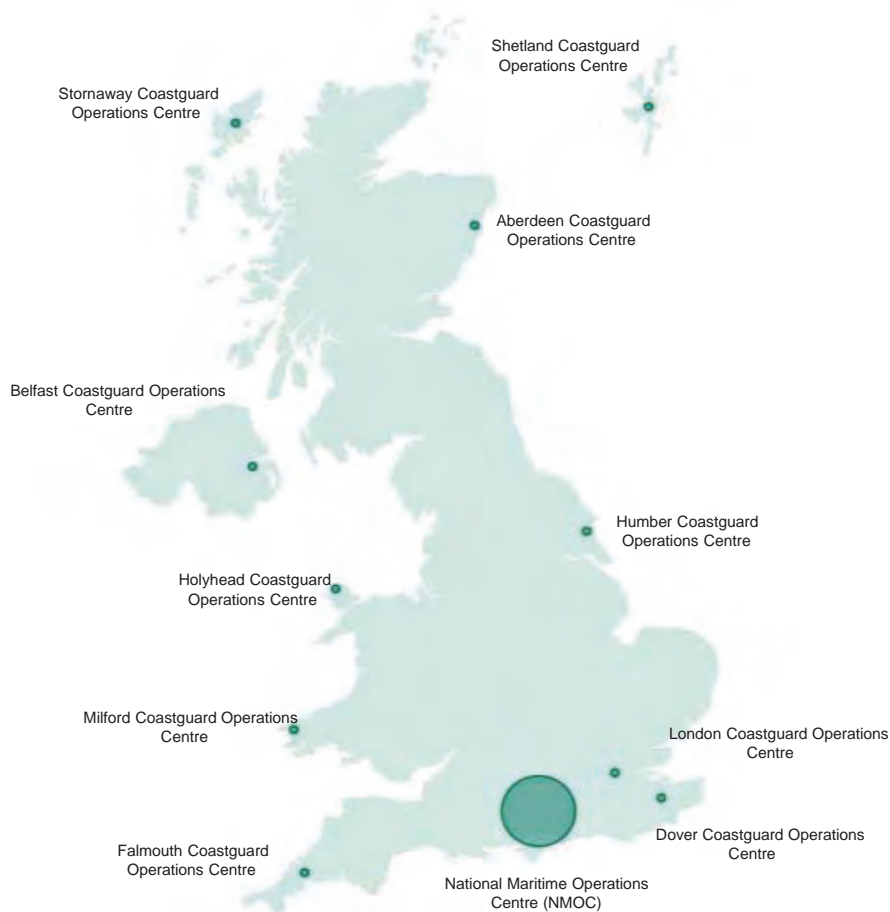
Figure 26: Locations of regional CGOCs and suggested staffing levels

Solstice capsized during the medium demand period and was reported overdue during the daytime shift. According to HMCG's suggested staffing levels (**Figure 26**), the minimum number of coastguard officers available for SAR on the network and on duty at Falmouth CGOC should have been 34 and 3 respectively. When the report was received, there were 38 coastguard officers on duty across the network and 2 coastguard officers in the Falmouth CGOC. The Milford Haven and Aberdeen CGOCs were also staffed by two operators; one below their suggested seasonal staffing levels.

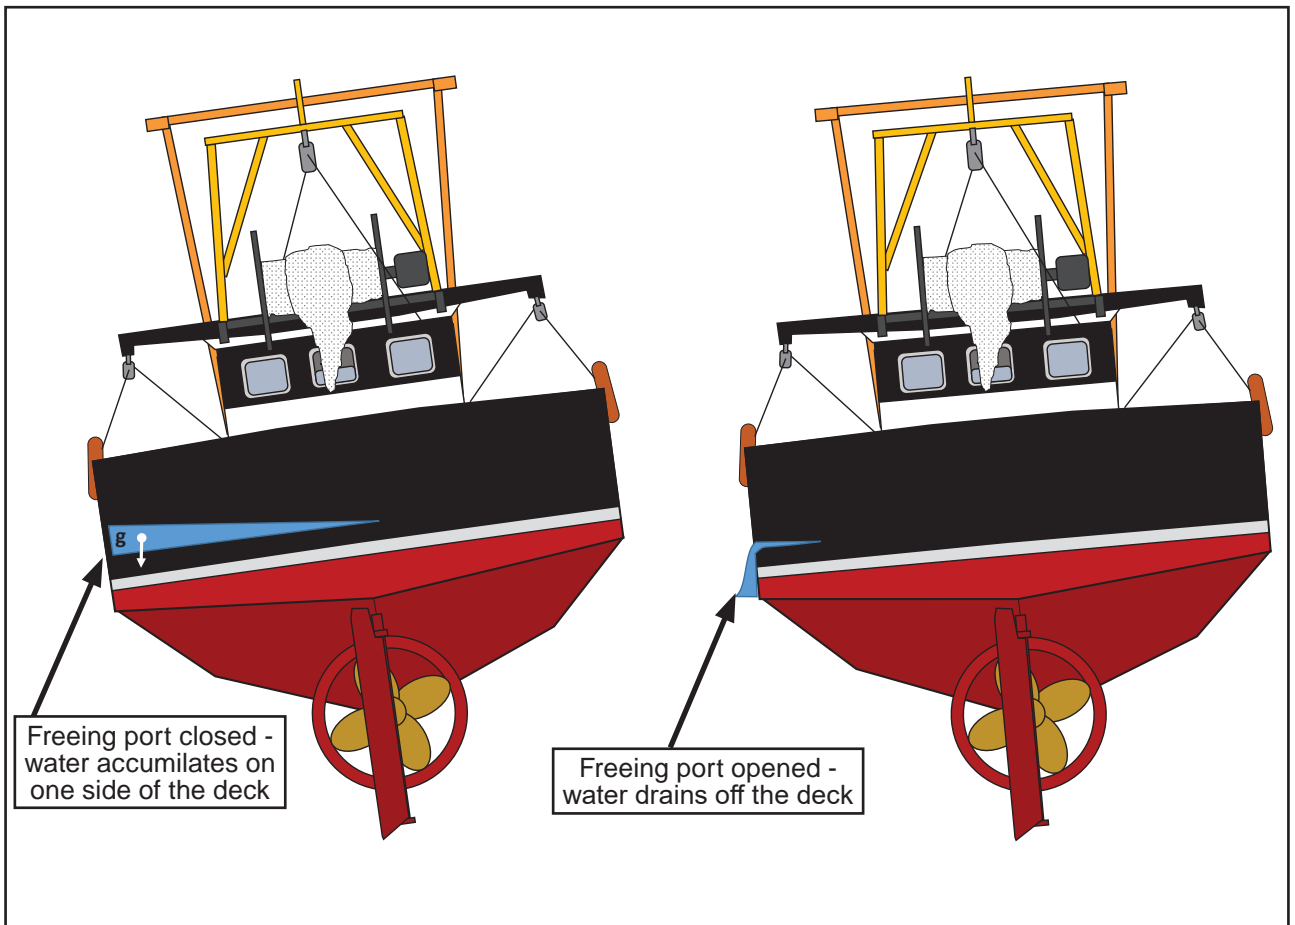
Figure 34: Free surface effect

Water on deck presents a serious stability hazard. Not only will the weight of the water reduce the vessel's freeboard and raise its VCG, but it will also introduce a 'free surface effect' as it sloshes across the deck (**Figure 34**). It is therefore essential that water is moved off the deck as quickly as possible. This is achieved by the provision of freeing ports in the bulwarks. Freeing ports must be of sufficient size and should never be closed or blocked, especially during critical fishing operations and in bad weather.
