Report on the investigation of the  
capsize of the fishing vessel  
***Laura Jane (SE80)***  
with the loss of one life  
in Plymouth Sound  
on 7 May 2018

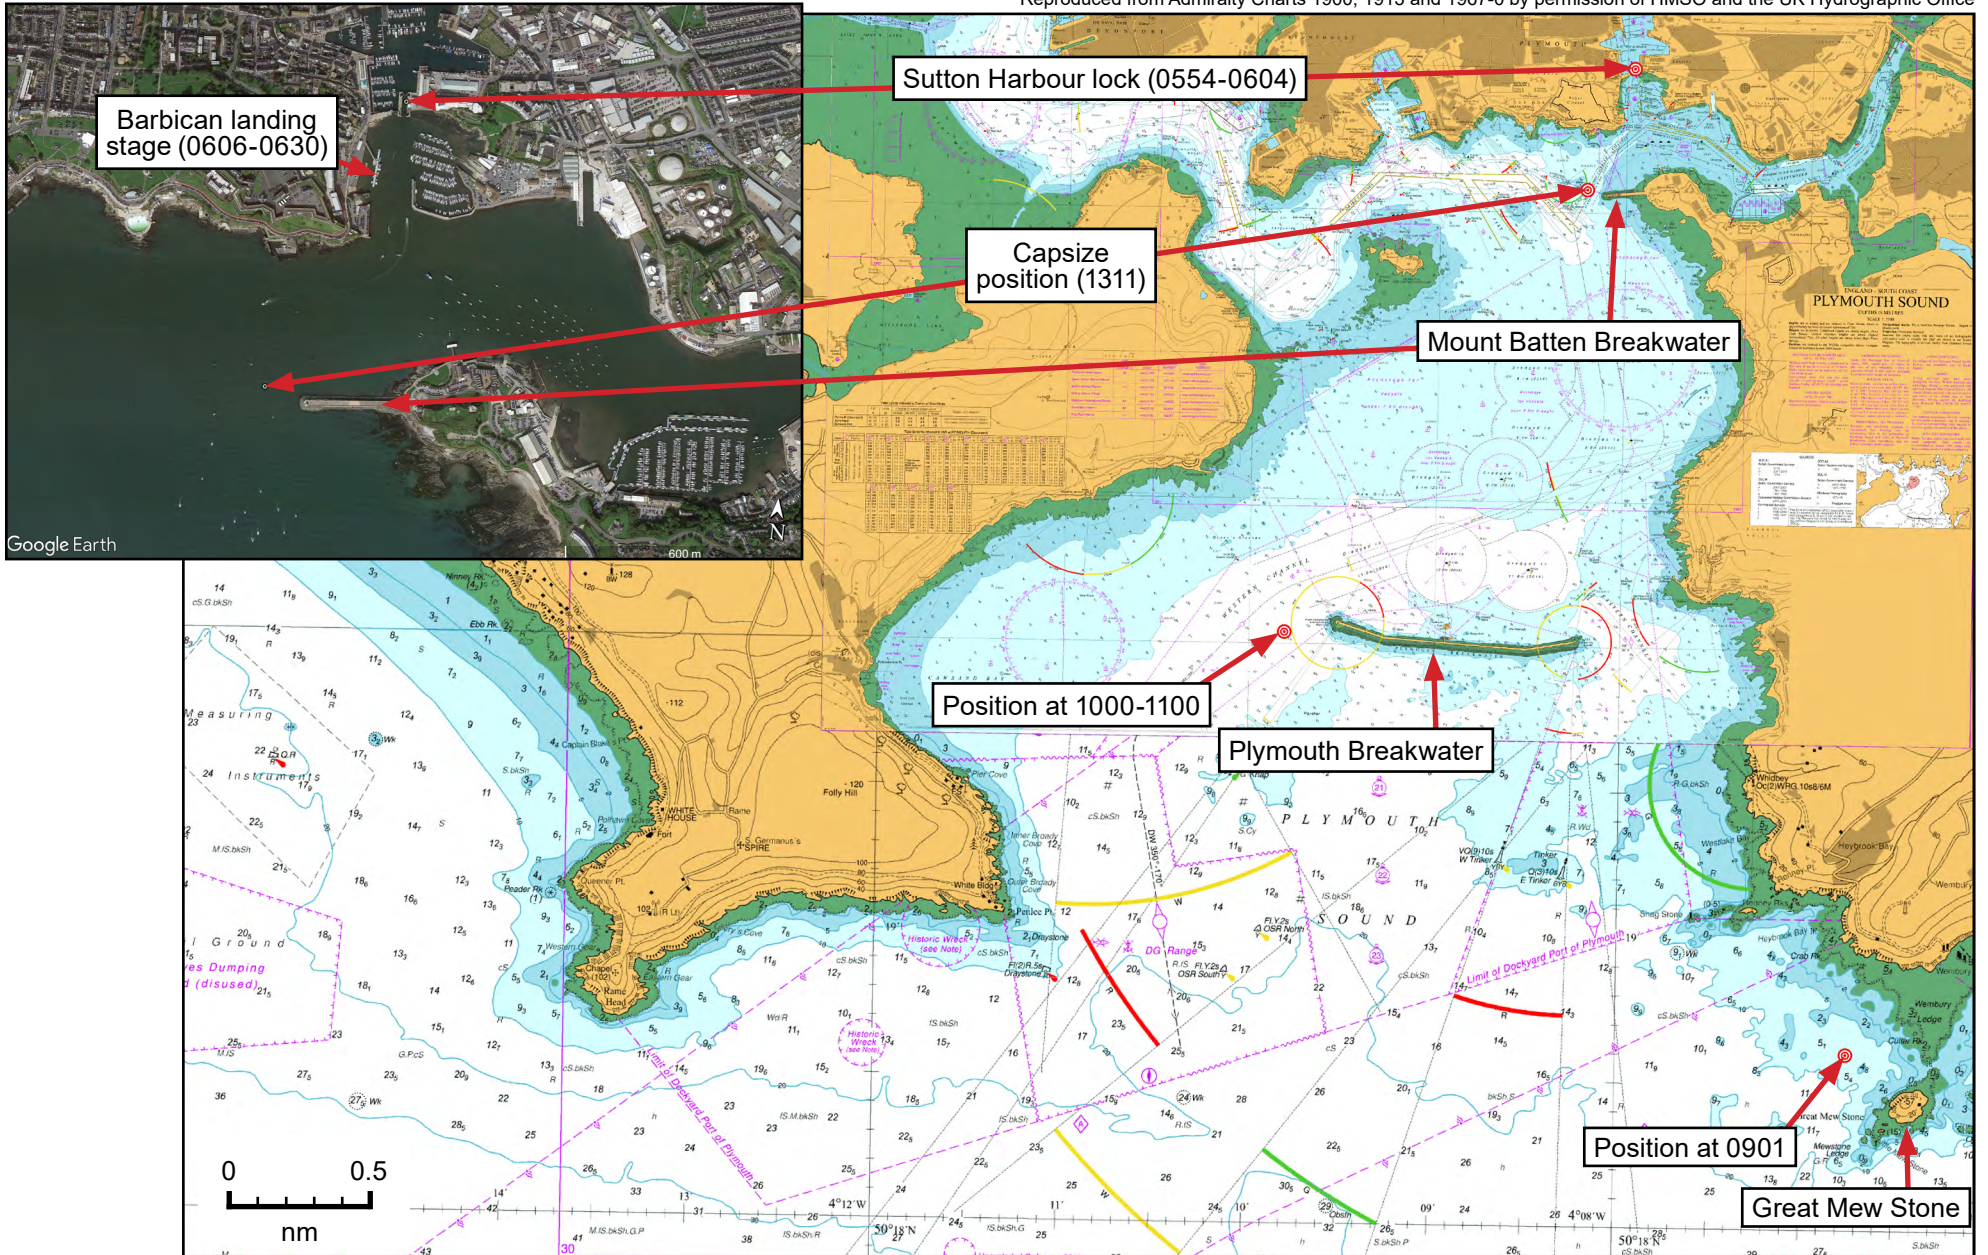
Figure 2: Movements of *Laura Jane* on 7 May 2018

*Laura Jane's* global positioning system (GPS) plotter recorded the vessel was near the Great Mew Stone at 0901. Between 1000 and 1100, the skipper of another fishing vessel saw *Laura Jane* fishing half a mile off the western end of Plymouth Breakwater.

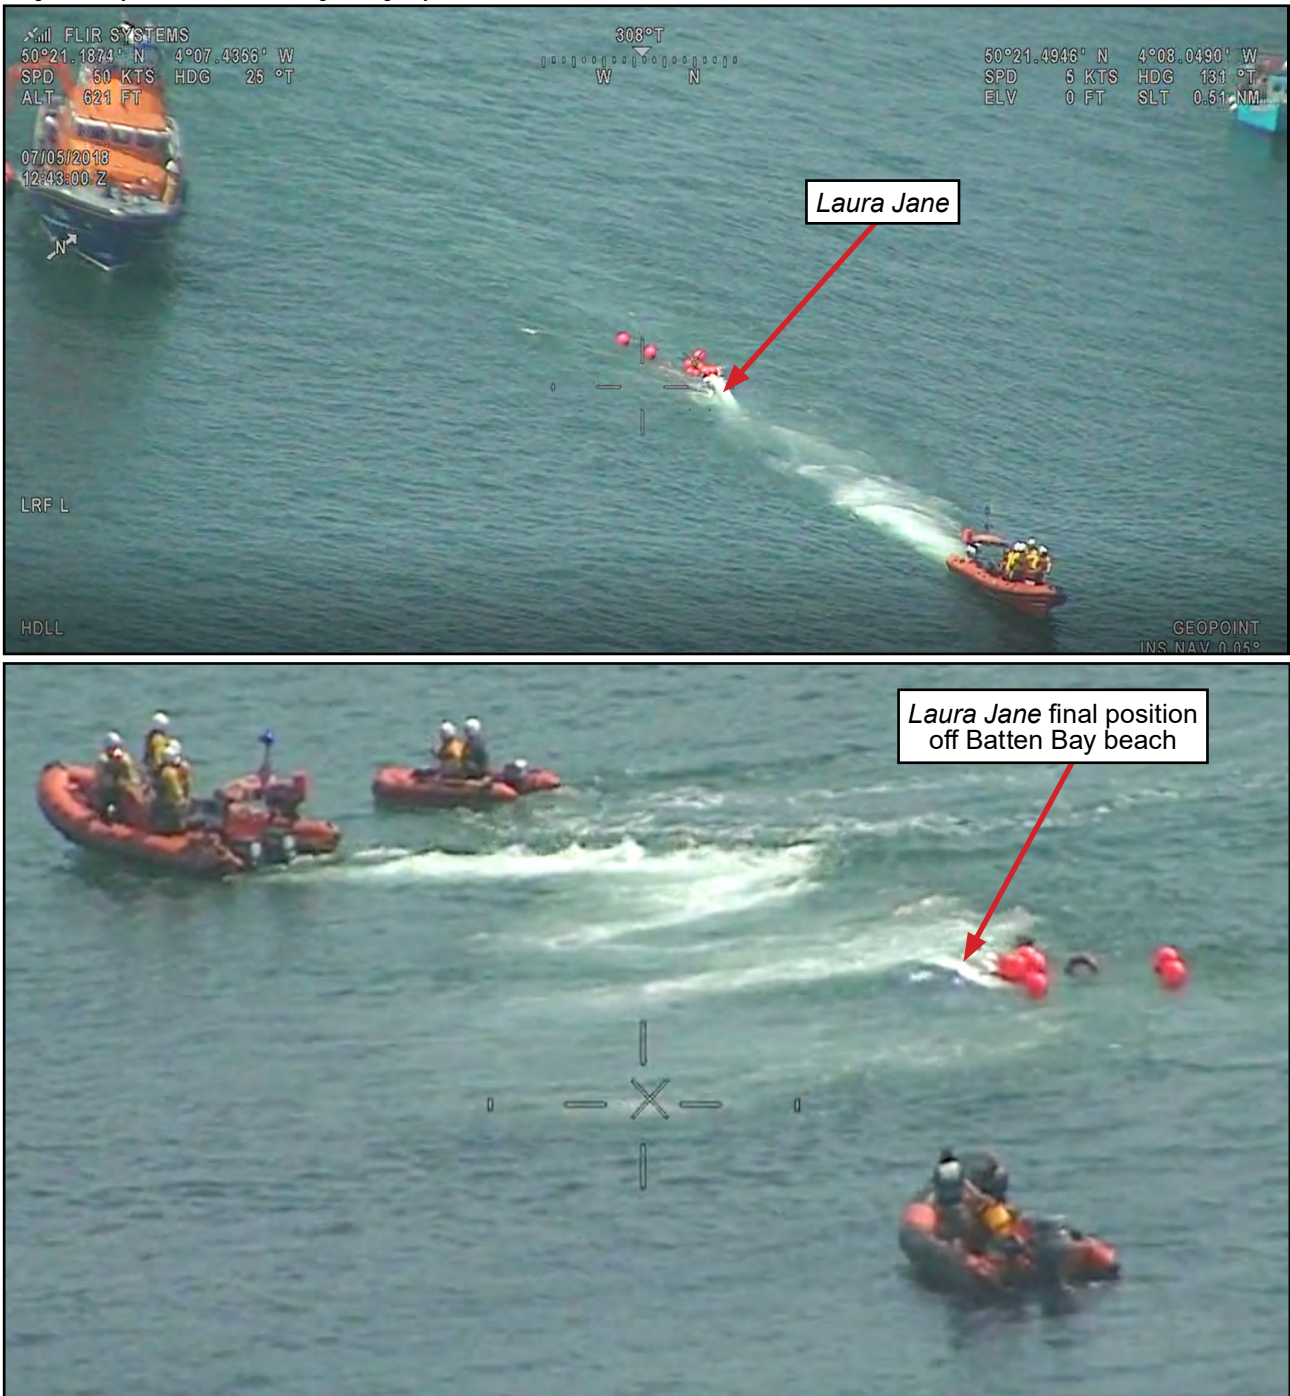
**Figure 5:** RNLi rescue effort

By 1326, the RNLI inshore lifeboat (ILB) had arrived at the scene and had started attaching more lines to the capsized vessel. By 1330, the all weather lifeboat (ALB) had arrived and had taken control of the rescue operation while the MOD police ensured that other boats did not interfere (**Figure 4**). The ALB coxswain assessed that breaking a wheelhouse window could sink the vessel; he had concluded that the water being ejected from its port side was due to a diminishing air pocket. He decided instead that *Laura Jane* should be towed into shallow water. The ILB dragged *Laura Jane* to Batten Bay, where the vessel was beached port side up with the wheelhouse window protruding above the water in an ebbing tide (**Figure 5**).

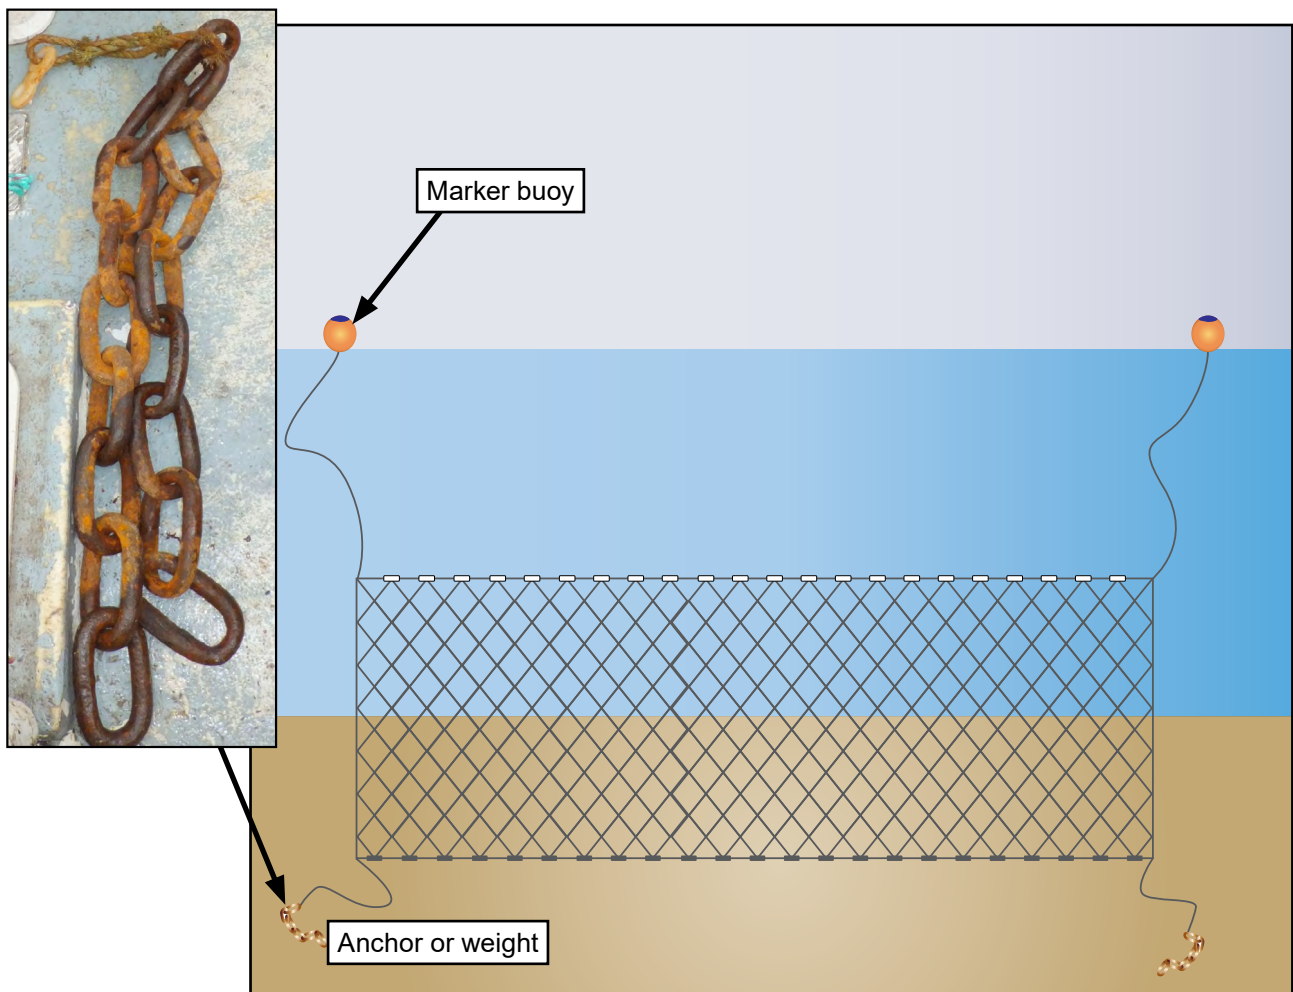
**Figure 10:** Gill or static netting method with net and chain weight (**inset**)

*Laura Jane*'s normal mode of fishing was gill netting. Gill or static nets are hung vertically in the water between a top rope fitted with small floats and a leaded bottom rope fitted with weights. The nets are kept in place by anchor weights at each end, which are marked by surface floats (**Figure 10**). Each net with associated weights weighed approximately 60kg. Once laid, the nets are left in place for 24 hours before they are retrieved.
