MARINE ACCIDENT  
INVESTIGATION BRANCH

# **SAFETY DIGEST**

**Lessons from Marine  
Accident Reports  
2/2019**

October 2019

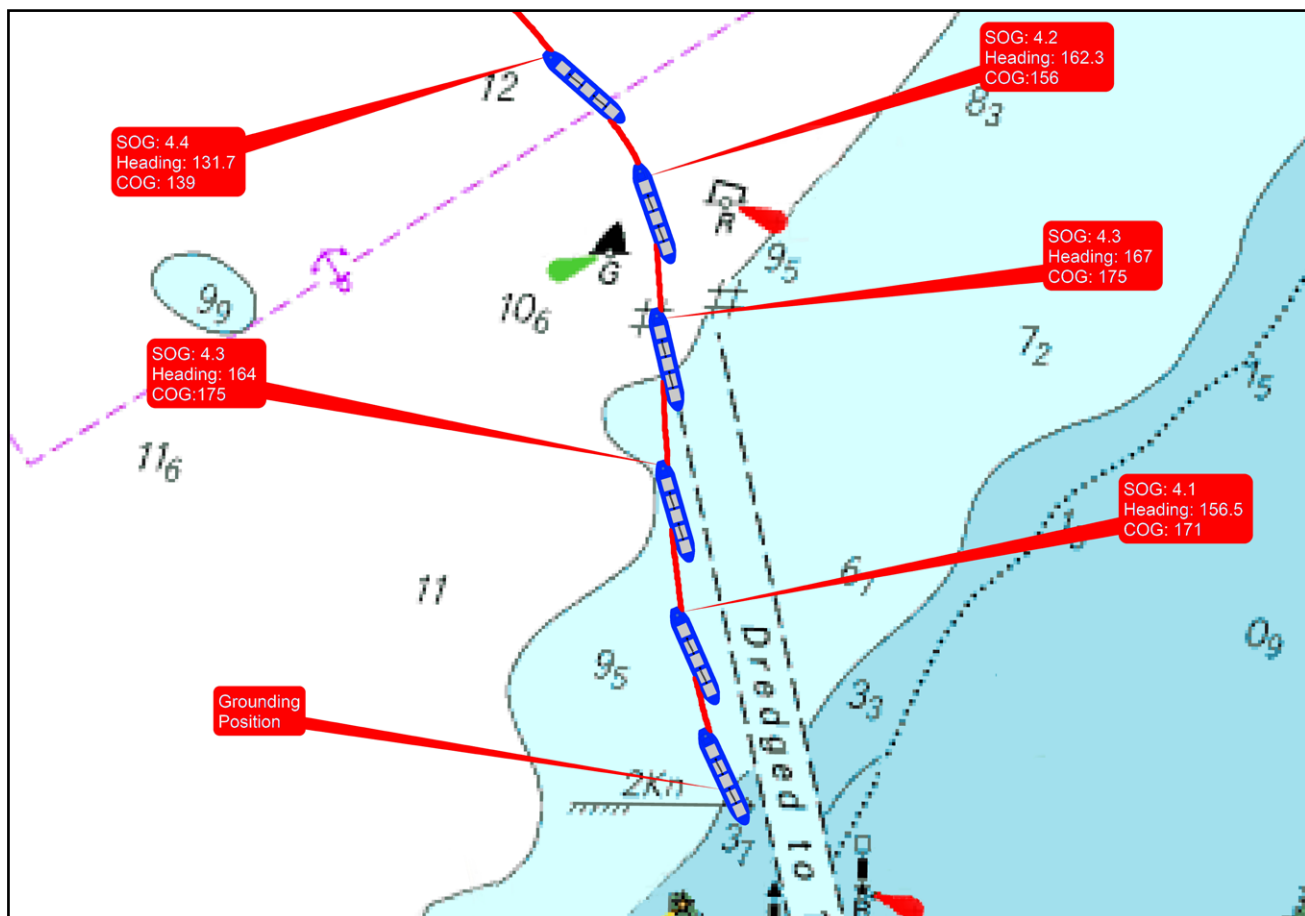
After the vessel passed between the outer of the channel's lateral buoys on a heading of 167° (see figure), it was set slowly to the west. The pilot ordered the helmsman to steer 165° and requested that the engine telegraph be set to 'dead slow ahead'. The master advised the pilot of the vessel's continued set towards the western side of the channel. In response, the pilot ordered a heading of 163°. Soon after, the echo sounder alarm went off and the second officer reported that the course over the ground was 174°. In response, the pilot ordered a heading of 157° and then steadied on 155°.

Two minutes later, the second officer advised that the speed was 4.1kts, and the pilot requested that the engine telegraph be set to 'slow ahead'. By that time, the bulk carrier was outside the channel and making good a course of 167°. The vessel's speed then slowly reduced as it took the ground in the shoaling waters near the next channel marker buoys.

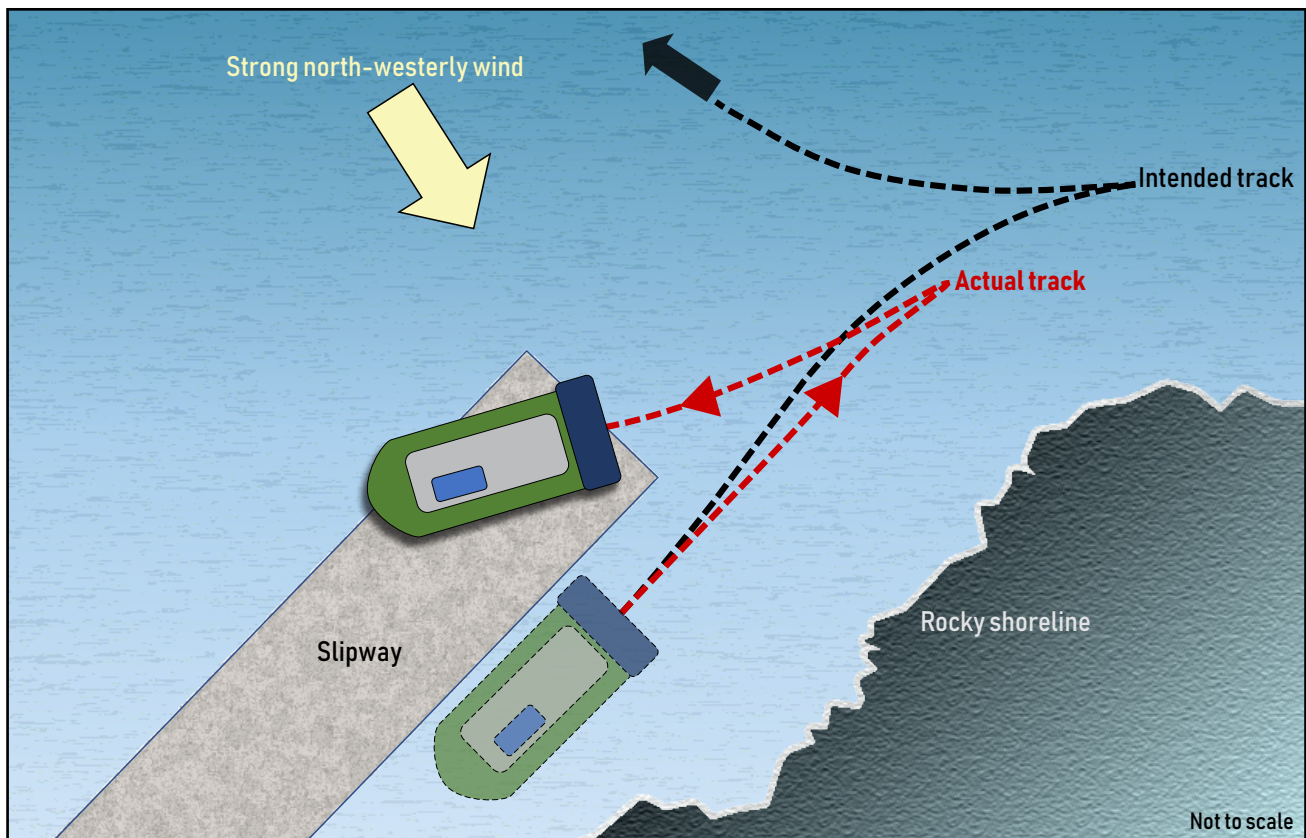
Figure 1: Diagram showing the intended and actual tracks of the ferry

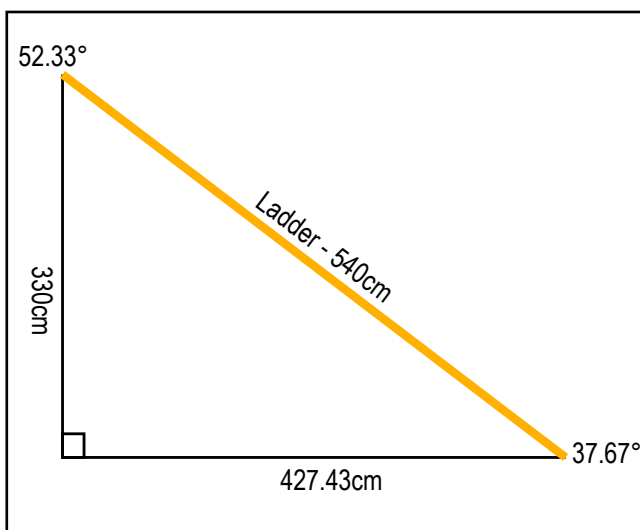
The master and chief engineer discussed the issue and decided that a temporary curtain arrangement should be rigged in the corridor to protect the pipework. The master then instructed the bosun to create a curtain, which could be hung at an opening in one of the frames in the port side corridor to reduce the wind effect. This was to be in position by the time they reached the colder weather in 3 weeks' time. The bosun immediately fashioned the curtain and instructed the duty AB and the day-work AB to help him rig it. The curtain needed to be fitted at deckhead height, a distance of 3.5m. The bosun had already placed a ladder in position; at 5.4m length, it had a pitch angle of approximately 38° (Figure 1).

Figure 1: Diagram showing the height of the ladder and the pitch angle

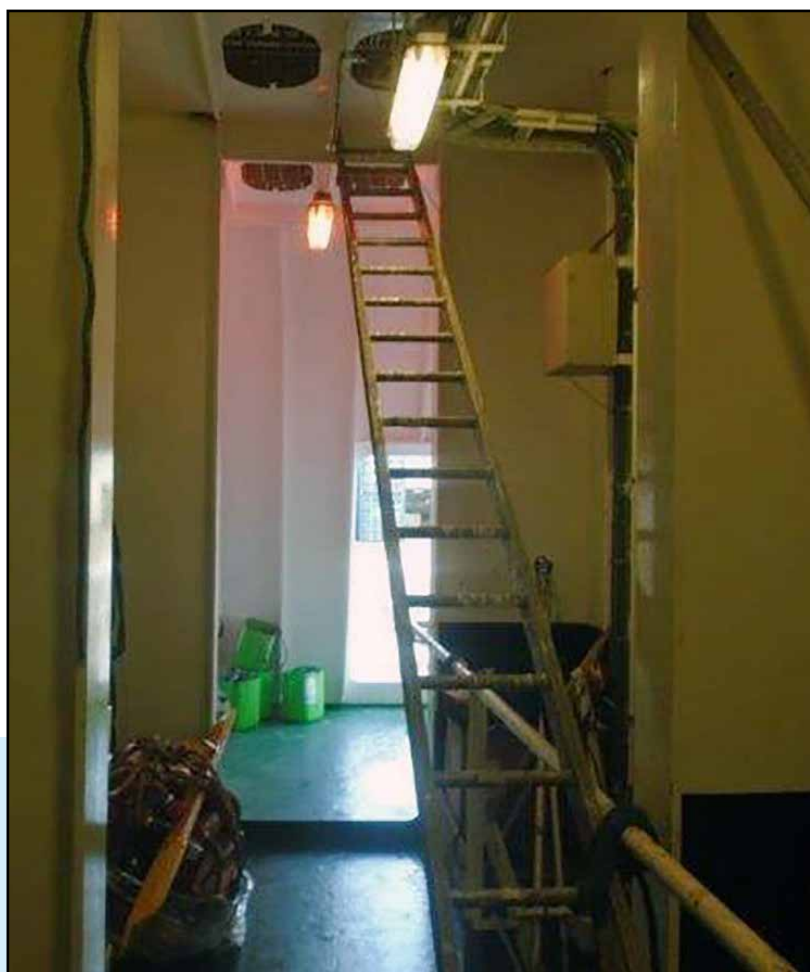
The duty AB was growing uneasy with the ladder arrangement as he struggled to maintain a decent footing. He asked the bosun to come down, but the bosun reassured him that all was well. A short time later the ladder slipped without warning and, as it cleared the bulkhead, the ladder twisted, throwing the bosun to the deck. The bosun landed heavily onto the opening's raised coaming.

Figure 2: Reconstruction of the scene

4. Working at height should be avoided whenever possible but, if it is necessary, the correct equipment must be used and rigged correctly. Advice on how to use ladders safely can be found in both the MCA's Code of Safe Working Practices and the HSE's leaflet INDG402 – Safe use of ladders and stepladders.

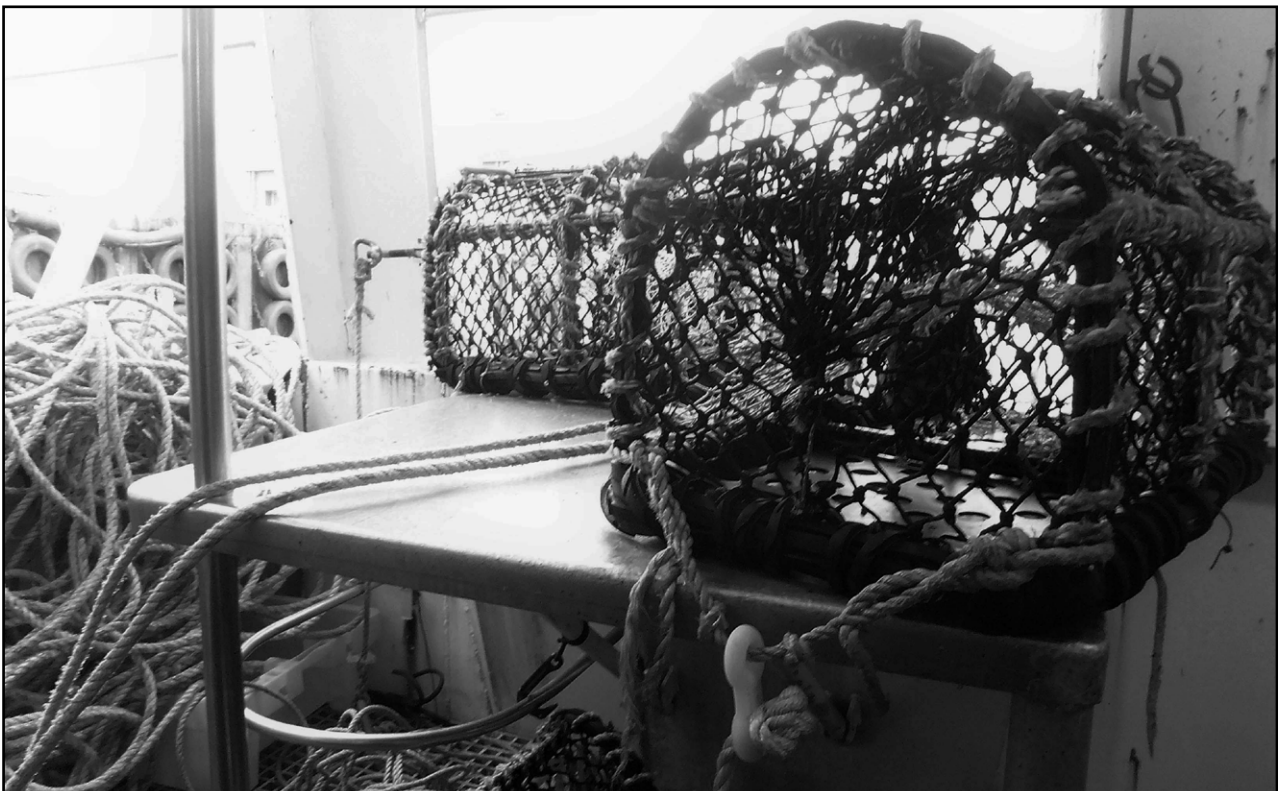
Figure: Creels on the shooting table

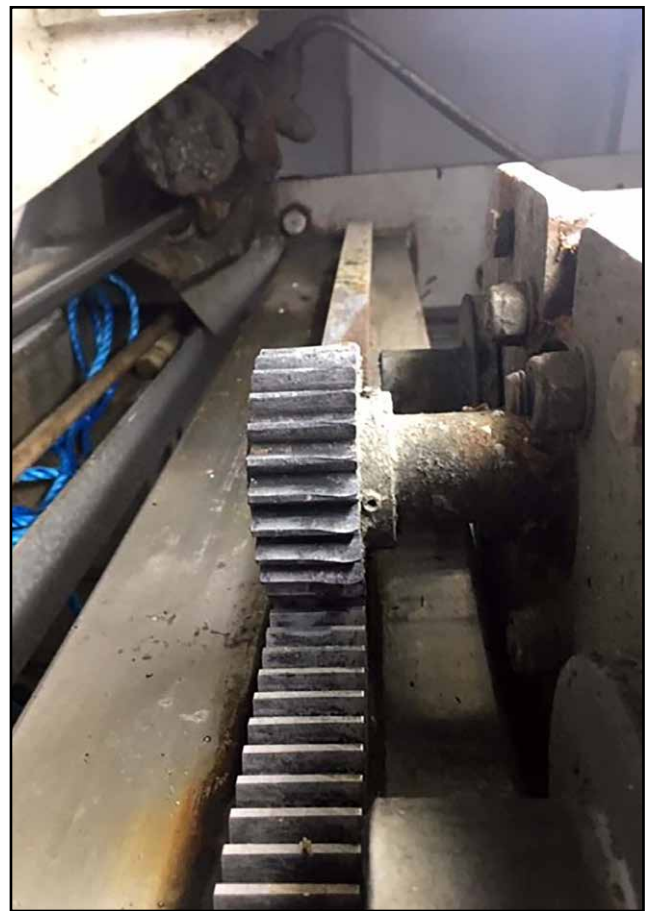
As the boat rolled in the swell, one of the deckhands reached to the deckhead above with his left hand to steady himself. In doing so, he inadvertently caught hold of the flaking machine's rack and pinion arrangement (Figure 1) just as the other deckhand operated the machine's remote control. The resulting movement of the pinion trapped the deckhand's little finger, causing him to shout out in pain and tell the other deckhand to move the machine back. When the machine was moved, the trapped deckhand again shouted out in pain, which led the other deckhand to think that he had moved the machine the wrong way. He panicked and moved the machine in the opposite direction, causing its pinion to run across the deckhand's trapped fingers.

Figure 1: Rack and pinion

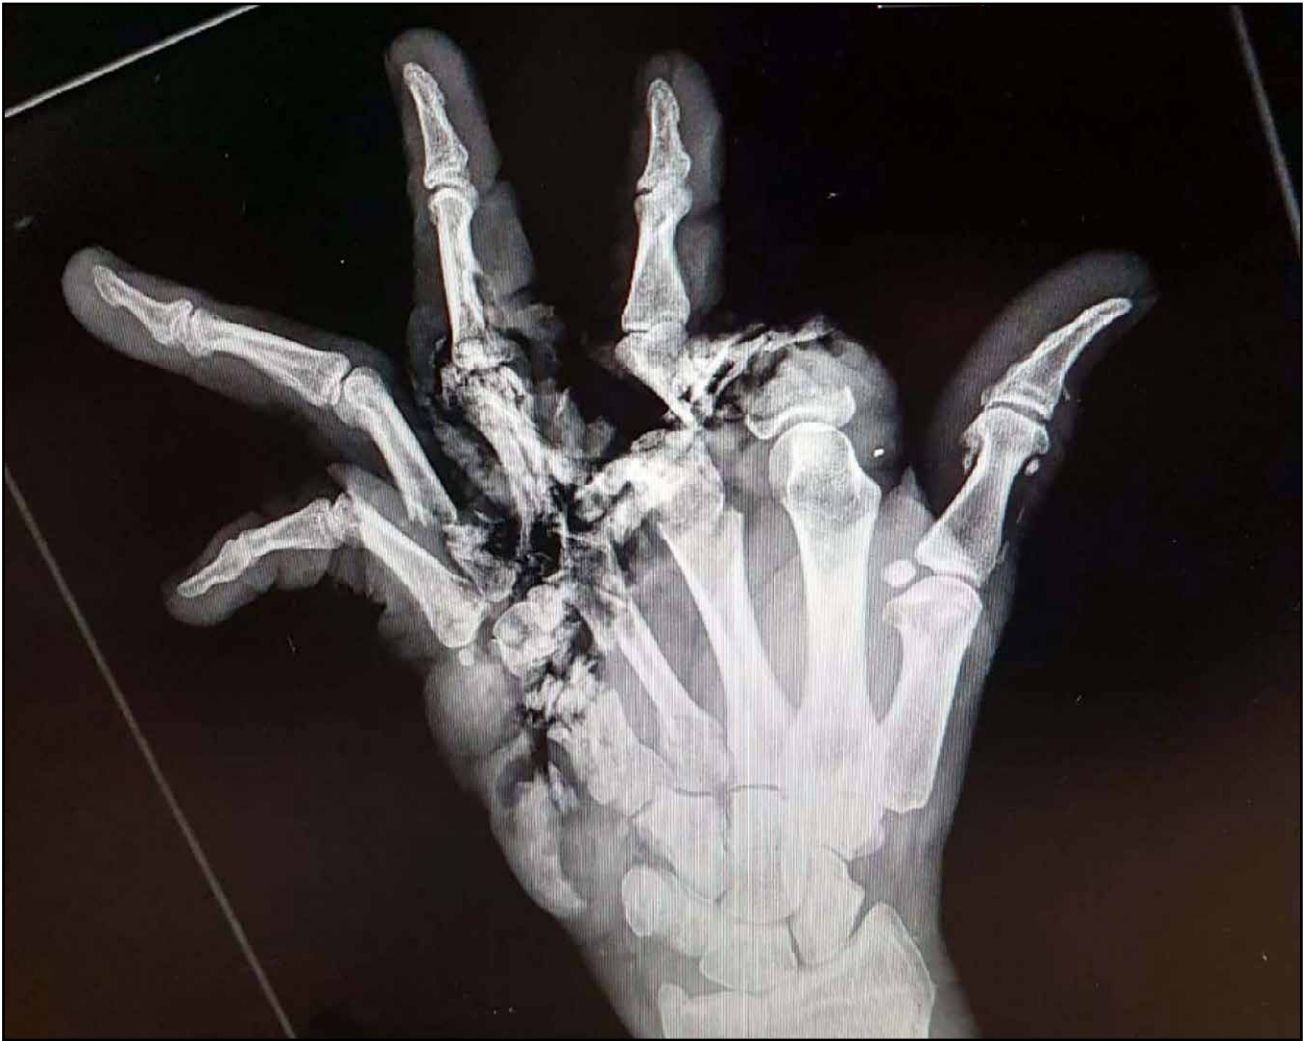
A helicopter transferred the injured deckhand to hospital where an X-ray (Figure 2) revealed the extent of his injuries. Fortunately, largely due to the first-aid treatment that had been given to the casualty by his crew mates on board, the hospital staff were able to save three of his partially severed fingers.

Figure 2: X-ray showing extent of injuries

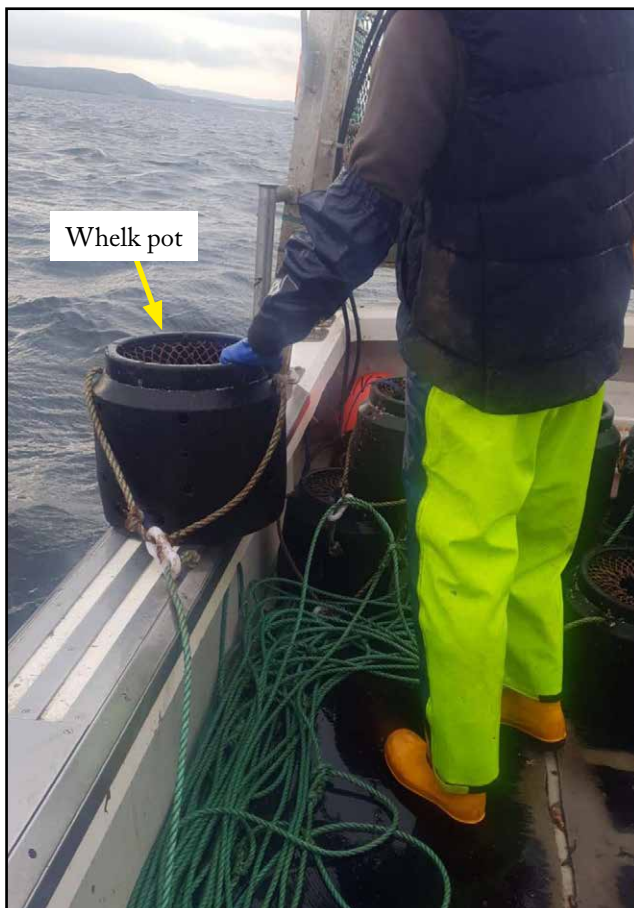
The first three pots had been recovered and rebaited by the crewman who was standing at the gunwale with the fourth pot in his hand (Figure 1) when, as the boat rolled, he lost balance, stumbled and fell overboard. The crewman was not wearing a lifejacket when he fell in.

Figure 1: Position of crewman at time of accident

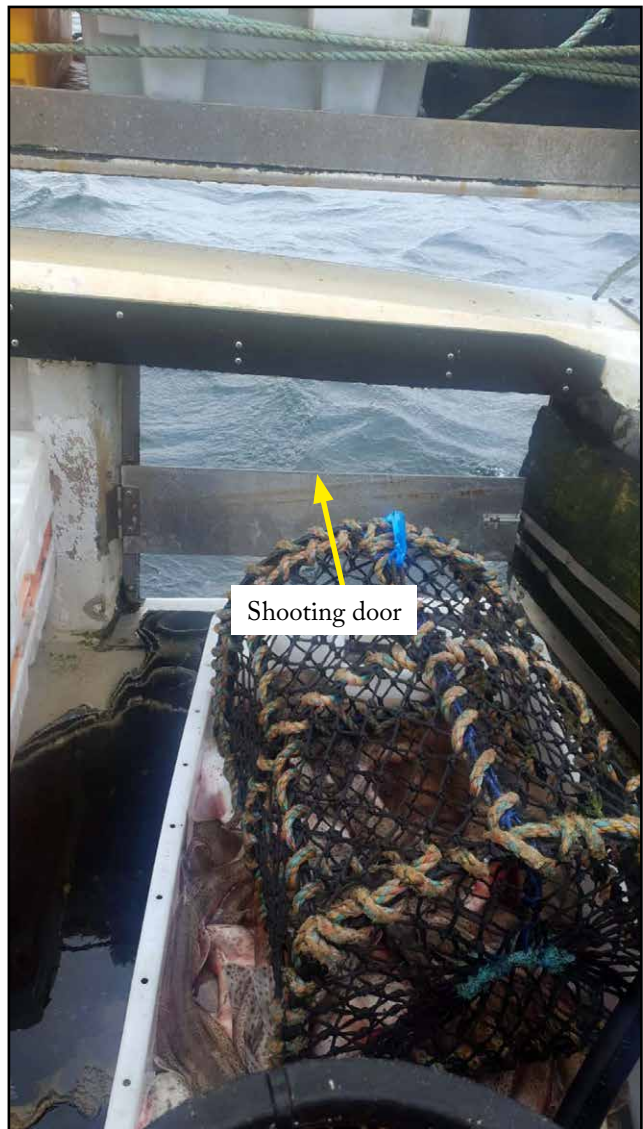
The skipper threw a line that the crewman was able to grab and hold on to; however, several attempts to haul the crewman back on board through the stern shooting door (Figure 2)

Figure 2: Stern shooting door

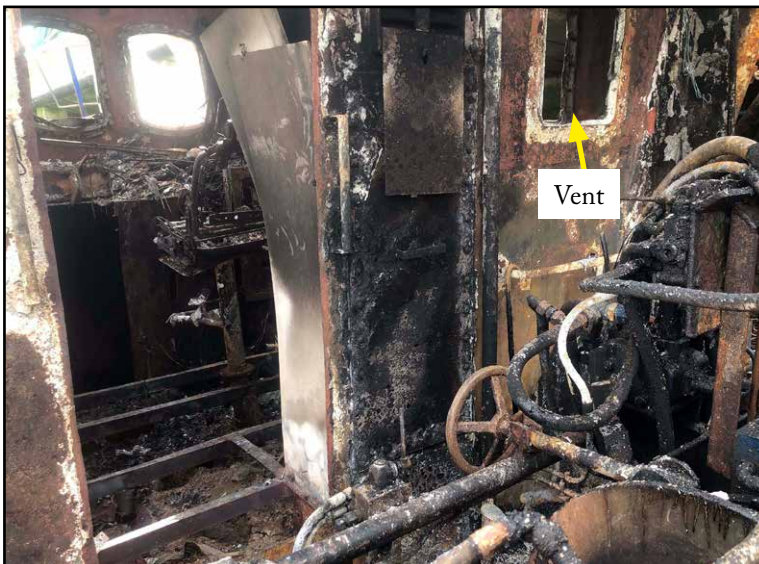
Three hours into the voyage, the skipper noticed that the air in the wheelhouse was getting warm. Initially believing it to be the heat from the sun, he left the wheelhouse to use the toilet. Outside, he saw smoke from the funnel vent by the wheelhouse door (Figure 1).

Figure 1: Funnel vent

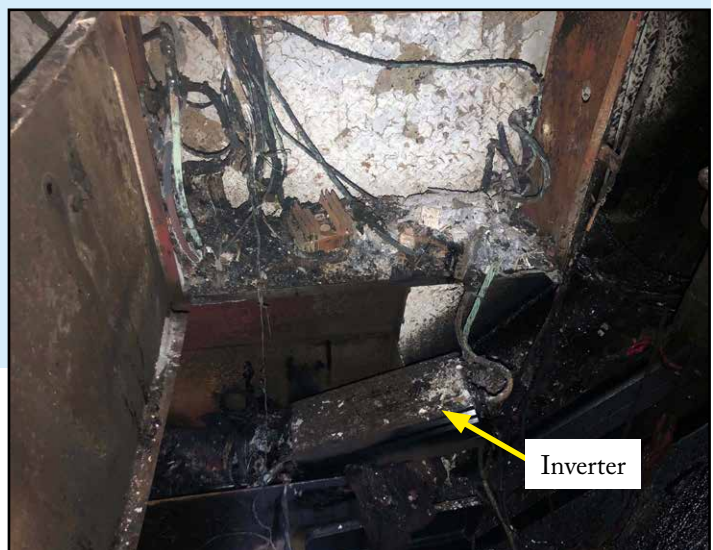
1. The post-fire investigation identified the most probable cause as being a 24V DC to 230V AC pure sine wave inverter (Figure 4). This had been professionally fitted at a previous refit the year before to power a small, low wattage oven and a kettle.

Figure 4: The wave inverter

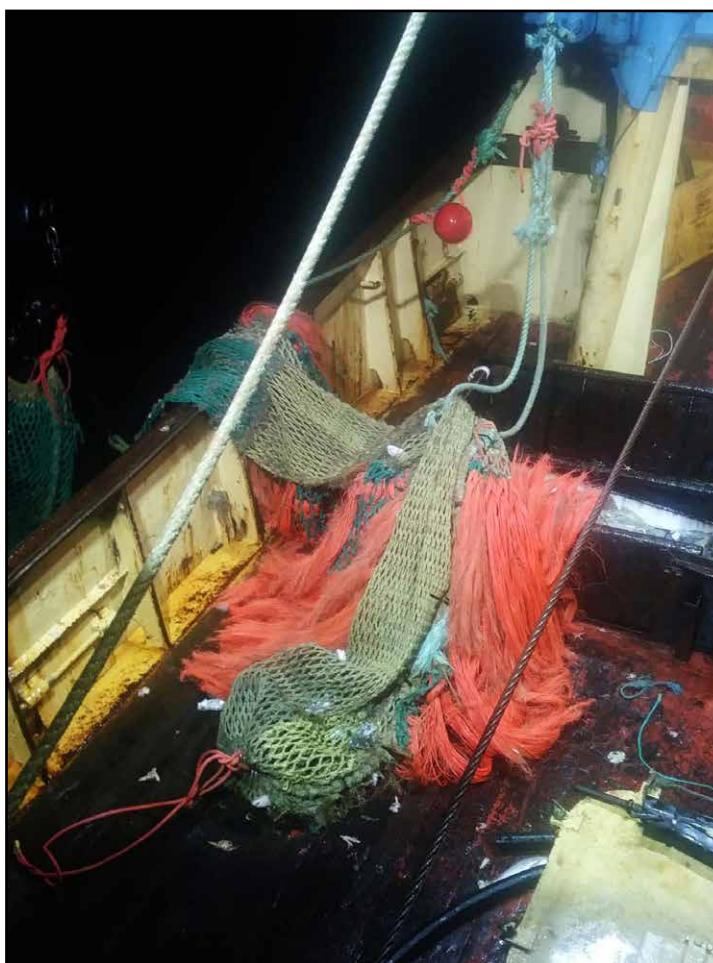
On entering the water, the crewman's lifejacket automatically inflated and he kicked off his boots. However, as the lifejacket he was wearing was not fitted with a light or personal locator beacon, the fishing vessel crew could not locate him. On coastguard advice the skipper implemented an expanding square search pattern and, on hearing shouts from the MOB, found him approximately 30 minutes later. The wind at that time was westerly force 9 accompanied by a 3m sea; the sea temperature was 9°C.

Figure 1: Crewman's location at the time of accident

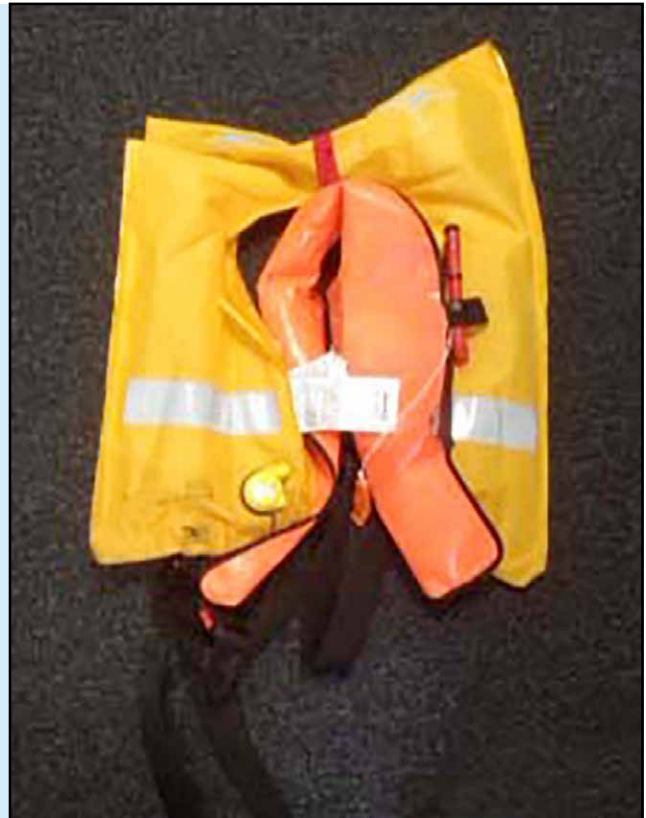
Figure 2: The lifejacket post-rescue

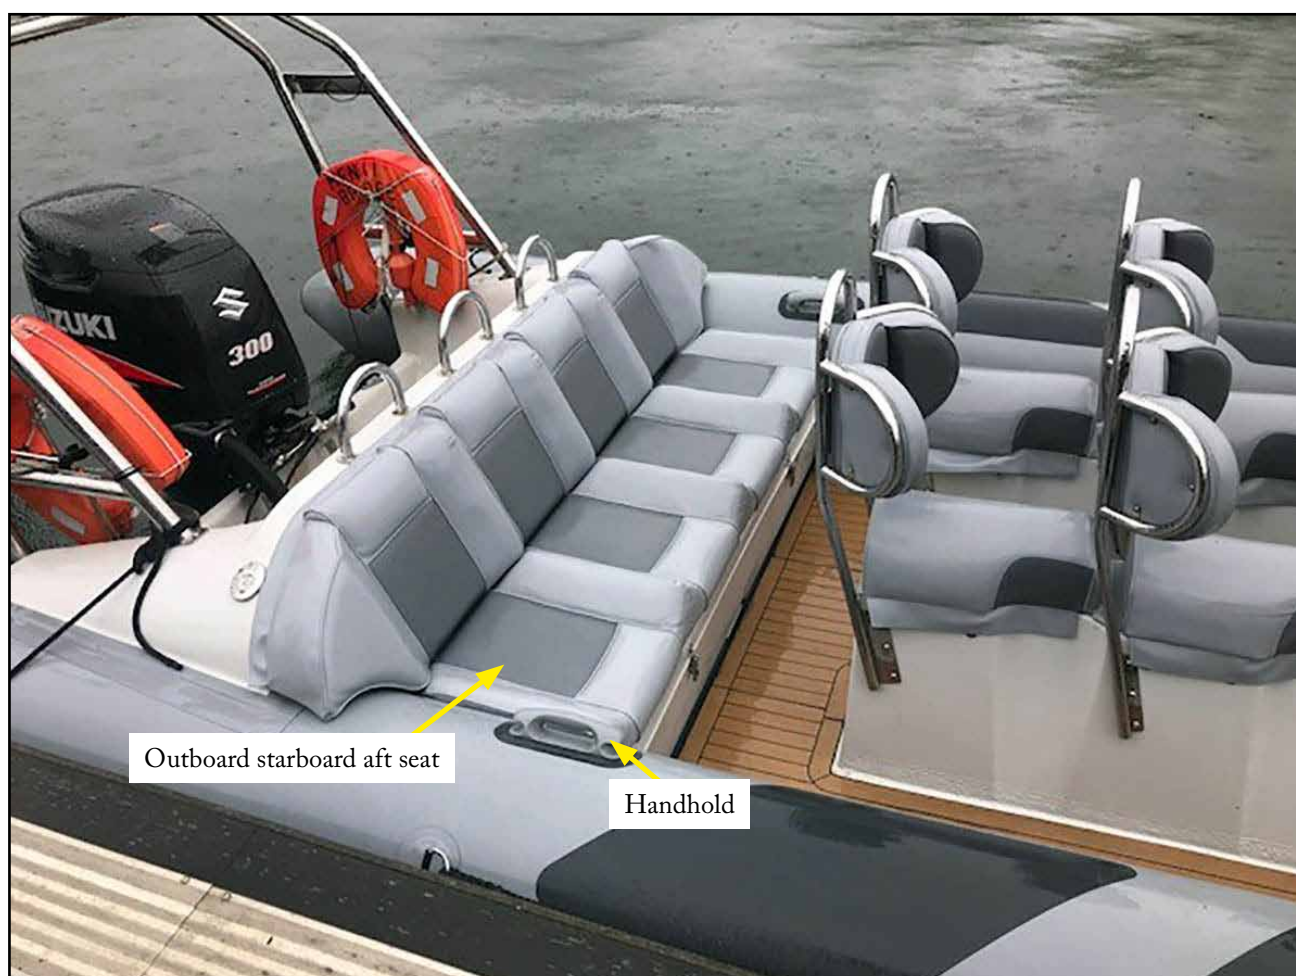
The RIB seating was configured with four rows of twin seats on the centerline running aft from the skipper's console, and a row of four seats athwartships at the aft end of the boat (Figures 1 and 2). The centerline seats had handholds for the occupants on the rear of the seats in front of them, but the aft seats had only a single handhold for each outboard passenger on the RIB's tubes.

The passenger who fell overboard was sitting in the outboard starboard aft seat. At the time of the incident he was not holding on and was looking through the viewfinder of a camera. It was also apparent that he had not heard the briefing relating to the 'S' turns over the noise of the engine.

Figure 2: Athwartships seating

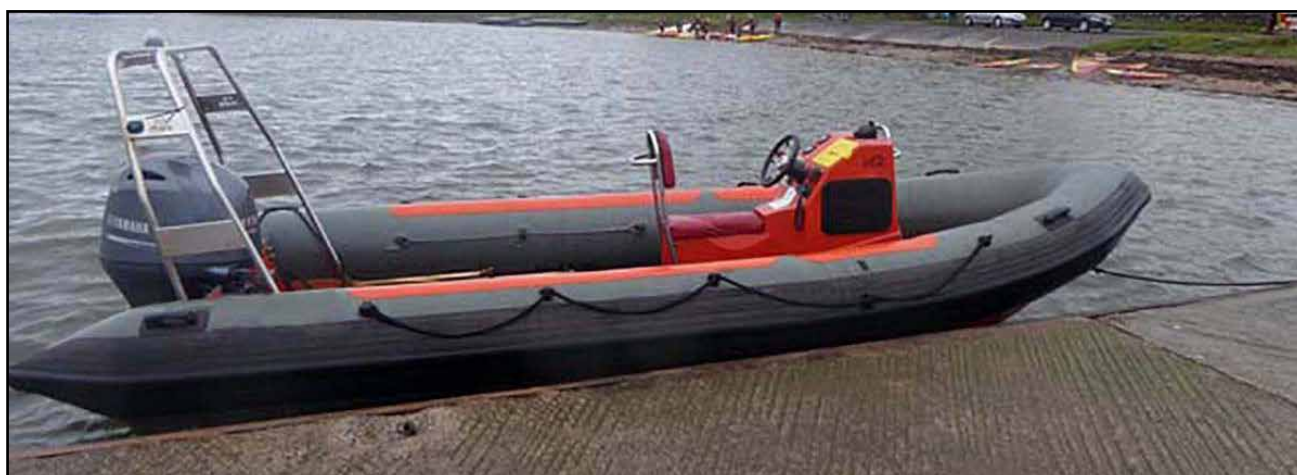
Two of the RYA training centre's 6m RIBs were used for the trip (Figure 1). Each RIB was driven by one of the training centre's experienced powerboat drivers and carried three sea scouts. The RIBs were powered by 150hp outboard engines and were designed to carry 10 persons: two on the driver's jockey seat and eight on the inflatable tubes. All the sea scouts were wearing wetsuits and buoyancy aids and were sitting on the rib's inflatable tubes for the trip.

Figure 1: Training centre RIB with driver's jockey seat only

2. Passengers should not use rib inflatable tubes as seats during fast rides or long boat excursions. A passenger's ability to maintain a good grip, particularly in cold and choppy conditions, can vary significantly depending on their age, strength and fitness. The risk of falling overboard is significant.

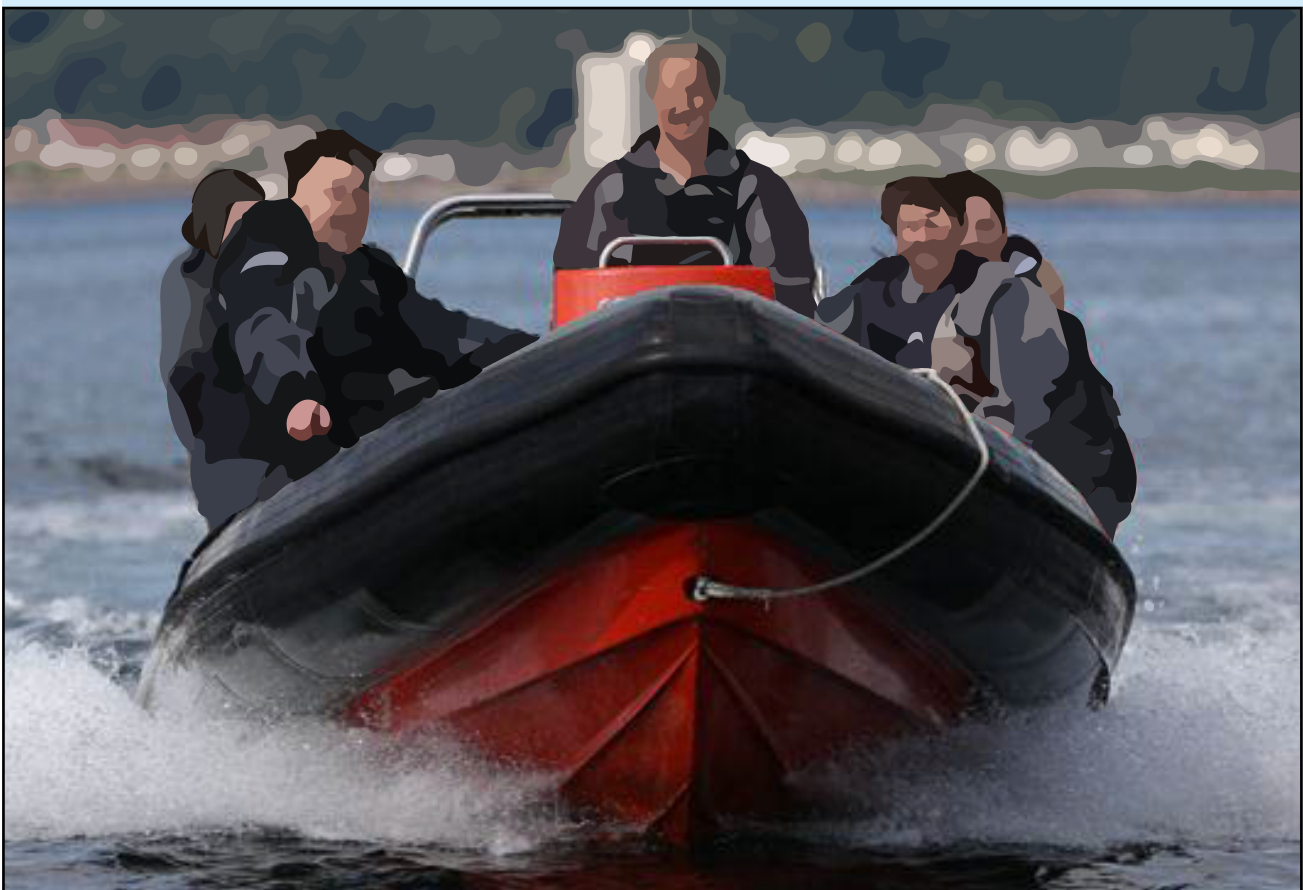
3. A person sitting on an inflatable tube will naturally assume a twisted posture (Figure 2). This will significantly increase the likelihood of them suffering impact-related lower back spinal injuries as the RIB impacts with the water surface. The risk of such injuries is reduced if passengers sit on suitably designed seats, for example jockey seats with handholds, or even full suspension seats (this issue is discussed in detail in MAIB report 1/2011).

Figure 2: Passengers sitting on RIB tubes twisted to face forwards

4. In circumstances where passengers have to be seated on tubes, care must be taken to ensure that appropriate lifejackets or buoyancy aids are fitted, and that the RIB driver or a crew member can observe them at all times. Consideration should also be given to the use of bump caps/helmets, and fitting propeller guards to outboard engines to minimise the risk of injury to anyone who has fallen overboard.

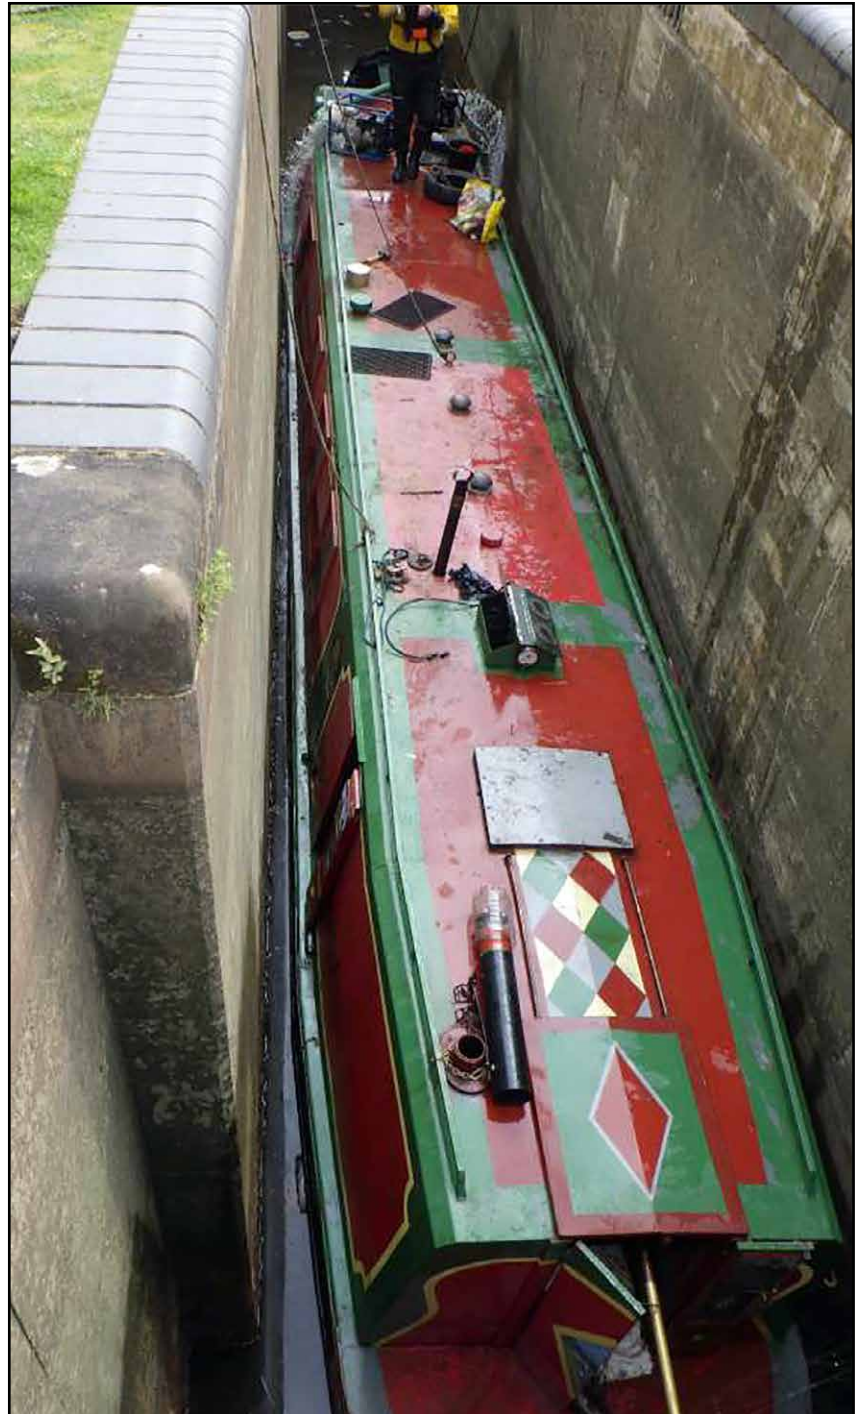
Figure 1: Narrowboat in lock

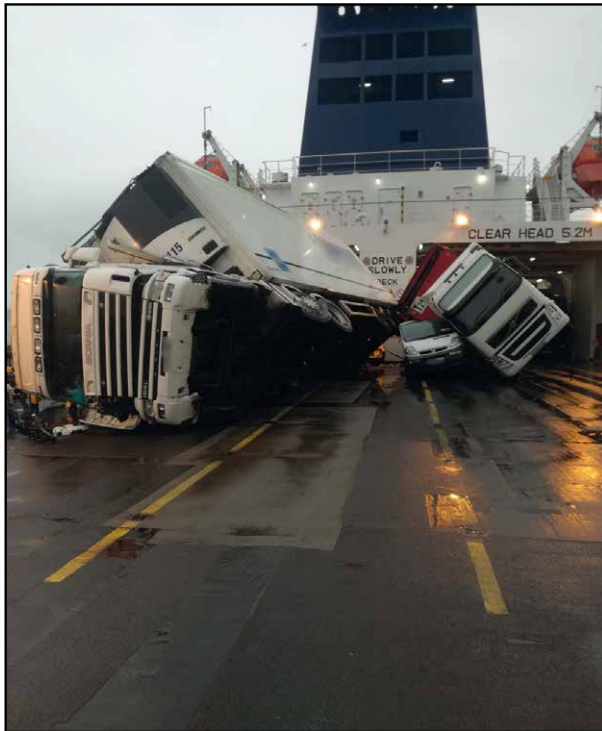
The MAIB is investigating the shift and toppling over of freight vehicles (**Figures 1, 2, 3 and 4**) on board the P&O ro-ro passenger ferry *European Causeway* during heavy weather while on passage from Larne, Northern Ireland, to Cairnryan, Scotland.

**Figure 1:** Trucks on upper deck aft

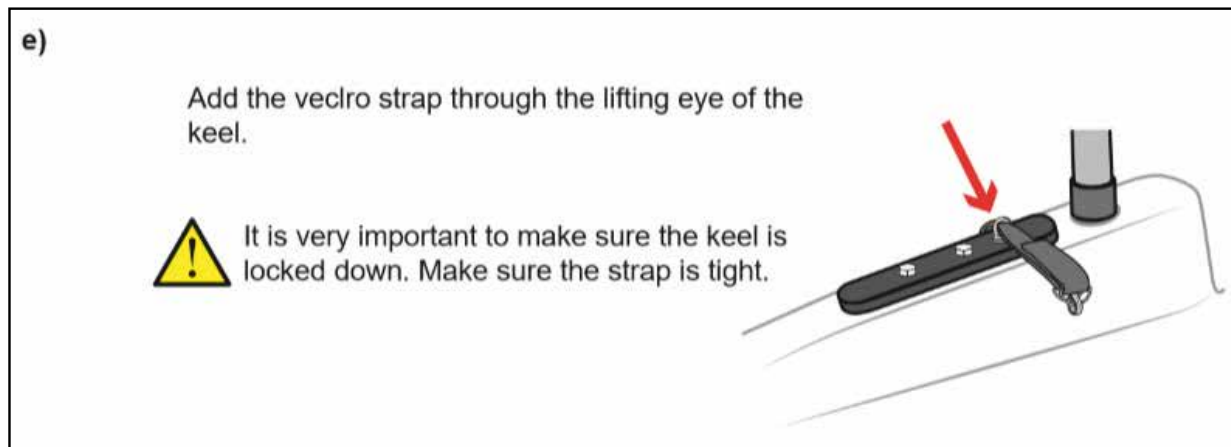
The importance of securing the retractable keel was highlighted in the manufacturer's rigging guide for the boat (**Figure 3**). However, this accident demonstrates that some users may not be aware of how critical this is.

**Figure 3:** Extract from the manufacturer's rigging guide

- Prior to use, checks should be made to ensure the manufacturer's instructions regarding the securing of the keel or weighted centreboard have been followed.
- Their procedures and drills for recovering a capsized boat include the scenario where the keel or centreboard has retracted from its 'lowered' position.
