The capsizing of fishing vessel *Anna-Marie II* (WK 875) Brora, East Scotland resulting in one fatality 23 September 2019

SUMMARY

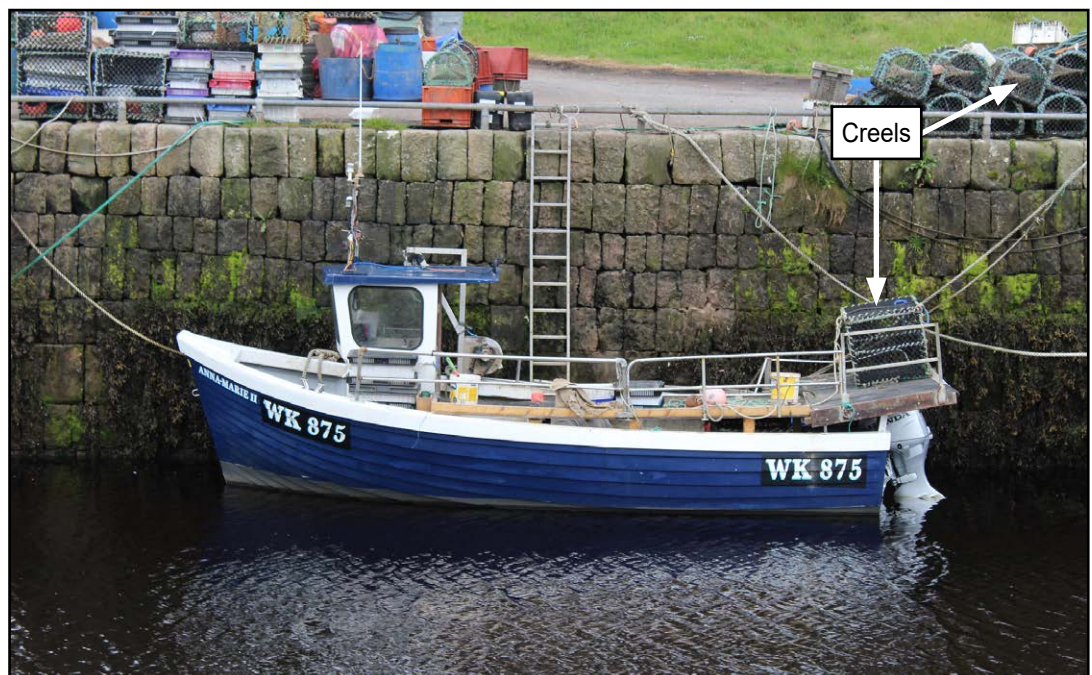
Figure 1: *Anna-Marie II*

Anna-Marie II was a 6.2m Seal Islander open boat design, constructed from glass reinforced plastic in Chichester in 2012. The vessel had been owned by the skipper for several years and was fitted with a 40 horsepower Honda outboard engine that was under a year old. The vessel's steering equipment was found to be operational after the accident.

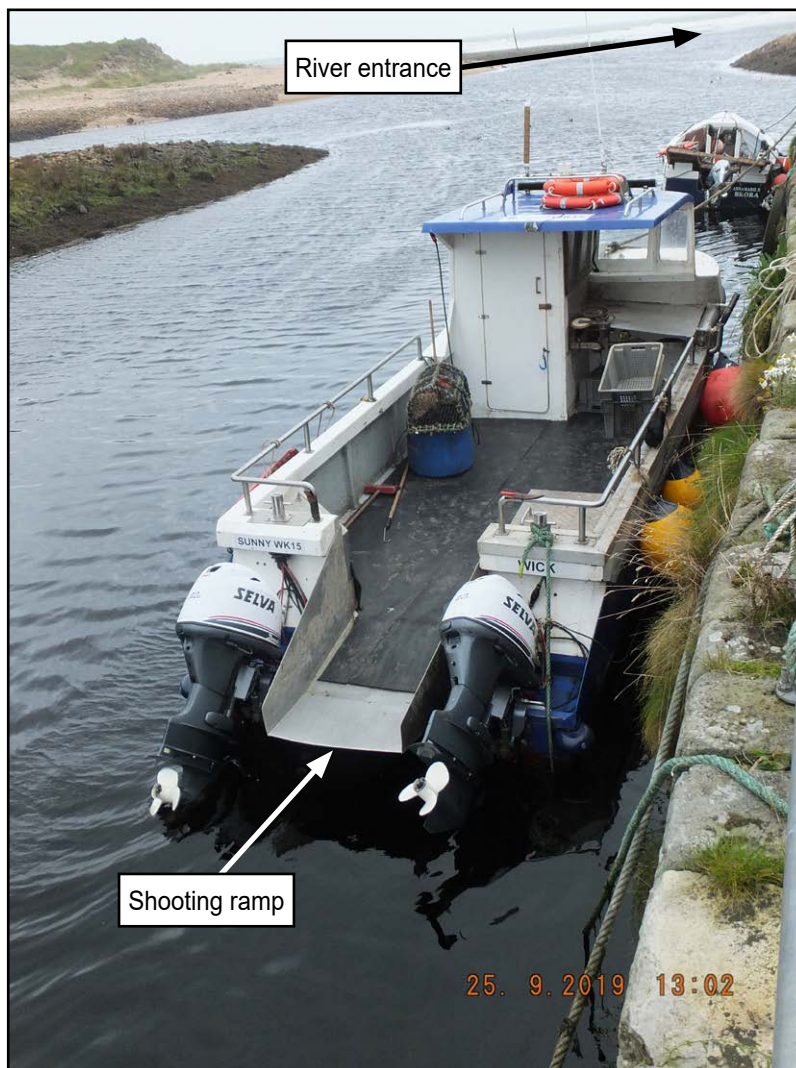
Figure 4: Fishing vessel *Sunny* berthed at Brora

As *Sunny* moved towards the river entrance, its skipper saw *Anna-Marie II's* skipper floating face-up and apparently conscious in the water. He immediately shouted to him, but did not get a response. He then manoeuvred *Sunny's* stern towards *Anna-Marie II's* skipper, and pulled him on board using the vessel's shooting ramp (**Figure 4**). *Sunny's* skipper realised that *Anna-Marie II's* skipper was not breathing and started cardiopulmonary resuscitation (CPR). He then began to manoeuvre *Sunny* back into the harbour, which he found difficult, as he had to avoid *Anna-Marie II's* creel lines in the water, prevent the vessel running aground and continue CPR. With the help of people on the quay, *Sunny* was tied up while the skipper continued to provide CPR.

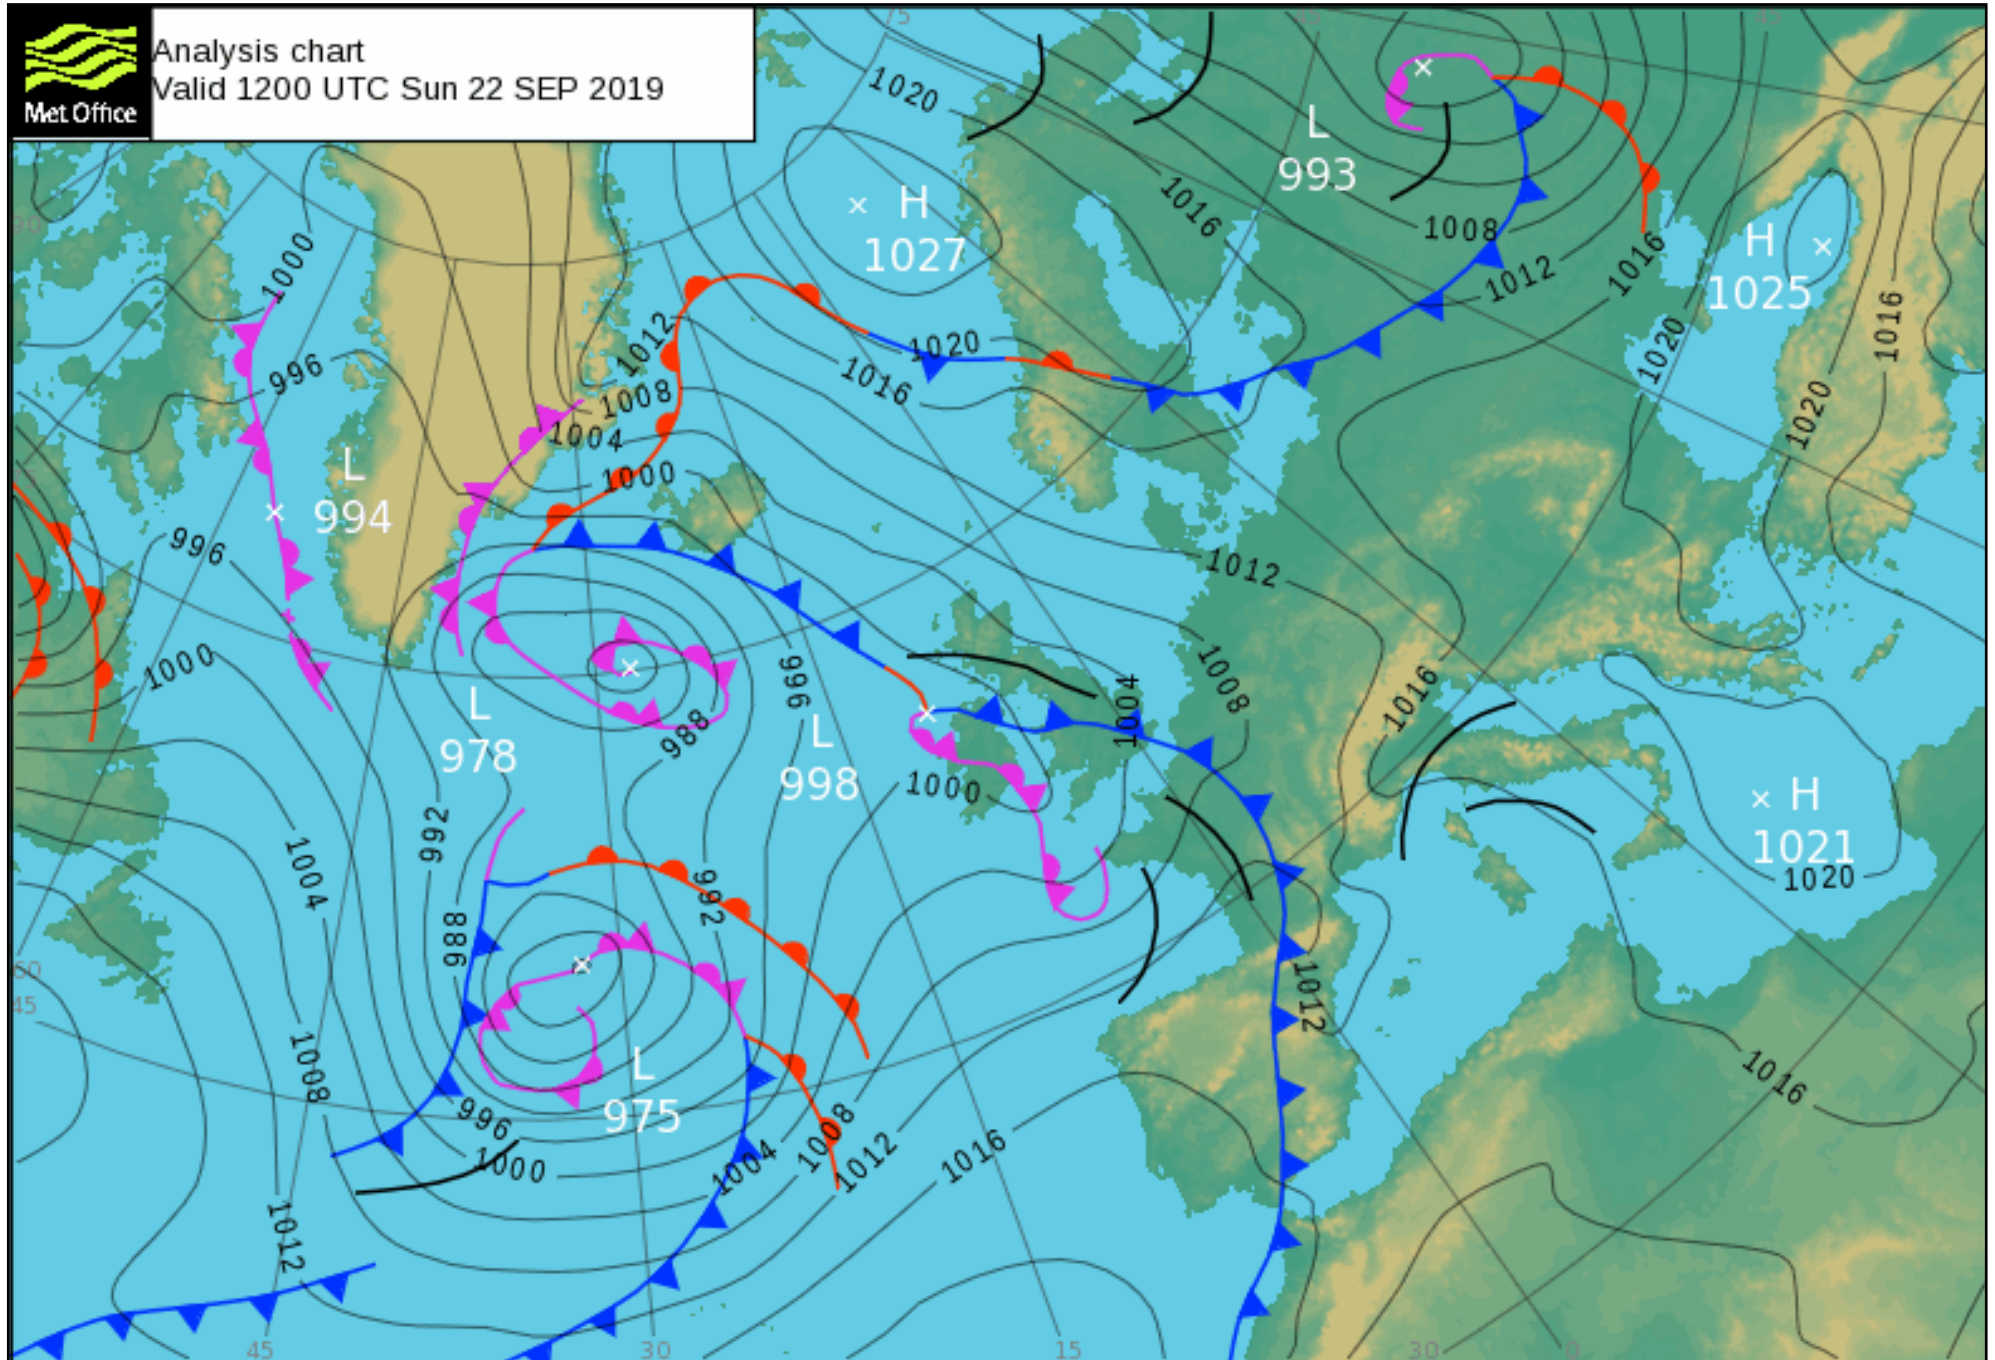
Figure 5: Synoptic weather chart indicating low pressure coming in from the west prior to accident

The forecast was for the weather to worsen towards the middle of the week as a low-pressure system was due to move in from the west (**Figure 5**).
