**100 Years of Embankment Dam
Design and Construction
in the
U.S. Bureau of Reclamation**

Bureau of Reclamation History Symposium
at
University of Nevada - Las Vegas
June 18-19, 2002

Richard Lyman Wiltshire, P.E.
Civil Engineer, Principal Designer
Geotechnical Services Division, Group 1
Technical Service Center
Bureau of Reclamation
U.S. Department of the Interior
Denver, Colorado

ABSTRACT

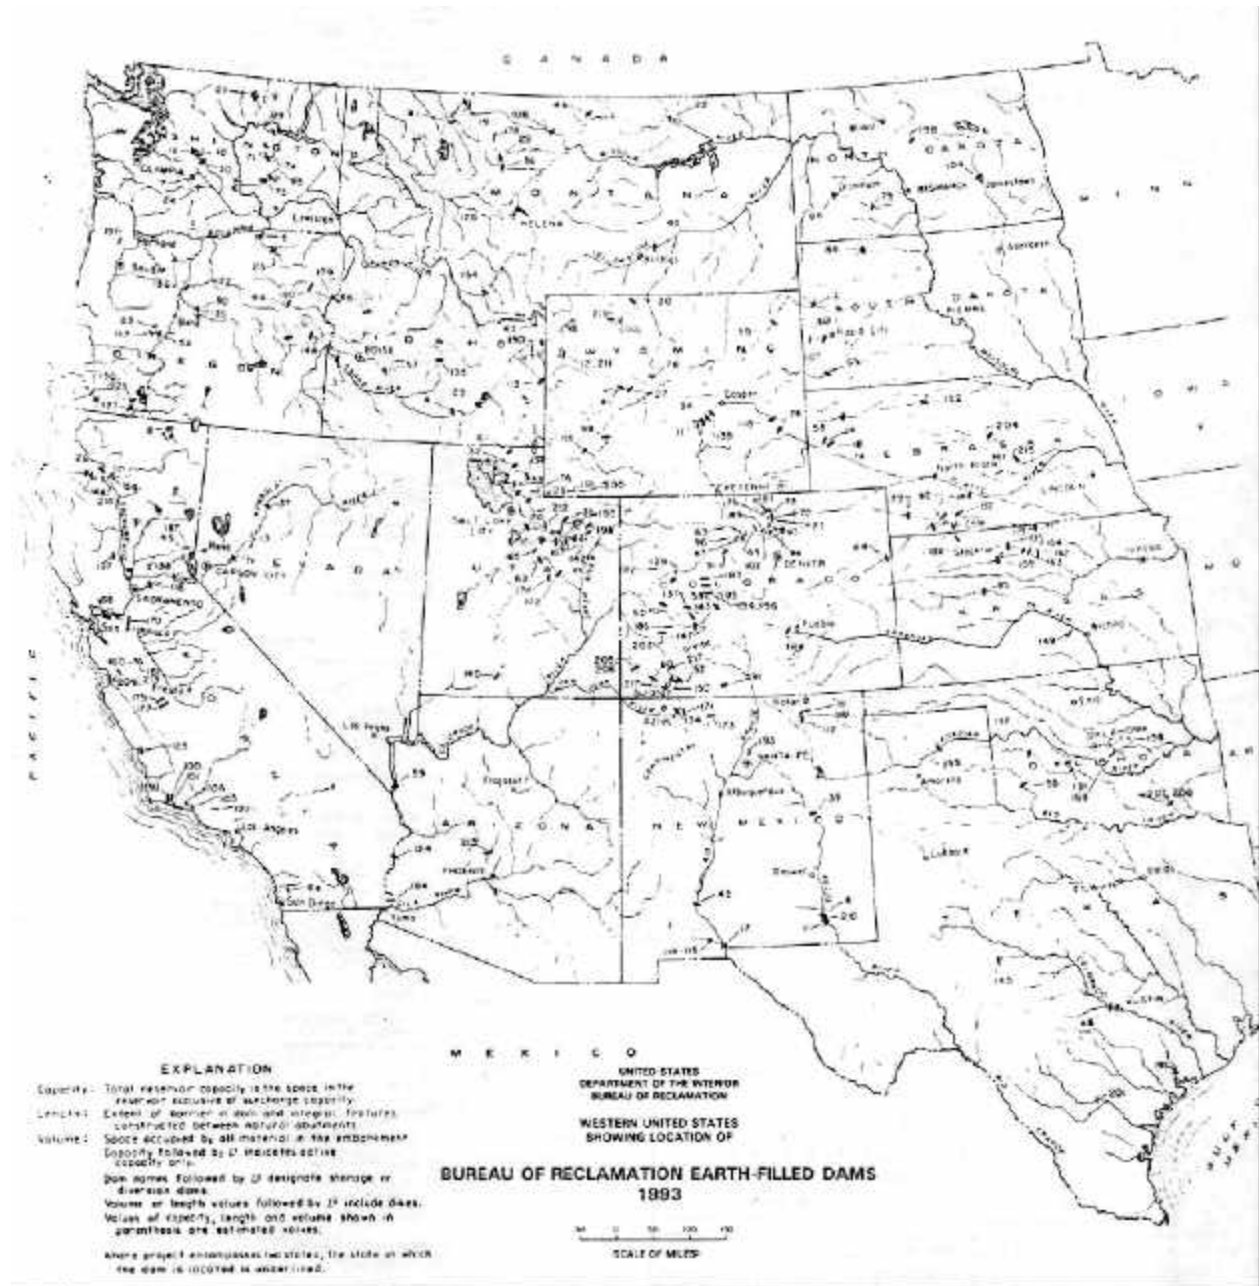
Figure 1

LOCATION INDEX
OF
BUREAU OF RECLAMATION EARTH-FILL DAMS

organizations. Over 240 reservoir-storage embankment dam structures have been designed and constructed by Reclamation during the past century. Some of the information presented in the following period sections on Reclamation's embankment dam design and construction history through 1958 is taken from *Development of Earth Dam Design in the Bureau of Reclamation* [7] by F. C. Walker, then Head of the Earth Dams Section, Dams Branch, Division of Design. The location map and map index of Reclamation's embankment dams are shown in **Figures 1 and 2** below and on the next page.

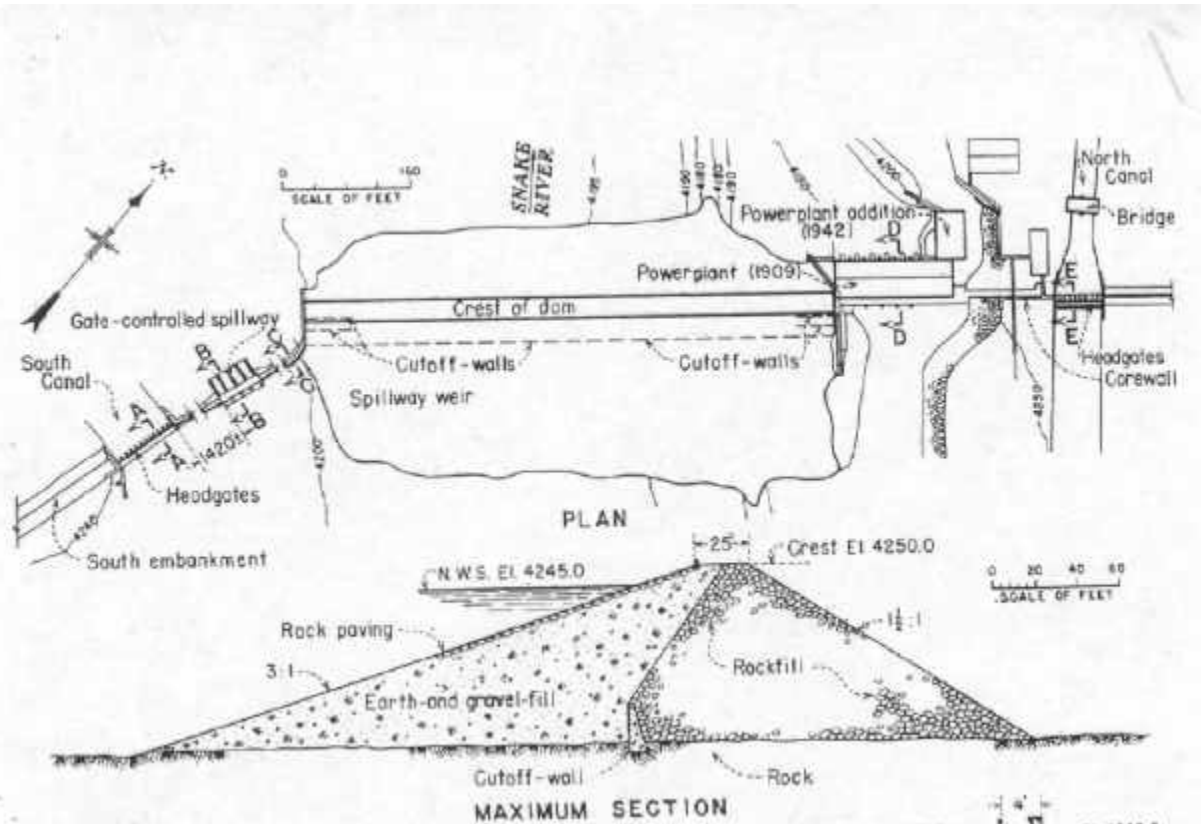
Figure 3 - Minidoka Dam Plan and Section

Period I embankment dams utilizing this type of cross-section included: Avalon, Clear Lake, Minidoka, and McMillan Dams and Elephant Butte Dike. Avalon and McMillan Dams, both on the Pecos River near Carlsbad, New Mexico, were actually the second or third reconstructions of earlier dams that had failed by overtopping during floods that breached both dams. Neither dam included a transition/filter zone between the earthfill and rockfill zones, which was added to later dams of this type. Avalon Dam also had a part sheet-pile, part concrete core/cutoff wall the full height of the dam. The upstream slope of these dams was typically 3:1 that was often steepened to 2:1 above the full reservoir level, and the downstream slope was typically 1.5:1. The relatively high cost of using rockfill material with the equipment then available was the reason that few of this type of embankment dam were constructed by Reclamation. The failure of several non-Reclamation dams of this type during this period probably contributed to the decision to stop building this type of dam.

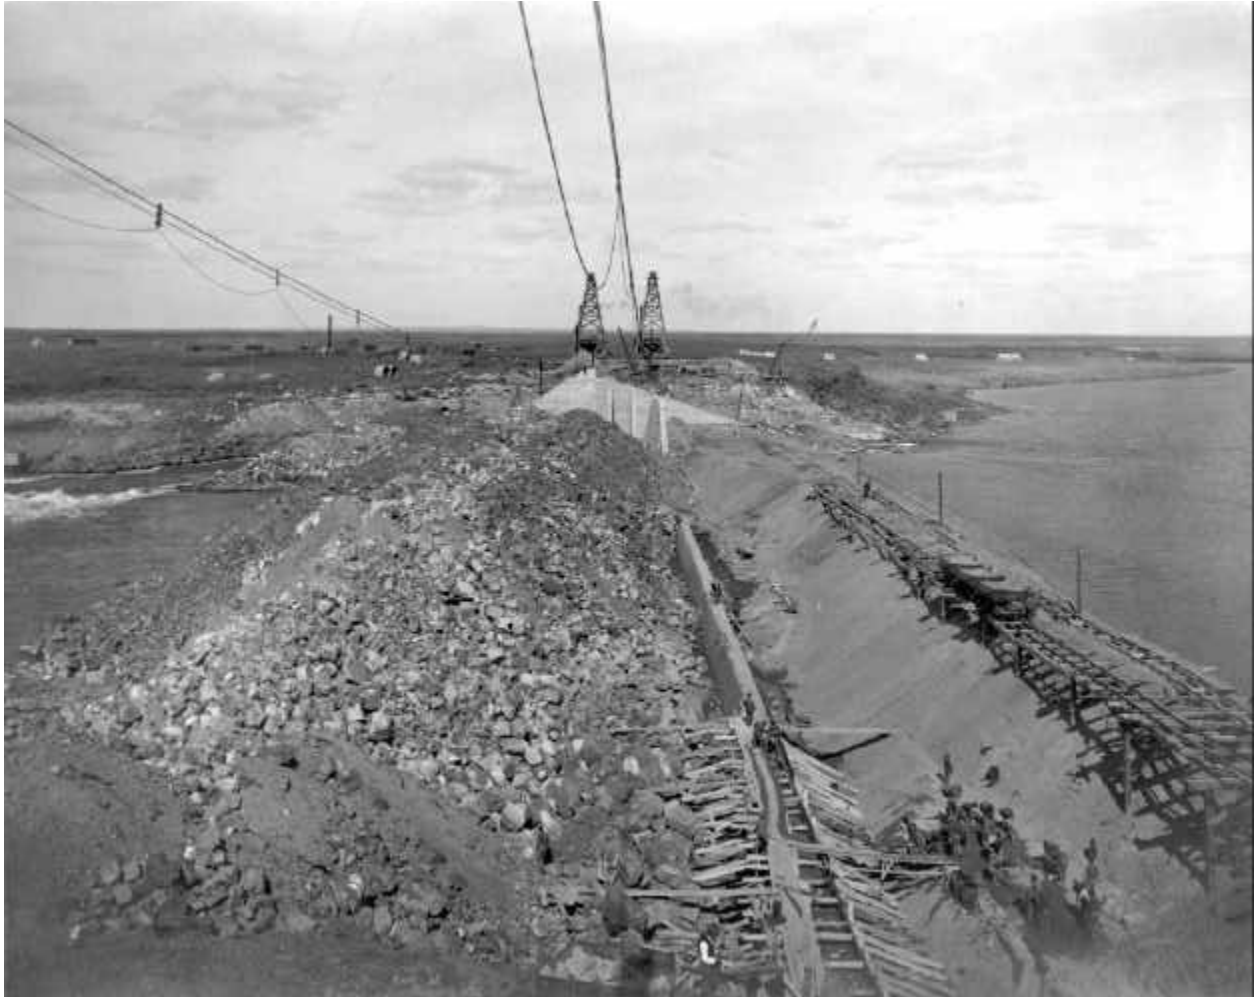
Figure 4 - Minidoka Dam Construction

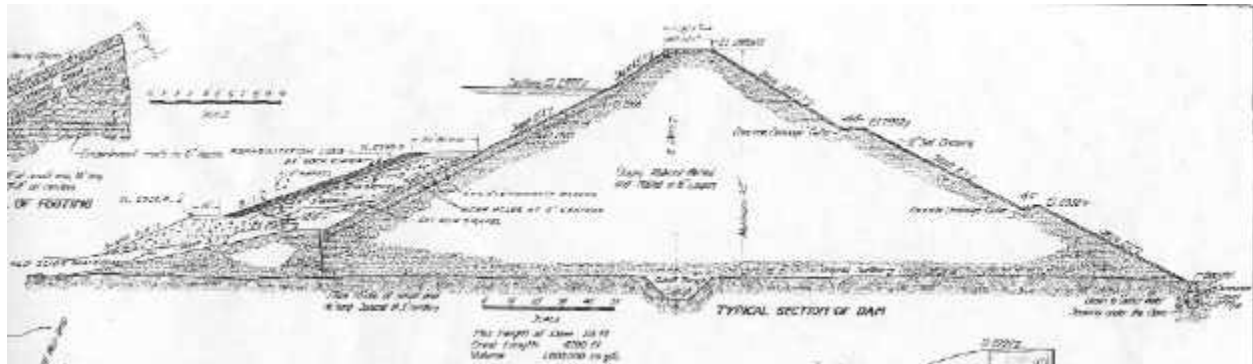
Figure 5 - Belle Fourche Dam Section

Belle Fourche Dam (locally called Orman Dam) is located on Owl Creek about 10 miles northeast of Belle Fourche, South Dakota, and was the most notable embankment dam constructed by Reclamation during Period I. The dam was constructed 115 feet high above its streambed with a crest length of 6,262 feet, an earthfill volume of 1,783,000 yd³, impounded a 192,000 acre-foot off-stream reservoir and a water-surface area of about 8,000 acres, and was fed by a 6-mile-long canal that conveyed a maximum of 1,600 ft³/s of water diverted by a diversion dam on the Belle Fourche River. Information on the embankment's as-built slopes is given above. The original upper slopes shown on the 1905 Belle Fourche Dam design drawings were 1:1 instead of 1.5:1 upstream and 1.75:1 instead of 1.655:1 downstream. The decision was made during construction

to flatten the upper upstream slope and flatten the upper downstream slope, moving the crest downstream (see **Figure 5** below).

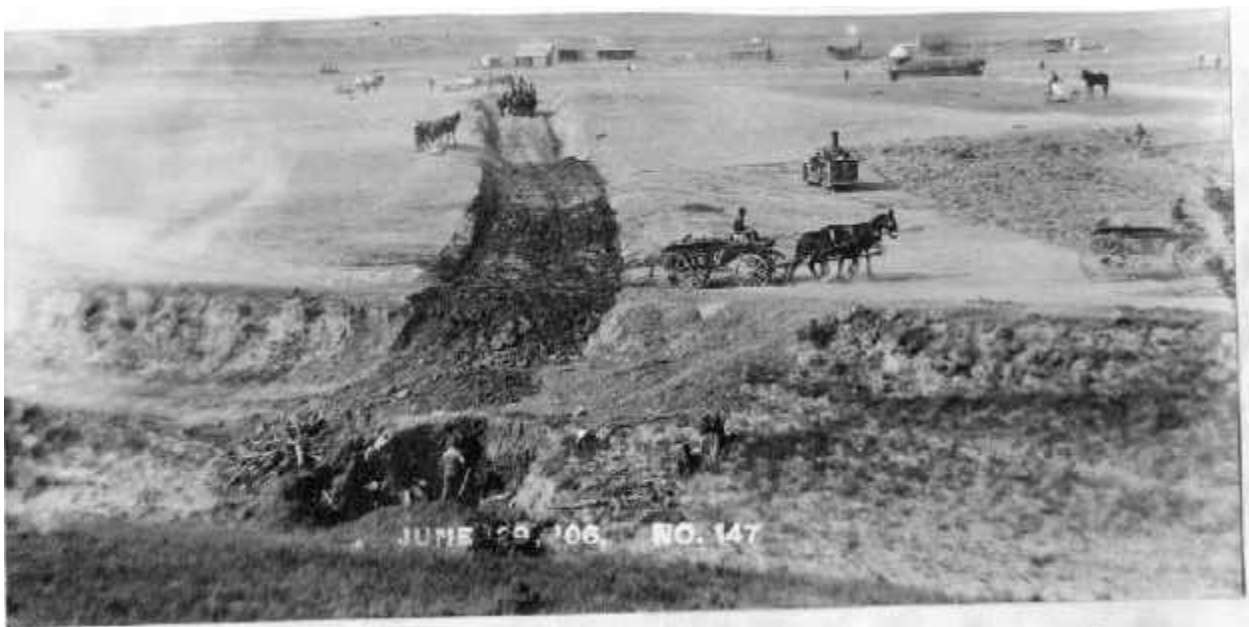
Figure 6 - Belle Fourche Dam - Cutoff Trench Construction

The cutoff trench was excavated by horse-drawn “wheel scrapers” and a locomotive crane, using

a ½-yd³ clamshell bucket, after which the trench was backfilled with compacted “select material” (see **Figure 6** on previous page). The earthfill material in the borrow area(s) was excavated by 70-ton and 75-ton steam shovels with a 2½-yd³ bucket/dipper and was dumped into the 4-yd³ Western side-dump cars (see **Figure 7** below). The trains of 10 to 13 side-dump cars (a total of about 60 side-dump cars were used) were pulled by 18-ton Dinkey locomotives that hauled the trains about ¾-mile to the embankment, up a maximum grade of about 4 percent onto the embankment surface. The 36-inch gage train tracks and wooden ties were moved every third layer as the embankment rose in height. Three-horse-team 1¼-yd³ dump wagons, filled by Western graders pulled by traction engines, were also used to haul earthfill from some of the upstream borrow pits.

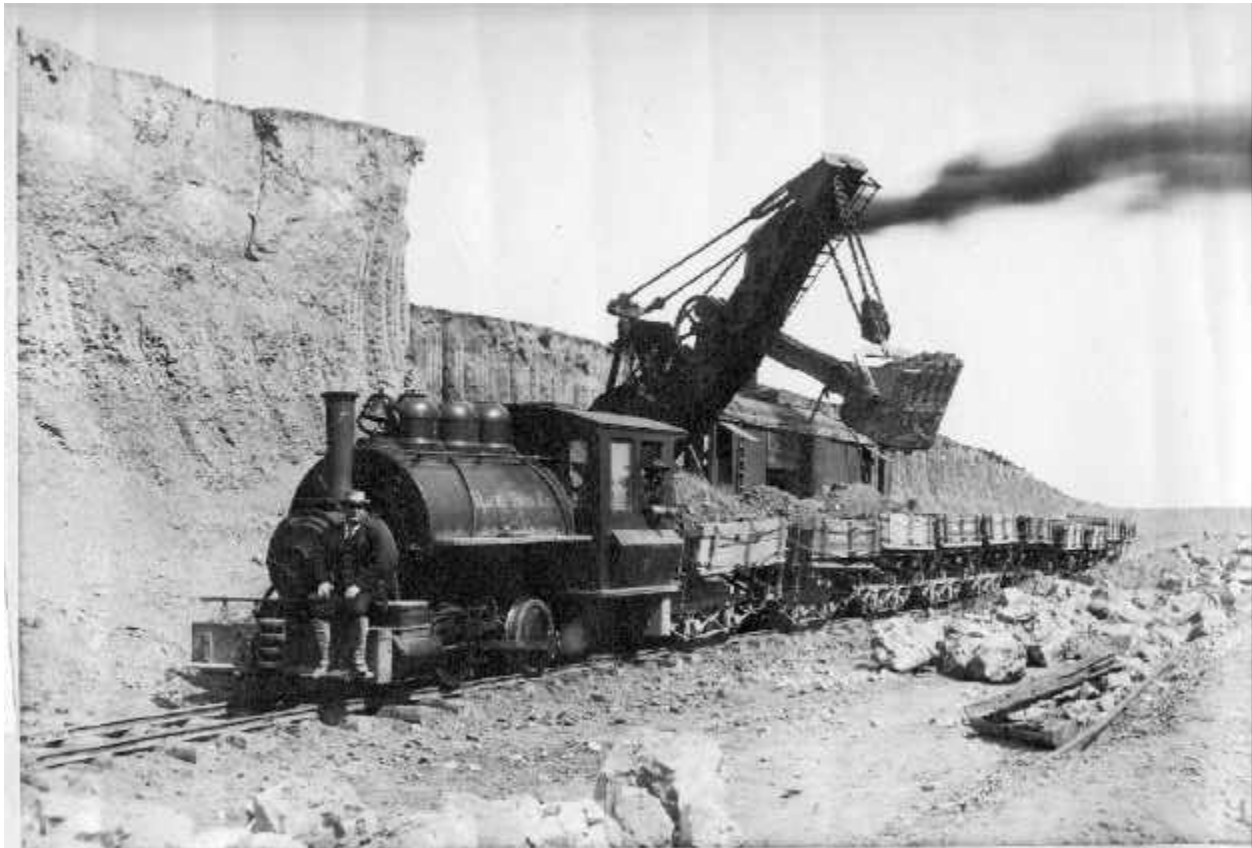
**Figure 7 - Belle Fourche Dam
Steam Shovel, Dinkey Locomotive, and Train of Side-Dump Cars in Borrow Pit**

the size of the equipment currently used to construct embankment dams. Compare the end-dump truck in **Figure 24** and its 35 yd³ capacity to the train of 4 yd³ side-dump cars used to construct Belle Fourche Dam in 1909 shown in **Figure 7**. Also compare the large excavator in **Figure 24** and its 12 yd³ bucket with steam shovel at Belle Fourche Dam with its 2½-yd³ bucket shown in **Figure 7**. During Period V, synthetic materials such as high-density polyethylene (HDPE) and polypropylene were developed into new products, such as corrugated pipe, geomembranes, and geotextiles, that were promptly put to use on embankment dams where judged appropriate. New types of equipment related to these new materials and products were developed, and quality control tests, testing equipment, and detailed test procedures were developed, with Reclamation's significant participation in these developments.

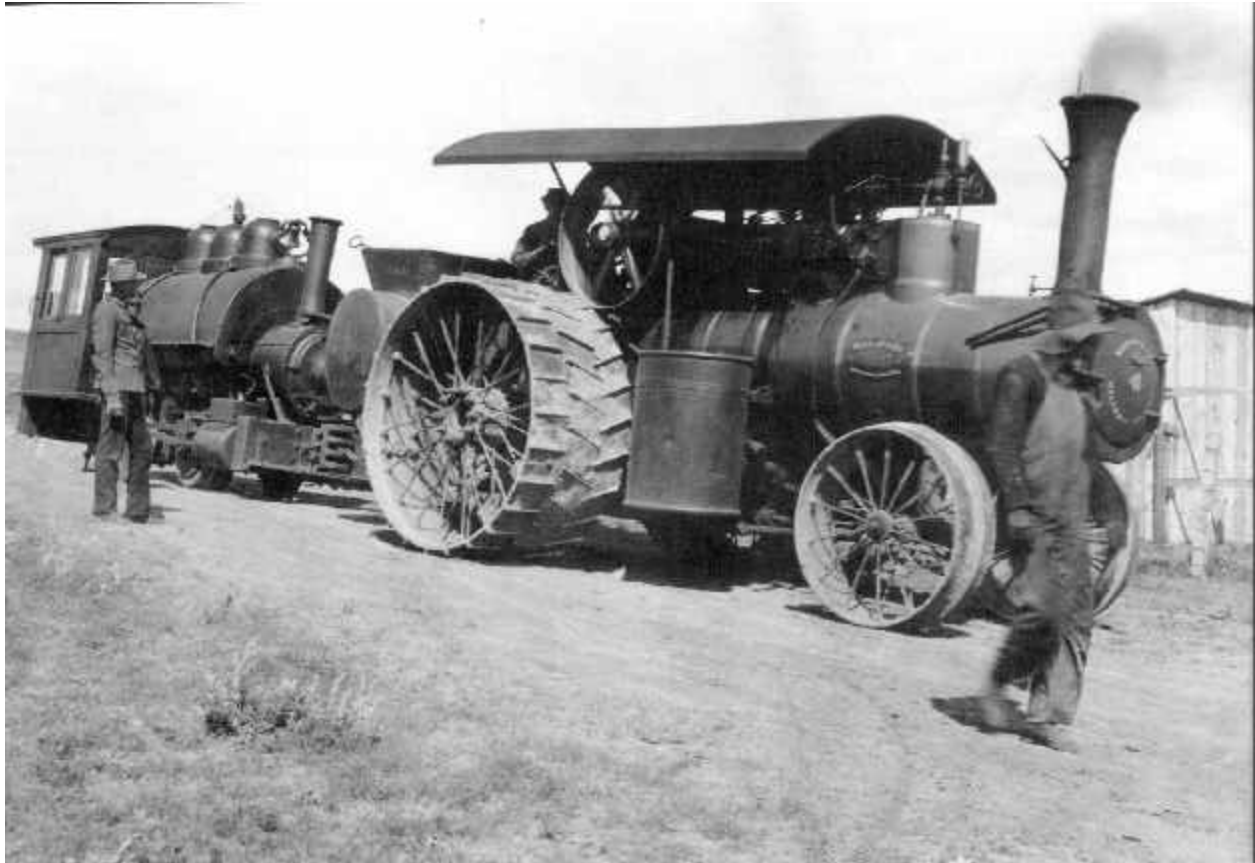
Figure 9 - Belle Fourche Dam - Traction Engine Hauling Dinkey Locomotive to Damsite

after being placed on the fill, little if any water needed to be applied. The specifications required that the earthfill material be placed and rolled in 6-inch layers using steam rollers weighing not less than “200 pounds per linear inch of roller rim.” According to O.T. Reedy’s article, one of the rollers used was a 12-ton roller with a 4-foot rolling base. According to the Belle Fourche Project History [17], an “8-ton asphalt dirt roller with smooth wheels” was also used, but it often became stuck on the slick surface of the embankment. However, most of the compaction was accomplished by four 32-horsepower 18-ton and 21-ton traction (steam) engines, with the rear wheels having been widened to create a 6-foot-wide “rolling base.” The traction engines accomplished the compaction more quickly due to their greater power (see **Figure 9** on next page).

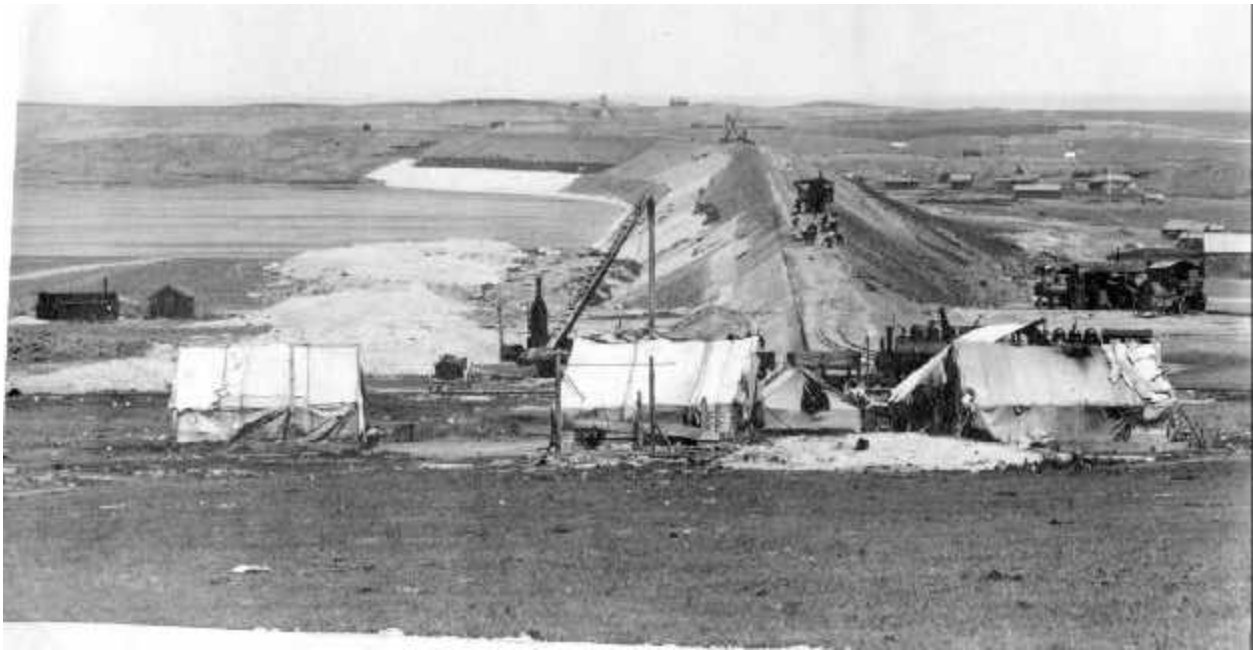
Figure 10 - Belle Fourche Dam - Embankment from Right Abutment

Another unique feature of the dam's design was the upstream slope protection. The nearest rock quarry was located 32 miles away and the sandstone's quality was considered poor, together causing its use to be rejected. The selected upstream slope protection consisted of 8-inch-thick concrete blocks/slabs that measured 5 feet by 6½ feet, and weighed about 3,000 pounds each. A concrete footing wall was constructed at the bottom of the 2:1 slope and the bottom course of blocks rested against this wall. Along the center portion of the embankment, the concrete footing wall was buttressed by 10-inch-diameter 16-foot-long timber piles driven into the earthfill on 3-foot centers. The concrete blocks were placed on a 24-inch-thick bed of gravel using stiff-leg 3-ton-capacity traveling derricks with 25-foot masts and 50-foot booms operated by 20-horsepower hoisting engines. The blocks were moved into place with the derrick and were then levered and hammered into place. **Figure 10** below shows the nearly-completed dam embankment from the

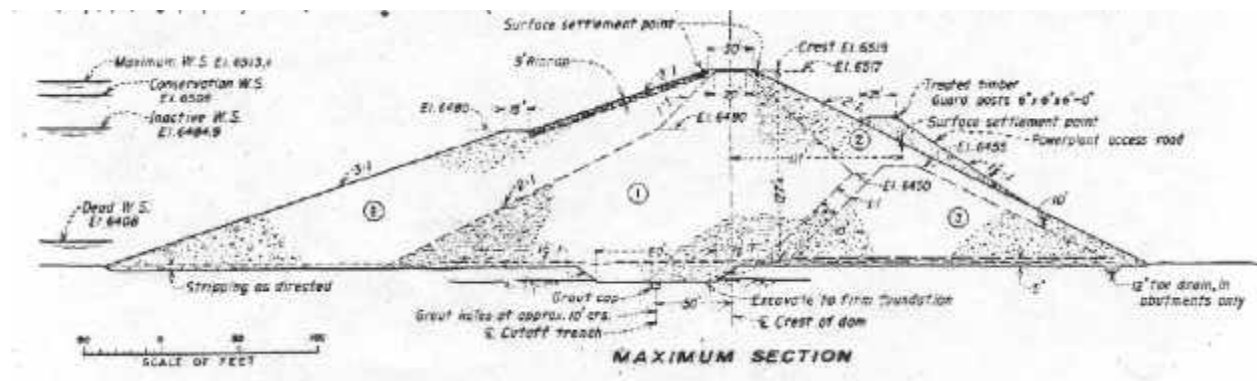
Figure 11 - Fontenelle Dam Section

Fontenelle Dam, completed in 1964 with a maximum height of 128 feet above streambed, included: irrigation canal outlet works in both abutments, a river outlet works near the middle of the dam capable of passing 18,700 ft³/s, a hydroelectric powerplant, and a right abutment overflow spillway of 20,000 ft³/s capacity at full pool. The river outlet works was large because it was less costly than increasing the size of the spillway. The embankment cross-section is shown in **Figure 11** below. The embankment zoning included: the zone 1 core, the zone 2

chimney and blanket drain of selected (pit run alluvium) sand, gravel, and cobbles, and a zone 3 miscellaneous fill that was completely enclosed within the Zone 2. The surface of the bedrock foundation was far more broken than had been anticipated, so the cutoff trench was deepened by 6 feet. The foundation and abutments were grouted by a single-row grout curtain installed through a grout cap. Grout takes in the upper 65 feet of the foundation were very large and a

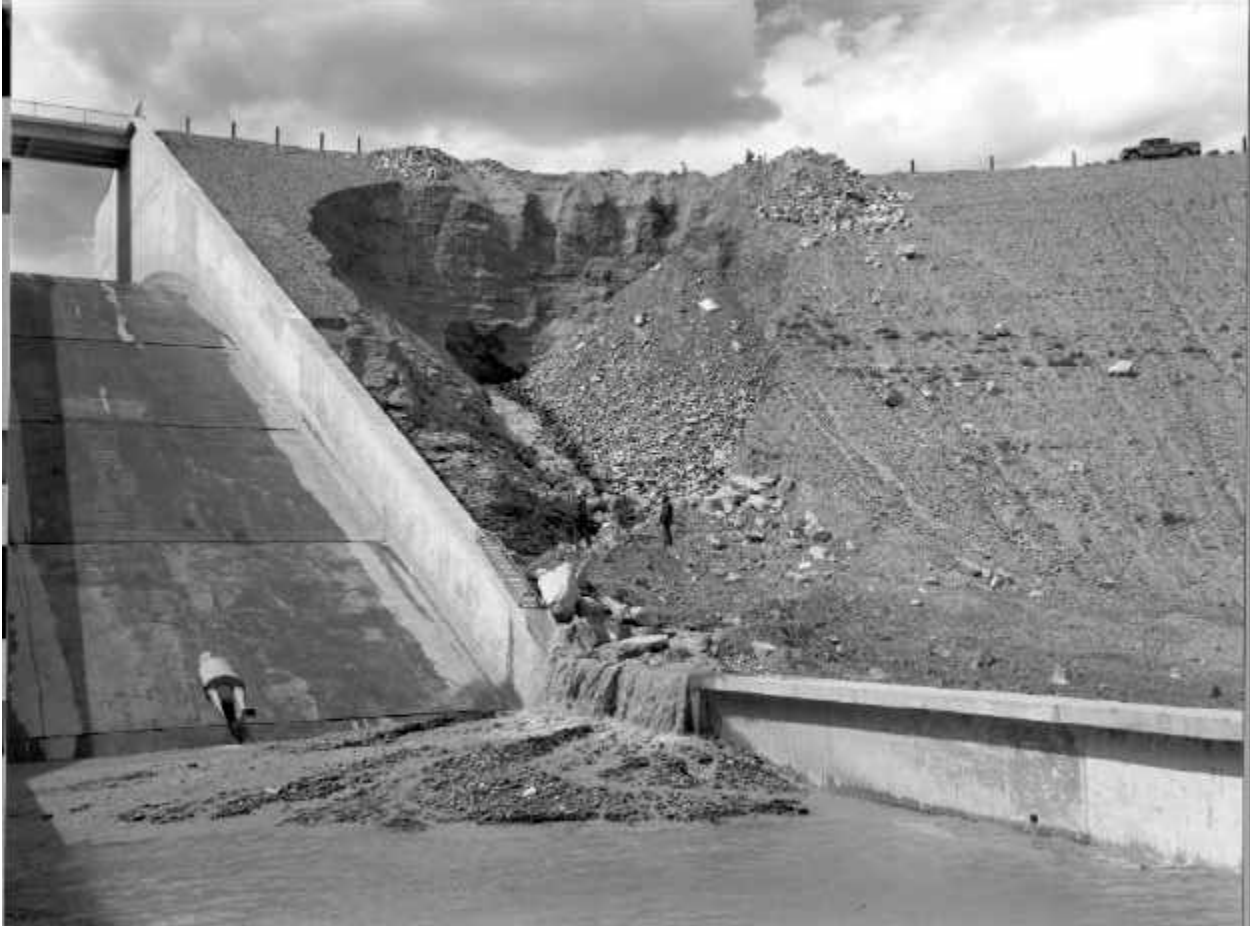
Figure 12 - Fontenelle Dam - Large Sinkhole on Downstream Slope

First filling of the 345,000 acre-foot reservoir commenced in April 1964. During the summer of 1964, after the reservoir had risen to a depth of about 49 feet, seepage appeared in the floor of an exhausted borrow area 2,000 feet downstream of the dam and stabilized at a flow of 6 ft³/s. The reservoir continued to fill through the spring runoff from the heavy snowpack winter of 1964-1965 (which produced a peak reservoir inflow of 17,560 ft³/s) until it reached a depth of about 85 feet in early June 1965. Seepage then began to discharge from a rock cut in the spillway discharge channel and from a cliff face about 0.6-mile downstream on the left abutment. The seepage flowing from the downstream borrow area also appeared to have increased. The reservoir began to spill on June 15th and the rate of total seepage increased to about 70 ft³/s. A small slough occurred at the edge of the embankment on the left side of the spillway chute at about the mid-height of the dam on June 29th, with about 1 ft³/s issuing from a crack in the rock beneath the chute. On the morning of September 3rd, a wet spot was observed on the downstream slope of the dam at about mid-height near the right abutment about 100 feet to the right of the slough that occurred in June. By mid-afternoon, seepage water started flowing from the wet spot area, causing erosion and sloughing of the dam embankment material. The flow that evening was estimated at about 5 ft³/s. Local officials were then alerted to stand by, ready to evacuate downstream residents. The next morning (September 4th), the seepage flows had increased to about 21 ft³/s and an estimated 10,500 yd³ of material had been eroded from the downstream slope (see **Figure 12** on next page). Rockfill was dumped into the hole on the downstream slope, trying to stop the erosion, and the seepage flows appeared to stabilize. On the morning of September 5th, it was decided to fully open the outlet works, and by the morning of the 6th the reservoir level had dropped 8 feet from the initial level. That afternoon, an area on the dam crest about 20 feet in diameter near the upstream edge collapsed (see **Figure 13** on page after next page) and dropped about 30 feet, exposing bedrock on the abutment side of the cavity. The reservoir continued to drop about 4 feet per day until the pool was low enough to halt the seepage.

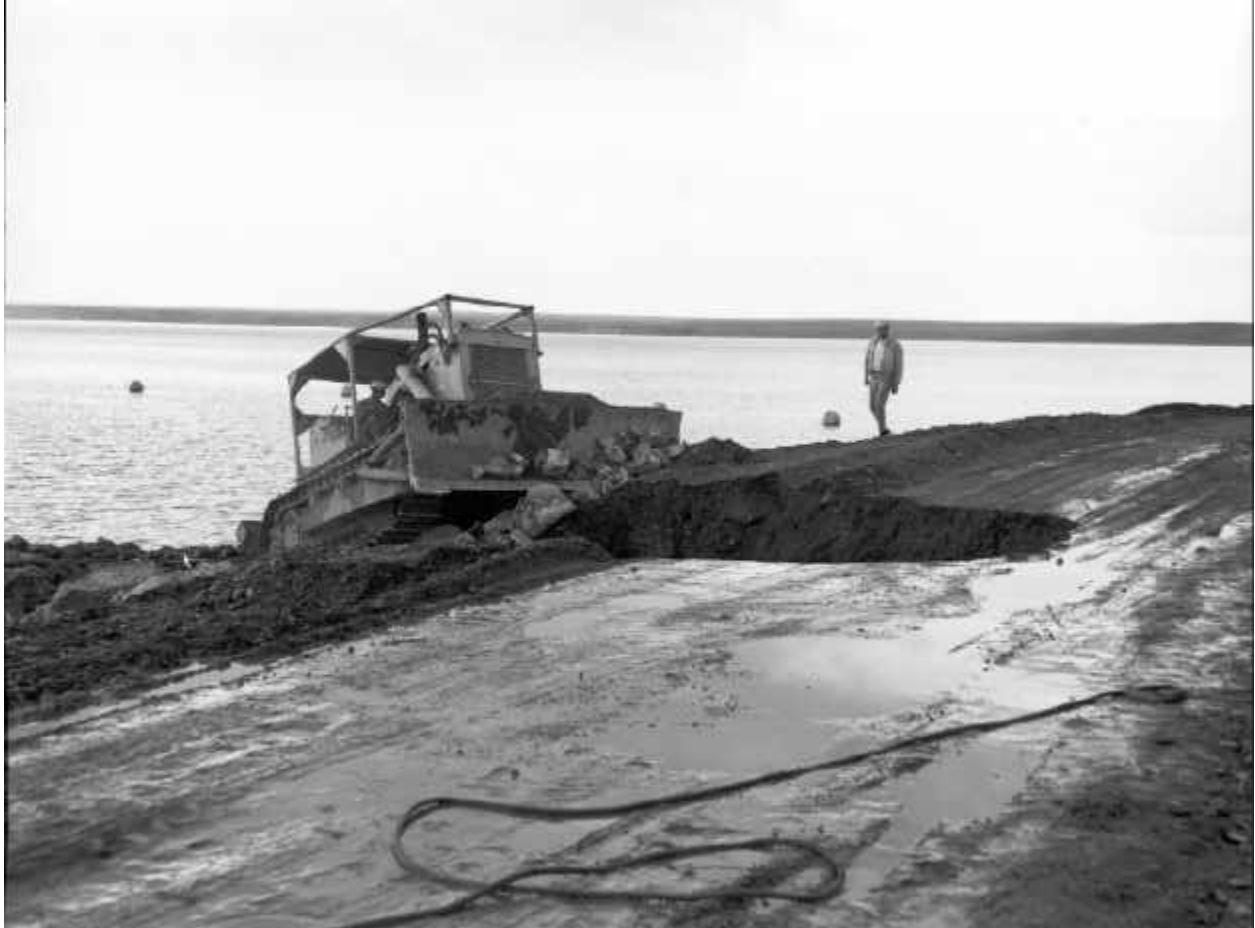
Figure 13 - Fontenelle Dam - Crest Sinkhole

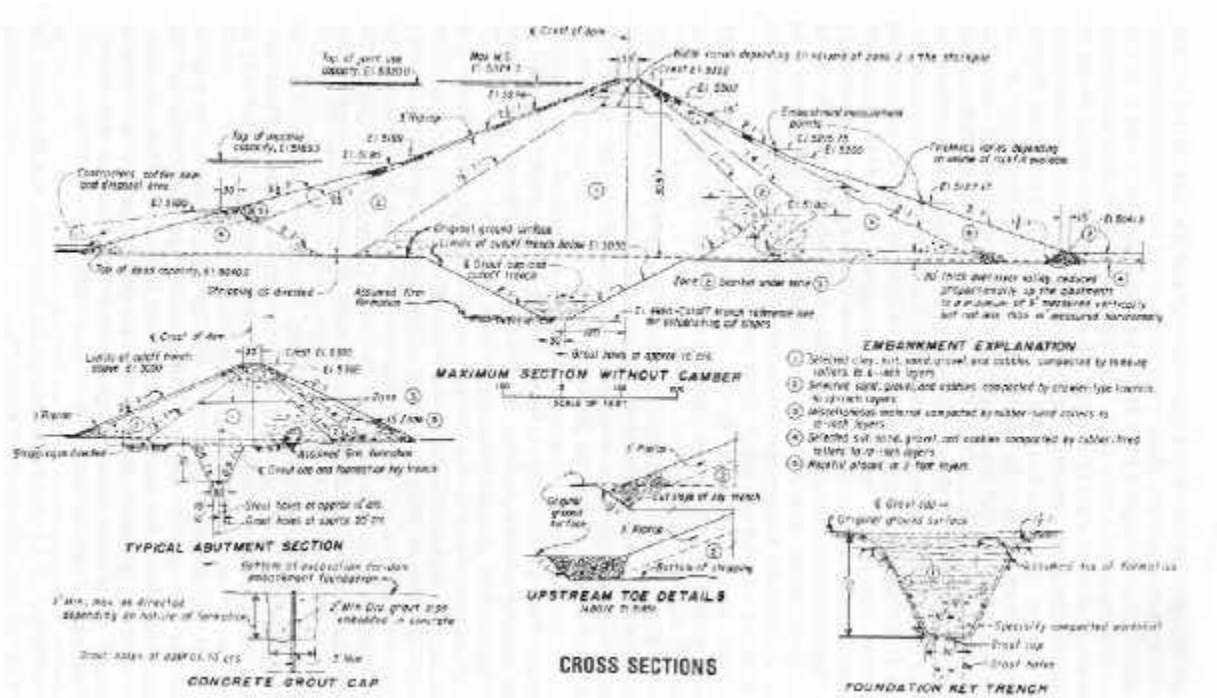
Figure 14 - Teton Dam Sections

Teton Dam was constructed between February 1972 and November 1975, with a maximum height of 305 feet above the streambed. The embankment cross-section was remarkably similar to that of Fontenelle Dam (see **Figure 14** below). The wide zone 1 core consisted of silt, flanked

upstream and downstream by zone 2, which consisted of (pit-run alluvium) selected sand, gravel, and cobbles. There was also a zone 3 miscellaneous earthfill zone downstream, with zone 2 constructed as a chimney filter/drain and as a 20-foot-thick drainage blanket beneath the zone 3 and up the abutments. The outlet works at Teton Dam consisted of the river outlet works with a capacity of 3,400 ft³/s and an auxiliary outlet works with a capacity of 850 ft³/s. The construction schedule required that the river outlet works be operational by May 1, 1976, but the contractor was behind schedule and only the auxiliary outlet works were operational to control reservoir filling.

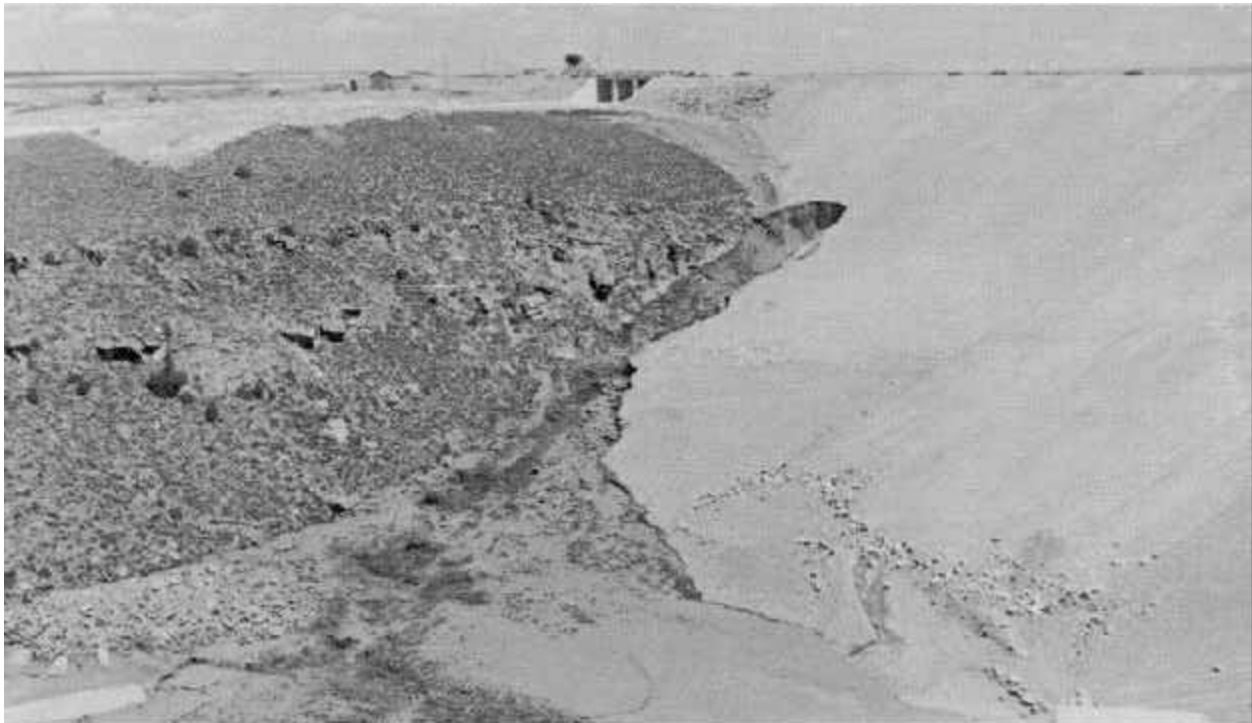
Figure 23.—Dozers lost in leak at El. 5200.

Figure 15 - Teton Dam - Downstream Sinkhole at About 11:20 a.m.

about 2 ft³/s. The lower leak at elevation 5045 was estimated to be flowing 40 to 50 ft³/s at about 9:30 a.m. Between 10:00 and 10:30 a.m., a wet spot was observed on the downstream slope of the dam at elevation 5200 and about 15 to 20 feet from the right abutment. The wet spot quickly increased to a flow of 10 to 15 ft³/s and was eroding the material on the downstream slope. At about 10:30 a.m., a loud sound (roar) was heard, followed by the sound of rapidly running water. At about 11:00 a.m., a whirlpool formed in the reservoir about 150 feet from the right abutment and its diameter rapidly began to expand. By about 11:20 a.m., attempts to bulldoze rockfill into the opening (as had been done at Fontenelle Dam) proved futile (see **Figure 15** on previous page).

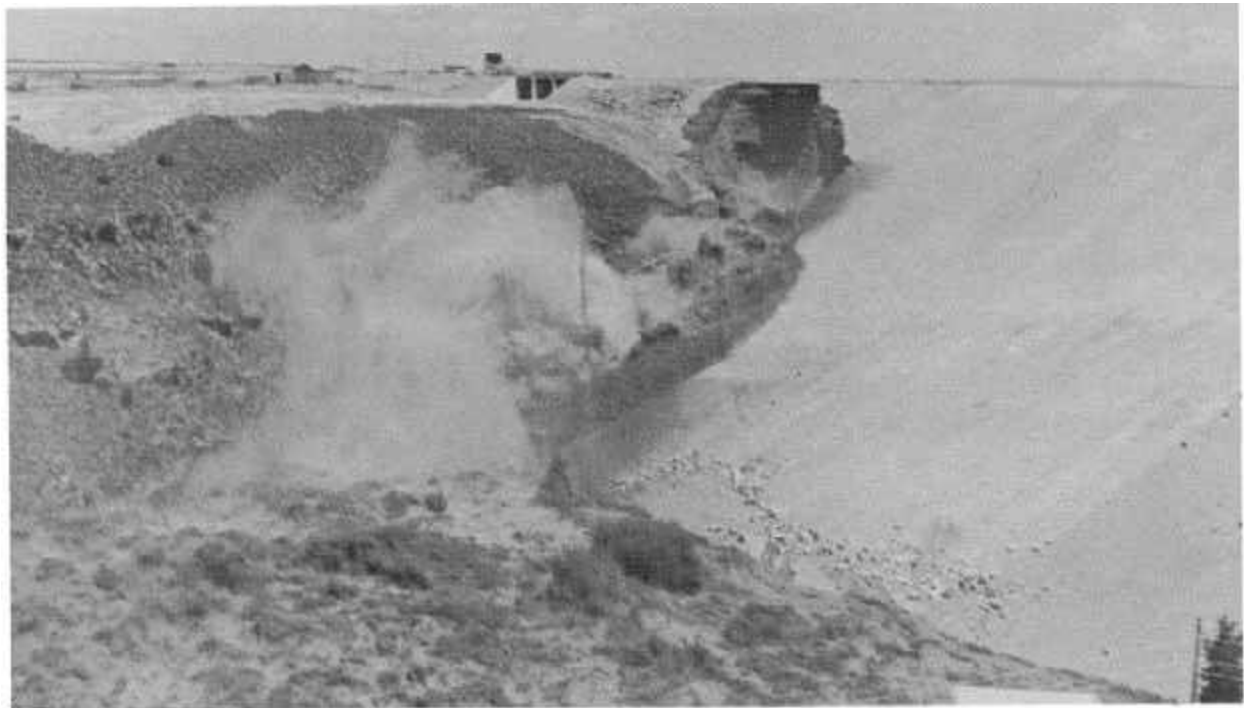
Figure 16 - Teton Dam - Crest Collapsed at 11:55 a.m.

A sinkhole developed on the downstream slope shortly before the embankment crest collapsed at 11:55 a.m. (see **Figure 16** above), and the dam was breached two minutes later at 11:57 a.m. (see **Figure 17** on next page). This sequence of observed new seepage, wet spots, erosion, sinkhole, whirlpool, crest collapse, and embankment breaching took only five hours from start to finish and the complete release of the reservoir followed. By 5:00 to 6:00 p.m. that same day, the reservoir had completely emptied.

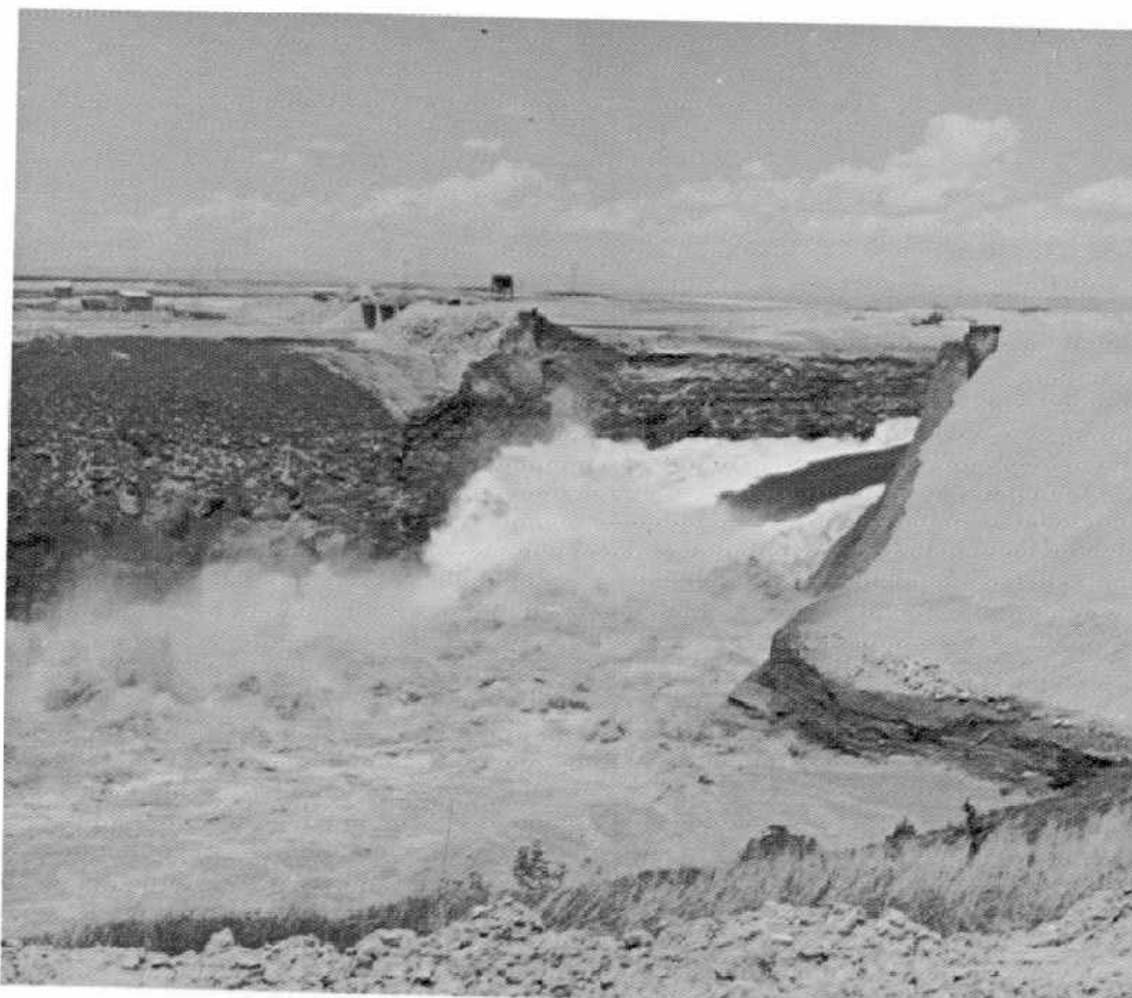
Figure 17 - Teton Dam - Dam Completely Breached

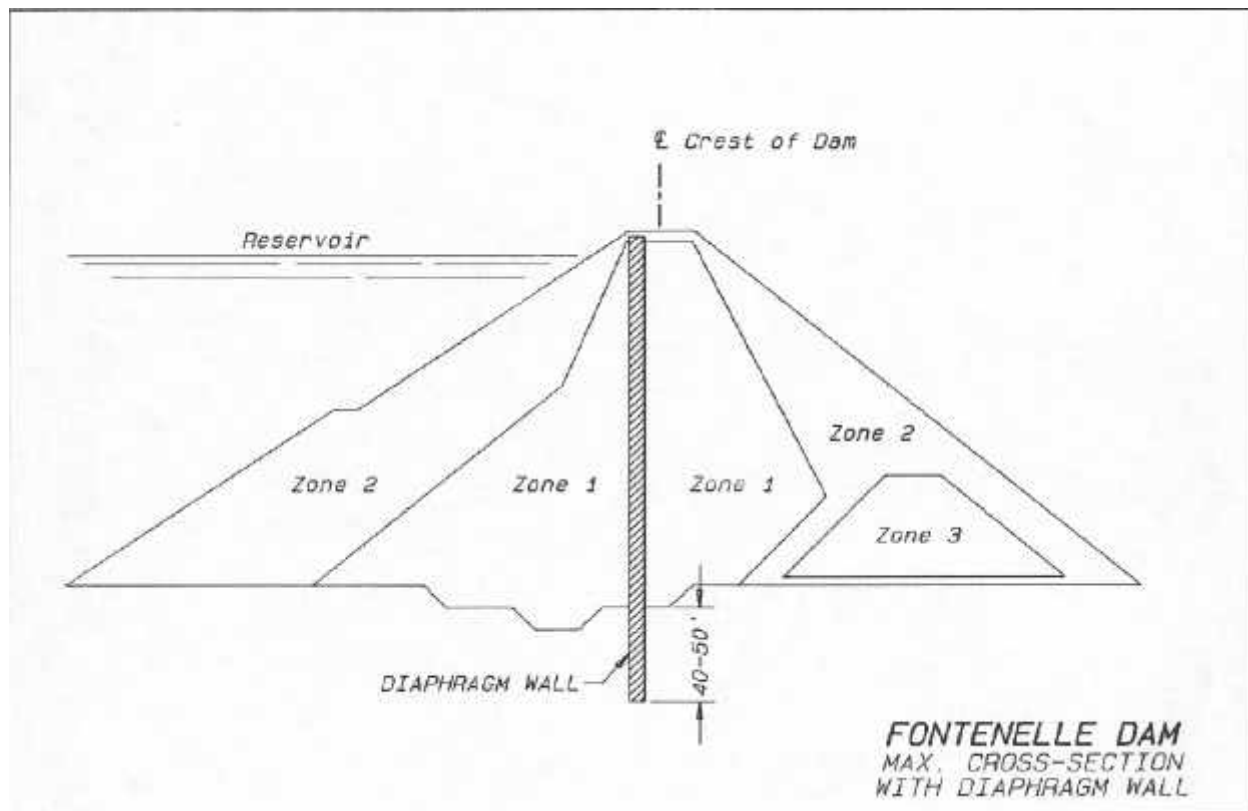
Figure 18 - Fontenelle Dam - Section of Embankment with Diaphragm Wall

Fontenelle Dam continued to have seepage and internal erosion/piping problems after it was supposedly fixed by the additional abutment grouting performed in 1966. Instrumentation monitoring data in 1983 indicated that a potential dam safety problem was developing, and the decision was made to modify the dam by installing a continuous concrete diaphragm wall through the dam and into the foundation. There were several aspects of the existing Fontenelle Dam embankment's design that were judged to have been partly responsible for the failure of Teton Dam, such as vertical to overhanging abutment cliffs, extensive joints and cracks in the abutments, no processed material placed as a chimney to filter the erodible silty zone 1 core as protection against internal erosion/piping, and silty core material placed directly against open, unsealed bedrock joints, cracks, and crevices. Only one solution was judged to be capable of alleviating all of these potential problems, and construction of a concrete diaphragm wall from the crest of the dam down through the embankment and the upper highly-fractured bedrock was selected as the appropriate modification (see **Figure 18** on next page). The concrete diaphragm wall had to avoid damaging the river outlet works near the middle of the embankment and the spillway on the right abutment. The concrete diaphragm wall modification was constructed between 1987 and 1989. **Figures 19 and 20** (on two pages after next page) show the rockmilling equipment used to excavate embankment and rock for the diaphragm wall at Fontenelle Dam.

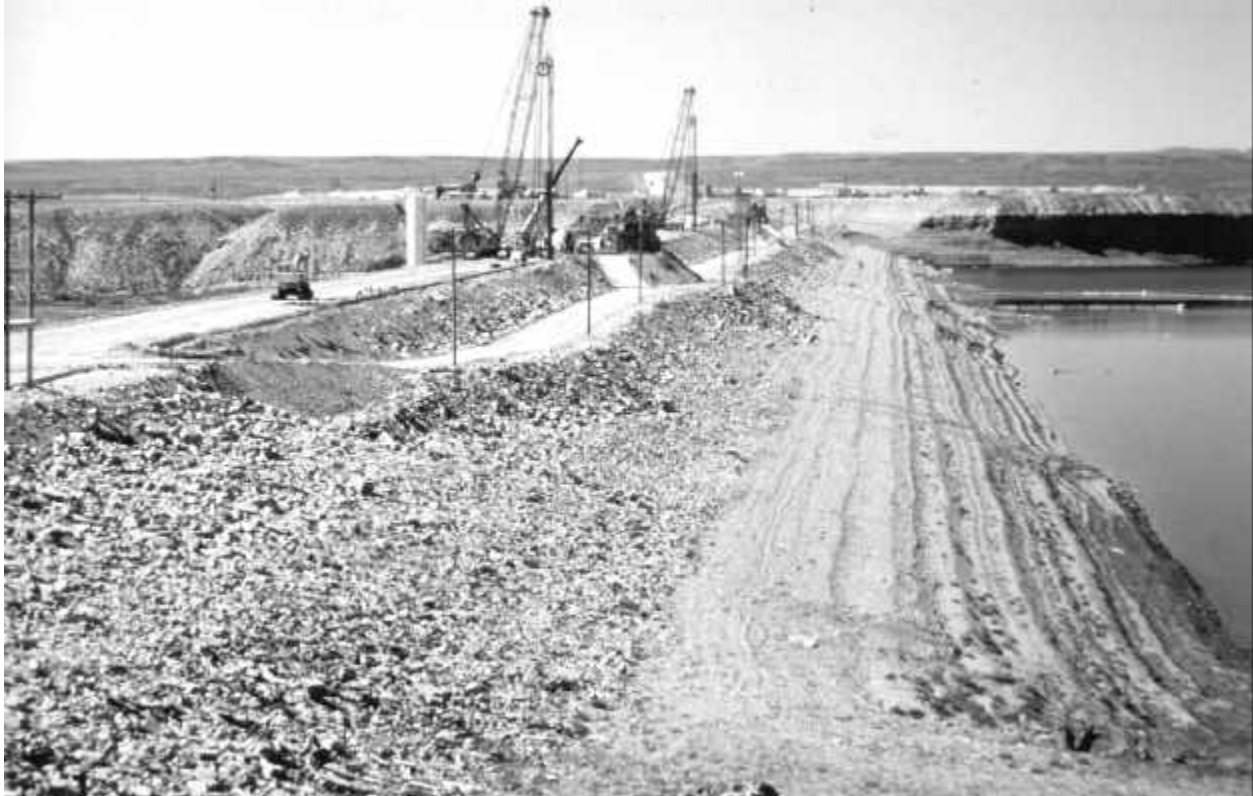
Figure 19 - Fontenelle Dam - Diaphragm Wall Construction

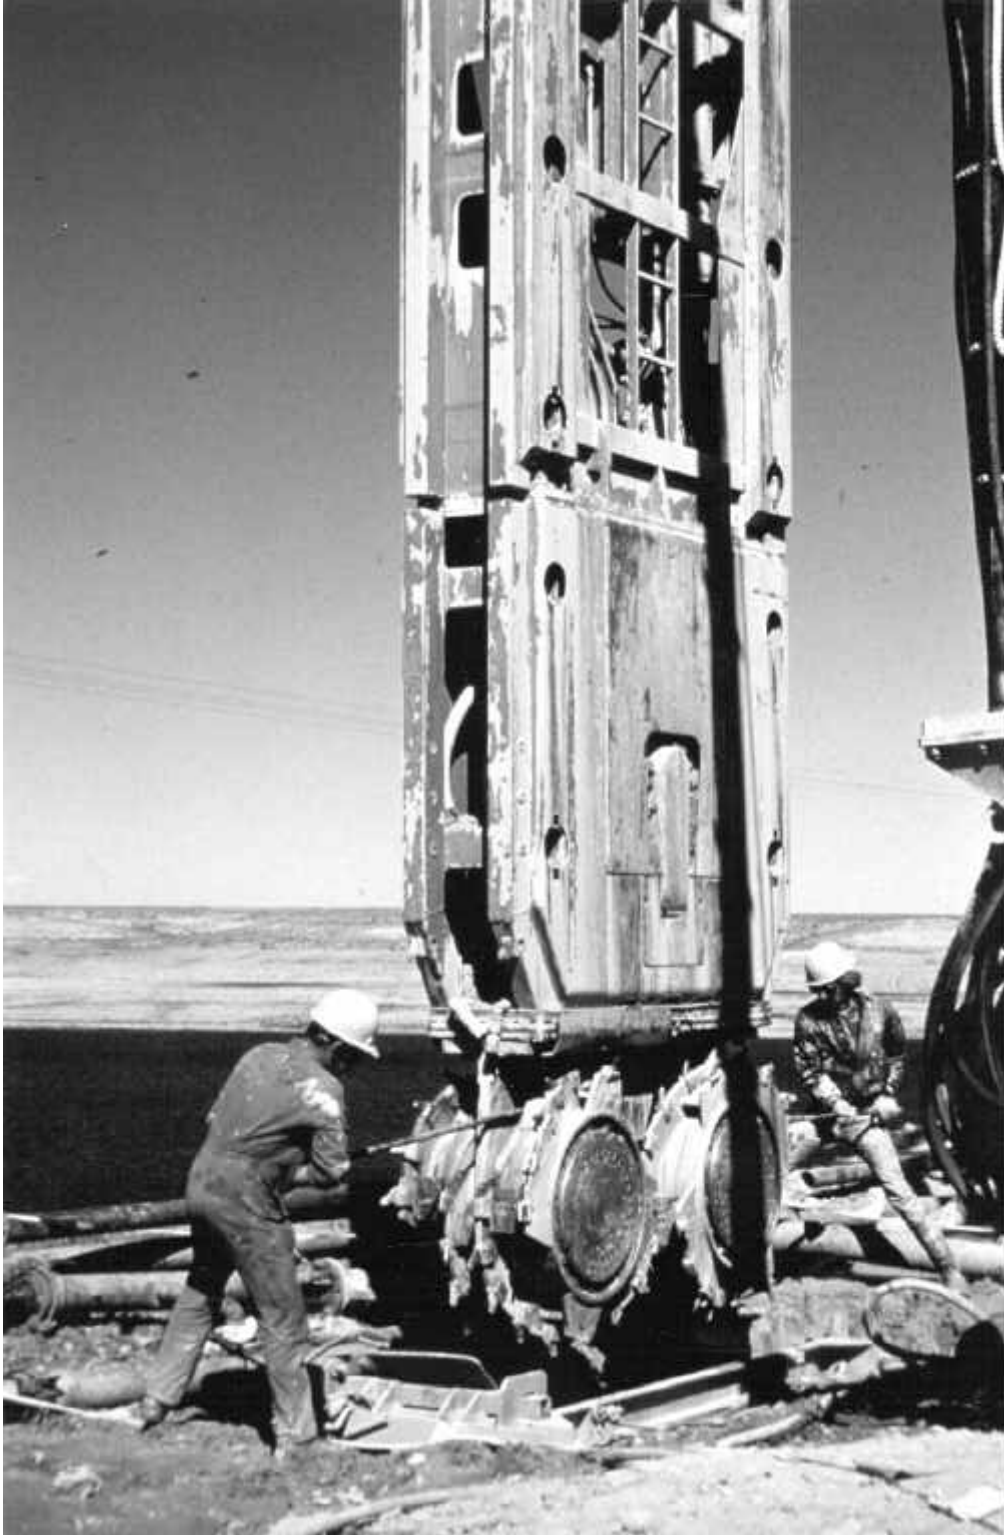
Figure 20 - Fontenelle Dam - Diaphragm Wall - Hydromill Rock Excavator
