**100 Years of Embankment Dam
Design and Construction
in the
U.S. Bureau of Reclamation**

Bureau of Reclamation History Symposium
at
University of Nevada - Las Vegas
June 18-19, 2002

Richard Lyman Wiltshire, P.E.
Civil Engineer, Principal Designer
Geotechnical Services Division, Group 1
Technical Service Center
Bureau of Reclamation
U.S. Department of the Interior
Denver, Colorado

ABSTRACT

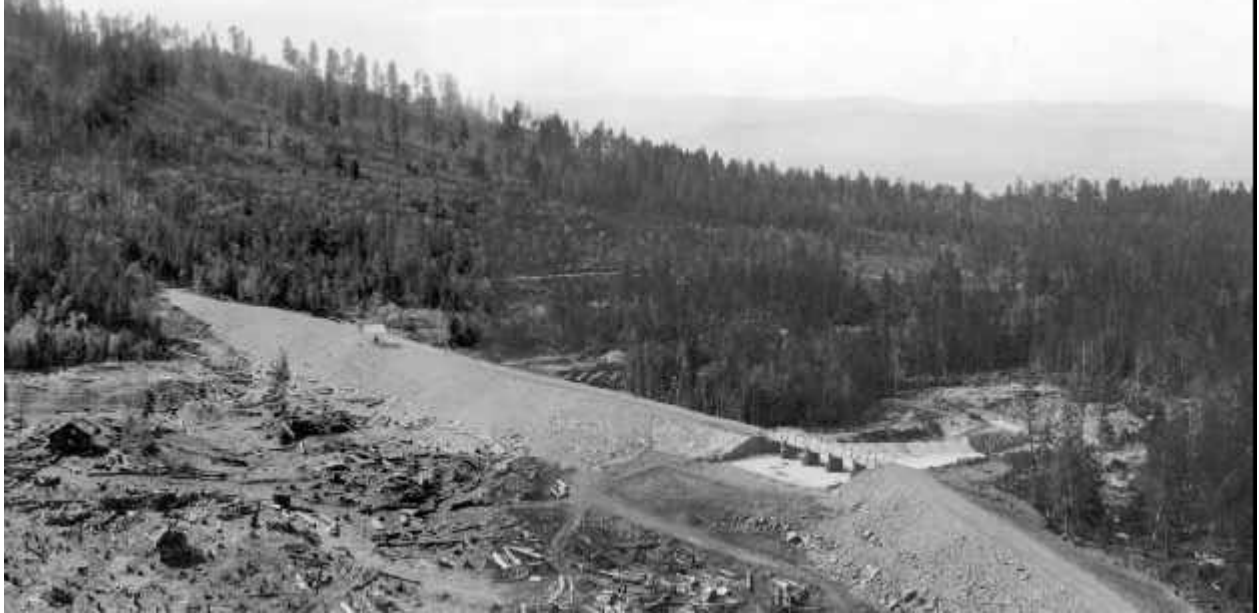
Figure 21 - McDonald Dam - Original Dam in 1920

time. The dam embankment had been constructed by Project Manager/Engineer Frank Crowe (Honorary Member, ASCE) using dumped and sluiced earthfill, with a puddled core created by sluicing the dumped earthfill (see **Figure 21** on page after next page). The embankment and an outwash foundation beneath part of the dam were judged susceptible to liquefaction and excessive deformation. Various alternatives were developed and evaluated, with the final decision reached to completely replace the existing dam embankment, spillway, and outlet works. These modifications were designed by Reclamation who also provided the construction management services. It should be noted that the Construction Engineer for McDonald Dam Modification was on the Design Team. The new McDonald Dam embankment was a completely different embankment design. The new embankment cross-section included: a textured geomembrane covered by earthfill and riprap on the upstream slope, an impervious earthfill zone behind the geomembrane, followed by an inclined processed chimney filter/drain, all of which rest against a large miscellaneous earthfill zone that sits on top of a blanket drain consisting of processed drainage material sandwiched between two layers of the processed filter material. The instrumentation consisted of piezometers in the embankment and foundation, embankment measurement points, and weirs to monitor seepage flows. These McDonald Dam modifications were constructed in 1994-1995 and 1999-2000 (see **Figure 22** also on page after next), after which its behavior during resumed filling of the reservoir in 2000 and beyond went very well [44].

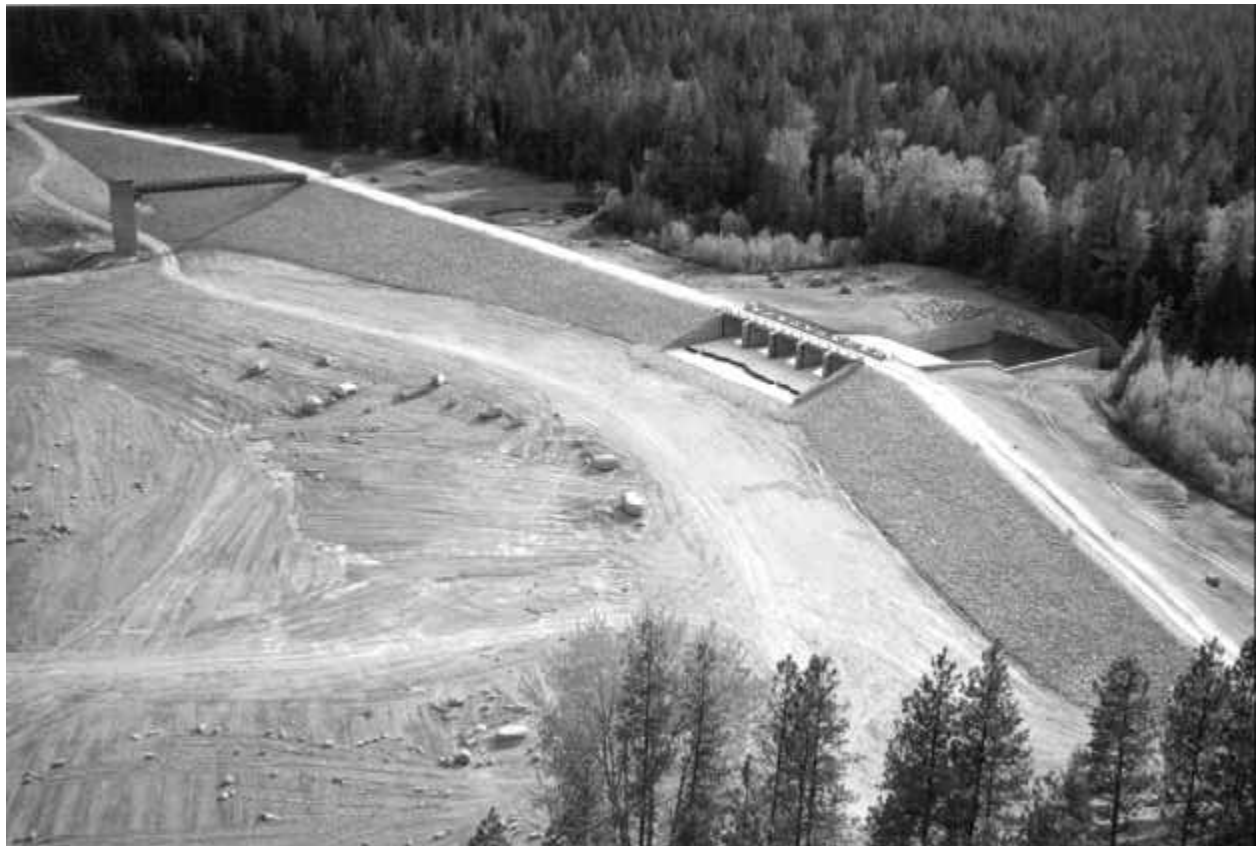
Figure 22 - McDonald Dam - New Dam in 2000

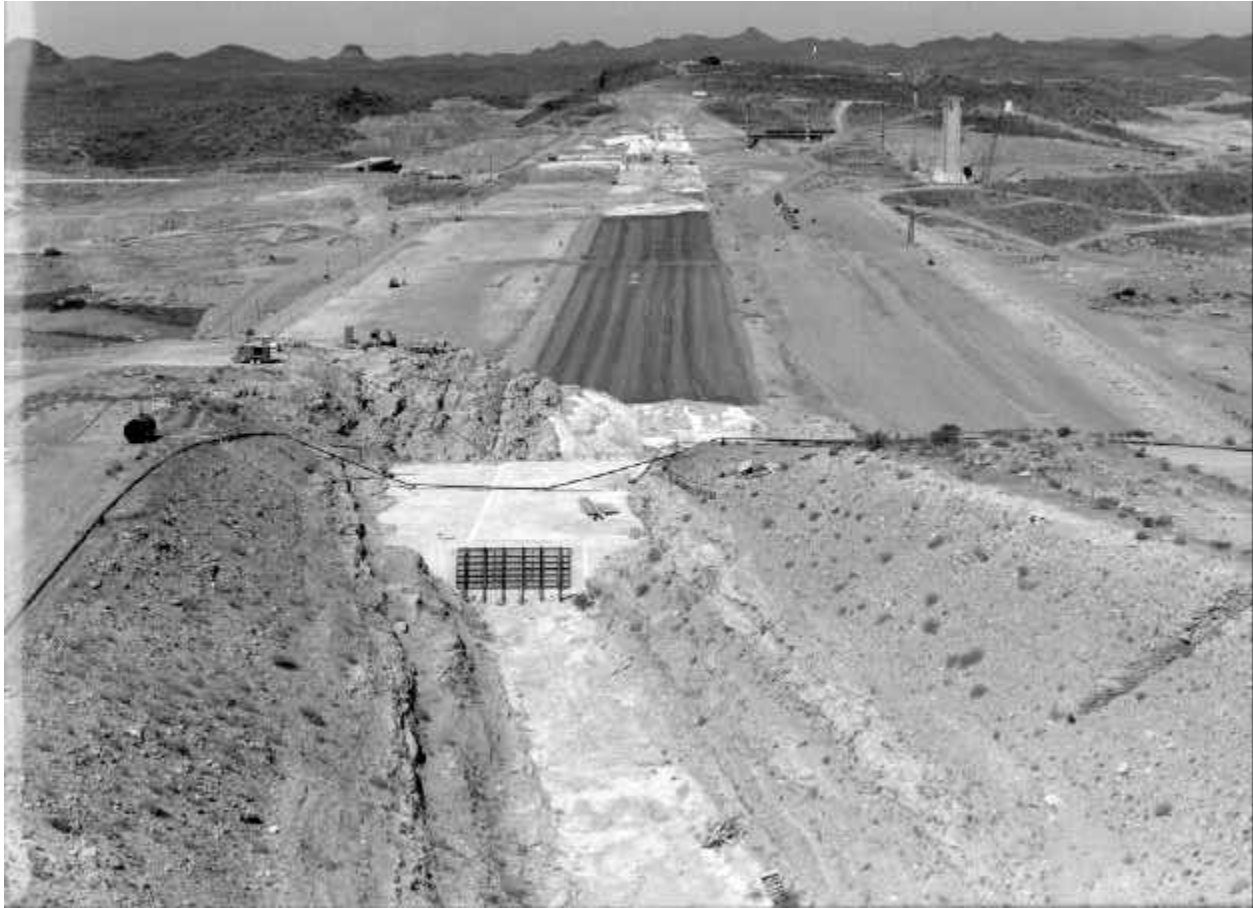
Figure 23 - New Waddell Dam Construction

During Period V, the variety of equipment available for the construction of embankment dams continued to improve in size, power, speed, and efficiency as usual. For example, **Figures 23 and 24** (see below and next page) show the construction of New Waddell Dam (1986-1992) and

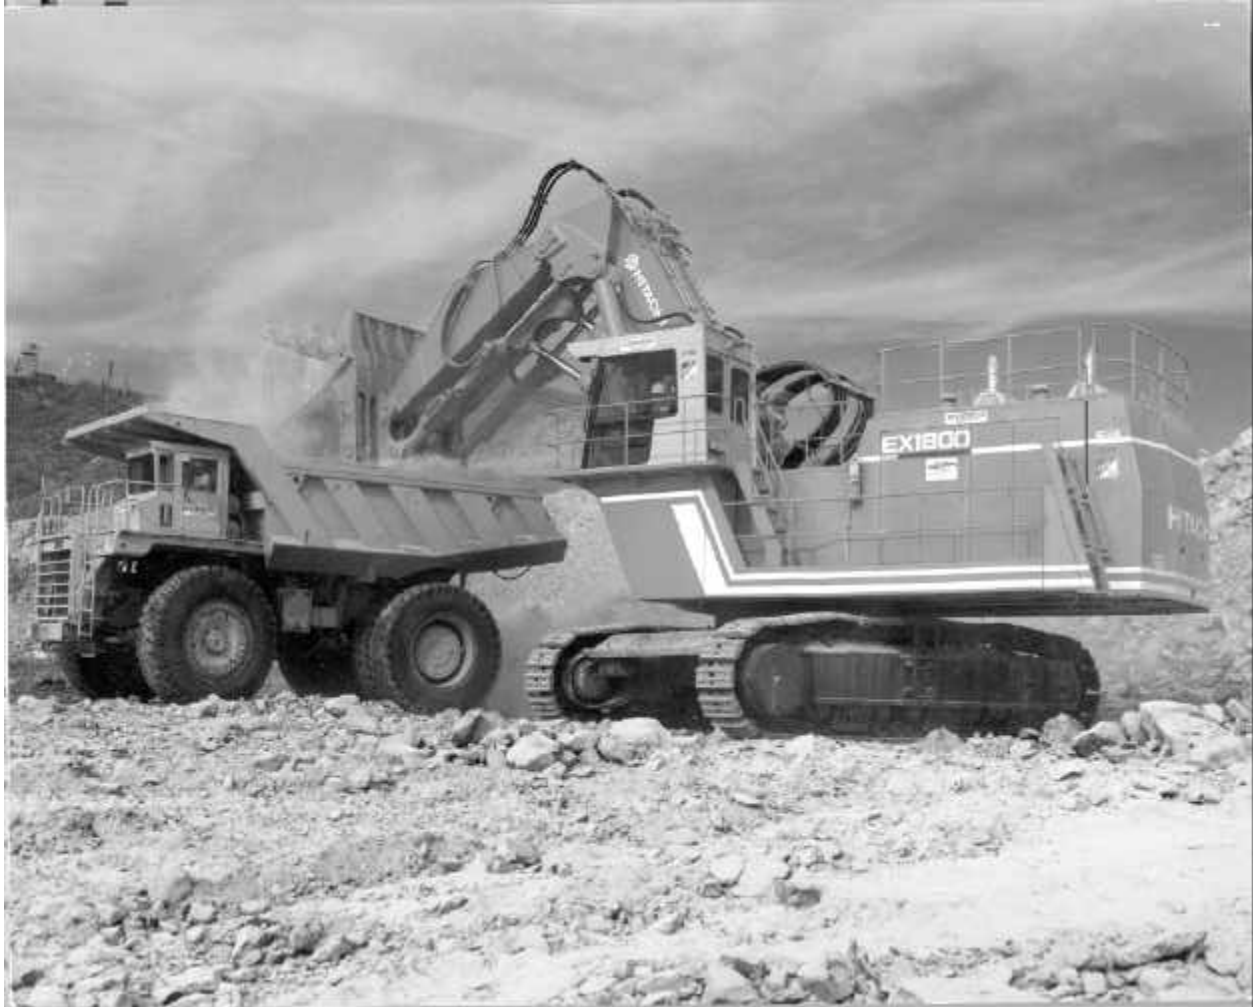
Figure 24 - New Waddell Dam - Construction Equipment

the size of the equipment currently used to construct embankment dams. Compare the end-dump truck in **Figure 24** and its 35 yd³ capacity to the train of 4 yd³ side-dump cars used to construct Belle Fourche Dam in 1909 shown in **Figure 7**. Also compare the large excavator in **Figure 24** and its 12 yd³ bucket with steam shovel at Belle Fourche Dam with its 2½-yd³ bucket shown in **Figure 7**. During Period V, synthetic materials such as high-density polyethylene (HDPE) and polypropylene were developed into new products, such as corrugated pipe, geomembranes, and geotextiles, that were promptly put to use on embankment dams where judged appropriate. New types of equipment related to these new materials and products were developed, and quality control tests, testing equipment, and detailed test procedures were developed, with Reclamation's significant participation in these developments.
