Portland's Blue Bike Lanes

*Improved Safety through
Enhanced Visibility*

CITY OF PORTLAND
OFFICE OF TRANSPORTATION
JULY 1, 1999

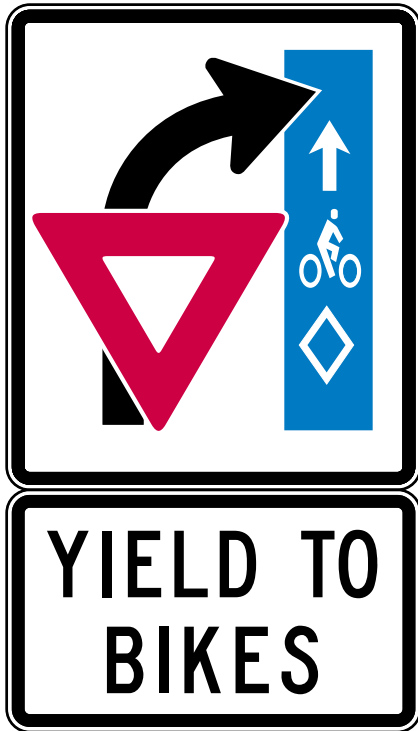
GROUP 1: Right-turn exit ramps

- ◆ Motorists yield to cyclists as they turn right to exit roadway.

At each site, crews mounted an accompanying sign depicting the conflict situation (see *Figure 1* for sign examples). The blue area and its accompanying sign are intended to remind motorists that they are crossing a bicycle lane and need to yield to through cyclists.

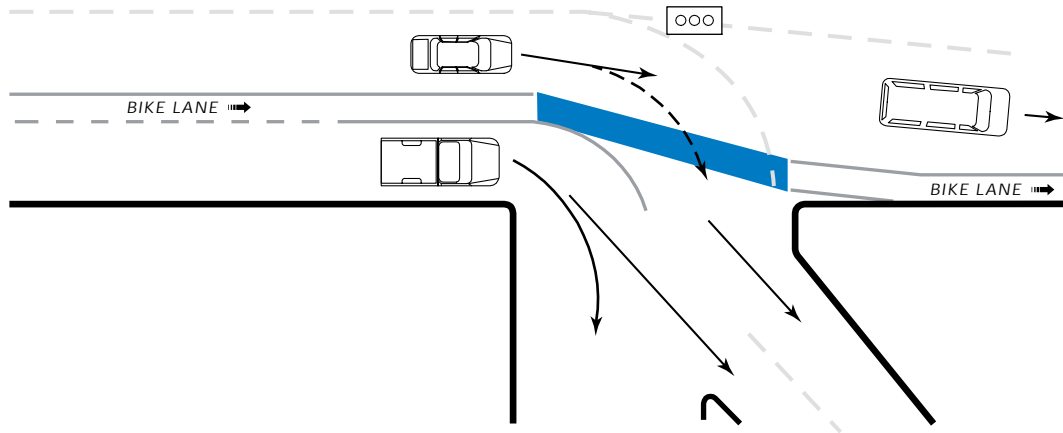
Site 1 *Broadway / Williams / I-5 entrance*

Motorists can either turn right as they exit the roadway or continue straight from the right lane. Right-turning exiting vehicles cross the bicycle lane.

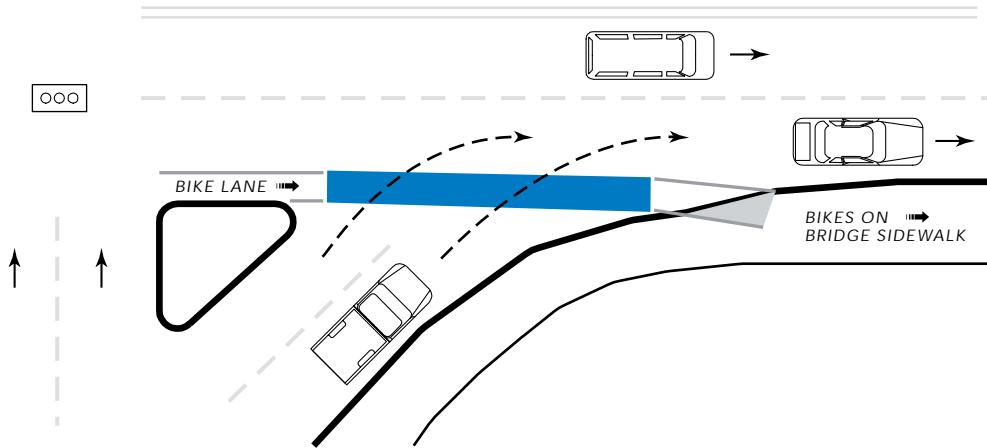
Site 9 *Broadway Bridge / Interstate Ave.*

Motorists cross the bicycle lane as they turn right to enter the roadway from a ramp.

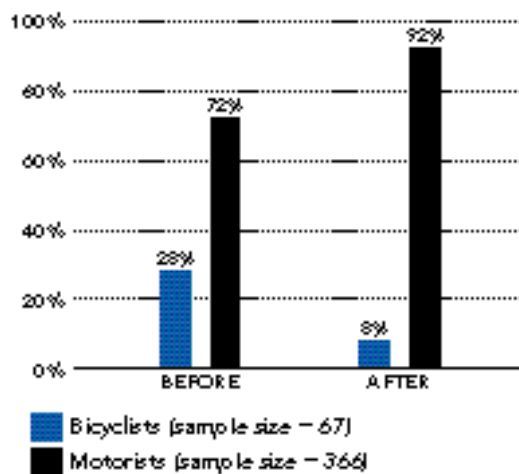
■ Figure 2. *Who yields?*

In the before period, 72 percent of motorists yielded to cyclists while 28 percent of cyclists yielded to motorists. In the after period, the percentage of motorists yielding increased to 92 percent, a 27 percent increase (see *Figure 2*). The percentage of cyclists yielding decreased to eight percent. The increase in motorist yielding was consistent at all levels of analysis. Significant change was noted at Broadway/Larrabee and Weidler/Victoria.

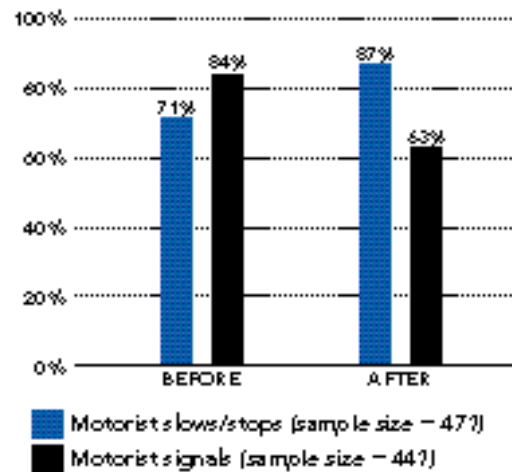
■ Figure 3. *Motorist behaviors*

Significantly more motorists slowed or stopped when approaching the blue area: 71 percent before and 87 percent after installation, a 23 percent increase (see *Figure 3*). However, when analyzed at the group and individual levels, no significant changes were found. In contrast, 25 percent fewer motorists used a turn signal (84 percent before versus 63 percent after — see *Figure 3*), with the exit ramp group experiencing an insignificant change and the right-turn lane group an increase in slowing or stopping.

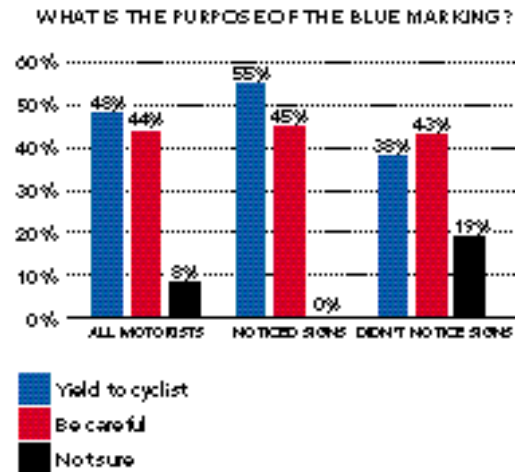
■ Figure 5. *Motorist survey*

Of the respondents who noticed the sign, 55 percent said the blue area meant “yield to cyclist,” and 45 percent said it meant, “be careful.” Of those who did not notice the sign, only 38 percent said it meant “yield to cyclist,” and 43 percent “be careful” (see *Figure 5*).

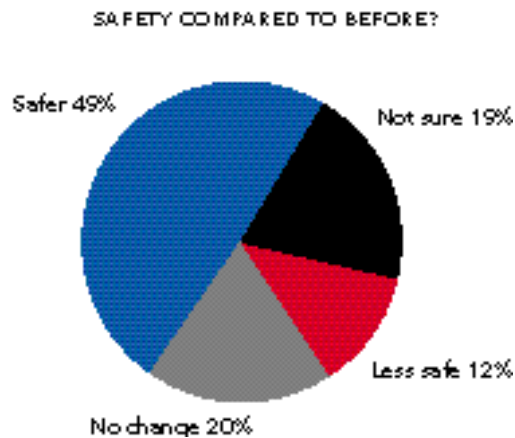
■ Figure 6. *Motorist survey*

Overall, almost 50 percent felt the areas were safer; another 40 percent said they were about as safe as before or were not sure (*Figure 6*). Of those who noticed the signs, 55 percent felt the areas were safer.

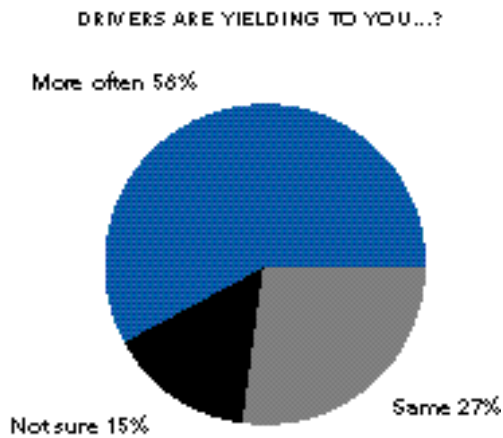
■ Figure 8. *Cyclist survey*

Fifty-eight percent felt that motorists were yielding more than before, and 27 percent the same as before (*Figure 8*).

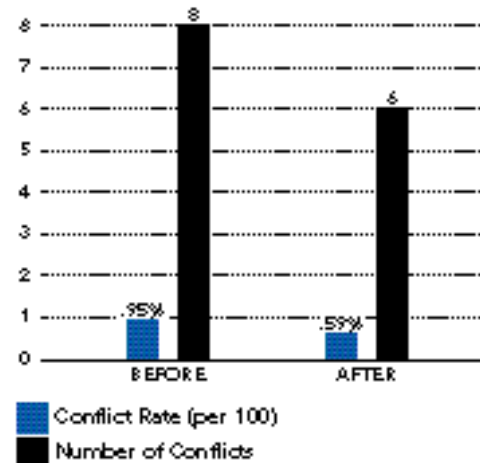
■ Figure 9. *Conflicts*

On the videotapes, researchers noted conflicts — defined as interactions forcing at least one of the parties to make a sudden change in speed or direction. Conflicts were infrequent, with eight in the before period and six in the after period. Conflict rates were similarly small, decreasing from .95 per 100 to .59 per 100 (*Figure 9*). Analysts judged all of the conflicts in the before period to be minor in nature, with one serious conflict in the after period. Five of the before conflicts occurred with bicyclists traveling eastbound on the Hawthorne Bridge. Four of the six after conflicts occurred at Weidler/Victoria, where motorists merge onto the street from a freeway off-ramp. Four of the eight before conflicts occurred in the uncolored bicycle lane, while five of the six after conflicts were in the blue pavement area.
