CASE STUDY

Portland Oregon Winning Combination Automotive Transporter Company

Portland Oregon Winning Combination
Automotive Transporter Company
 continued

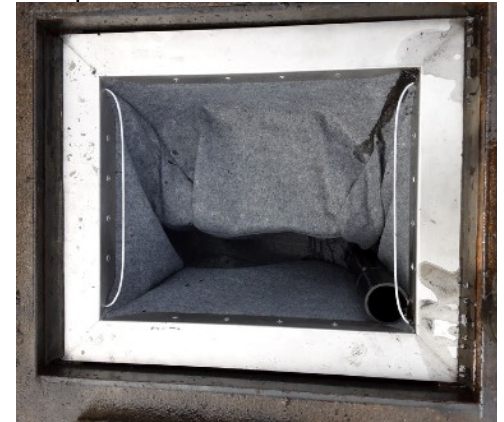
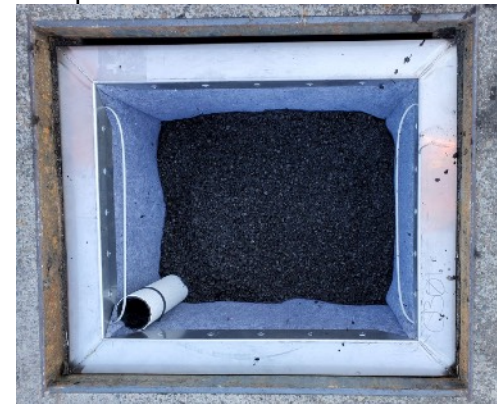
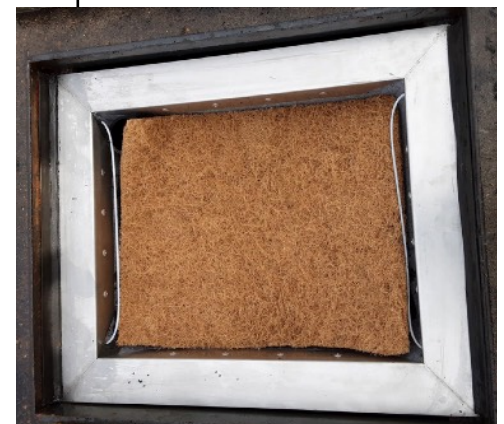
Below are the test results for testing done before replacing of the competitors product and after the new BMPs including **BiocharBASIC™** was utilized.

Test Date	Copper µg/L	Lead µg/L	Zinc µg/L	Iron µg/L	TSS mg/L
2/16/17	4.8	1.1	501	NT	17.2
4/24/17	4	0	70	NT	0
11/13/17	7	1.4	174	441	22
12/19/17	19.8	6.7	269	2440	142
12/20/18	5.6	0.9	85.5	NT	34
3/13/19	15.9	5.2	116	2050	8.96
3/28/19	10.2	5.2	47.5	653	32.5
Average Before Treatment	9.61	2.93	180	1396	36.67
Benchmark Before 2021	20	40	120	1000	100
10/10/20	5.8	0	66.4	101	8
11/5/20	5	0	52.7	181	6
3/19/21	5.1	0.733	44.07	417.7	5
4/5/21	4.2	0.367	33.13	131.7	0
11/17/21	3.6	0.233	31.07	108.5	1.33
12/1/21	5.1	0.267	34.13	169.3	0
Average After Treatment	4.8	0.27	43.6	185	3.39
	Copper	Lead	Zinc	Iron	TSS
Average Reduction	50%	90%	74%	84%	99.9%
