A GUIDE TO THE REPAIR OF HISTORIC BRICKWORK

Comhshaol, Oidhreacht agus Rialtas Áitiúil
Environment, Heritage and Local Government

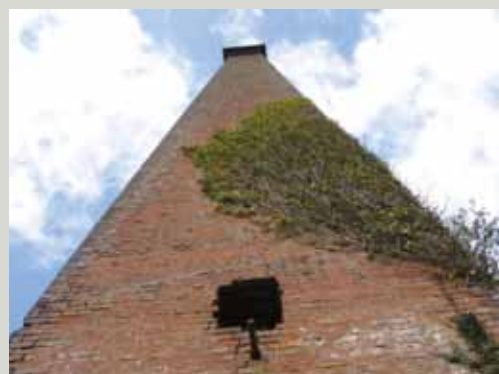
A kiln chimney at Youghal, Co. Cork, now disused

Kilns were permanent structures which, until the nineteenth century, had to be loaded (or set), fired, cooled, and un-loaded before they could be set and fired again. These are known as intermittent kilns. The first were updraught kilns, wasteful of fuel, where the fire was lit at the base, travelled up through the bricks and tiles, and exited at the top. By the middle of the nineteenth century the more efficient downdraught kiln was developed, whereby the heat was drawn over the top and down through the goods. This gave greater control and improved the quality and regular colour of the bricks. The second half of the nineteenth century saw the introduction of continuous kilns, where the fire travelling through the kiln never goes out. The bricks go through the pre-heating, firing, cooling and unloading processes in separate but interconnected chambers. The first was the 'Hoffmann Kiln' patented by Friedrich Hoffmann in 1856. Modern continuous kilns include the 'tunnel' kiln, where the bricks travel on rails through all the zones, or the 'moving-hood' kiln, which is brought to, and lowered over, the setting of bricks and then ignited.

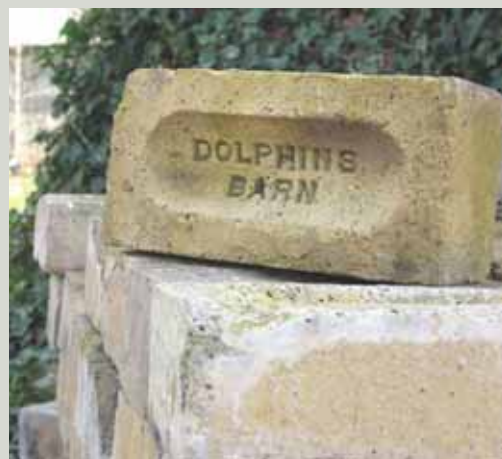
Machine-made brick from the Dolphin's Barn Factory in Crumlin dating from the early twentieth century is recognisable from its distinctive yellow colouring and the manufacturer's name impressed into the 'frog' or indentation in the bed face of the brick

Machine-made bricks are those made by a mechanised process, such as an extruded 'wirecut', pressed and 'simulated' handmade. Machine-made bricks can be solid, perforated, or panelled and are often stamped with the maker's name.

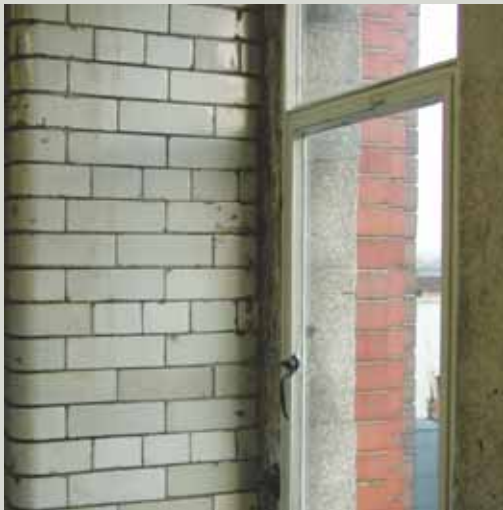
Glazed bricks, in white or pale colours, were often used to the sides of windows and in light wells to reflect more light into the interior of a building

The early glazing of bricks came about as a direct result of the combination of wood fires and high temperatures against the face of the bricks in the firing tunnels. These bricks were then used to create decorative patterns within a brick wall, including diaper work. Later glazed bricks were machine-made, usually with one glazed surface. The earliest were termed 'salt-glazed' and were generally brown in colour. Later developments in the mid nineteenth century led to the fired brick being dipped into a prepared solution of liquid clay. This was usually white, but could be pigmented to create a wide range of colours and then re-fired at a higher temperature. Glazed bricks were often used, because of their light-reflecting and self-cleansing qualities, on shop fronts, toilets, dairies, and light wells in the nineteenth and early twentieth century buildings.

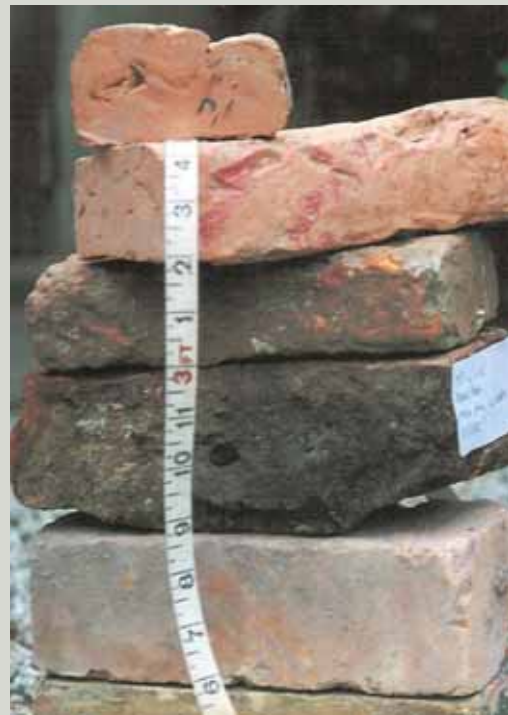
The changing sizes of brick: this image shows, from the top, the thin bricks of the seventeenth century, an eighteenth-century handmade brick and a nineteenth-century machine-made brick

Size and visual appearance can give some assistance in dating bricks, particularly those made in the period before bricks were machine-made and stamped. Due to the nature of early moulding, bricks were generally thin in the medieval period and gradually became thicker, with improved moulding techniques, during the seventeenth century.

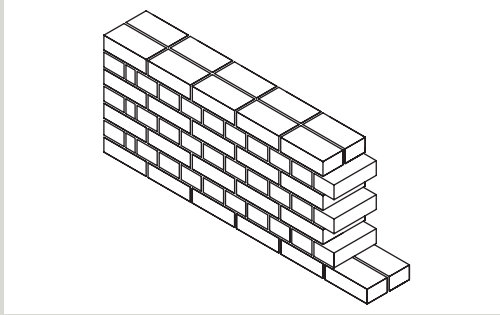
English bond – commonly used on seventeenth century buildings until overtaken by Flemish bond brickwork; its use was revived in the late-nineteenth century

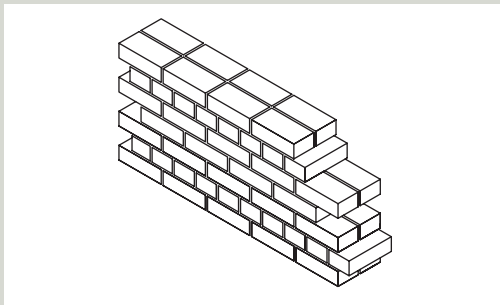
English Garden Wall bond – commonly used on early twentieth-century buildings

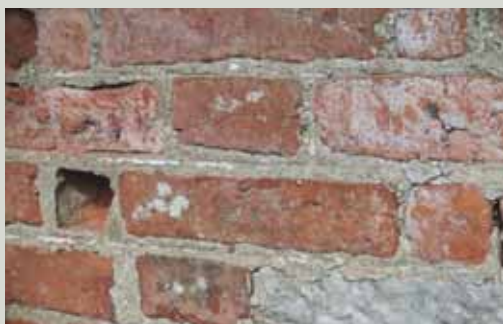
Colour washed bricks with traces of pencilling to the joints at the Hell Fire Club, Desmond's Castle, Askeaton, Co. Limerick

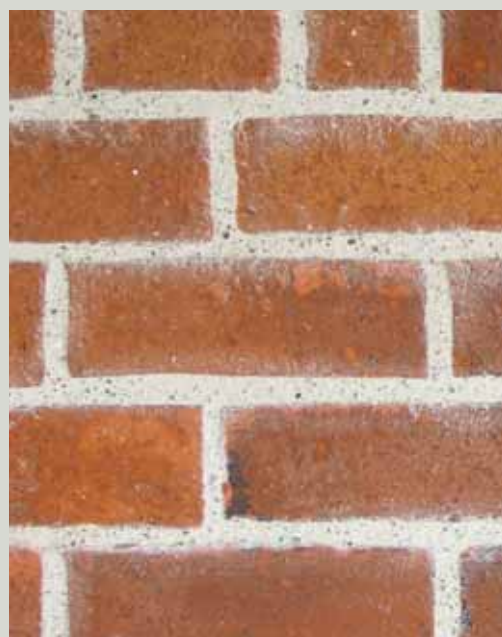
Recent repointing of a brick wall with a lime-based mortar

In most historic thick-walled masonry construction the pointing and bedding mortars were lime-based. These mortars complemented the original stones or bricks and did not restrict moisture and thermal movement. To undertake repairs, repointing, and re-construction of historic brickwork, the selection of the correct class of lime, associated materials (such as, aggregates, water, pigments and pozzolans), and their ratio to one another, are absolutely crucial.

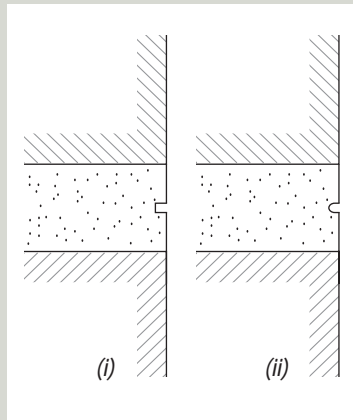
**Ruled joints**

This joint profile is found on historic buildings as a square (i) or rounded (ii) profile

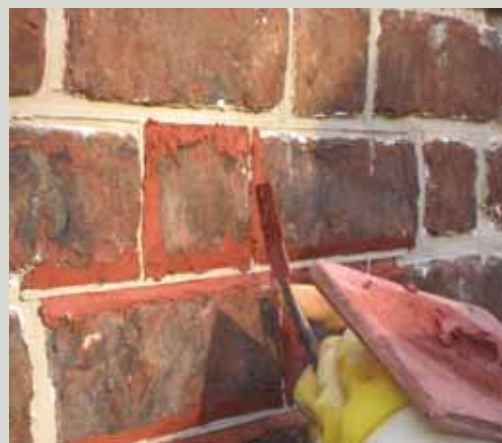
ii) *laying in the pigmented stopping mortar up to the ribbon*

The preparation of a sample of wiggging repair

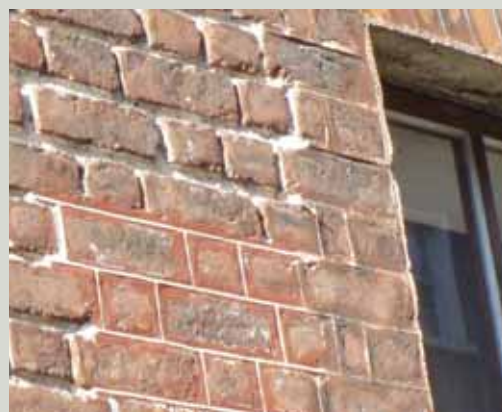
iii) *the finished wiggging sample*

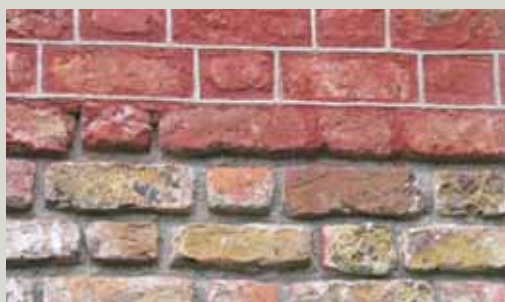
Tuck pointing in practice

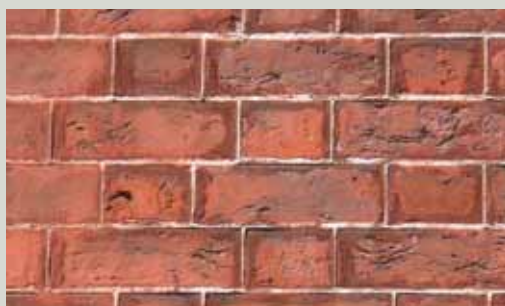
Façade with historic wiggled brickwork

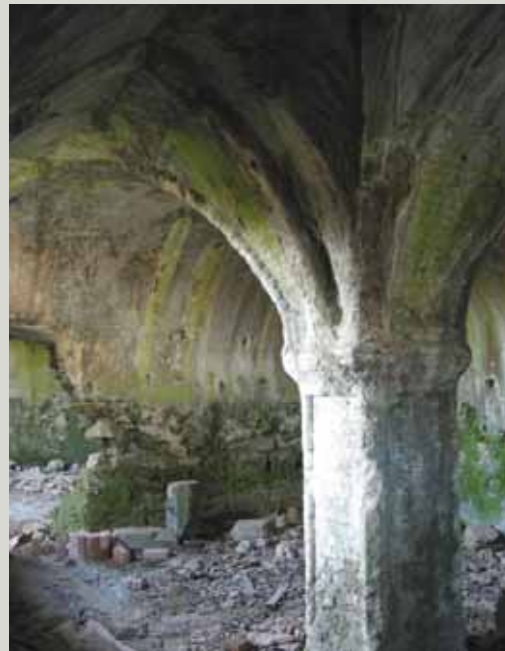
The brick-vaulted undercroft of Jigginstown House, Co. Kildare

Skilfully built (or 'turned') over a carefully positioned temporary timber framework (or 'centre') of suitable size, one of the earliest examples of ribbed vaulting, or cross vaulting in brick, is found in the undercroft of Jigginstown House. This general method of construction became more widely adopted during the eighteenth century; when most buildings with

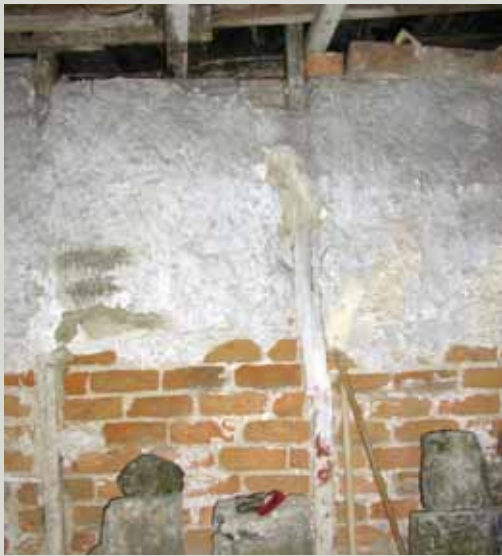
Handmade brick used in a brick nogged internal partition, now exposed where the original plaster coating has fallen away

Internal walls of brick, timber-framed walls infilled with brick (known as nogging), and brick wall linings are frequently seen in Irish buildings of the eighteenth and nineteenth centuries. In nearly all cases, this brickwork was plastered over and never intended to be seen. The stripping of plasterwork to expose internal brickwork is generally unsatisfactory because of the inferior quality of the brick selected for that specific purpose, the condition and appearance of the mortar joints and a frequently lower standard of overall workmanship. Sometimes however, brick vaults in basements and internal brickwork in garden buildings, stables, and out buildings were intended to be seen and were not rendered but simply lime-washed. This is an attractive finish that is practical and easy to maintain. Wherever possible, limewash finishes should be maintained or renewed.

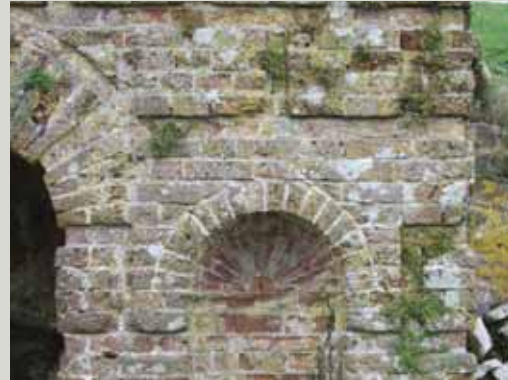
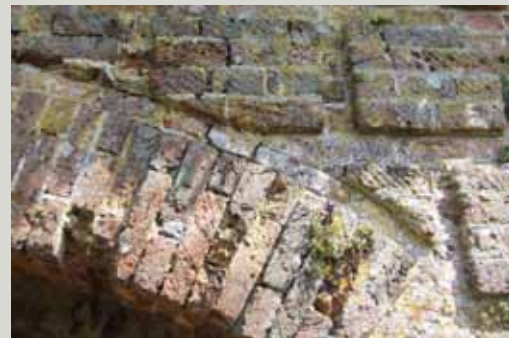
Rusticated brickwork at Ballyannan, Co. Cork. The detailed view shows beautiful axed work

contrast to the general red brick creating polychromatic brickwork. There is one surviving example of an unusual deep undulating cut-and-rubbed window arch of red and buff coloured bricks. The delightful brick-built pavilion in the grounds of Ballyannan Castle (c.1660), near Middleton, County Cork, has cut and rubbed projecting rustication and two niches set either side of the arched main entrance. The bricks were deliberately finished with strokes of a brick axe.

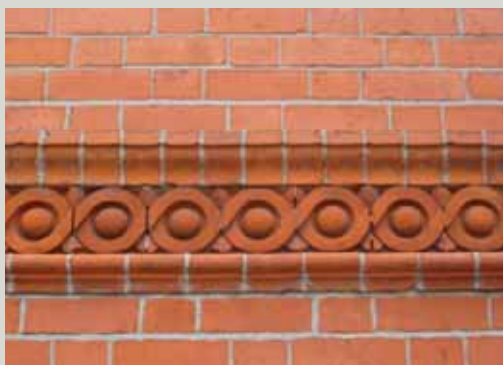
A example of the decorative use of moulded brickwork and terracotta in a stringcourse

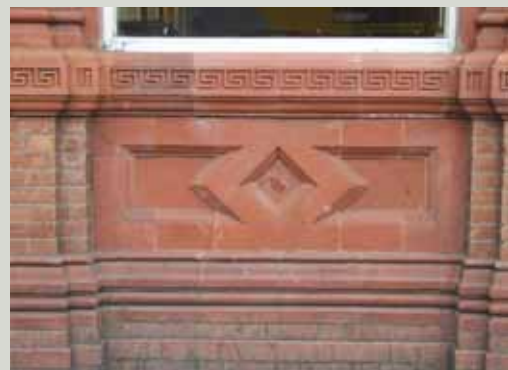
This terracotta panel has been carefully repaired following the removal of an automatic teller machine which had been inserted beneath the window

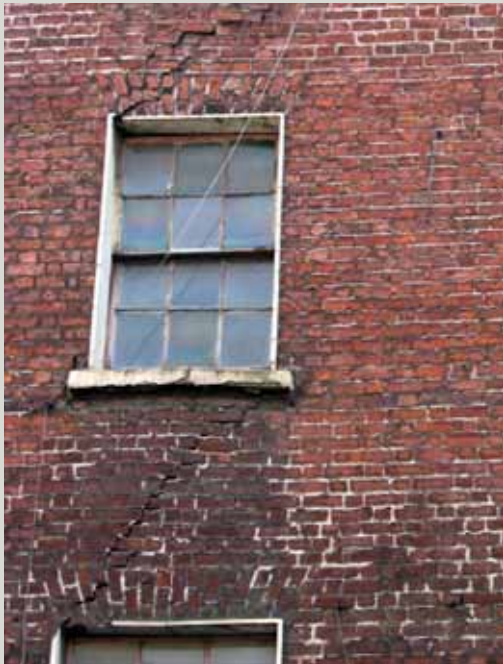
Façade brickwork showing evidence of structural movement in the cracks stretching between the windows

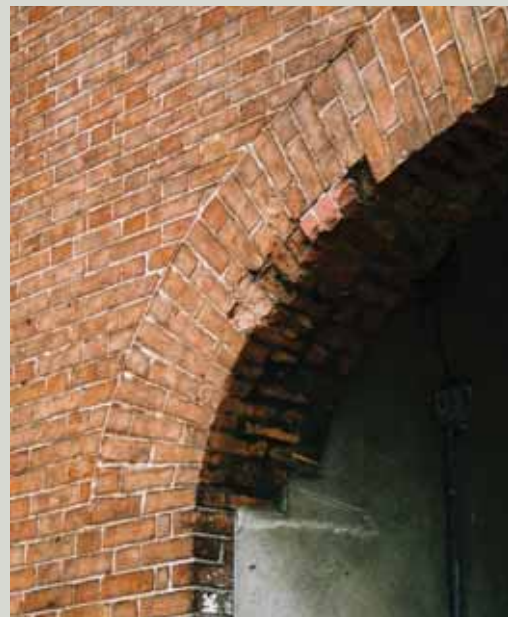
Bricks can be damaged by impact, in this case from a vehicle striking a brick archway

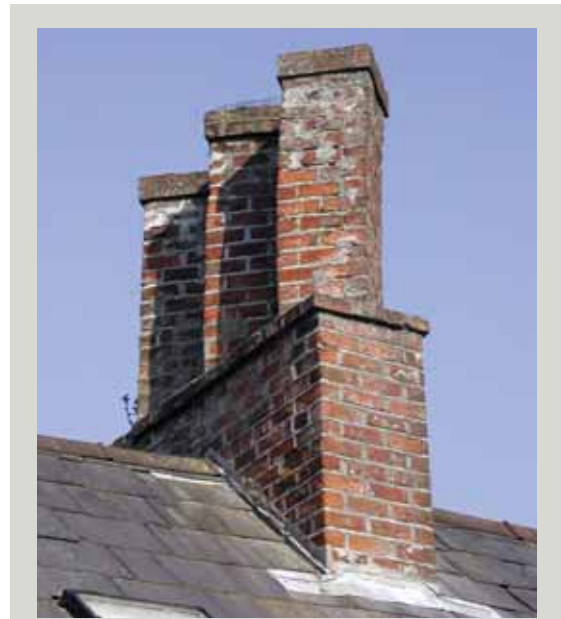
Because of their high exposure, chimneystacks are vulnerable to decay and defects in stacks may be difficult to spot because of their relative inaccessibility. However, their condition should be carefully monitored to avoid any public safety issues arising

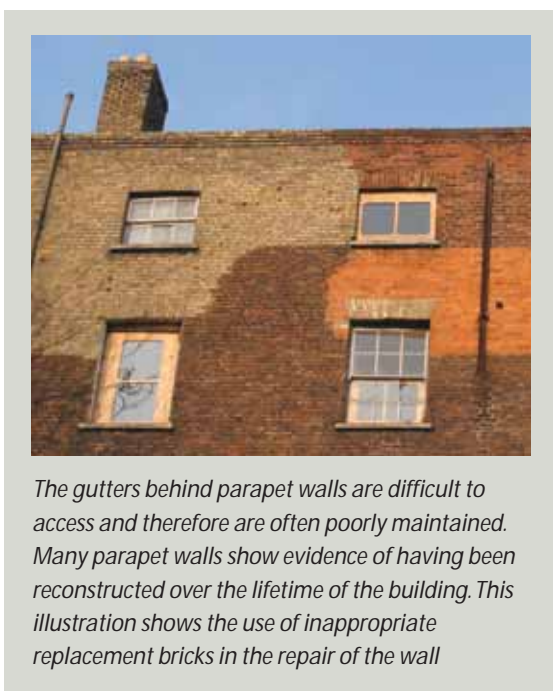
The gutters behind parapet walls are difficult to access and therefore are often poorly maintained. Many parapet walls show evidence of having been reconstructed over the lifetime of the building. This illustration shows the use of inappropriate replacement bricks in the repair of the wall

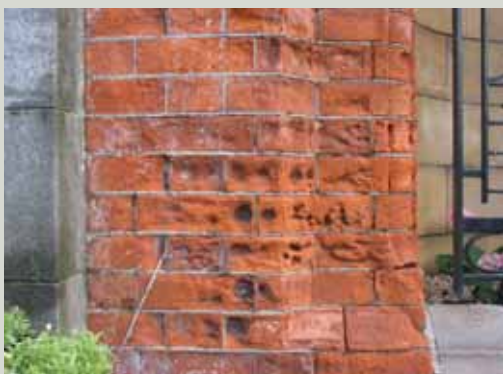
Weathering of brickwork can in some cases be severe. In this case, the decay may have been exacerbated by the mortar being too strong

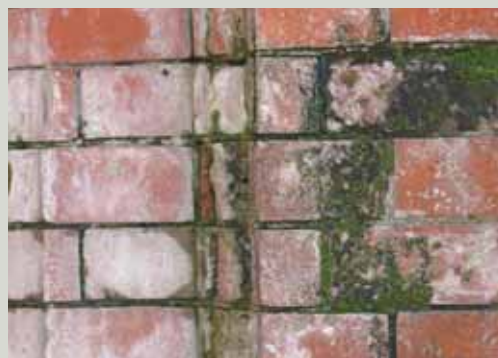
Soluble salts visible on the surface of this brickwork have been caused by rising damp in the wall. The moss growth present is another symptom of the excessive dampness of the bricks the cause of which needs to be diagnosed and treated

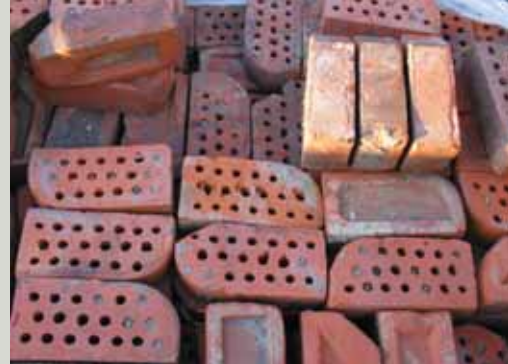
Bricks that were originally set in a lime-based mortar can be readily cleaned off and reused in repairs but it is important to establish the provenance of any reclaimed bricks to ensure that they have not been taken from another historic building that should not have been demolished in the first place

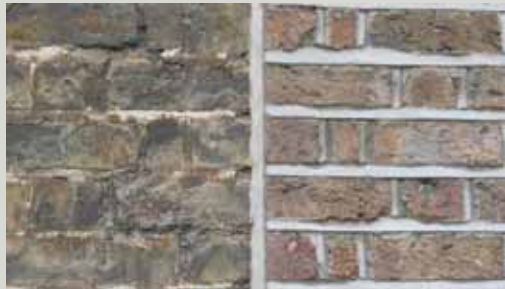
Ill-advised repointing using cementitious mortar is seen on the brickwork to the right. It is not only visually unacceptable (using inappropriate heavy-handed weather struck and cut profile which is incorrect for the period of construction of the building) but will cause serious problems to the building in the long-term and will be impossible to remove without damage to the bricks

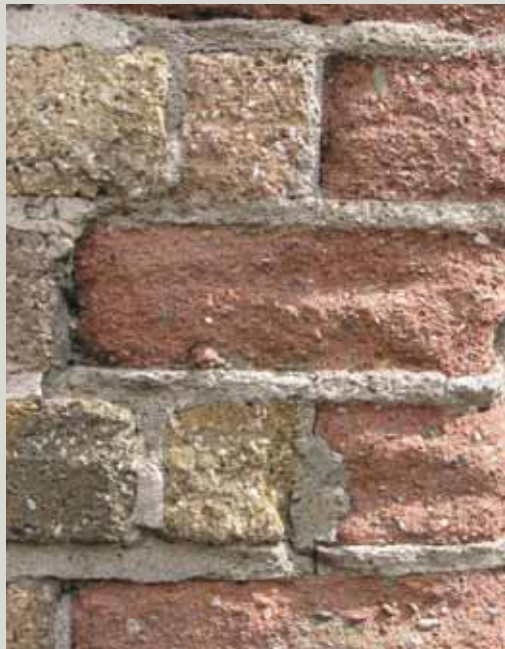
Soft, handmade bricks, such as these with a granulated structure, are particularly vulnerable to damage and decay as a result of poor-quality re-pointing

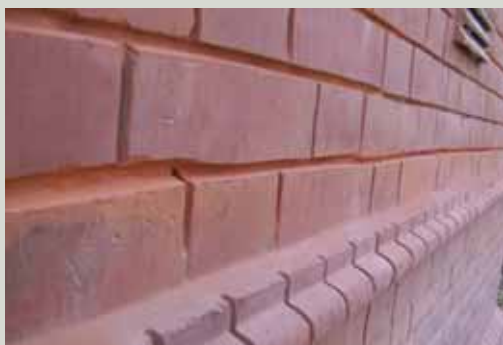
Existing mortar joints should not be cut out using mechanical cutters such as angle grinders as this will inevitably lead to damage of the edges, or arrises, of the bricks. The use of mechanical tools to remove cement repointing should generally never be used on historic brickwork unless specifically manufactured for use in historic brick repair and used only by experienced specialist conservators

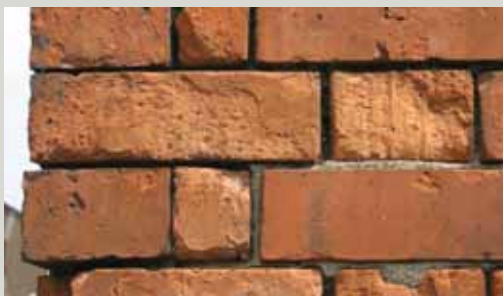
The mortar has weathered back or been washed out of this brickwork to a severe extent and it is now in urgent need of repair and repointing

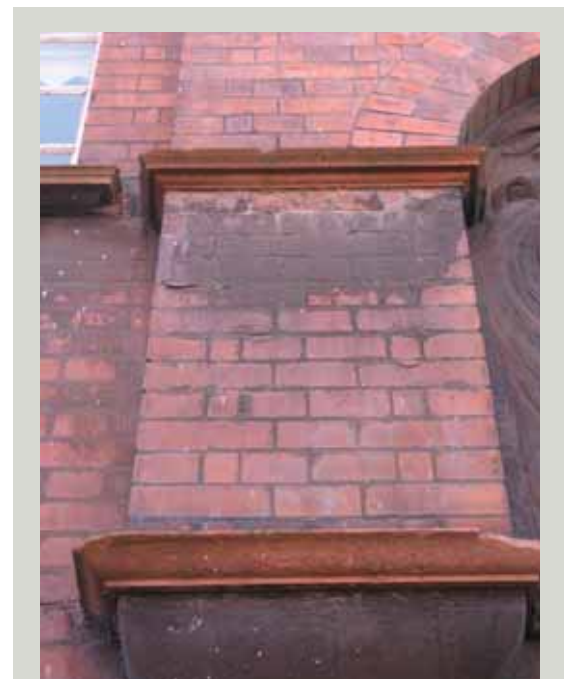
Brickwork stained with heavy sulphur dioxide deposits

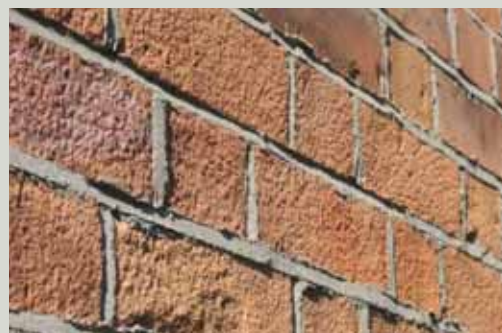
This brickwork shows evidence of damage by over-heavy abrasive cleaning which has removed the fireskin from the bricks making them vulnerable to accelerated decay exacerbated by the cementitious pointing
