6 PRESERVATION BRIEFS

Dangers of Abrasive Cleaning to Historic Buildings

U.S. Department of the Interior National Park Service Cultural Resources

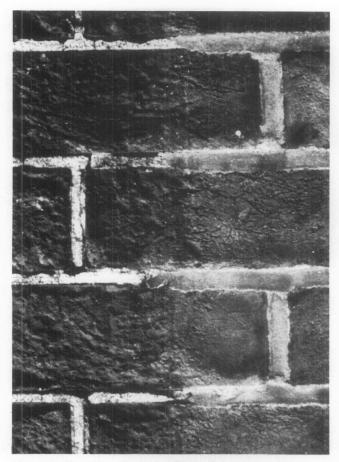
Abrasively Cleaned vs. Untouched Brick. Two brick rowhouses with a common façade provide an excellent point of comparison when only one of the houses has been sandblasted. It is clear that abrasive blasting, by removing the outer surface, has left the brickwork on the left rough and pitted, while that on the right still exhibits an undamaged and relatively smooth surface. Note that the abrasive cleaning has also removed a considerable portion of the mortar from the joints of the brick on the left side, which will require repointing.

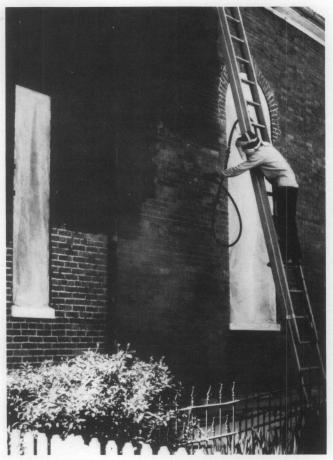
"Line Drop." Even though the operator of the sandblasting equipment is standing on a ladder to reach the higher sections of the wall, it is still almost impossible to have total control over the pressure. The pressure of the sand hitting the lower portion of the wall will still be greater than that above, because of the "line drop" in the distance from the pressure source to the nozzle. (Hugh Miller)

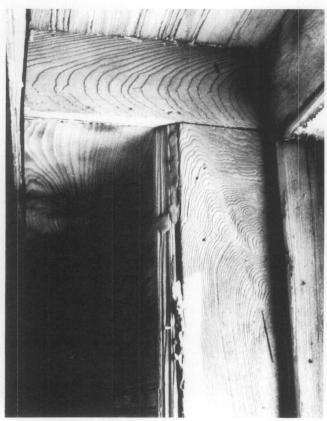
Abrasive Cleaning of Wood. This wooden windowsill, molding and paneling have been sandblasted to remove layers of paint in the rehabilitation of this commercial building. Not only is some paint still embedded in cracks and crevices of the woodwork, but more importantly, grit blasting has actually eroded the summer wood, in effect raising the grain, and resulting in a rough surface.

Wood: Most types of wood used for buildings are soft, fibrous and porous, and are particularly susceptible to damage by abrasive cleaning. Because the summer wood between the lines of the grain is softer than the grain itself, it will be worn away by abrasive blasting or power tools, leaving an uneven surface with the grain raised and often frayed or "fuzzy." Once this has occurred, it is almost impossible to achieve a smooth surface again except by extensive hand sanding, which is expensive and will quickly negate any costs saved earlier by sandblasting. Such harsh cleaning treatment also obliterates historic tool marks, fine carving and detailing, which precludes its use on any interior or exterior woodwork which has been hand planed, milled or carved.

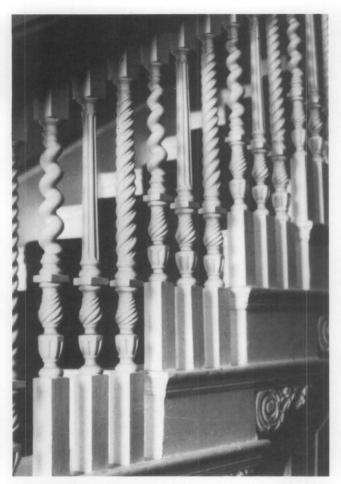
Do not Abrasively Clean these Interiors. Most historic residential and some commercial interior spaces contain finished plaster and wooden elements such as this stair balustrade and paneling which contribute to the historic and architectural character of the structure. Such interiors should not be subjected to abrasive techniques for the purpose of removing paint, dirt, discoloration or plaster.

Thus, it is not acceptable to clean abrasively interiors of historic residential and commercial properties which have *finished* interior spaces featuring milled woodwork such as doors, window and door moldings, wainscoting, stair balustrades and mantelpieces. Even the most modest historic *house* interior, although it may not feature elaborate detailing, contains plaster and woodwork that is architecturally significant to the original design and function of the house. Abrasive cleaning of such an interior would be destructive to the historic integrity of the building.
