One Canal Apartments Boston, Massachusetts

- TYPE
Commercial
- SIZE
4,000 sq. ft.
- COMPLETION
July 2019

Type
Remediation

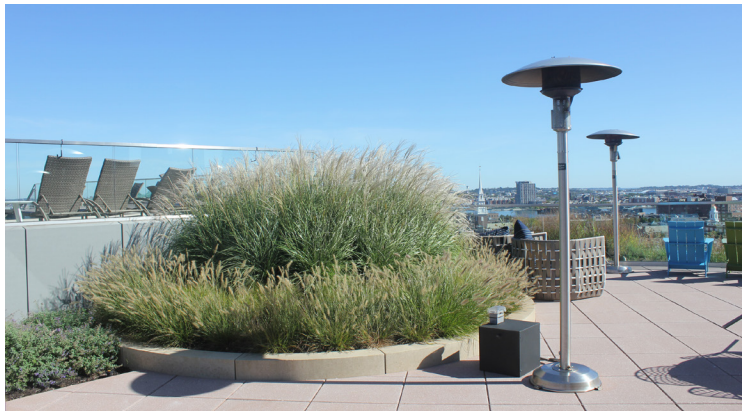
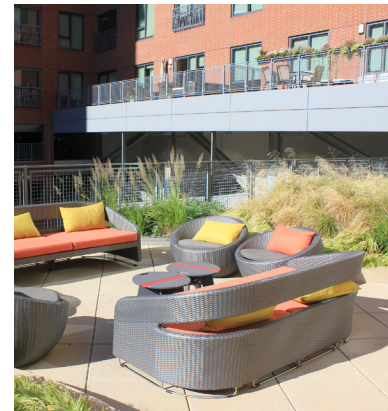
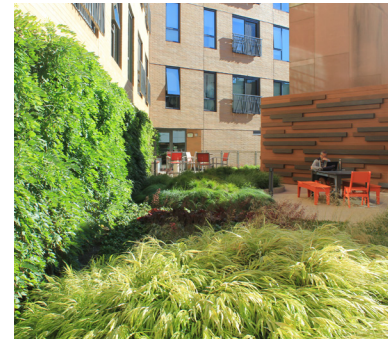
Top left to bottom right: Mounded beds support grasses that flow in the wind / Third floor seating areas are surrounded by mounded planting areas for added privacy / A wall of trumpet vines hides the parking garage from seating areas on the third floor green roof

Recover worked with One Canal Apartment Group and Copley Wolff Design Group to remediate two green roofs on a multi-use building located at Boston's Rose Kennedy Greenway. The existing third-floor terrace and 13th-floor pool deck had seen massive plant die-offs due to an irrigation failure that left plants without watering for an extended period. The plantings on the pool deck had also seen extensive damaged from high winds that resulted in wind scour and soil erosion.

As part of the remediation, Recover's field crew installed a new irrigation system in mounded beds and replaced multiple sections of irrigation across the two roofs. After initial updates, Recover replanted about 95% of the roofs. The green roofs have now been restored to their original intention, providing habitat for birds, stormwater retention, and aesthetic appeal for building residents.
